LONG-TERM MONITORING OF MECHANICAL PROPERTIES OF FRP REPAIR MATERIALS

July 2013

COLORADO DEPARTMENT OF TRANSPORTATION
DTD APPLIED RESEARCH AND INNOVATION BRANCH

Report No. CDOT 2013-13

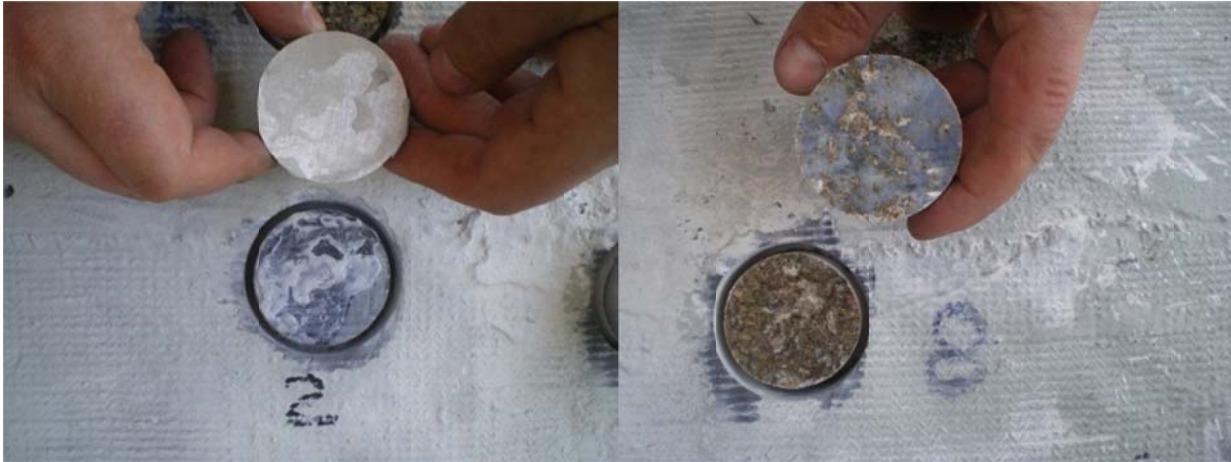
The maximum stress applied and failure modes of the tests were recorded in accordance with ASTM D7522. The results of the pull-off tests can be found with the results from CTC-Geotek tests in tables in Appendix B. Failure modes A, B, E, F, and G as defined above in Table 2.1 occurred during the testing. Representative photographs of these different failure modes are shown below.

Figure 3.14. Failure Mode A: bonding adhesive failure at loading fixture (on left), failure Mode E: adhesive failure at CFRP/substrate adhesive interface (on right)

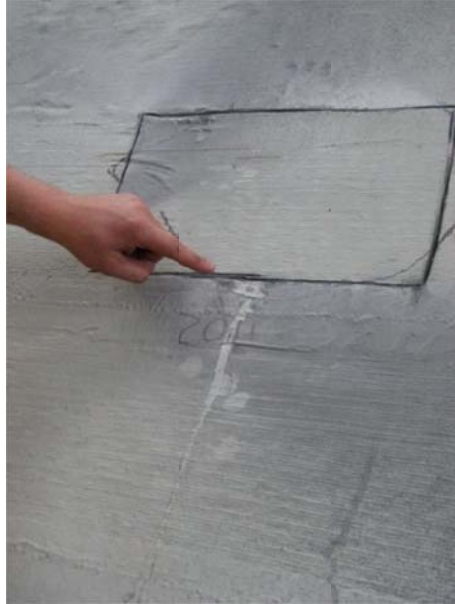
Upon cutting the lower edge of the CFRP rectangle, water exited the cut at the bottom of the void revealing standing water at the interface between the CFRP and substrate. Photographs of the void and the removal of the CFRP layer are shown in Figures 3.20, 3.21 and 3.22 below.

Figure 3.21. Water exiting the void area directly after the lower cut through the CFRP was completed

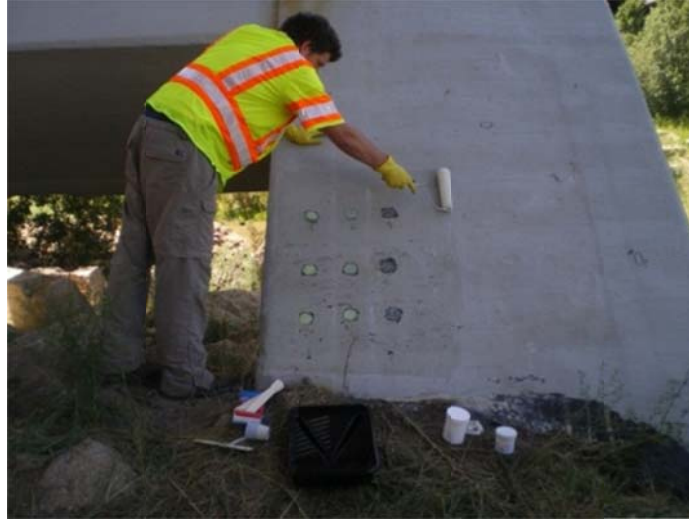
Figure 3.25. Applying a primer coat to the areas for repair

Once the holes were filled with epoxy, the 3 areas of pull-off tests and the 2 areas of removed CFRP (debonded regions) were prepared for a repair process. First these areas were washed using a non-toxic, biodegradable, soap and water, then they were cleaned with 70% Isopropyl alcohol to remove any remaining soap film. CFRP patches must overlap a minimum of 6"; therefore primer was applied to the affected areas of the arches plus a minimum of 6" in each direction. The primer used for the repair was a two part epoxy made by HJ3, STRONGHOLD Primer Epoxy (STR-BW-200A). The mix ratio was 2 parts of the PC-200 Primer Resin, Part "A", to 1 part of the PC-200 Primer Hardener, Part "B". Once the two-part epoxy was well mixed, the primer was distributed to the repair areas using 9" rollers as seen in the photograph below.

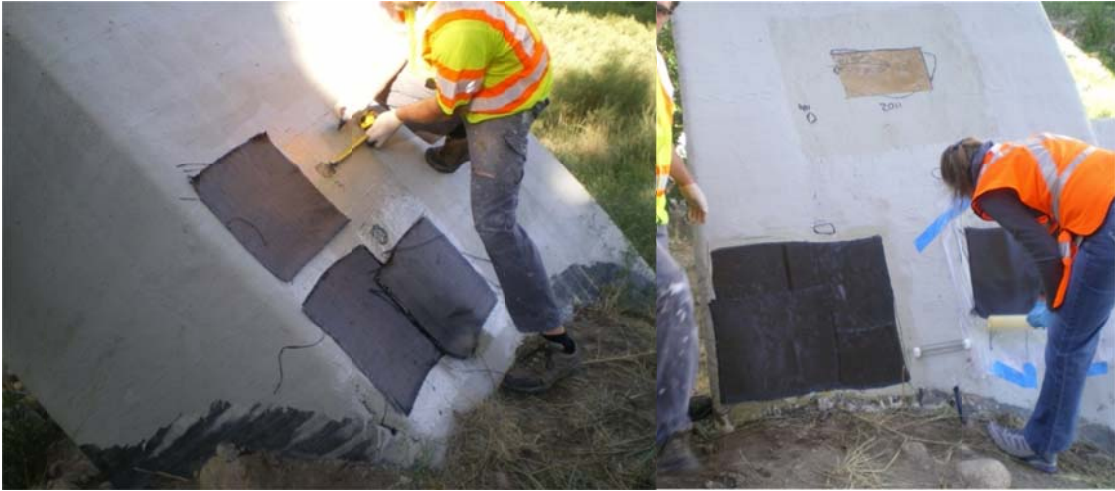
Figure 3.26. Allocating fabric for repair and applying the second layer of CFRP to the area of pull-off tests on the east arch

The CFRP fabric was saturated by applying a well-mixed two part epoxy, two parts of HJ3 SRS-400-A Resin and one part HJ3 SRS-400-B Hardener, to both sides of the fabric. The two part epoxy was also applied to the repair areas identical to that of the primer. The saturated fabric was then placed on the arch and the use of hand pressure and rollers eliminated air bubbles and pockets between the fabric and

the substrate. Unidirectional CFRP fabric was used to repair the area where the patches were removed. Proper alignment of the fiber direction in the transverse direction was necessary to repair the transverse wraps. The pull-off tests were conducted closer to the edge of the arches damaging both transverse and longitudinal sections. Therefore, biaxial patches were used to repair these areas. This process is represented in the photographs below. Following the CFRP repair, 24 hours was allowed for curing before the areas were painted

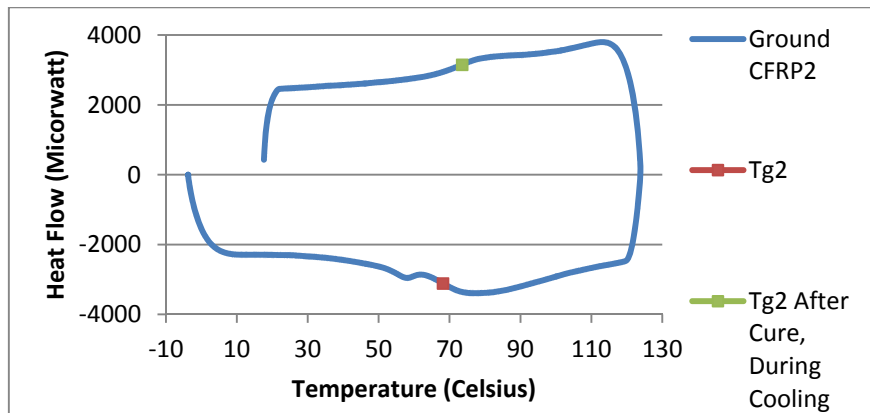
Figure 4.17. Ground CFRP2

The T_{gs} were very close to that of Ground CFRP1, 68.13°C and 73.56°C respectively, as was the general response and presence of the irreversible behavior. Diced CFRP was also analyzed as opposed to the ground CFRP. The diced CFRP had slightly lower values of T_g , possibly due to the heat added to the ground specimens but the difference was fairly marginal. All three plots are combined in the figure below.

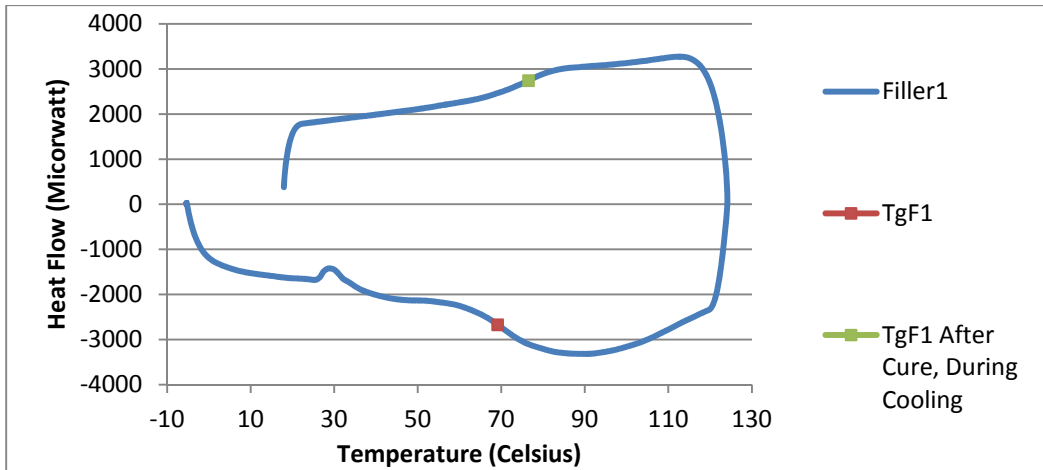
Figure 4.19. Filler resin1 DSC curve

The first filler resin tested was Filler Resin1, which resulted in a DSC curve that had erratic behavior early in the test that was presumed to be irreversible behavior. The plot of this curve is in the figure below.

Due to the erratic behavior near 30°C during heating, it was decided to re-run this analysis with a new specimen, but to heat the specimen up to 40°C then return the specimen to -10°C and restart the DSC test. This would hopefully remove any irreversible behaviors without post-curing the specimen and consequently increasing the Tg. The erratic behavior was not however present in the second sample labeled Filler Resin2. The start temperature was moved back to -30°C for the analysis of Filler Resin2 and Bonded Filler Resin. The plot is below.

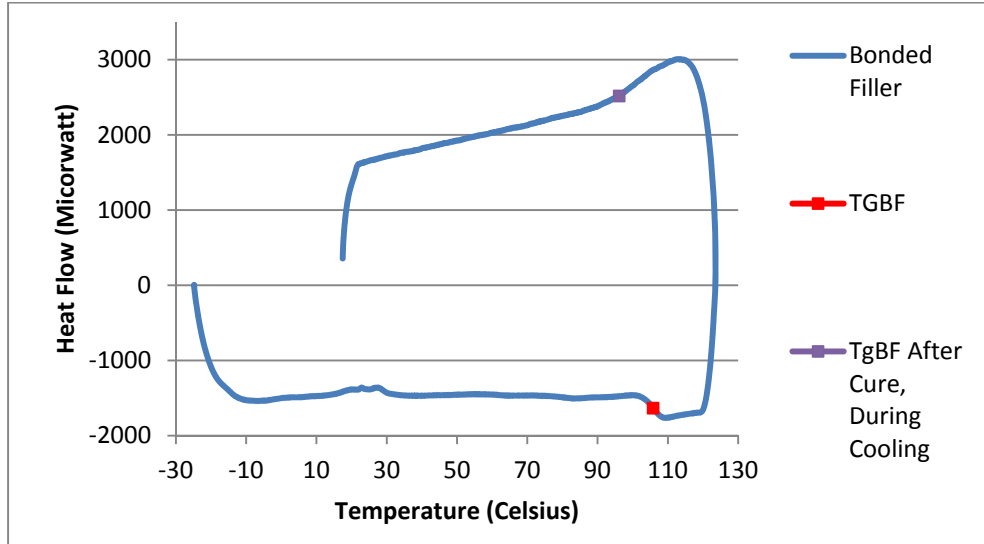
Figure 4.21. Bonded filler resin DSC curve

The Bonded Filler Resin specimen was prepared similar to the other Filler Resin Specimens, but resulted in significantly different behavior and a higher T_g value. The T_g values are tabulated below the plots of the Bonded Filler Resin and the plot of all three Filler Resins.

The response of the Bonded Filler Resin is somewhat peculiar. It is possible that the milky white filler resin had higher water content, acting as a plasticizer reducing the T_g of the Filler Resin1 and Filler Resin2 specimens. As previously mentioned, even though there was water in direct contact to the CFRP patch of Filler Resin1 and Filler Resin2, by the time the material was tested, the moisture content was likely the same for all the specimens and very similar to that of the environment. All filler resins likely had similar if not the same curing conditions also making the higher T_g of the Bonded Filler Resin somewhat surprising.

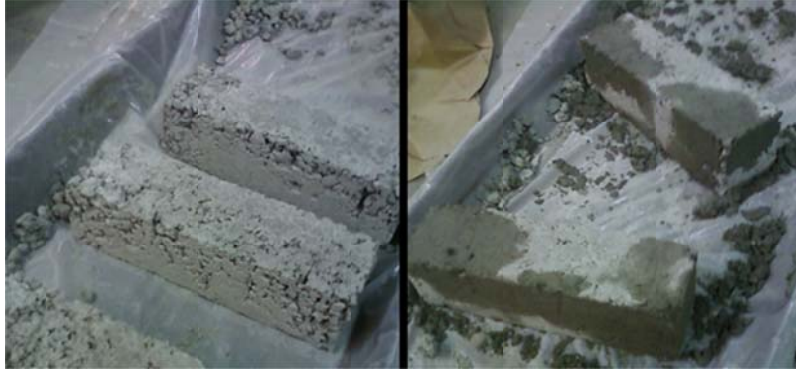
Following the removal of the blocks and beams from the forms, it was observed that some of the small beams showed a considerable amount of voids/ air pockets on the sides. Since Class D concrete has a significant amount of large aggregate, the workability of the mix was low which made it difficult to achieve proper compaction in small molds. Such behavior was not anticipated as previous related studies did not specify the maximum aggregate size used in their concrete samples. As a result, a total of 9 beams were repaired and patched using Class S mortar mix, and allowed to harden for 30 minutes before they were placed in water containers with the other specimens for curing. Figure 6.9 shows the characteristics of the specimens before and after mortar patching. All specimens were fully submerged in water for the remaining 23 days of the curing stage to provide them with as much moisture as possible and prevent cracking during this period.

Figure 6.9. Concrete beams before (left) and shortly after (right) patching

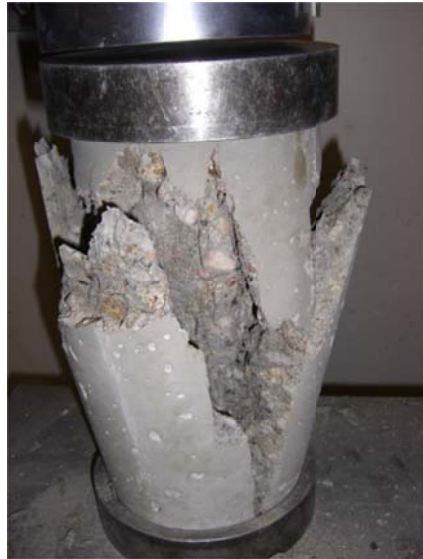
Figure 6.17. Characteristic failure for compression tests

A total of four cylinders were tested in compression during Stage 0. Cylinders were of the standard size of 6 in x 12 in (15.2 cm x 30.4 cm). A high average strength of 6.26 ksi (43.16 MPa) was seen in this group. Table 6.5 shows the individual and average values for compressive load and compressive strength. Figure 6.17 shows the characteristic failure corresponding to the four specimens.

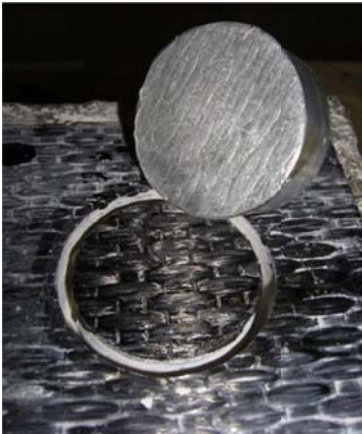
Figure 6.18. Pull-off Mode A failure

A total of six pull-off tests were conducted for stage zero. Block #1, equivalent to test labels 1, 2, and 3 showed results of 374 psi (2.58 MPa), 442 psi (3.05 MPa), and 391 psi (2.70 MPa), respectively. Out of the three pull-off tests planned on Block #1, test 1 showed an adhesive failure between the dolly

and the CFRP, labeled as failure Mode A by ASTM D7522/D7522M (2009), not an acceptable failure for statistical validation. Figure 6.18 below illustrates the adhesive failure mode from test 1.

The persistence of the adhesive failure modes was attributed to two main reasons. Twisting of the dolly during adhesion could have caused minor air voids in the dolly-CFRP interface which decreased the suitability of the bond. The second possibility for adhesive failure could be the curing time of the Devcon epoxy. For all previous tests the epoxy was allowed to cure for 24 hours, and failure Mode A was still showing. Therefore, tests 9 and 10 on block #2 were allowed to cure for 5 days to ensure that the epoxy was fully cured. For these last two tests the dollies were not twisted, they were slowly placed on the surface uniform pressure was applied for 30-90 seconds to avoid slippage. As a result, tests 9 and 10 showed strengths of 433 psi (2.98 MPa) and 439 psi (3.03 MPa), respectively, with acceptable Mode F failures. Figures 6.20 and 6.21 illustrate the strengths and failure modes of all the pull-off tests performed during Stage 0. The notations on Figures 6.20 and 6.21 represent the test number, the ASTM D7522/D7522M failure mode letter, and the strength in psi. These results are also summarized in Table 6.6.

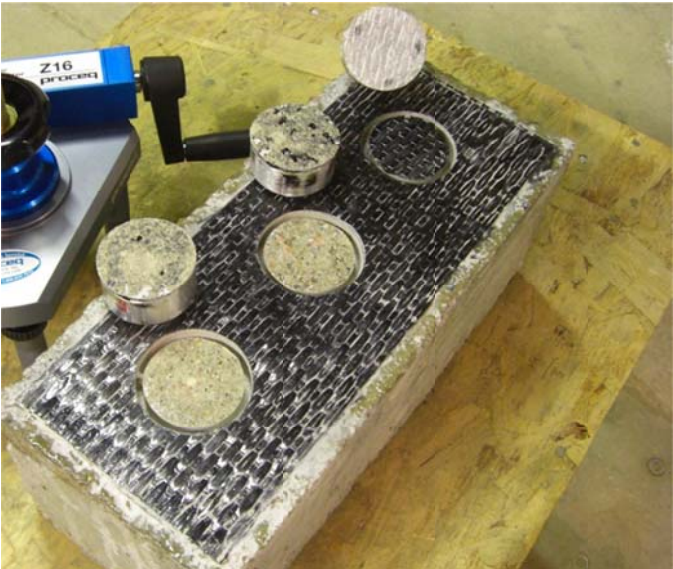
Figure 6.19. Pull-off tests 1, 2, and 3 failure modes

As illustrated in Figure 6.19, the dollies from tests #2 and #3 show mostly concrete failure but with some black spots in which the CFRP did not adhere to the concrete during the reinforcement process. In the case of block #2, equivalent to tests 4, 5, and 6, all three showed a Mode A failure, with strengths of 444 psi (3.06 MPa), 270 psi (1.86 MPa), and 266 psi (1.83 MPa).

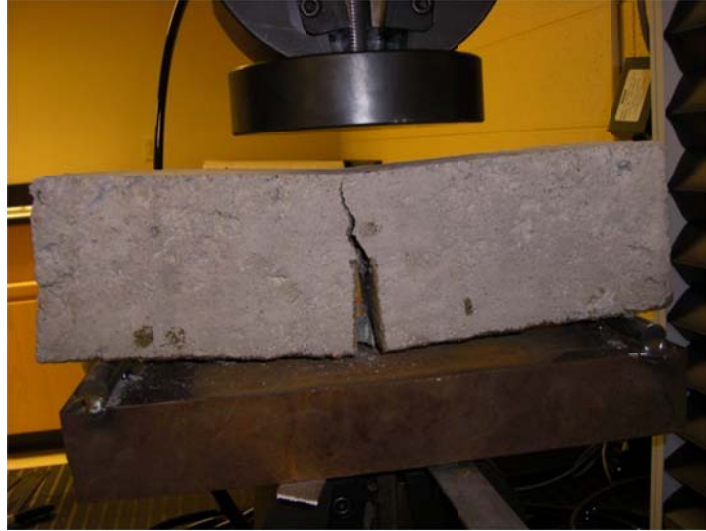
Figure 6.22. Beam following crack failure

Stage 0 contained three small beams to be tested under three-point flexure. Due to an error with the testing machine, one specimen was prematurely damaged so the remaining two were used as the control specimens. As previously mentioned, a United Testing Machine Model SFM- 300 kN was used and the parameters recorded were time, force, and deflection as measured by the crosshead position. Figure 6.22 shows failure of one of the beams and how a single flexural crack was developed at the top of the saw cut, as desired.

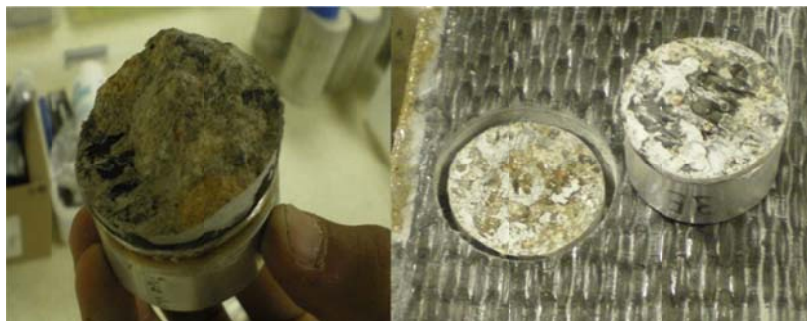
Figure 6.26. Test #35 (left) vs. test #38 (right)

Finally, throughout testing the forty five pull-offs, three special cases were encountered. A special note worth discussing in the chloride based deicer group with triple layer reinforcement is the large discrepancy encountered within the six pull-offs. Test #38 resulted in the absolute lowest value for the entire stage, with a strength of 80 psi (0.55 MPa). On the other hand, Test #35 resulted in the absolute highest value among the 45 pull-off tests performed in this stage, with a strength of 627 psi (4.32 MPa). This particular pull-off was characterized as an ideal concrete failure, Mode G in ASTM D7522. It is believed that the reasons for the extremely large discrepancies among the specimens that underwent the exact same conditioning is due to the large aggregate present on test #35, as well as the presence of moisture within the concrete-FRP interface on test #38. This moisture was noticed because of the lighter color of the concrete, as well as a softer and more clayey feel to the touch. Notice in Figure 6.26 the large aggregate on test #35, as well as the lighter color and thinner layer of concrete on test #38.

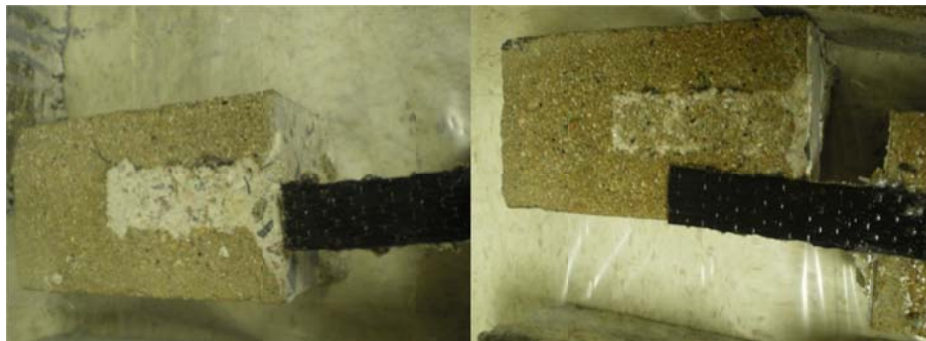
Figure 6.29. Beam #1 (left) vs. beam #8 (right) failure

Two control specimens were kept at dry conditions and room temperature. From the thirteen beams tested, these two possessed the highest peak load values at 4.242 kip (18.87 kN) and 3.843 kips (17.09 kN). The absolute lowest load experienced on the beams was identified on beam #8, corresponding to immersion in non-chloride based deicer. Figure 6.29 below clearly demonstrates the major differences in the bond between one of the control specimens (beam #1) and beam #8. The larger area of darker spots in the bond between one of the control specimens (beam #1) and beam #8. The larger area of darker spots on the concrete surface where the CFRP failed was found noticeable. The dark spots correspond to the cured epoxy adhesive that did not fully bond with the CFRP strip. Although it is possible that the non-chloride deicer may have contributed to degradation of the bond, the other potential cause for this behavior is improper adhesion of the CFRP onto the concrete during preparation.

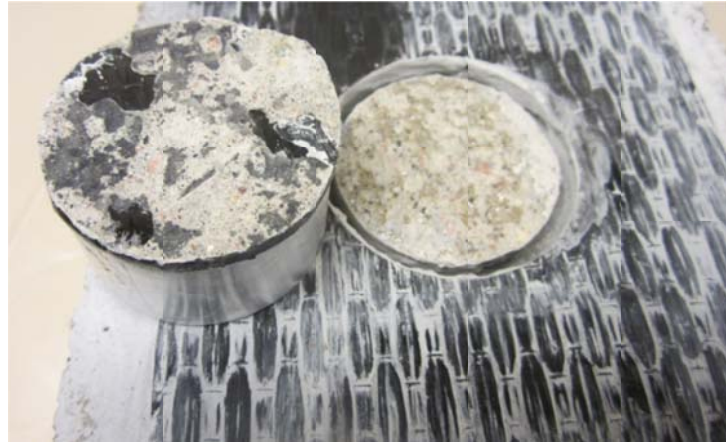
Figure 6.30. Representative Mode F failure for Stage 2

Once again, the most common failure type corresponds to Mode F. Thirty two of the forty five pull-off tests resulted in this failure mode, equivalent to 71% of the total. Figure 6.30 below shows a representative failure for these thirty two dollies. The black spots on the dolly correspond to sections where the CFRP did not fully adhere to the concrete, followed by partial concrete detachment within the same dolly.

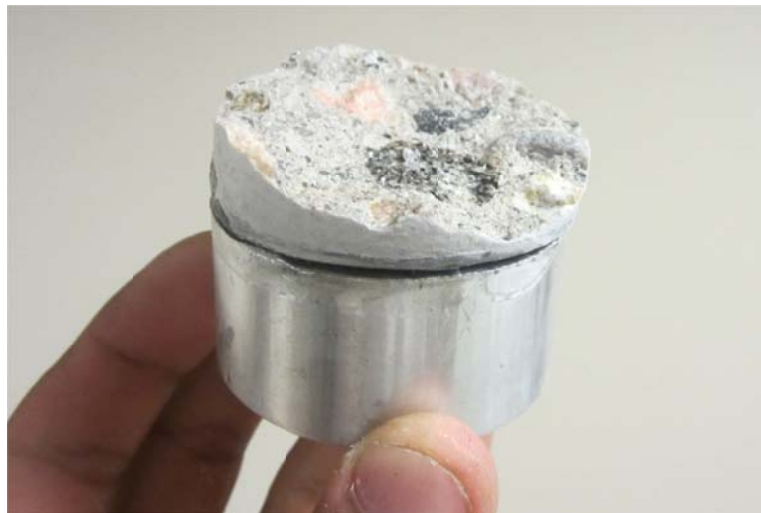
Figure 6.31. Mode G failure in dolly #20

Four blocks were exposed to a non-chloride based deicer, equivalent to a total of twelve pull-off tests. Two of these blocks were reinforced with two layers of CFRP, and the remaining two blocks with three layers of CFRP. Failure modes varied from Mode A in three pull-offs, Mode F in eight dollies, and the last one corresponded to an ideal Mode G failure. Figure 6.31 shows the Mode G failure that was witnessed on dolly #20 from this stage, corresponding to one of the blocks reinforced with two layers of CFRP.

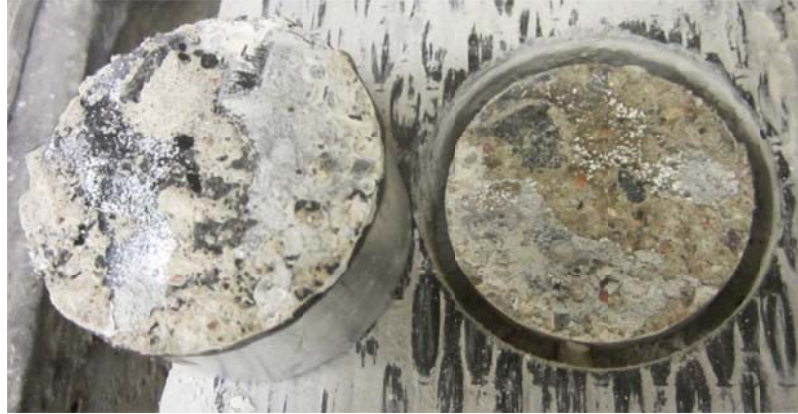
Figure 6.32. Presence of moisture on dollies

In this stage, the presence of moisture in some of the dollies was also witnessed. Two of the dollies within the water exposure group, three within the wet-dry cycle group, three within the non-chloride based deicer group, and nine within the chloride-based deicer group, were the specimens that showed moisture between the concrete and FRP. Once again, the different tonalities of gray as well as a softer more clayey feel to the touch helped identify which dollies showed levels of moisture. The amount of moisture ranged from very small spots around the edges, to larger areas within the dolly. Figure 6.32 shows a characteristic image of the presence of moisture in the specimens. As far as moisture – strength relationship in the water group, no logical pattern was found. In fact, dollies #8 and #9 resulted in the highest bond strength in the group, even though these were the ones that showed some moisture within the group. However, dollies #25, #26, and #27 did turn out to be weakest ones within the non – chloride based deicer group. For the chloride based deicer group, the moisture-strength relationship makes sense in the double-layer reinforcement ones, where dollies #28, #29, #32, and #33 showed the lowest strengths as oppose to the drier ones. These patterns, however, are difficult to interpret, as the moisture was not present within individual blocks, but rather within individual dollies.

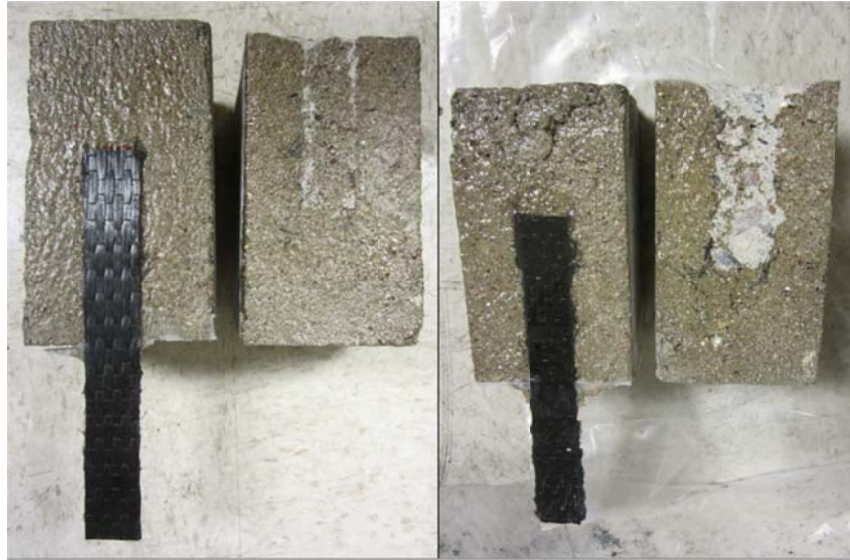
debonding on one of the FRP-concrete interfaces is witnessed. The lowest strength corresponded to beam #4, in the wet-dry group. It is unknown if that specific environmental exposure might have been the main cause of strength degradation. However, it was observed that those beams exhibiting lower strengths were the ones that showed more adhesive marks on the concrete, meaning the FRP strip did not fully adhere to the surface. Figure 6.34 illustrates the significant difference there is between a proper bond and an improper one. This clearly had an effect in strength, especially in beams #4, #5, #6, and #12. Table 6.14 shows the peak loads with respect to each environmental conditioning. Table 6.14 also shows the values for the bond shear stress.

Figure 6.34. Beam #6 (left) vs. beam #1 (right)

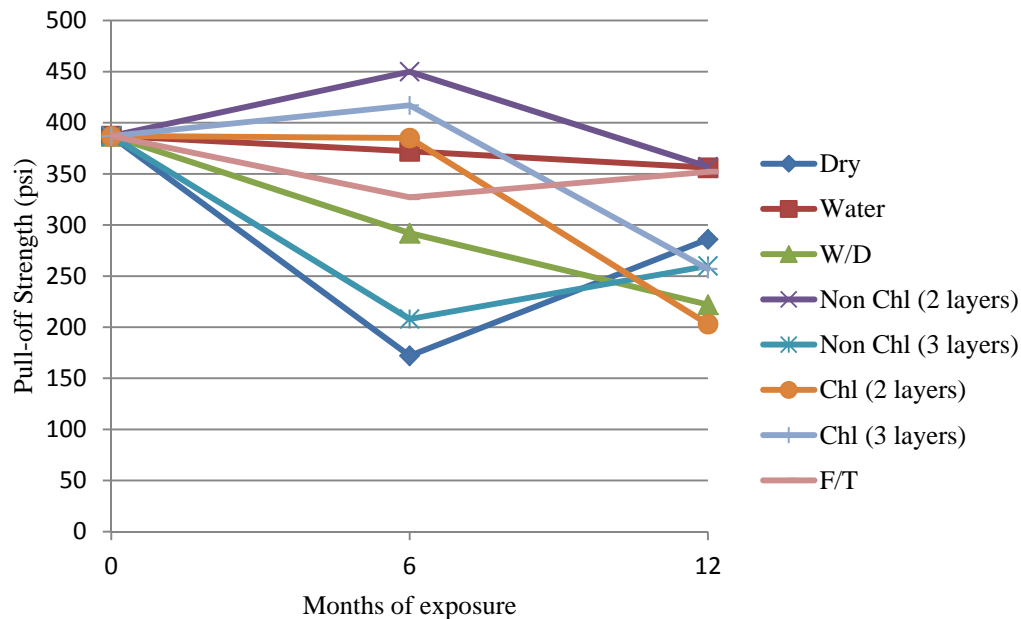
Figure 6.35 illustrates the average results from the 6-month and 12-month exposures for the pull-off tests, classified per conditioning. For the most part, there was a strength degradation observed in the specimens exposed for an additional six months. The only exceptions were in the groups of freeze-thaw, and the non-chloride specimens with three FRP layers. Also, there was a decrease in strength in the control specimens between 0 and 6 months, but it increased at the end of the twelve month period.

Figure 6.35. Average pull-off results for the 6-month and 12-month exposure

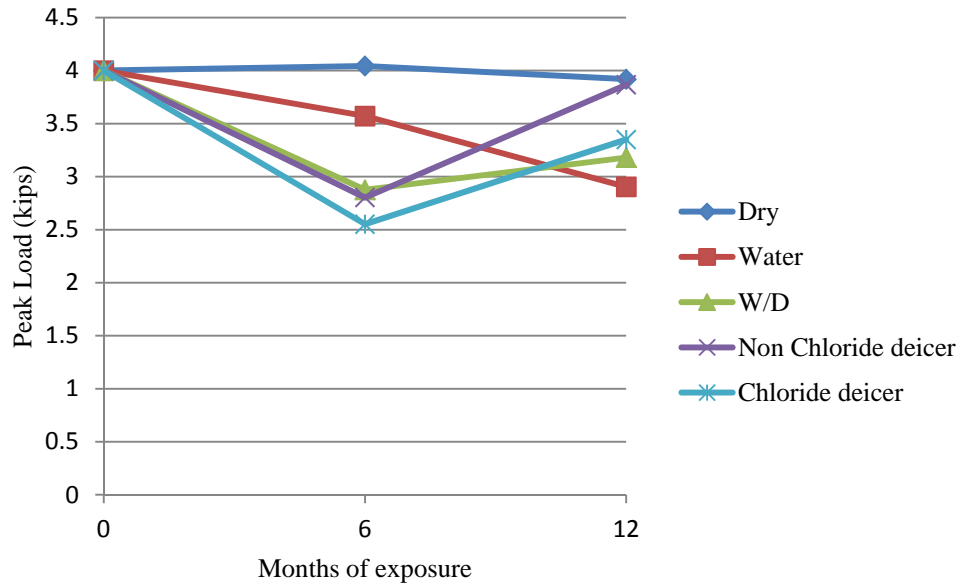
Figure 6.36 shows a comparison plot of the beams tested at all stages. As expected, the dry (control) beams were the strongest ones throughout the entire durability study. In addition, a decrease in strength was witnessed in the water group. However, for unknown reason there was an increase in strength during the last six months of exposure for the rest of the groups. This may have been due to an increase in the concrete strength during conditioning.

Figure 6.36. Average beam results for the 6-month and 12-month exposure

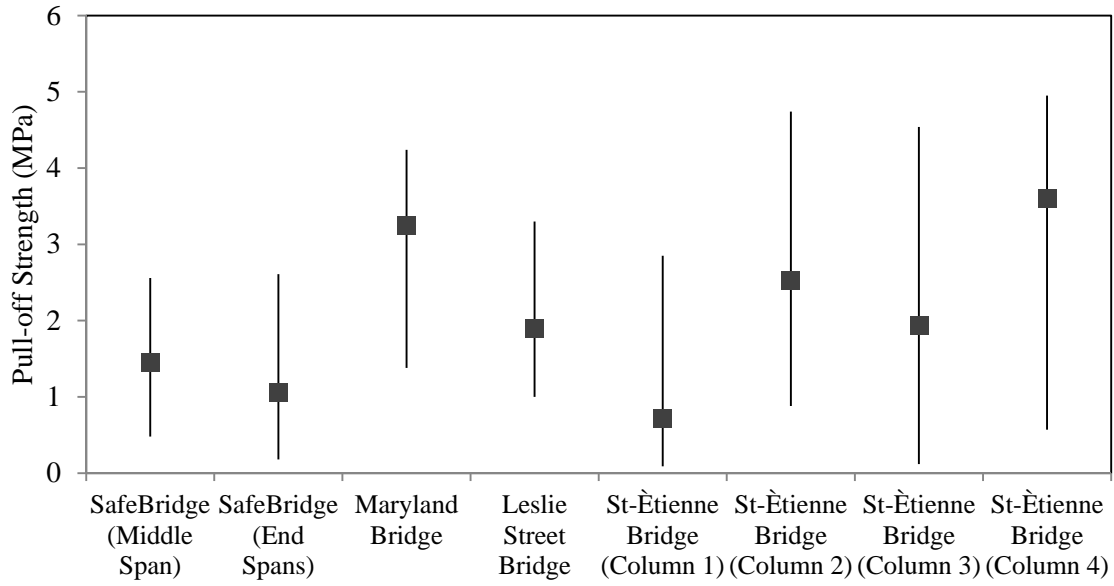
Interpretation of these results is challenging for several reasons. Failure modes were not specified in this study. Therefore, it is unknown what material controlled the bond strength; whether it was a concrete substrate failure or an FRP failure. In addition, the strength of concrete at the time of testing, which most likely varied among the different bridges, has significant influence on results and is important to interpret them. Finally, the lack of baseline or control values makes it difficult to understand whether low strengths represent poor application of the repair or degradation of bond strength over time. Figure 7.1 shows a plot of the values obtained for each structure.

Figure 7.1. Pull-off Strength Results (Banthia, Abdolrahimzadeh, and Boulfiza, 2009). The ends of the vertical lines represent the lowest and highest values, and the boxes represent the mean values.

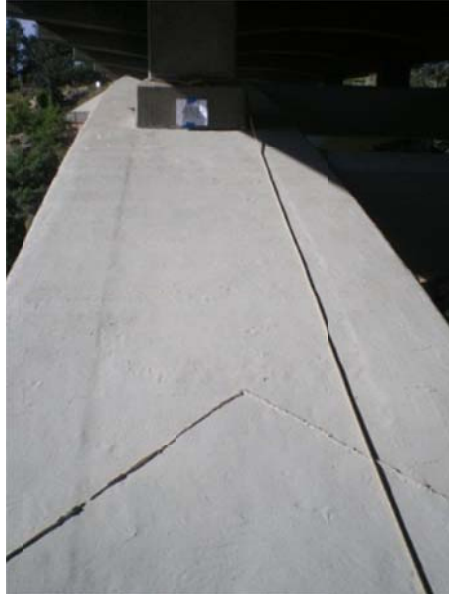
Bay 4NE: 1 Void

Figure A13. Bay 4NE, V-shaped silicone bead water diverter

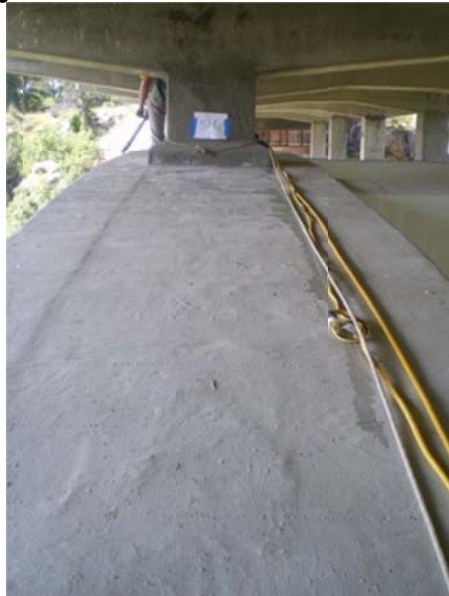
Figure A14. Bay 5NE

Bay 5NE: No Defects Found

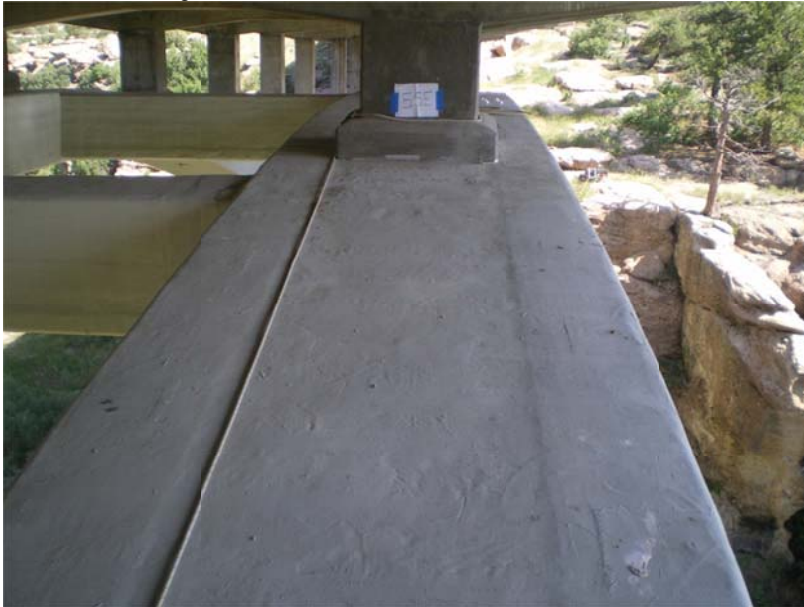
Figure A15. Bay 5SE

Bay 5SE: No Defects Found

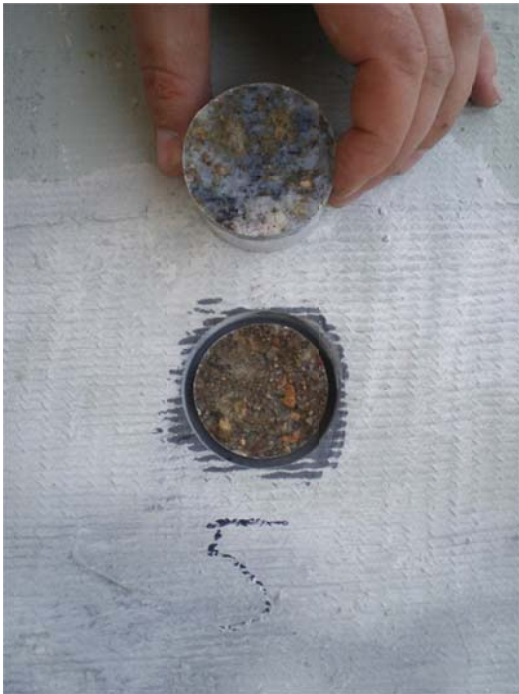
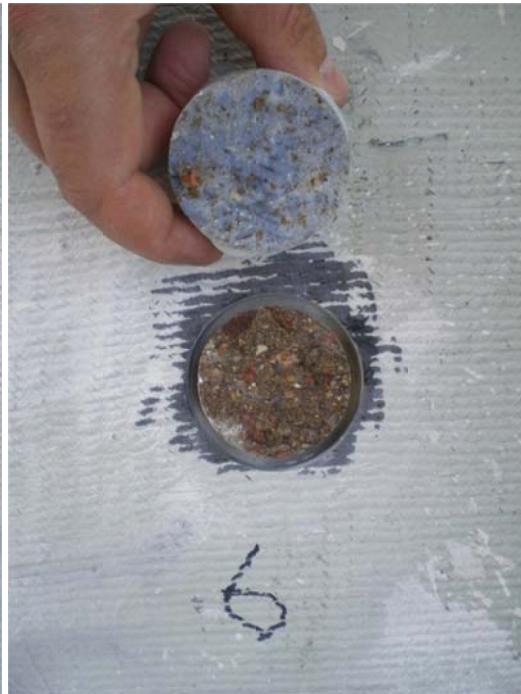
Figures B12 and B13. Test No.14, weak bond strength, and test No.15, weak bond strength

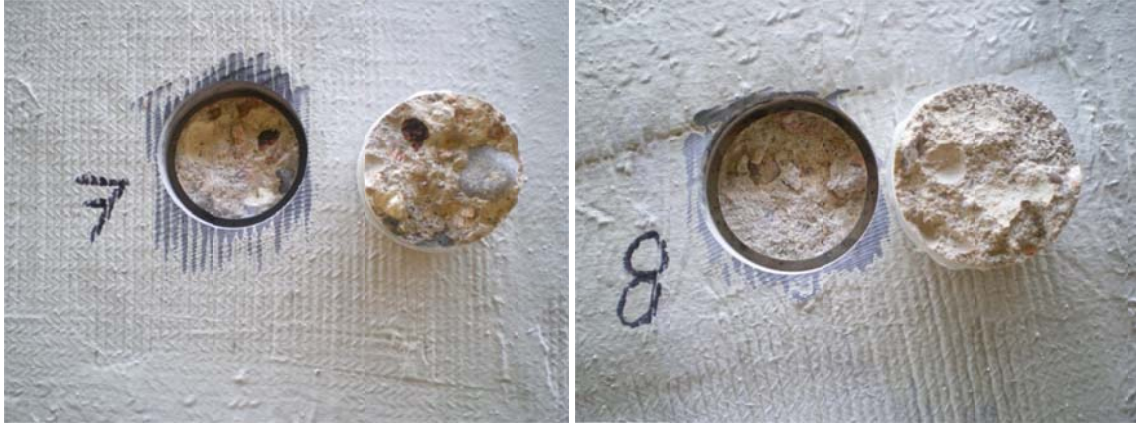
Figures B22 and B23. Test No.25 and test No.26, note very weak bond strength (poorly mixed concrete?)
