WISCONSIN HIGHWAY RESEARCH PROGRAM

1. Report No. WHRP 0092-11-08	2. Government Accession No	3. Recipient's Catalog No	
4. Title and Subtitle Procedures, Cost and Effectiveness for Deteriorated Bridge Substructure Repair		5. Report Date March 2013	6. Performing Organization Code Wisconsin Highway Research Program

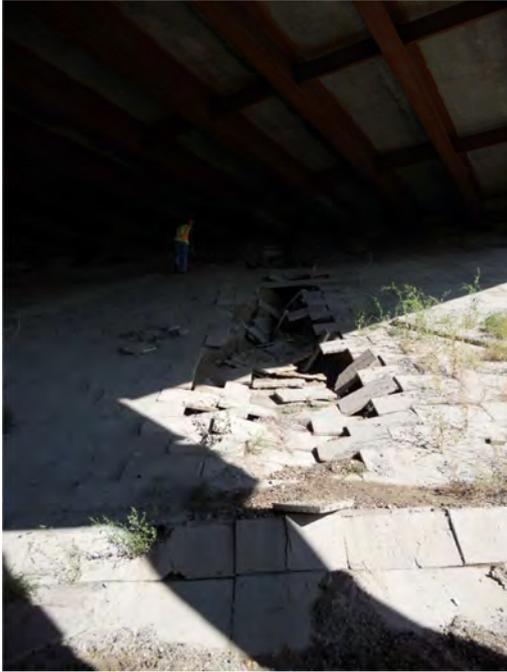
The north slope embankment for bridge B-40-0115 is composed of concrete blocks or tiles. It is currently identified as experiencing major deterioration. Portions of the slope embankment have collapsed as evidenced by Figures 2.1 and 2.2. The slope embankment failure was caused by erosion of the soil beneath the concrete blocks. The erosion was approximately 2-4 feet deep and covered a 10-foot by 30-foot plan area. According to an inspection from March 16, 2011, a spalled median barrier wall was thought to instigate the erosion. The spalled median barrier wall allowed runoff from the bridge deck to land on the slope protection, causing the subsequent erosion of the slope embankment. The recommended repair from the inspection was to fill in the missing subgrade beneath the tiles/blocks and replace the damaged portions of the slope embankment, since the spalled median barrier had previously been repaired. Erosion issues were noted throughout several of the other bridges that were visited, but to a much lesser extent.

Figure 2.1 B-40-0115 Slope Embankment Failure

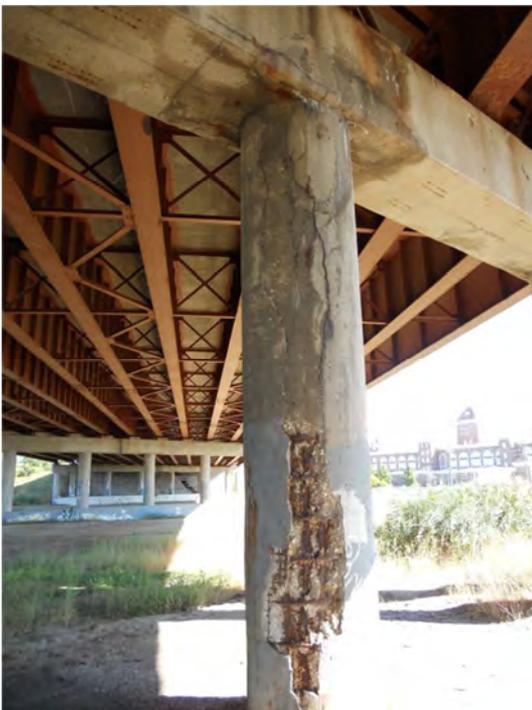
There are 88 pier columns in Bridge B-40-0115, with a typical diameter of three feet. The pier columns have severe deterioration due to reinforcement corrosion. There is extensive delamination present that exposes the reinforcement. Figure 2.8 provides a visual of one of the delaminations, which occurred on the lower half of Column 6 at Pier 1. As evidenced by the heavy rust staining and cracking on the top of the column, this deterioration was most likely due to a leaking expansion joint in the bridge

Figure 2.8 B-40-0115 Pier Column Delamination

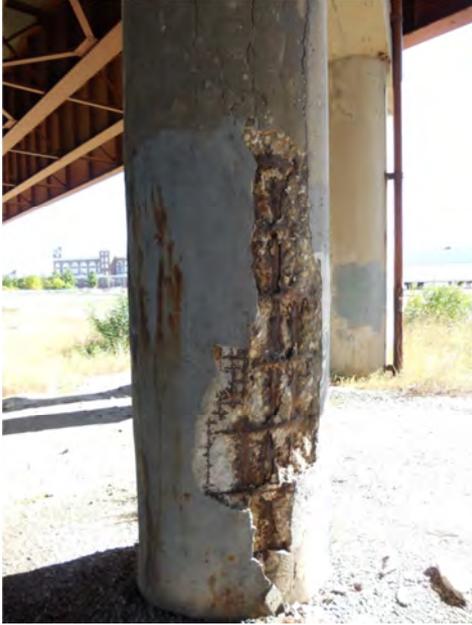
superstructure. A more detailed image of this particular column is provided in Figure 2.9.

Figure 2.9 B-40-0115 Pier Column Delamination

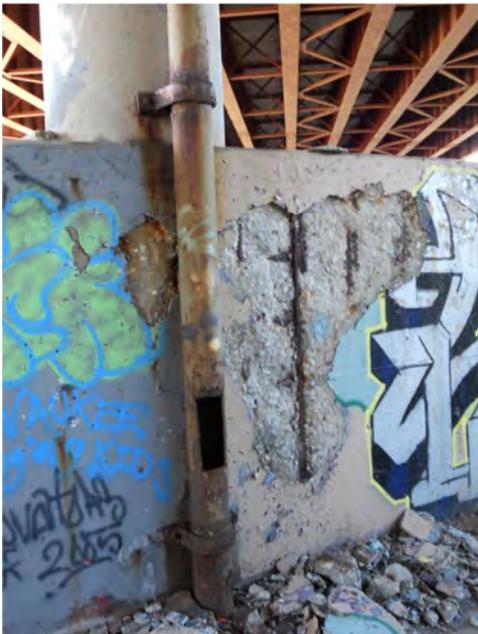
There are 650 feet of concrete pier walls in Bridge B-40-0115. These pier walls are experiencing severe delamination and cracking. The delamination has caused spalling for many of the pier walls. The spalling shown in Figure 2.10 is typical of what the pier walls are experiencing throughout the bridge. Figure 2.10 displays one of the more advanced stages of deterioration present on the pier walls.

Figure 2.10 B-40-0115 Pier Wall Delamination

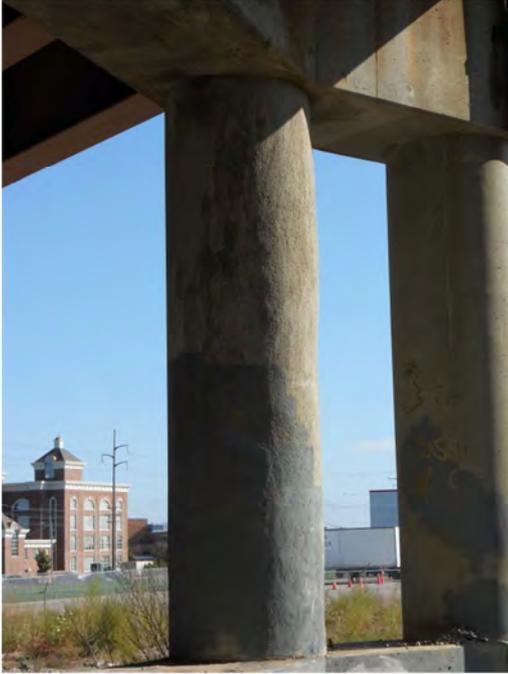
Bridge B-40-0115 has also experienced several repairs on deteriorated substructure members. Figure 2.11 shows a successful repair over the entire length of a column. The age of this particular repair was unknown since it was not documented. The repair showed no signs of deterioration and appeared to be sound. Figure 2.12 shows a patch repair on a column and pier cap. The patches were not observed to have any deterioration at the time of the inspection.

Figure 2.11 B-40-0115 Full Column Repair

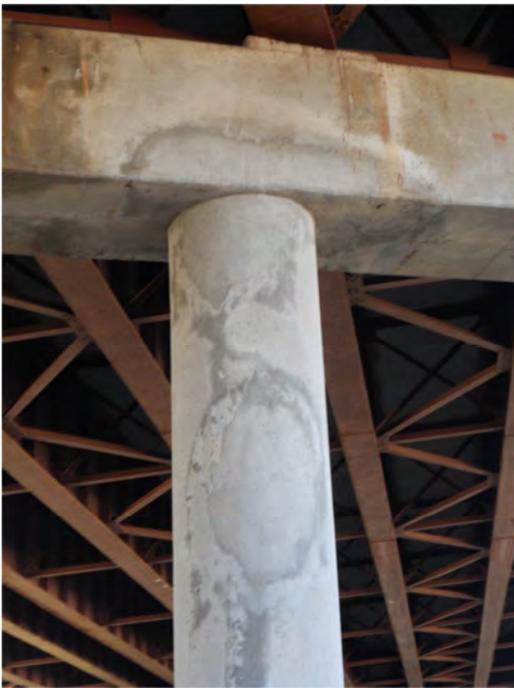
Figure 2.12 B-40-0115 Column and Pier Cap Patch Repair

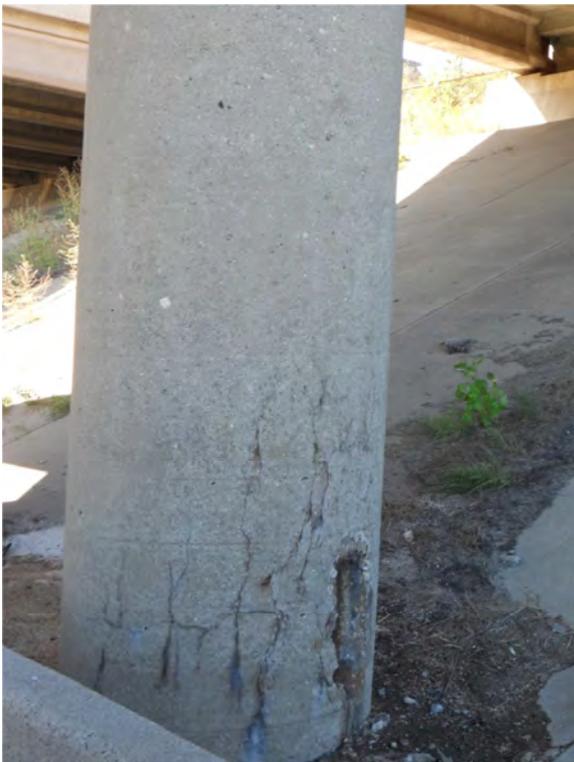
The pier columns in bridge B-40-0226 have deterioration issues that are typical in the southeastern region of WisDOT. Figure 2.14 shows the delamination and vertical cracking on the pier column. The delamination has exposed a small amount of steel reinforcement near the bottom of the column. The deterioration normally occurs on this portion of the column resulting from application of de-icing chemicals. As snowplows pass, snow is thrown against the column and packed, providing a condition for chemically saturated snow to adhere to the surface of the pier column. The extended amount of time that the snow pack has been allowed to stay on the face of the column is what has greatly accelerated the corrosion of the reinforcement.

Figure 2.14 B-40-0226 Pier Column Deterioration

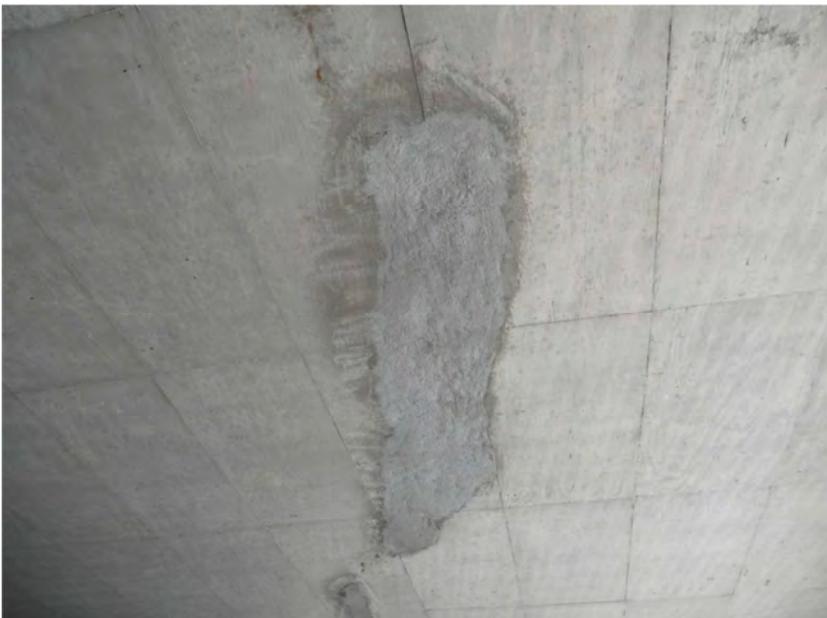
The underside of the bridge deck was repaired using sacrificial anodes and spray-on concrete. Figures 2.16 and 2.17 illustrate locations that were repaired using this method. The repair is four years old at the time of this report and it is still rated in a good condition state based on the last inspection report. Some new spalling has occurred on other sections of the underside of the deck. Figure 2.18 is included to show the typical condition the concrete was in before the sacrificial anodes and spray-on concrete were applied.

Figure 2.16 B-40-0494 Sacrificial Anode Repair

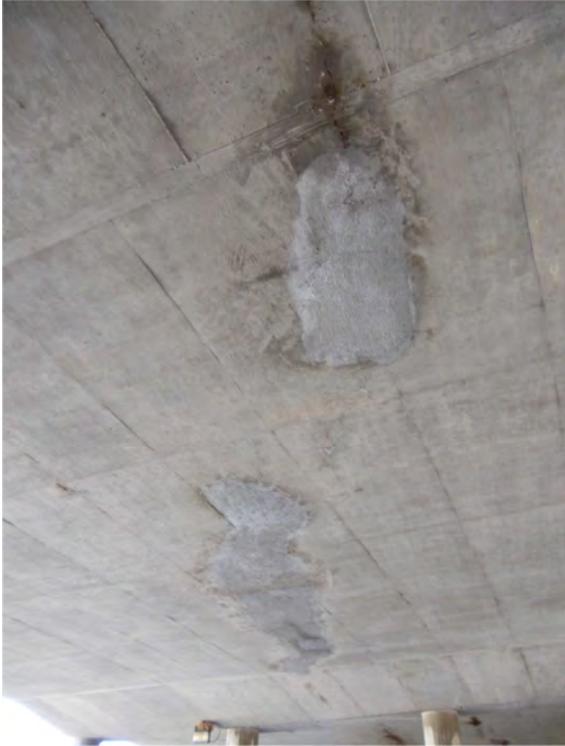
Figure 2.17 B-40-0494 Sacrificial Anode Repair
