# Laboratory and Field Testing of an Accelerated Bridge Construction Demonstration Bridge: US Highway 6 Bridge over Keg Creek

**Final Report**  
**April 2013**

**Sponsored by**  
Federal Highway Administration  
Iowa Department of Transportation  
(InTrans Project 11-411)

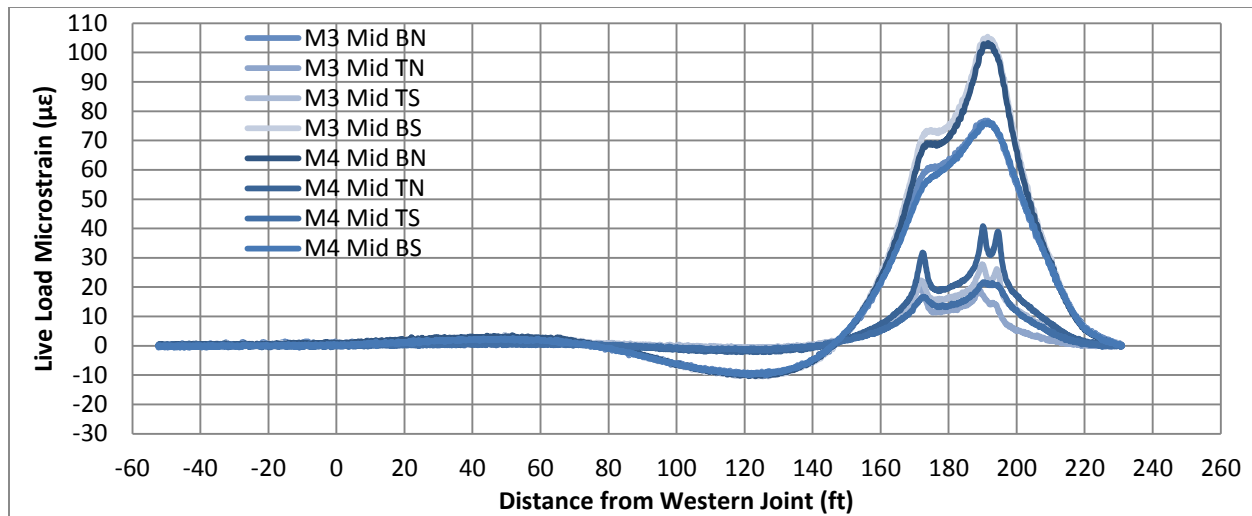
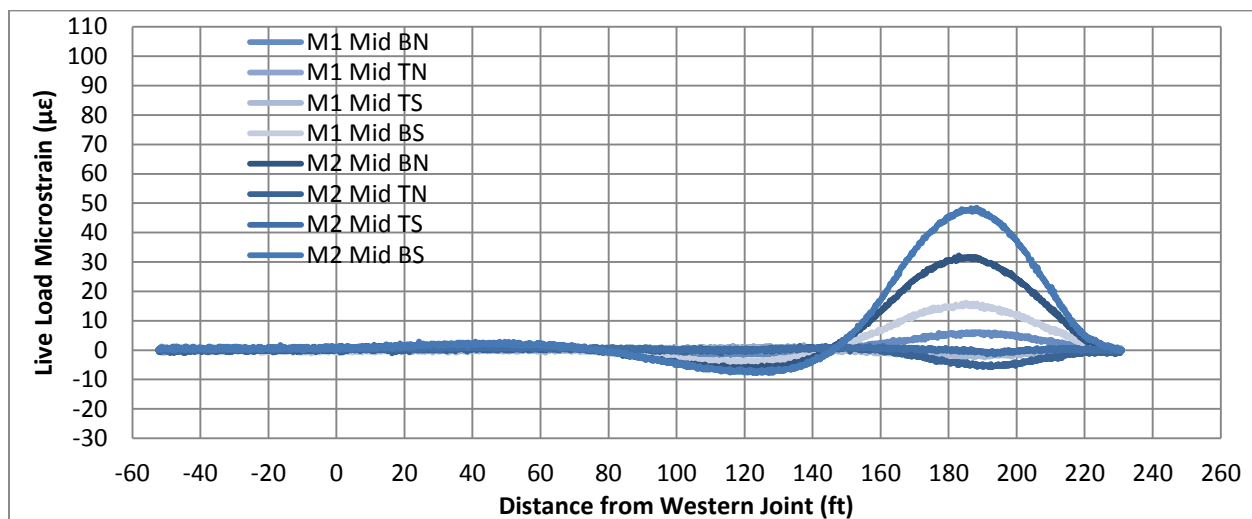
The results also show a difference in strain response between the more heavily loaded girders and the girders farther away from the load path, while the test truck is on the east end span. For girders farther away from the load path, strain values recorded in the bottom flange are tensile strains while strains in the top flange are recorded as compressive strains, indicating the neutral axis is located somewhere within the steel beam.

For modules 1 and 2 the neutral axis is typically calculated between 24 and 29 in. from the underside of the bottom flange of the steel girders which are W30X99 steel beams having a depth of 29.65 in. For the girders underneath the load path, transducers on both the bottom and top flange are recording tensile strains, indicating a neutral axis above the top flange.

These results are not necessarily unexpected due to the precast deck panels being compositely constructed with the steel girders, but the extent to which the neutral axis is above the steel girders is unexpected. At the extreme, the neutral axis is calculated to even exceed the height of the precast deck by as much as 10 in. (This is discussed further later in this report.)

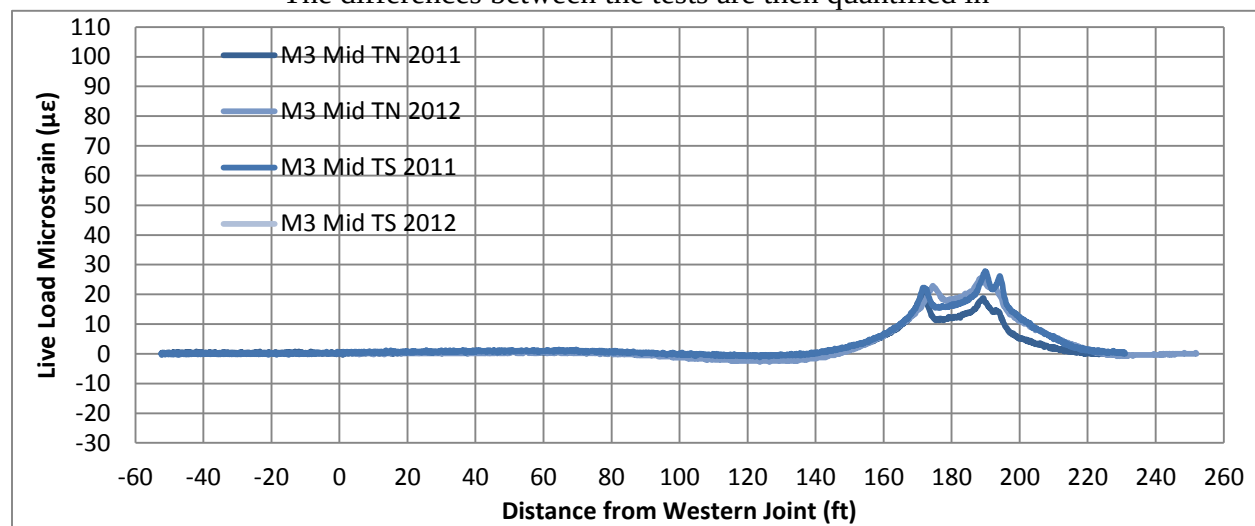
**Figure 4.22. Comparison of live load strains from 2011 to 2012 of transducers on top flange of girder at midspan for module 3 from load path 4**

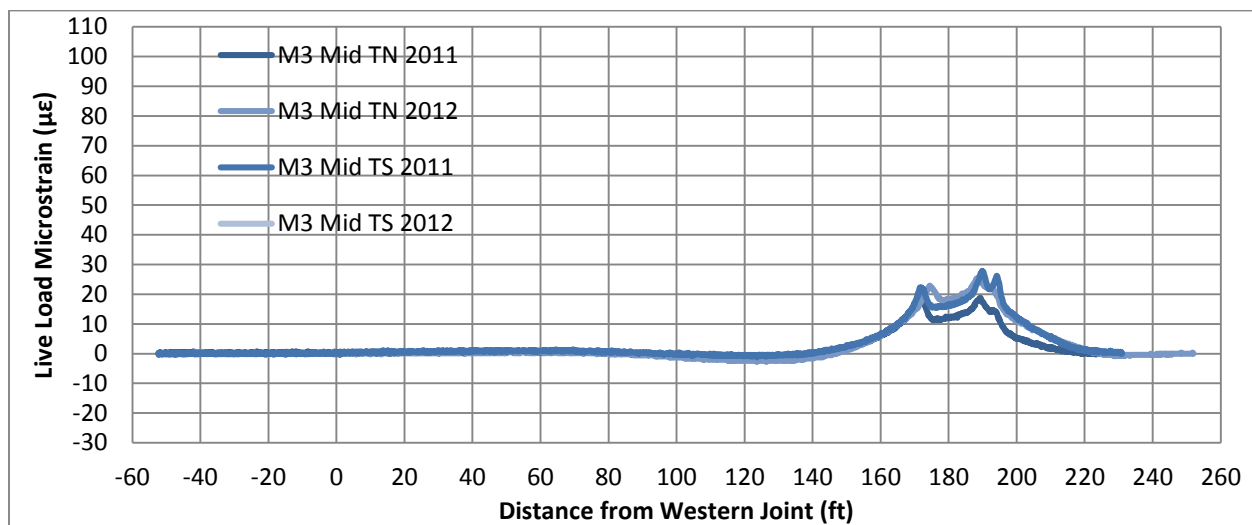
Figure 4.21 and Figure 4.22 show comparisons of representative samples of data between the 2011 and 2012 test for module 3 strains recorded in the top and bottom flanges for load path 4. The differences between the tests are then quantified in

**Figure 4.22. Comparison of live load strains from 2011 to 2012 of transducers on top flange of girder at midspan for module 3 from load path 4**
