*Midwest States Regional Pooled Fund Research Program  
Fiscal Year 2011 (Year 21)  
Research Project Number TPF-5(193) Supplemental #31  
NDOR Sponsoring Agency Code RFP-11-MGS-1*

# **MIDWEST GUARDRAIL SYSTEM (MGS) WITH SOUTHERN YELLOW PINE POSTS**

MwRSF Research Report No. TRP-03-272-13

September 4, 2013

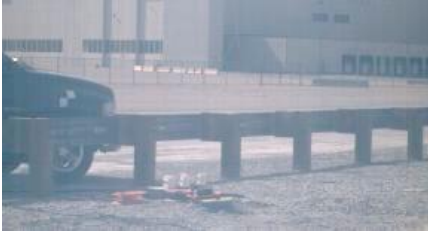
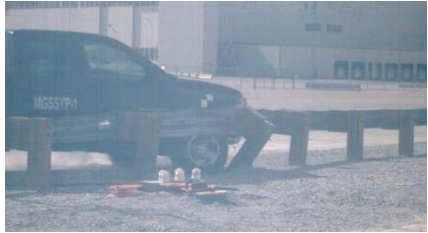
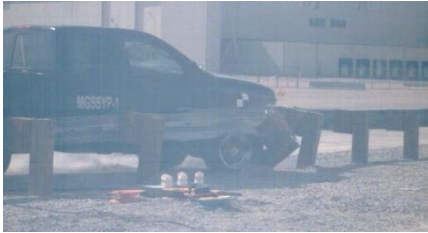
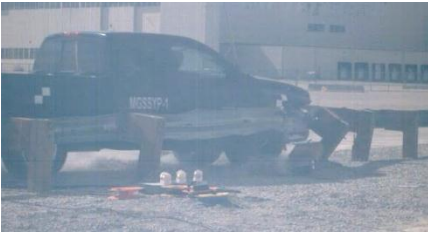
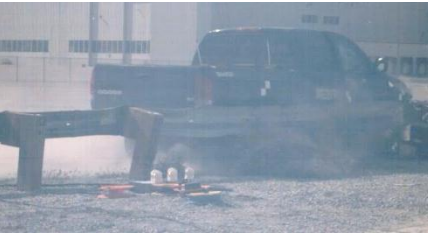
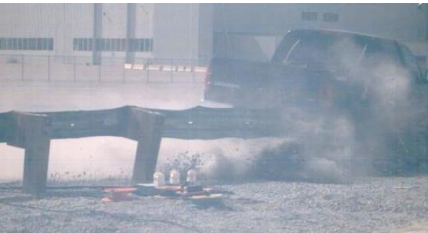
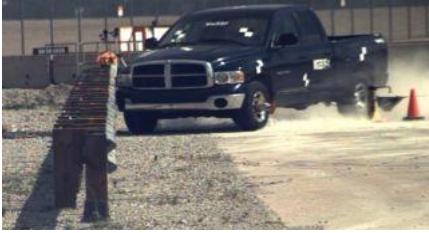
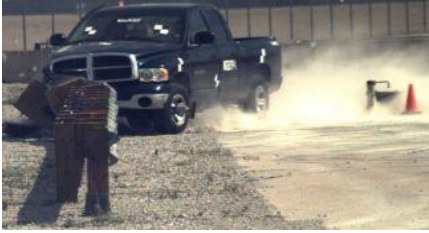
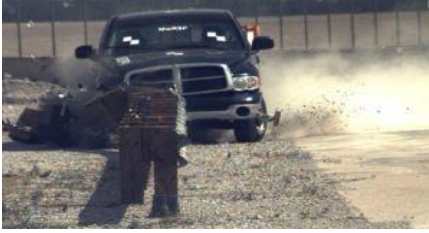
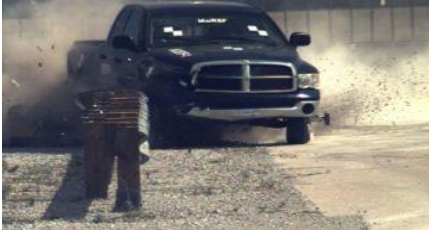
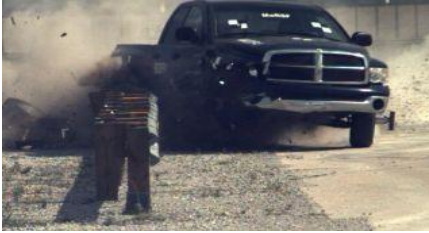
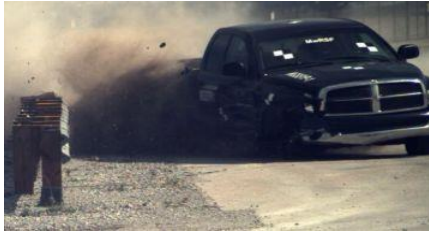
Figure 32. Summary of Test Results and Sequential Photographs, Test No. MGSSYP-1

The 5,199-lb (2,358-kg) pickup truck impacted the MGS with SYP wood posts at a speed of 62.2 mph (100.1 km/h) and at an angle of 24.9 degrees. A summary of the test results and sequential photographs are shown in Figure 32. Additional sequential photographs are shown in Figures 33 and 34.

The results of the occupant risk analysis, as determined from the accelerometer data, are summarized in Figure 32. The recorded data from the accelerometers and the rate transducers are shown graphically in Appendix E.

Evaluation Criteria		Transducer		MASH Limit
		EDR-3	DTS	
OIV ft/s (m/s)	Longitudinal	-14.20 (-4.33)	-13.25 (-4.04)	≤ 40 (12.2)
	Lateral	-14.77(-4.50)	-14.74 (-4.50)	≤ 40 (12.2)
ORA g's	Longitudinal	8.39	-8.14	≤ 20.49
	Lateral	-7.65	-8.51	≤ 20.49
THIV – ft/s (m/s)		NA	19.82 (6.04)	not required
PHD – g's		NA	11.36	not required
ASI		0.70	0.70	not required

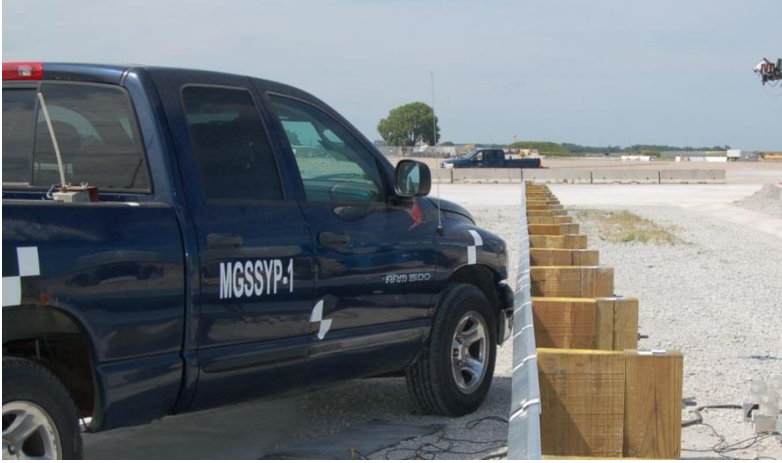
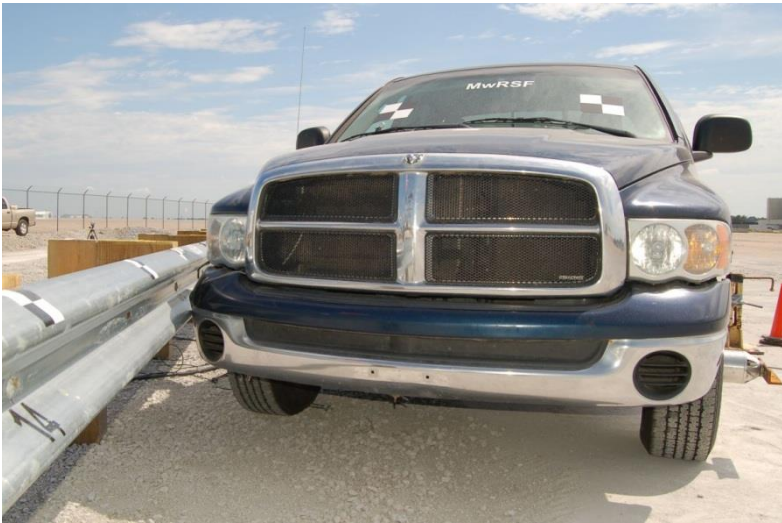
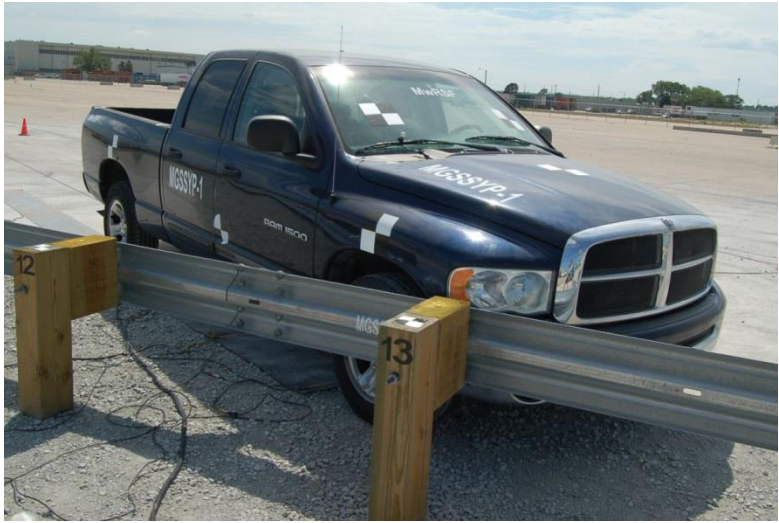
Figure 35. Impact Location, Test No. MGSSYP-1

Initial vehicle impact was to occur 12 ft (3.7 m) upstream of the center line of post no. 15, as shown in Figure 35, which was selected using the CIP plots found in Section 2.3 of MASH to maximize pocketing and the propensity of wheel snag. The actual point of impact was 12 ft – 6 in. (3.8 m) upstream of post no. 15. A sequential description of the impact event is

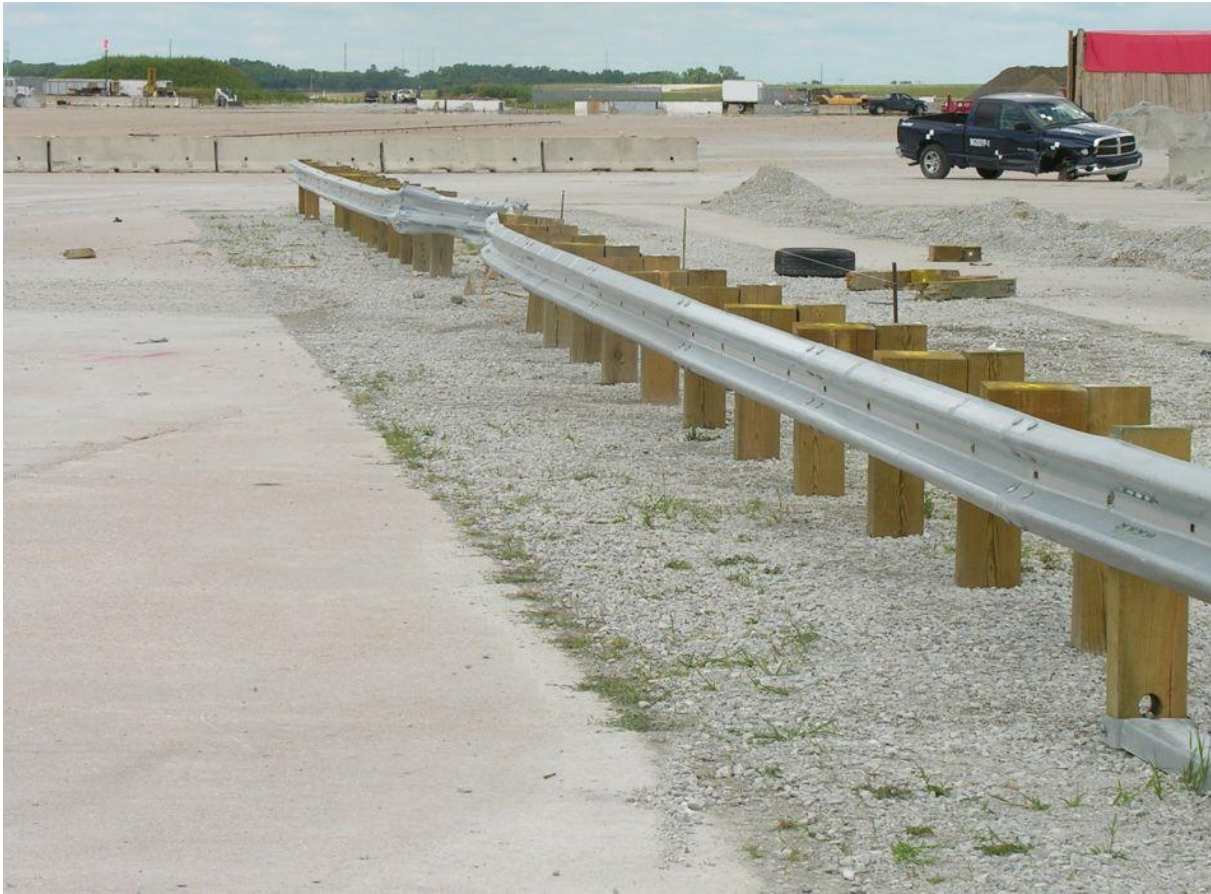
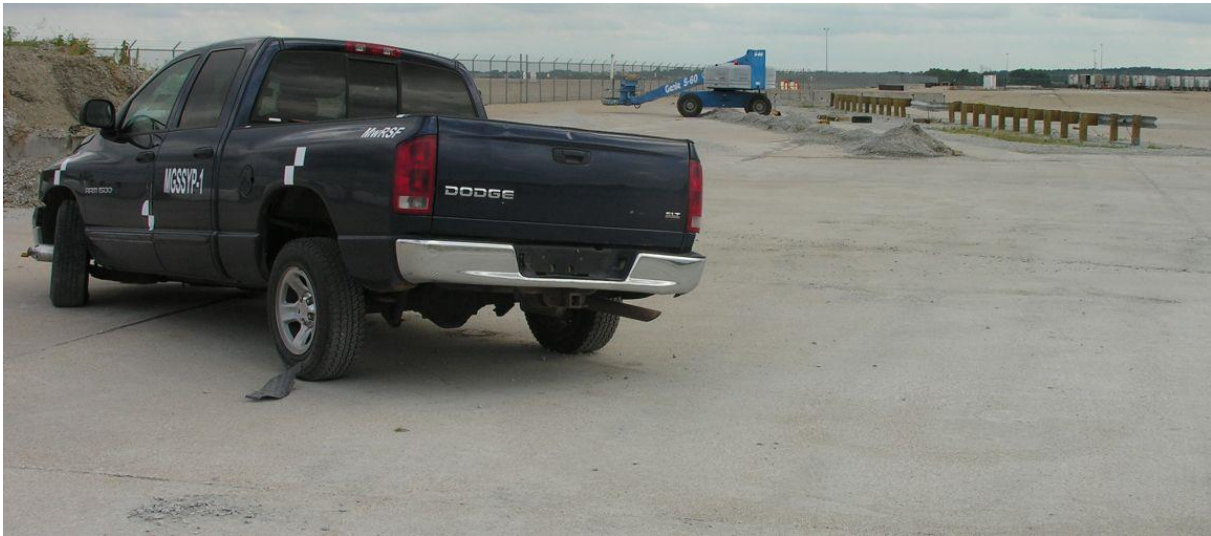
Figure 36. Vehicle Final Position and Trajectory Marks, Test No. MGSSYP-1

contained in Table 4. The vehicle came to rest 209 ft (63.7 m) downstream of the impact point and 56 ft – 10 in. (17.3 m) laterally behind the barrier system, and its trajectory did not violate the bounds of the exit box. The vehicle trajectory and final position are shown in Figures 32 and 36.

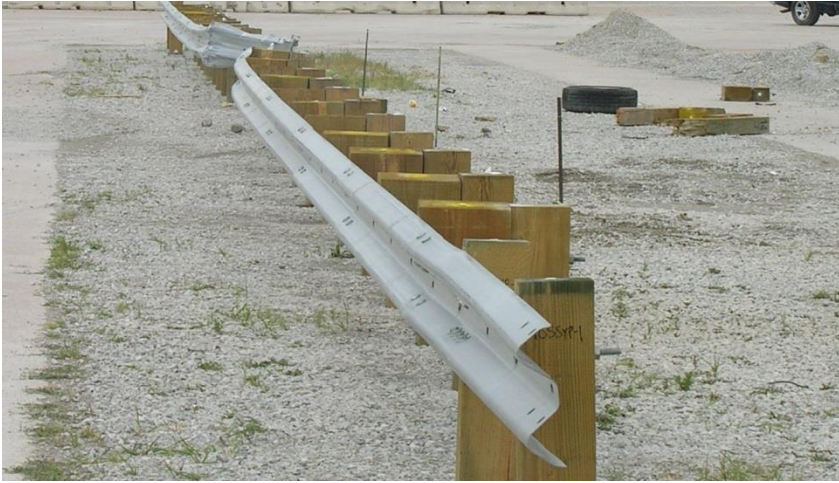
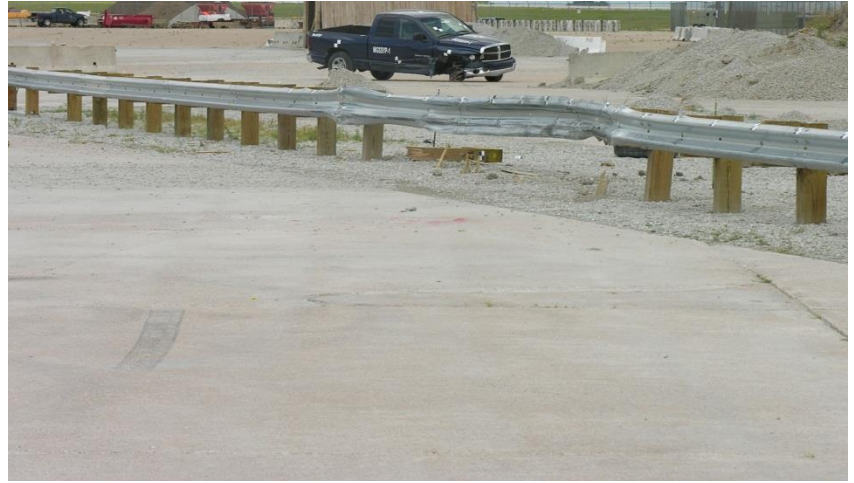
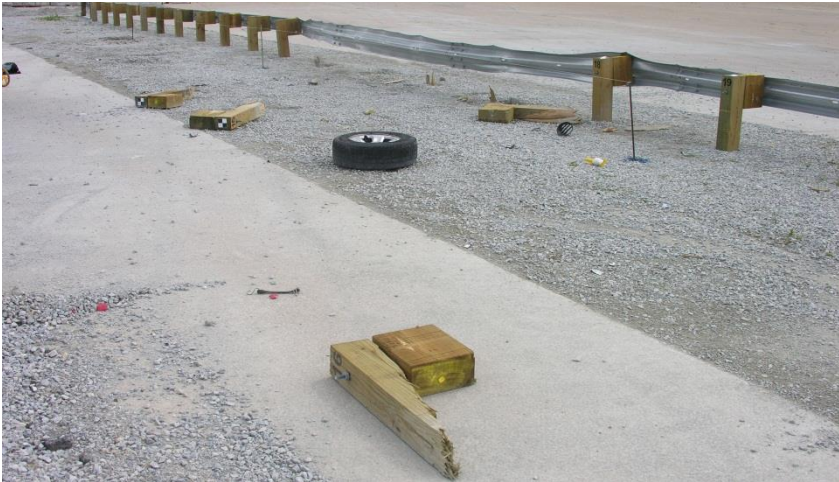
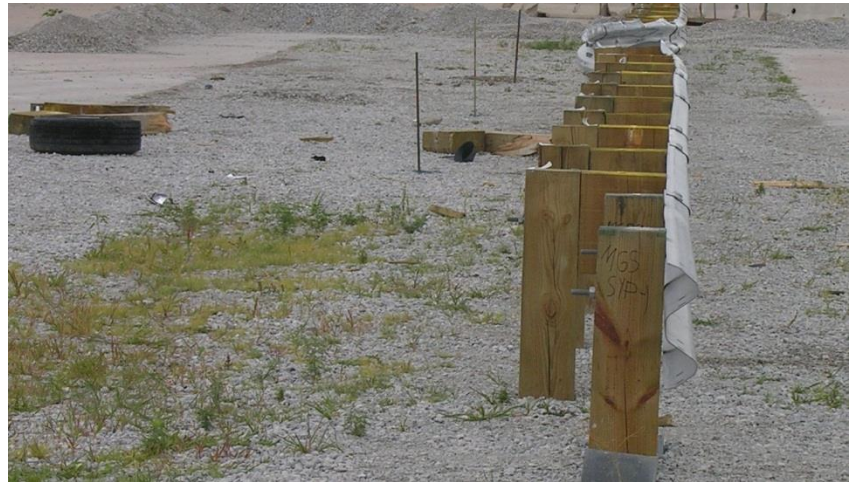
Figure 37. System Damage, Test No. MGSSYP-1

Damage to the barrier was moderate, as shown in Figures 37 through 38 . Barrier damage consisted of deformed guardrail, fractured posts, and contact marks on the front face of the W-beam guardrail. The length of vehicle contact along the barrier was approximately 34 ft – 4 in. (10.5 m) which spanned from 4 in. (102 mm) upstream of the centerline of post no. 13 and extended to 33 in. (838 mm) downstream of post no. 18.

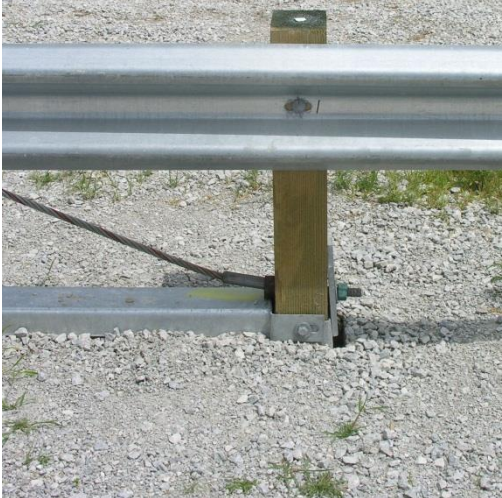
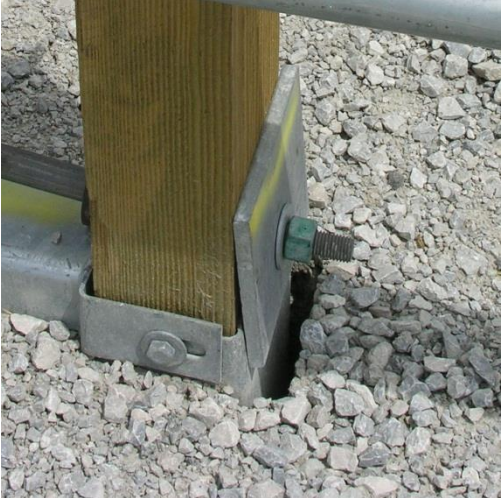
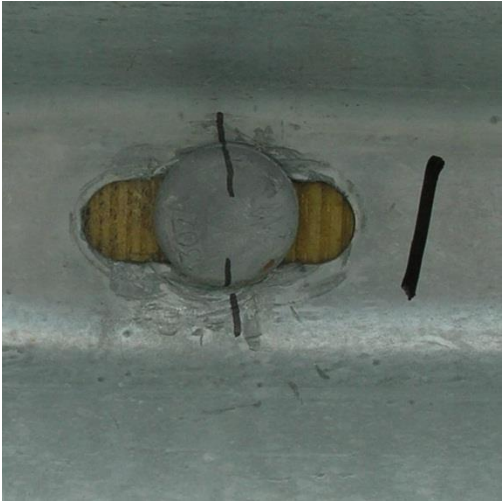
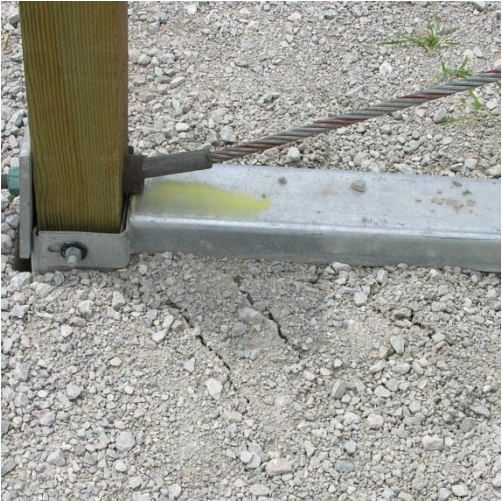
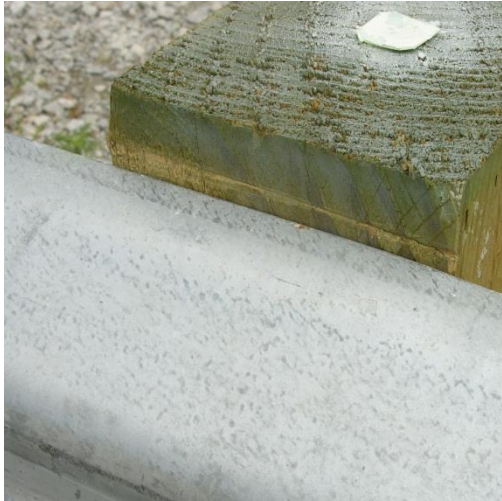
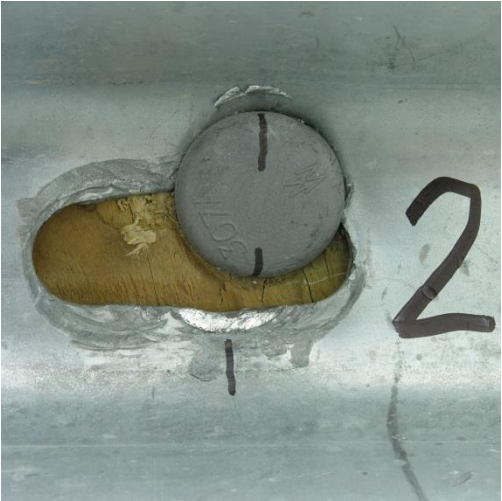
Figure 44. Local Rail Tearing at Post Nos. 3, 7, and 14, Test No. MGSSYP-1

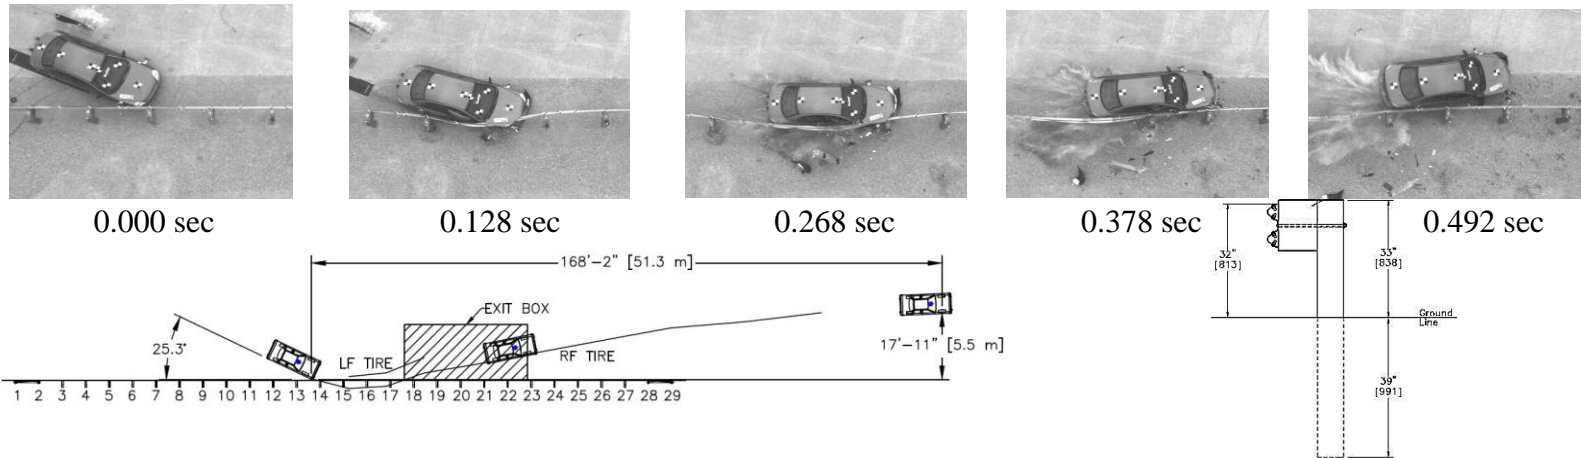
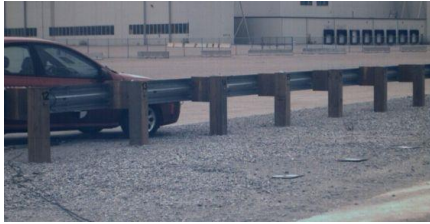
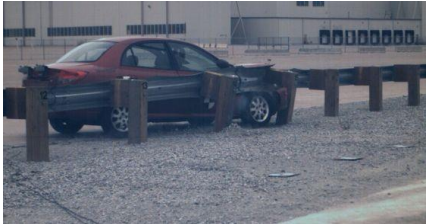
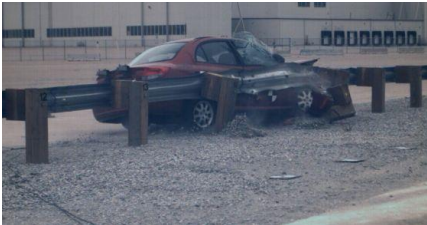
Figure 49. Summary of Test Results and Sequential Photographs, Test No. MGSSYP-2

The analysis of the test results for test no. MGSSYP-2 showed that the system adequately contained and redirected the 1100C vehicle with controlled lateral displacements of the barrier. There were no detached elements or fragments which showed potential for penetrating the occupant compartment nor presented undue hazard to other traffic. Deformations of, or intrusions into, the occupant compartment that could have caused serious injury did not occur. The test vehicle did not penetrate nor ride over the barrier and remained upright during and after the collision. Vehicle roll, pitch, and yaw angular displacements, as shown in Appendix F, were deemed acceptable because they did not adversely influence occupant risk safety criteria nor cause rollover. After impact, the vehicle exited the barrier at an angle of 13.6 degrees. Therefore, test no. MGSSYP-2 was determined to be acceptable according to the MASH safety performance criteria for test designation no. 3-10.

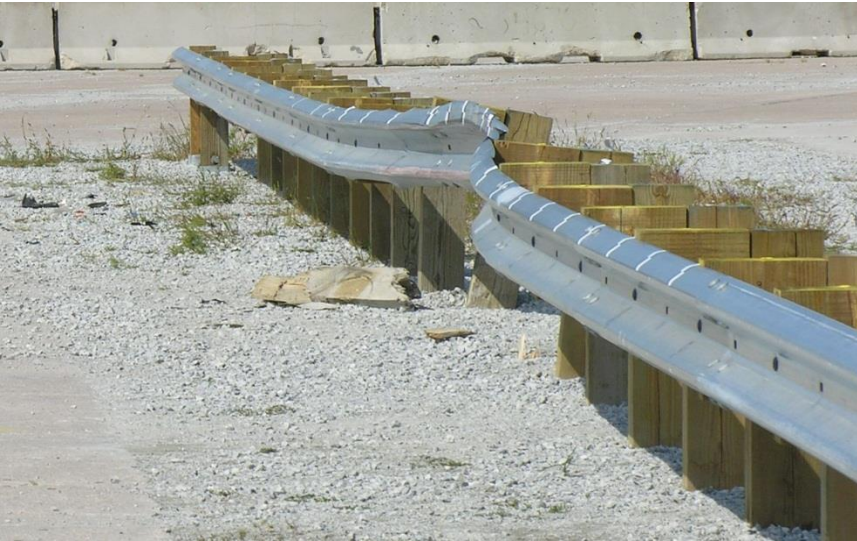
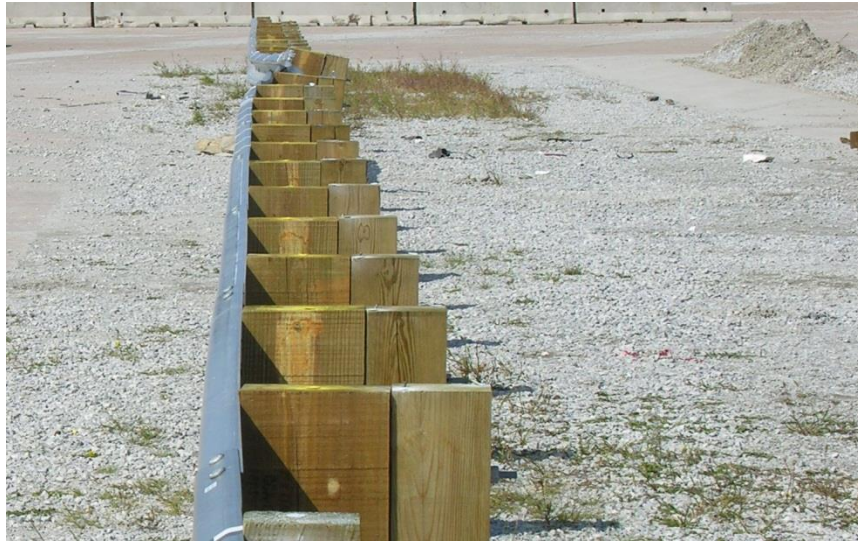
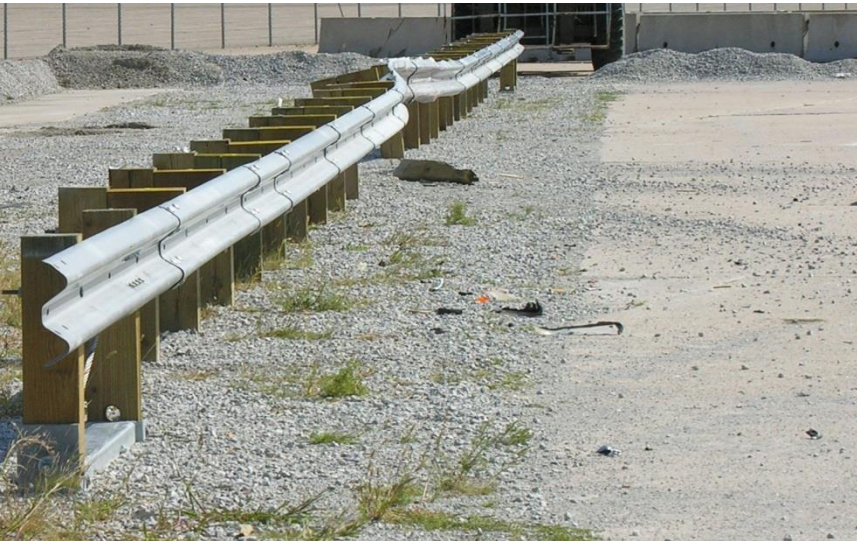
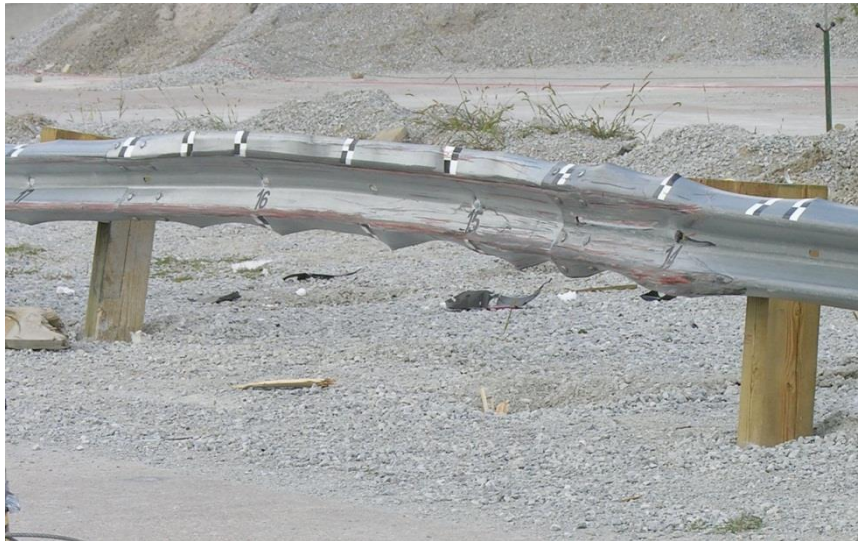
Figure 54. System Damage, Test No. MGSSYP-2

Damage to the barrier was moderate, as shown in Figures 54 through 56. Barrier damage consisted of deformed guardrail, rotated and fractured posts, and contact marks on the guardrail and posts. The length of vehicle contact along the barrier was approximately 23 ft – 1 in. (7.0 m) which spanned from 2 ft – 6½ in. (775 mm) upstream of post no. 14 to 1 ft – 9½ in. (546 mm) downstream of post no. 17.

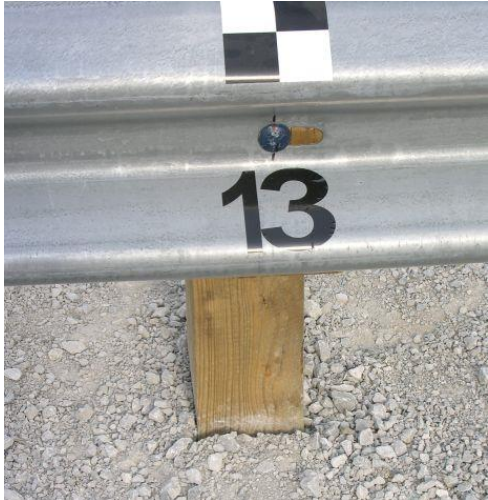
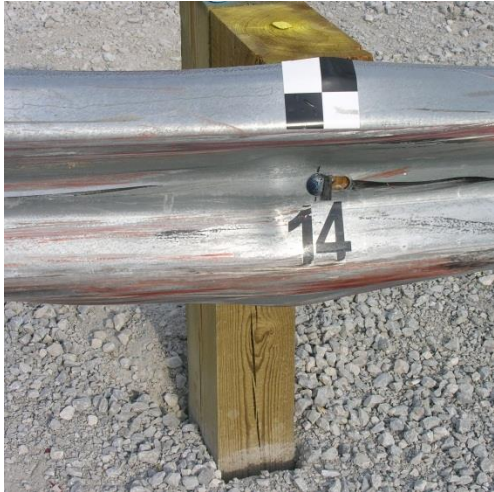
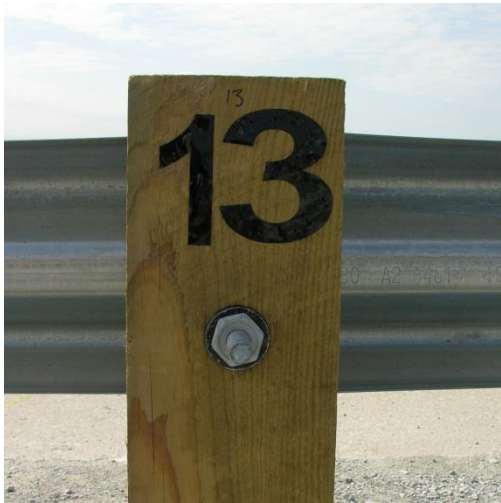
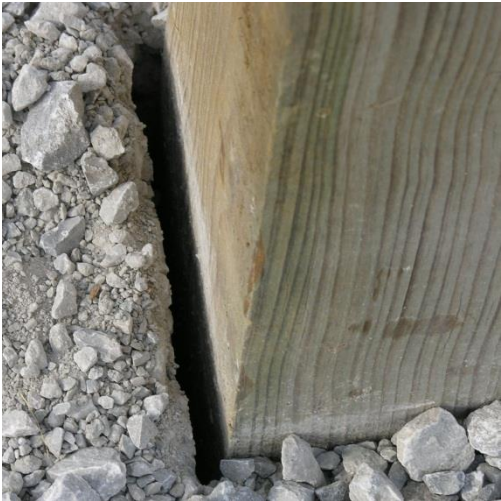
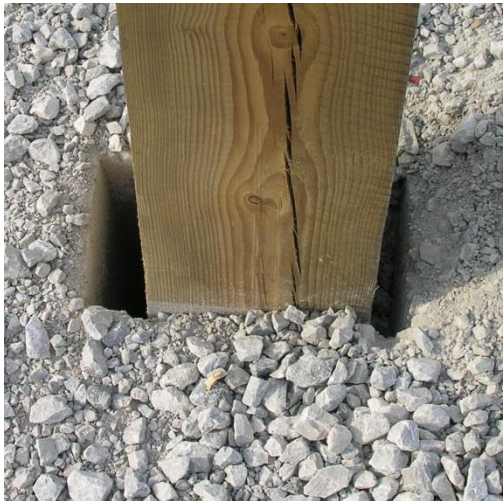
Figure 57. Post Nos. 13 and 14 Damage, Test No. MGSSYP-2

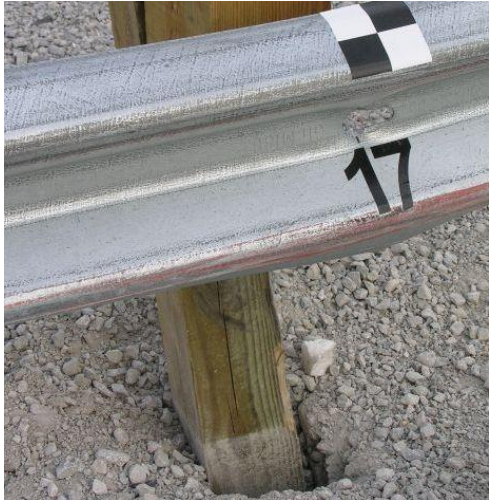
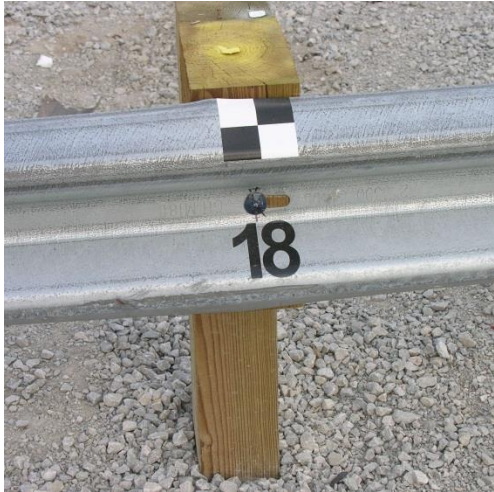
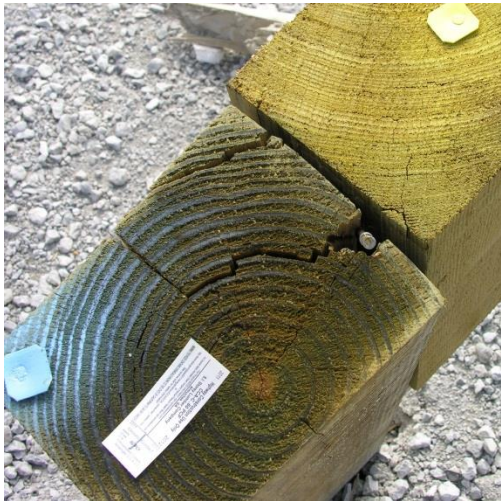
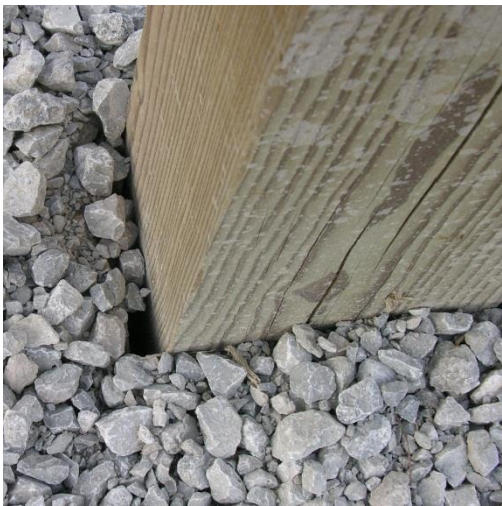
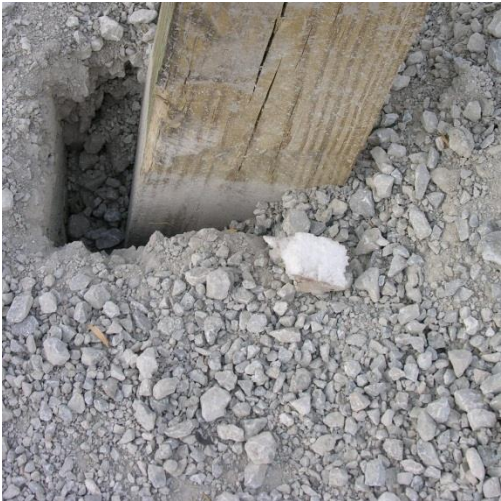
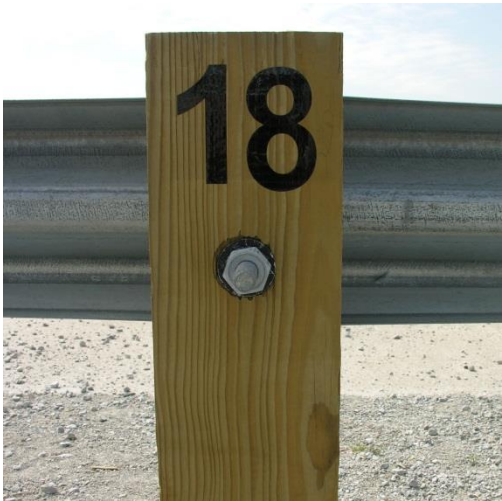
Figure 59. Post Nos. 17 and 18 Damage, Test No. MGSSYP-2

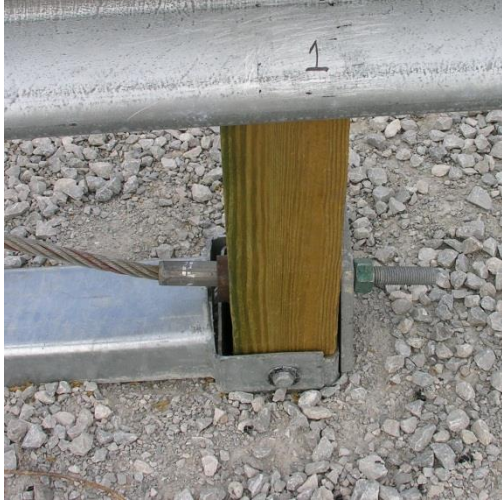
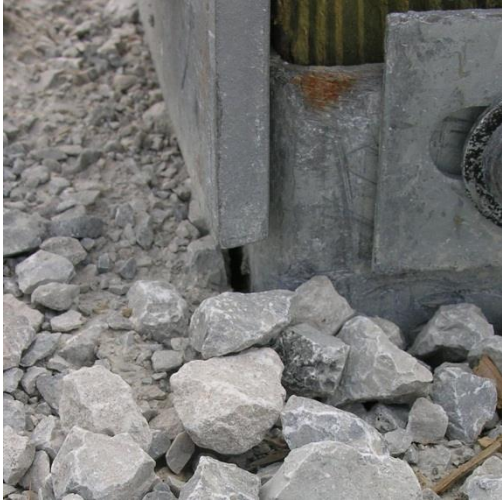
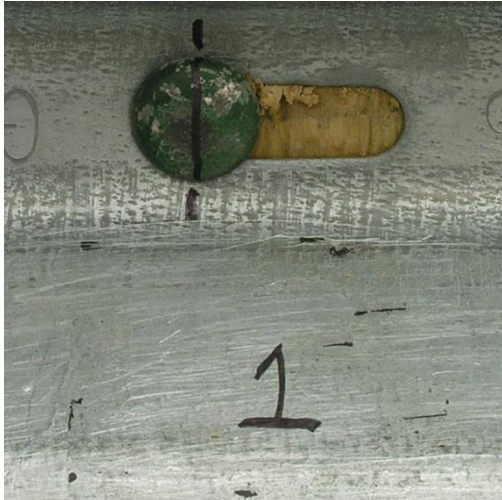
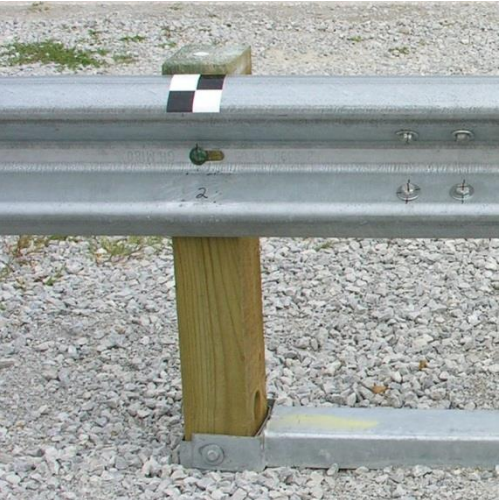
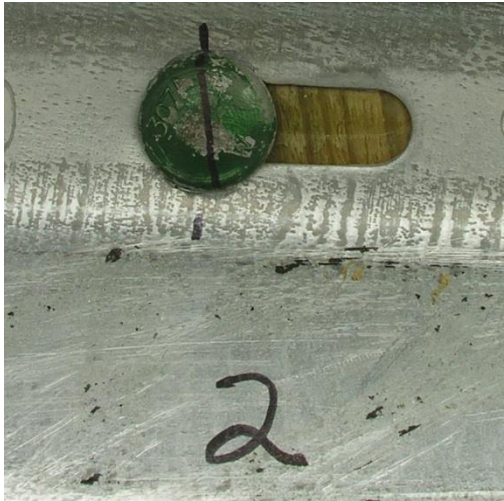
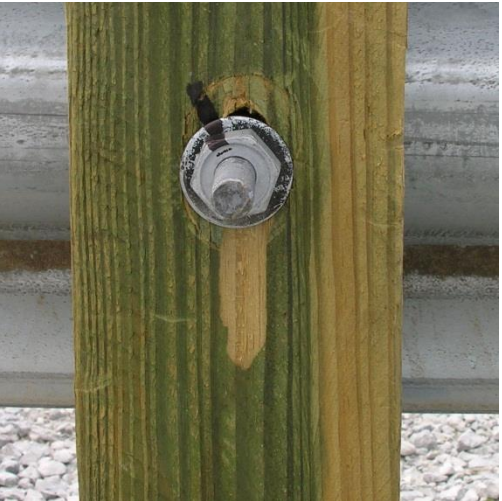
Figure 60. Upstream Anchor Damage, Test No. MGSSYP-2

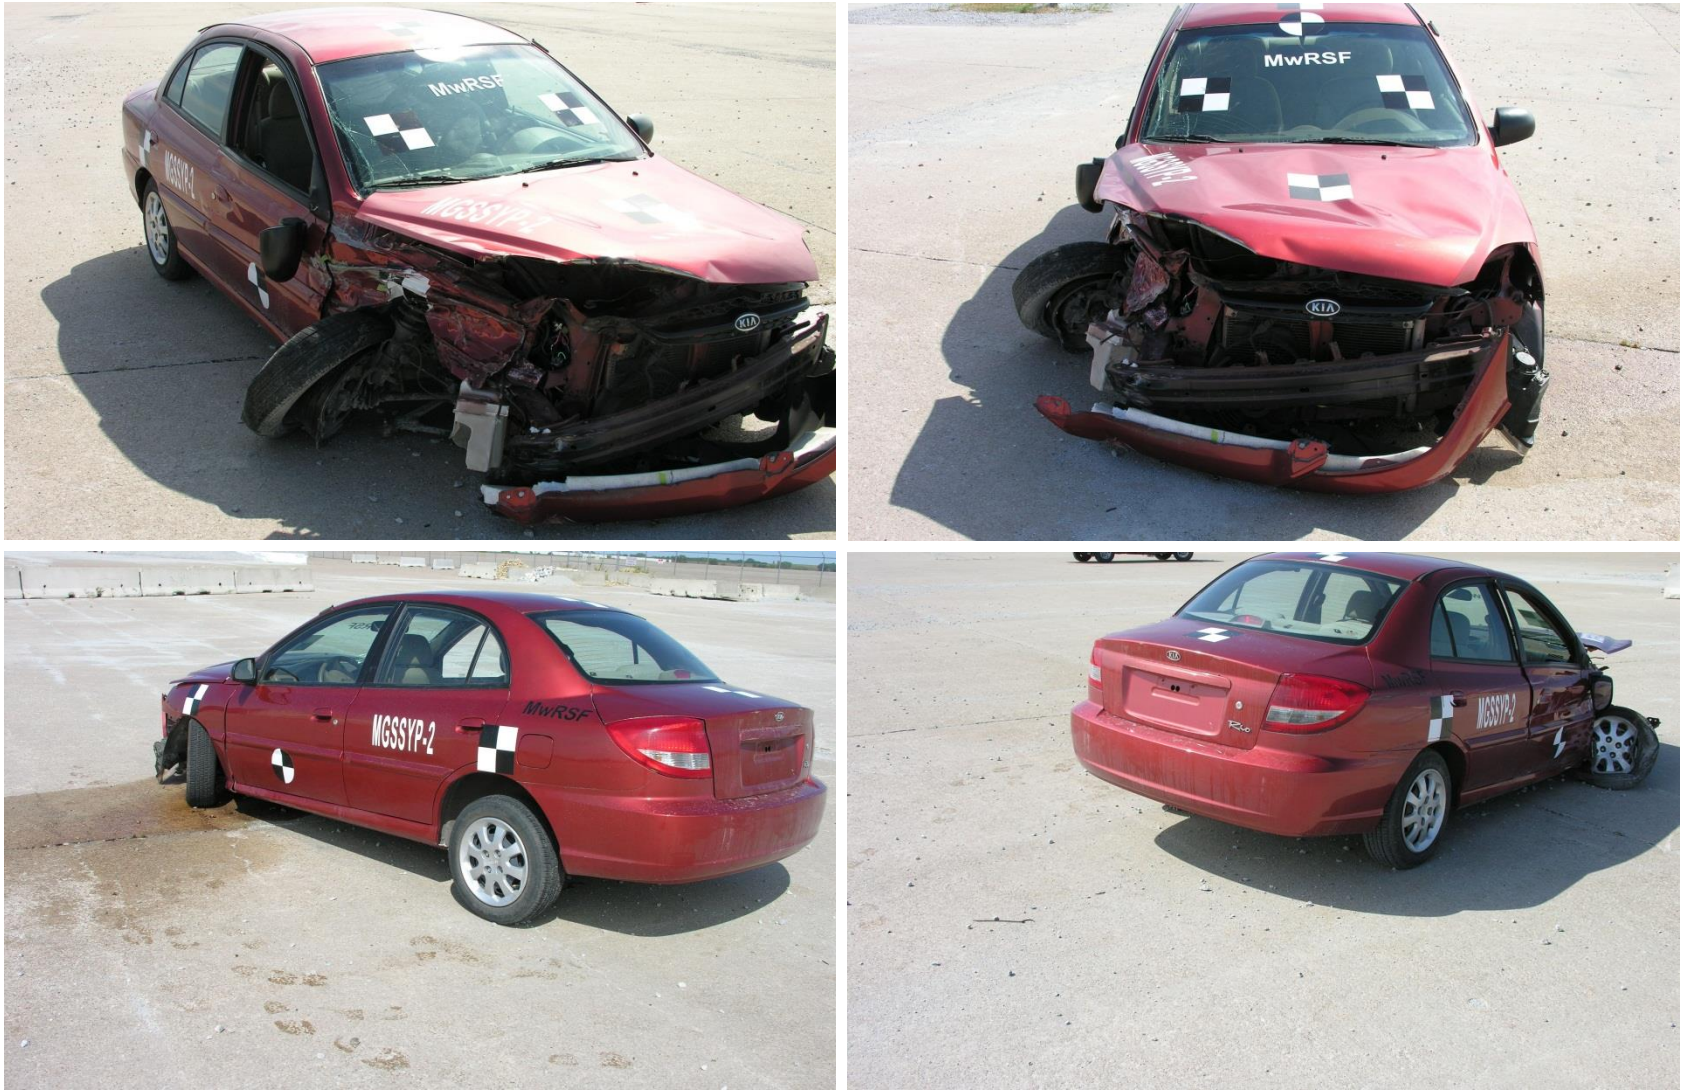
Figure 61. Vehicle Damage, Test No. MGSSYP-2

The damage to the vehicle was moderate, as shown in Figures 61 and 62. The maximum occupant compartment deformations are listed in Table 12 along with the deformation limits established in MASH for various areas of the occupant compartment. Note that none of the MASH established deformation limits were violated. Complete occupant compartment and vehicle deformations and the corresponding locations are provided in Appendix D.
