Western Iowa Missouri River Flooding —  
Geo-Infrastructure Damage Assessment, Repair  
and Mitigation Strategies

# Geo-Infrastructure Post-Flood Damage Assessment, Repair and Mitigation Strategies

tech transfer summary

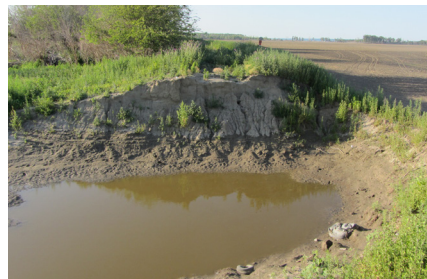
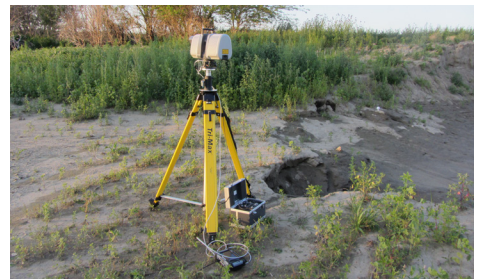
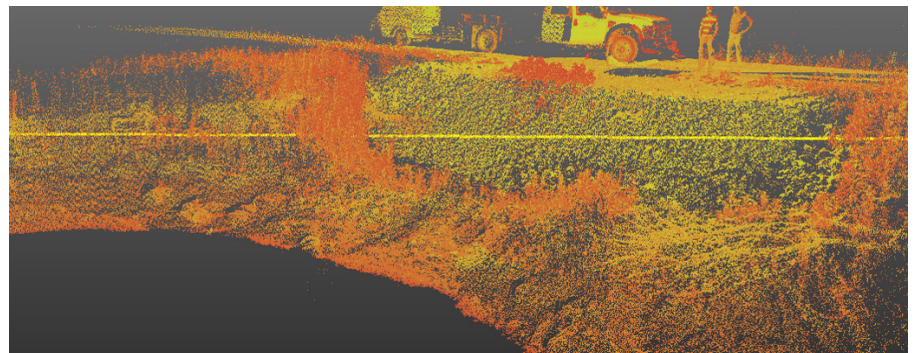
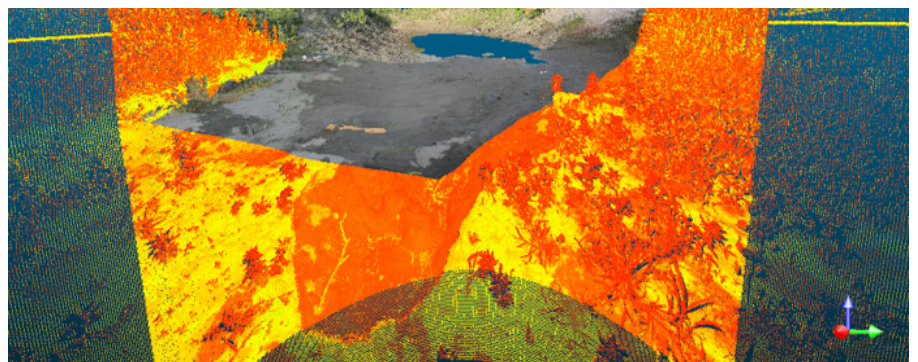
*Figure 3. Laser scanning at a bridge site showing raw point cloud data and merged point cloud with photo*

- Three-dimensional (3D) laser scanning was performed at a breach site to demonstrate rapid and accurate volumetric calculations.
- A flow chart relating the damages, assessment techniques, and 20 different potential repair/mitigation solutions was developed (Figure 6).
