# Evaluation of the Overheight Detection System Effectiveness at Eklutna Bridge

## Final Report

March 2013

FHWA-AK-RD-13-01

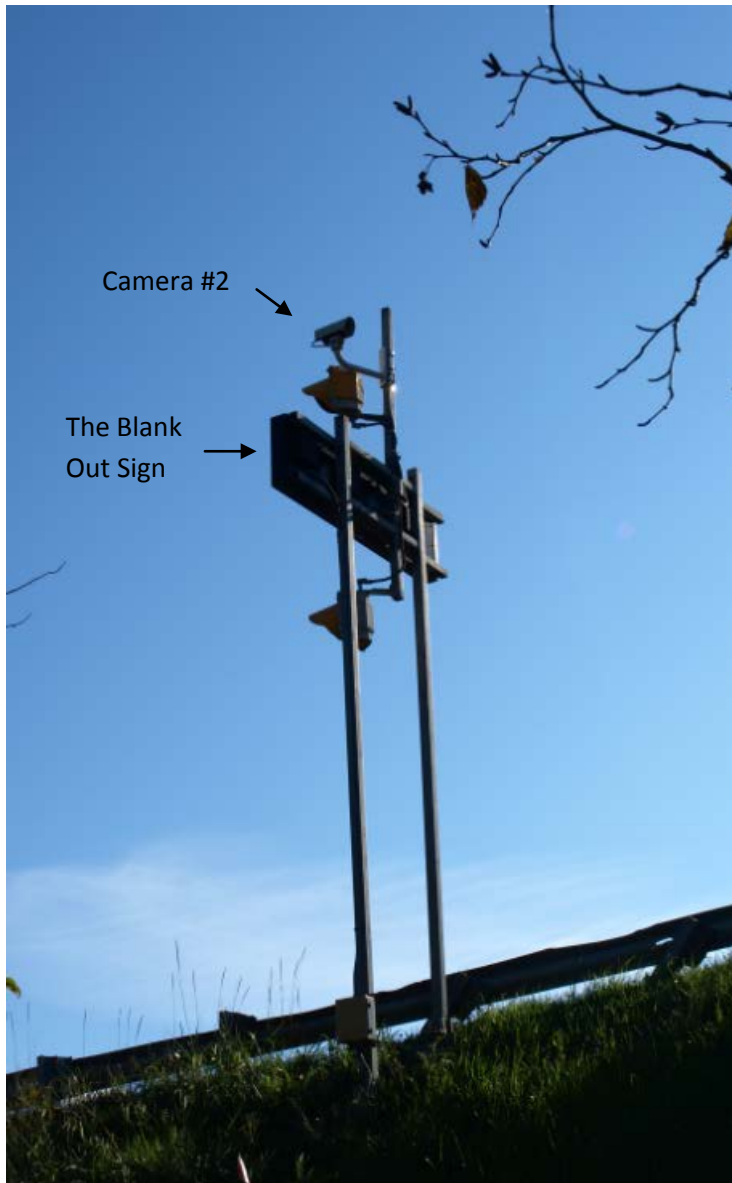
**Figure 7 Camera #2**

The most significant technical issue with camera#2 is focus adjustment. During the duration of data collection, camera#2 went through three periods of time in which the camera was out of focus to the degree that only flashes can be picked out from the images (see Figure 11). When the camera is out of focus like this, technicians need to go to the controller at the site and manually adjust the camera back to focus. Note that a real-time communication between the controller and a remote agent via available communication lines can help detect the out-of-focus problems early. Currently, such communication is not available (see details in the previous section on wireless modem).

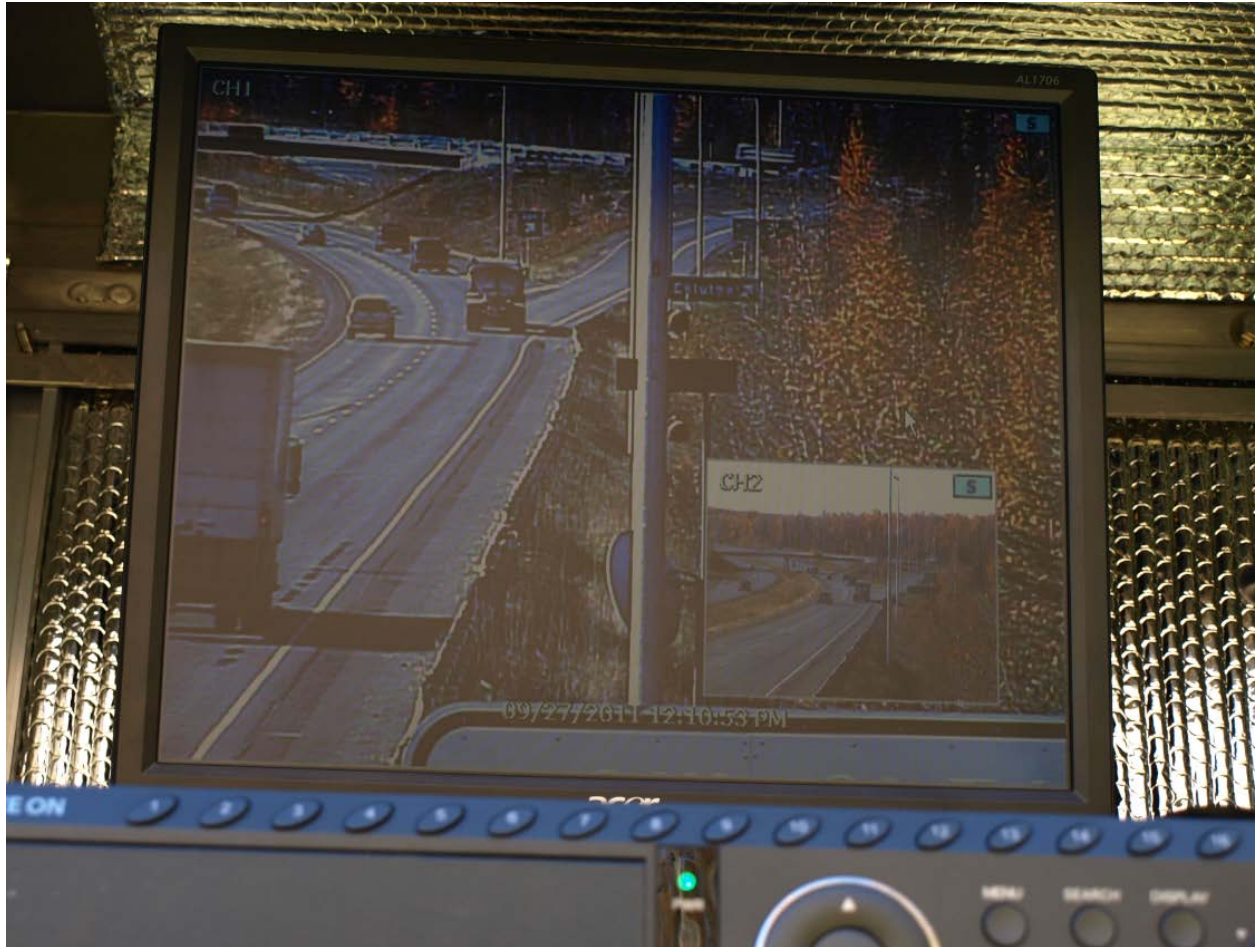
**Figure 8 Video images captured by camera #1 (CH1) with a separate view of camera #2 (CH2)**

Camera #1, mounted on the pole with the detector (see Figure 7), is to provide streaming video of the Blank Out Sign (blankout sign) that directs overweight vehicles to exit the highway in advance of the overpass. This camera also captures the violating vehicles in both lanes as they approach the blankout sign/flashers. Figure 9 shows the video image captured by camera and displayed on the monitor housed in the system cabinet.

Figure 9 also shows the DVR unit (i.e., underneath the monitor) that is connected to the cameras and the iSINC controller. The DVR is currently set up to record for 15 seconds whenever the blankout sign/flashers are turned on by the controller. The DVR has the capacity to advance and retain frames prior to the trigger. This feature allows the saved video clips to demonstrate that the blankout

sign/flashers were actually turned on for a specific vehicle and were not false alarms. The video clip will show the actual activation as the truck approaches the sign.

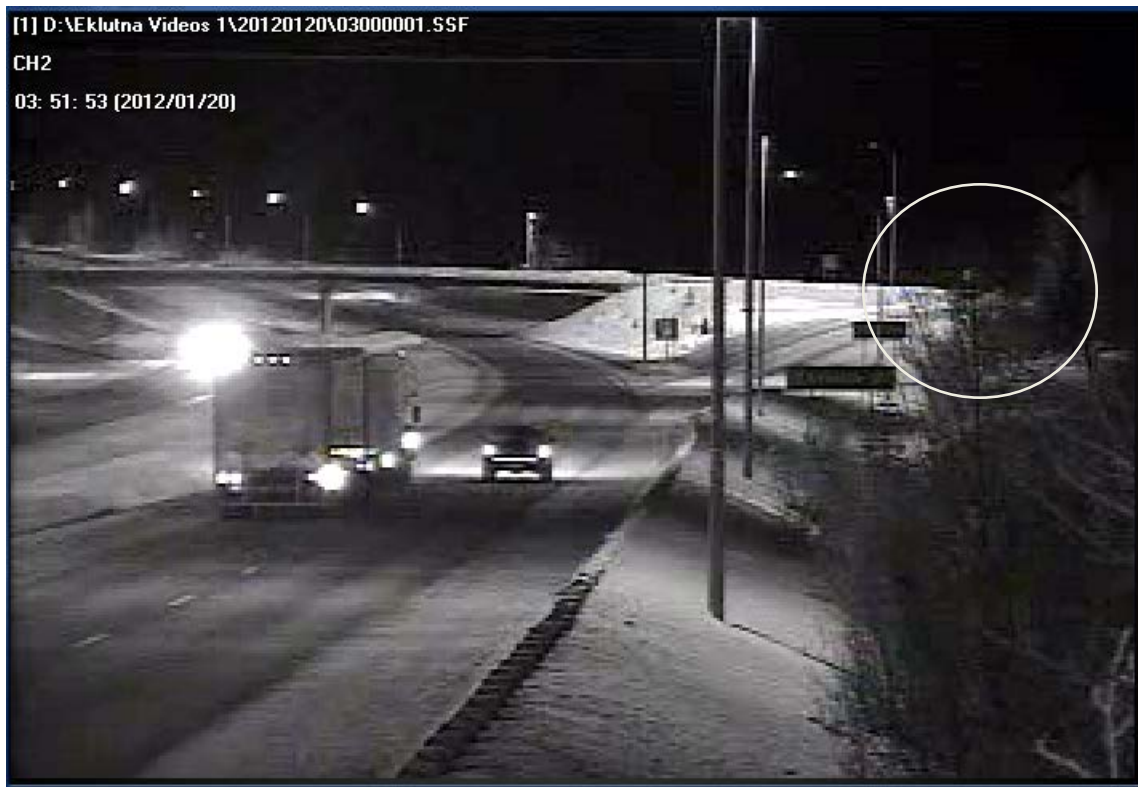
**Figure 11 The VMS before flashing (located in center of the circle area)**

The VMS sign is located at a spot near the visible limit of the images recorded by Camera#2. The activation of the VMS sign can be verified through the video images captured by Camera#2 in winter nights. Figure 12 and Figure 13 show the VMS sign before and after. When compared with Figure 12, it can be seen that VMS was illuminated in the center of the circle in Figure 13.

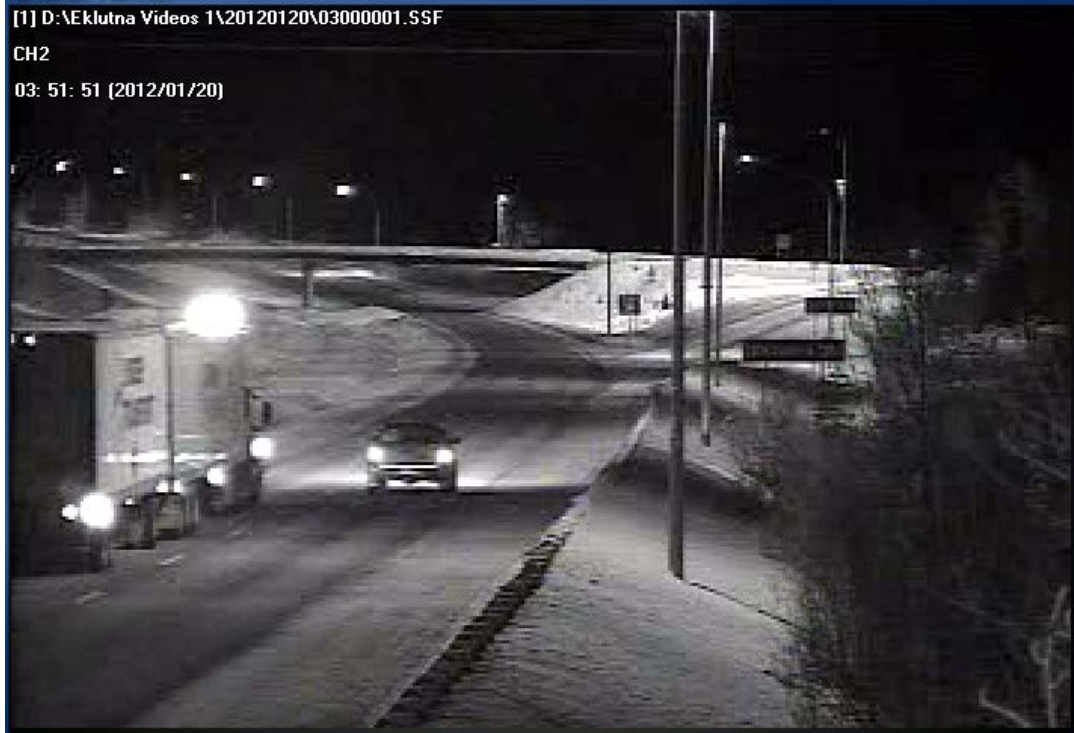
We also examined if we can unmistakably identify the triggering overheight vehicle from the images recorded by Camera#2. Specifically, we would like to know if it is possible to read the license plate numbers of the overheight trucks. After reviewing all videos, we concluded that, with the camera resolution and the lighting as they are, the only situation in which a vehicle may be identified is when the sides of the trailers are painted with recognizable signs of the trucking company. Figure 23 demonstrates one of such events. However, Figure 24 shows a more typical event in which identification of the truck in the image is not possible even during daylight hours. If one of the purposes of an overheight detection system is to gather evidence for investigating specific bridge impacts, the resolution of camera#2 would need to be increased, or an additional camera close to the bridge need to be installed. Note that there may not be existing electrical conduits to be used to connect the additional camera. Thus, if an additional camera is to be used, additional cost to put in the conduits may be required.

Figure 22 Truck with visible marking on the trailer

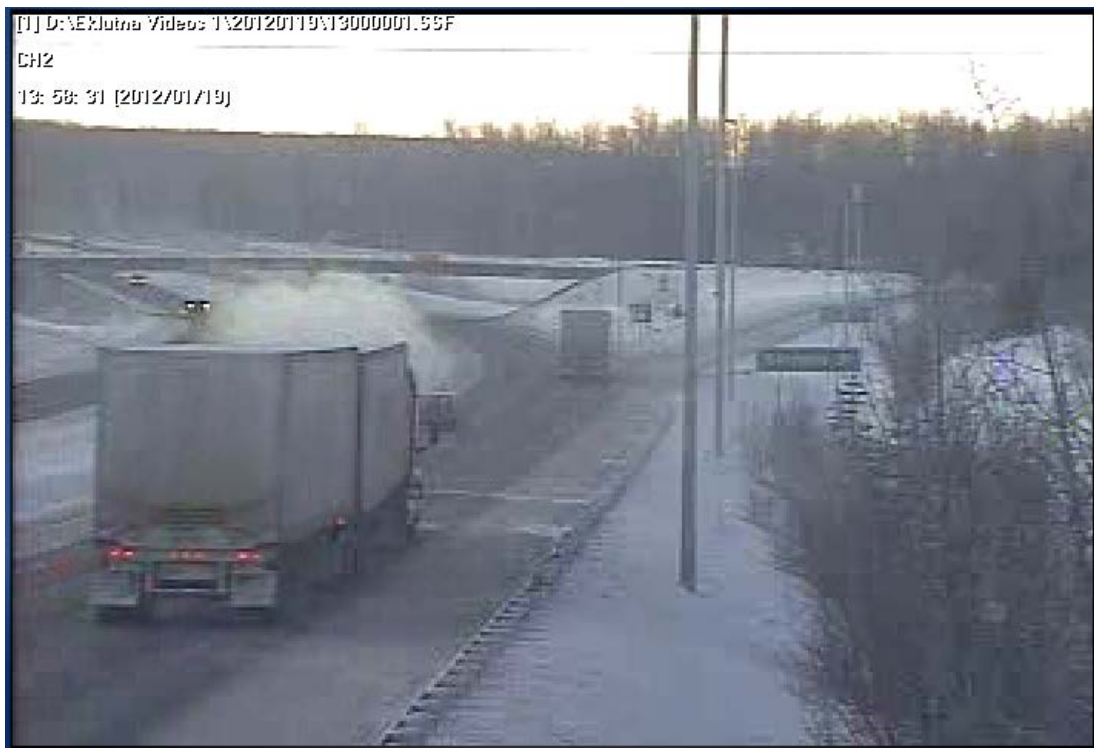
Figure 23 Truck with no visible marking on the trailers
