Western Iowa Missouri River Flooding— Geo-Infrastructure Damage Assessment, Repair, and Mitigation Strategies

SEPTEMBER 2013

Final Report

Federal Highway Administration
Iowa Highway Research Board
(IHRB Project TR-638)
Iowa Department of Transportation
(InTrans Project 11-419)

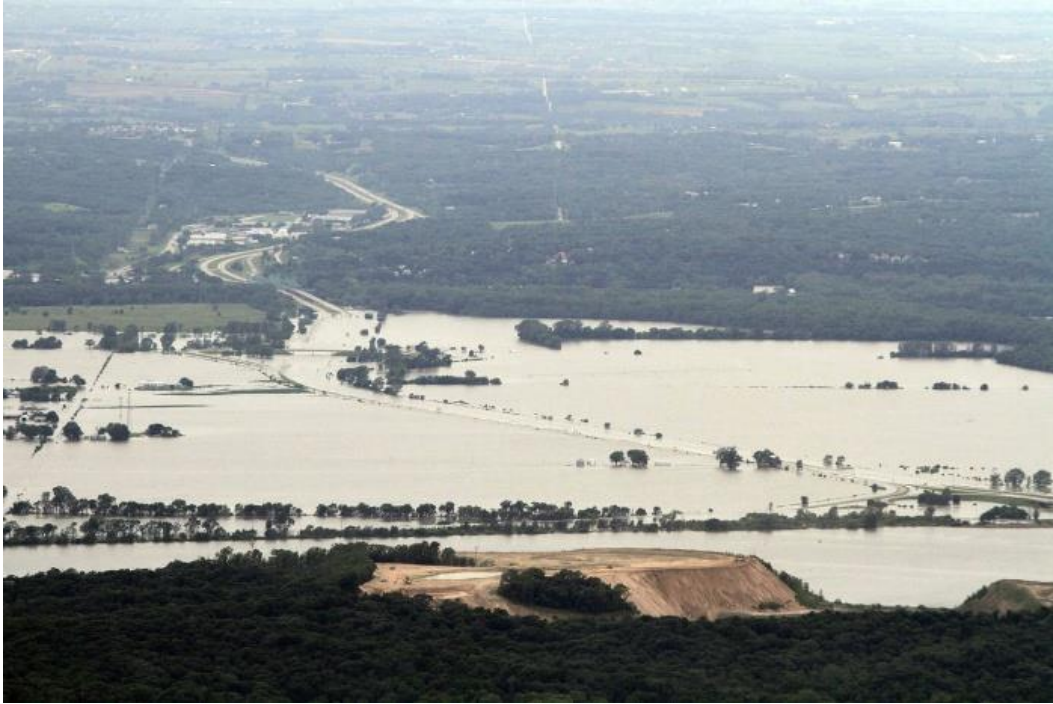
Figure 10. Aerial photo of the flooding on I-29 between Council Bluffs and Hamburg, Iowa on June 16, 2011 (Image Courtesy of Rodney White, The Register)

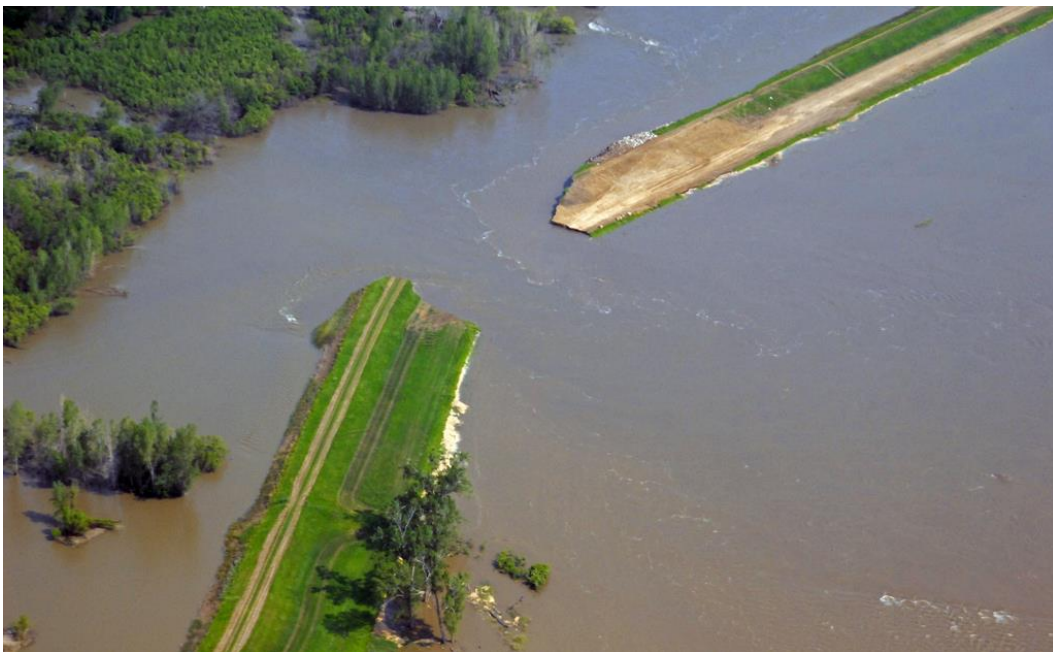
Figure 11. Aerial photo of the full breach at Federal levee 575 near Hamburg, Iowa, on June 14, 2011 (Image Courtesy of USACE <http://www.flickr.com/photos/usacehq/5837117182/in/photostream/>)

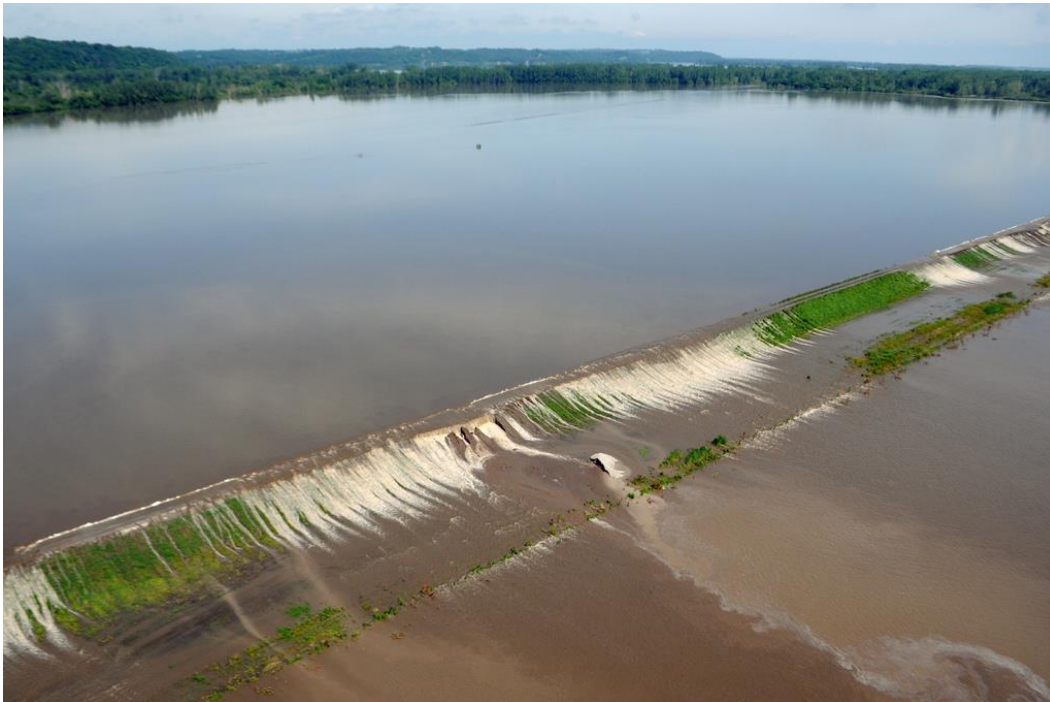
Figure 13. Aerial photo of the overtopping of Federal levee 550 near Highway 136 in Atchison County, Missouri, on June 19, 2011 (Image Courtesy of USACE <http://www.flickr.com/photos/usacehq/5849817627/in/photostream/>)

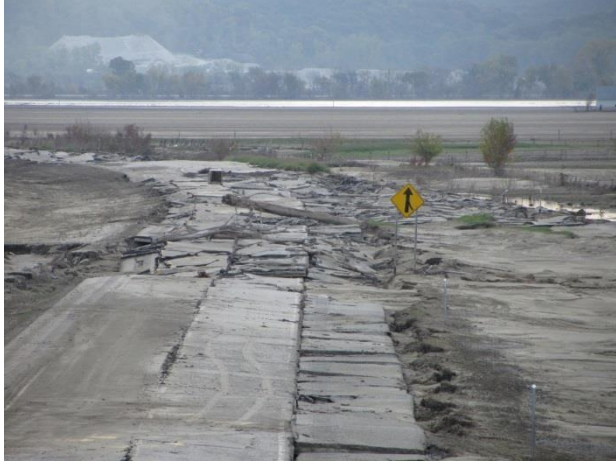
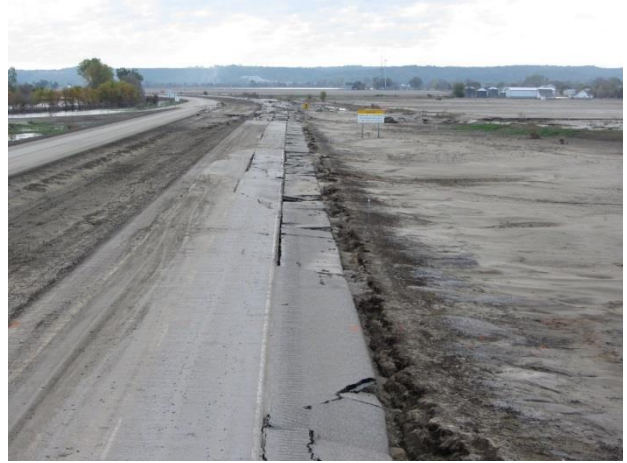
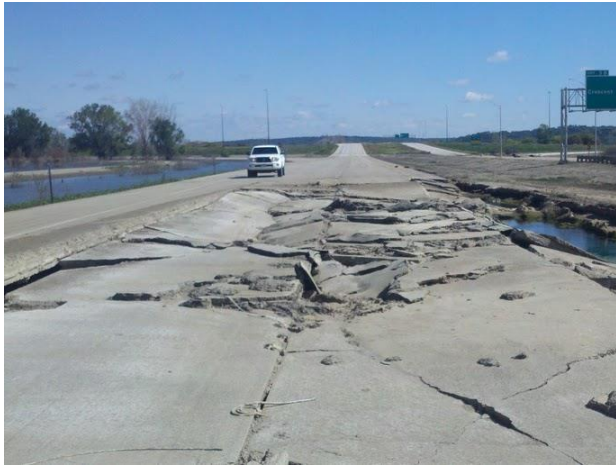
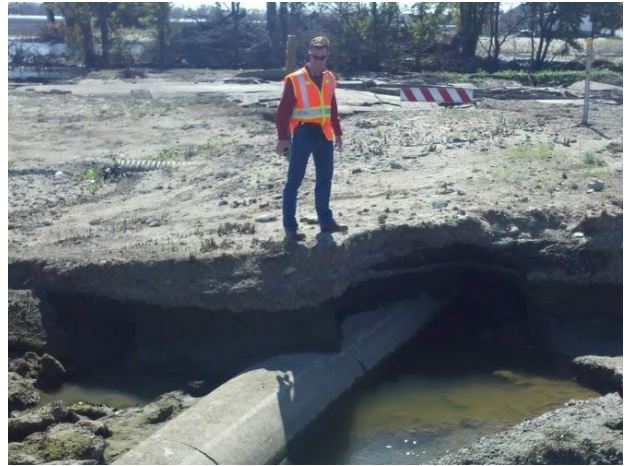
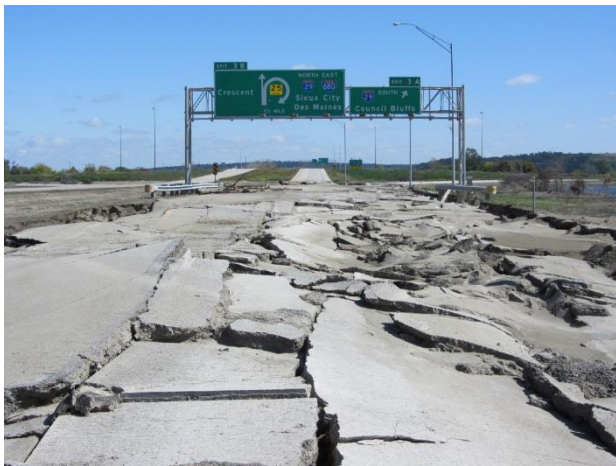
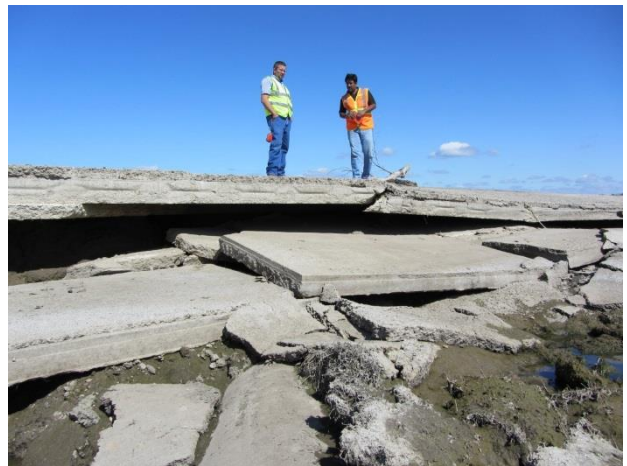
Figure 27. Pictures taken near I-29 and I-680 intersection north of Council Bluffs on 9/21/2013

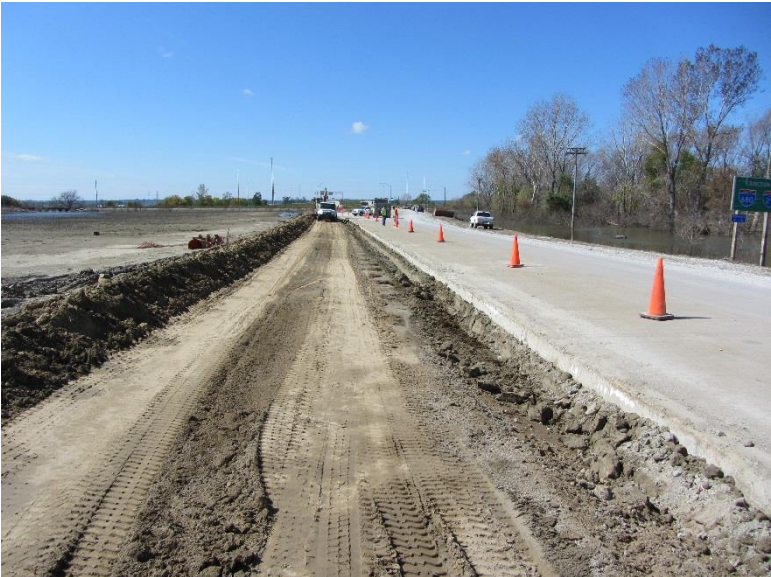
Figure 41. Eroded shoulder next to PCC pavement being reconstructed on 9/21/11 – Old Mormon Road (looking west towards I-680 and I-29 intersection), Pottawatamie County (Photos taken on 9/21/11)

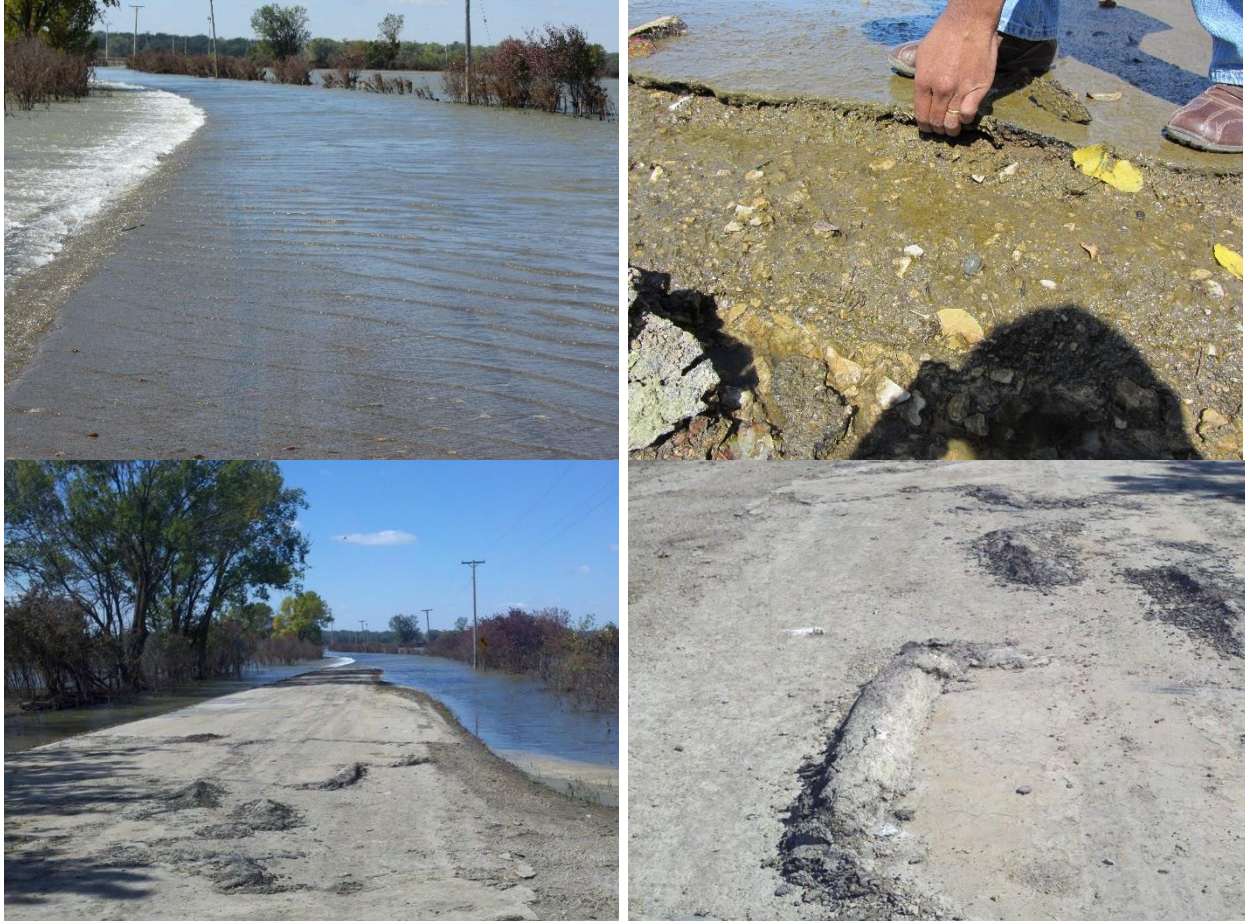
Figure 42. Water overtopping a thin chipseal coat surfaced road underlain by oil stabilized granular base on 9/21/11 showing delamination of chipseal and rolled asphalt at the surface – Desoto Avenue, Pottawattamie County (Photos taken on 9/21/11)

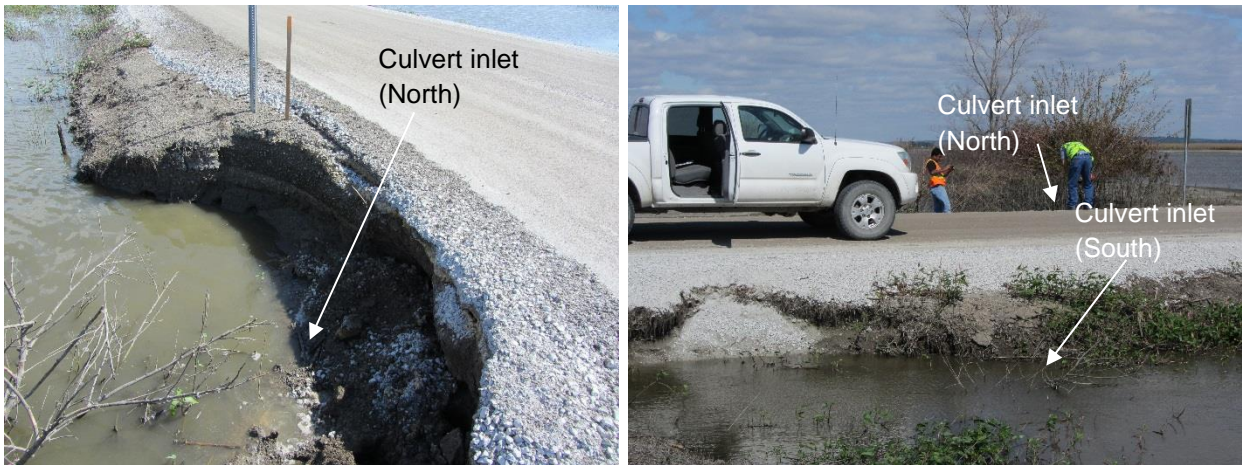
Figure 43. Clogged culvert inlets due to scouring and erosion of embankment material beneath chipseal coat surfaced road on 9/21/11 – Desoto Avenue, Pottawatamie County (Photos taken on 9/21/11)

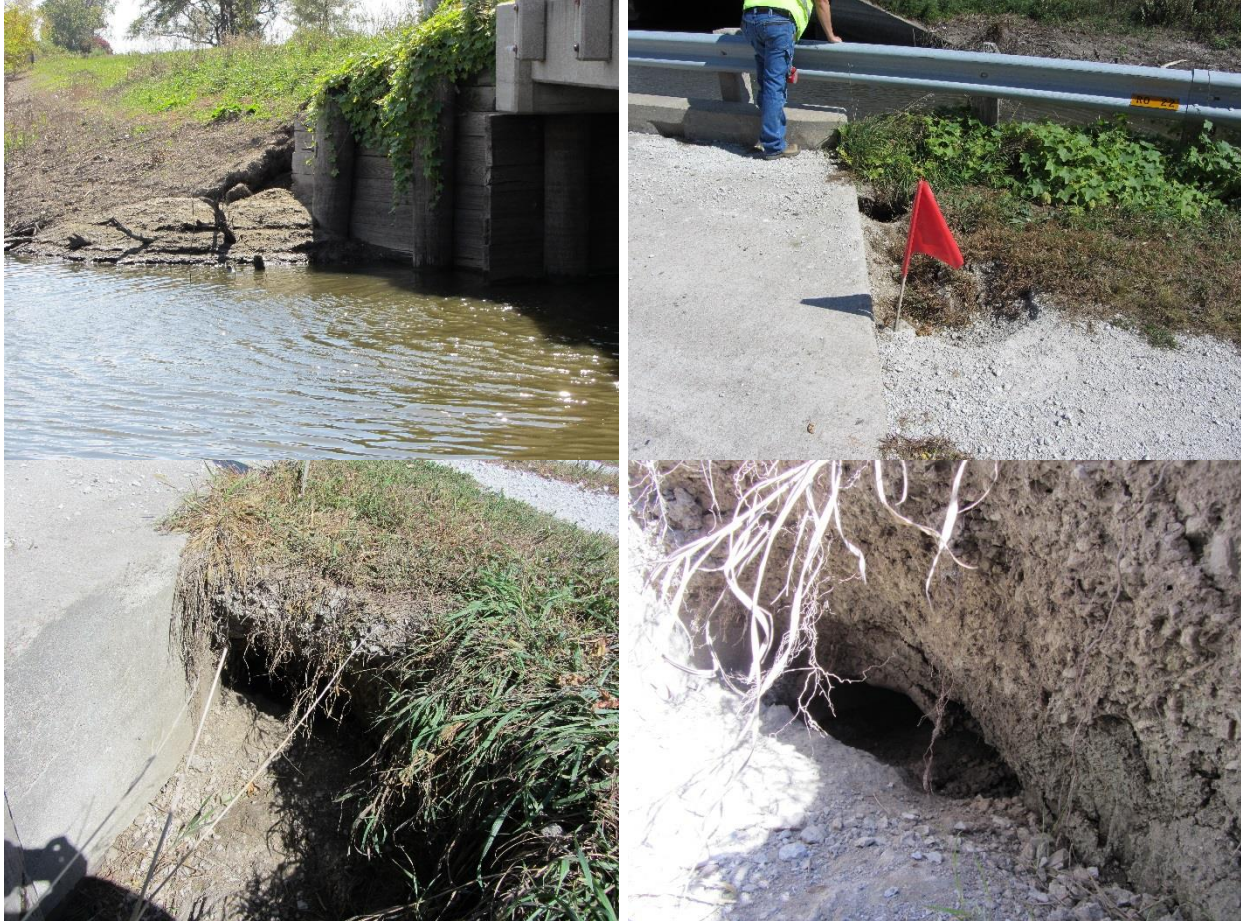
Figure 44. Scouring and erosion of bridge backfill material around a timber abutment supporting a concrete bridge deck – Pottawatamie County (Photos taken on 9/21/11)

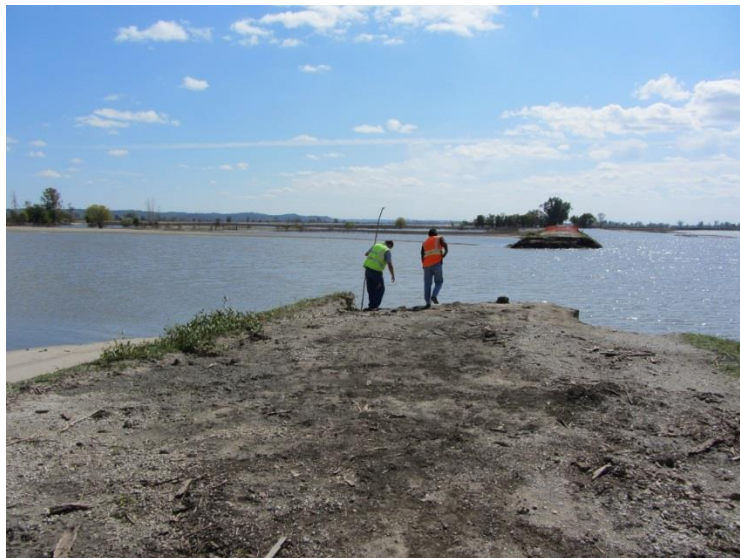
Figure 45. Full breach of about 150 m (500 ft) long unsurfaced access road – Pottawatamie County (Photo taken on 9/21/11)

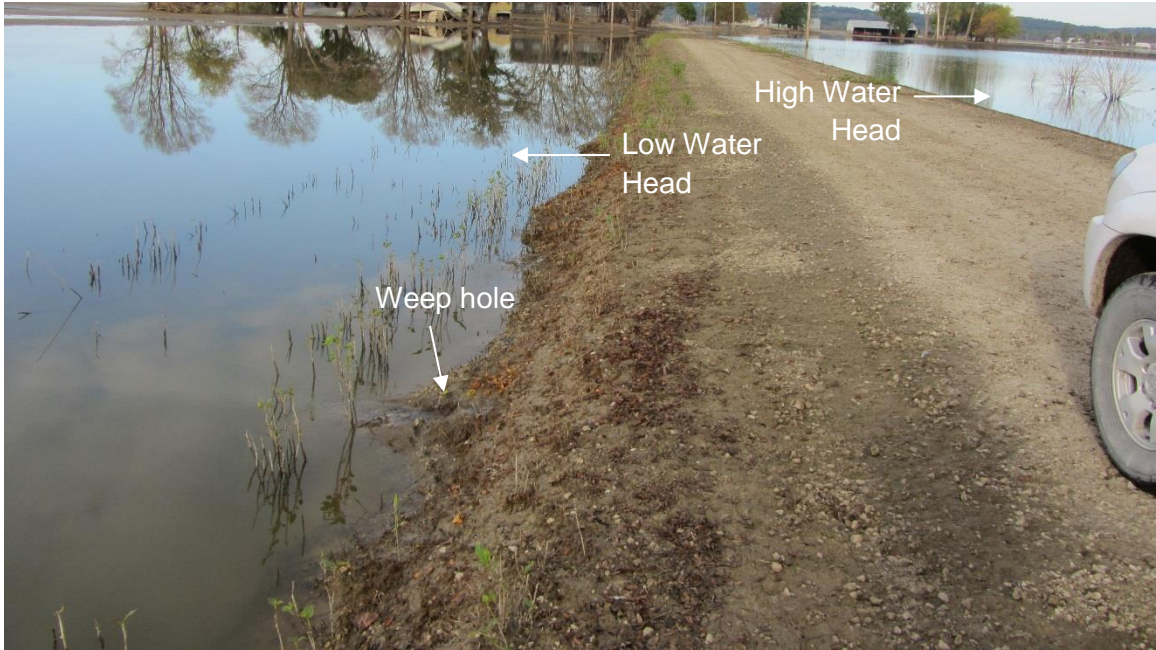
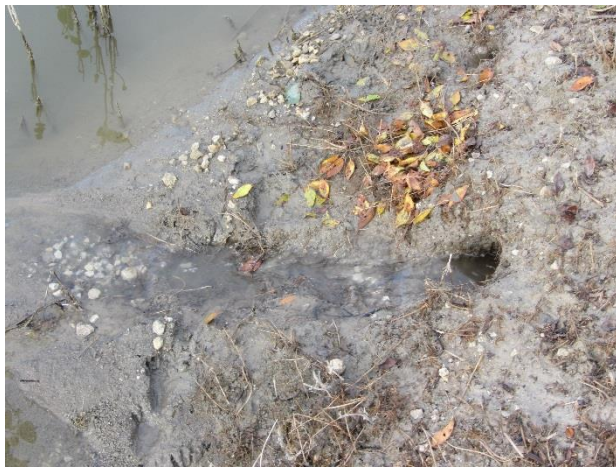
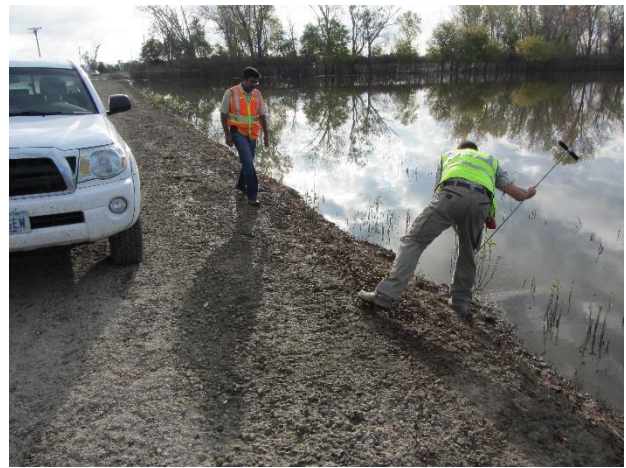
Of the areas that were surveyed during the field visits, two areas posed significant safety concerns to traffic due to damage that was not apparent at the surface (i.e., due to damage that occurred beneath the surface). One of those areas resulted in deep potholes on a gravel road due to eroded backfill around a culvert in Pottawattamie County (see Figure 46) and the other resulted in deep voids beneath roadway due to eroded backfill around a bridge abutment in Fremont County (see Figure 54). Such areas can go undetected with just visual surveys at the surface and pose a significant risk to traffic.

Figure 46. Potholes (with about 0.5 m (1.5 ft) diameter) under gravel road due to erosion of backfill material around a culvert located beneath the road – Pottawatamie County (Photos taken on 9/21/11 and 9/23/11)

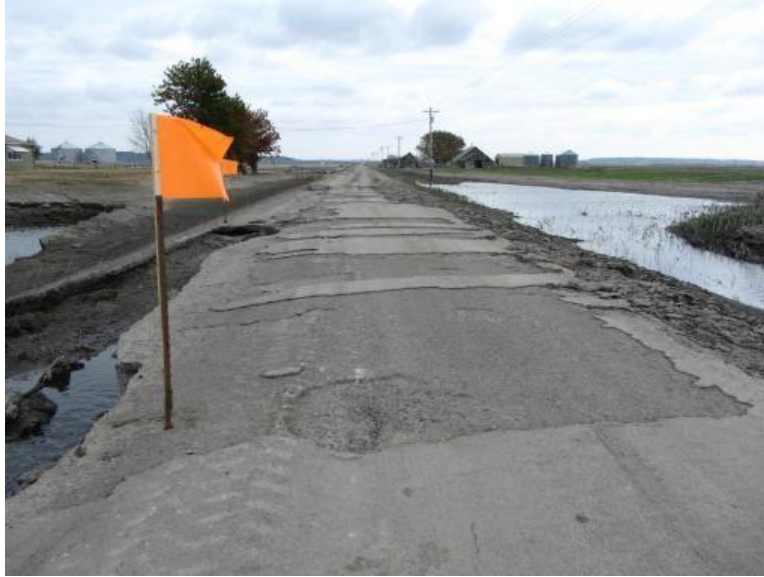
Figure 49. Erosion of shoulder and roadbed on a chip seal surfaced gravel road – Fremont County (Photo taken on 10/26/11)

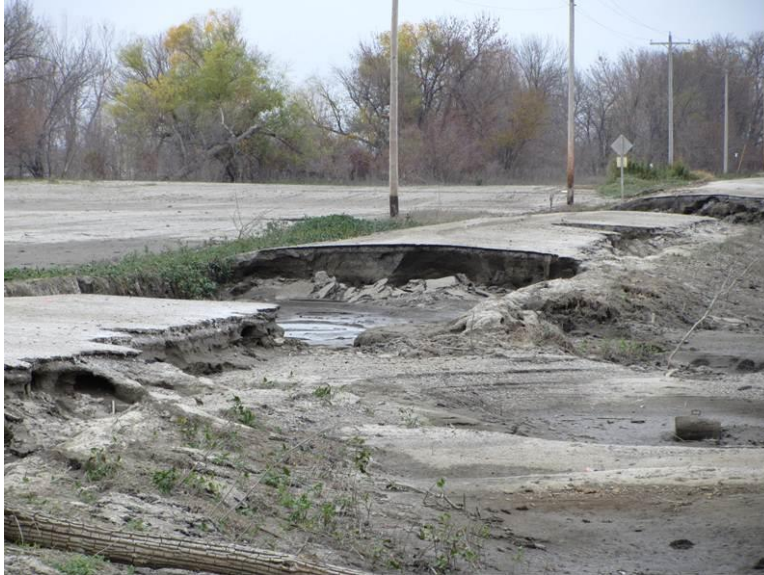
Figure 51. Full breach of a gravel road (about 100 m (330 ft) long) – Fremont County (Photo taken on 10/26/11)

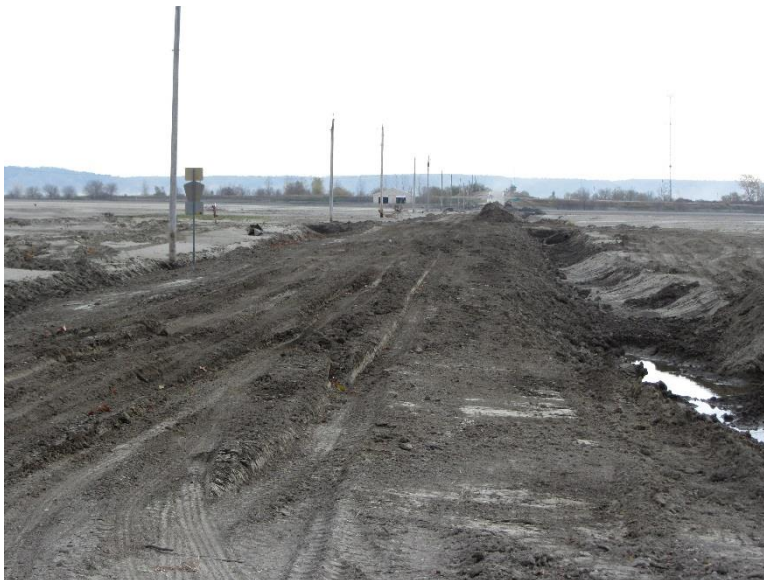
Figure 52. Gravel road segments washed away during floods – Fremont County (Photo taken on 10/26/11)

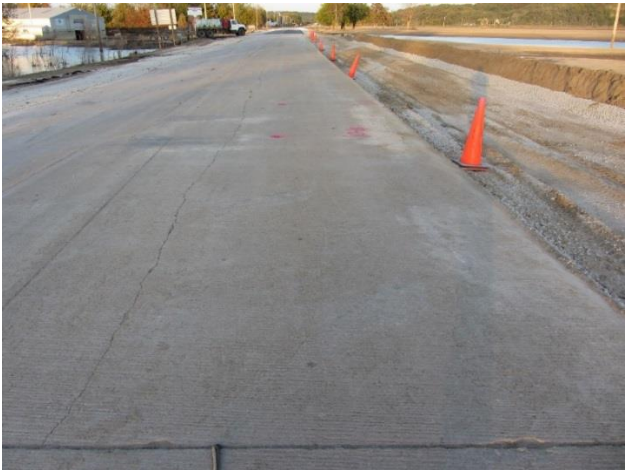
During the 2011 flood event, the test segment was fully submerged for about two months (Figure 62). Reportedly, the flood waters receded in the area on 9/1/11. The TS reportedly experienced heavy water currents as the water levels fluctuated during the flood event. The granular shoulders were completely eroded, a portion of the pavement was washed away, and subbase layer under the pavement was eroded in a portion of the TS (Figure 63). The section where the pavement was washed away was replaced with a new 230 mm (9 in.) thick PCC pavement placed directly over the subgrade. Flowable cement grout was used to fill the voids formed due to subbase layer erosion. Pictures taken two days after cement grout was placed are shown in Figure 63. The grout was very soft and did not setup even two days after placement. Field engineers indicated that there could have been water beneath pavement during grouting. Longitudinal cracks were observed on a few panels where the subbase layer was eroded (Figure 64).

Figure 64. Longitudinal cracks on PCC pavement with undermined base material on TS2 (Photo taken on 9/21/11) – Pottawattamie County

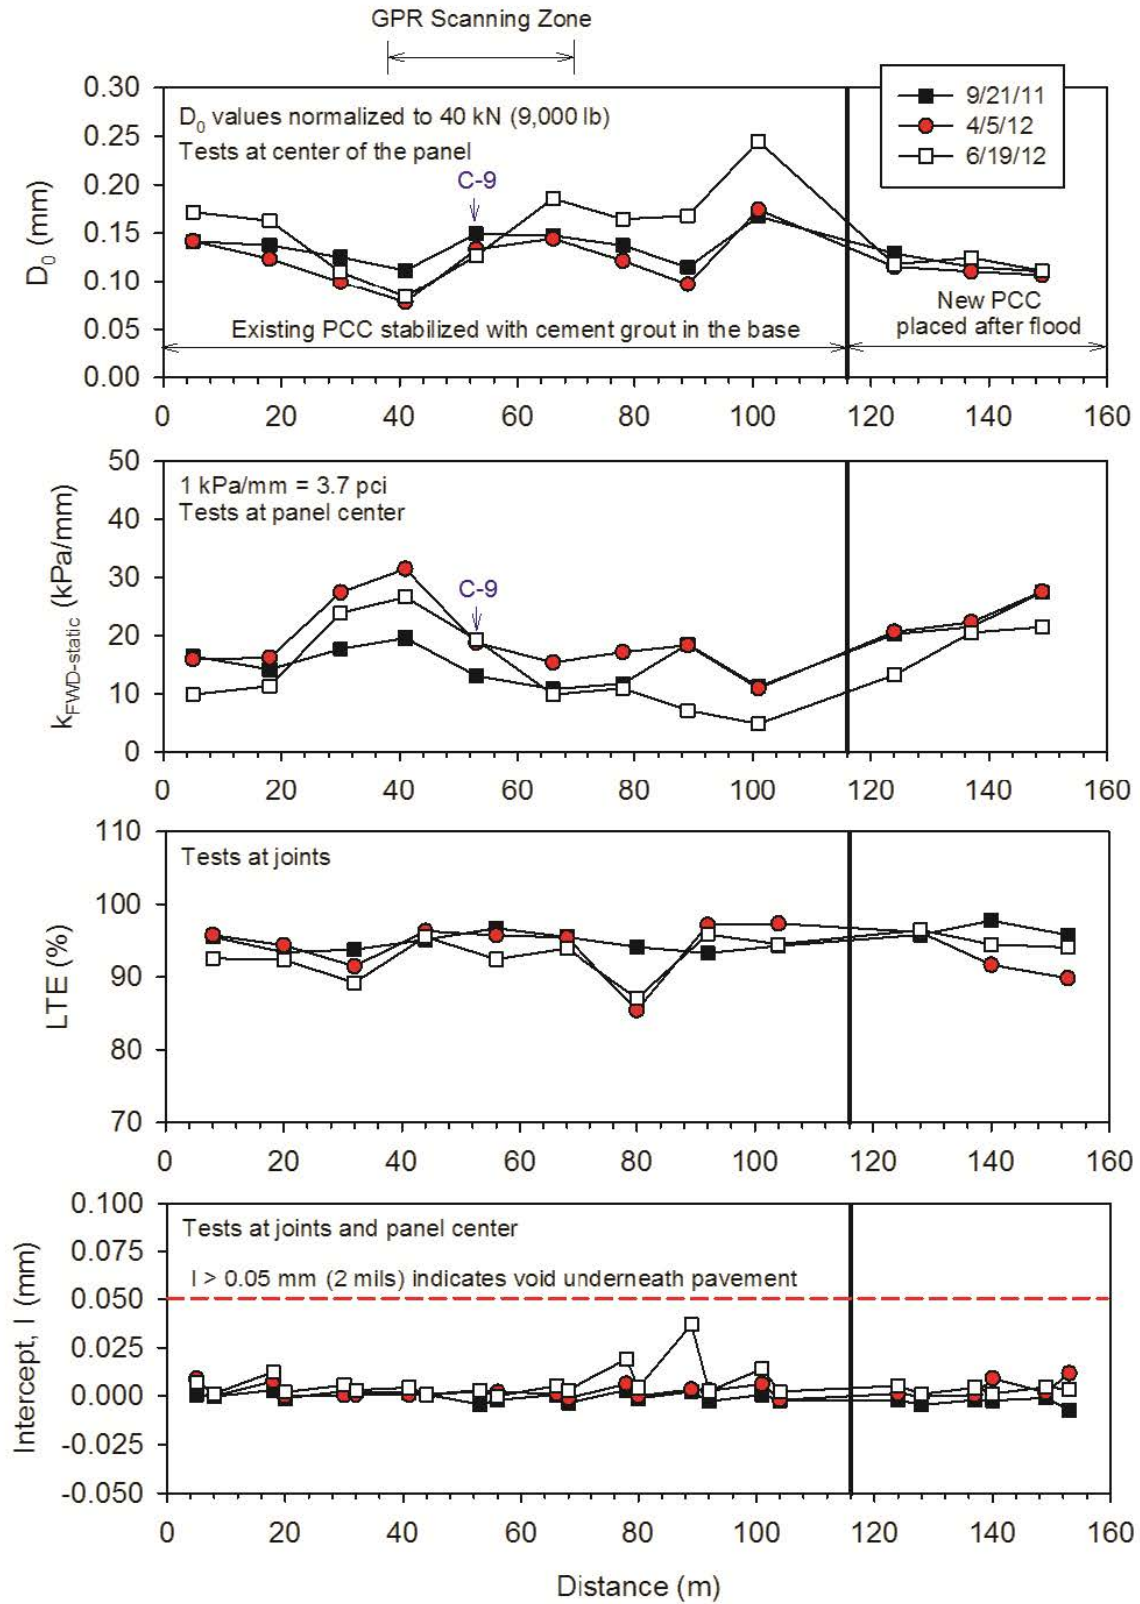
Figure 65. FWD results from three different testing times after flooding on TS2 – Pottawattamie County

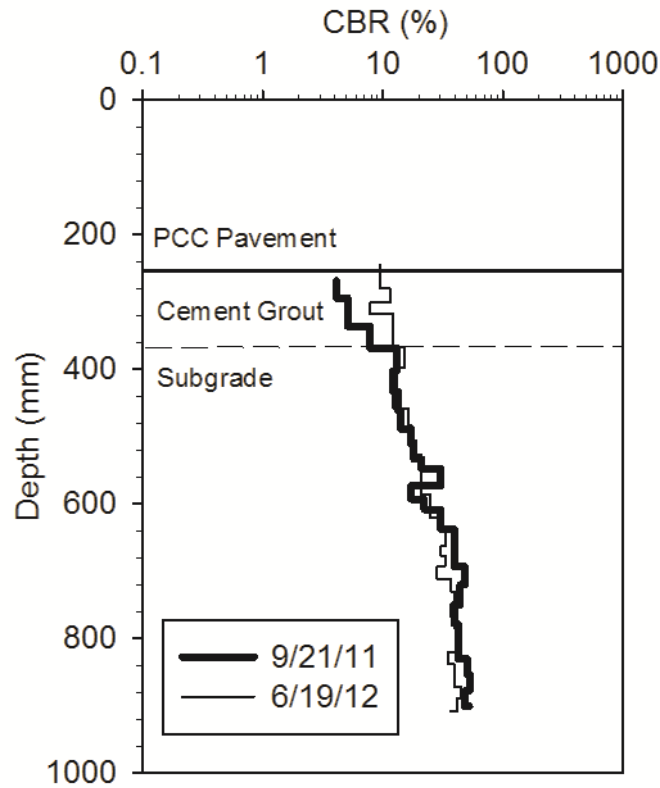
Figure 66. DCP-CBR profiles at one test locations at two different times after flooding on TS2 – Pottawattamie County

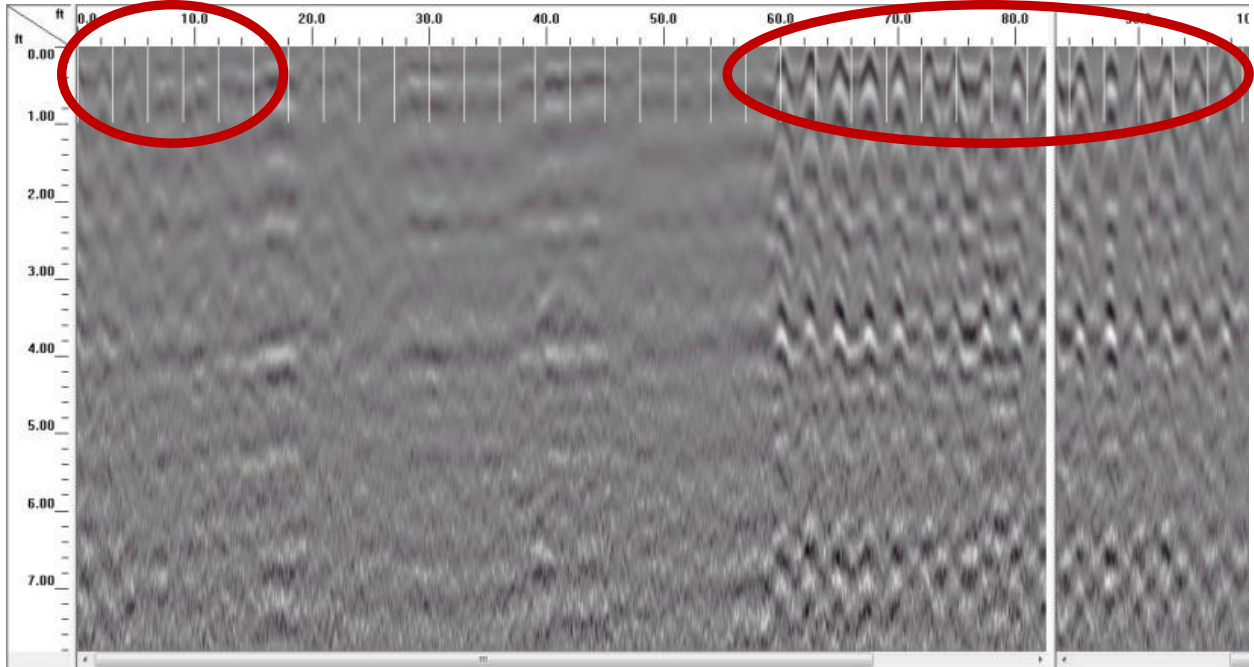
Figure 68. GPR scan using 400 MHz antenna along the north side of the east bound lane on TS2 (note 0 ft on the figure represents the 38 m station and the 100 ft on the figure represents the 68 m station of the TS) – areas circled in red denote rebar in pavement – Pottawattamie County

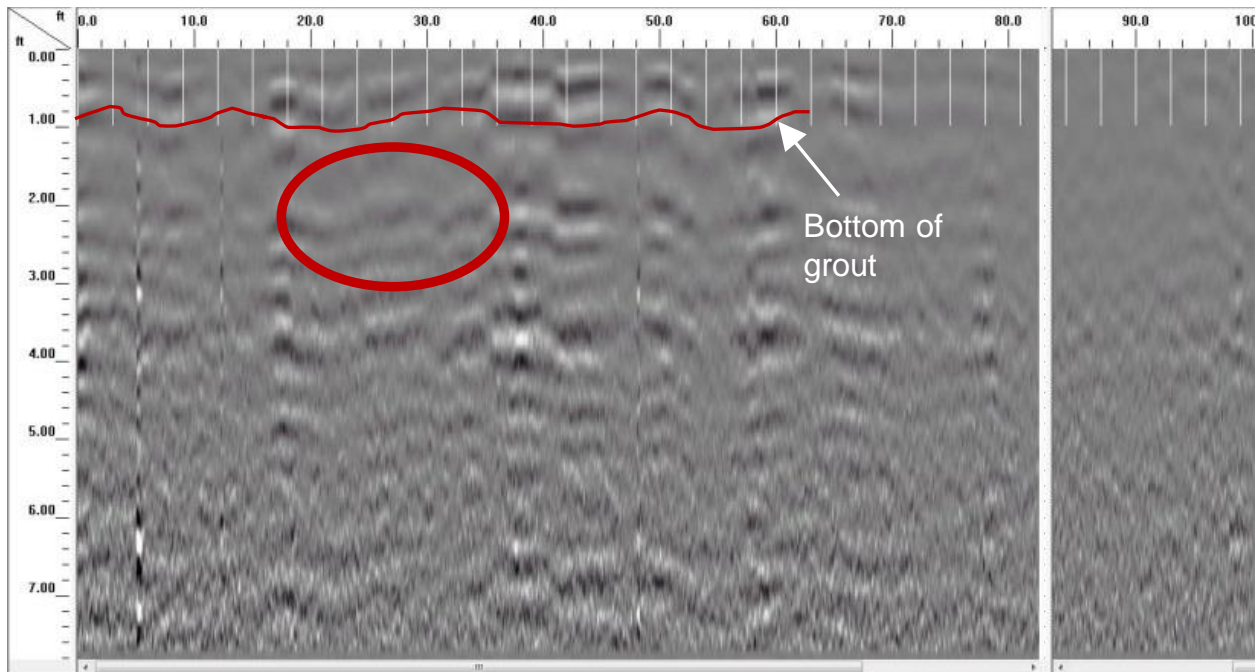
Figure 70. GPR scan using 400 MHz antenna along the south side of the east bound lane on TS2 (note 0 ft on the figure represents the 38 m station and the 100 ft on the figure represents the 68 m station of the TS) – area circled in red denote a potential void zone beneath pavement – Pottawattamie County

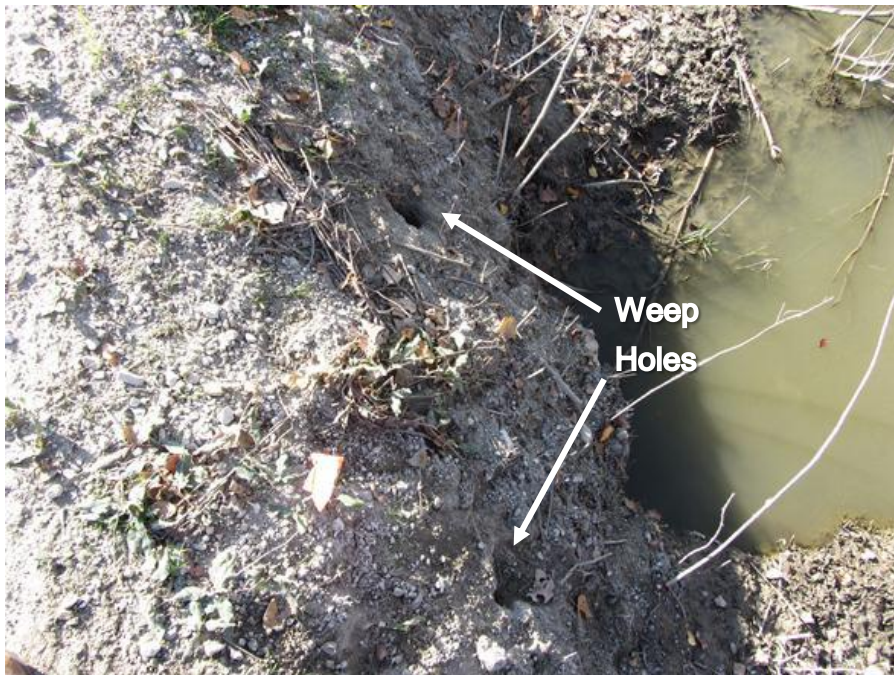
- Ground water level was located at about 1.27 m below surface under the roadway, while the water level in the ditches was about 0.15 m below the gravel surface during 9/22/11 testing (about 21 days after flooding). Moisture contents varied from about 18 to 22% above the water table. During field visit on 10/25/11, some subsurface weep holes were observed around the culvert (Figure 73), indicating erosion of material around the culvert.

Figure 73. Weep holes near culvert on TS3 (Photo taken on 10/25/2011) – Pottawattamie County

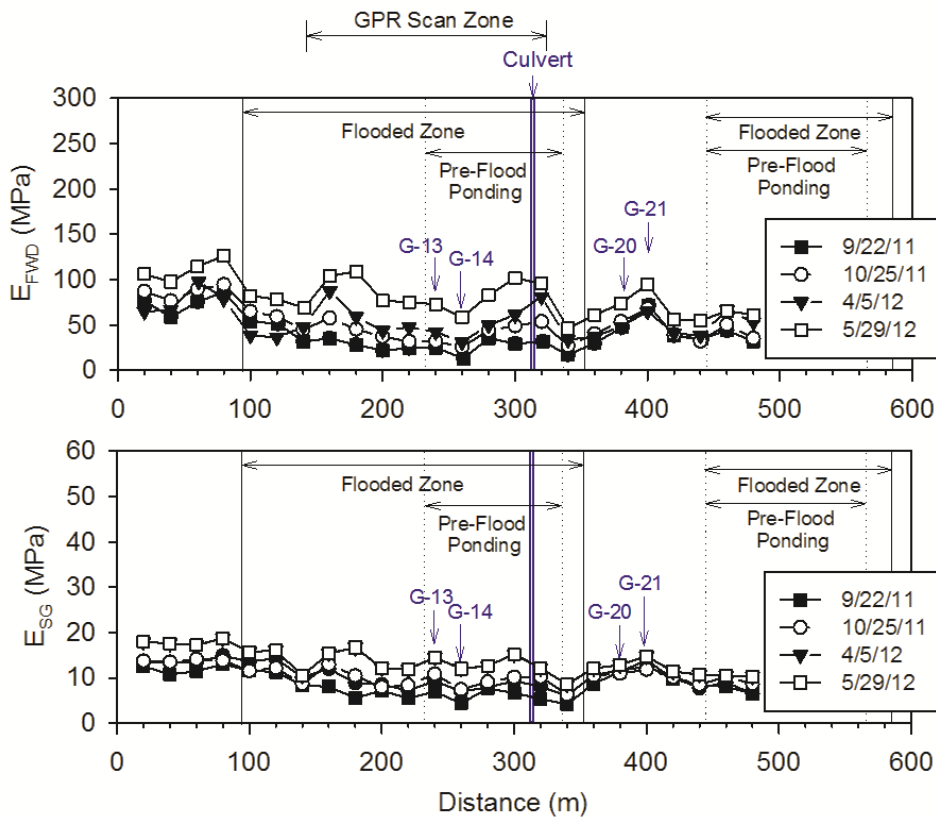
- The DCP and FWD test results on this test segment illustrate that both subgrade and the surface gravel layers gained strength with time, likely because of subgrade material drying over time.

Figure 75. Surface FWD modulus and subgrade modulus at four different times after flooding on TS3 – Pottawattamie County

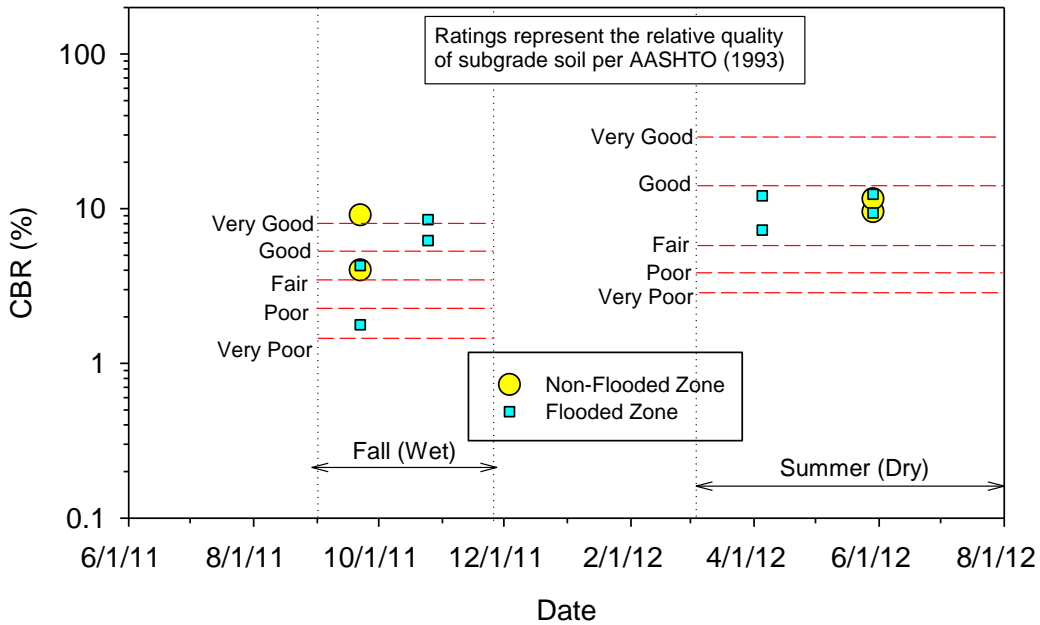
- The subgrade CBR values (averaged over the top 300 mm) in the flooded zone increased (from 1.7 to 6.4 and 4.0 to 8.5 at the two locations) from 21 to 54 days after flooding. At 21 days after flooding, subgrade CBR values in the non-flooded zone were higher (4.5 and 8.2) than the values in flooded zone (1.7 and 4.0), but they were about the same (10 to 12) at 8 months after flooding.

Figure 78. Comparison of subgrade CBR values in flooded and non-flooded zones with relative quality ratings on TS3 – Pottawattamie County

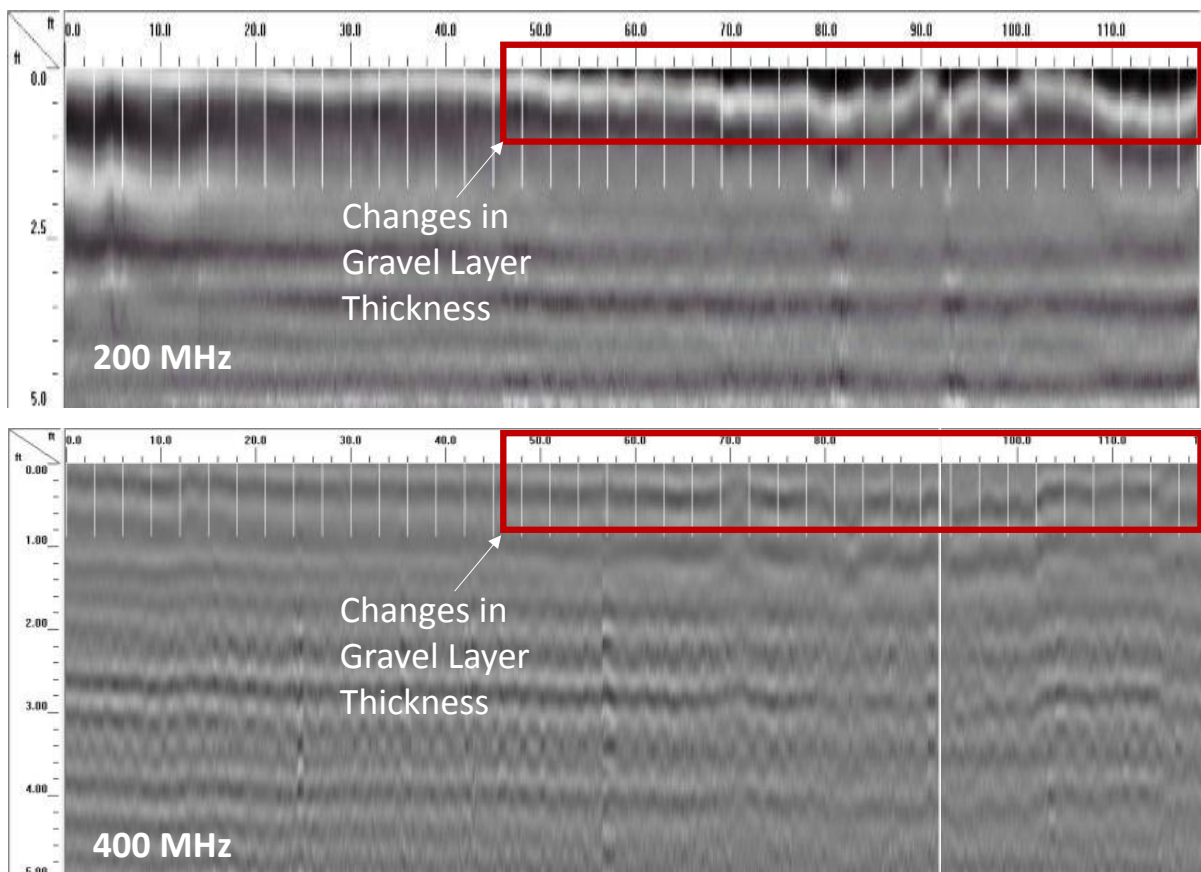
- Changes in gravel layer thickness along the roadway were identified in both 200 MHz and 400 MHz antenna scans (Figure 68). Note that the depths on the vertical scale were not calibrated with the actual depth measurements and they must be considered approximate. However, if calibrated (i.e., if verified with a known feature at known depth in situ), gravel layer thickness can be obtained accurately.

Figure 79. GPR scans using 200 and 400 MHz antennas on TS3 (note 0 ft on the figure represents the 130 m station of the TS) – Pottawattamie County

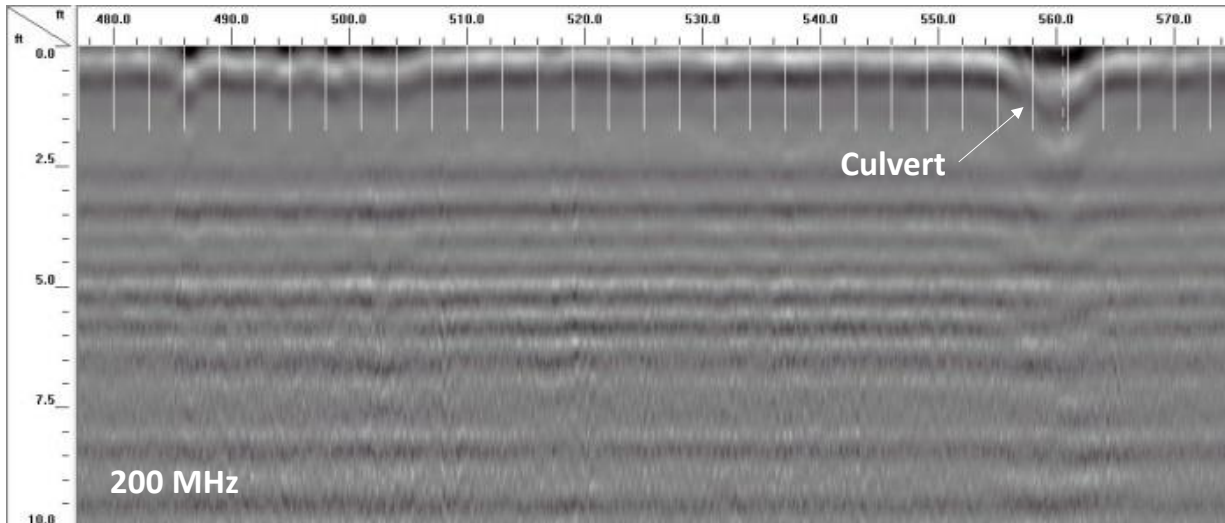
- Culvert location was identified in the scans as shown in Figure 80.
- No weep holes were noted in the scans. Although they were visible near the culvert during 10/25/11 field visit, they were not seen at the time of scanning on 6/19/12.

Figure 80. GPR scan using 200 MHz antenna on TS3 (note that 560 ft on the figure represents the 310 m station (at culvert) of the TS) – Pottawattamie County

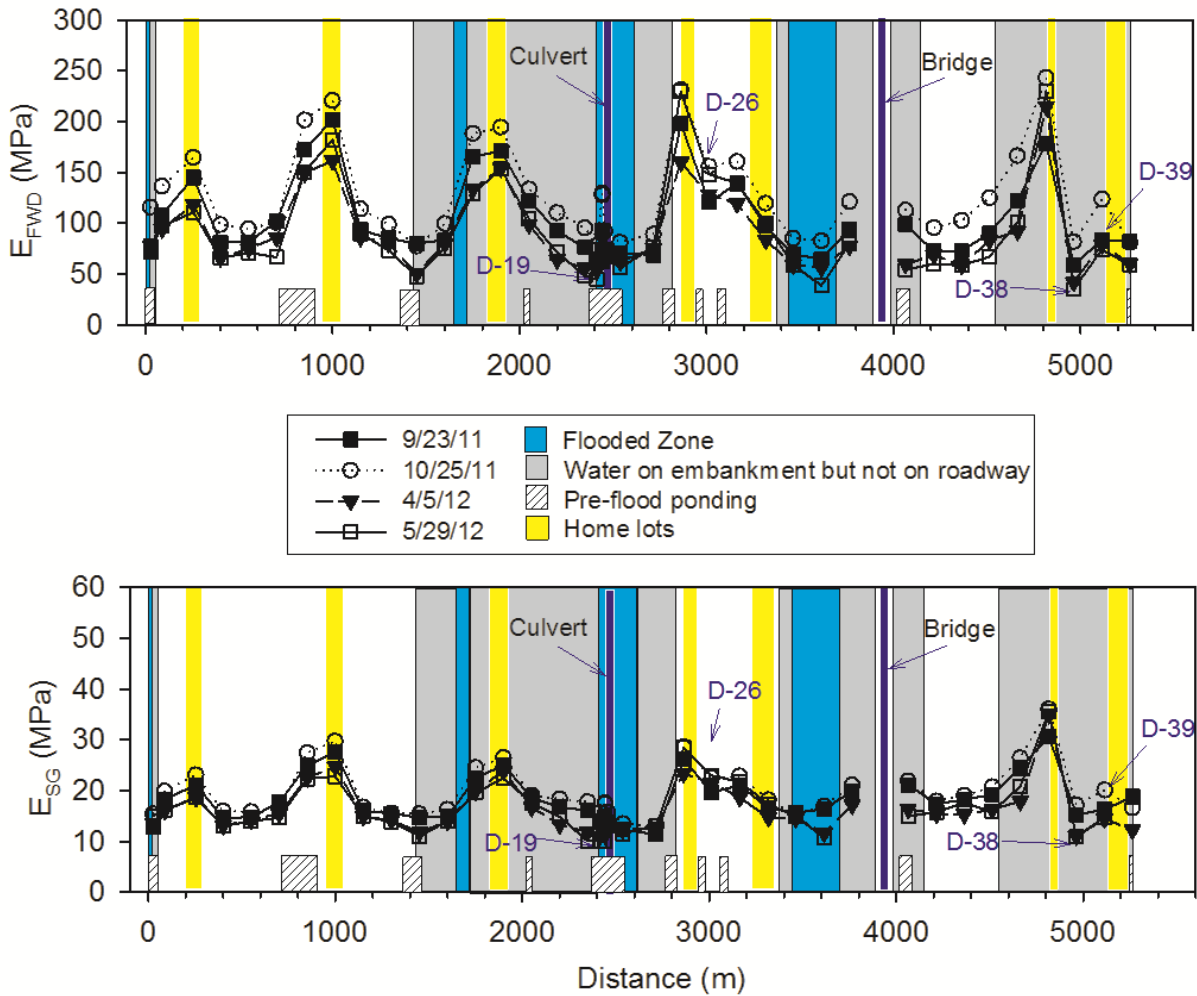
- The DCP and FWD test results on this TS illustrate that flooded areas were comparatively softer than the non-flooded areas and remained the same even at 8 months after flooding.

Figure 83. Surface FWD modulus and subgrade modulus at four different times after flooding on TS4 (highlighted in color are drainage, flooding, and home lot features observed from aerial maps) – Pottawattamie County

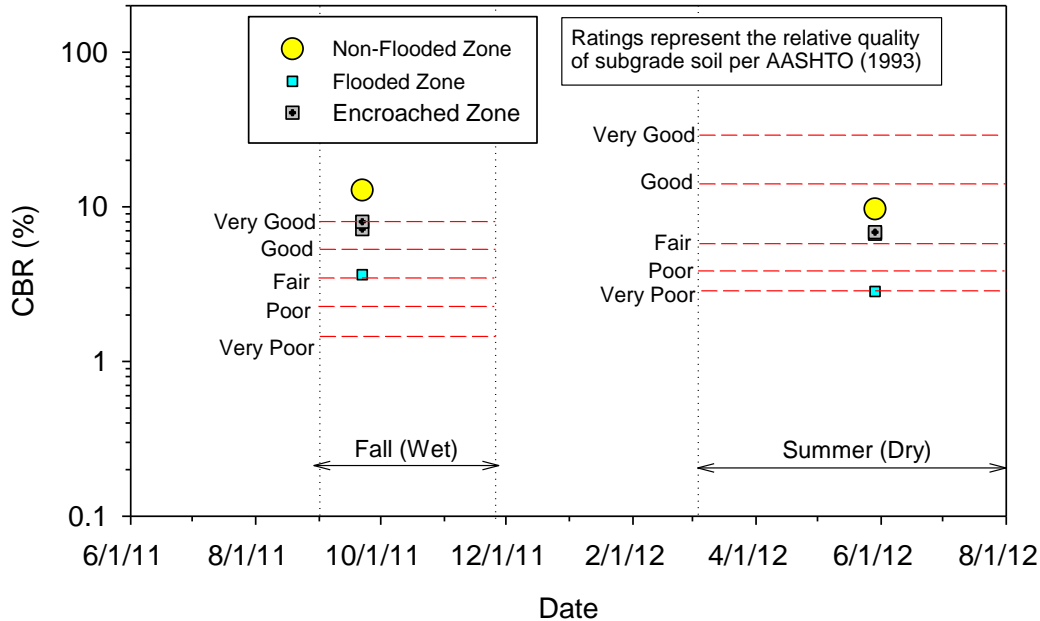
- The CBR of the stabilized gravel layer was about the same in flooded and non-flooded zones (>50), but the CBR of the subgrade layer (in the top 300 mm) was not. At 22 days after flooding, the subgrade CBR was about 3.7 in the flooded zone, 7.7 in the encroached zone, and about 14 in the non-flooded zone. This trend remained the same but the values decreased slightly during testing at 8 months after flooding (see Figure 86).

Figure 86. Comparison of subgrade CBR values in flooded and non-flooded zones with relative quality ratings on TS4 – Pottawattamie County
