Western Iowa Missouri River Flooding— Geo-Infrastructure Damage Assessment, Repair, and Mitigation Strategies

SEPTEMBER 2013

Final Report

Federal Highway Administration
Iowa Highway Research Board
(IHRB Project TR-638)
Iowa Department of Transportation
(InTrans Project 11-419)

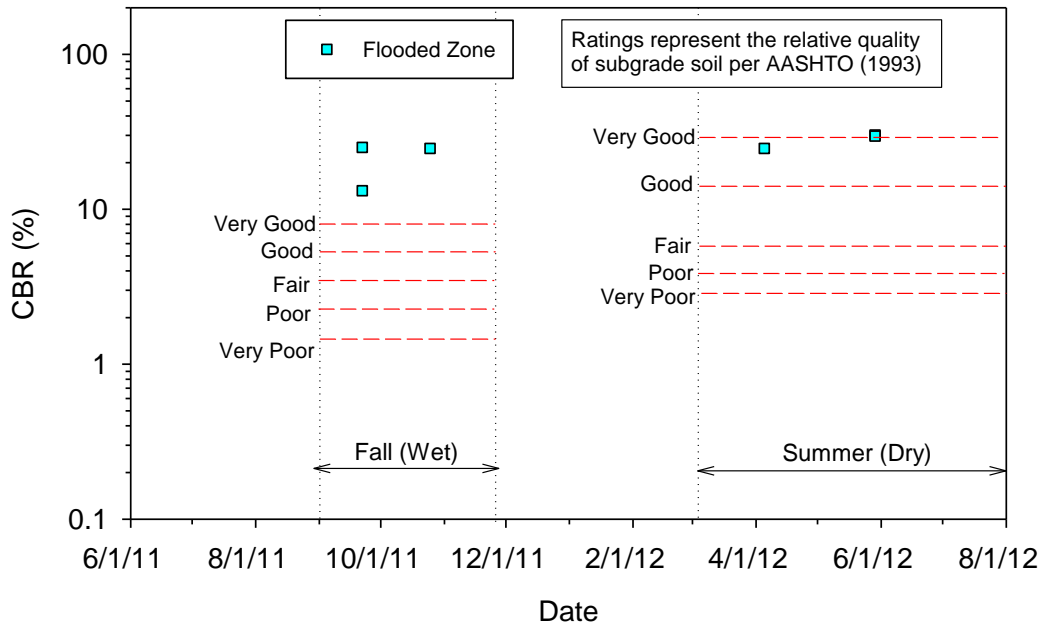
- Ground water level was located at about 0.58 m below surface under the roadway, while the water level in the ditches was close to the gravel surface during 9/23/11 testing (about 21 days after flooding). Moisture contents varied from about 12 to 18% above the water table and the material consisted of clayey to fine sand material.
- On average, the E_{SG} values in the whole TS were low and the quality is rated as “very poor” to “poor,” per AASHTO (1993). The E_{SG} values improved slightly over time (on average from about 17 to 23 MPa), likely because of subgrade material drying.
- Although limited, DCP-CBR results were in contrast with the E_{SG} values. Subgrade CBR values at two locations were > 10 on 9/23/11, which is rated as “very good,” per AASHTO (1993). Results increased over time to about 30 on 5/29/12 (Figure 96).

Figure 96. Subgrade CBR values at different testing times with relative quality ratings on TS5 – Pottawattamie County

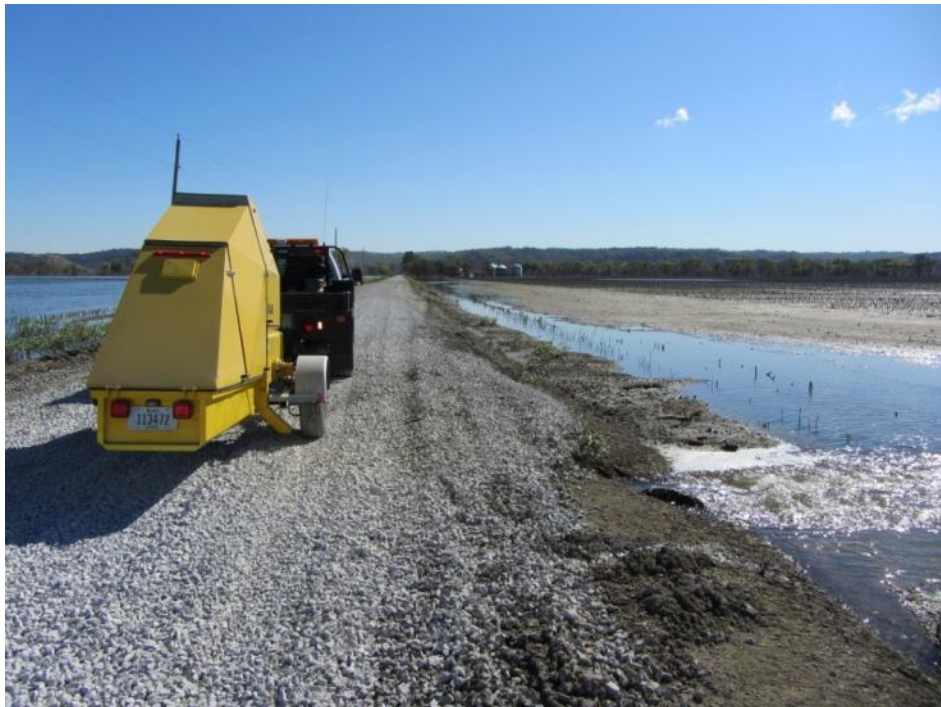
- The FWD test results showed soft conditions ($E_{SG} \leq 10$ MPa) in areas close to culverts, where the gravel was washed away and new gravel was placed, at all times of testing.

- DCP-CBR results also indicated “very poor” subgrade conditions (with $CBR < 2$ within the top 200 mm of subgrade) at 23 days after flooding, at a test location that showed the lowest E_{SG} value (9 MPa). The test area was located near a culvert, where gravel was washed away and new gravel was placed. The subgrade CBR values improved to “fair” to “good” conditions (with $CBR = 6.0$ and 8.8) at 6 and 8 months after testing (Figure 117).

Figure 111. Newly placed gravel showing rutting near culvert (Picture taken on 9/23/2011) – Pottawattamie County

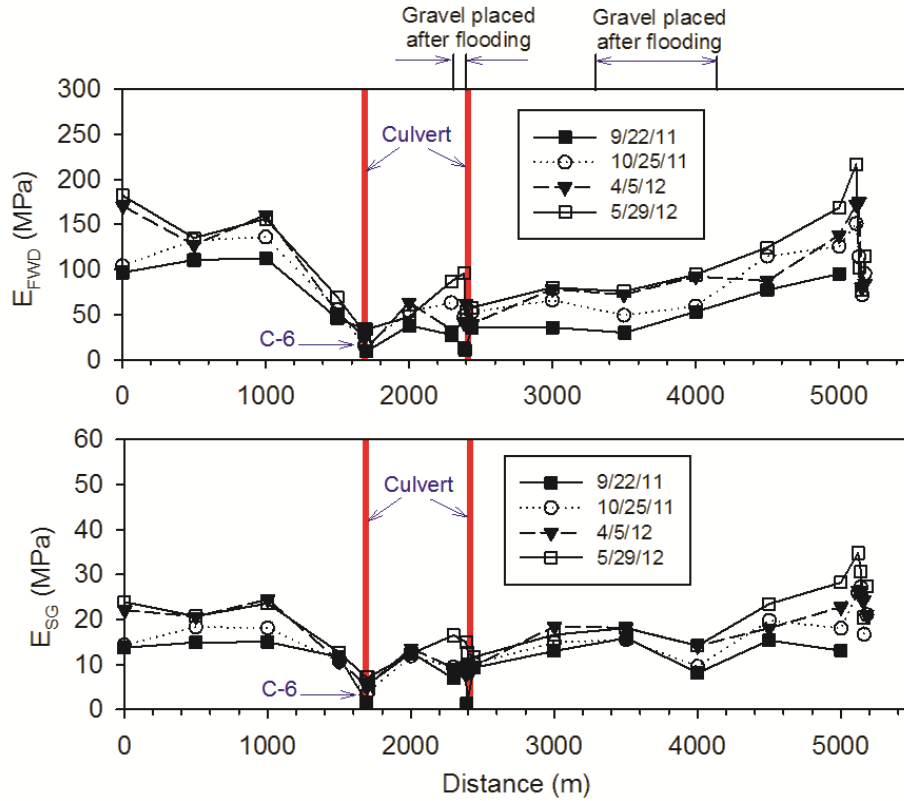
Figure 114. Surface FWD modulus and subgrade modulus at four different times after flooding on TS6 – Pottawattamie County

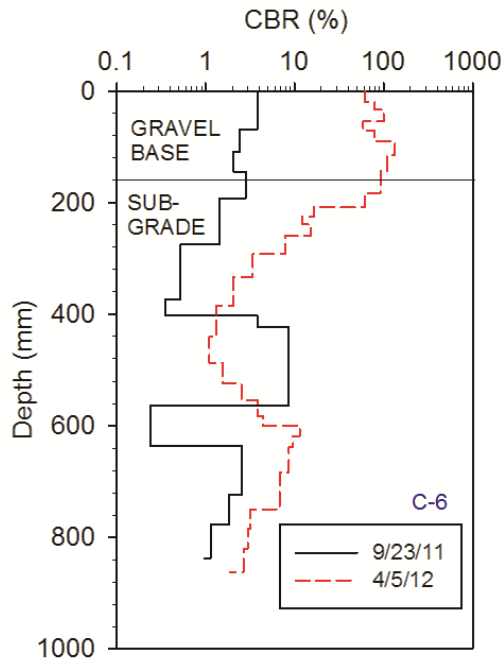
Figure 115. DCP-CBR profiles from two different testing times at C-6 test location on TS6 – Pottawattamie County

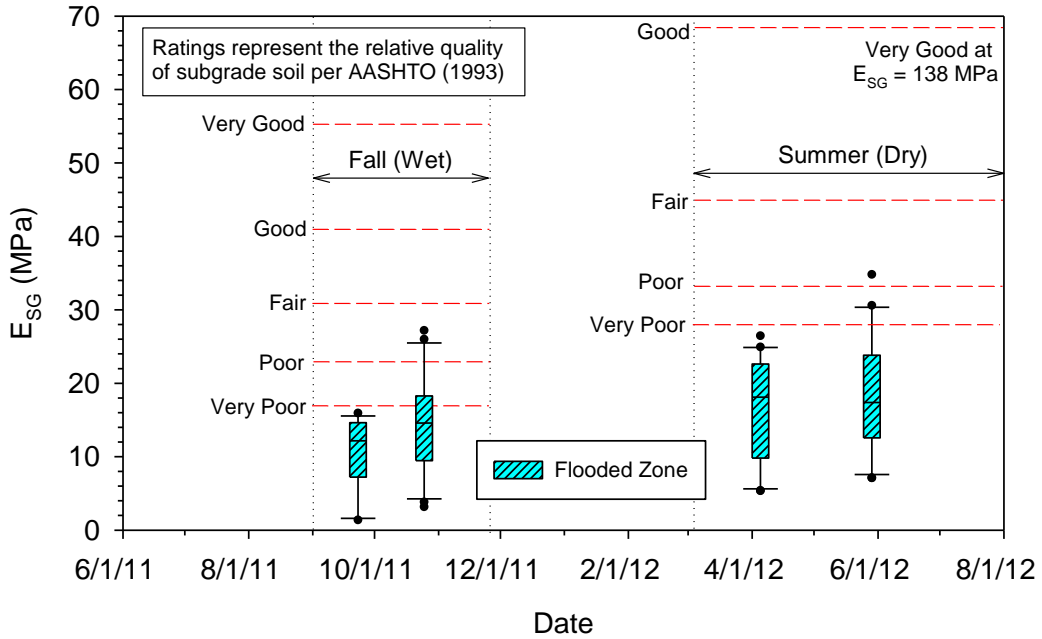
Figure 116. Box plots of subgrade modulus values in comparison with relative quality ratings on TS6 – Pottawattamie County

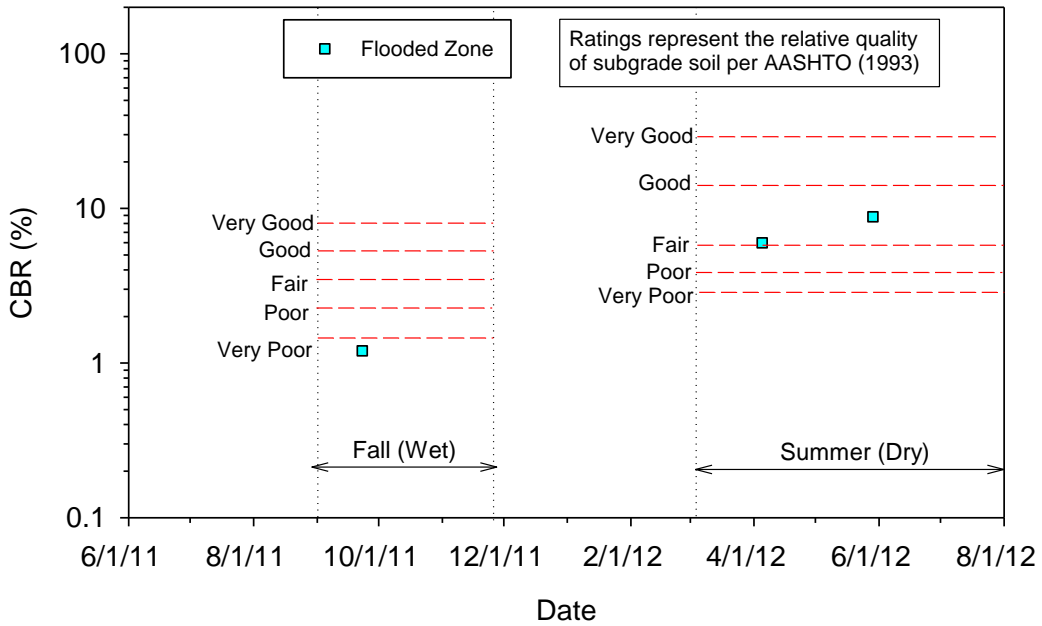
Figure 117. Subgrade CBR values at different testing times with relative quality ratings on TS6 – Pottawattamie County

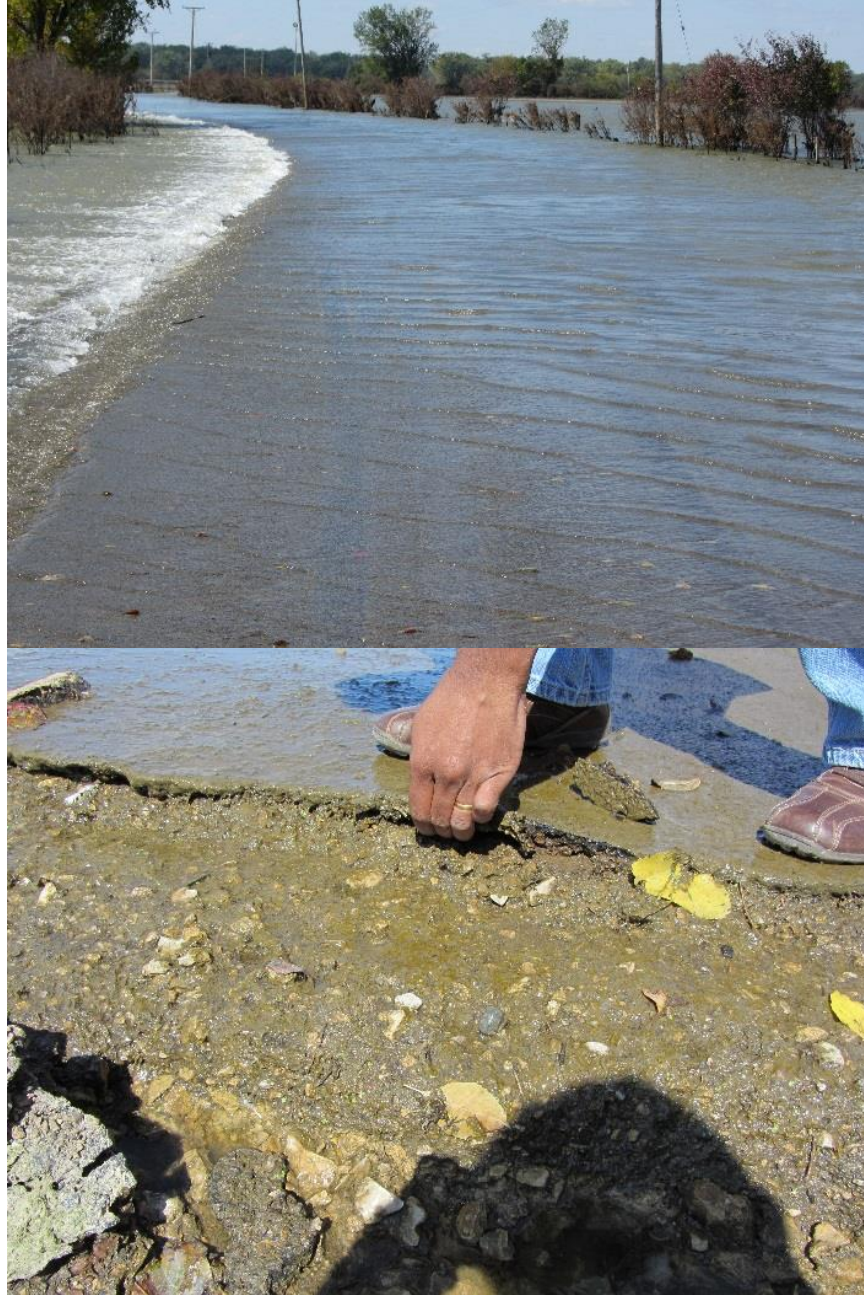
During the 2011 flood event, this TS was fully submerged under water for nearly one to three months (Figure 118 and Figure 119). The flood waters receded in a portion of this TS on 9/1/11, but in some areas flood waters overtopped the roadway till 9/31/11. During the flood event, chipseal coat was stripped off (delaminated) at a few locations and granular shoulder material was eroded at isolated locations (shown as road scour in Figure 119). Weep holes were observed around culverts along the TS. Photos taken during field testing are shown in Figure 120 and Figure 122.

Figure 120. Water overtopping Desoto Avenue on 9/21/11 and delamination of chipseal coat at the surface (Pictures taken on 9/21/11) – Pottawattamie County

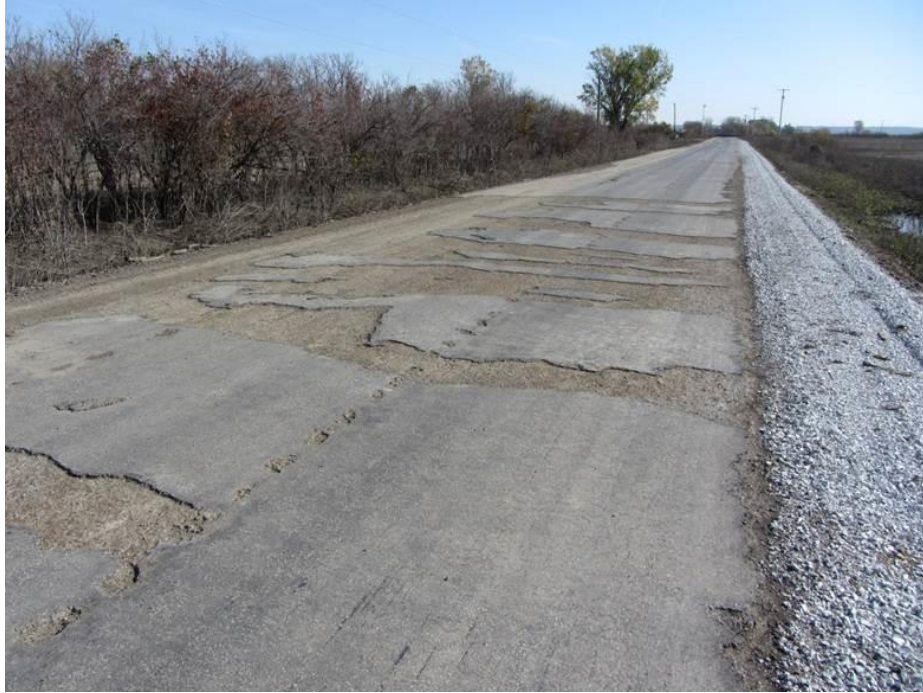
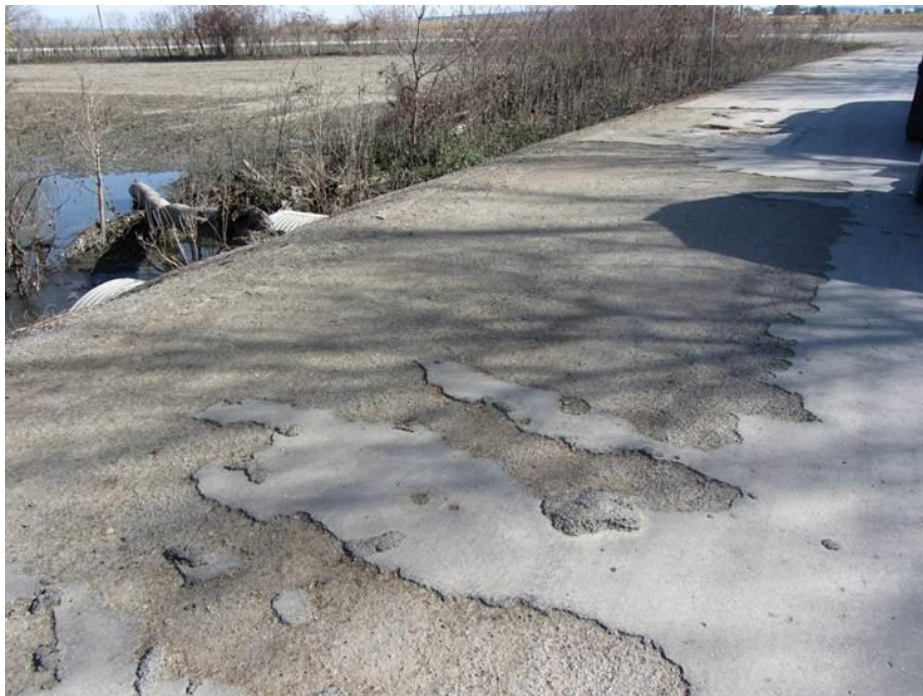
Figure 121. Delaminated surface chipseal on Desoto Avenue due to flood waters overtopping the roadway (Pictures taken on 10/25/11) – Pottawattamie County

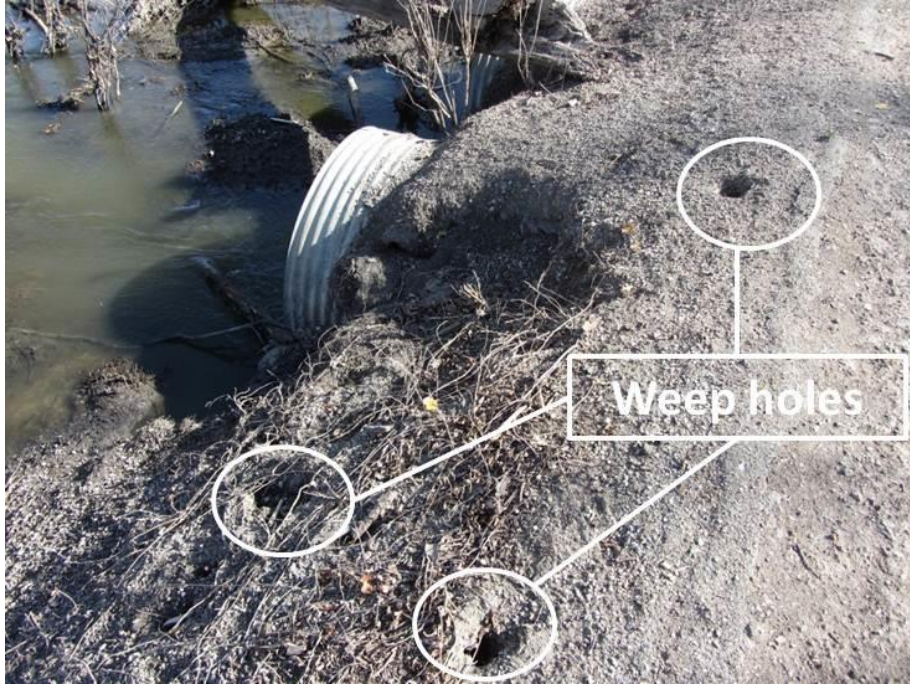
- The E_{SG} values in the whole TS were low and the quality is rated as “very poor” to “poor,” per AASHTO (1993). The E_{SG} values did not change over time (varied on average from 16 to 17 MPa).
- With the exception of granular shoulder loss at a few locations, which was replaced shortly after the flood event, no significant distresses or damages were noted on this roadway. Some weep holes were observed around culvert locations and were also found in GPR scans as discussed below.

Figure 122. Weep holes around culvert inlets on TS7 (Picture taken on 10/25/11) – Pottawattamie County

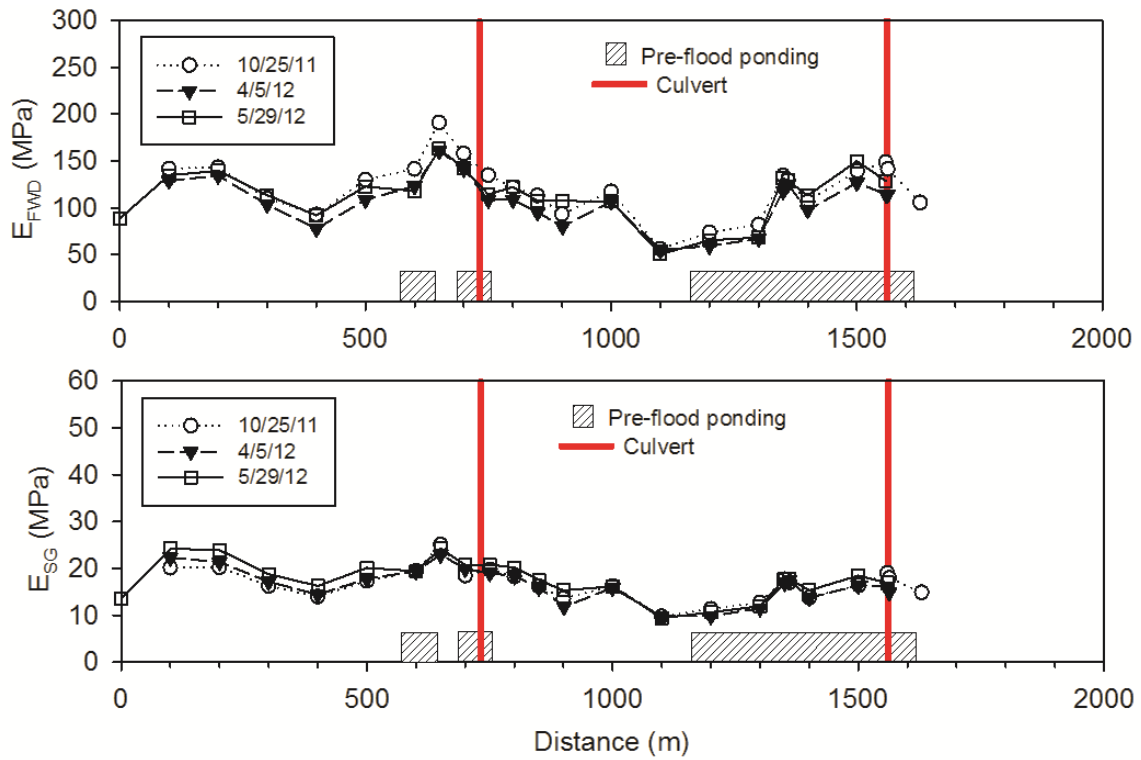
Figure 123. Surface FWD modulus and subgrade modulus at three different times after flooding on TS7 (entire TS was flooded and pre-flood ponding zones identified from aerial maps) – Pottawattamie County

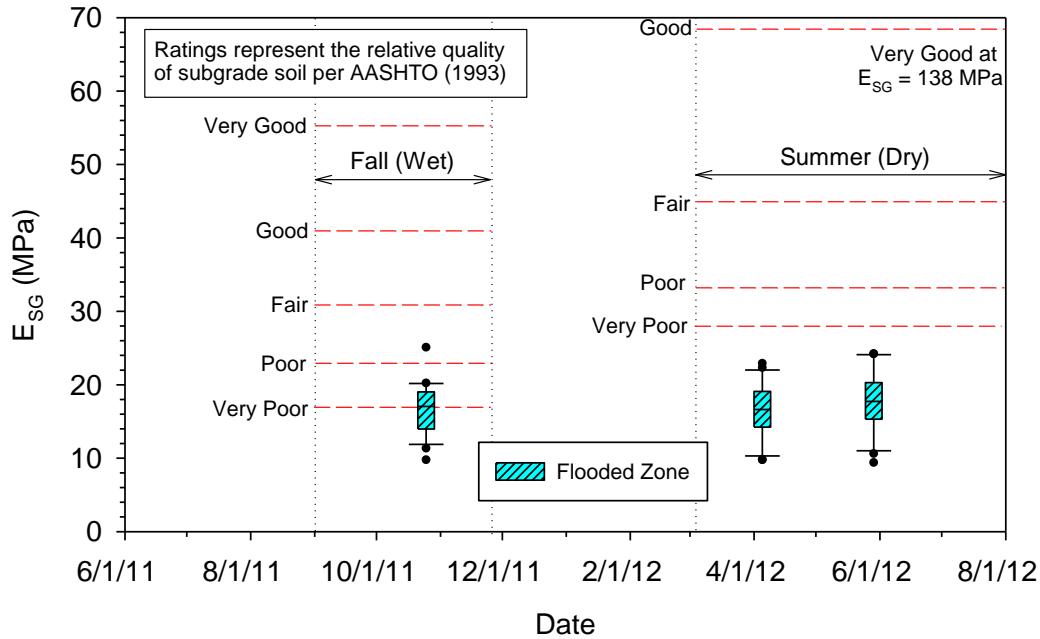
Figure 124. Box plots of subgrade modulus values in comparison with relative quality ratings on TS7 – Pottawattamie County

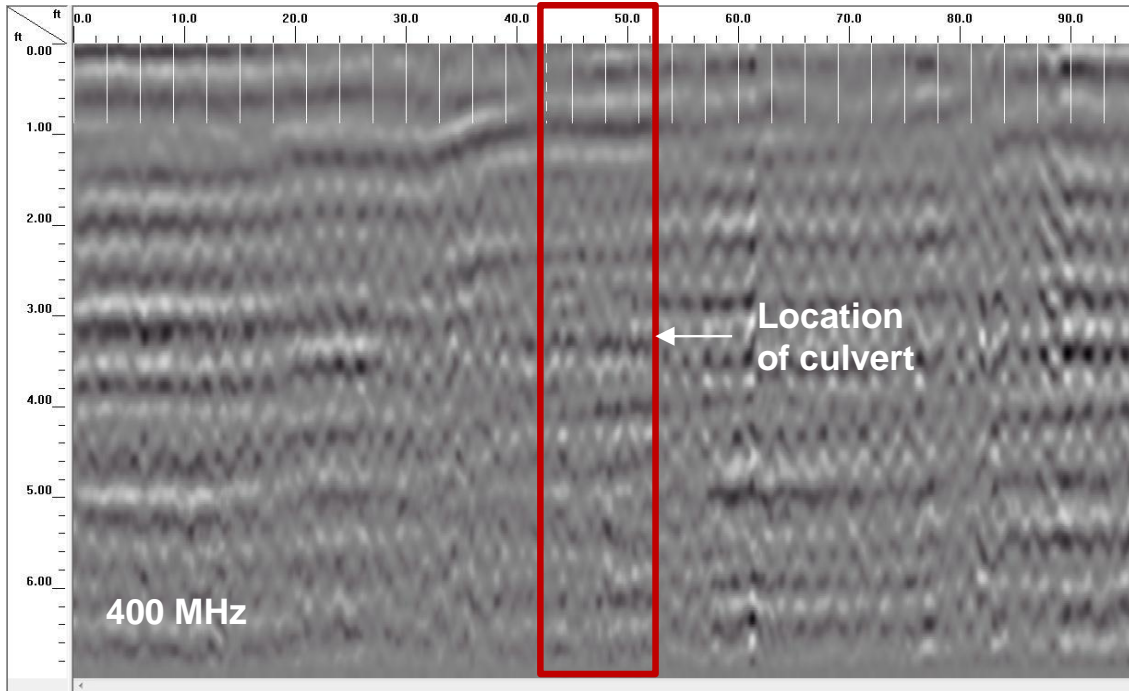
- Culvert location was not clearly identified in the scans shown in Figure 125.
- Weep holes were noted at several locations in the scans as shown in Figure 126 and Figure 127.

Figure 125. GPR scan using 400 MHz antennas on TS7 showing location of culvert (at station 724 m) – Pottawattamie County

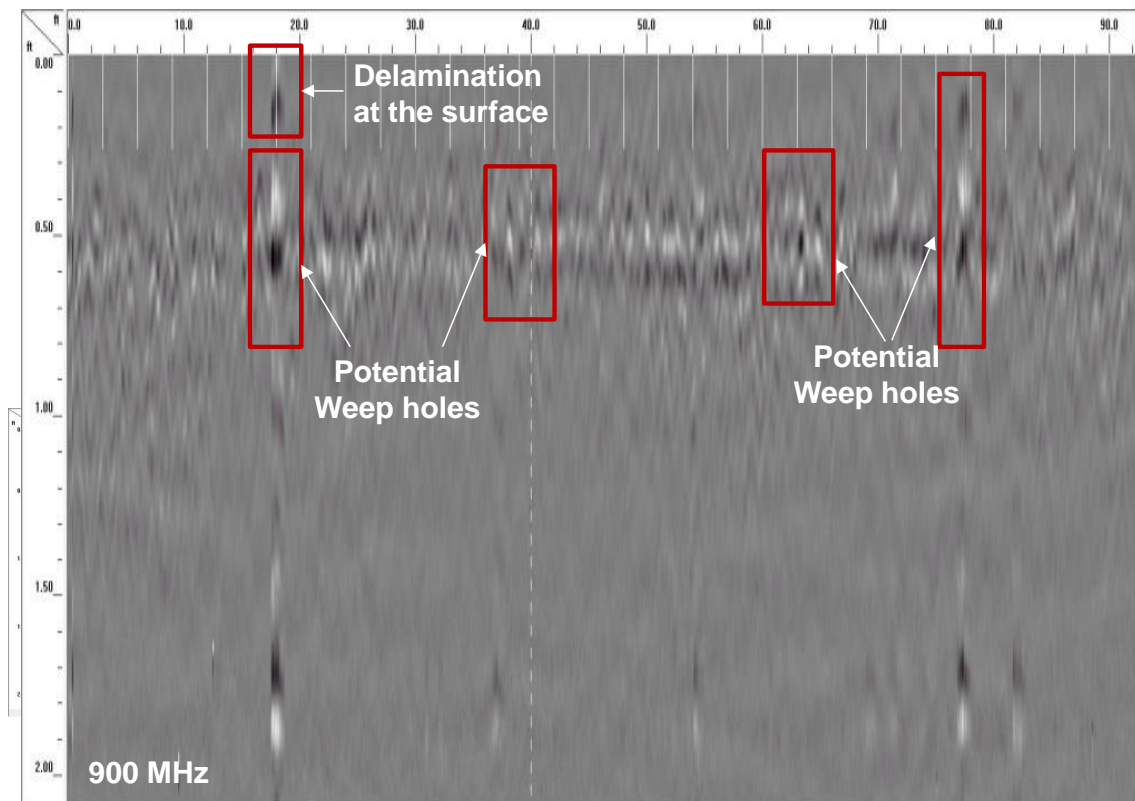
Figure 126. GPR scan using 900 MHz antenna on TS7 showing potential weep holes in the subgrade (between 720 m and 750 m stations on east bound lane) – Pottawattamie County

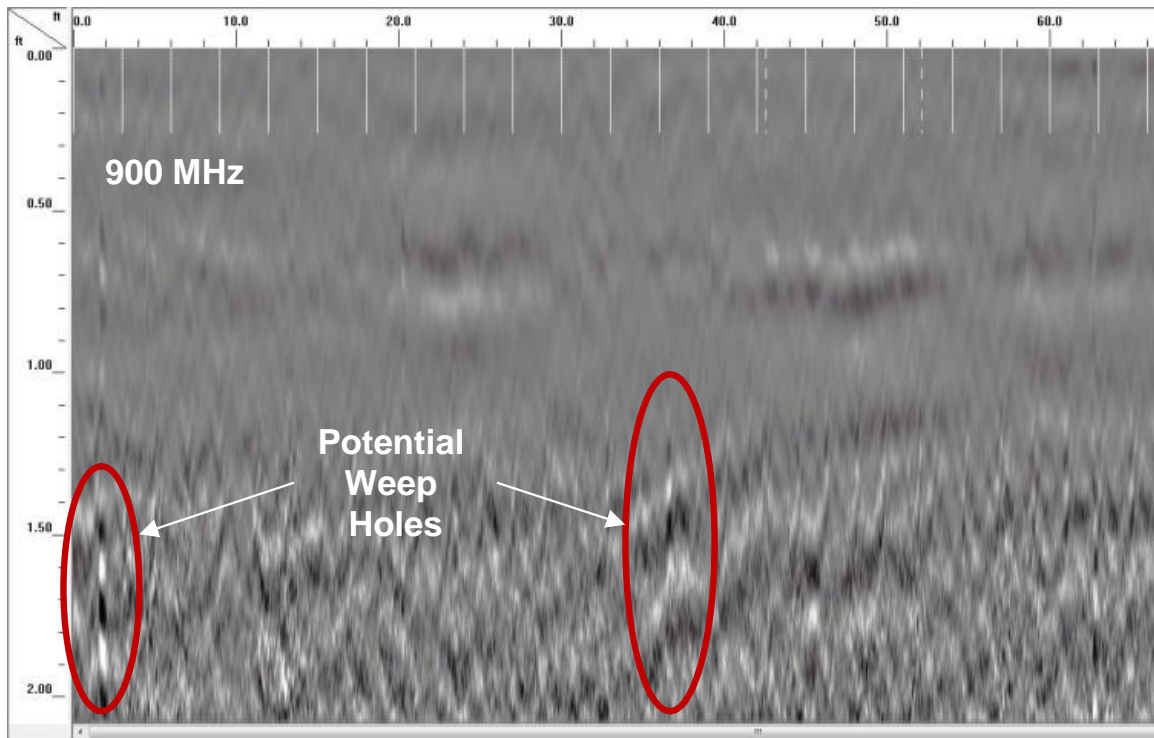
Figure 127. GPR scan using 900 MHz antenna on TS7 showing potential weep holes in the subgrade (between 1550 m and 1580 m stations on east bound lane) – Pottawattamie County

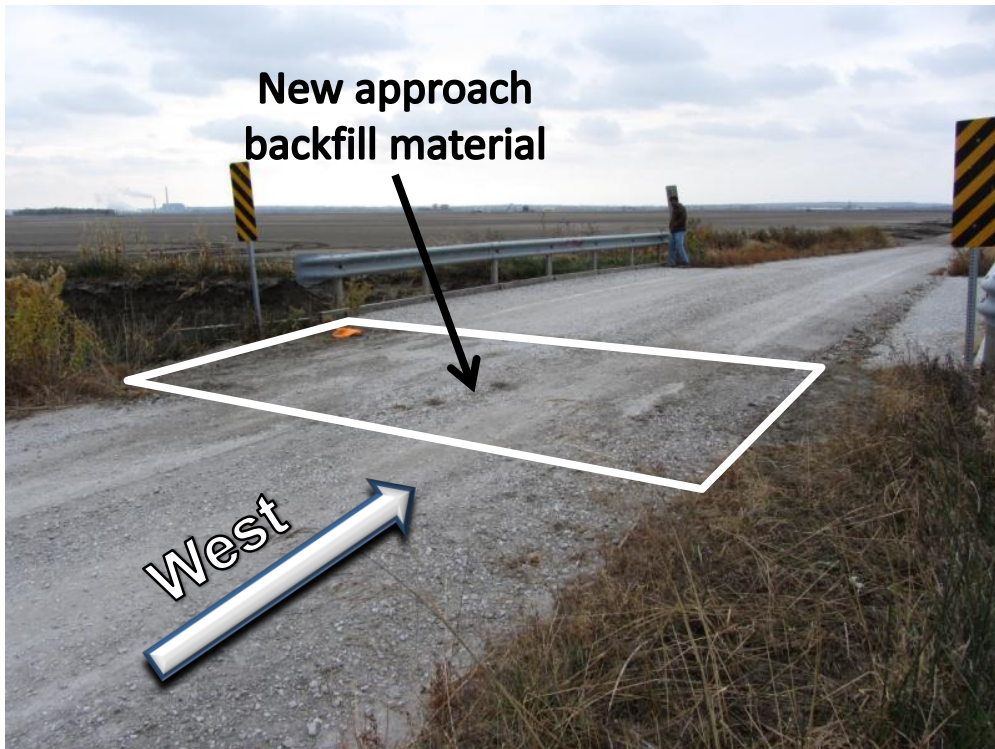
During the 2011 flood event, the TS was partially submerged for about two to three months (Figure 129). Reportedly, the flood waters receded in the area during mid-September 2011. During the flood event, backfill material behind the east bridge approach was eroded away and new fill was placed prior to testing (Figure 130). The bridge crosses a drainage ditch. The drainage ditch embankment slopes (close to the bridge abutments) were scoured during the flood event (see pictures from 10/25/11 in Figure 131 to Figure 133). Field observations during 4/4/12 indicated continued erosion of backfill materials abutment, and scoured embankments (Figure 134). The scoured embankment slopes and bridge abutments were repaired by 6/19/12 using on-site clay fill material (Figure 135).

Figure 130. New bridge approach backfill material placed along the east approach on TS1 (Picture taken on 10/26/11) – Fremont County

- Field observations indicated that clay fill material was used to stabilize the bridge abutments and block erosion of the backfill materials through the abutment walls. However, this material can be scoured away easily during a future flood event. Use of rip rap material as scour protection for the abutment wall would be a better repair and mitigation alternative.

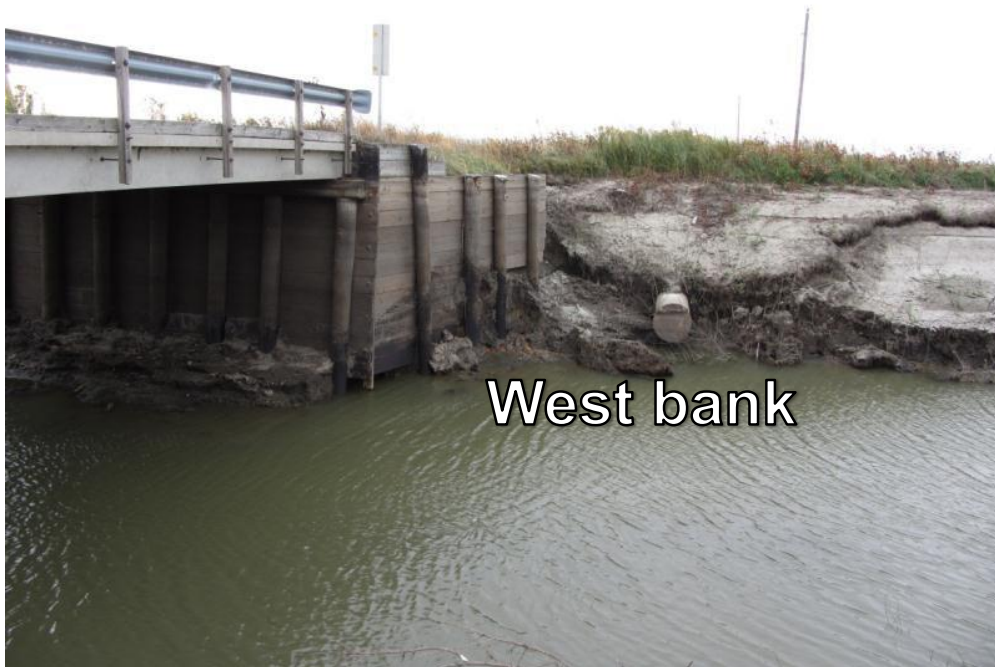
Figure 131. Erosion of embankment material along the west bank on TS1 (Picture taken on 10/26/11) – Fremont County

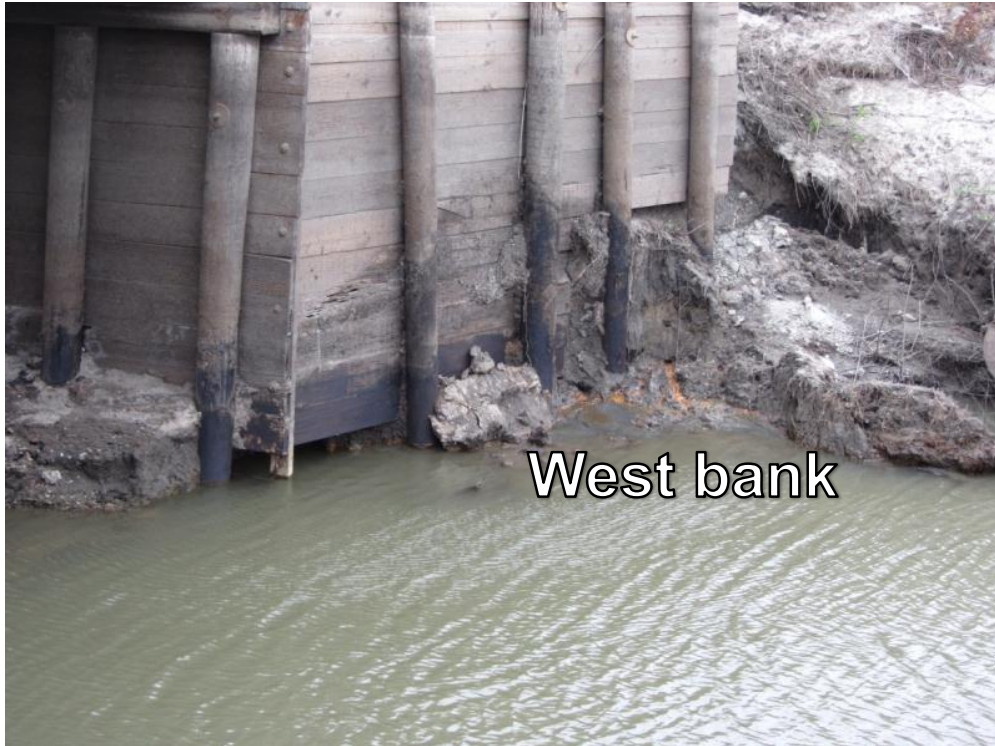
Figure 132. Erosion of embankment material along the west bank near abutment wing walls on TS1 (Picture taken on 10/26/11) – Fremont County

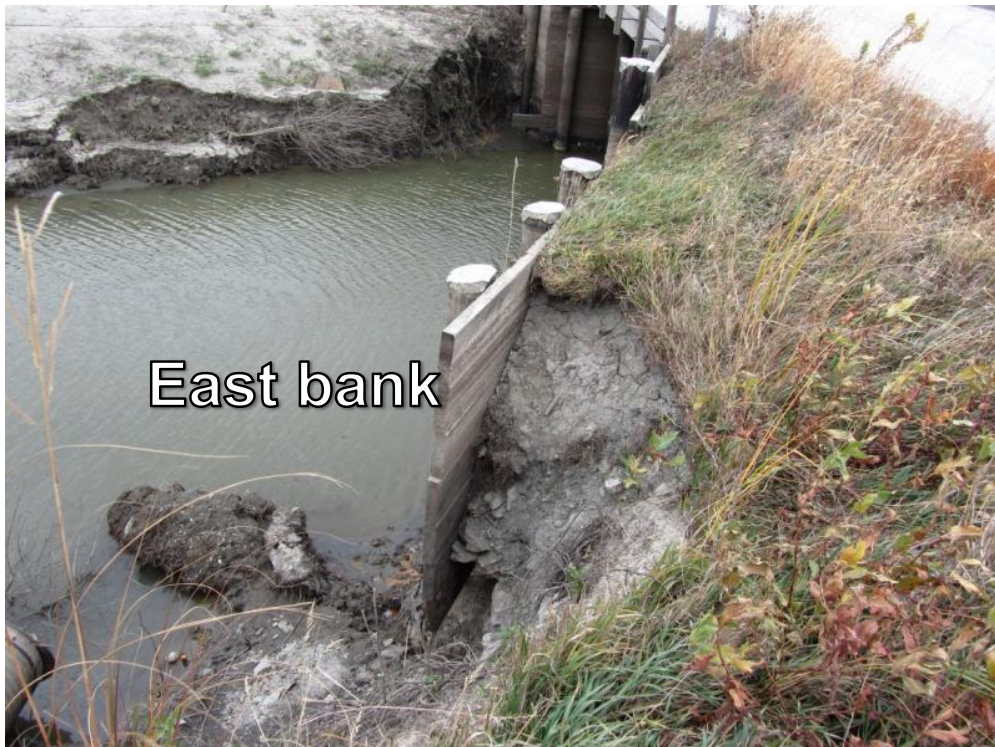
Figure 133. Erosion of backfill material behind the wing wall on TS1 (Picture taken on 10/26/11) – Fremont County

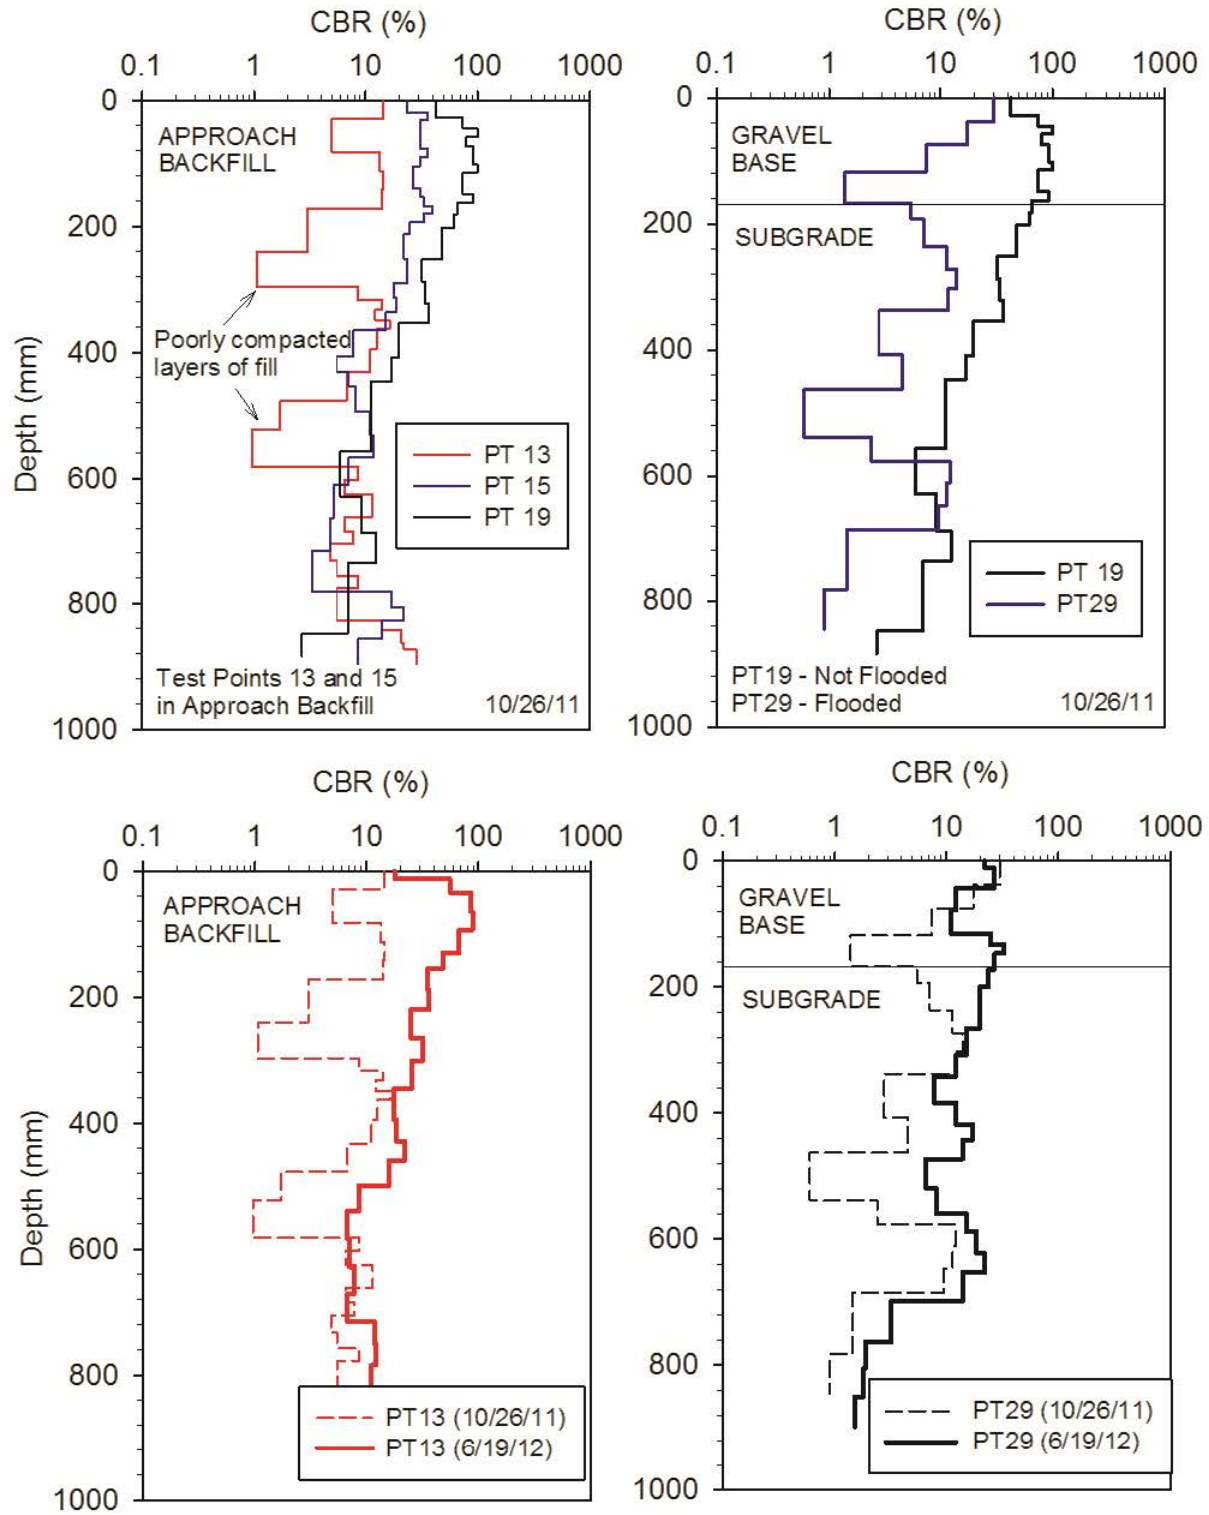
- DCP-CBR profiles (see PT13 on 10/26/11 in Figure 138) indicated that the approach backfill material close to the bridge approach (about 0.6 m away from the abutment) consisted of poorly compacted layers of fill with depth (with $CBR < 2$), which is typically a result of thicker lifts placed during compaction.

Figure 138. DCP-CBR profiles from two different testing times at five test locations on TS1 – Fremont County

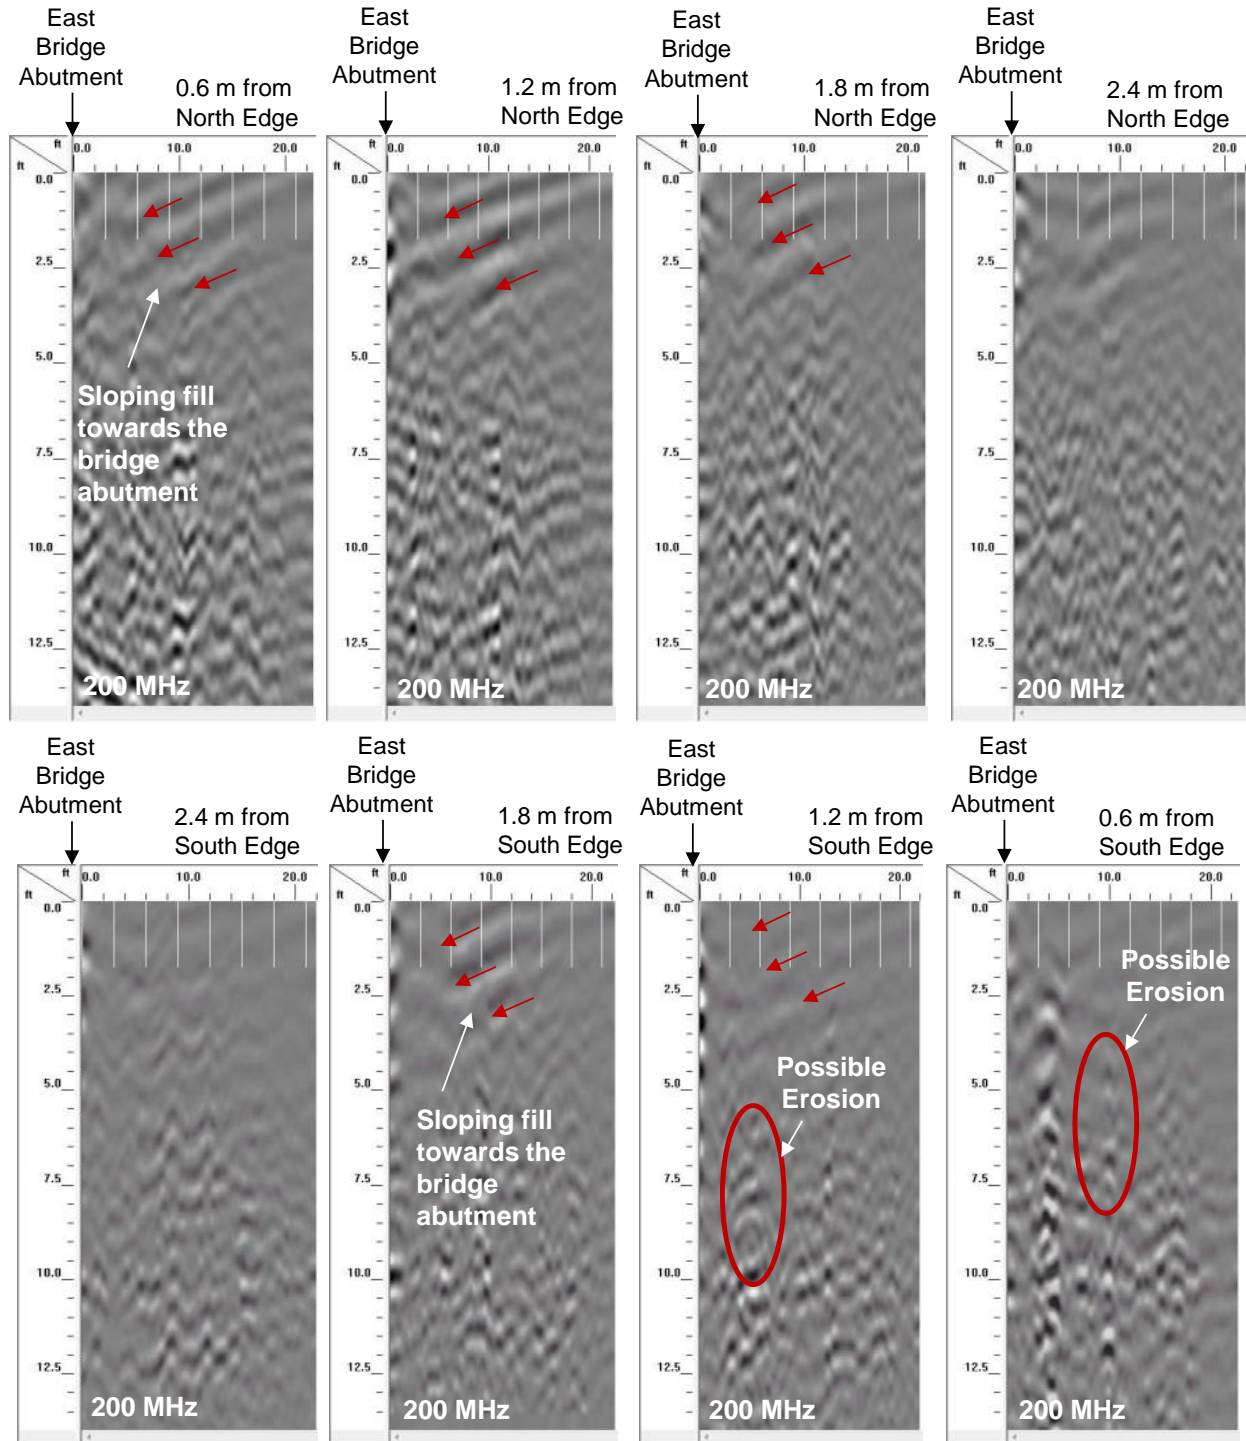
- Backfill material layers sloped towards the bridge abutment are detected in the scans. This sloping is more apparent in scans closer to the edges (within 1m of the edge) than in scans that are close to the center.
- Areas with potential voids/backfill erosion are detected at about 0.76 m to 2.4 m beneath the surface.

Figure 142. GPR scans using 200 MHz antenna on TS1 longitudinally along the east bridge approach backfill at 0.6 m to 2.4 m away from the north and south edges of the bridge (note: 0 ft mark on the horizontal scale represents about 6.7 m (22 ft) away from the west abutment – Fremont County

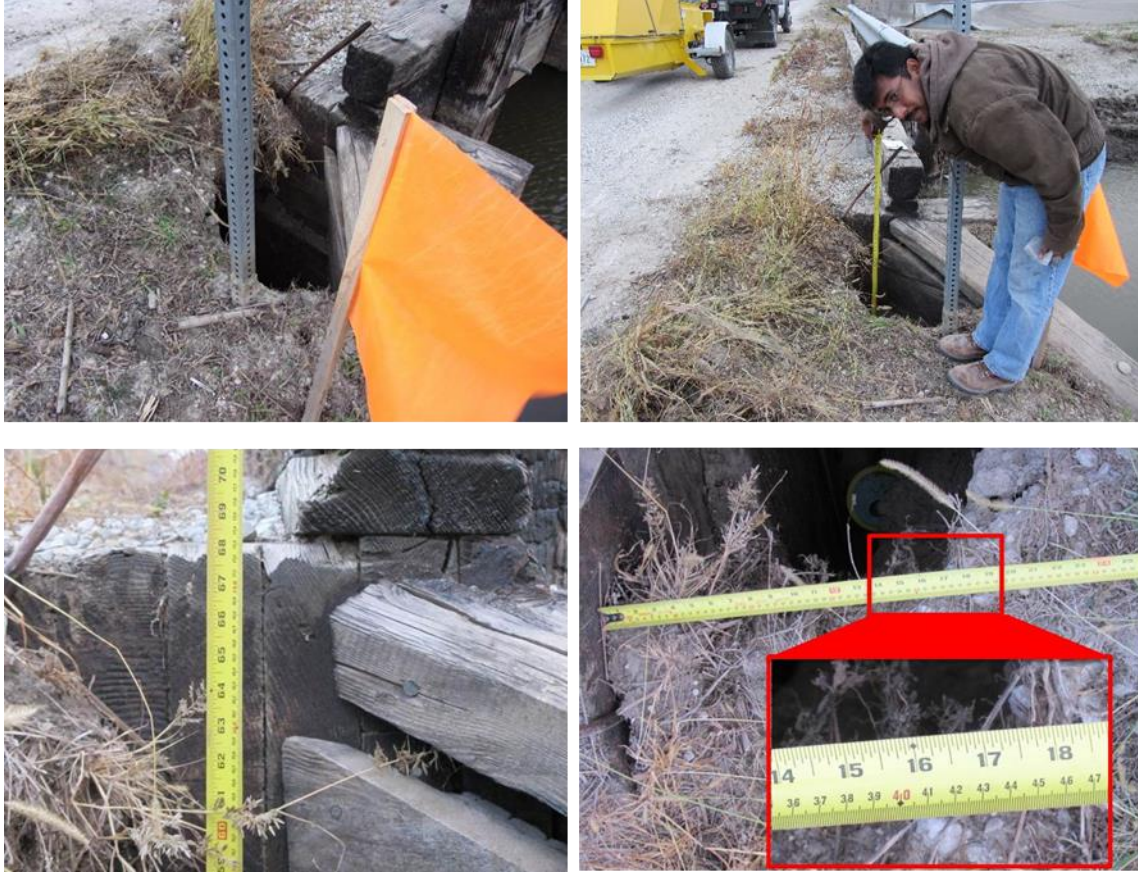
During the 2011 flood event, the TS was partially submerged for about two to three months (Figure 143). Reportedly, the flood waters receded in the area during mid-September 2011. During the flood event, backfill material behind the west bridge approach was eroded away forming voids beneath the surface gravel layer. Pictures taken on 10/26/11 are shown in Figure 144 to Figure 146. Field observations on 4/4/12 indicated that the eroded backfill material on the west abutment was repaired, but some surface subsidence was observed, and new voids were observed on the east abutment (Figure 147).

Figure 146. Void behind the west abutment wall due to erosion of backfill material at TS2 bridge (Pictures taken on 10/26/11) – Fremont County

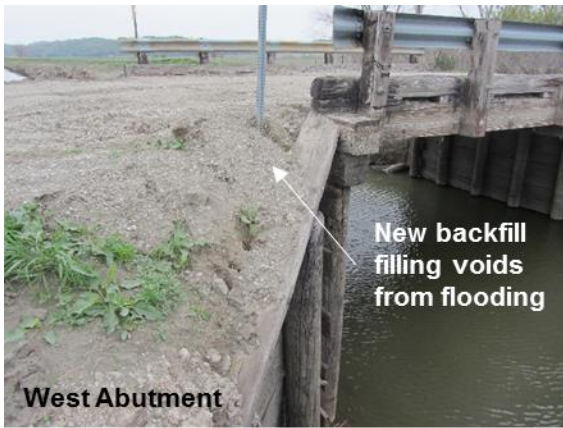
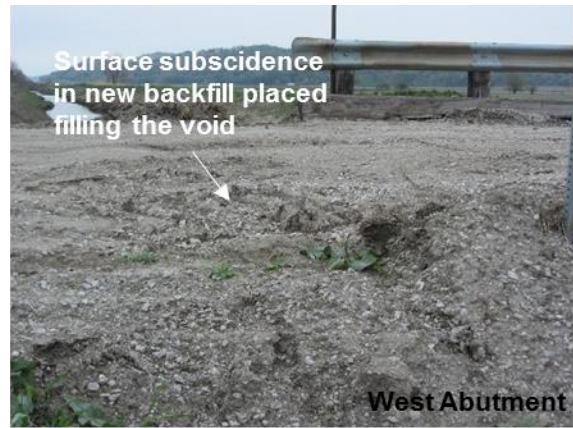
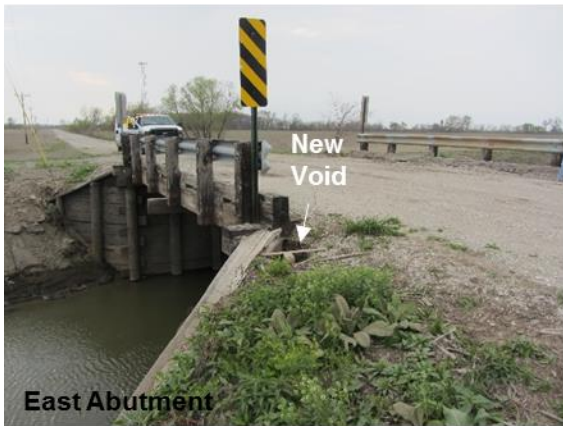
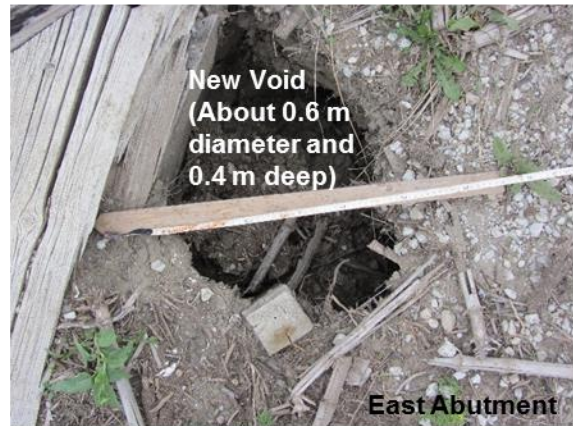
Figure 147. West and east abutments on TS2 bridge (Pictures taken on 4/4/11) – Fremont County

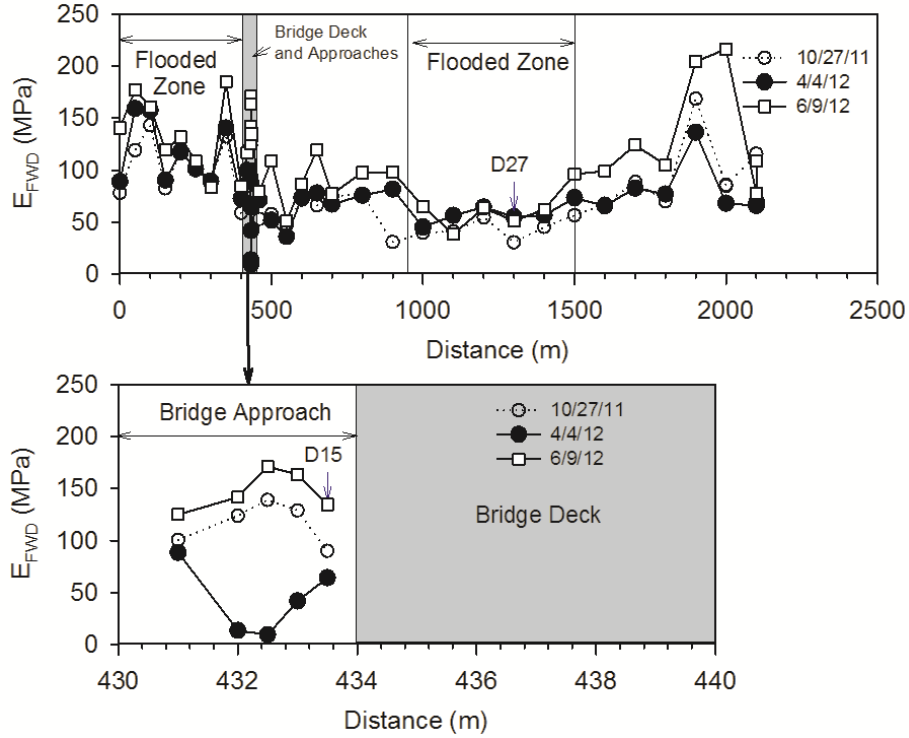
“poor,” per AASHTO (1993). Lowest values were located in the flooded zone (close to D-27 as noted on Figure 148 and Figure 149) that is located at a lower elevation (i.e., area that experienced deep waters above the roadway).

Figure 148. Surface FWD modulus at three different times after flooding on TS2 – Fremont County

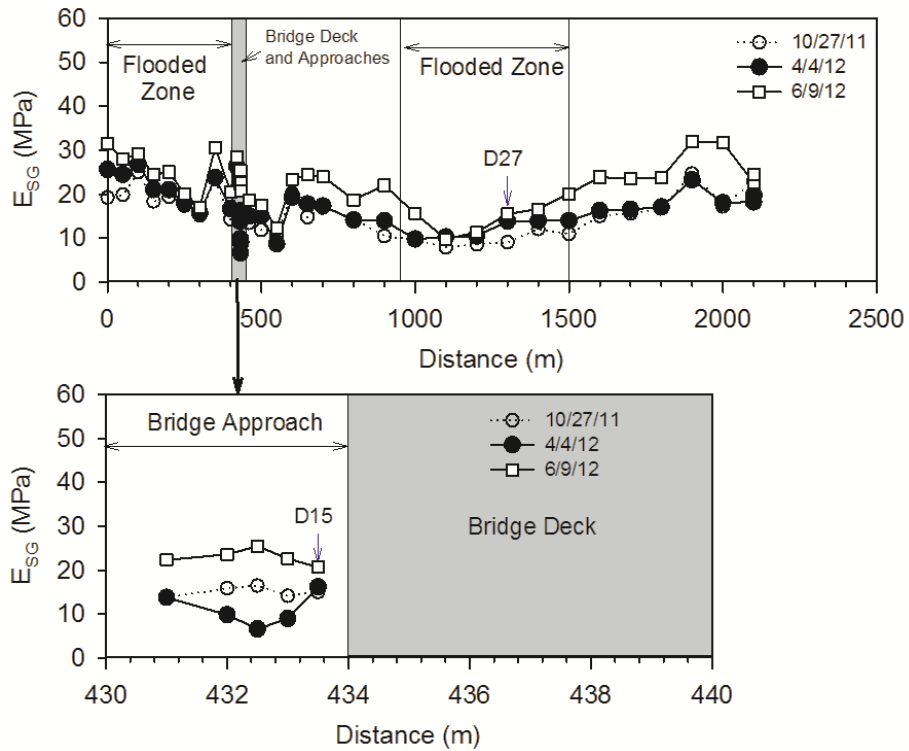
Figure 149. Subgrade modulus measurements at three different times after flooding on TS2 – Fremont County
