Western Iowa Missouri River Flooding— Geo-Infrastructure Damage Assessment, Repair, and Mitigation Strategies

SEPTEMBER 2013

Final Report

Federal Highway Administration
Iowa Highway Research Board
(IHRB Project TR-638)
Iowa Department of Transportation
(InTrans Project 11-419)

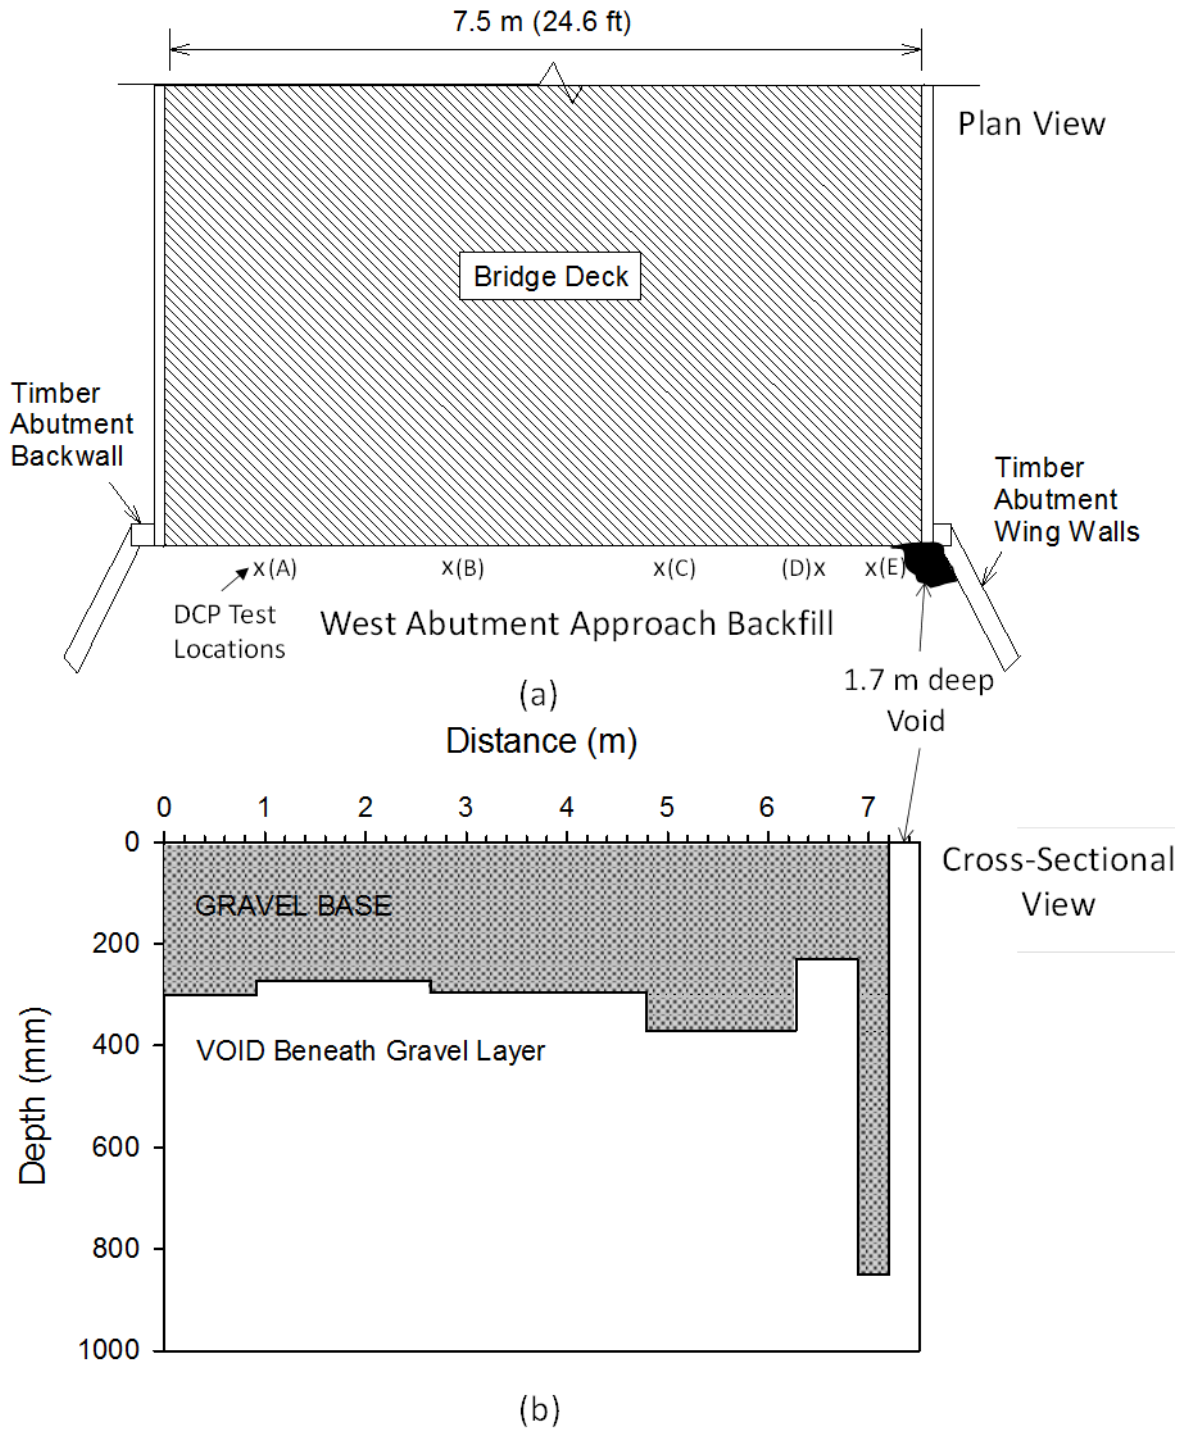
- DCP tests indicated void at depths of about 300 to 850 mm below surface (Figure 150).

Figure 150. TS2 bridge approach: (a) Bridge deck plan view showing DCP test locations on the approach backfill, and (b) cross-sectional view showing thickness of gravel base and void beneath the gravel layer across the bridge (tests conducted on 10/25/11) – Fremont County

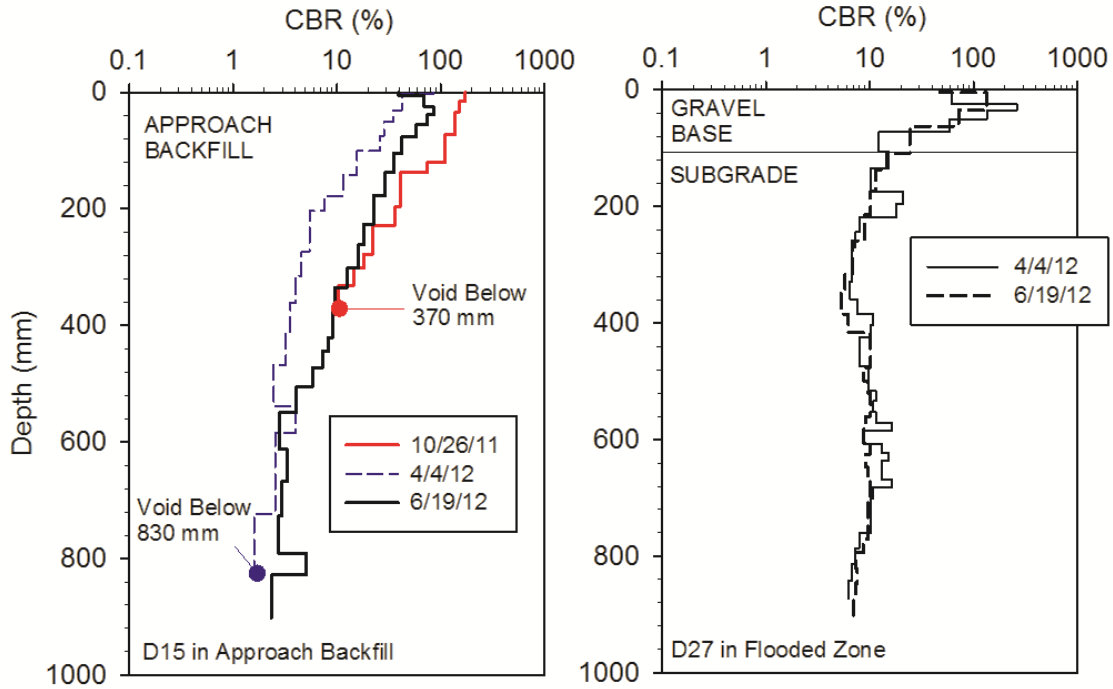
Figure 151. DCP-CBR profiles from three different testing times on TS2 – Fremont County

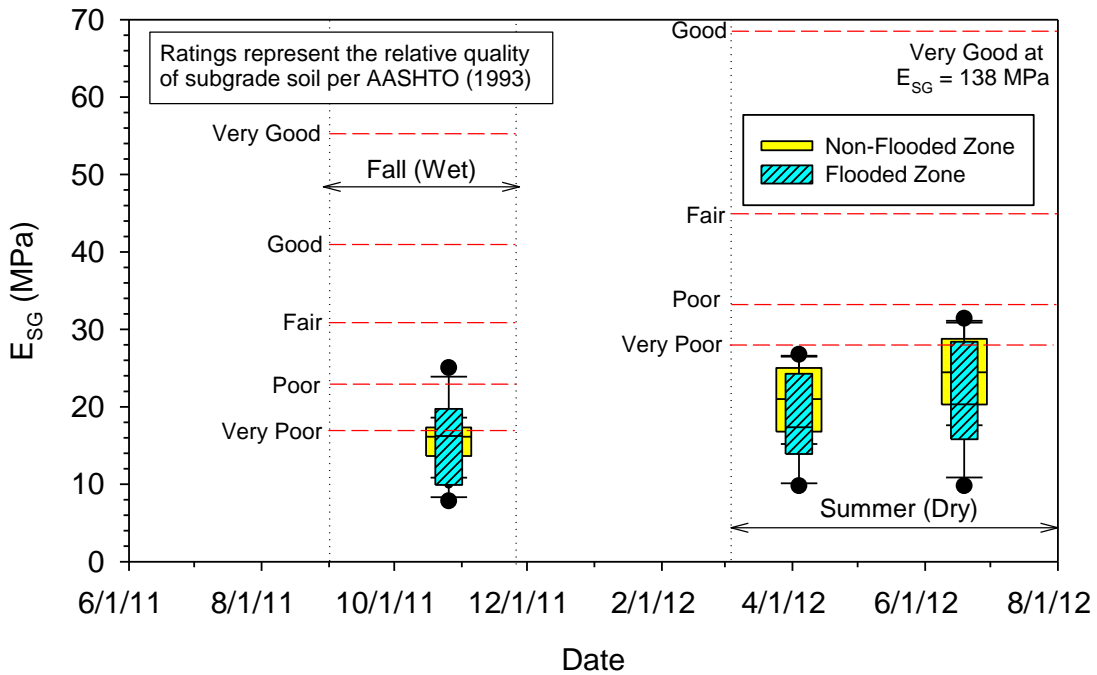
Figure 152. Box plots of subgrade modulus values in flooded and non-flooded zones in comparison with relative quality ratings on TS2 – Fremont County

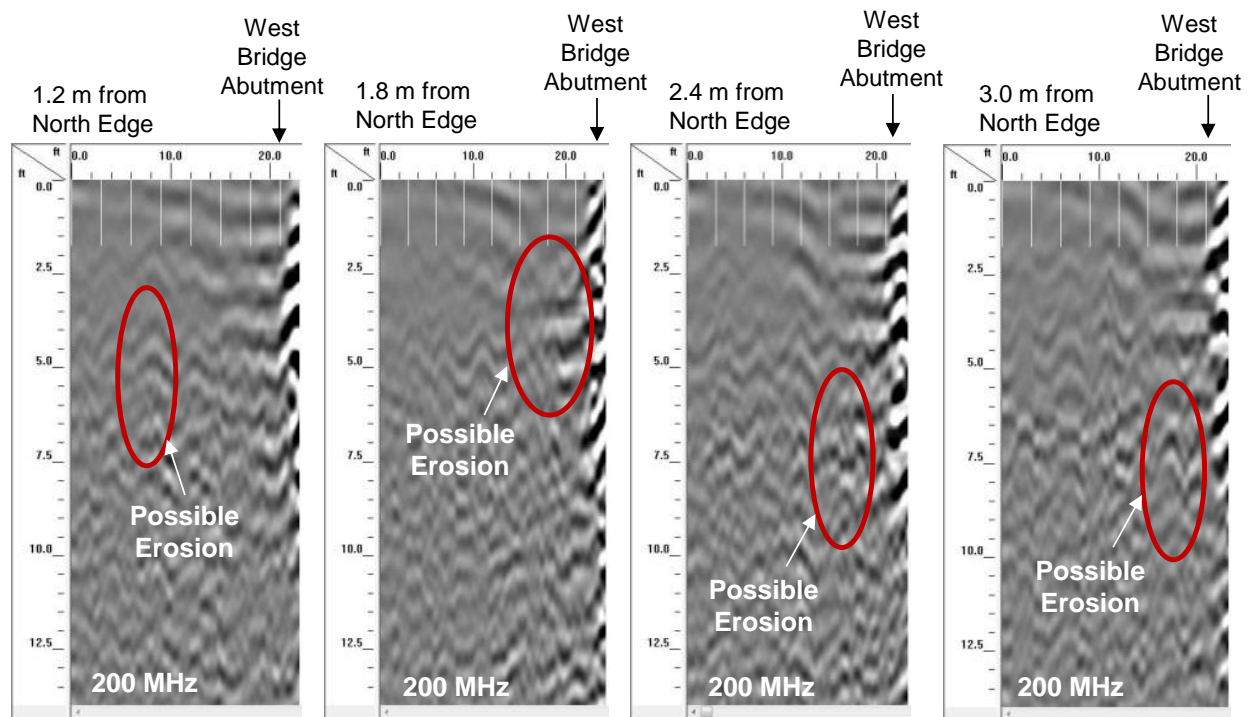
GPR scans were performed using a 200 MHz antennas on 6/19/12 along the west approach at 1.2 m to 3.0 m away from the north and south edges of the bridge. The scanning was conducted to identify potential voids/erosion beneath the surface in the backfill material, which can potentially cause gradual or sudden subsidence of the backfill material. GPR scan results are shown in Figure 153. Some key features observed in the GPR scans are as follows:

Figure 153. GPR scans using 200 MHz antenna on TS2 longitudinally along the west bridge approach backfill at 1.2 to 3.0 m away from the north edge of the bridge (note: 0 ft mark on the horizontal scale represents about 6.7 m (22 ft) away from the west abutment) – Fremont County

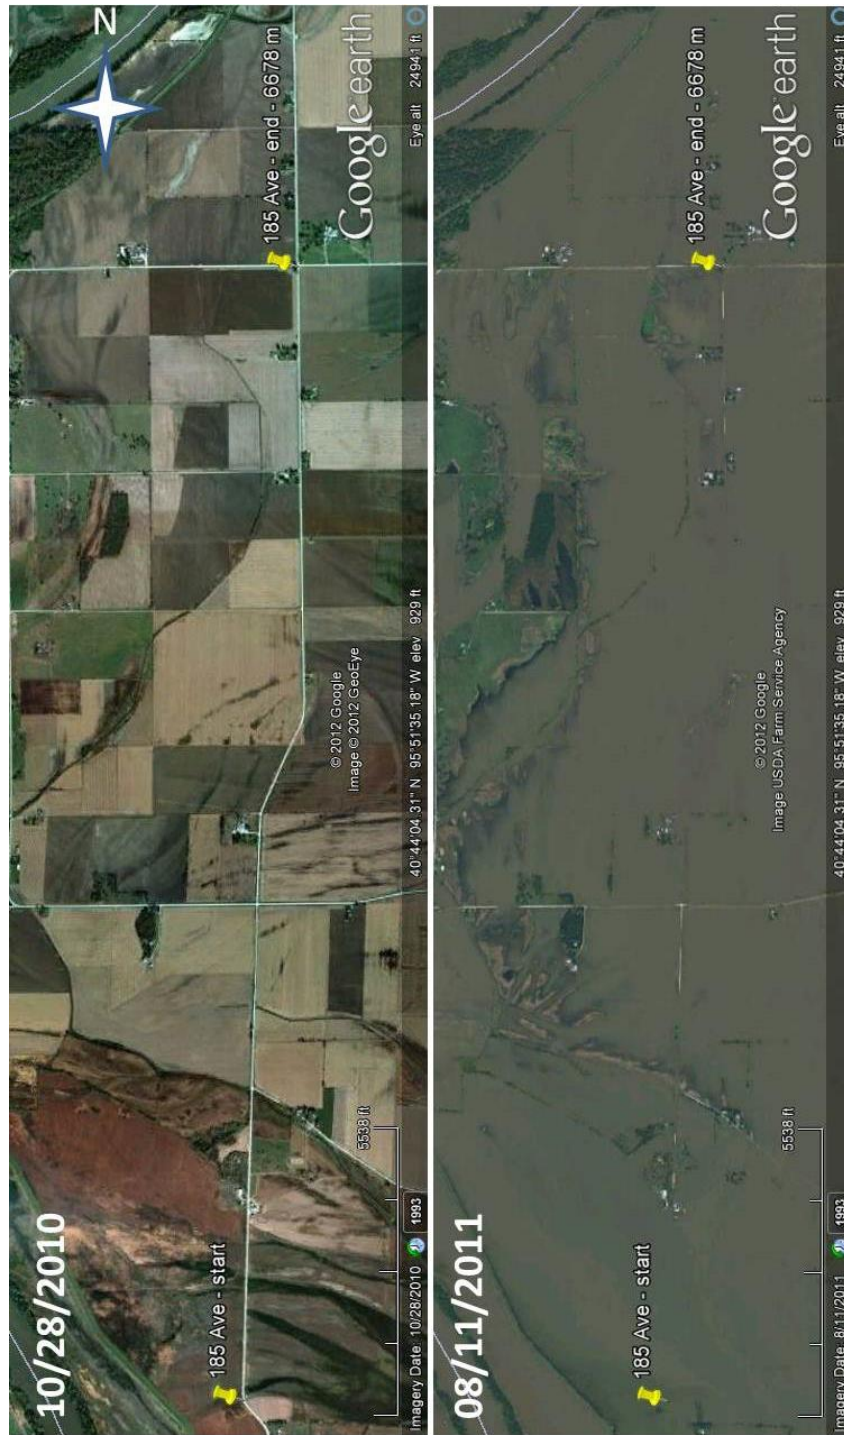
During the 2011 flood event, the test segment was fully submerged for about one to three months (Figure 154). Reportedly, the flood waters receded in the area during mid-September. Roadway damages noted on this test segment include eroded gravel surface layer, sand/silt deposits on the road, rutting under wheel loads at isolated locations (Figure 155, Figure 156).

Figure 154. Aerial imagery before flooding on left (from 10/28/10) and during flooding on right (from 8/11/11) on TS3 – Fremont County

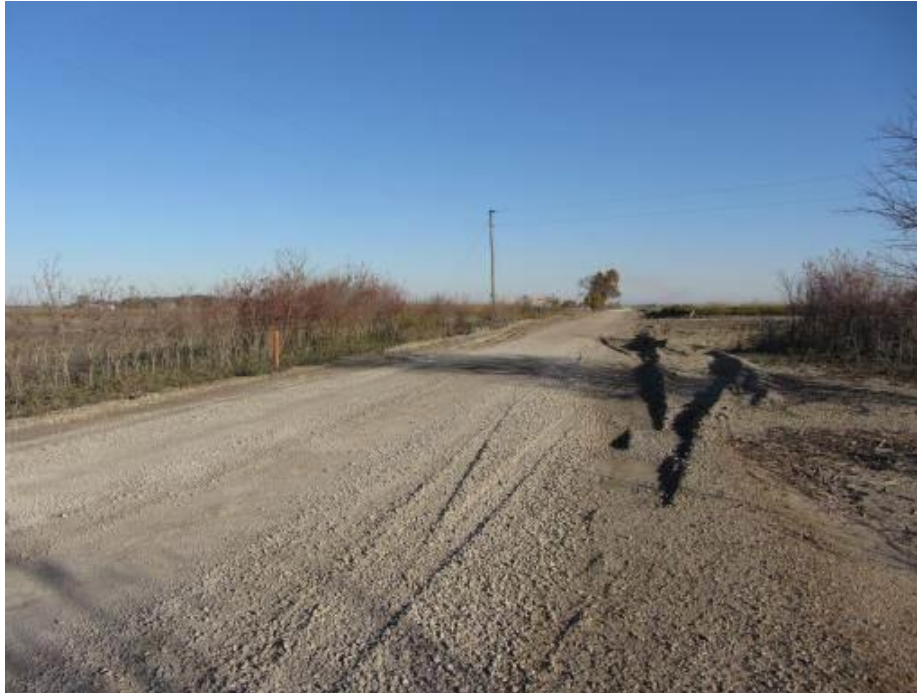
Figure 155. Newly placed gravel near a culvert at about 4700 m station on TS2 (Picture taken 10/27/11)

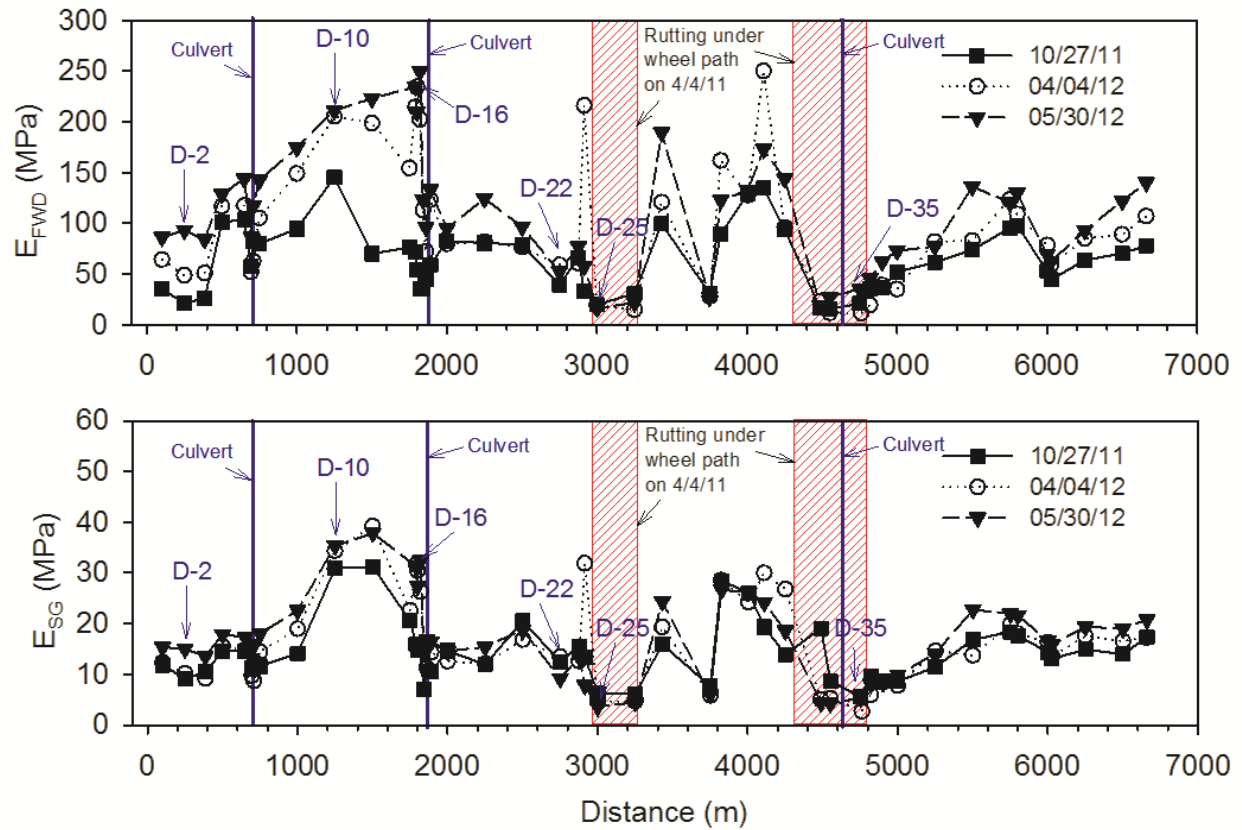
Figure 157. Surface FWD modulus (top) and subgrade modulus (bottom) at three different times after flooding on TS3 – Fremont County

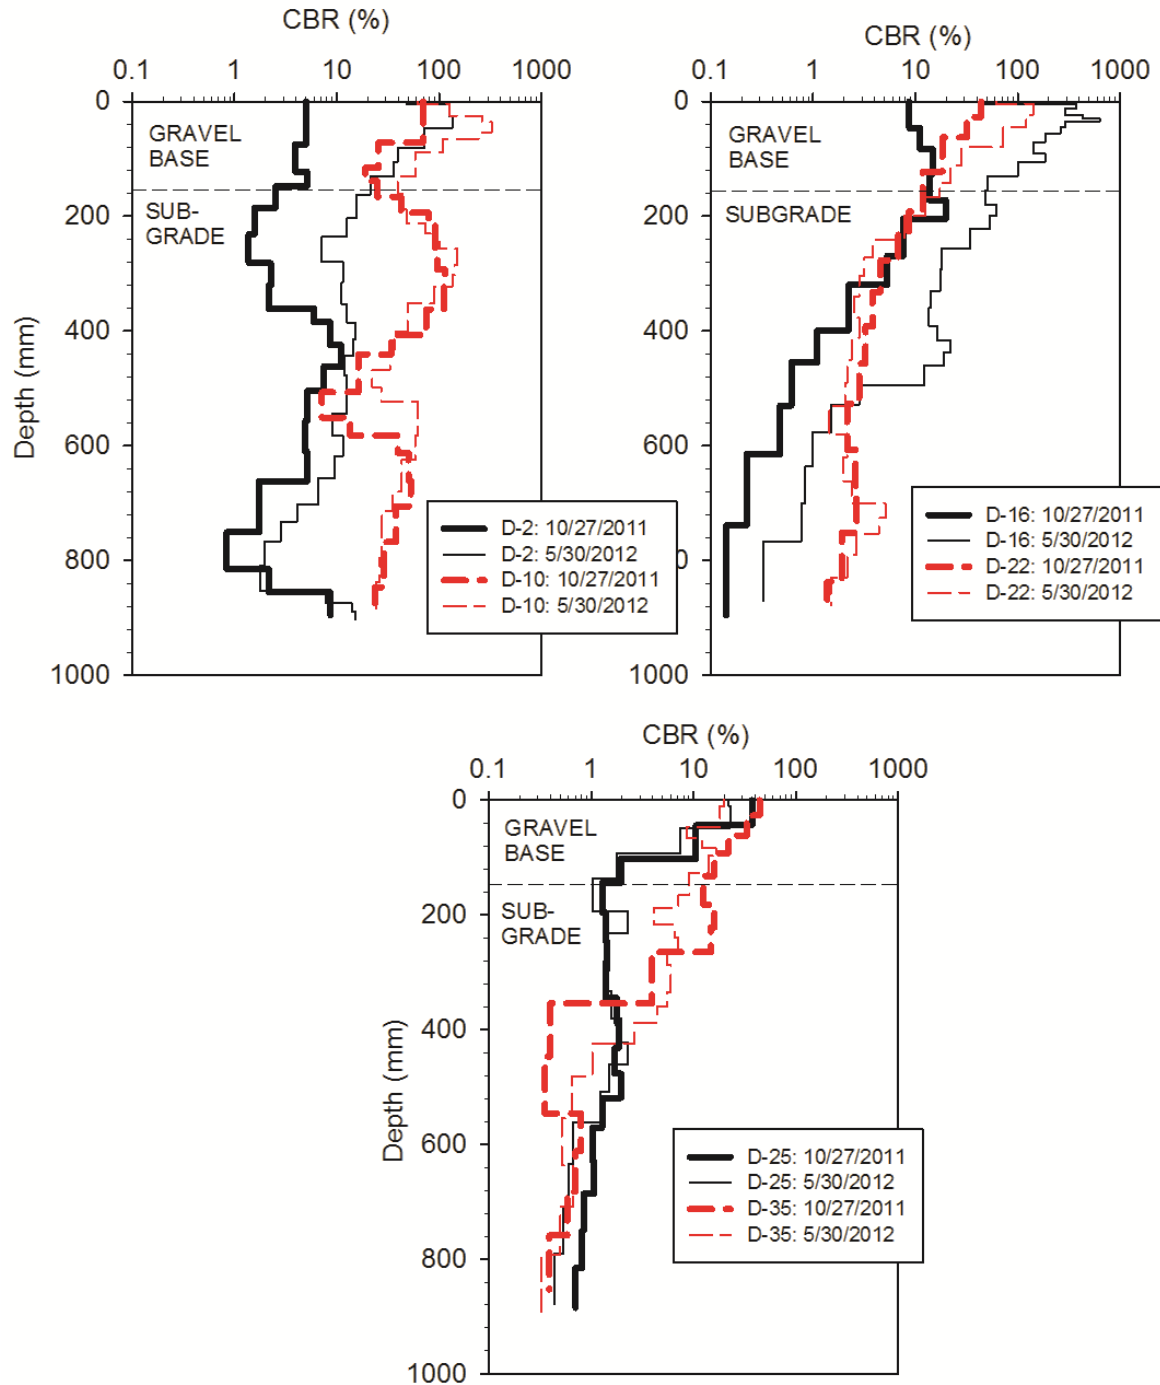
- Subgrade CBR values (in the top 300 mm of subgrade) indicated mixed results with quality varying from “poor” to “very good.” Some locations with low CBR values in the subgrade showed improvement over time (e.g., at PT2 from about 5.2 to 17), while some locations did not (e.g., at PT25 which remained at about 1.8).

- Significant rutting (about 125 mm) was observed under wheel paths near PT25 (near Sta. 3000), where the subgrade CBR was about 1.9. Rutting was also observed at PT 35 (near Sta. 4700), where subgrade CBR (averaged in the top 300 mm) was higher than at PT 25 (7.9). Examining the full CBR profile indicated that CBR in the subgrade ranged from about 0.3 to 2.0 below about 420 mm.

Figure 158. DCP-CBR profiles at three different times after flooding at six test locations on TS3 – Fremont County

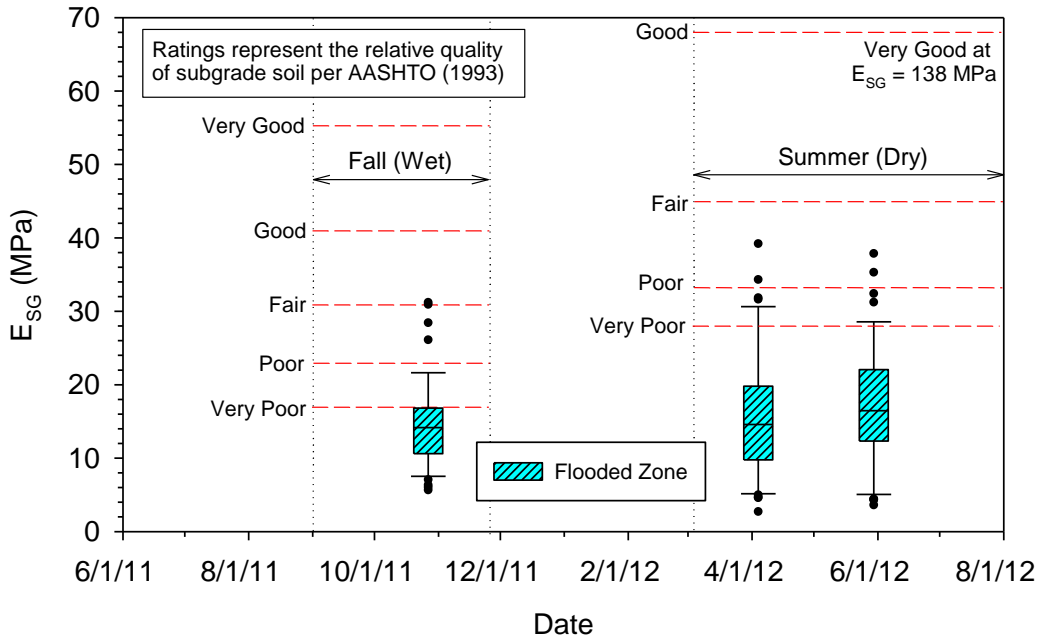
Figure 159. Box plots of subgrade modulus values in comparison with relative quality ratings on TS3 – Fremont County

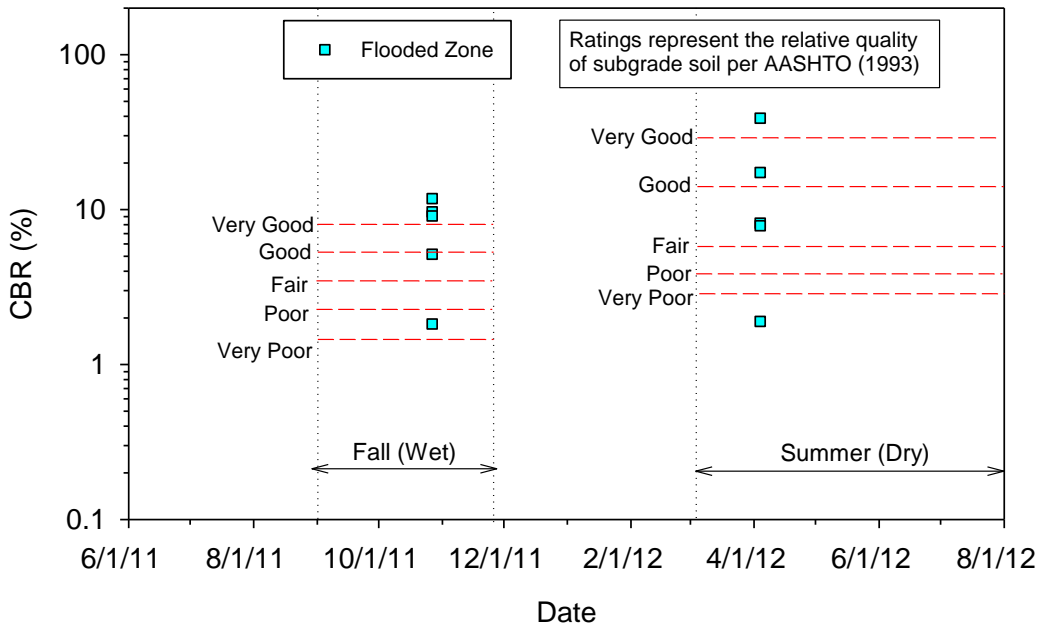
Figure 160. Comparison of subgrade CBR values with relative quality ratings on TS3 – Fremont County

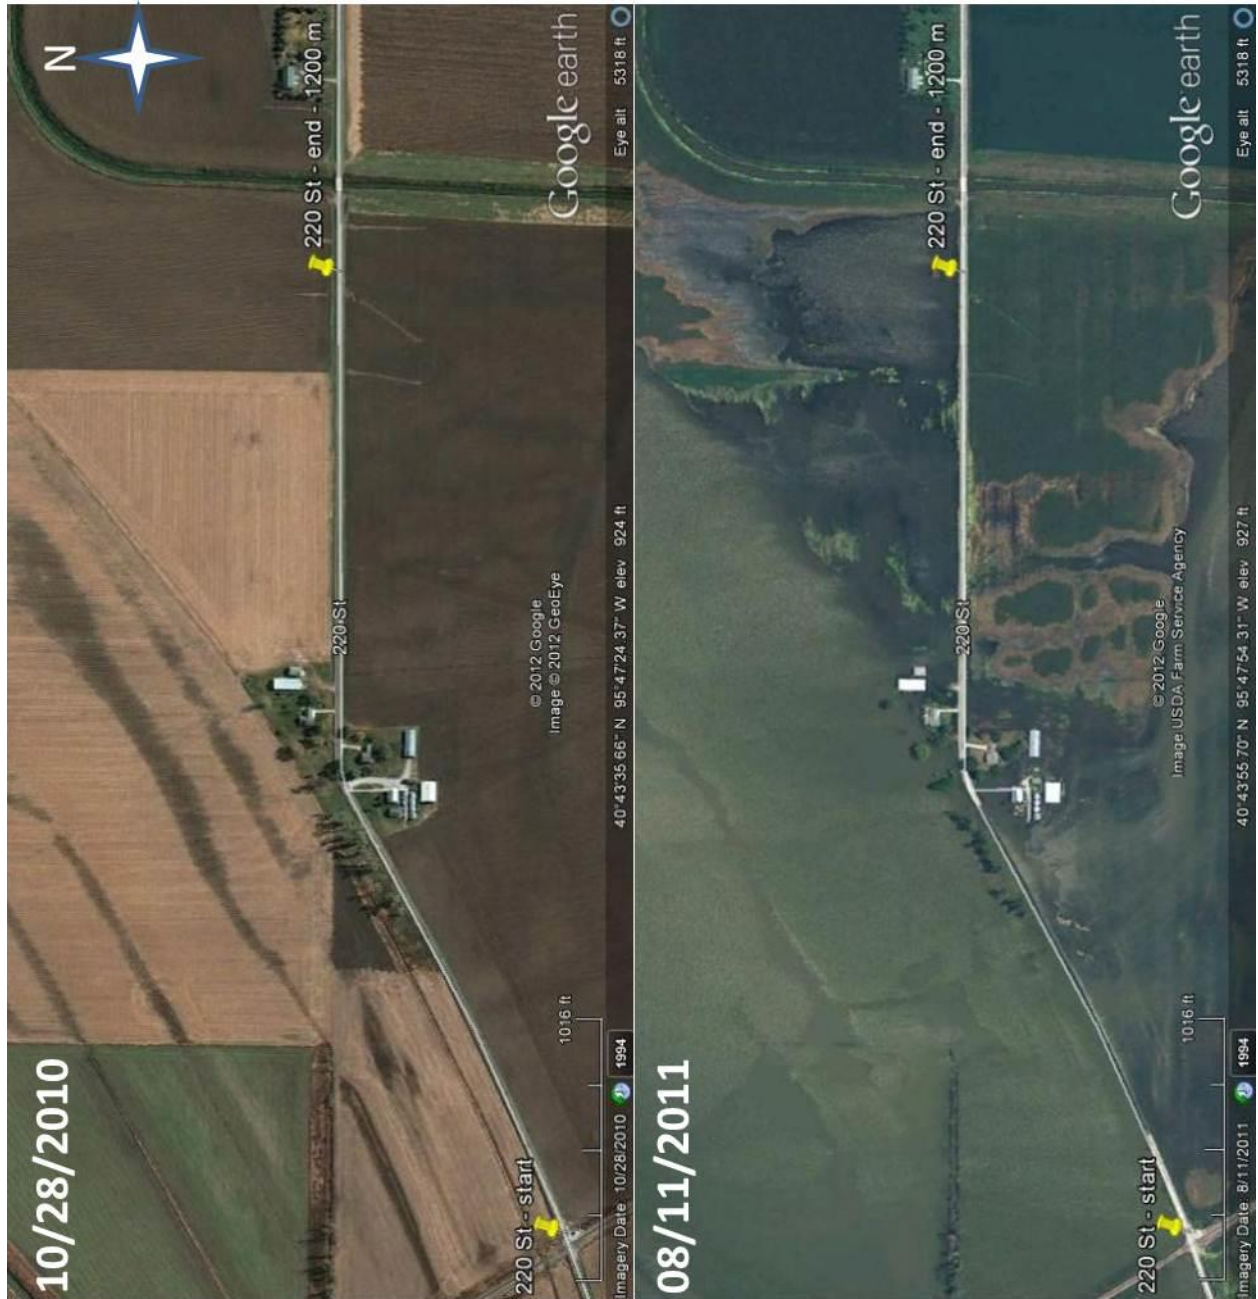
During the 2011 flood event, the test segment was partially submerged for about two to three months (Figure 161). Reportedly, the flood waters receded in the area during mid-September 2011. Roadway damages noted on this test segment include rutting under wheel paths and cracks on the chipseal surfacing, eroded chipseal and gravel over culvert location (patched prior to testing), and eroded granular shoulders. Pictures from this test segment are shown in Figure 162 and Figure 163.

Figure 161. Aerial imagery before flooding on left (from 10/28/10) and during flooding on right (from 8/11/11) on TS4 – Fremont County

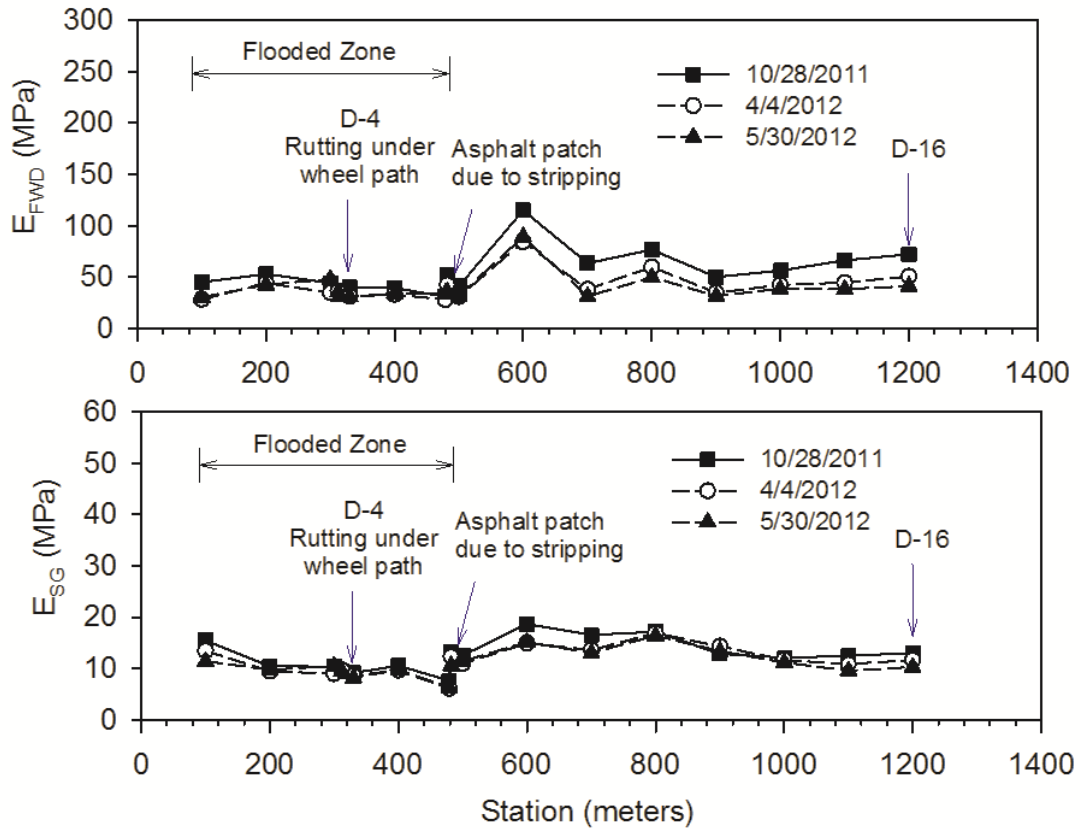
- On average, E_{FWD} values were about 1.3 to 1.7 times higher in the non-flooded area than in the flooded area, at all times of testing. Similarly, E_{SG} values were about 1.3 times higher in the non-flooded area than in the flooded area. The E_{FWD} values, however, have decreased over time. On average, the E_{FWD} values decreased from about 71 to 46 MPa in the non-flooded area, and from about 42 to 36 MPa in the flooded area, from about 1 month after flooding to about 7 months after flooding. The E_{SG} values did not vary much over time (varied from 15 to 13 MPa in non-flooded area and 11 to 10 MPa in flooded area).
- The E_{SG} values in the whole TS were low and the quality is rated as “very poor,” per AASHTO (1993). Lowest values were located in the middle of the flooded zone.

Figure 164. Surface FWD modulus (top) and subgrade modulus (bottom) at three different times after flooding on TS4 – Fremont County

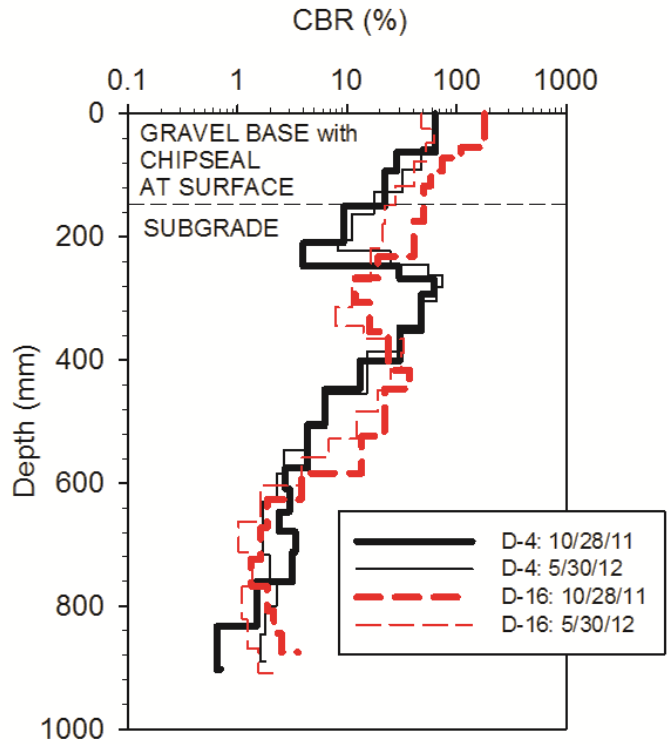
Figure 165. DCP-CBR profiles at two test locations from two different testing times on TS4 – Fremont County

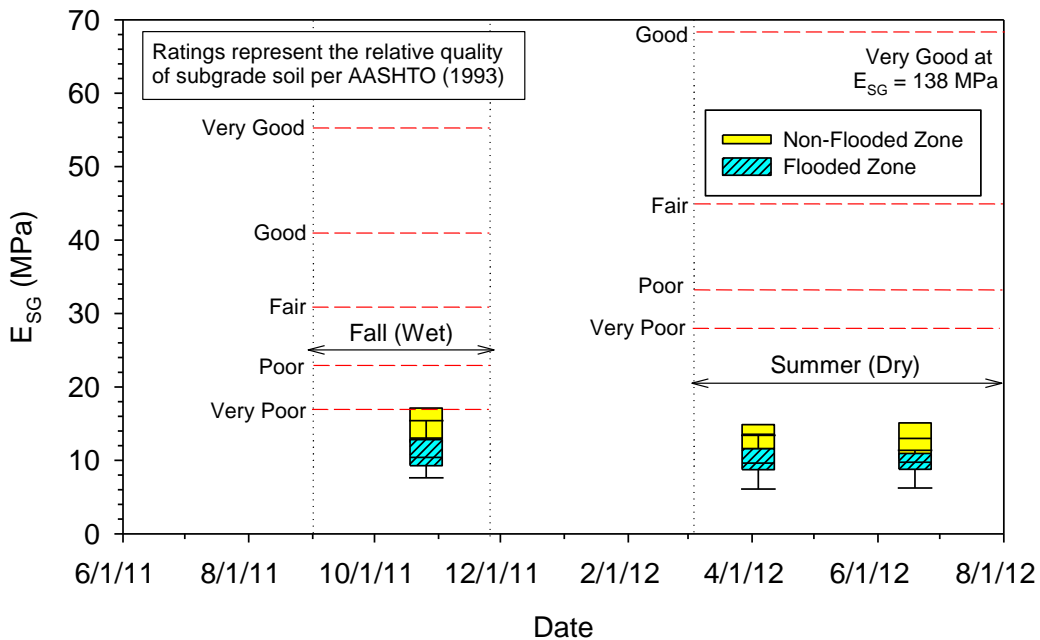
Figure 166. Box plots of subgrade modulus values in flooded and non-flooded zones in comparison with relative quality ratings on TS4 – Fremont County

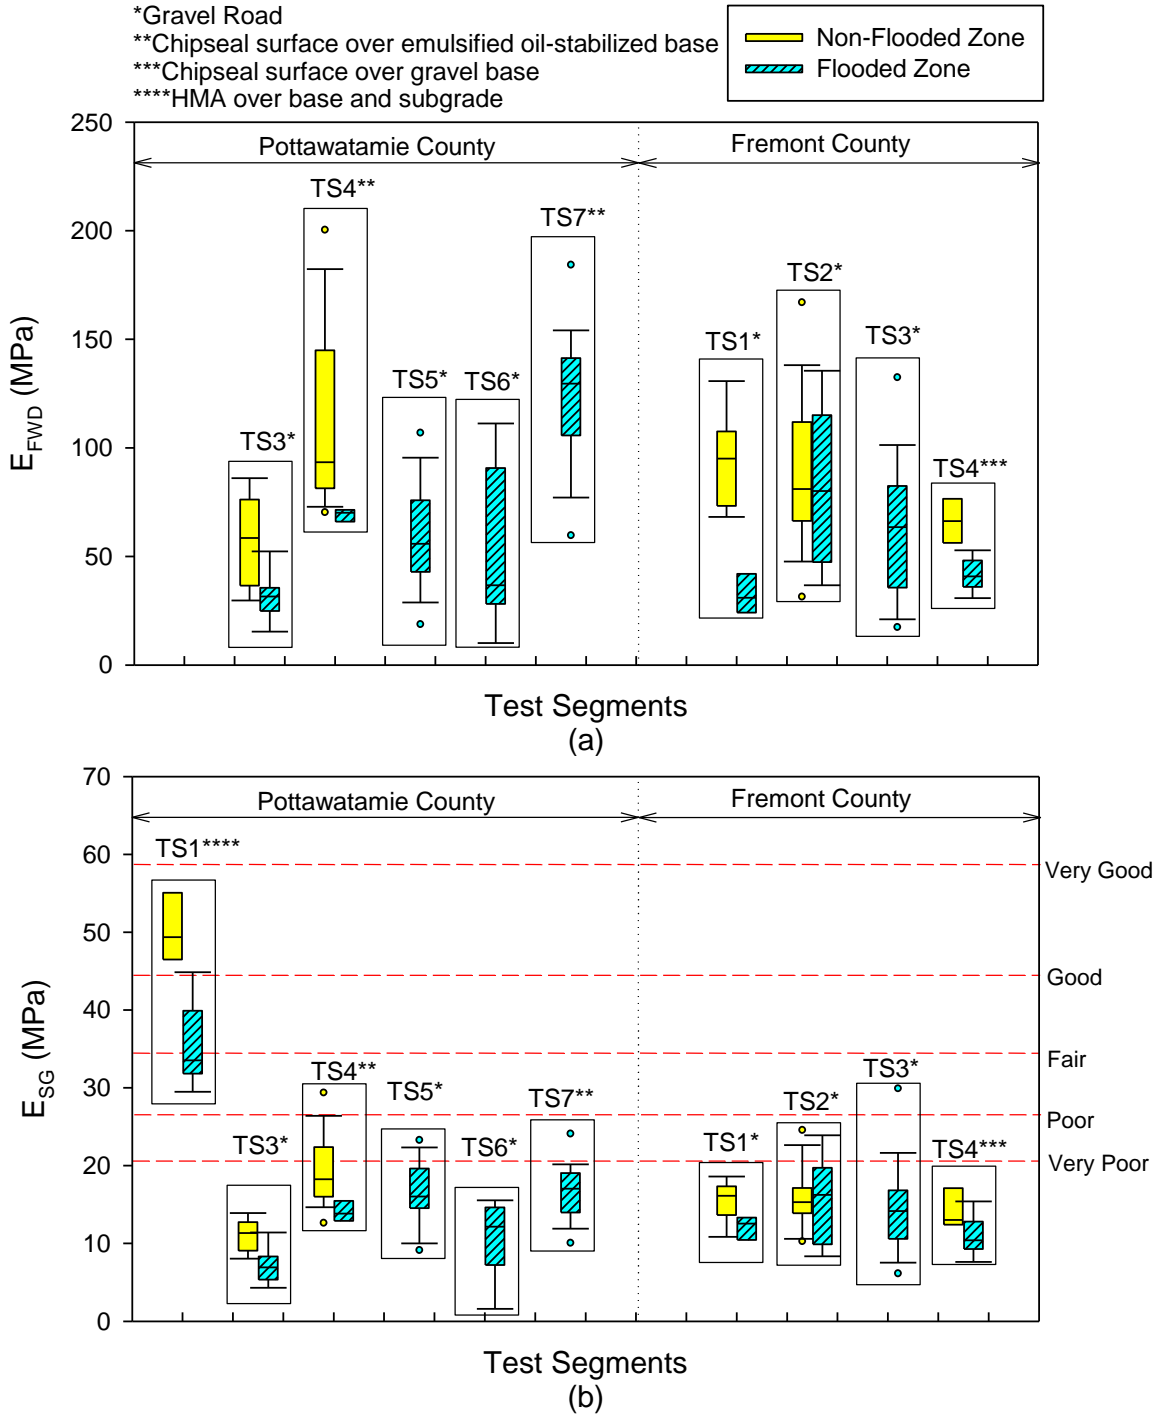
The comparisons presented in Figure 167 and Figure 168 and the statistical t-test results indicate that out of the 6 test segments (where non-flooded and flooded zones sections were present within a test segment), 5 test segments had statistically significant difference between flooded and non-flooded zones. On average, the E_{FWD} and E_{SG} values in non-flooded zones were about 1.3 to 3.6 times greater than the values in non-flooded zones, in the test segments where the difference was statistically significant. Results obtained about 7 to 8 months after flooding were statistically significant in only 3 out the 6 test segments. This indicates that in those test segments, the foundation layers in the flooded zone gained strength over time, likely as drainage occurred and the degree of saturation in the subgrade layers decreased.

Figure 167. Box plots of (a) E_{FWD} and (b) E_{SG} obtained shortly after flooding (about 20 to 30 days) from all test segments in flooded and non-flooded zones

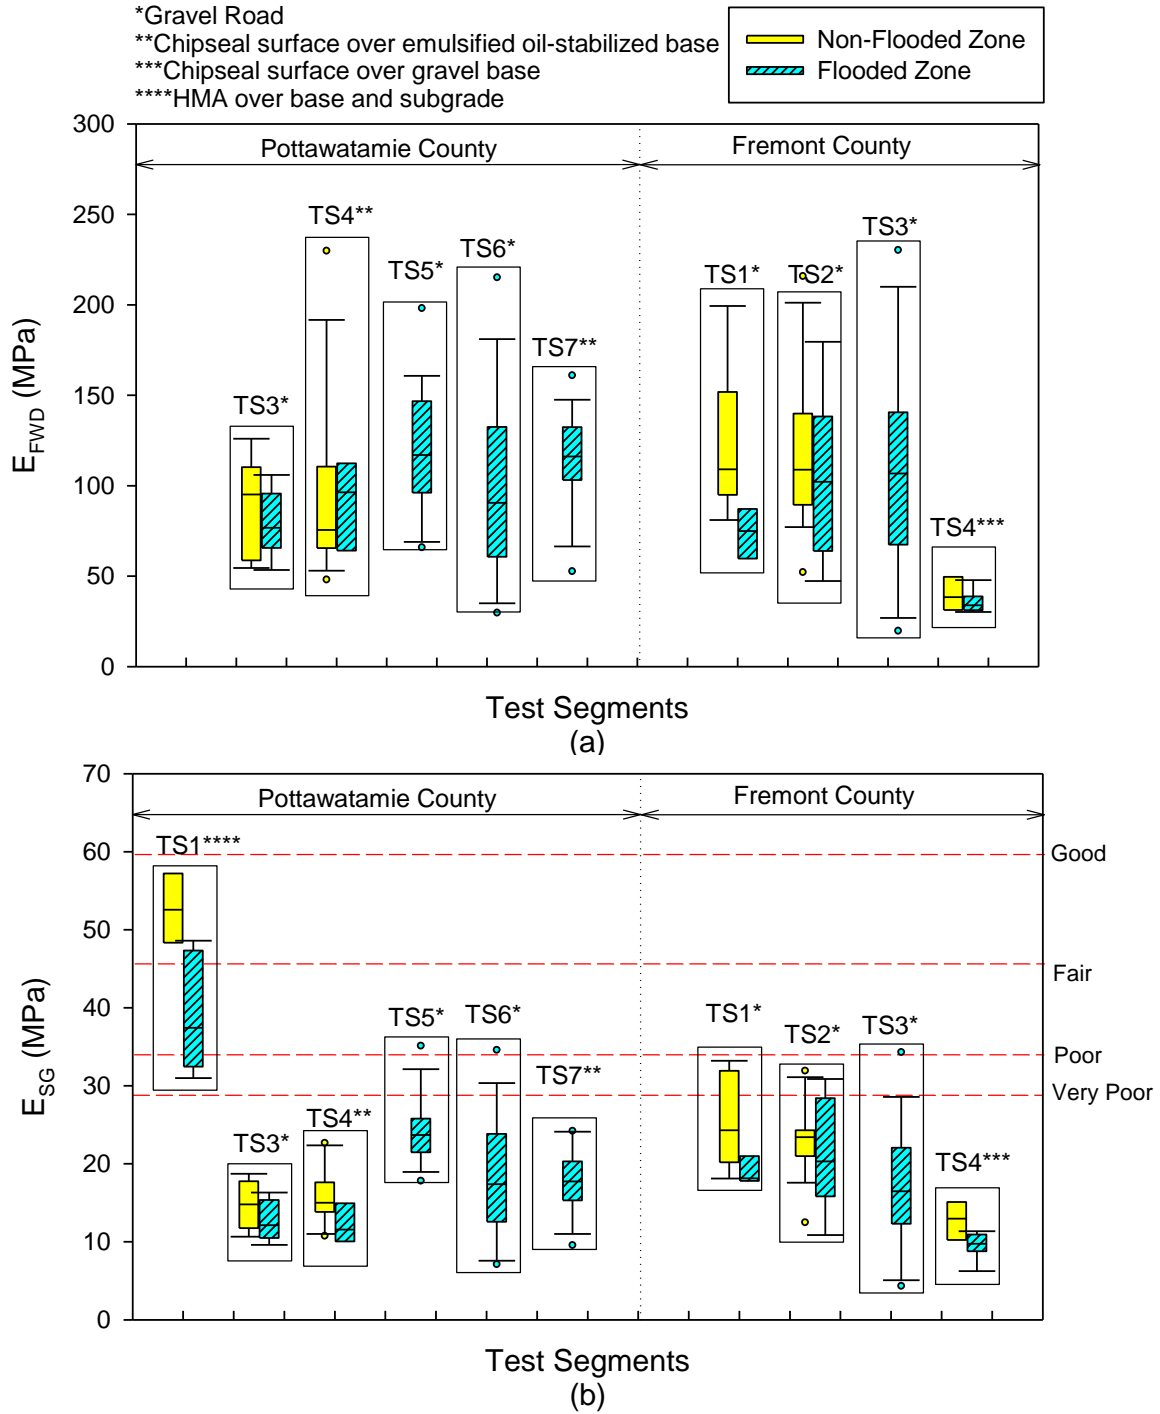
Figure 168. Box plots of (a) E_{FWD} and (b) E_{SG} obtained about 7 to 8 months after flooding from all test segments in flooded and non-flooded zones

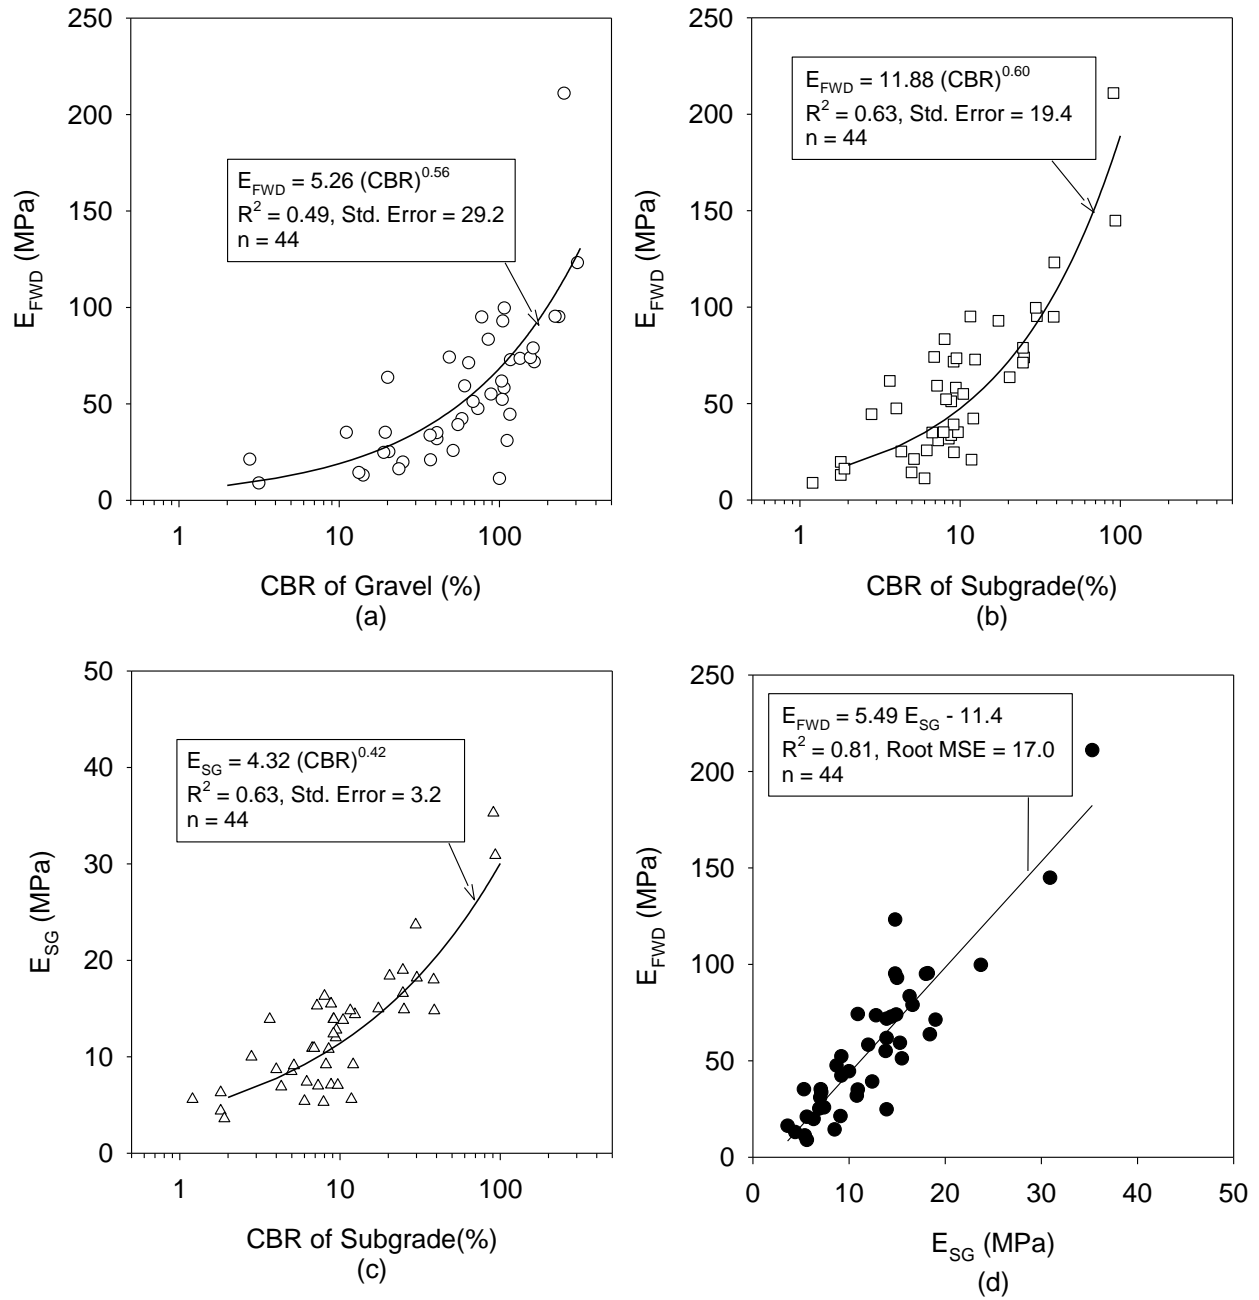
The correlations between CBR of subgrade and FWD measurements yielded power relationships with higher R² values (0.63) than the correlation between CBR of gravel and E_{FWD} (R² = 0.49). Correlation between E_{FWD} and E_{SG} yielded a linear relationship with R² = 0.81. The standard error of the predictions are also shown in Figure 169.

Figure 169. Regression analysis between: (a) CBR of Gravel and E_{FWD} , (b) CBR of subgrade and E_{FWD} , (c) CBR of subgrade and E_{SG} , and (d) E_{SG} and E_{FWD}

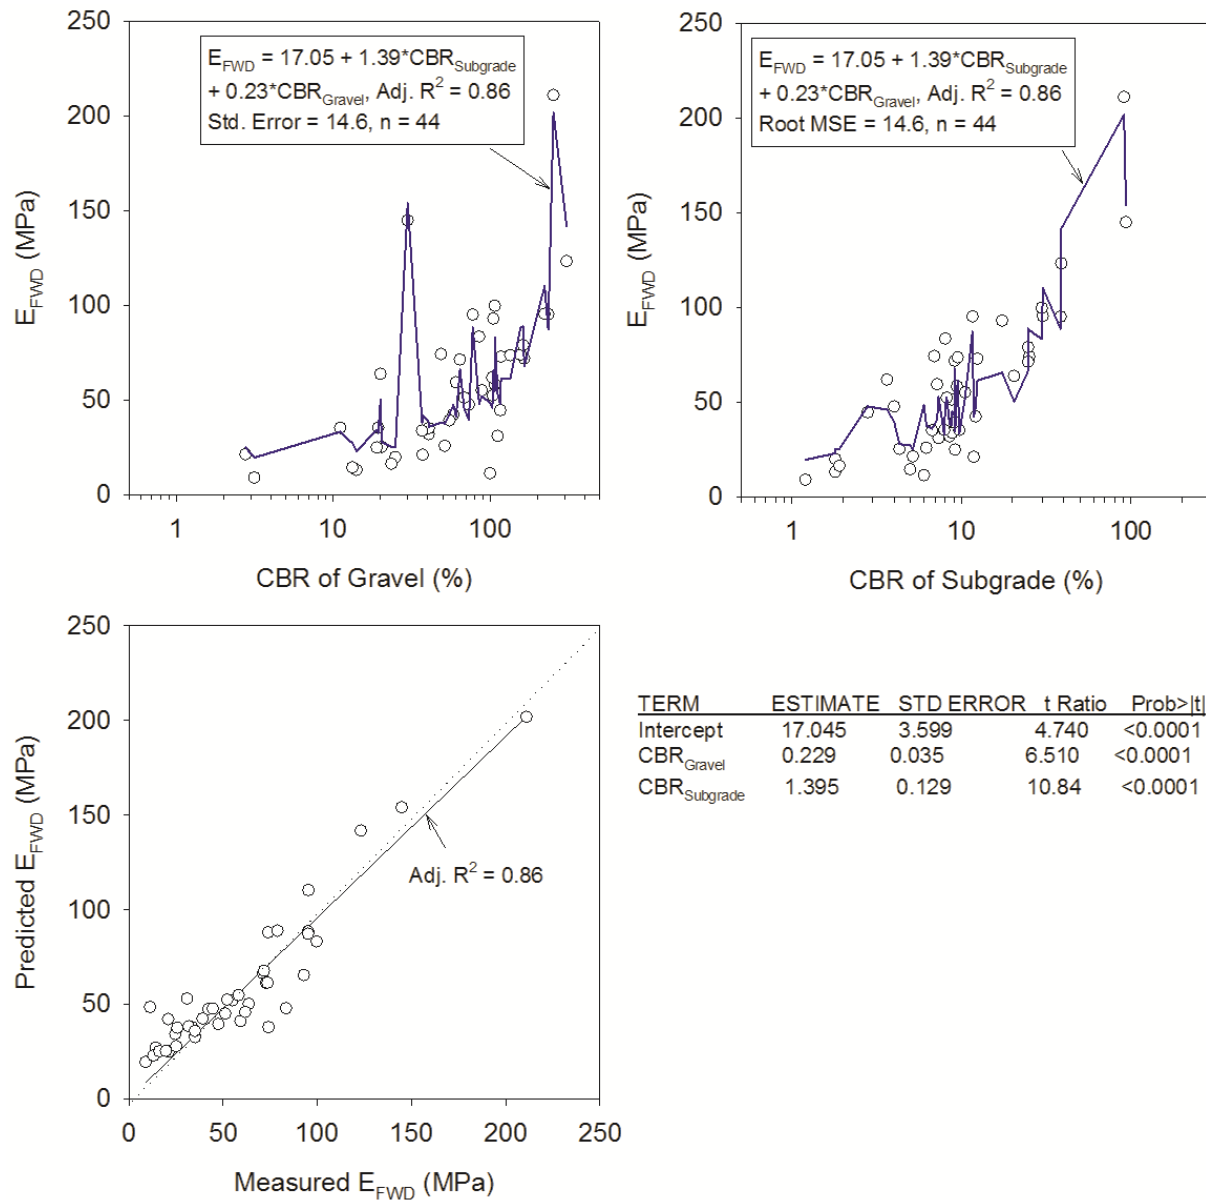
The relative statistical significance of the subgrade and gravel layer CBR measurements on E_{FWD} was assessed using multivariate analysis results shown in Figure 169. The p-value and t-value statistics indicated that both CBR of subgrade and gravel layers are statistically significant. Using Eqs. 17 and 18, the subgrade layer has about 86% of influence on the surface layer FWD measurements while the gravel layer has about 14% influence. This finding has practical importance because it indicates that the response to dynamic traffic loading at the surface will be more dependent on the relatively soft subgrade layer. In cases where subgrade layer is “soft”

Figure 170. Results of multivariate regression analysis to predict E_{FWD} from CBR of gravel and CBR of subgrade
