Western Iowa Missouri River Flooding— Geo-Infrastructure Damage Assessment, Repair, and Mitigation Strategies

SEPTEMBER 2013

Final Report

Federal Highway Administration
Iowa Highway Research Board
(IHRB Project TR-638)
Iowa Department of Transportation
(InTrans Project 11-419)

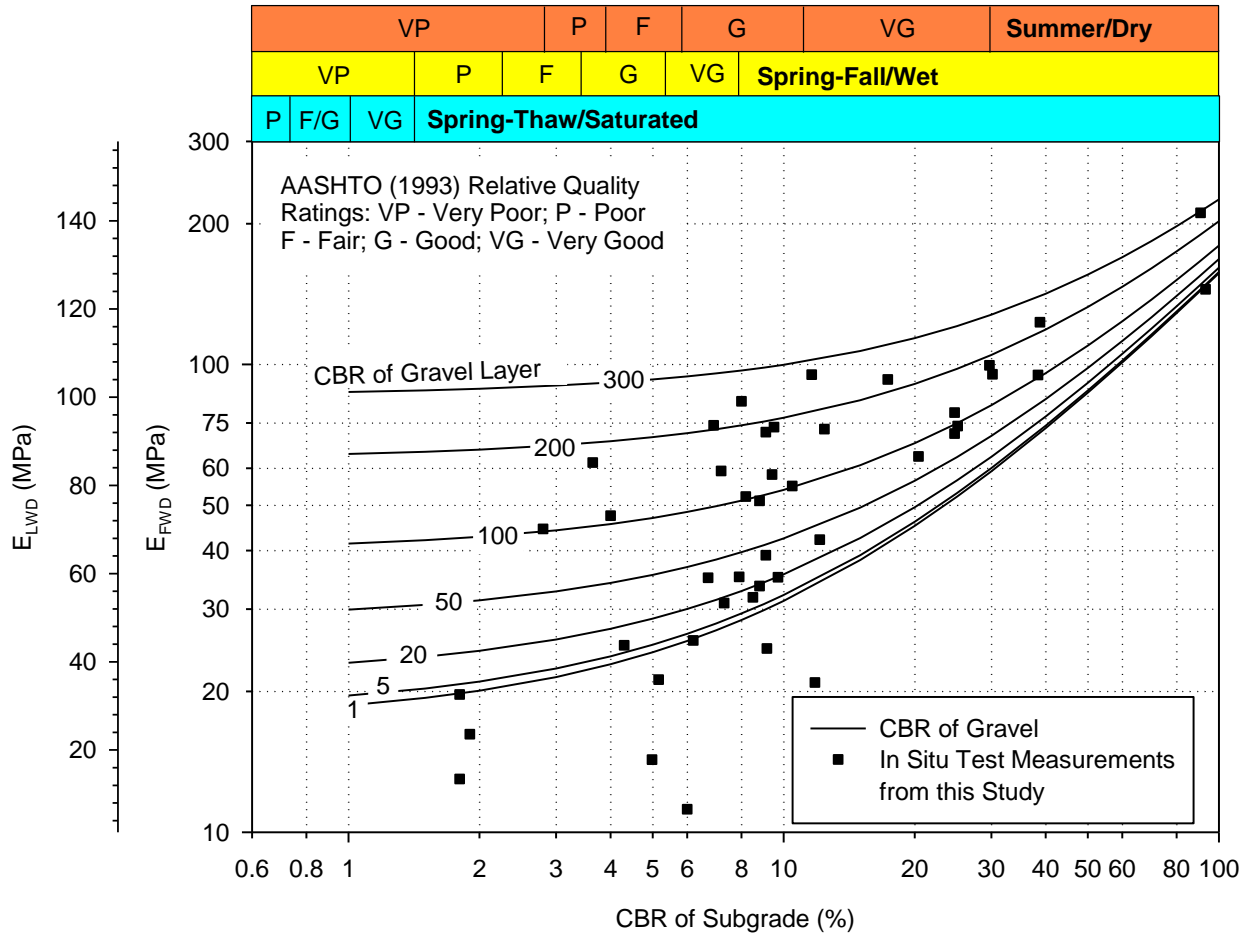
Using the multivariate regression relationship, a chart was developed to predict E_{FWD} from CBR of subgrade and gravel layer values, as shown in Figure 171. The chart shows the subgrade quality ratings per AASHTO (1993) and the in situ test measurements obtained from this study. Results from 7 out of the 44 test locations were outside of the predicted zone, due to uncertainty in the prediction. The curves presented in the charts are based CBR of subgrade = 1.2 to 93, CBR of gravel = 2.8 to 307, FWD modulus = 9 to 211 MPa (1,305 to 30,600 psi), and gravel layer thickness = 90 to 200 mm (3.5 to 7.9 in.). Figure 171 also includes light weight deflectometer modulus (E_{LWD}) on y-axis based on E_{FWD} versus E_{LWD} correlations presented in White et al. (2013a) from tests conducted on 150 mm (6 in.) thick gravel roads.

Figure 171. Chart to estimate FWD or LWD surface modulus from CBR of subgrade and gravel layers overlaid with in situ test measurements and AASHTO (1993) subgrade relative quality ratings

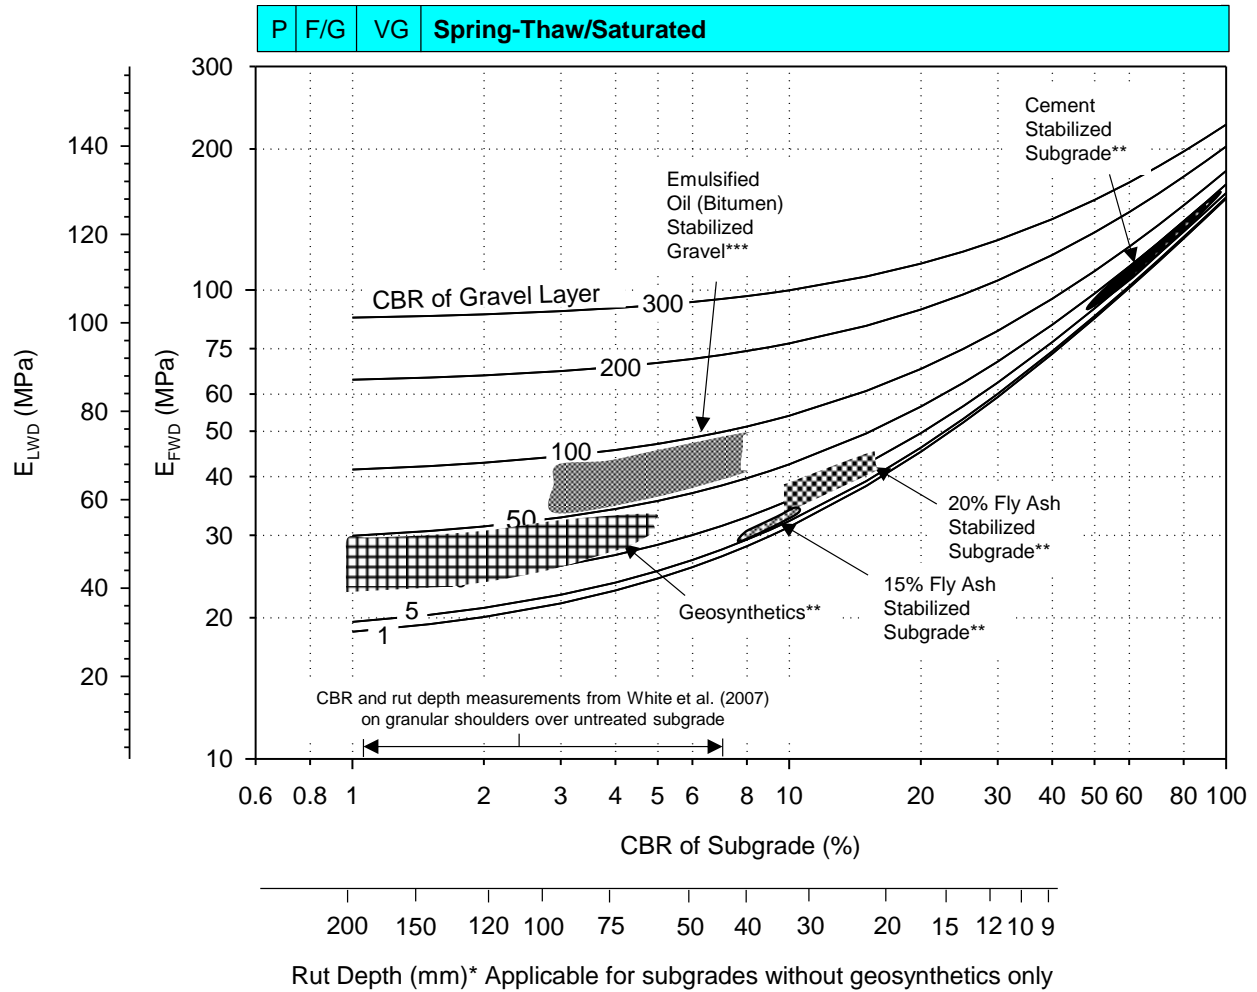
Typical CBR values for subgrade and gravel layers in wet condition (during spring-thaw), which were originally constructed using different stabilization techniques (from White et al. 2013b) are overlaid on this chart in Figure 172. Also included in Figure 172 is rut depth scale on x-axis based on relationships between CBR of subgrade (untreated) and rut depth under a 80 kN (18 kips) axle load for 100 loading cycles on a 152 mm (6 in.) thick gravel layer (untreated), as presented in White et al. (2007).

The chart presented in Figure 172 are developed to help determine target values in the field. A few example scenarios on how the chart can be used to determine target values is provided below:

Figure 172. Chart showing relationship between CBR, rut depth, and FWD and LWD modulus, and typical range of CBR values observed after spring-thaw in Iowa (White et al. 2013b) for different stabilization methods

Scenario 1: Assume that a gravel road is to be designed for an allowable rut depth of 50 mm. Based on the chart, a minimum CBR of subgrade = 6 and CBR of gravel = 6 are needed, as measured using a DCP test. As an alternate, LWD (using 300 mm diameter plate Zorn LWD) or FWD (using a 300 mm diameter plate Kuab FWD) tests can be conducted and the respective target values corresponding to CBR of subgrade and gravel = 6 are 48 MPa (6,960 psi) and 27 MPa (3,915 psi), respectively. If these values cannot be achieved, alternative treatments to subgrade (e.g., geosynthetics, chemical stabilization, mechanical stabilization) can be used. Note that the geosynthetic treatment zone highlighted on Figure 172 does not correspond to the rut depth measurements, as the CBR to rut depth relationship from White et al. (2007) was for materials without any geosynthetic. Use of geosynthetics can help reduce rutting under traffic loading.

Scenario 2: Assume that a new subgrade layer with a target design CBR = 10 in wet conditions, is required. Based on the chart, stabilization technologies to achieve a minimum CBR = 10 in the subgrade is with 20% fly ash stabilization, mechanical stabilization, or cement stabilization of subgrade. FWD and LWD target values can also be determined for the different stabilization technologies.

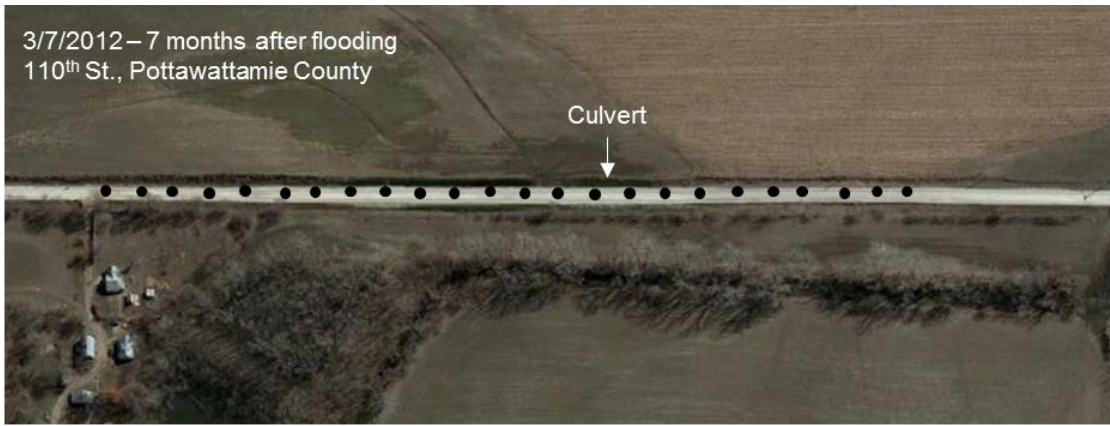
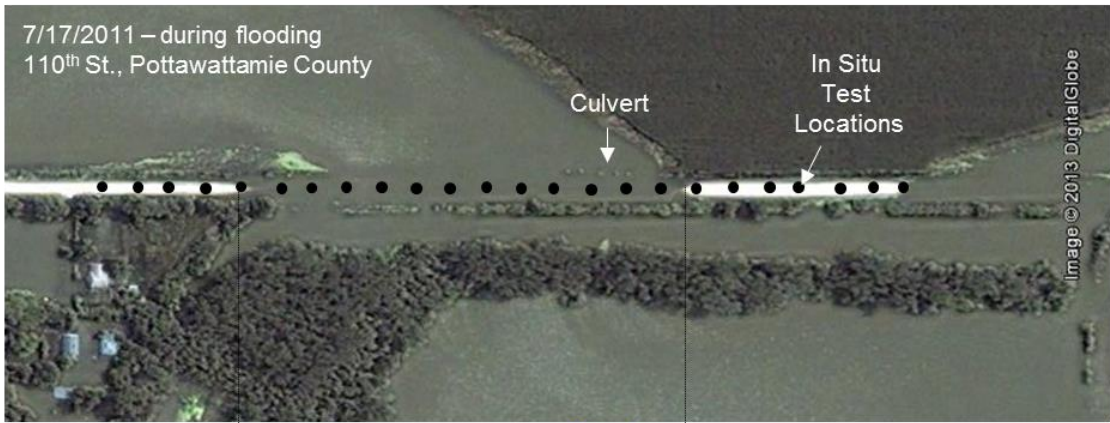
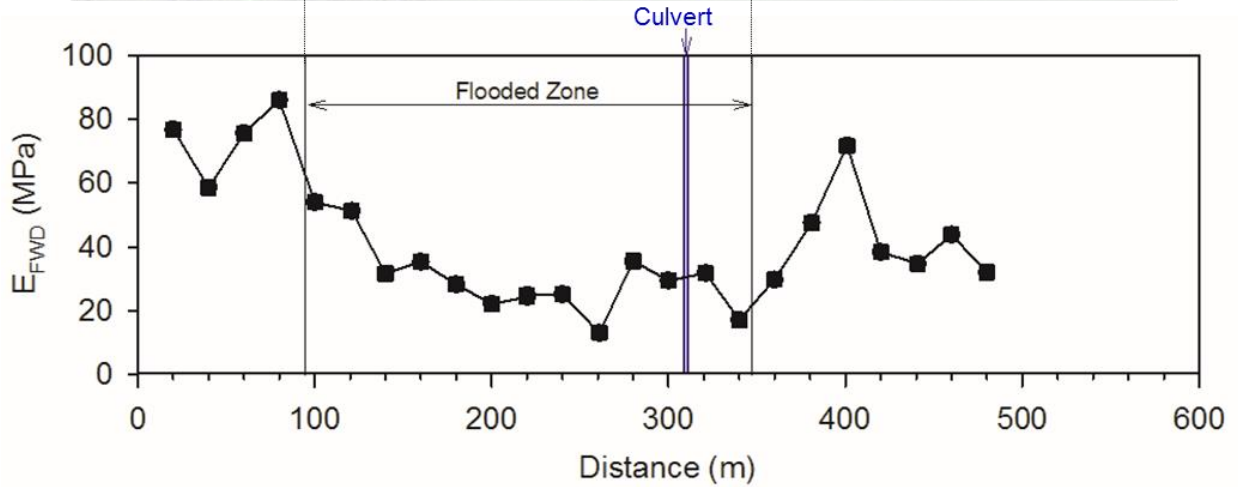
Figure D2. Aerial imagery showing during flood and after flood conditions, and FWD test results in flooded and non-flooded areas (imagery from Google Earth)

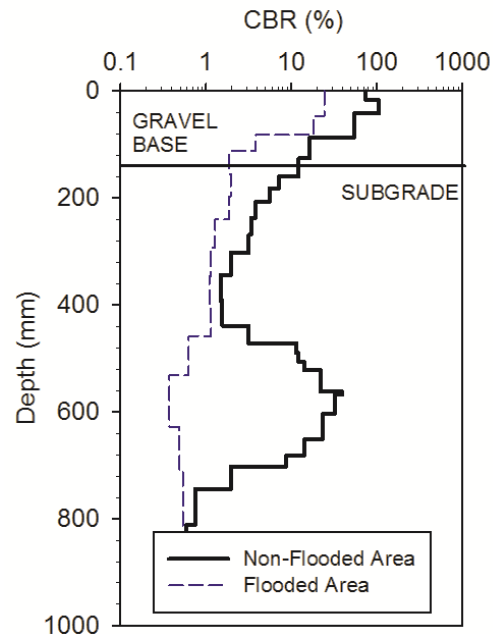
Figure D9. Dynamic cone penetrometer testing (left) and an example plot comparing DCP-CBR profiles in flooded and non-flooded areas

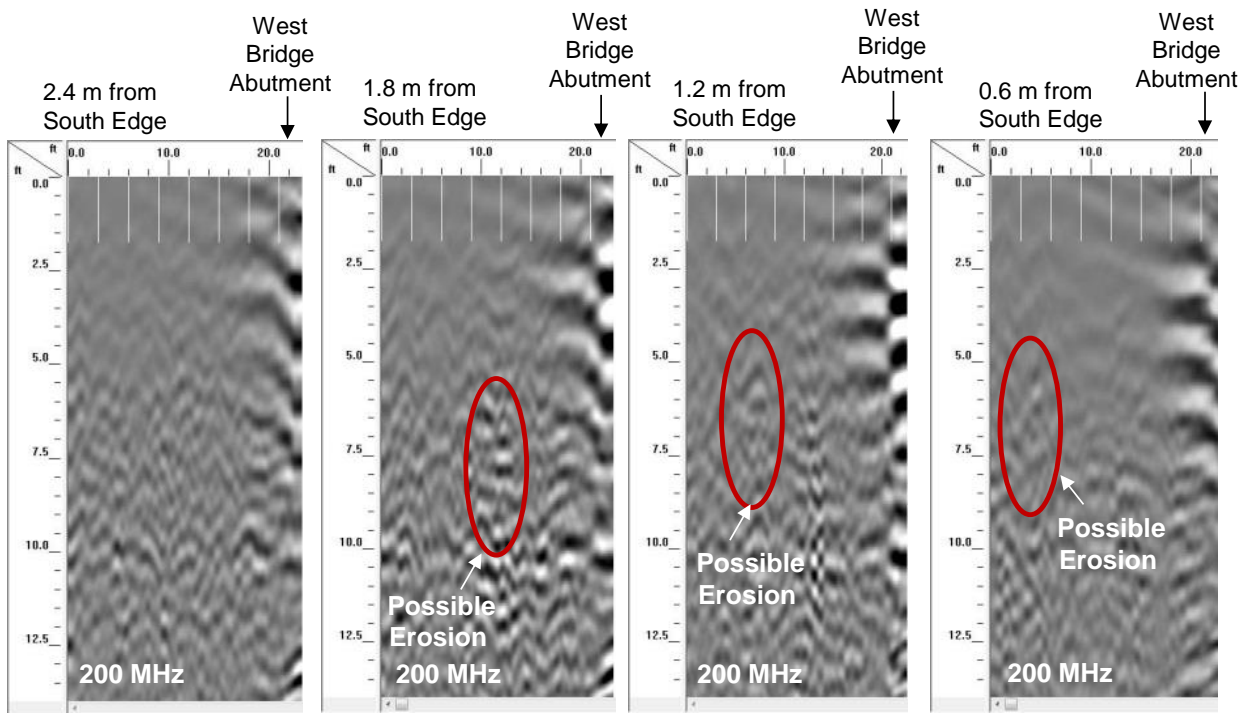
Figure D14. GPR scans using 200 MHz antenna on bridge approach backfill materials at several locations from the edge of the bridge identifying possible erosion/voids beneath surface

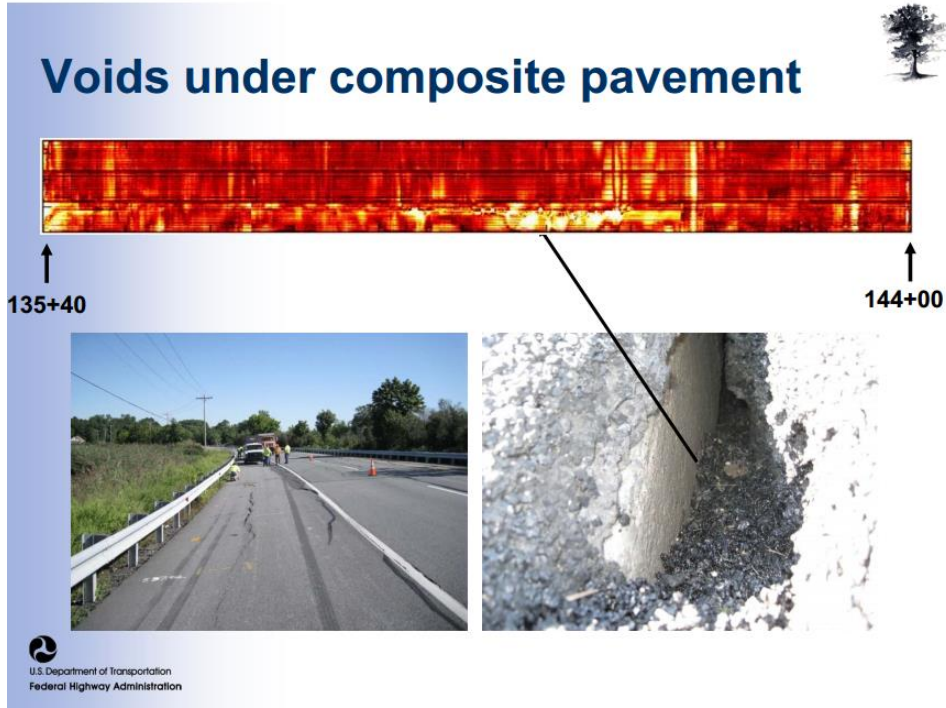
Figure D17. GPR scan map showing voids under composite pavement (Yu 2012)

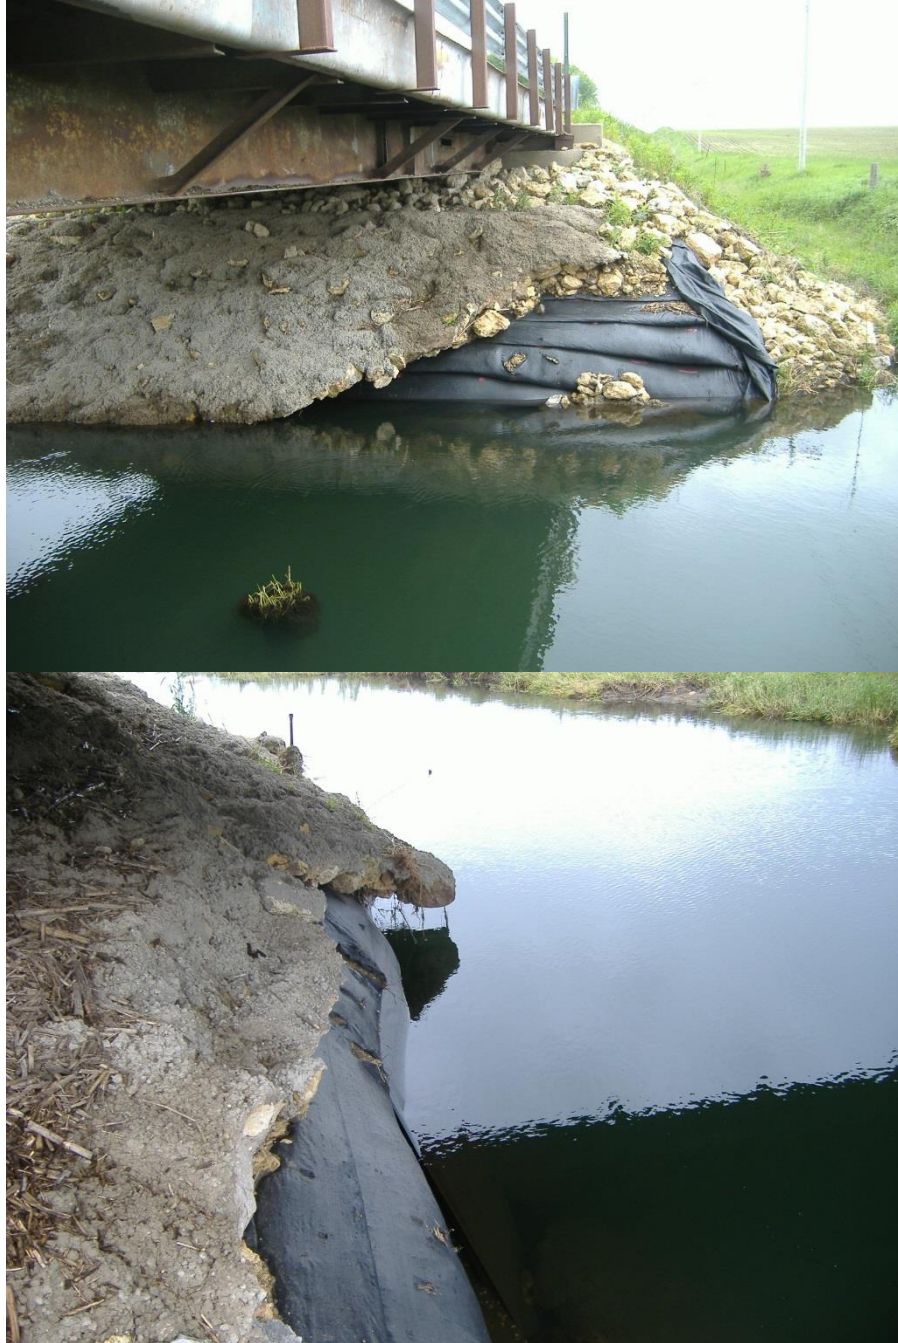
Recently, two case study projects are documented in Vennapusa et al. (2012) for bridges constructed in Buchanan County using GRS fill in bridge abutments. One of the bridge sites (Olympic Ave.) included GRS fill constructed with a slope and riprap capped with cement grout was used for erosion protection (Figure D38, Figure D39). Another bridge site (250th St.) included supporting the bridge on GRS fill using the existing bridge abutment and soil as facing (Figure D40). A summary of the 250th St. bridge construction costs are provided in Table D6. Both these bridges experienced flash flooding during summer of 2013 and flood waters overtopped during the flood event. At the Olympic Ave. bridge site, some of the rip rap facing was eroded (Figure D41) and at the 250th St. bridge site, some of the gravel surfacing was eroded into the ditches. Despite these, no other distresses were observed at the two sites (Figure D42).

Figure D41. Pictures of a bridge site in Buchanan County (Olympic Ave.) after flash flooding occurred in May 2013

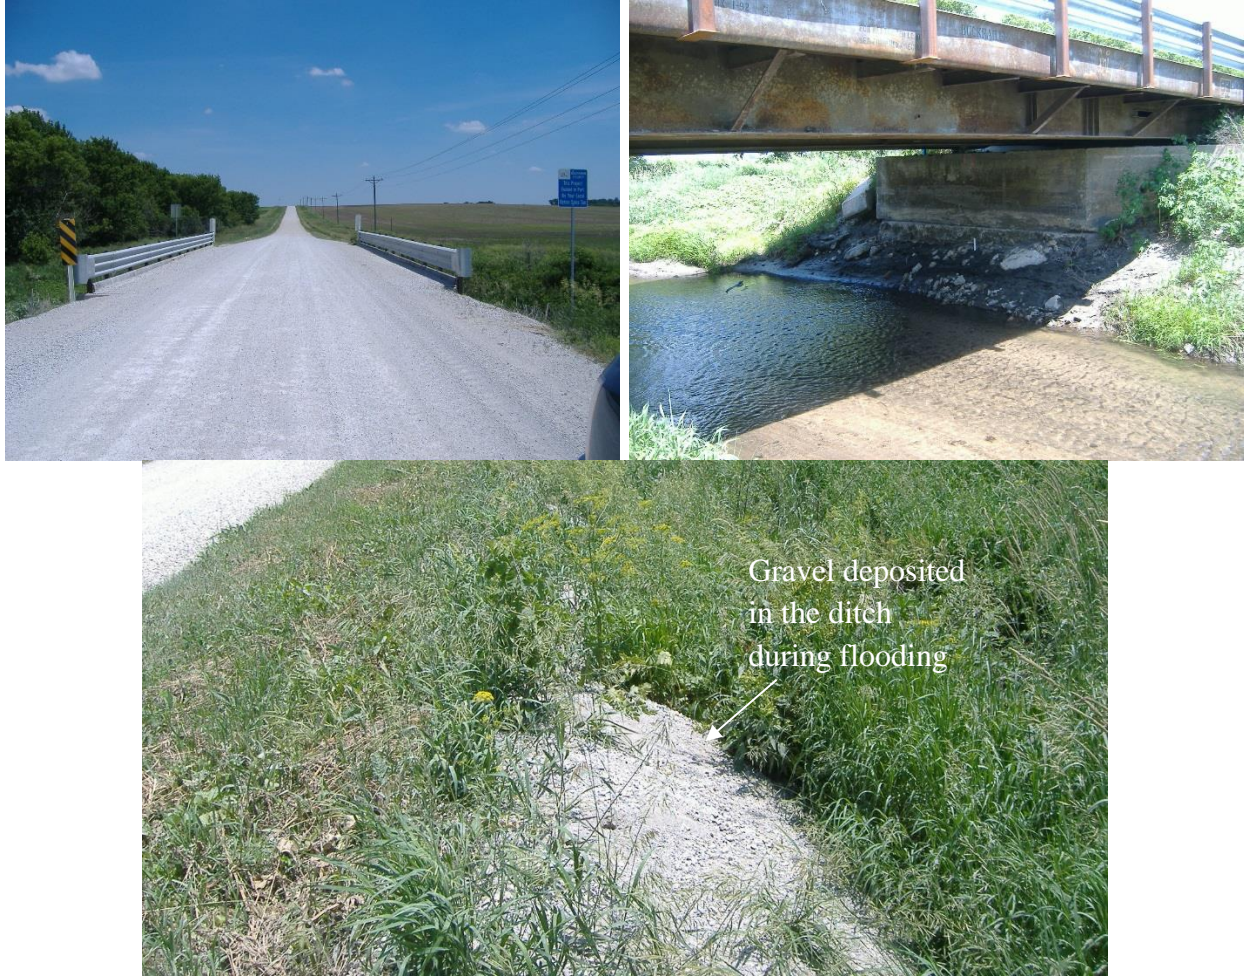
Figure D42. Pictures of a bridge site in Buchanan County (250th Street) after flash flooding occurred in May 2013
