# DEVELOPMENT AND EVALUATION OF A *MASH* TL-3 31-INCH W-BEAM MEDIAN BARRIER

## Test Report 9-1002-12-8

TEXAS A&M TRANSPORTATION INSTITUTE  
COLLEGE STATION, TEXAS

TEXAS DEPARTMENT OF TRANSPORTATION

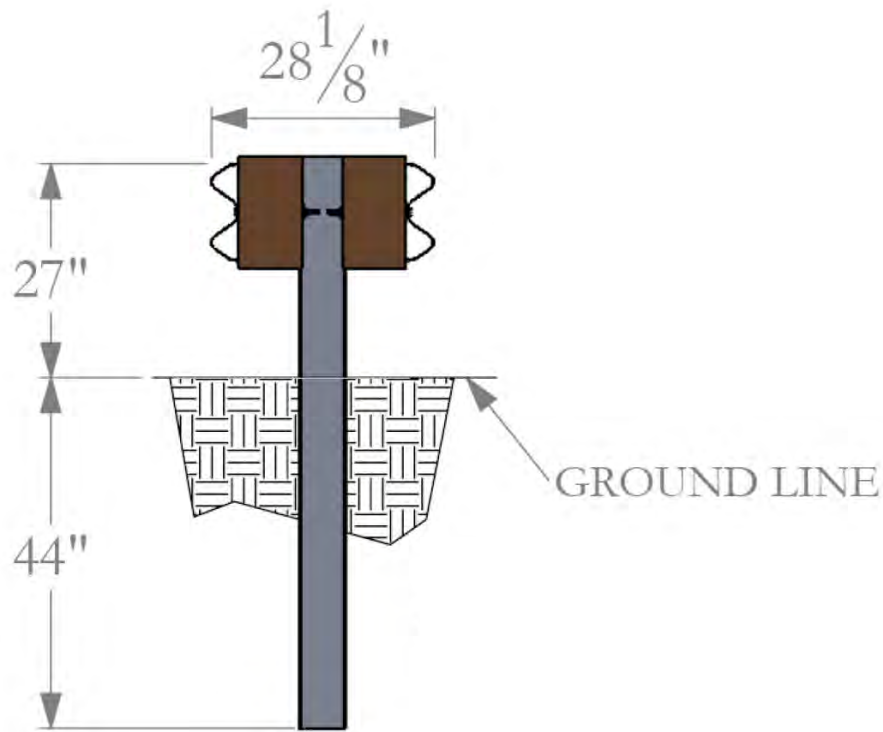
**Figure 1.1. Cross Section of the 27-Inch MB4 W-Beam Median Barrier.**

Figure 1.1 shows a cross section of the MB4 W-beam median barrier. The first test on the median barrier was with the small car (1100C vehicle). The installation was then repaired and used for the test with the pickup (2270P vehicle).

The MB4 W-beam median barrier did not contain or redirect the 2270P vehicle. The vehicle overrode the installation. Maximum dynamic deflection of the W-beam during the test was 23.2 inches. The impact speed and angle for this test were 64.0 mi/h and 25.1 degrees, respectively. The impact speed and angle were within the acceptable limits prescribed in *MASH*. However, the impact condition represented an impact severity 15.3 percent greater than the target *MASH* condition (62.2 mi/h and 25 degrees).

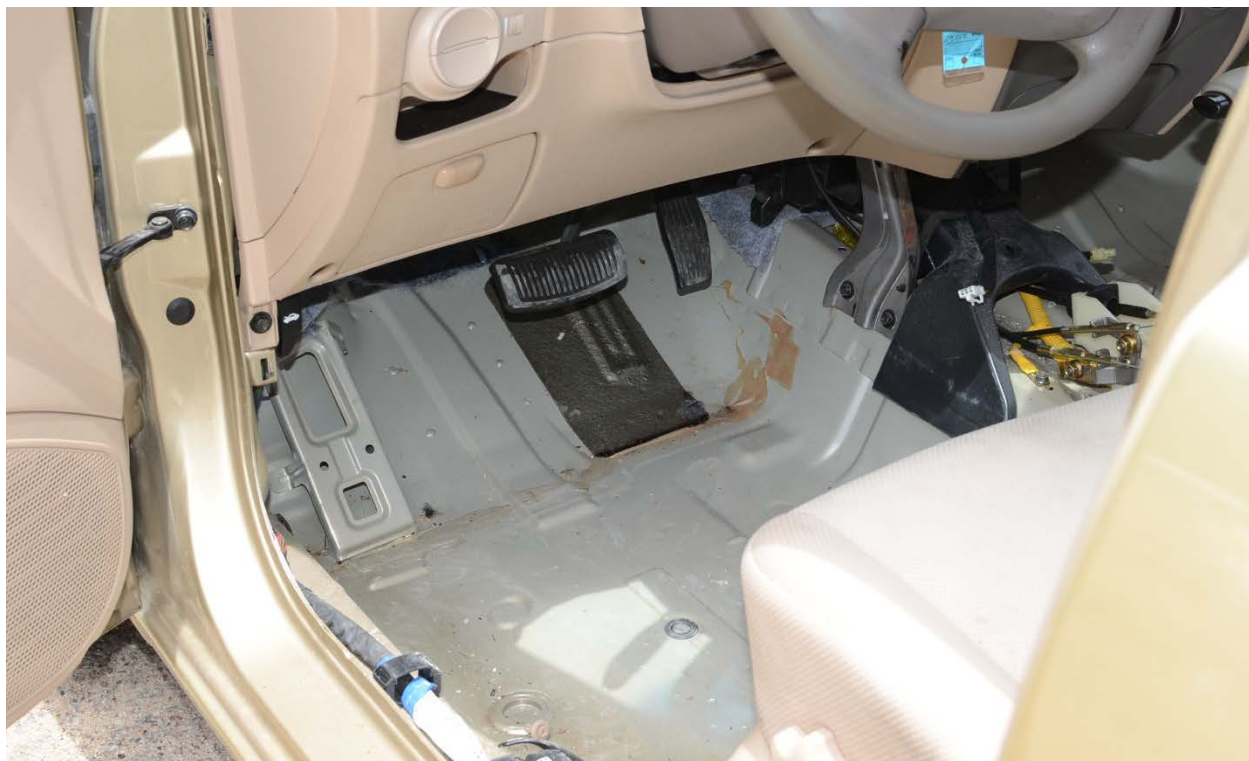
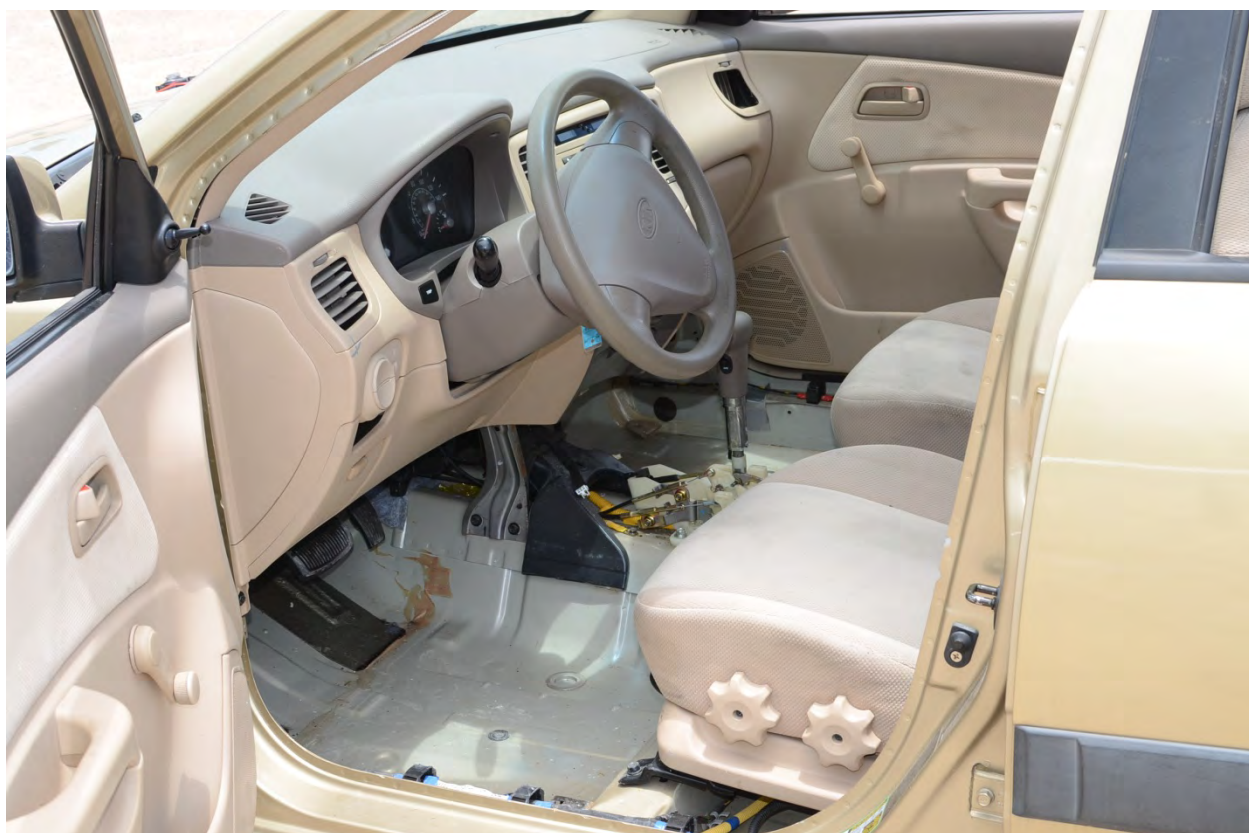
**Figure 6.6. Interior of Vehicle for Test No. 490023-3.**

Figure 6.5 shows damage to the 1100C vehicle. The front bumper, hood, radiator and support, left front strut and tower, left front tire and wheel rim, left front fender, and left front door were damaged. The hood was pushed into the windshield, which shattered the lower portion of the windshield. Maximum exterior crush to the 1100C vehicle was 13.0 inches in the side plane at the left front corner just above bumper height. No occupant compartment deformation was noted. Figure 6.6 provides photographs of the interior of the vehicle, and Tables D1 and D2 provide exterior and occupant compartment measurements.

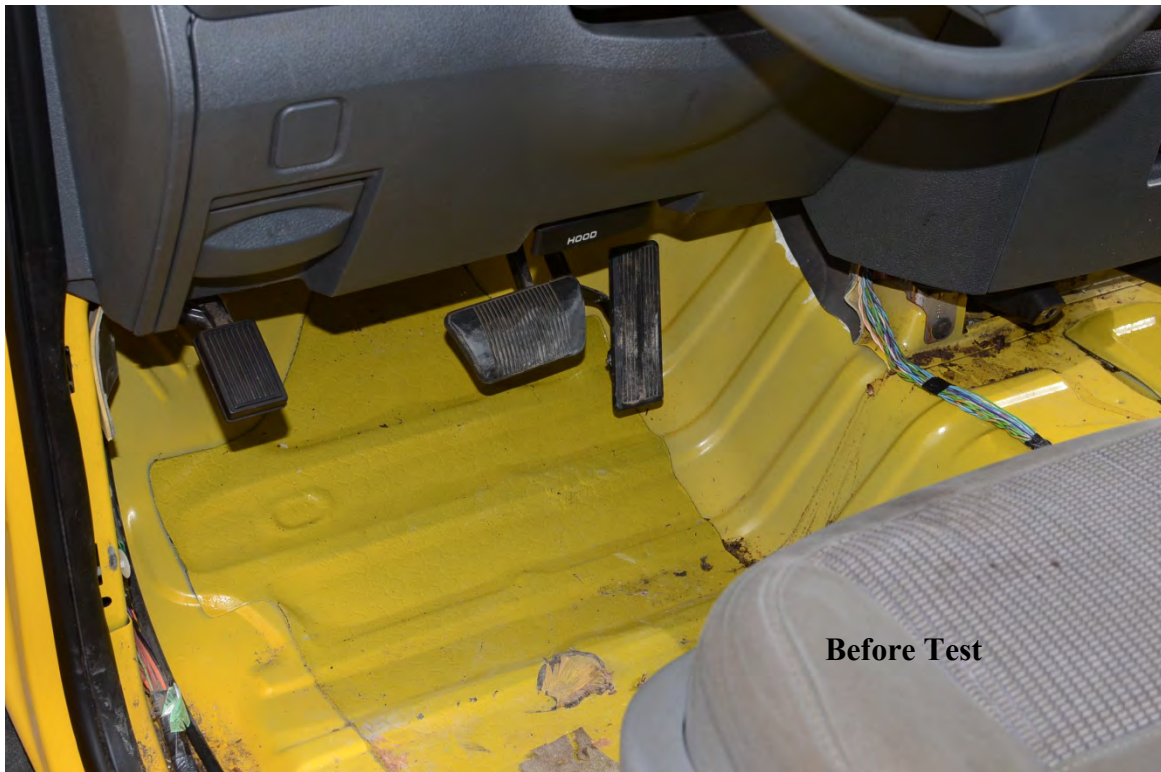
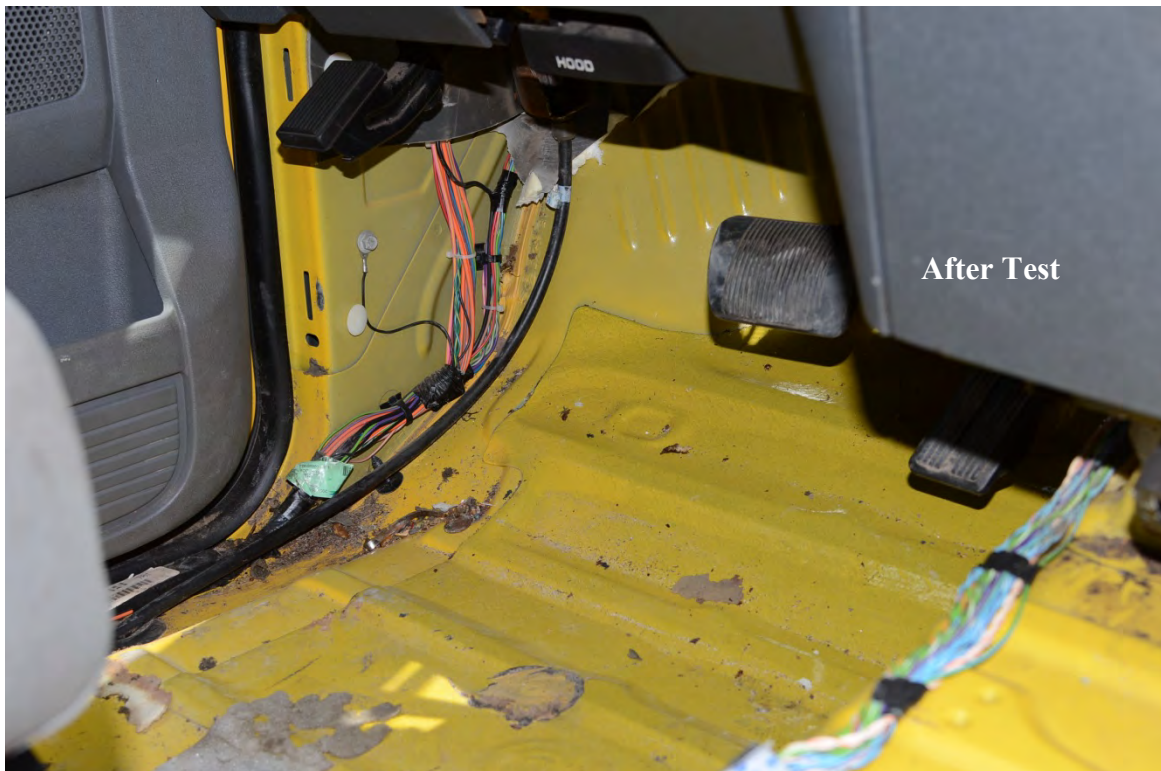
**Figure 7.6. Interior of Vehicle for Test No. 490023-4.**

Figure 7.5 shows damage to the 2270P vehicle. The left front tie rod, left front lower A-arm, left front frame rail, and left front hub assembly were deformed. Also damaged were the front bumper, grill, left front tire and wheel rim, left front fender, left front door, left rear door, left rear exterior bed, left rear tire, and rear bumper. Maximum exterior crush to the vehicle was 11.0 inches in the side plane at the left front corner just above bumper height. No occupant compartment deformation occurred. Figure 7.6 shows the interior of the vehicle before and after the test. Tables E3 and E3 in Appendix E present the measurements made on the vehicle.
