## CRASH TEST AND EVALUATION OF THE TxDOT T631 BRIDGE RAIL

**Test Report 9-1002-12-10**

# **CRASH TEST AND EVALUATION OF THE TxDOT T631 BRIDGE RAIL**

Report 9-1002-12-10  
Project 9-1002-12  
Project Title: Roadside Safety Device Crash Testing Program

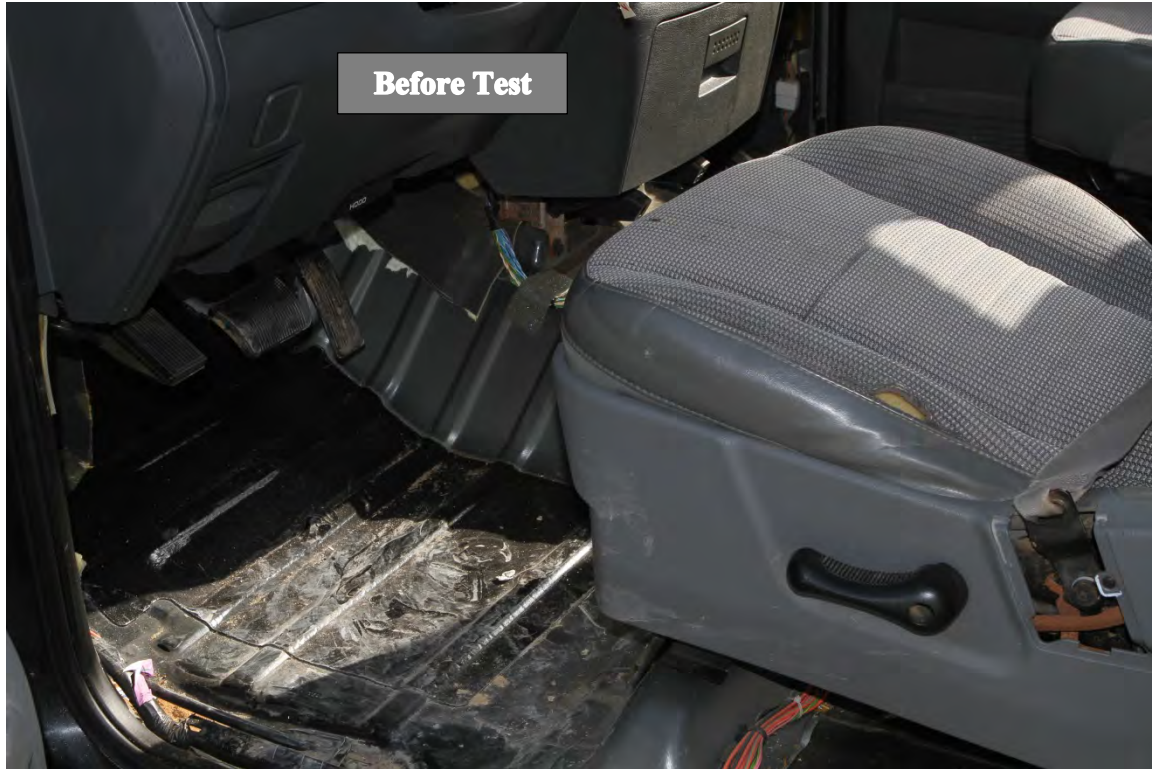
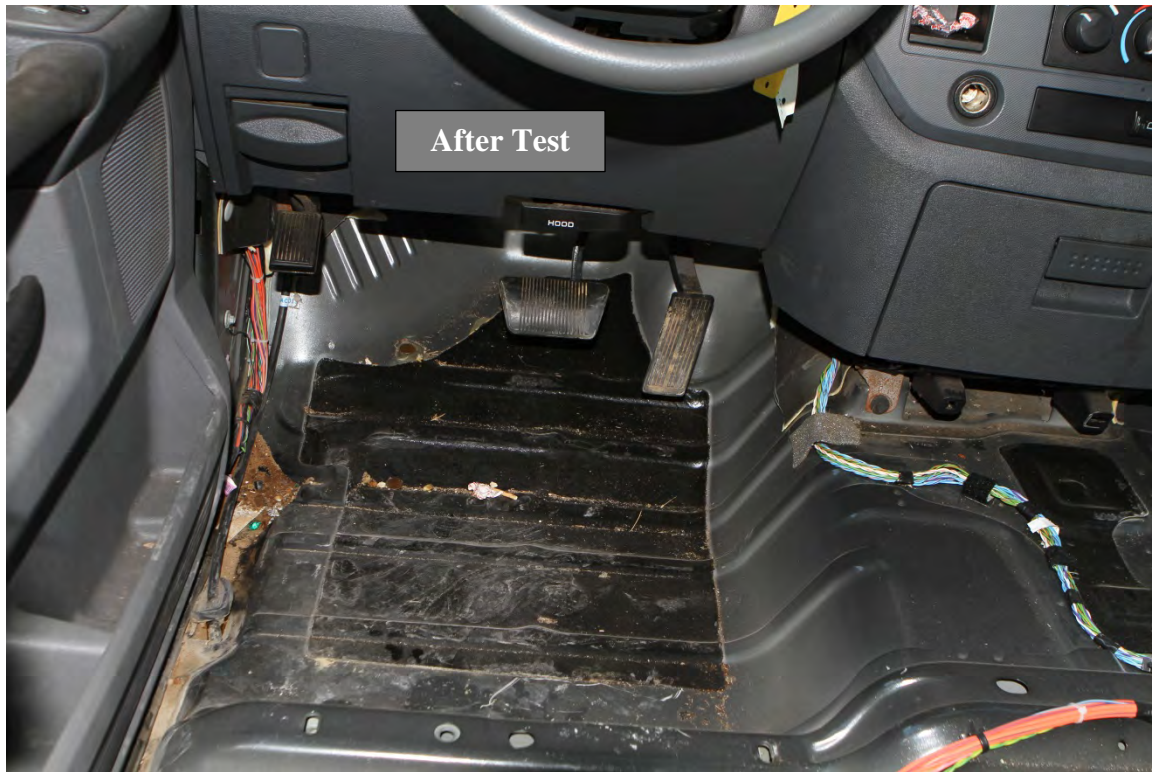
**Figure 5.6. Interior of Vehicle for Test No. 490023-6-1a.**

Figure 5.5 shows damage to the exterior of the vehicle. The left front wheel assembly broke from the upper and lower ball joints; the left upper and lower ball joints, A-arms, and left front tie rod end were deformed. Also damaged were the front bumper, left front fender, left front brake line, left front door, left front tire and wheel rim, left rear tire, left rear exterior bed, and the left rear bumper. Maximum exterior crush to the vehicle was 6 inches in the side plane at the left front corner at bumper height. No occupant compartment deformation or intrusion occurred. Figure 5.6 provides photographs of the interior of the vehicle. Tables C3 and C4 in Appendix C provide exterior crush and occupant compartment measurements.

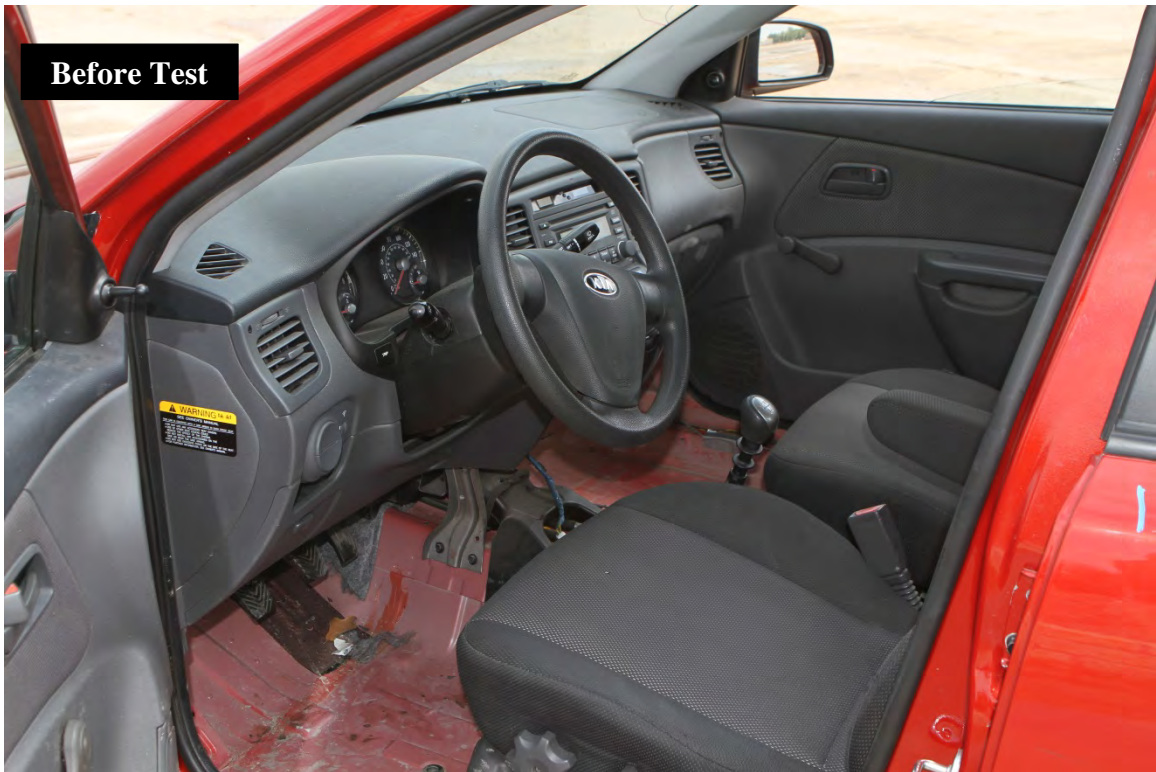
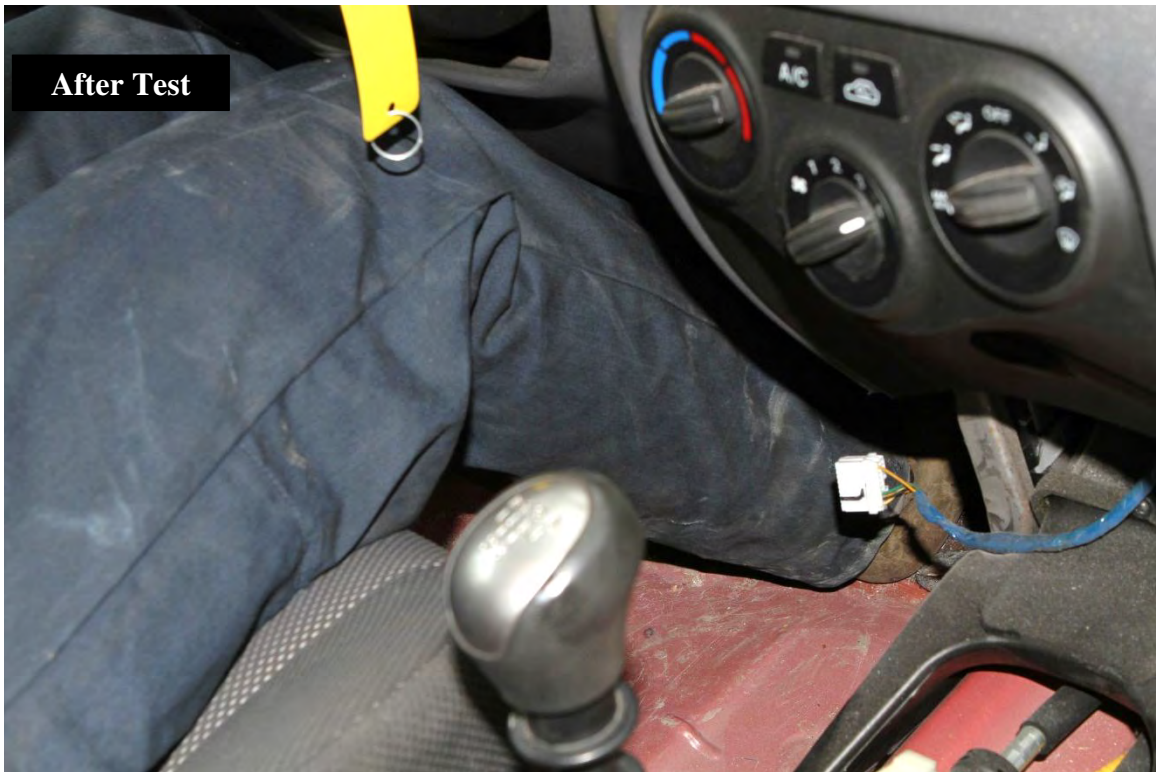
**Figure 6.6. Interior of Vehicle for Test No. 490023-6-2.**

Figure 6.5 shows damage to the 1100C vehicle. The left strut, strut tower, and left tie rod end were deformed. Also damaged were the front bumper, hood, left front fender, left front tire and wheel rim, and the left front door. Maximum exterior crush to the vehicle was 9.5 inches in the side plane at the left front corner at bumper height. No occupant compartment deformation or intrusion occurred. Figure 6.6 provides photographs of the interior of the vehicle. Tables D3 and D4 in Appendix D provide exterior crush and occupant compartment measurements.

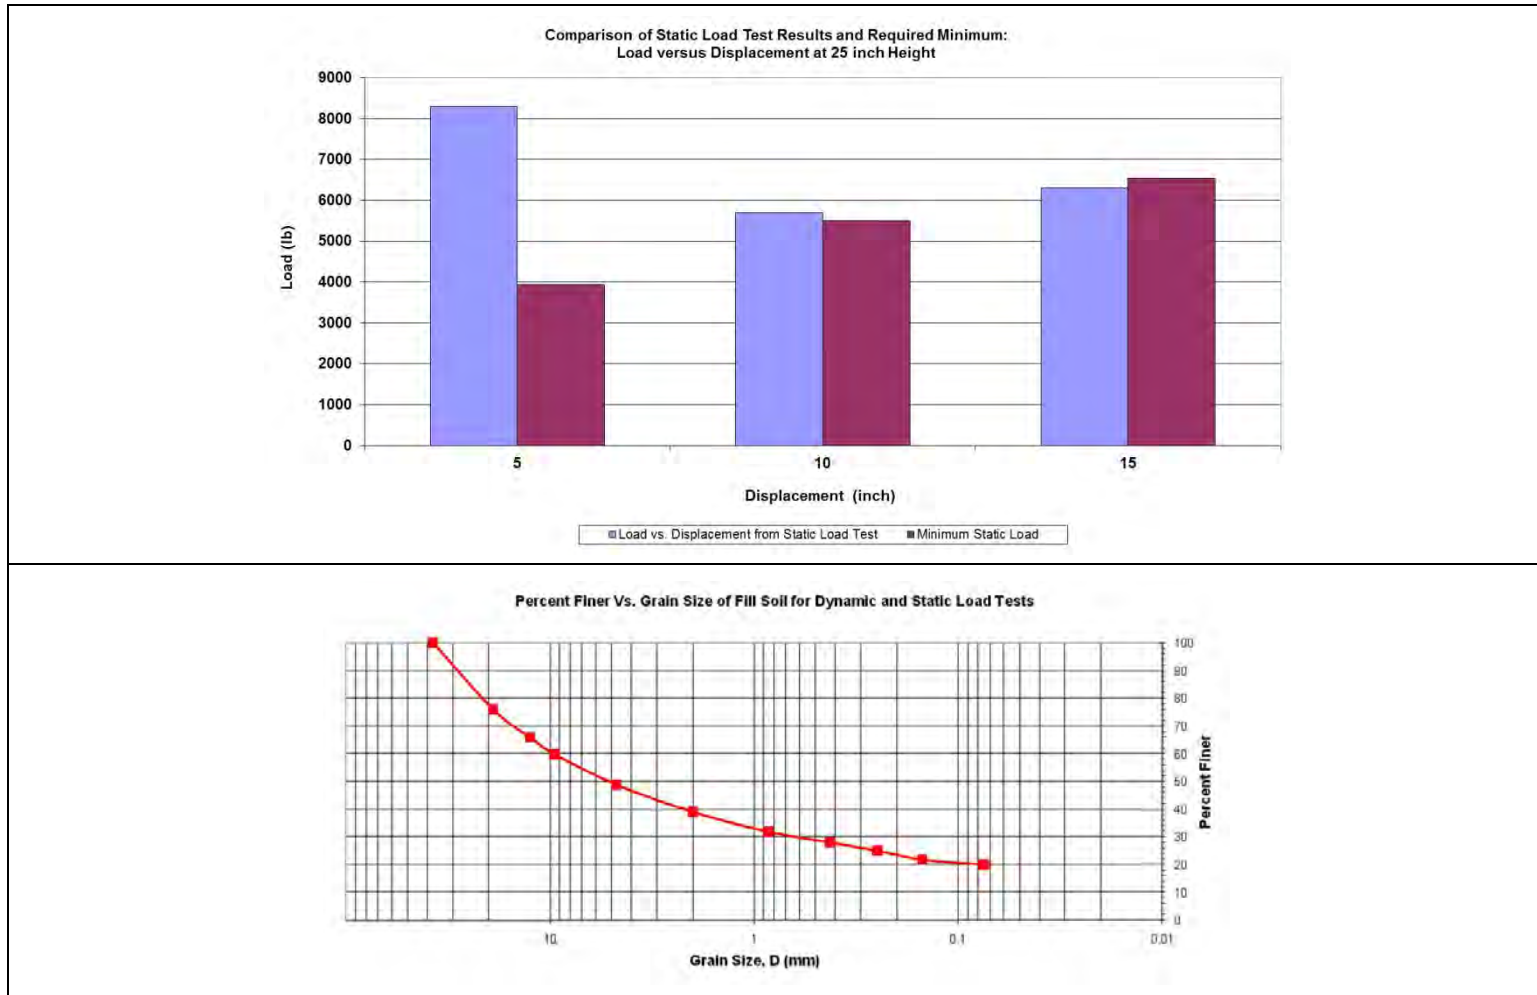
**Figure C2. Test Day Static Soil Strength Documentation for Test No. 490023-6-1a.**

On the day of Test No. 490023-1a, August 13, 2013, load on the post at deflections of 5 inches, 10 inches, and 15 inches was 8300 lbf, 5700 lbf, and 6300 lbf, respectively. The strength of the backfill material was slightly below minimum requirements at 15 inches (see Figure C2 in Appendix C); however, the soil was considered appropriate for testing. On the day of Test No. 490023-2, August 15, 2013, load on the post at deflections of 5 inches, 10 inches, and 15 inches was 7800 lbf, 8838 lbf, and 7926 lbf, respectively. The strength of the backfill material met minimum requirements (see Figure C3 in Appendix C).
