Evaluation of Rutting Distresses on I-20 near Mound to Delta Scales

LTRC Project No. 13-01TA-B

January 2014

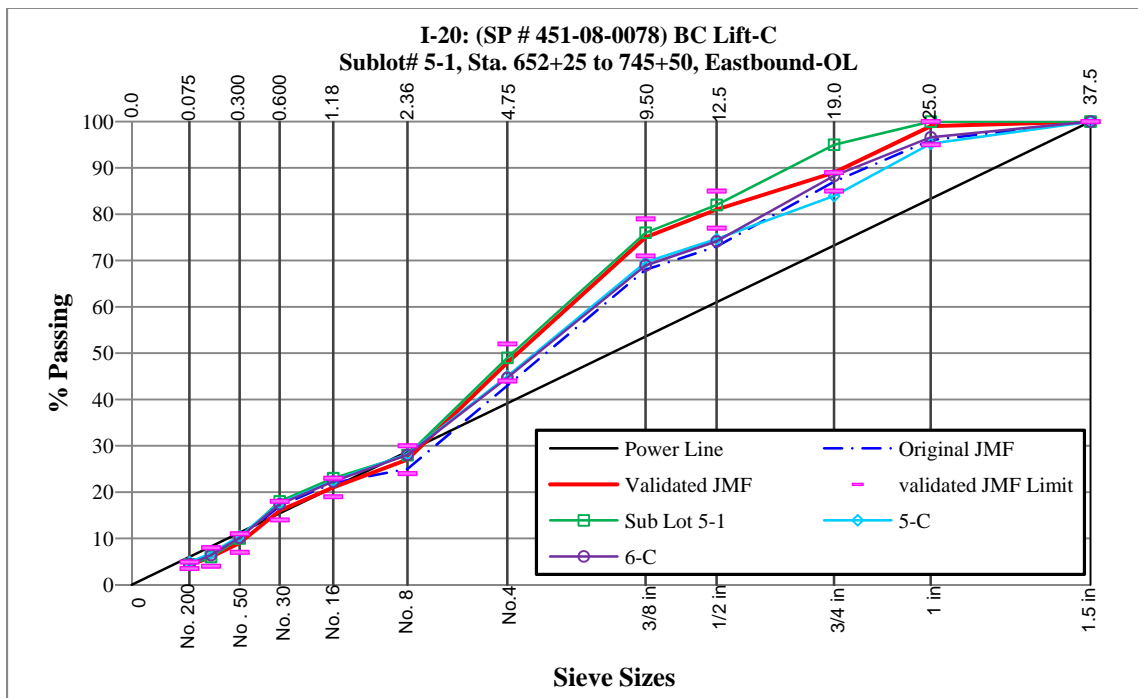
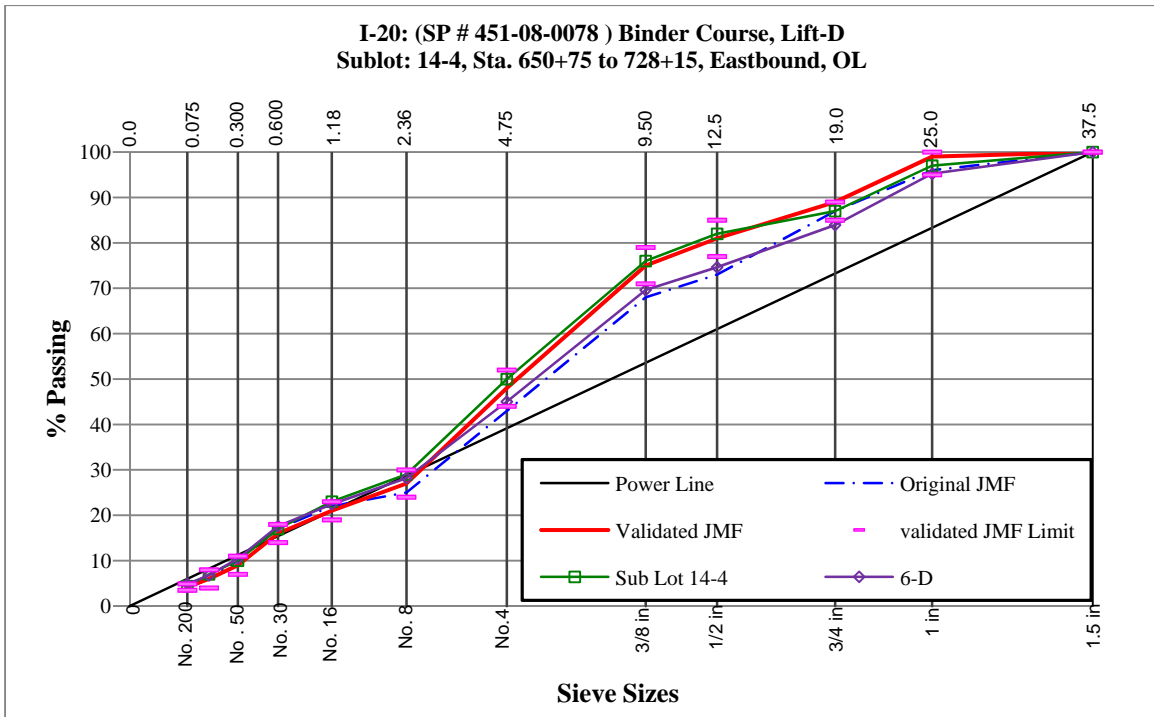
Figure 28

sample, Core 2L, were separated into different lifts and used for burn gradations. It should be noted that Core 5 and Core 6 were collected from station 664+63 to station 664+79 area (Approximate Logmile: 29.17) whereas, Core 2L was collected from station 669+10. The plant records indicate that Lift C for Core 5 and Core 6 represent mix from Sublot 5-1, Lift D for Core 5 and Core 6 represent mix from Sublot 14-4, Lift C for Core 2L represent mix from Sublot 4-1, and Lift D for Core 2L represent mix from Sublot 14-1, respectively. Figures 28 and 29 show a comparison of blended aggregate gradations during production of Sublot 5-1, Sublot 14-4, Sublot 4-1, Sublot 14-1, and the gradations found from the corresponding roadway core lifts. It is evident that the extracted aggregate gradations of roadway cores did not always match the gradations reported in the plant data. In most cases, the aggregate structures from roadway cores were found to be slightly coarser especially on 3/8 inch and 1/2 inch sieves. However, except for Lift C cores 5 and 6, the extracted gradations are very comparable to the gradations reported during production.

Comparisons of blended aggregate gradations for sublots 5-1 and 14-4

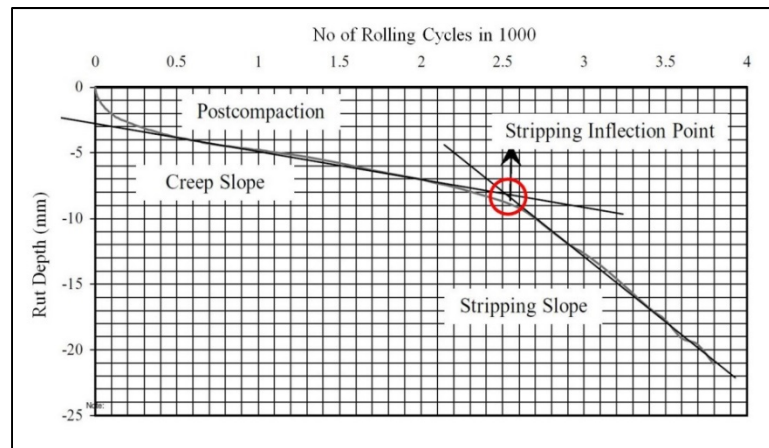
Figure 30
Typical LWT graph

To evaluate the rutting potential and moisture susceptibility of Superpave mixtures used in this project, roadway cores were evaluated with LWT (Hamburg) tests in accordance with the AASHTO T 324 test method. In this test, a steel wheel is rolled across the surface of an asphaltic specimen submerged at 50°C water and the deformation is presented as a function of the number of wheel passes. Each steel wheel passes for 20,000 cycles or until 20 mm deformation, whichever is reached first. An abrupt change in the rate of deformation indicates the stripping of asphalt binder from the aggregate in the asphalt mixture specimen. As shown in Figure 30, there are four different parts in a LWT test result plot: post-compaction, creep slope, stripping slope, and stripping inflection point. The creep slope is used to measure the rutting susceptibility, whereas the stripping slope and the stripping inflection points measure the moisture damage potential. Stripping inflection point, assumed to be the initiating point of moisture failure, is the number of wheel passes at the intersection of creep slope and stripping slope.

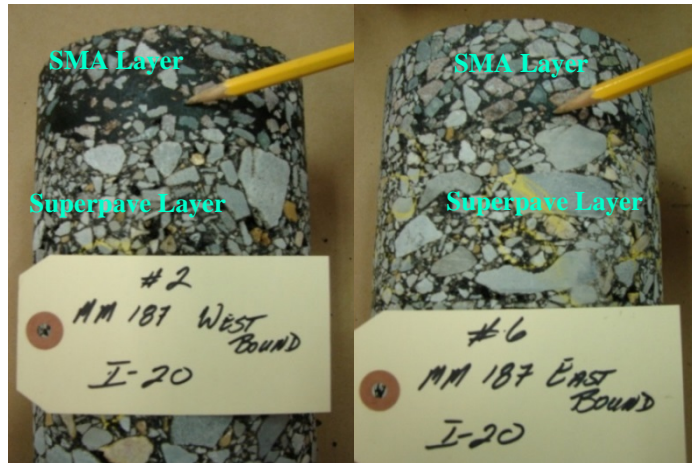
Figure 40
Aggregate arrangement in the SMA mixture

In mid-December 2011, the LTRC Asphalt Materials Lab performed a first-round of forensic evaluation of the above titled I-20 site at the request of District 05. In mid-February, LTRC received another request from District 05 to perform a second forensic evaluation of six roadway cores collected from the same project. The locations and sampling dates of the second set of roadway cores are presented in Table 6. These new samples were taken from the wheel-path region of the mainline roadway that was indicated to LTRC as a good roadway section. Longitudinal sectional views and relative aggregate arrangements in two sample cores are shown in Figure 40.
