Inspection of the Advanced Engineered Lumber Railroad Ties at the New Meadows Bridge

Final Report 2009

A Publication from the Maine Department of Transportation's Research Division

FINAL REPORT
Inspection of the Advanced Engineered Lumber
Railroad Ties at the New Meadows Bridge
AEWC Project 048

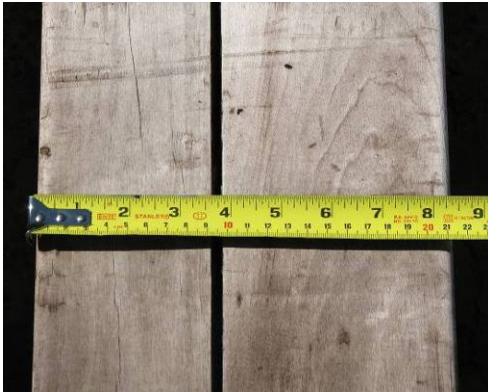
Figure 2: Top view of bridge ties

In order to obtain the required 8-inch wide ties, EMM manufactured multiple-lamination glulam beams, where multiple width boards are face bonded edge to edge, with an unbounded edge joint. In this case, the 8-inch ties fabricated using 3.5-inch and 4.5-inch wide boards were used, as shown in Figure 2 (top view of AEL tie). The unbounded edge joint was staggered through the depth of the beam as shown schematically in Figure 3. The following observations were made during the inspection:
