Nondestructive Evaluation of MoDOT Bridge Decks – Pilot Study

Report cmr14-010

**NONDESTRUCTIVE EVALUATION OF MODOT BRIDGE DECKS
– PILOT STUDY**

MARCH 2014

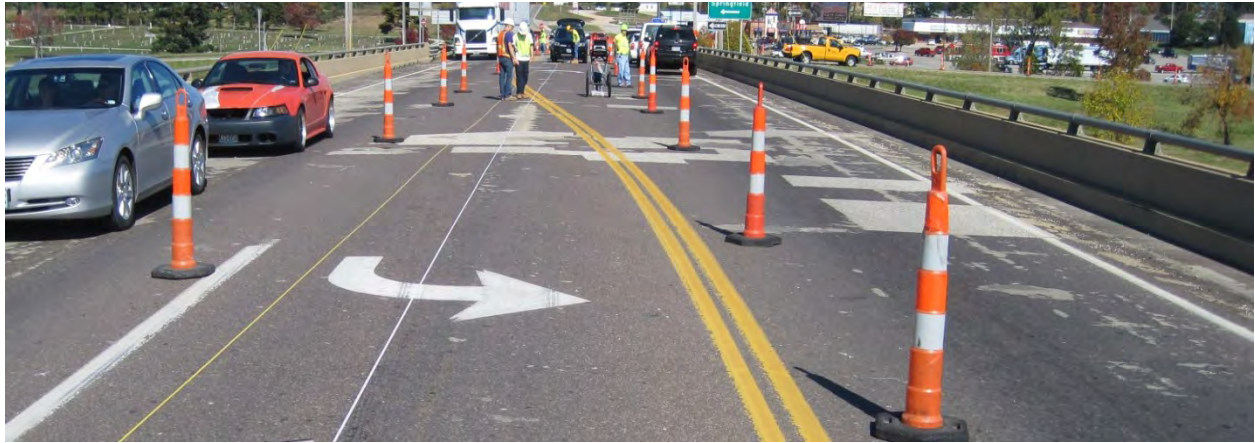
Figure 3-8 Bridge A2966 Overview of Bridge Deck Observed During Field Investigation

There were 119 defects documented during the field investigation of Bridge A2966. The deck surface had many traverse cracks, along with some concrete patches, asphalt filled potholes, and some unfilled potholes in the concrete. The deck was partially covered with a chip seal, which was worn away in many areas of the deck, especially in the wheel paths. Figure 3-8 shows an overview of the deck.

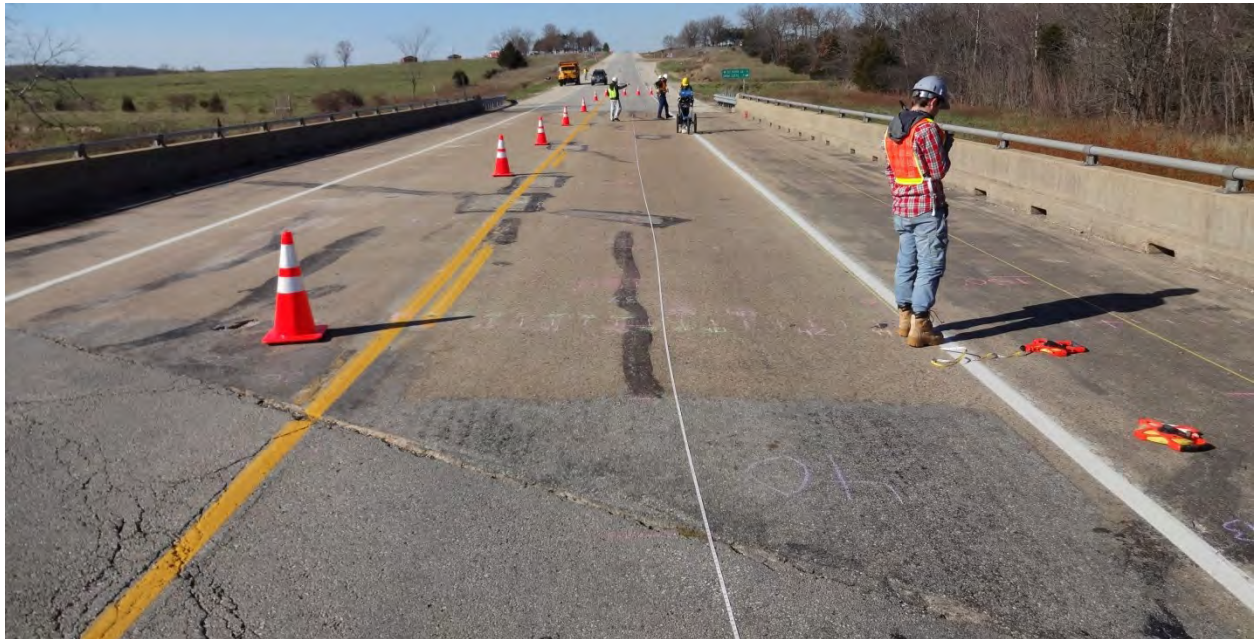
Figure 3-10 Bridge A3405 Overview of Bridge Deck Observed During Field Investigation

There were 43 defects documented on the deck surface of Bridge A3405. The majority of the defects were cracks, in both the longitudinal and transverse directions. Most of the cracks had been filled with asphalt. Some concrete patches were also observed. The ends of the bridge had asphalt wedges to allow for a smoother ride on and off the bridge. The bridge deck appeared to be in relatively good shape considering the age at investigation (38 years old). Figure 3-10 shows an overview of Bridge A3405 during the deck investigation. Darker lines in the image are cracks that have been filled with oil or bitumen.

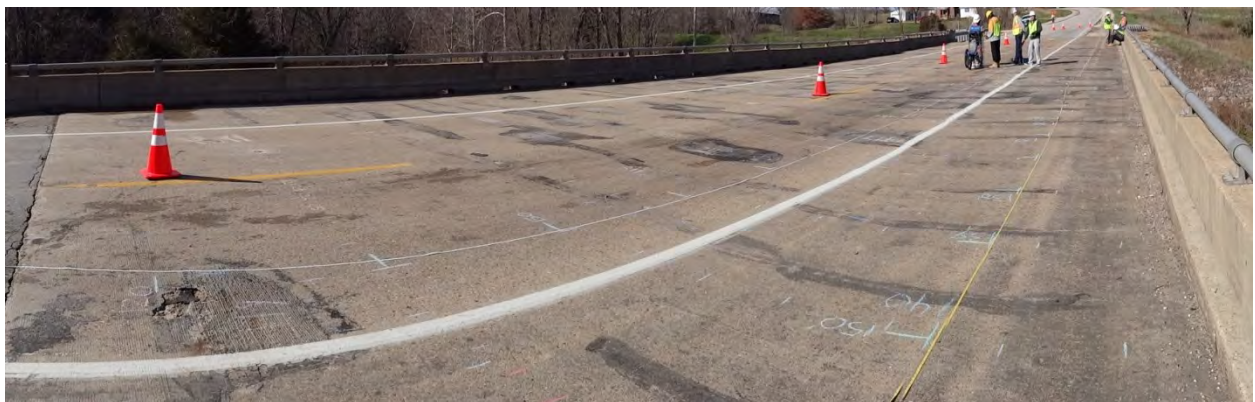
Figure 3-11 Bridge A3406 Overview of Bridge Deck Observed During Field Investigation

There were 141 defects documented during the investigation of Bridge A3406. The bridge deck surface appeared to be heavily deteriorated. Numerous transverse cracks and concrete patches were observed. The majority of the cracks were filled with oil or bitumen. Figure 3-11 shows an overview of the deck during the field investigation.

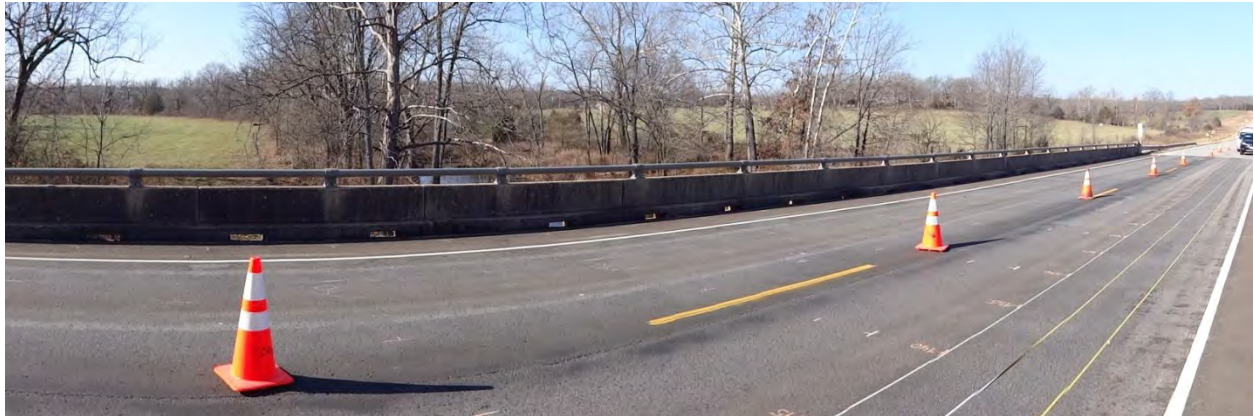
Figure 3-12 Bridge K0197 Overview of Bridge Deck Observed During Field Investigation

No visual defects were documented during the investigation of Bridge K0197. The deck had an asphalt wearing surface that appeared to be in good condition with no visible signs of deterioration. The asphalt overlay was approximately 2.5 in. as was visible in the deck curb drains. The soffit was deteriorated around the curb drains, with reinforcing steel visible in several areas. Figure 3-12 shows an overview of the deck.

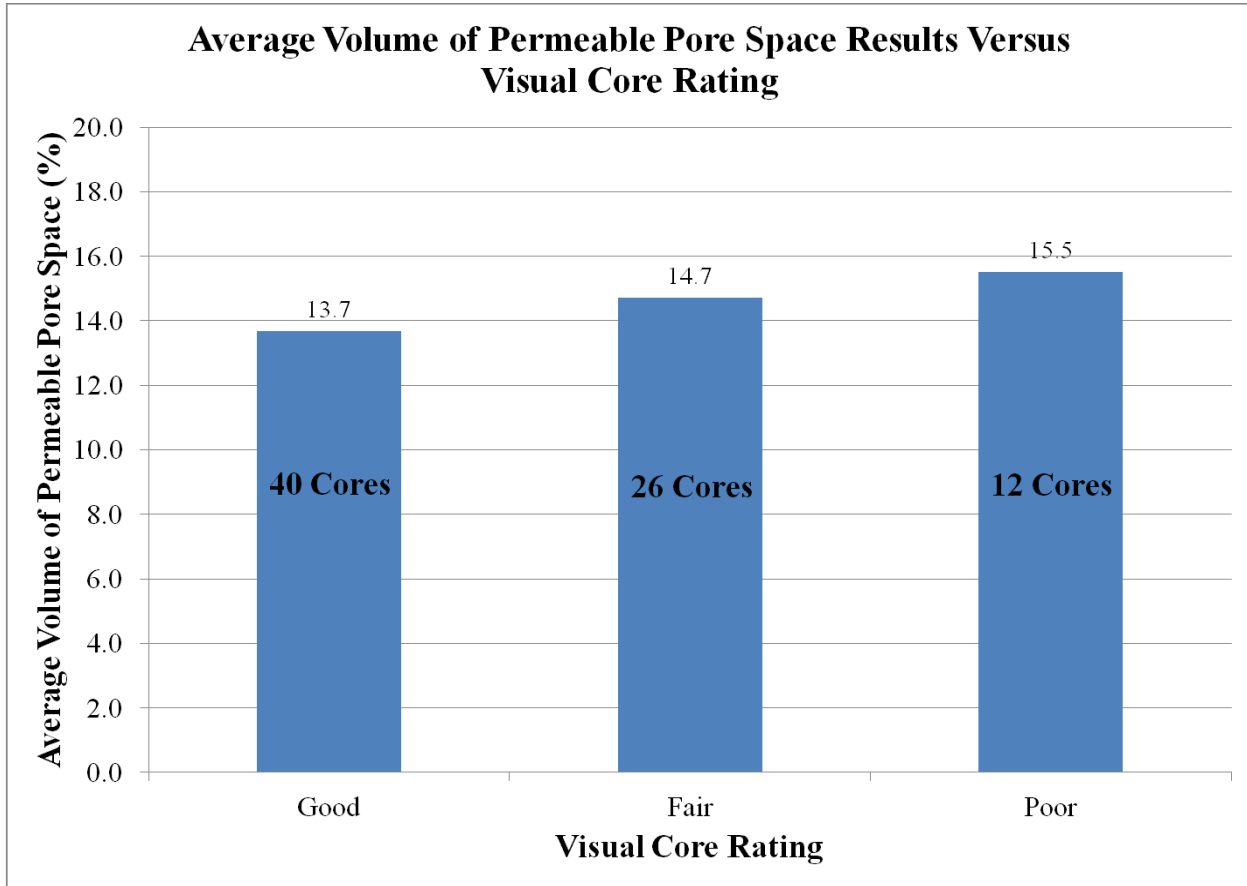
Figure 4-24 Average Volume of Permeable Pore Space Results Based on Visual Core Rating

A total of 83 cores were extracted from the 11 bridges investigated. Of those cores, 40 were rated as Good, 26 were rated as Fair, and 12 were rated as Poor using the classification system discussed in Section 4.1. The volume of permeable pore space was determined for 78 of the 83 extracted cores. Cores with no results available either consisted completely of asphalt or were too heavily deteriorated for the testing procedure. Figure 4-24 shows the average volume of permeable pore space for those cores that were assigned a visual core rating of either Good, Fair, or Poor. Figure 4-24 shows that on average, cores with higher volume of permeable core space tended to have a lower visual core rating.

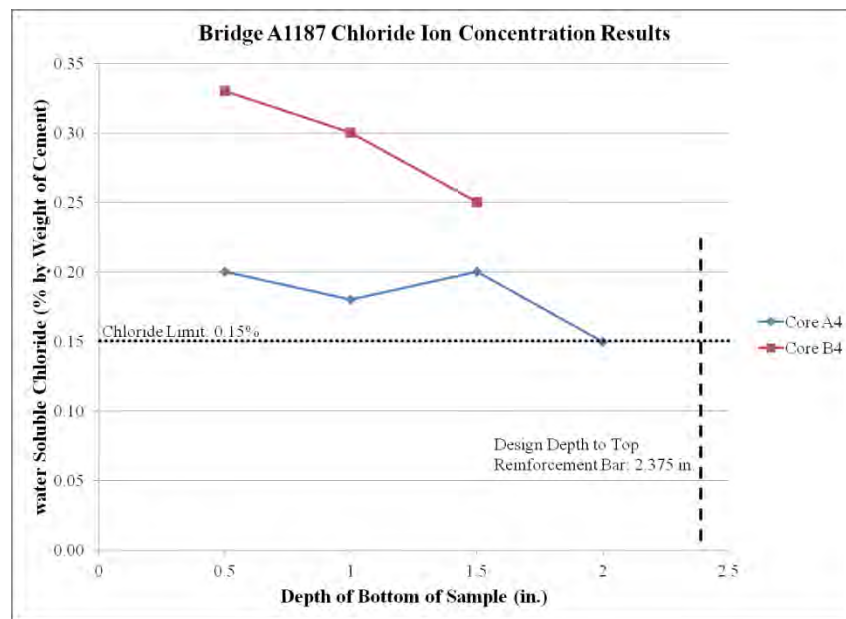
Figure 5-2 Bridge A1187 Chloride Ion Concentration Results

Figure 5-2 shows the chloride ion concentration results for Cores A4 and B4 from Bridge A1187. Results were not available at the design depth of top reinforcing bar, but projection of the trends in the figure suggest that chloride ion concentration levels would be slightly below the threshold limit for both cores.

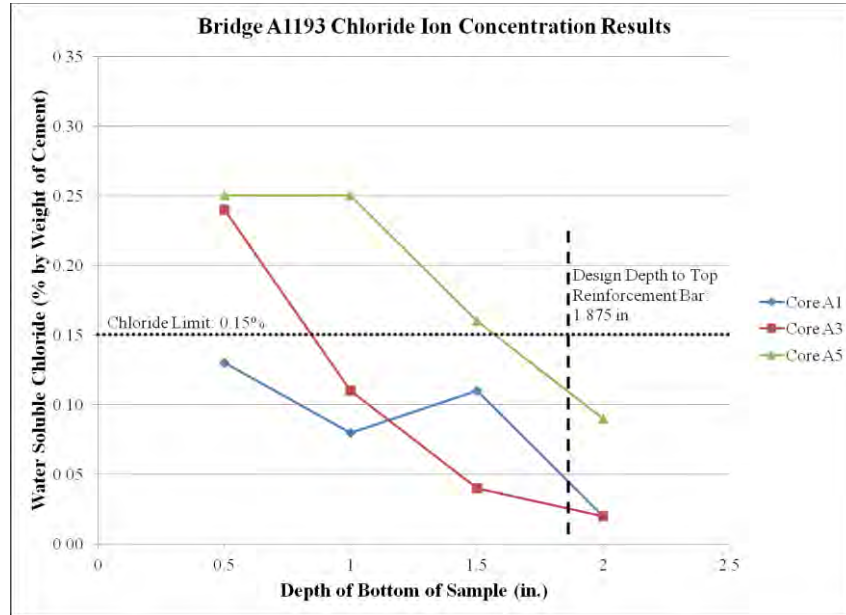
Figure 5-3 Bridge A1193 Chloride Ion Concentration Results

Figure 5-3 shows the chloride ion concentration results for Cores A1, A3, and A5 from Bridge A1193. Results indicate that chloride ion concentration levels are less than the threshold limit for each core.

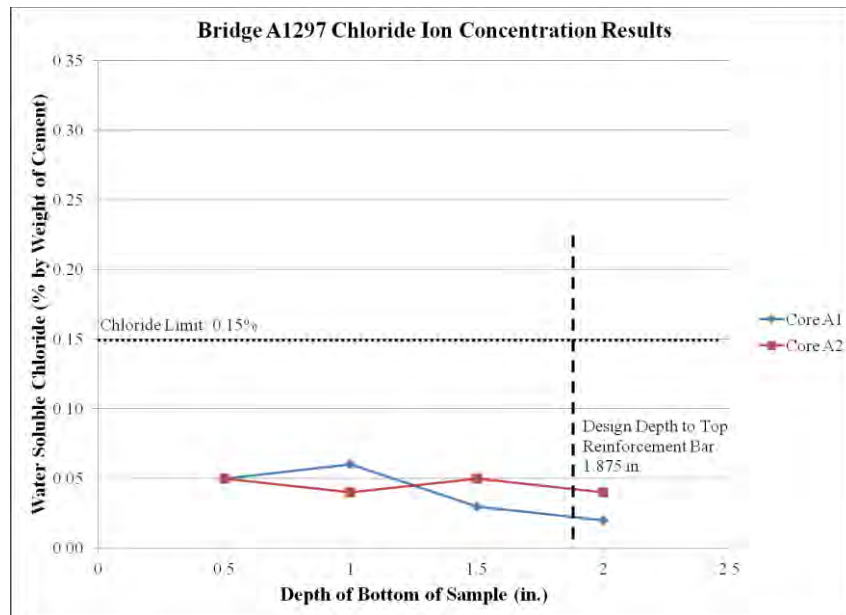
Figure 5-4 Bridge A1297 Chloride Ion Concentration Results

Figure 5-4 shows the chloride ion concentration results for Cores A1 and A2 from Bridge A1297. Results indicate that chloride ion concentration levels are less than the threshold limit for both cores.

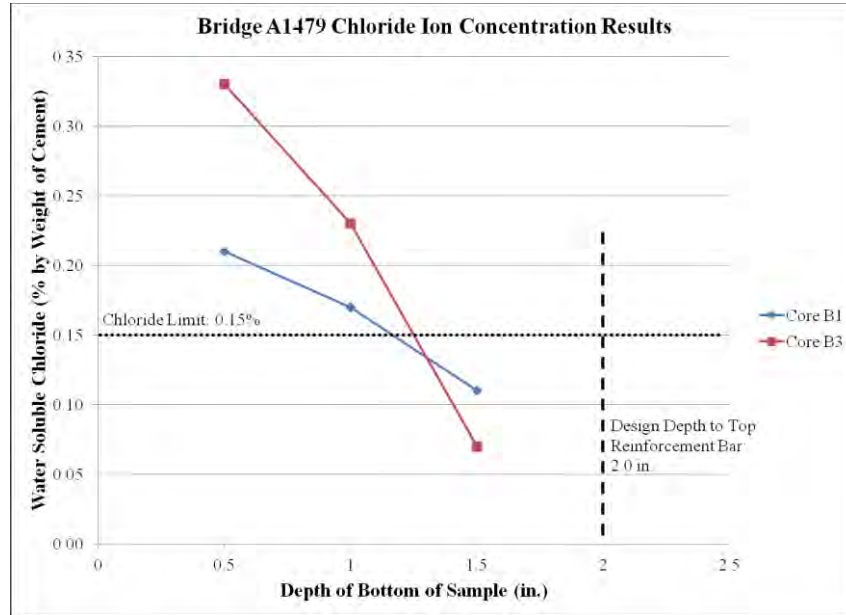
Figure 5-5 Bridge A1479 Chloride Ion Concentration Results

Figure 5-5 shows the chloride ion concentration results for Cores B1 and B3 from Bridge A1479. Results were not available at the design depth of top reinforcing bar, but projection of the trends in the figure suggest that chloride ion concentration levels would be below the threshold limit for both cores.

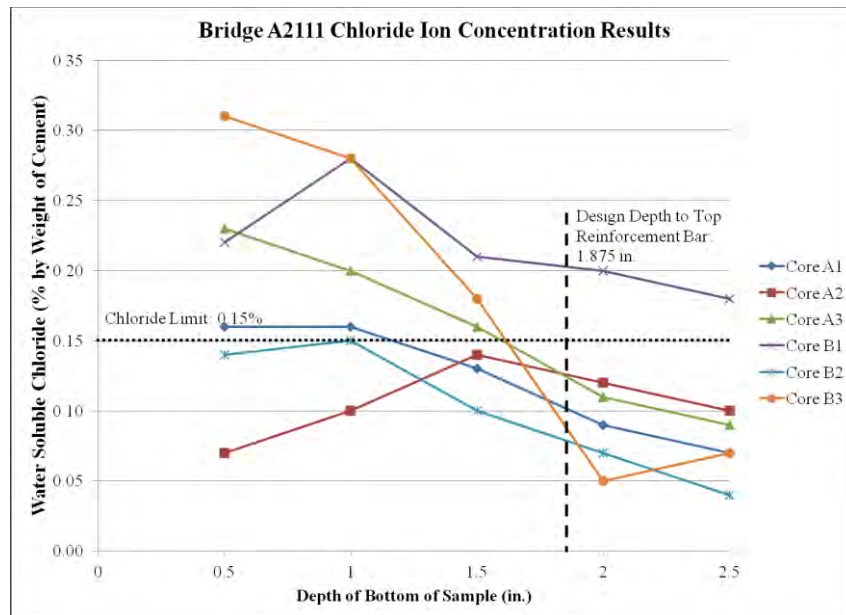
Figure 5-6 Bridge A2111 Chloride Ion Concentration Results

Figure 5-6 shows the chloride ion concentration results for Cores A1, A2, A3, B1, B2, and B3 from Bridge A2111. Results indicate that chloride ion concentration levels are less than the threshold limit for each core with the exception of Core B1, which had a measured chloride ion concentration above the threshold limit.

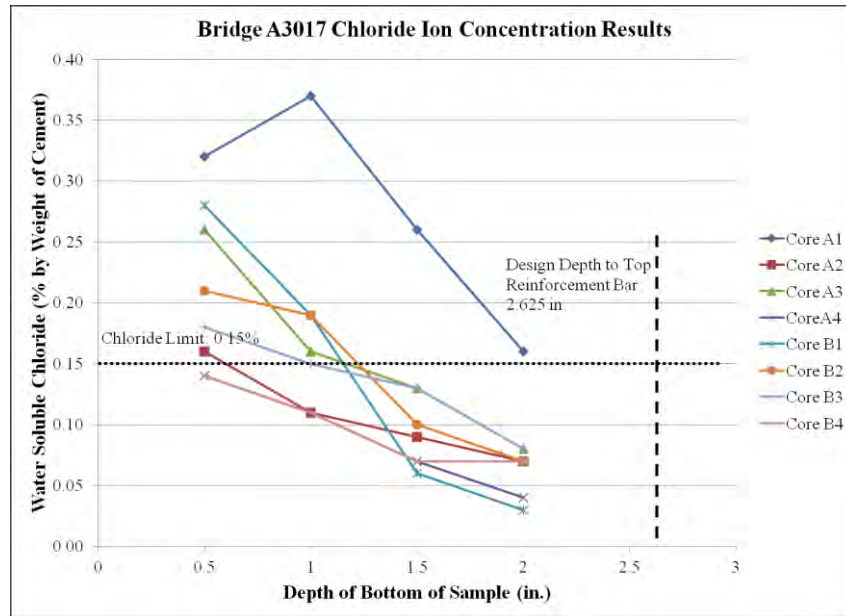
Figure 5-7 Bridge A3017 Chloride Ion Concentration Results

Figure 5-7 shows the chloride ion concentration results for Cores A1, A2, A3, A4, B1, B2, B3, and B4 from Bridge A3017. Results were not available at the design depth of top reinforcing bar, but projection of the trends in the figure suggest that chloride ion concentration levels would be below the threshold limit for each core.

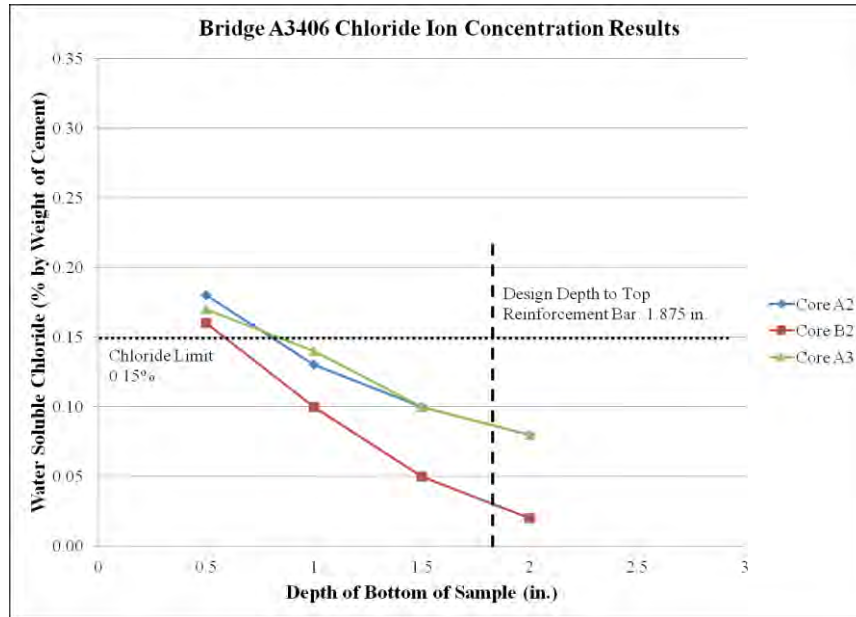
Figure 5-8 Bridge A3406 Chloride Ion Concentration Results

Figure 5-8 shows the chloride ion concentration results for Cores A2, A3, and B2 from Bridge A3406. Results indicate that chloride ion concentration levels are less than the threshold limit for each core.

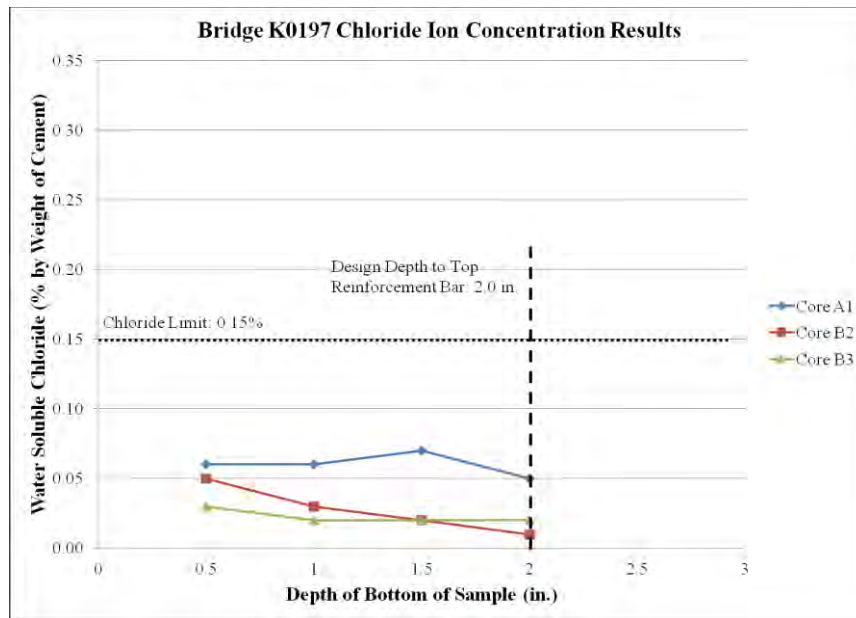
Figure 5-9 Bridge K0197 Chloride Ion Concentration Results

Figure 5-9 shows the chloride ion concentration results for Cores A1, B2, and B3 from Bridge K0197. Results indicate that chloride ion concentration levels are less than the threshold limit for each core.

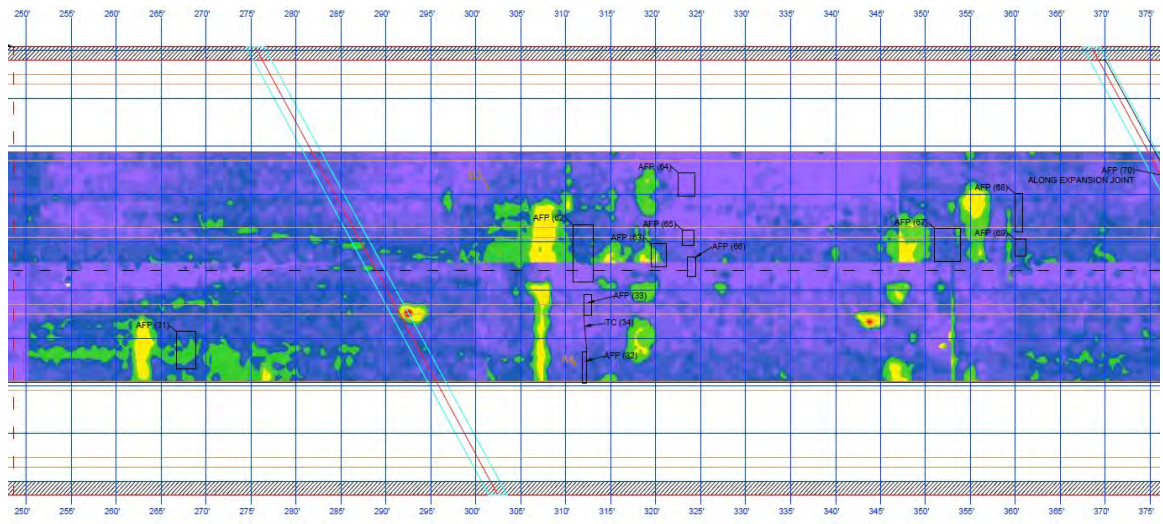
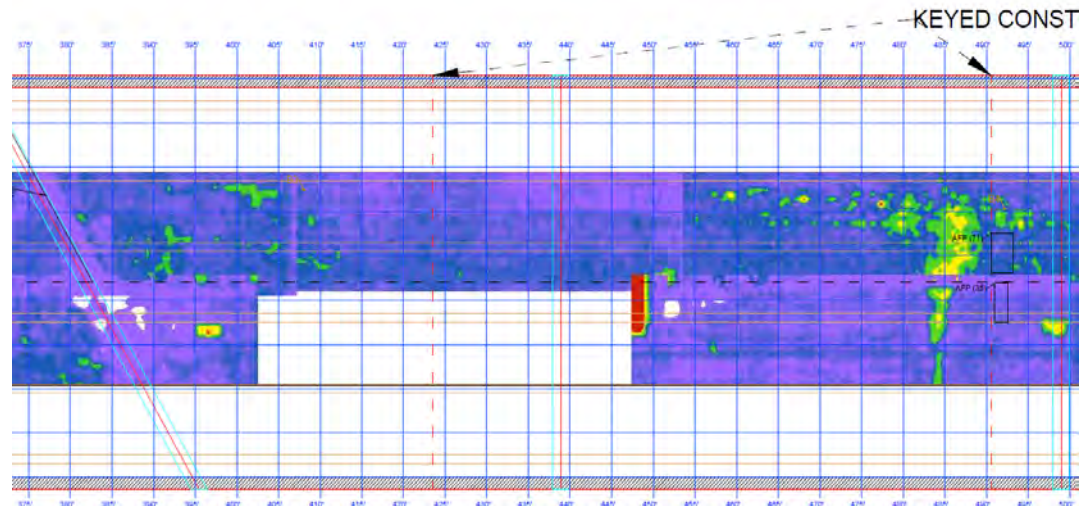
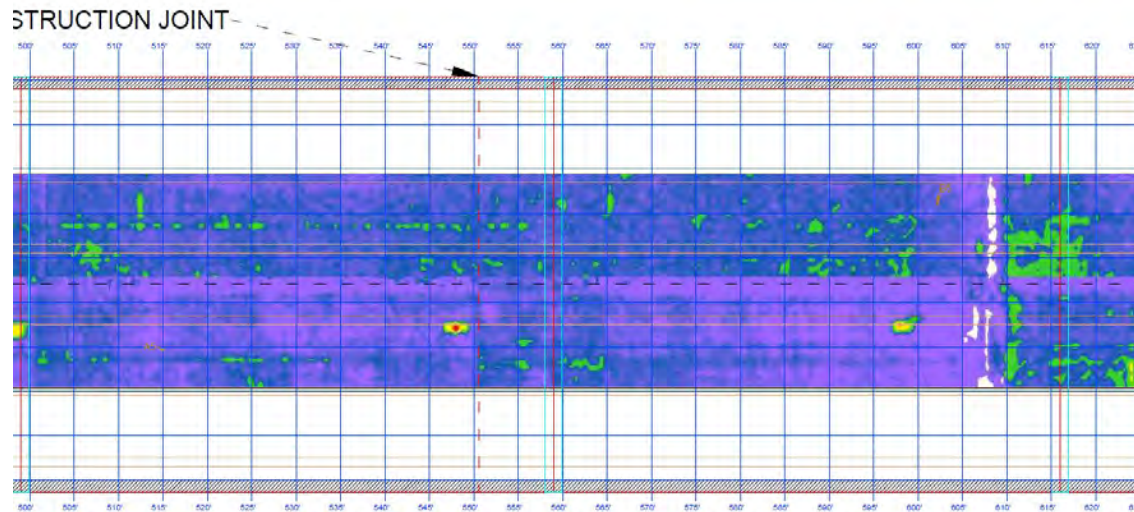
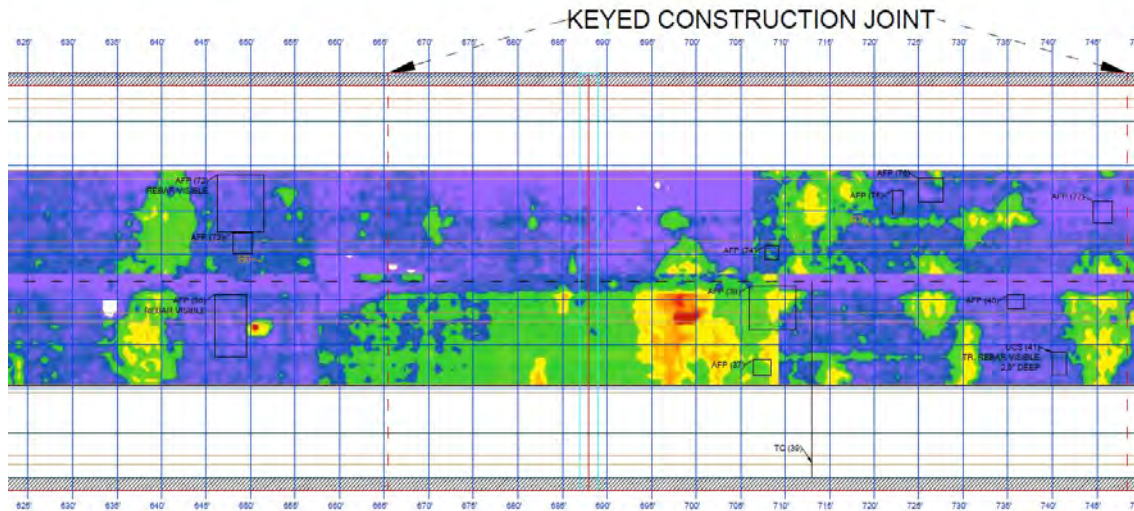
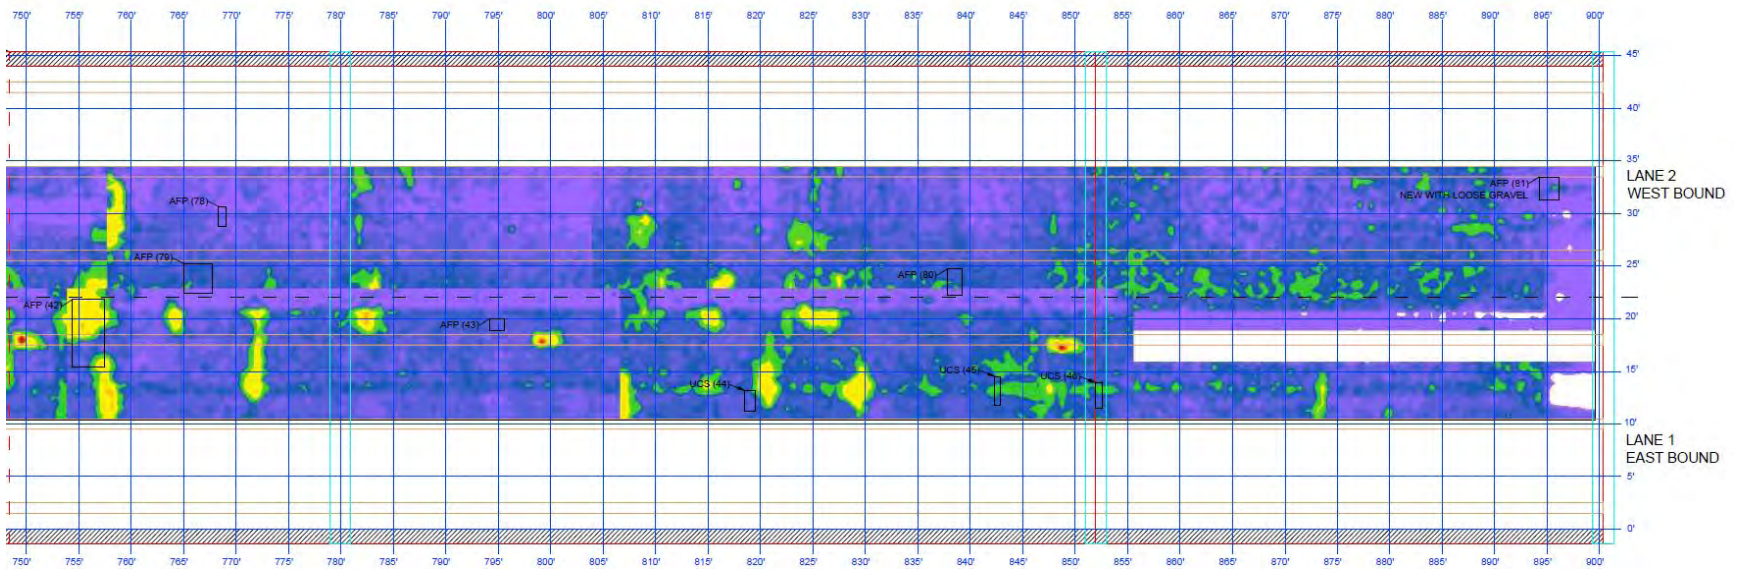
Figure 6-5 Bridge A1193 Drawing Including Lidar Rehabilitation Survey and Visual Investigation Results (Cont.)

Figure 6-5 shows the lidar scan results for Bridge A1193 in 125 ft. long segments. The scale for depth difference (corresponding to thickness of material removal) for the lidar results in Figure 6-5 is shown in Figure 6-6. It should be noted that data were not captured in certain areas of the deck, therefore these segments were omitted and are not plotted in Figure 6-5. The amount (percentage of surface area surveyed) of concrete removed in each of the three categories defined in Section 6.1 is shown in Figure 6-7.

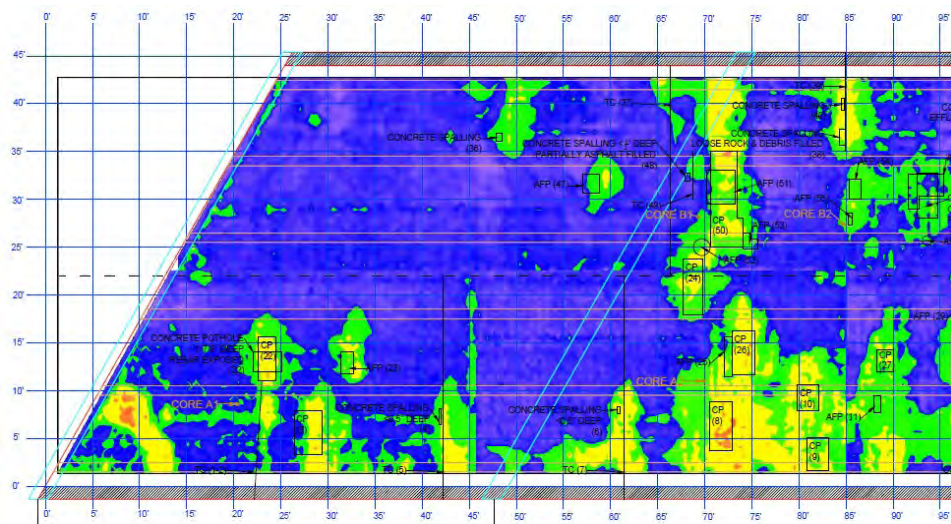
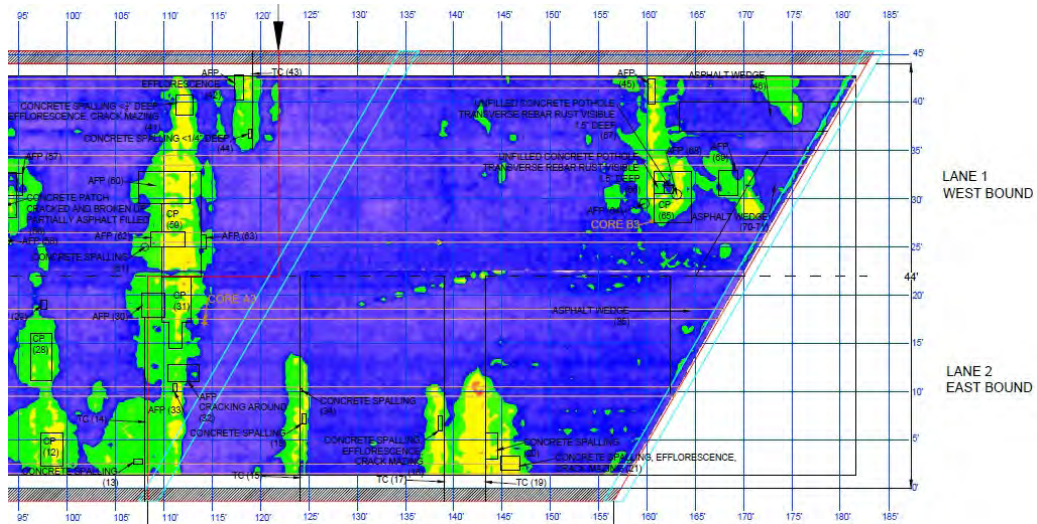
Figure 6-8 Bridge A1297 Drawing Including Lidar Rehabilitation Survey and Visual Investigation Results

Figure 6-8 shows the lidar scan results for Bridge A1297 in 95 ft. long segments. The scale for depth difference (corresponding to thickness of material removal) for the lidar results in Figure 6-8 is shown in Figure 6-9. The amount (percentage of surface area surveyed) of concrete removed in each of the three categories defined in Section 6.1 is shown in Figure 6-10.

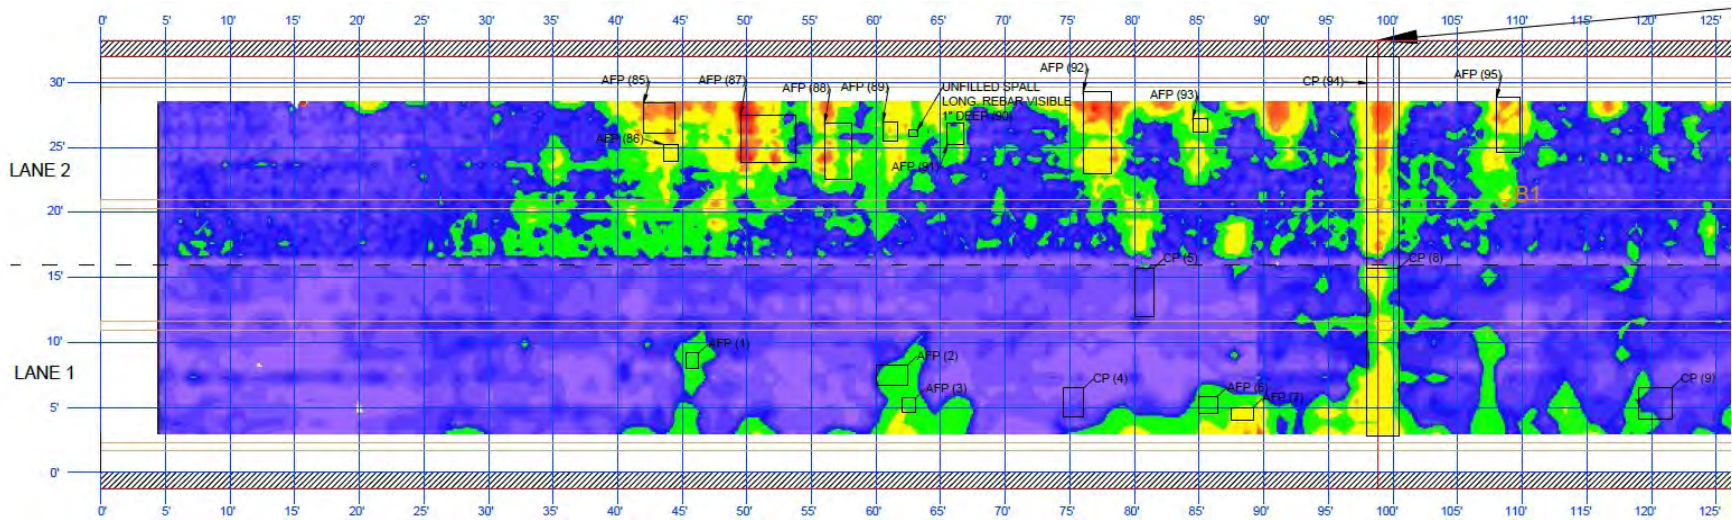
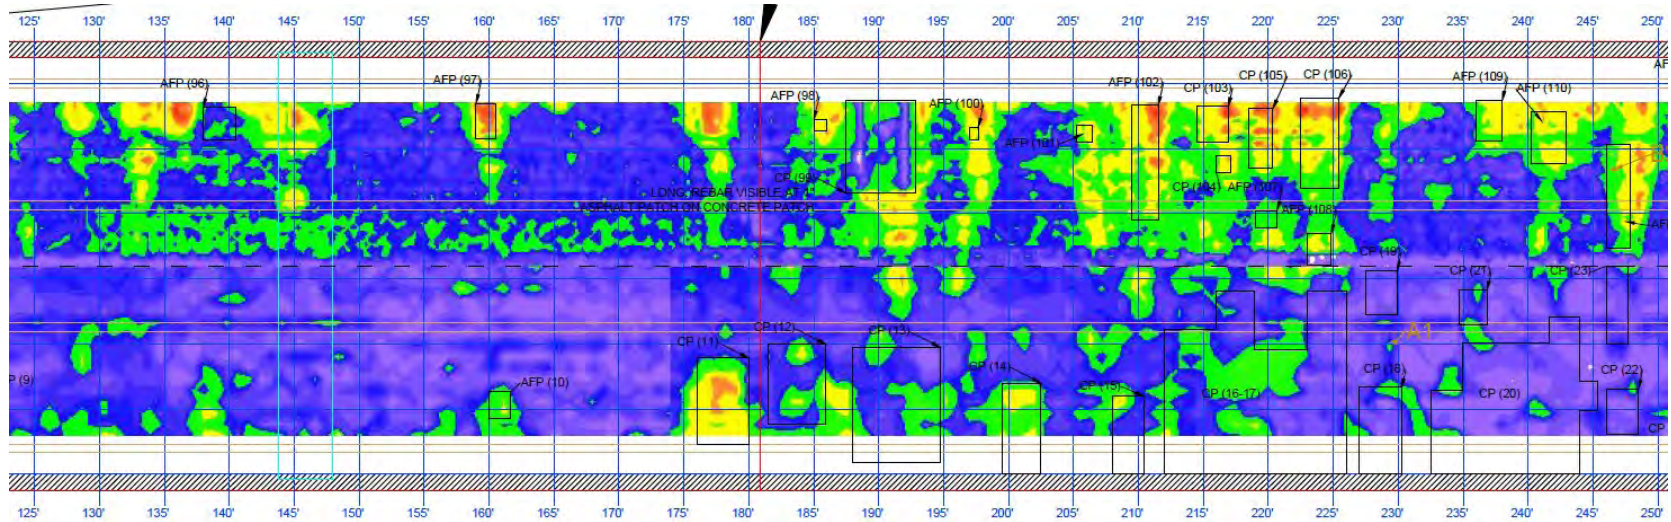
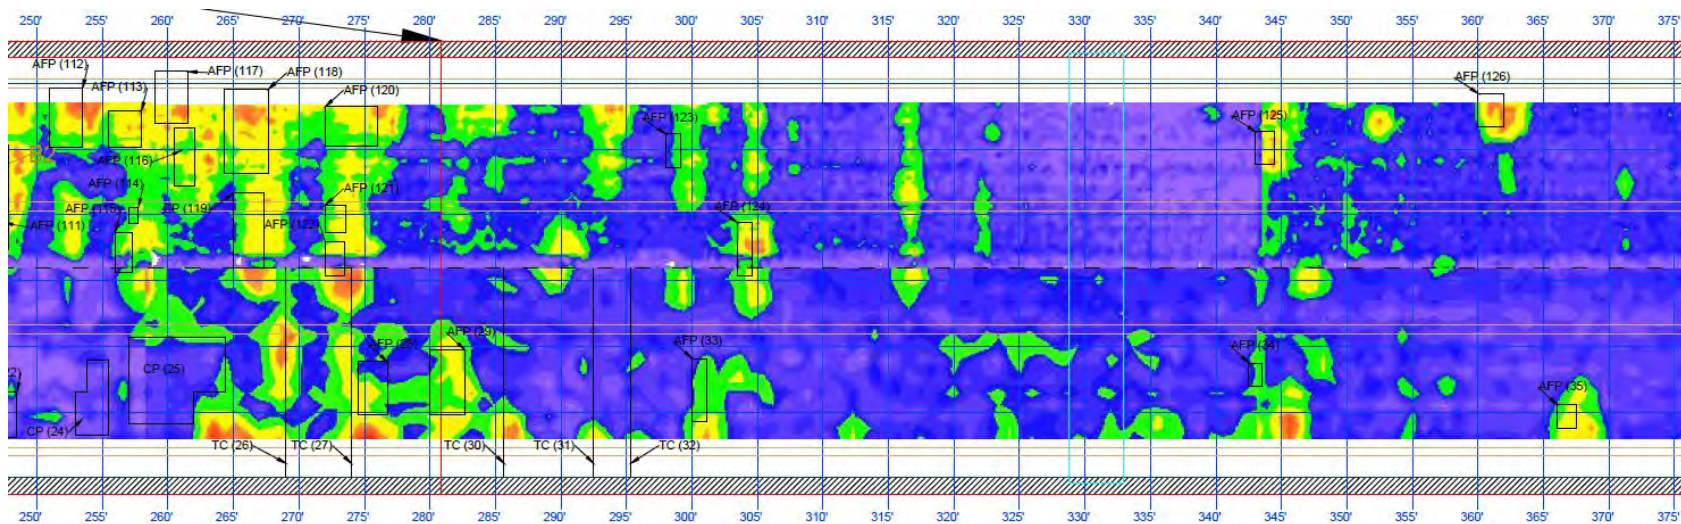
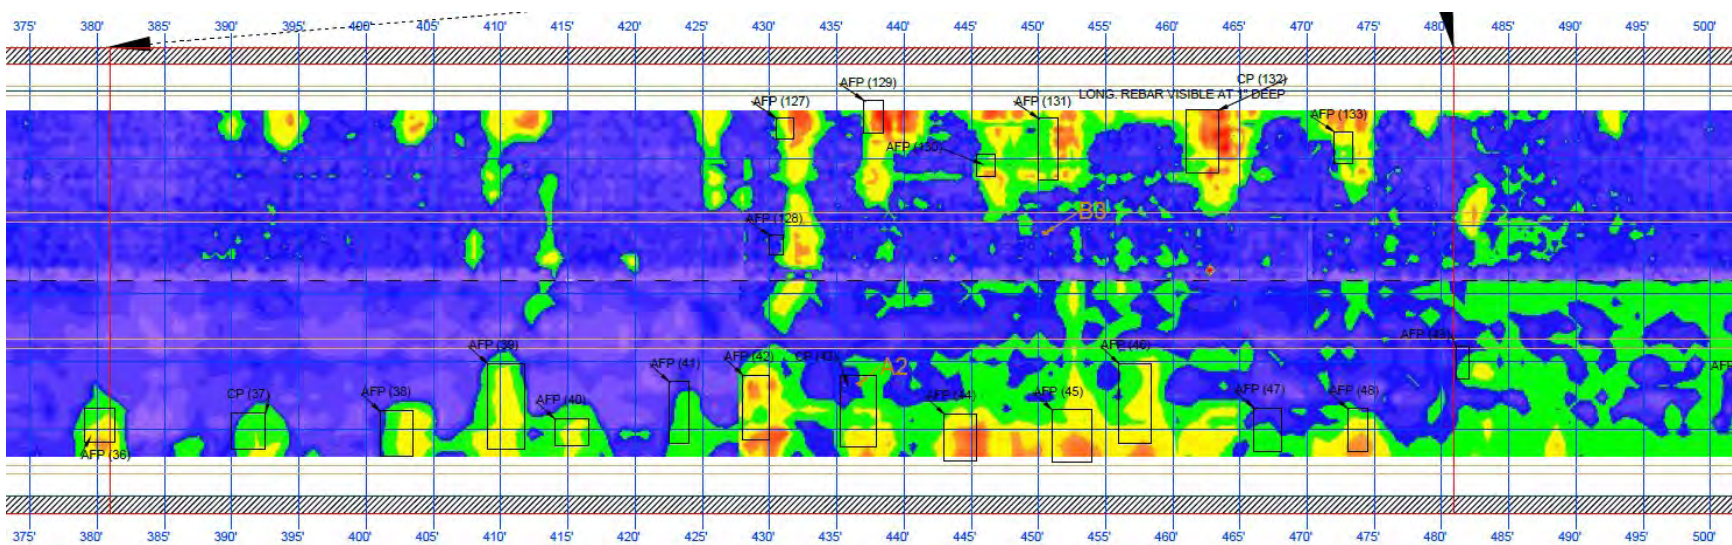
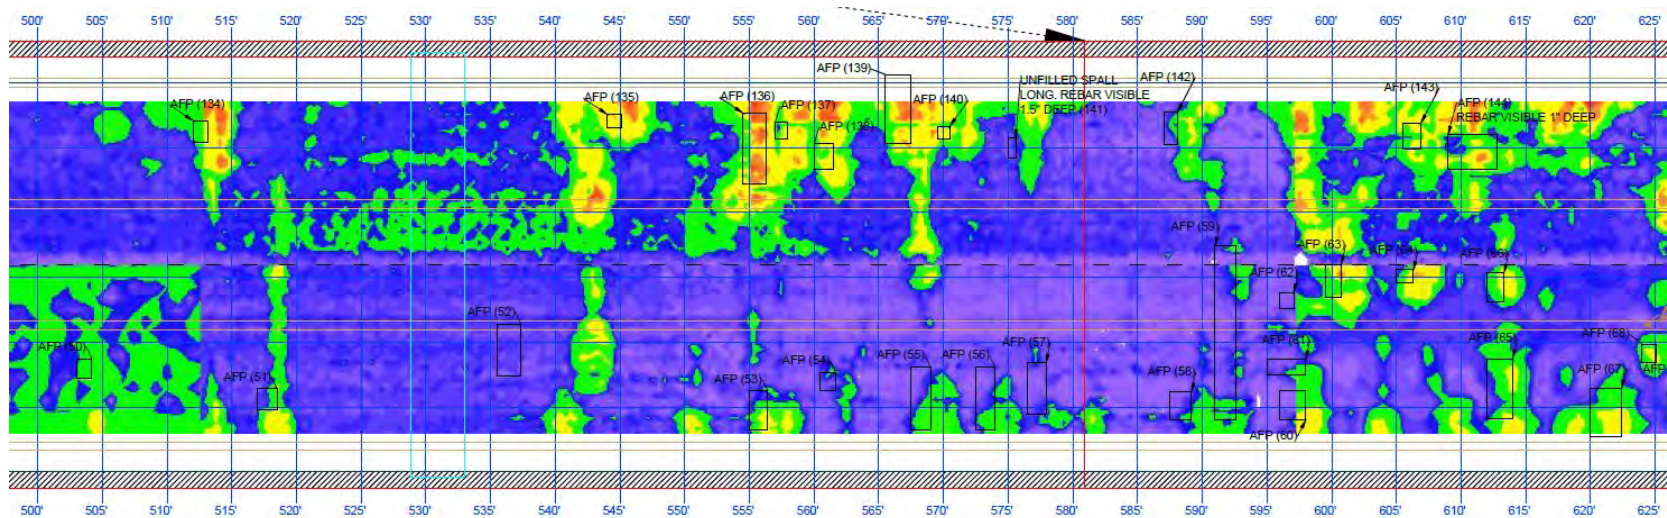
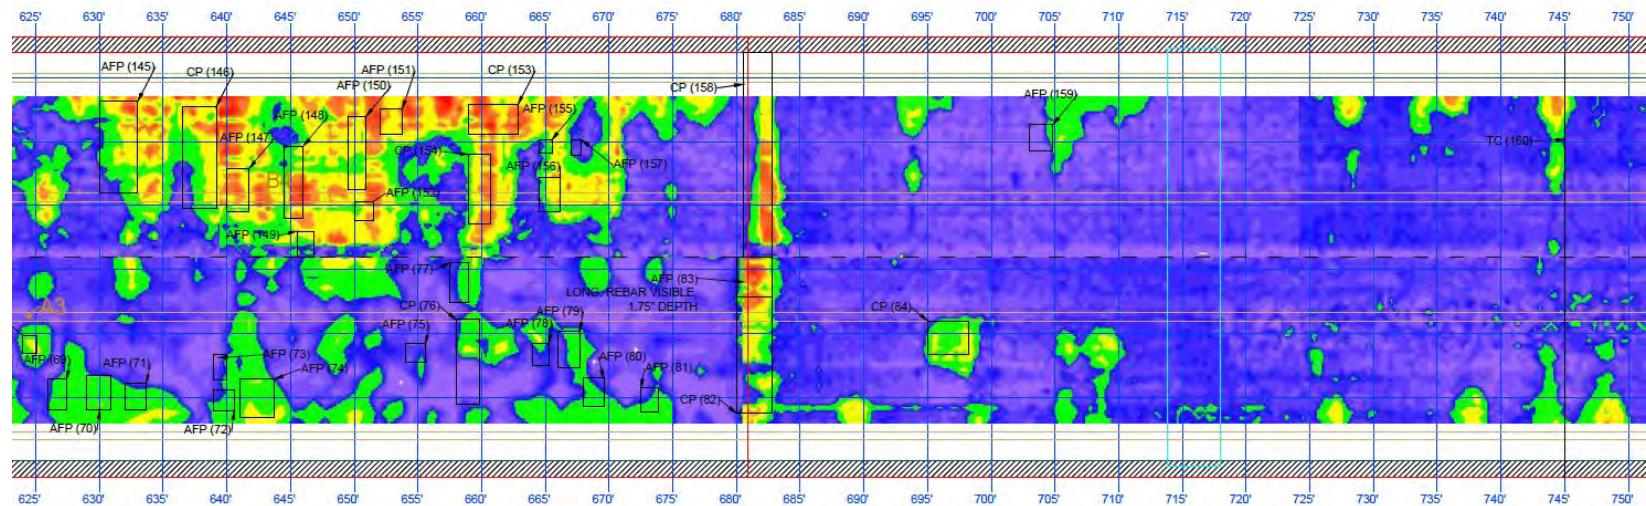
Figure 6-11 Bridge A1479 Drawing Including Lidar Rehabilitation Survey and Visual Investigation Results

Figure 6-11 shows the lidar scan results for Bridge A1479 in 125 ft. long segments. The scale for depth difference (corresponding to thickness of material removal) for the lidar results in Figure 6-11 is shown in Figure 6-12. The amount (percentage of surface area surveyed) of concrete removed in each of the three categories defined in Section 6.1 is shown in Figure 6-13.

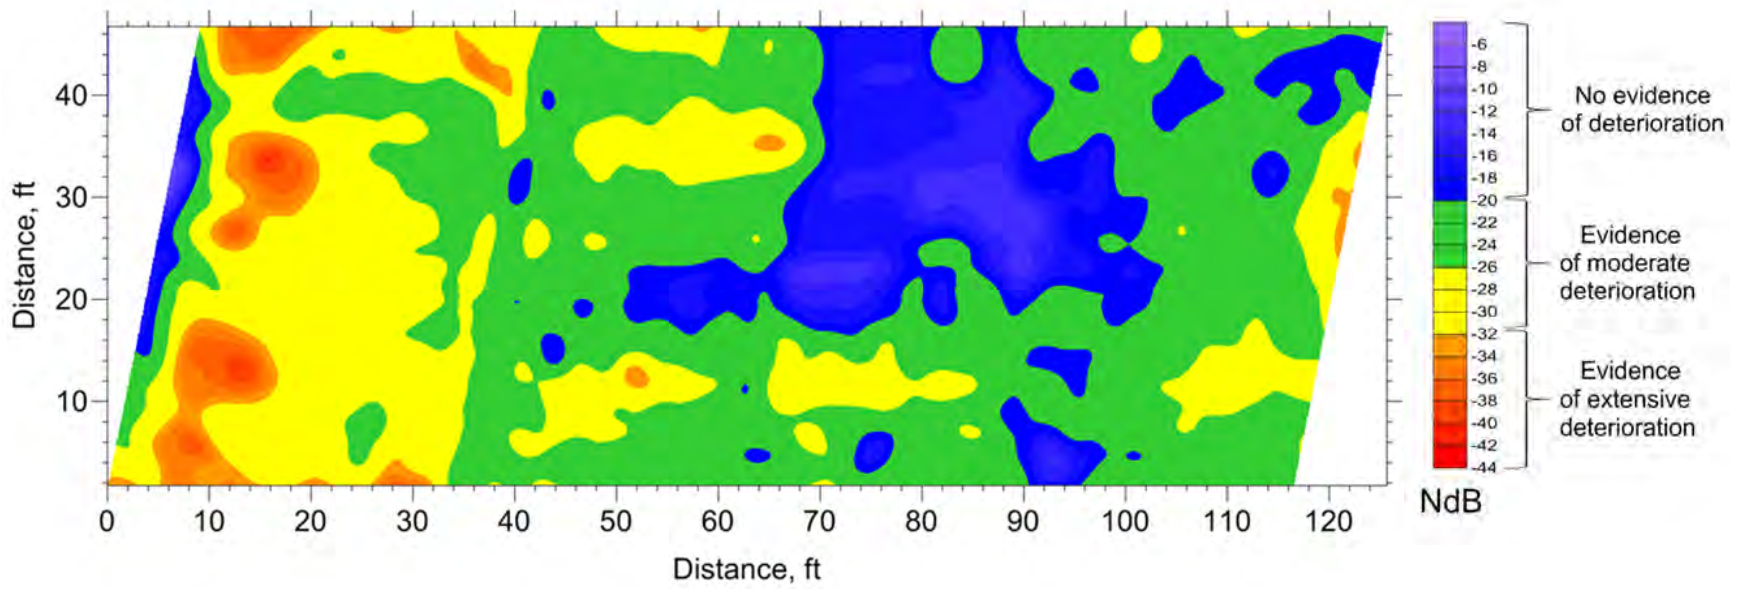
Figure 7-9 GPR Amplitude Map Based on Top Bar Reflection for Bridge Deck A1187 with Superposed Core Locations and Visual Surface Condition Features, After Resurfacing

The GPR data were acquired along parallel traverses spaced at 1 ft intervals. The acquisition parameters employed were 512 samples/scan, 120 scans/second, and 90 scans/ft. The dielectric constant was assumed to be 10.0. Map of reflection amplitudes from the top layer of transverse rebar are shown in Figures 7-8 and 7-9, before and after resurfacing, respectively. Amplitude ranges for three deterioration categories shown in Figure 7-8 were defined based on correlation of the GPR data with the visual evaluation of the cores. Area and percentage distribution of all three deterioration categories were calculated for the bridge deck area, before and after resurfacing, are shown in Figure 7-10 and 7-11, respectively.

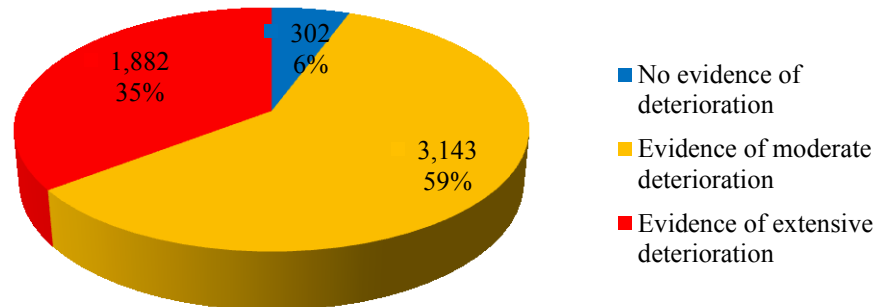
Figure 7-10 Graph Showing Predicted Distribution of Deterioration of the Bridge Deck A1187 (Investigated Area; Prior to Resurfacing) in Each Category (Based on the Amplitude of the Reflection from the Top Layer of Rebar). Total Area Investigated - 5,327 ft²; No Evidence of Deterioration - 302 ft²; Evidence of Moderate Deterioration - 3,143 ft²; Evidence of Extensive Deterioration 1,882 ft².

Figure 7-10 shows that 6% of the area investigated on the bridge deck of Bridge A1187 exhibited no evidence of deterioration, 59% exhibited evidence of moderate deterioration, and 35% exhibited evidence of extensive deterioration based on the deterioration categories defined for the GPR amplitude results.

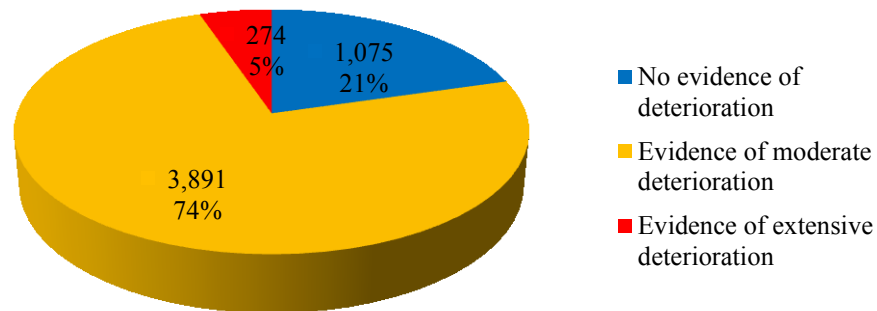
Figure 7-11 Graph Showing Predicted Distribution of Deterioration of the Bridge Deck A1187 (Investigated Area; After Resurfacing) in Each Category (Based on the Amplitude of the Reflection from the Top Layer of Rebar). Total Area Investigated - 5,240 ft²; No Evidence of Deterioration - 1,075 ft²; Evidence of Moderate Deterioration - 3,891 ft²; Evidence of Extensive Deterioration 274 ft².

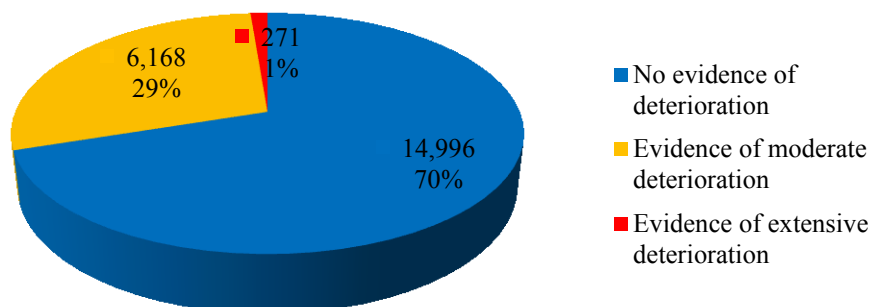
Figure 7-14 Graph Showing Predicted Distribution of Deterioration of the Bridge Deck A1193 in Each Category (Based on the Amplitude of the Reflection from the Top Layer of Rebar). Total Area Investigated - 21,435 ft²; No Evidence of Deterioration – 14,996 ft²; Evidence of Moderate Deterioration - 6,168 ft²; Evidence of Extensive Deterioration 271 ft².

Figure 7-14 shows that 70% of the area investigated on the bridge deck of Bridge A1193 exhibited no evidence of deterioration, 29% exhibited evidence of moderate deterioration, and 1% exhibited evidence of extensive deterioration based on the deterioration categories defined for the GPR amplitude results.

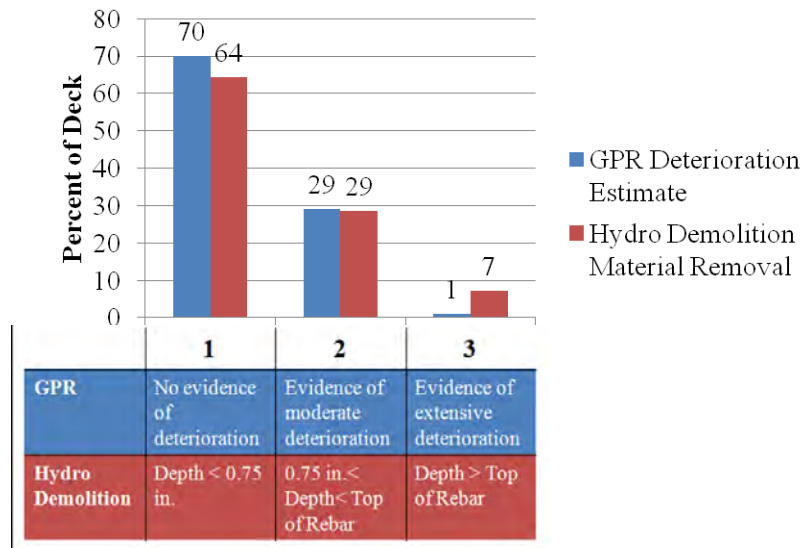
Figure 7-15 Percentage of Bridge Deck Area for Bridge A1193 Categorized by GPR Results and Rehabilitation Lidar Survey

For a quantitative comparison, Figures 7-15, 7-19, and 7-23 compare the percentage of the bridge deck within each of the three categories defined for the GPR grade classification with the percentage of the deck within the three categories defined for depth of concrete material removed. Although good correlation between the two classifications is observed in Figure 7-15 for Bridge A1193, the correlations in Figures 7-19 and 7-23 for Bridges A1297 and A1479 are

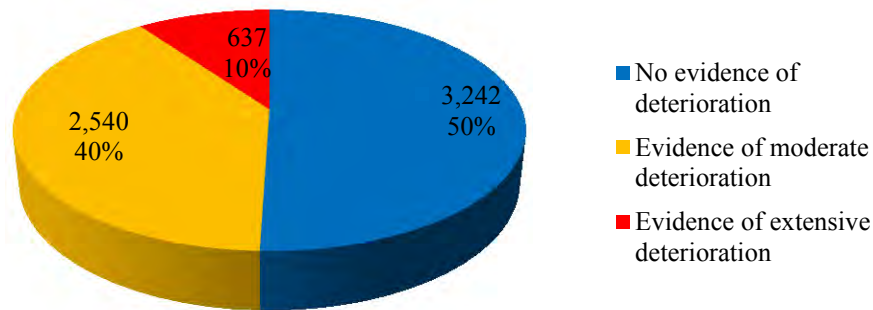
Figure 7-18 Graph Showing Predicted Distribution of Deterioration of the Bridge Deck A1297 in Each Category (Based on the Amplitude of the Reflection from the Top Layer of Rebar). Total Area Investigated - 6,419 ft²; No Evidence of Deterioration – 3,242 ft²; Evidence of Moderate Deterioration - 2,540 ft²; Evidence of Extensive Deterioration 637 ft².

Figure 7-18 shows that 50% of the area investigated on the bridge deck of Bridge A1297 exhibited no evidence of deterioration, 40% exhibited evidence of moderate deterioration, and 10% exhibited evidence of extensive deterioration based on the deterioration categories defined for the GPR amplitude results.
