Nondestructive Evaluation of MoDOT Bridge Decks – Pilot Study

Report cmr14-010

**NONDESTRUCTIVE EVALUATION OF MODOT BRIDGE DECKS
– PILOT STUDY**

MARCH 2014

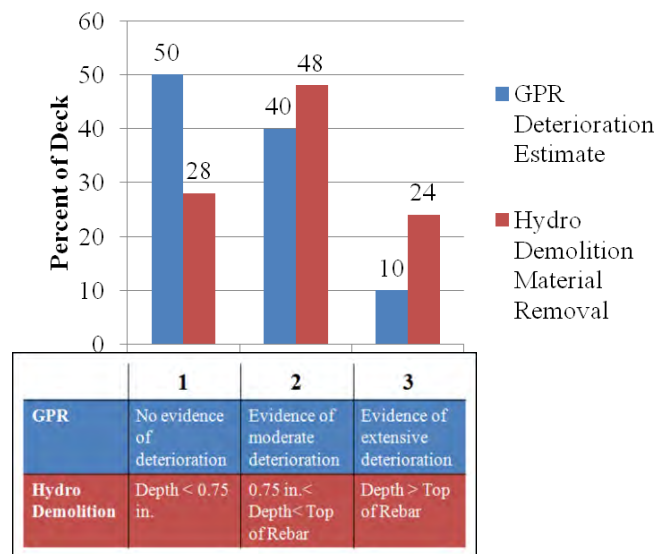
Figure 7-19 Percentage of Bridge Deck Area for Bridge A1297 Categorized by GPR Results and Rehabilitation Lidar Survey

For a quantitative comparison, Figures 7-15, 7-19, and 7-23 compare the percentage of the bridge deck within each of the three categories defined for the GPR grade classification with the percentage of the deck within the three categories defined for depth of concrete material removed. Although good correlation between the two classifications is observed in Figure 7-15 for Bridge A1193, the correlations in Figures 7-19 and 7-23 for Bridges A1297 and A1479 are

not as strong. It must be noted that perfect correlation between the GPR maps and the lidar maps is not expected. The GPR responds to the presence of saline moisture present in the deck, whereas rehabilitation removes weaker concrete. GPR and rehabilitation results are therefore expected to correlate best in those areas where the pore space within physically degraded concrete is infilled with slightly saline moisture. Apparent discrepancies between the GPR and lidar results could also be caused by the fact that the GPR maps reflect degradation and saline moisture in a section of concrete that was removed by milling prior to hydrodemolition. Furthermore, the GPR results presented in this report are based on the reflection amplitude from the top transverse layer of reinforcement and do not represent the condition of the concrete below the top transverse reinforcement. Therefore category 3 of the depth of concrete material removed (depth > top of rebar) is not reflected directly in the GPR results, because the GPR results used in the interpretations do not extend deeper than the top transverse reinforcement bar. Thus, the two classifications systems do not have a direct physical correlation.

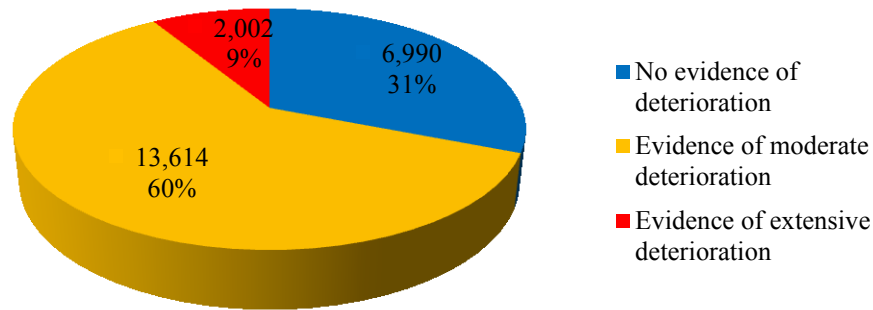
Figure 7-22 Graph Showing Predicted Distribution of Deterioration of the Bridge Deck A1479 in Each Category (Based on the Amplitude of the Reflection from the Top Layer of Rebar). Total Area Investigated - 22,606 ft²; No Evidence of Deterioration – 6,990 ft²; Evidence of Moderate Deterioration - 13,614 ft²; Evidence of Extensive Deterioration 2,002 ft².

Figure 7-22 shows that 31% of the area investigated on the bridge deck of Bridge A1479 exhibited no evidence of deterioration, 60% exhibited evidence of moderate deterioration, and 9% exhibited evidence of extensive deterioration based on the deterioration categories defined for the GPR amplitude results.

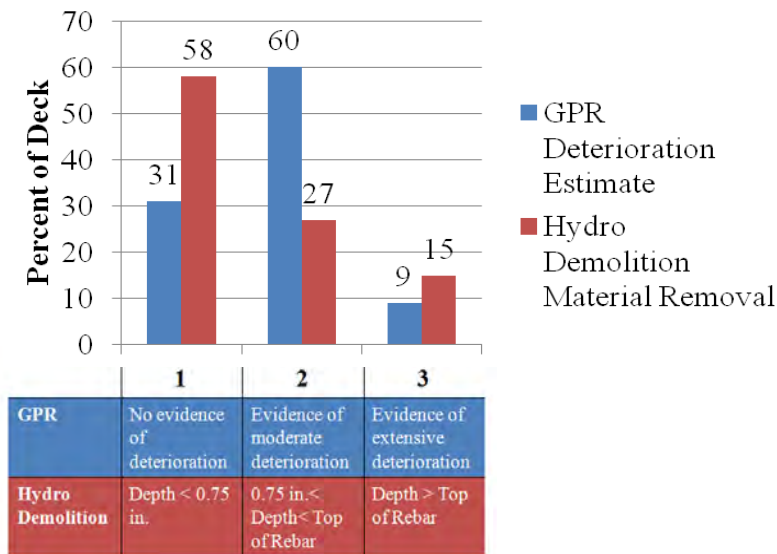
Figure 7-23 Percentage of Bridge Deck Area for Bridge A1479 Categorized by GPR Results and Rehabilitation Lidar Survey

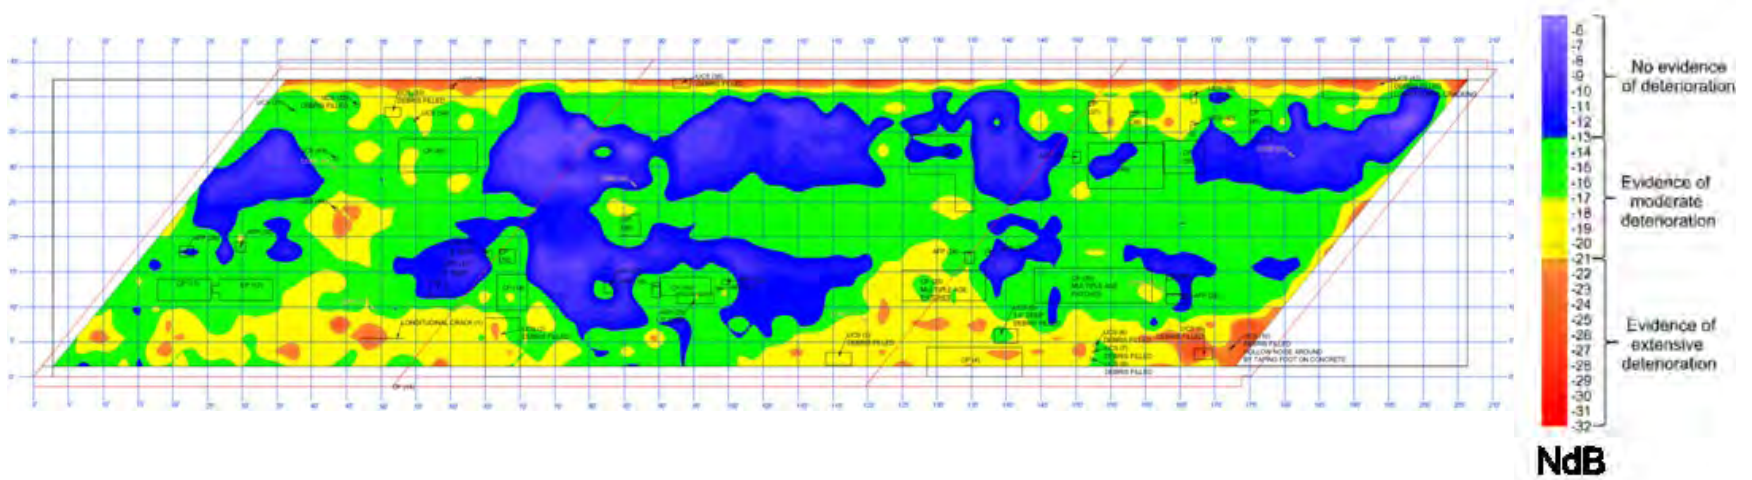
Figure 7-24 GPR Amplitude Map Based on Top Bar Reflection for Bridge Deck A2111 with Superposed Core Locations and Visual Surface Condition Features

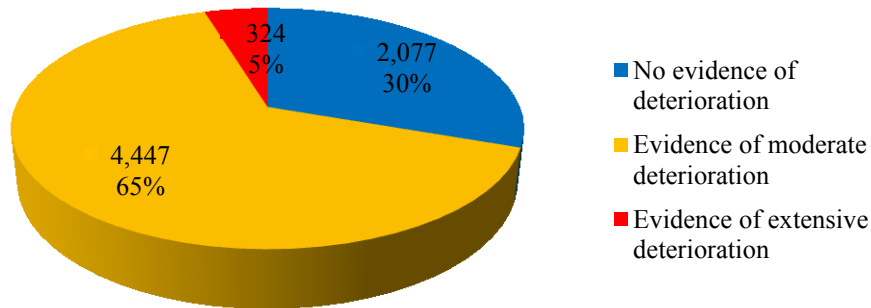
Figure 7-25 Graph Showing Predicted Distribution of Deterioration of the Bridge Deck A2111 in Each Category (Based on the Amplitude of the Reflection from the Top Layer of Rebar). Total Area Investigated - 6,848 ft²; No Evidence of Deterioration – 1,075 ft²; Evidence of Moderate Deterioration - 3,891 ft²; Evidence of Extensive Deterioration 274 ft².

Figure 7-25 shows that 30% of the area investigated on the bridge deck of Bridge A2111 exhibited no evidence of deterioration, 65% exhibited evidence of moderate deterioration, and 5% exhibited evidence of extensive deterioration based on the deterioration categories defined for the GPR amplitude results.

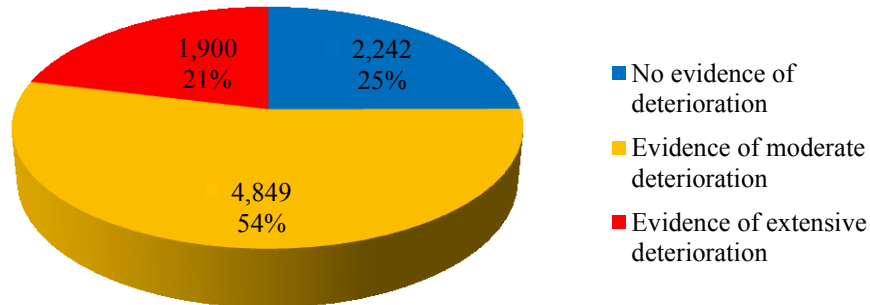
Figure 7-27 Graph Showing Predicted Distribution of Deterioration of the Bridge Deck A2966 in Each Category (Based on the Amplitude of the Reflection from the Top Layer of Rebar). Total Area Investigated - 8,991 ft²; No Evidence of Deterioration – 2,242 ft²; Evidence of Moderate Deterioration - 4,849 ft²; Evidence of Extensive Deterioration 1,900 ft².

Figure 7-27 shows that 25% of the area investigated on the bridge deck of Bridge A2966 exhibited no evidence of deterioration, 54% exhibited evidence of moderate deterioration, and 21% exhibited evidence of extensive deterioration based on the deterioration categories defined for the GPR amplitude results.

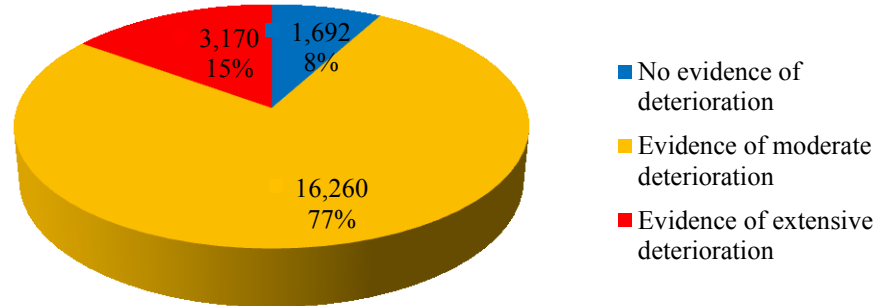
Figure 7-29 Graph Showing Predicted Distribution of Deterioration of the Bridge Deck A3017 in Each Category (Based on the Amplitude of the Reflection from the Top Layer of Rebar). Total Area Investigated - 21,122 ft²; No Evidence of Deterioration – 1,692 ft²; Evidence of Moderate Deterioration - 16,260 ft²; Evidence of Extensive Deterioration 3,170 ft².

Figure 7-29 shows that 8% of the area investigated on the bridge deck of Bridge A3017 exhibited no evidence of deterioration, 77% exhibited evidence of moderate deterioration, and 15% exhibited evidence of extensive deterioration based on the deterioration categories defined for the GPR amplitude results.

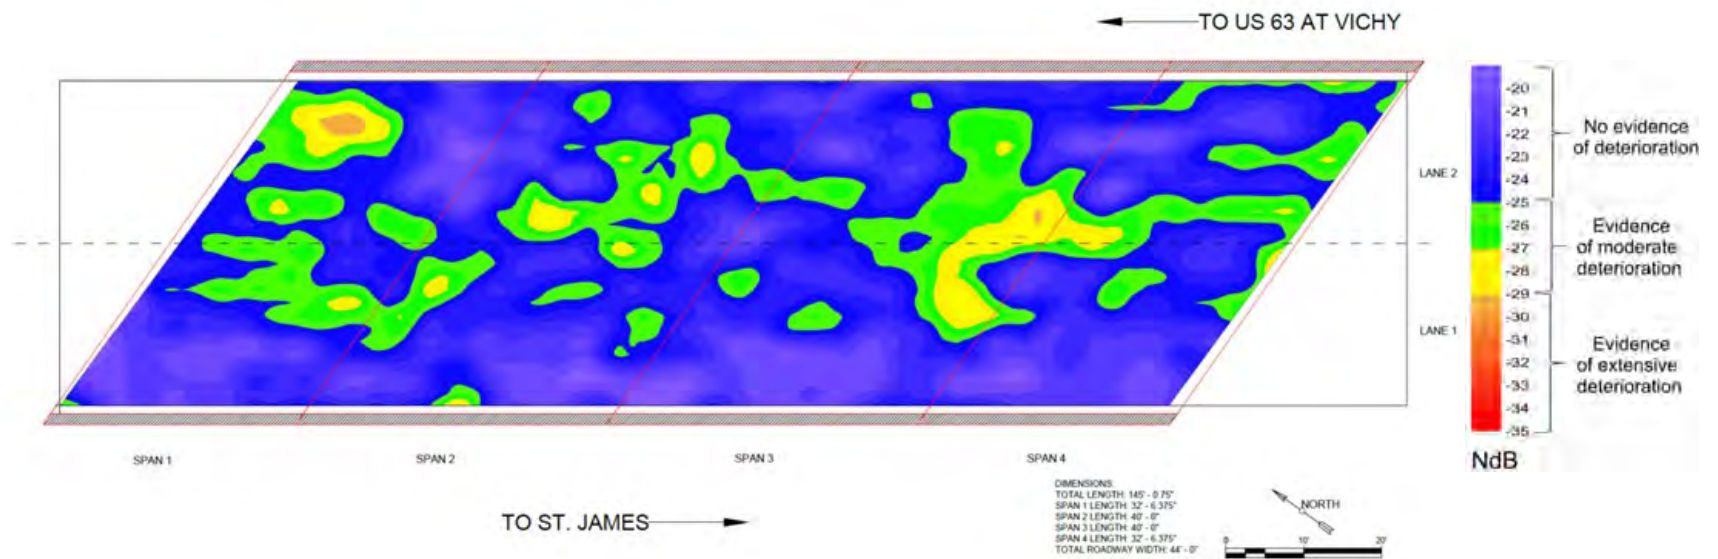
Figure 7-30 GPR Amplitude Map Based on Top Bar Reflection for Bridge Deck A3405 with Superposed Core Locations and Visual Surface Condition Features

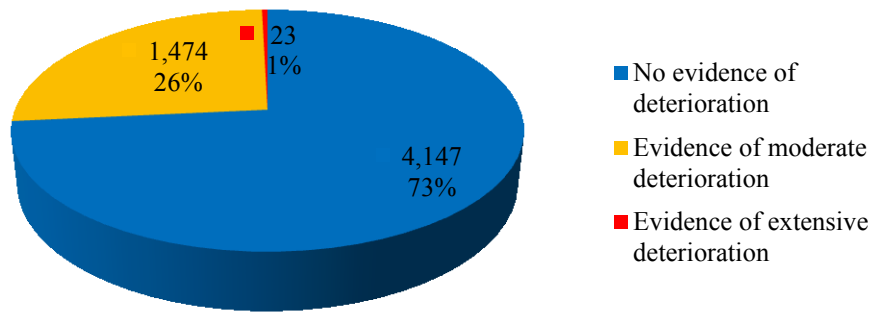
Figure 7-31 Graph Showing Predicted Distribution of Deterioration of the Bridge Deck A3405 in Each Category (Based on the Amplitude of the Reflection from the Top Layer of Rebar). Total Area Investigated - 5,644 ft²; No Evidence of Deterioration – 4,147 ft²; Evidence of Moderate Deterioration - 1,474 ft²; Evidence of Extensive Deterioration 23 ft².

Figure 7-31 shows that 73% of the area investigated on the bridge deck of Bridge A3405 exhibited no evidence of deterioration, 26% exhibited evidence of moderate deterioration, and 1% exhibited evidence of extensive deterioration based on the deterioration categories defined for the GPR amplitude results.

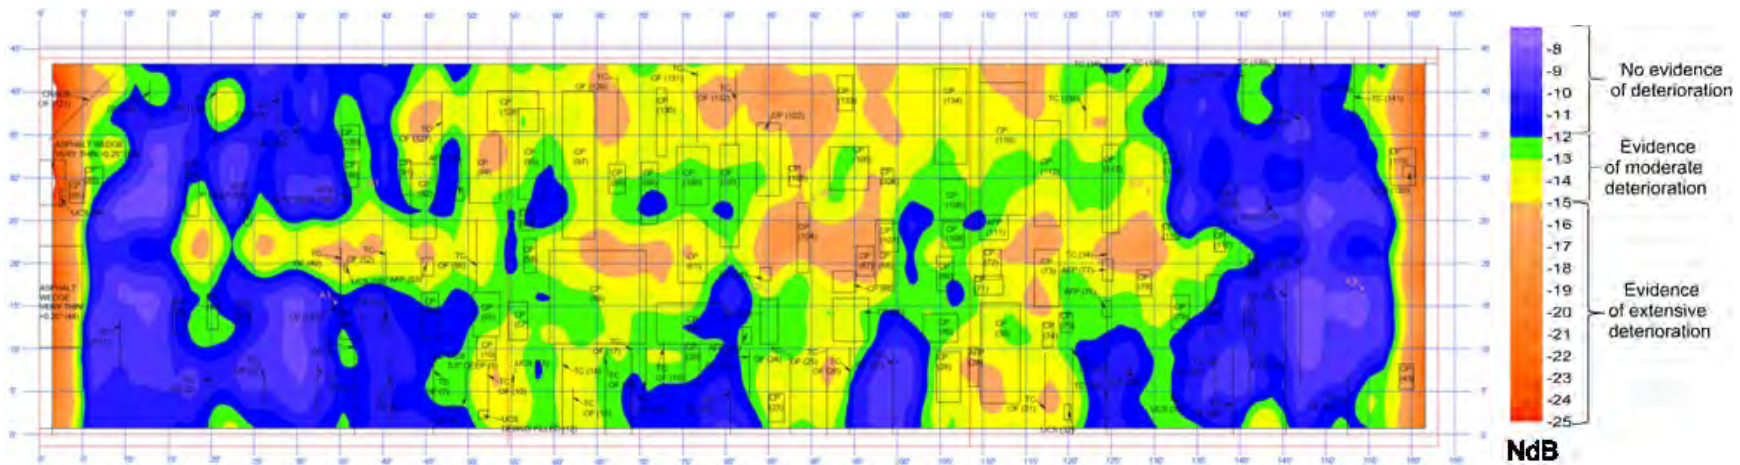
Figure 7-32 GPR Amplitude Map Based on Top Bar Reflection for Bridge Deck A3406 with Superposed Core Locations and Visual Surface Condition Features

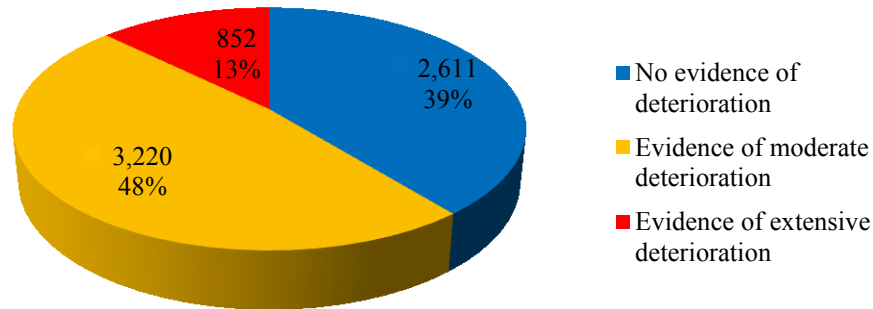
Figure 7-33 Graph Showing Predicted Distribution of Deterioration of the Bridge Deck A3406 in Each Category (Based on the Amplitude of the Reflection from the Top Layer of Rebar). Total Area Investigated - 6,683 ft²; No Evidence of Deterioration – 2,611 ft²; Evidence of Moderate Deterioration - 3,220 ft²; Evidence of Extensive Deterioration 852 ft².

Figure 7-33 shows that 39% of the area investigated on the bridge deck of Bridge A3406 exhibited no evidence of deterioration, 48% exhibited evidence of moderate deterioration, and 13% exhibited evidence of extensive deterioration based on the deterioration categories defined for the GPR amplitude results.

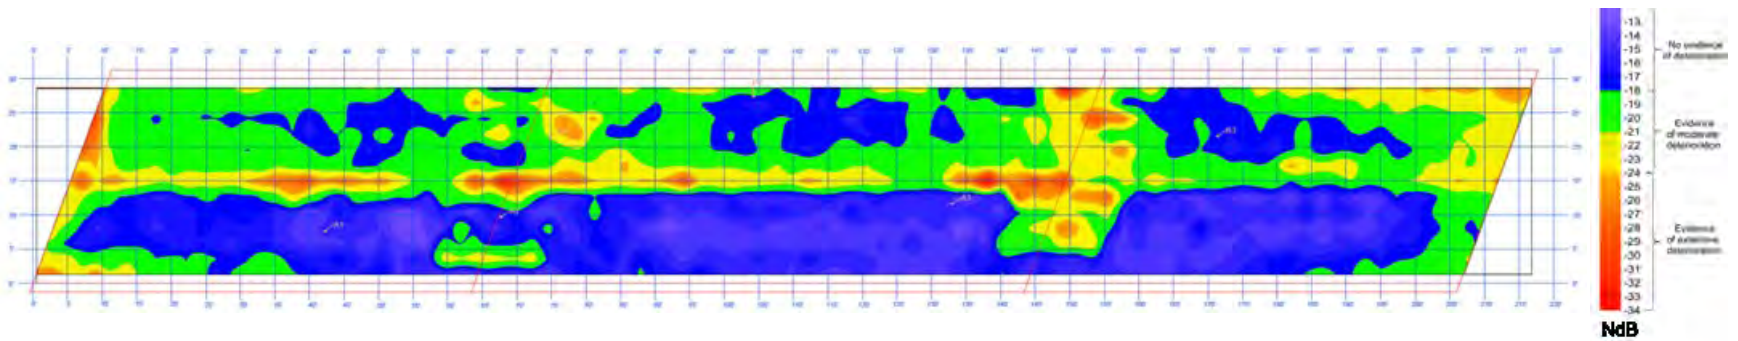
Figure 7-34 GPR Amplitude Map Based on Top Bar Reflection for Bridge Deck K0197 with Superposed Core Locations and Visual Surface Condition Features

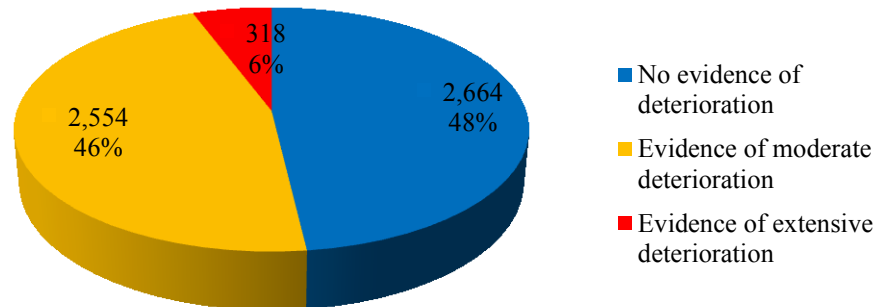
Figure 7-35 Graph Showing Predicted Distribution of Deterioration of the Bridge Deck K0197 in Each Category (Based on the Amplitude of the Reflection from the Top Layer of Rebar). Total Area Investigated - 5,536 ft²; No Evidence of Deterioration – 2,664 ft²; Evidence of Moderate Deterioration - 2,554 ft²; Evidence of Extensive Deterioration 318 ft².

Figure 7-35 shows that 48% of the area investigated on the bridge deck of Bridge K0197 exhibited no evidence of deterioration, 46% exhibited evidence of moderate deterioration, and 6% exhibited evidence of extensive deterioration based on the deterioration categories defined for the GPR amplitude results.

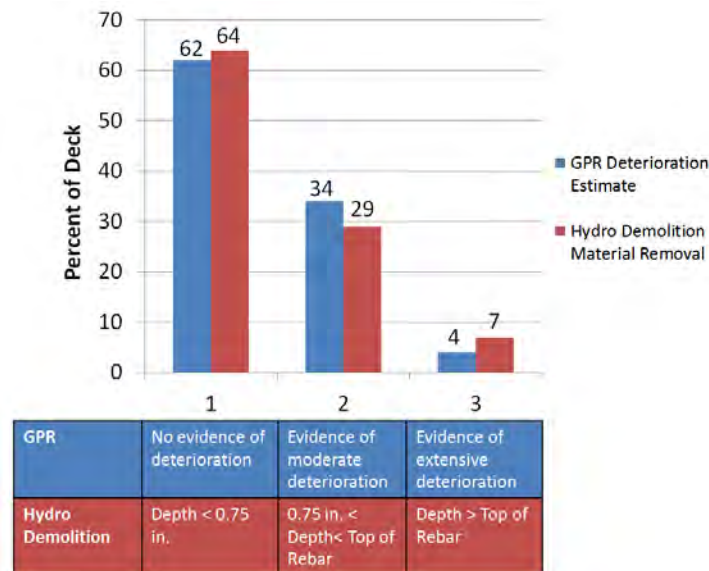
Considering the issues discussed in the previous paragraph, additional study was initiated to investigate the potential for improving the correlation between these two data sets. This process involved reevaluation of the amplitude ranges for defining the three GPR classifications by altering the threshold values, without consideration of other factors used in the initial interpretations of the data (e.g., visual evaluation data). Threshold values were artificially adjusted higher or lower until the best correlation between the GPR and the material removal percentages was achieved for each bridge deck. This work is ongoing at the time of this report, but preliminary results shown in Figures 7-36, 7-37, and 7-38 for Bridges A1193, A1297, and A1479, respectively, suggest that improved correlation is possible. Presently, a statistical approach is being used in an attempt to correlate the amplitude of the reflection with concrete removal depth for each data point for each of the three bridges. The major challenge, however, is to understand how to determine the GPR threshold values a priori, without having the benefit of the control data. Therefore, it should be noted that the results shown in Figures 7-36, 7-37, and 7-38 are not predictive.

Figure 7-36 Percentage of Bridge Deck Area for Bridge A1193 Categorized by GPR Results with adjusted threshold levels and Rehabilitation Lidar Survey

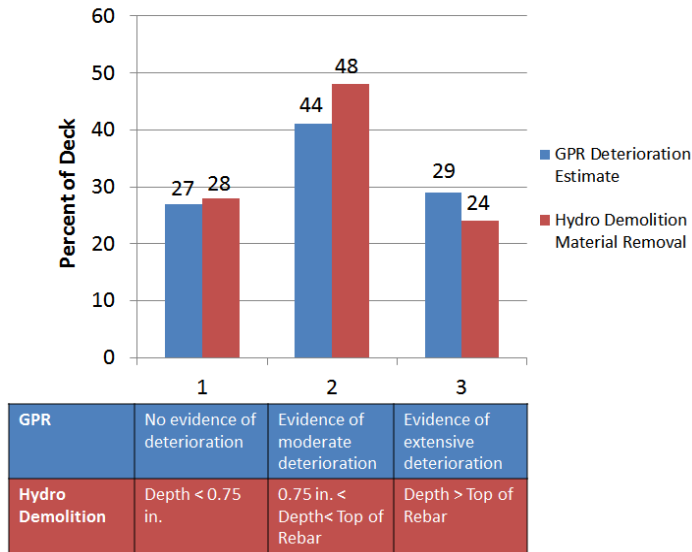
Figure 7-37 Percentage of Bridge Deck Area for Bridge A1297 Categorized by GPR Results with adjusted threshold levels and Rehabilitation Lidar Survey

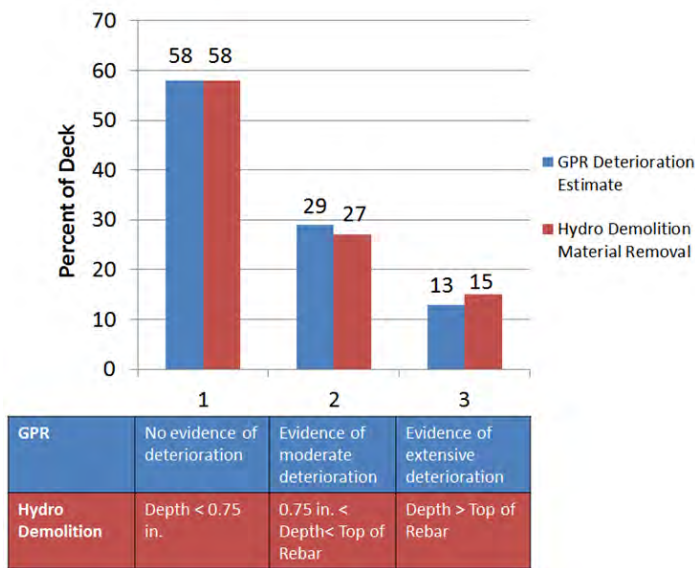
Figure 7-38 Percentage of Bridge Deck Area for Bridge A1479 Categorized by GPR Results with adjusted threshold levels and Rehabilitation Lidar Survey

Several factors might affect the amplitude threshold values, including but not limited to variable depth of top rebar layer, and different weather conditions prior and/or during GPR data acquisition. Further data analysis can enhance a data correlation between the concrete material depth removal and GPR amplitudes from top of rebar, and increase reliability of concrete material removal depth prediction based on the GPR data.

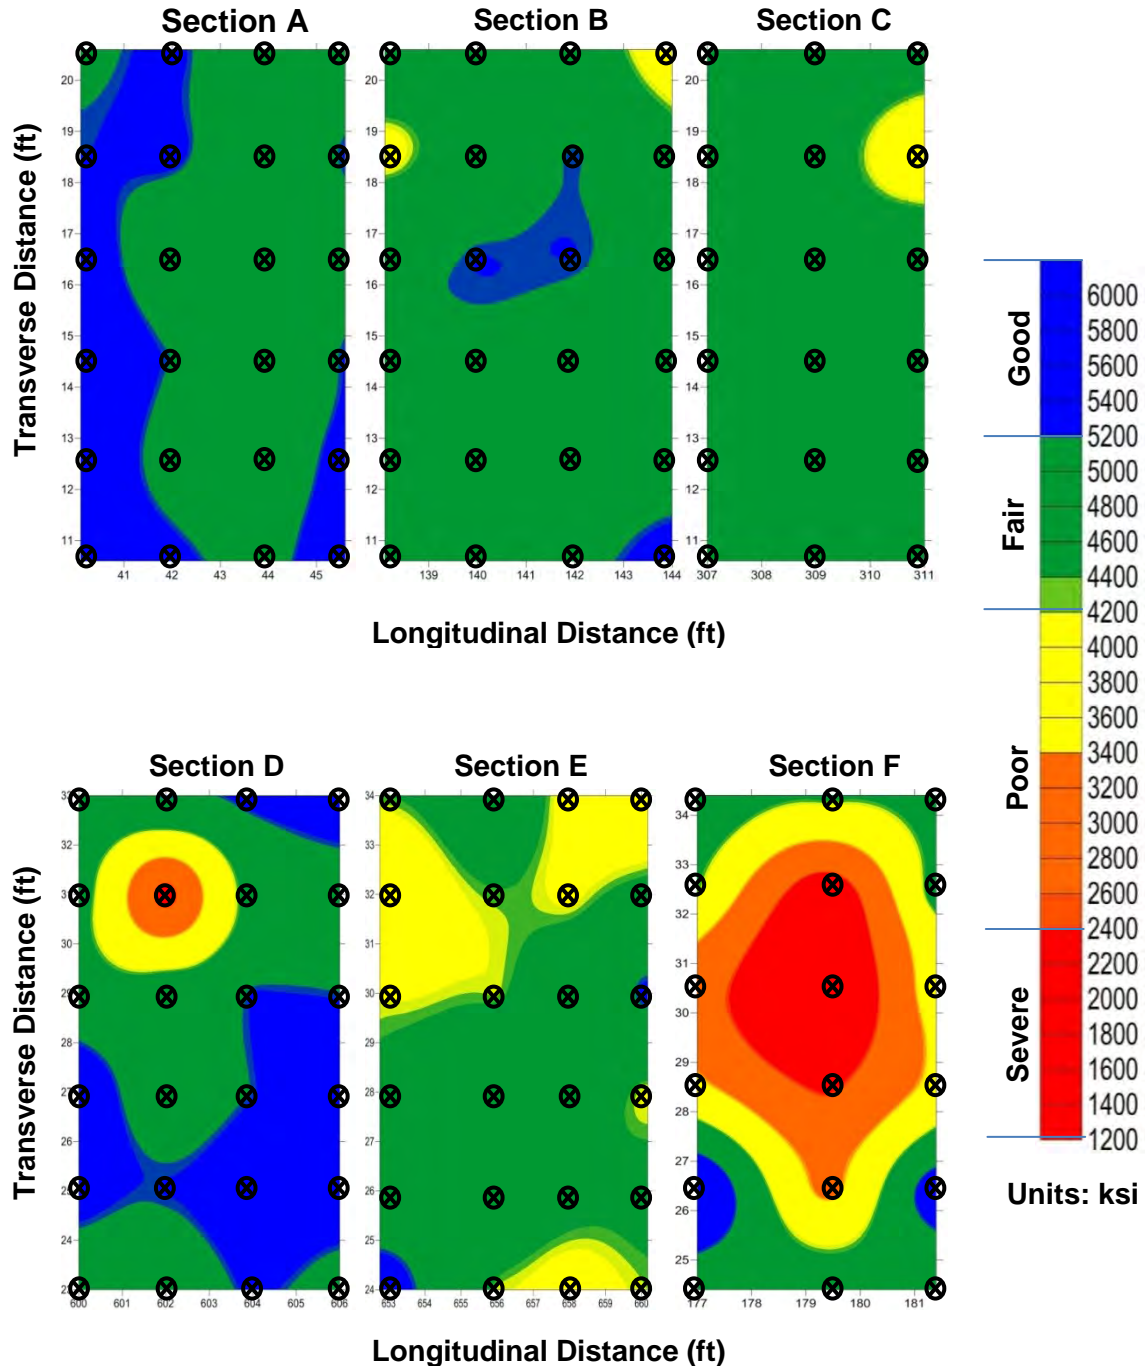
Figure 8-7 Bridge A1193 map of average elastic modulus (Young's Modulus) values for each PSPA section

Of the 141 test points acquired on Bridge A1193, 19% of the PSPA test points located in the USW map (Figure 8-7) indicate concrete deterioration (Poor or Severe condition). 8% of the PSPA test points located in the IE map (Figure 8-8) indicate concrete deterioration (Poor or Severe condition). To determine correlation with other data sets, the PSPA USW results are compared to the hydrodemolition and GPR data sets in Figures 8-9 and 8-10. 15% of the PSPA test points located in lidar map (Figure 8-9) indicate concrete deterioration (warm color). 34% of PSPA test points located in GPR map (Figure 8-10) indicate moderate concrete deterioration (warm color). The correlation of the PSPA results is good between the USW and hydrodemolition results. The correlation of PSPA results is fair between USW and GPR results.

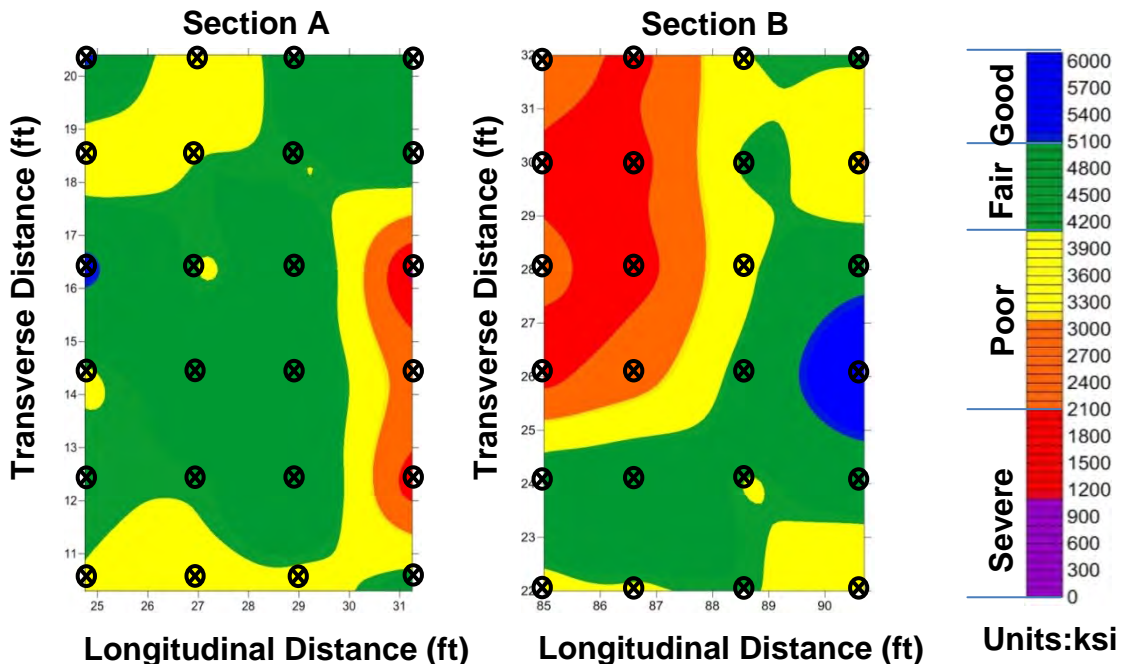
Figure 8-12 Bridge A1297 map of average elastic modulus (Young's Modulus) values for each PSPA section

Of the 56 test points acquired on Bridge A1297, 56% of the PSPA test points located in the USW map (Figure 8-12) indicate concrete deterioration (Poor or Severe condition). 33% of the PSPA test points located in the IE map (Figure 8-13) indicate concrete deterioration (Poor or Severe condition). To determine correlation with other data sets, the PSPA USW results are compared to the hydrodemolition and GPR data sets in Figures 8-14 and 8-15. 48% of the PSPA test points located in lidar map (Figure 8-14) indicate concrete deterioration (warm color). 70% of PSPA test points located in GPR map (Figure 8-15) indicate moderate concrete deterioration (warm color). The correlation of the PSPA results is good between the USW and hydrodemolition results. The correlation of PSPA results is fair between USW and GPR results.

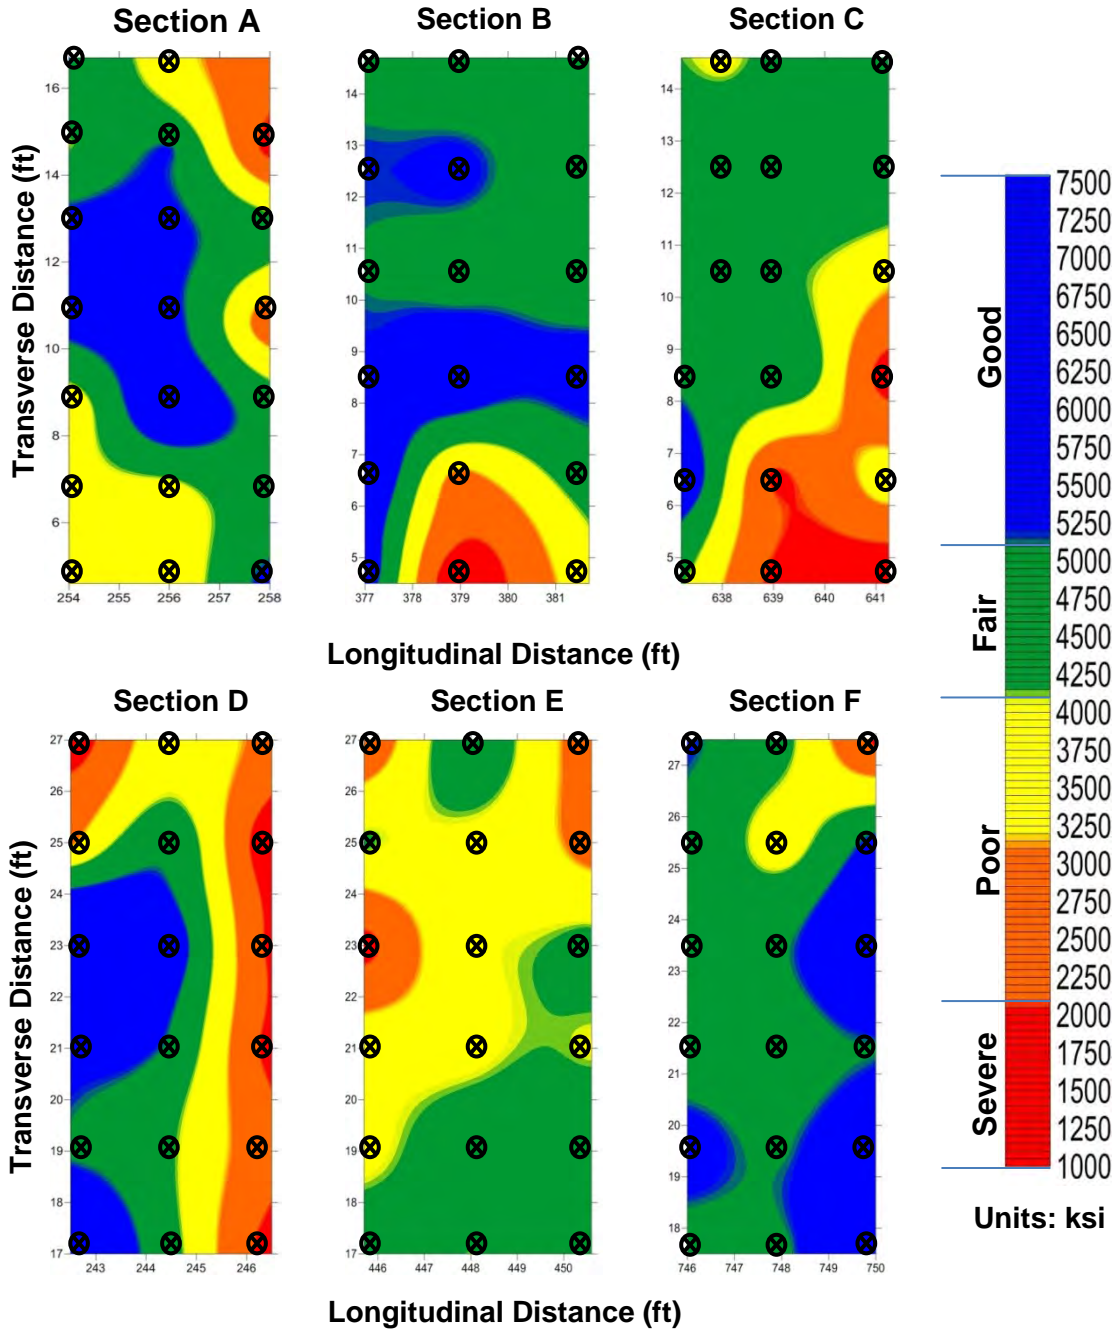
Figure 8-17 Bridge A1479 map of average elastic modulus (Young's Modulus) values for each PSPA section

Of the 120 test points acquired on Bridge A1479, 35% of the PSPA test points located in the USW map (Figure 8-17) indicate concrete deterioration (Poor or Severe condition). 17% of the PSPA test points located in the IE map (Figure 8-18) indicate concrete deterioration (Poor or Severe condition). To determine correlation with other data sets, the PSPA USW results are compared to the hydrodemolition and GPR data sets in Figures 8-19 and 8-20. 38% of the PSPA

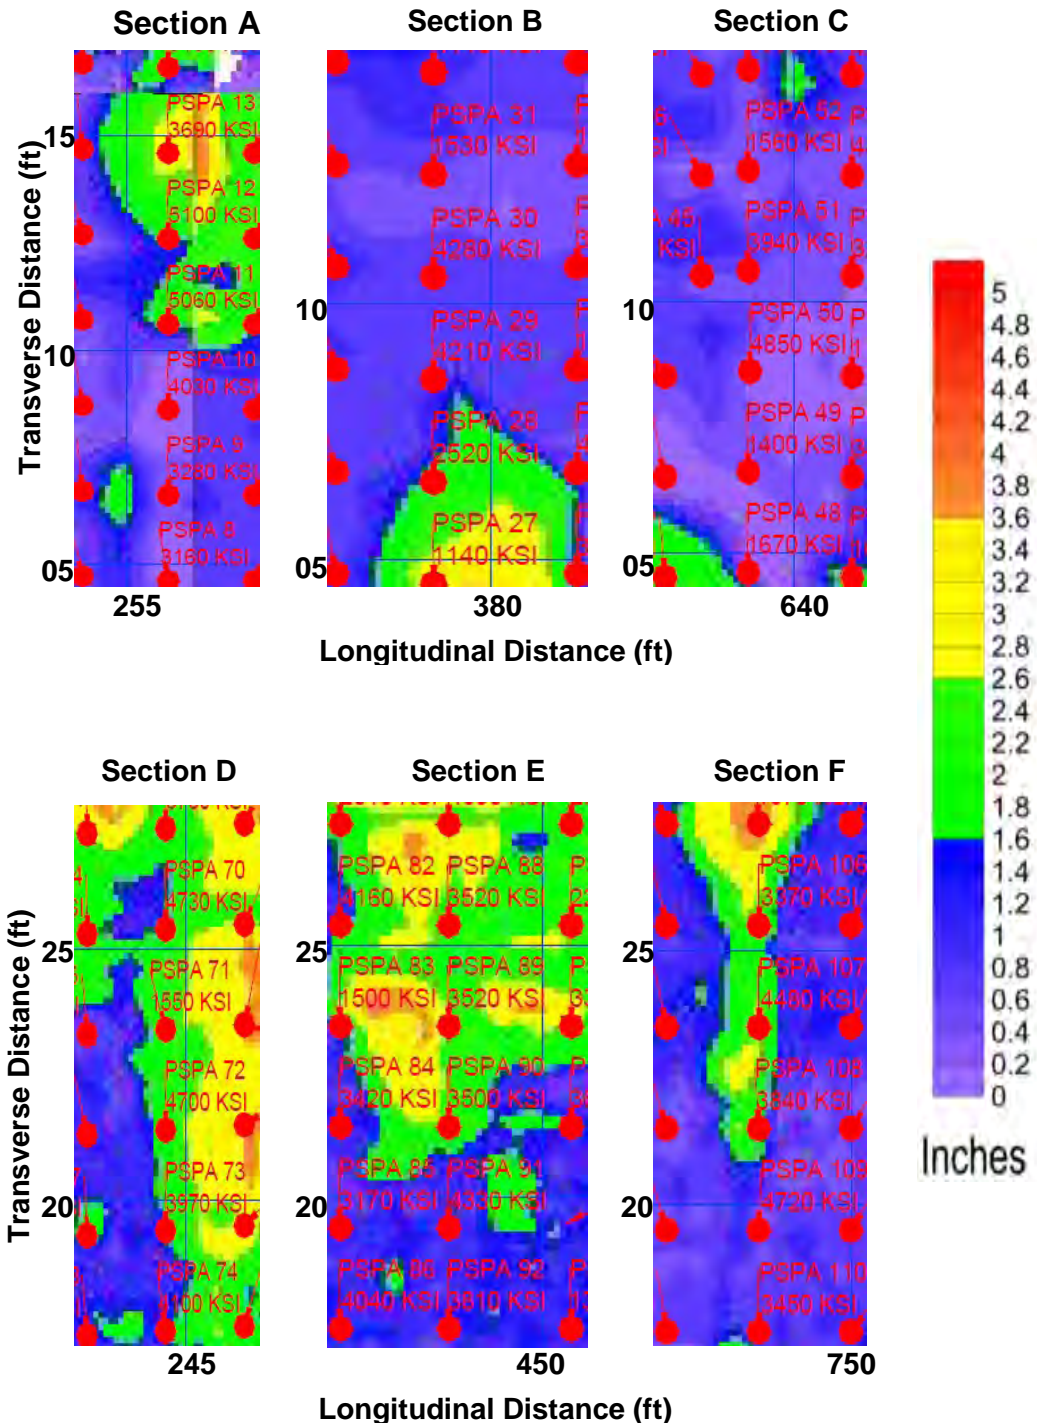
Figure 8-19 Bridge A1479 lidar data superposed with PSPA test points

test points located in lidar map (Figure 8-19) indicate concrete deterioration (warm color). 72% of PSPA test points located in GPR map (Figure 8-20) indicate moderate concrete deterioration (warm color). The correlation of the PSPA results is good between the USW and hydrodemolition results. The correlation of PSPA results is poor between USW and GPR results.
