## **SAFETY PERFORMANCE EVALUATION OF THE NON-BLOCKED MIDWEST GUARDRAIL SYSTEM (MGS)**

### **MIDWEST ROADSIDE SAFETY FACILITY**

MwRSF Research Report No. TRP-03-262-12

January 24, 2013

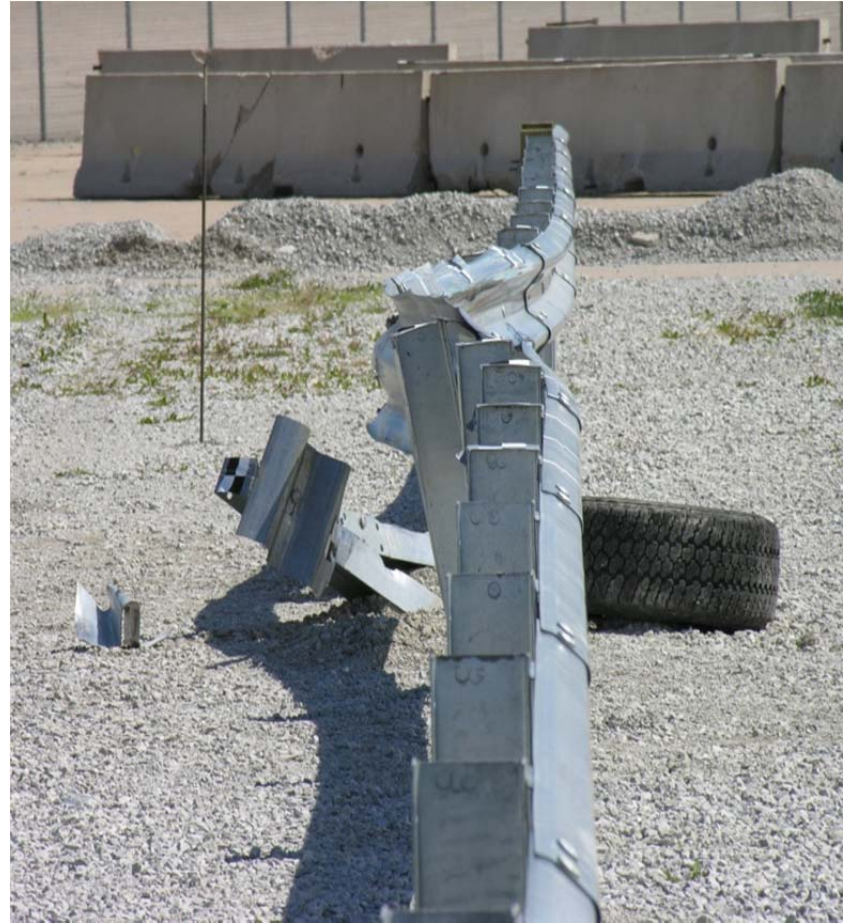
Figure 39. System Damage, Test No. MGSNB-1

Damage to the barrier was moderate, as shown in Figures 39 through 42. Barrier damage consisted of deformed W-beam rail, deformed posts, and contact marks on sections of guardrail and posts. The length of vehicle contact along the barrier was approximately 23 ft – 6 in. (7.2 m) which spanned from 21 in. (533 mm) upstream of the centerline of post no. 13 to 41¾ in. (1,060 mm) downstream of the centerline of post no. 16.

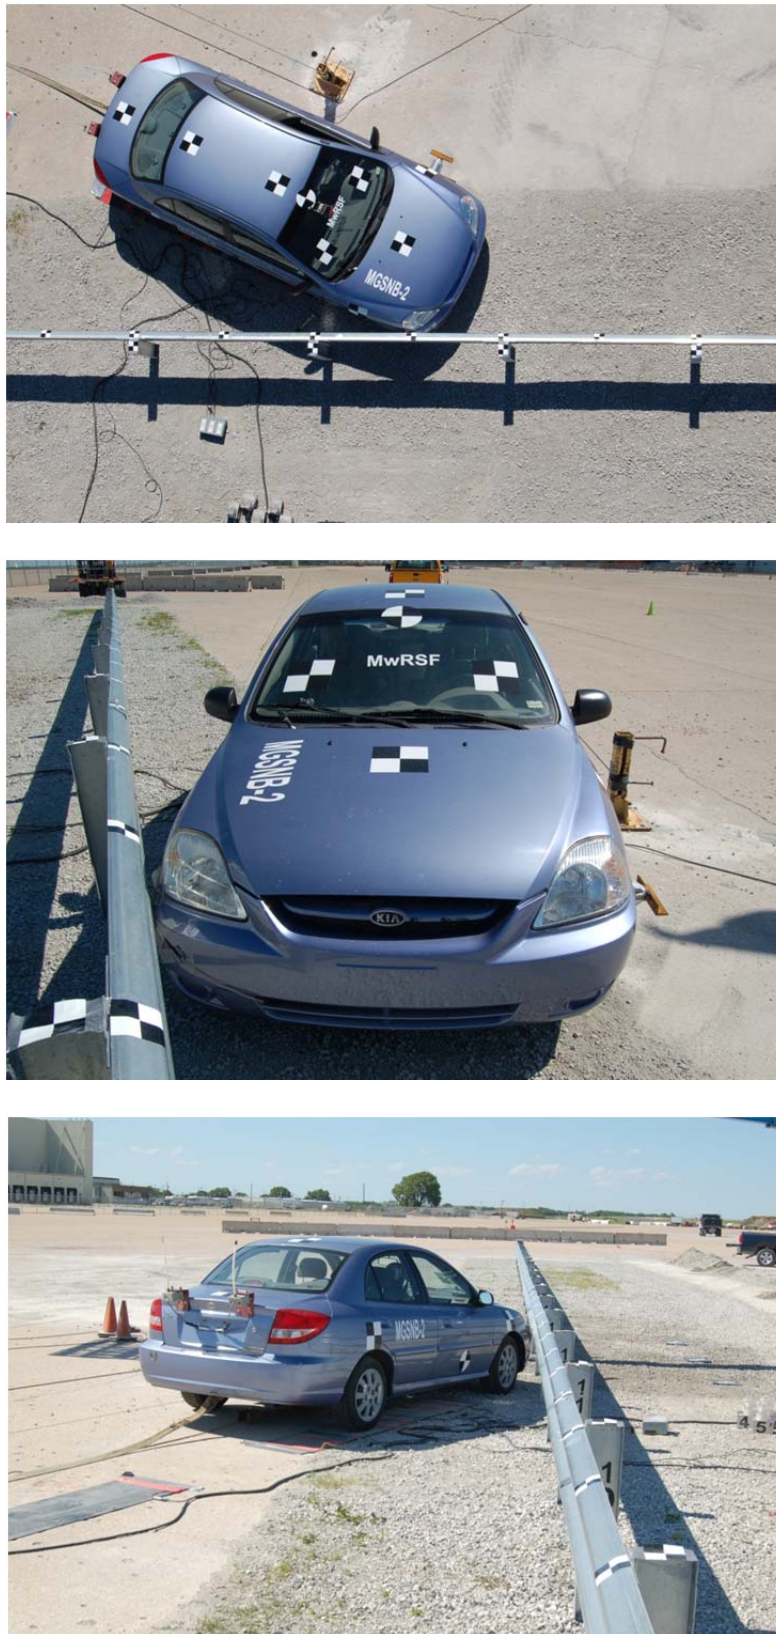
Figure 52. Impact Location, Test No. MGSNB-2

Initial vehicle impact was to occur 9 ft – 3½ in. (2.8 m) upstream of the center line of post no. 15, as shown in Figure 52, which was selected using the CIP plots found in Section 2.3 of MASH. The actual point of impact was 4¼ in. (108 mm) downstream of the intended impact point. A sequential description of the impact events is contained in Table 8. The vehicle came to rest in contact with the barrier system 78 ft – 9 in. (24.0 m) downstream of the impact point. The vehicle trajectory and final position are shown in Figure 53.

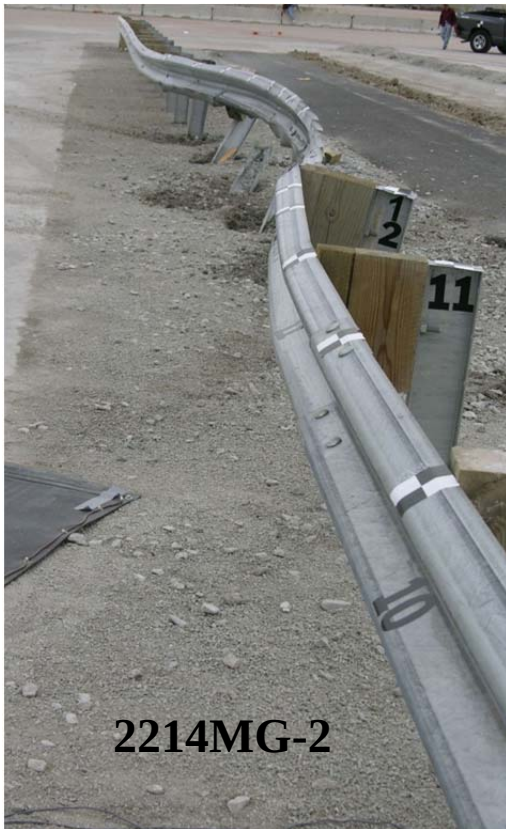
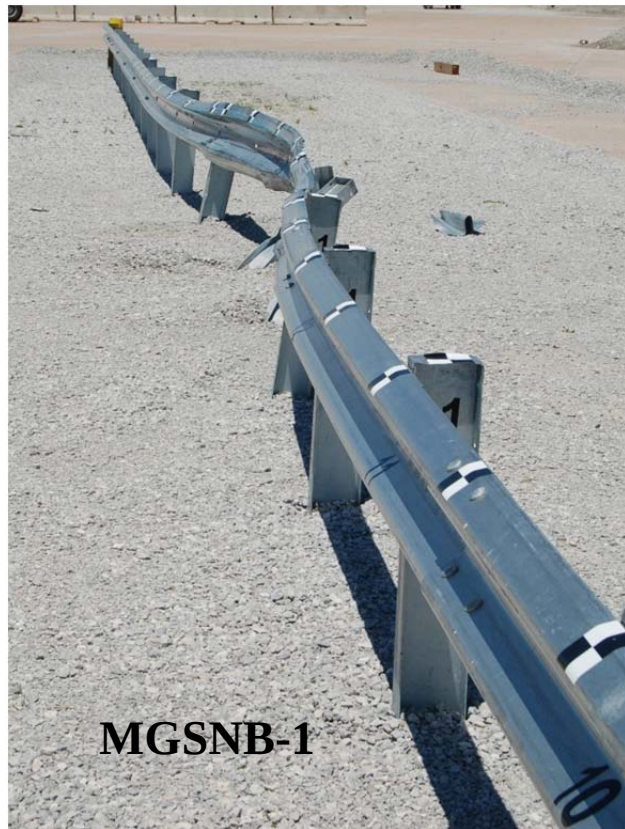
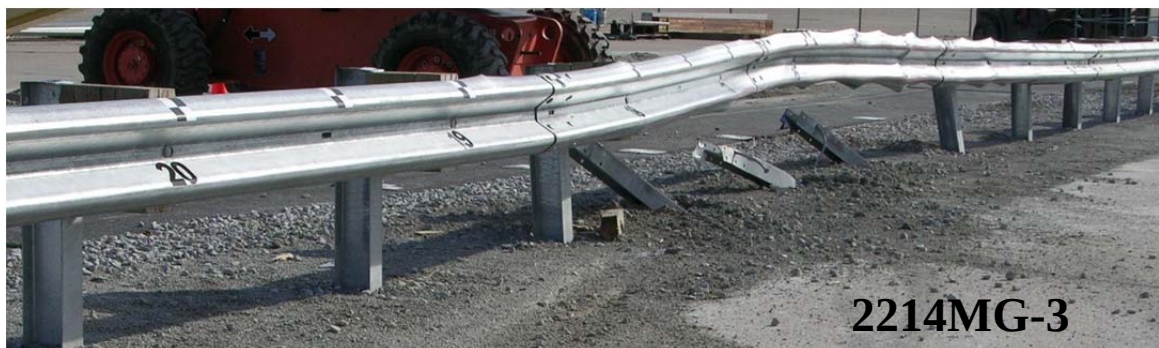
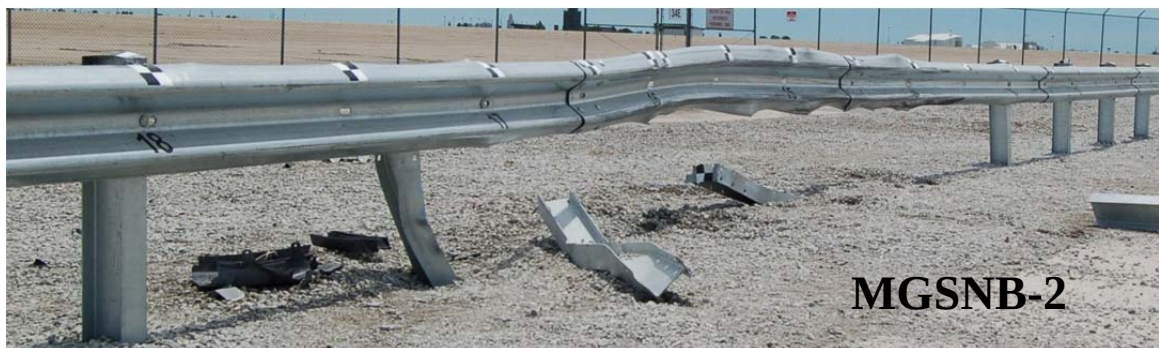
Figure 62. Barrier Damage

A comparison between the blocked and non-blocked MGS for both the 2270P truck and 1100C small car is presented in Table 11. Rear-view sequentials for the 2270P and 1100C tests are shown in Figures 60 and 61, respectively. Barrier damage and vehicle damage are shown in Figures 62 and 63, respectively. Longitudinal and lateral change in velocity plots are shown in Figure 64.

For the 2270P vehicle, the non-blocked test when compared to the blocked test had significantly reduced rail deflections, a roll into the barrier as opposed to away from the barrier, fewer posts detached from the rail, and fewer posts snagged by the tire. The ORDs and OIVs were, percentage wise, much higher for the non-blocked system; these differences are also somewhat evident by examining the change in velocity plots. However, the occupant risk measures for both systems were small enough to not cause undue concern. In general, the blocked MGS had higher rail deflections and lower occupant risk numbers.

Much of the rail deflection differences can probably be attributed to the soil conditions. The more recent non-blocked MGS testing was performed in soil that used a relatively new compaction method, which has been determined to provide a somewhat stiffer soil condition. This, most likely, reduced dynamic deflections. Soil conditions for all tests were well within MASH recommendations.

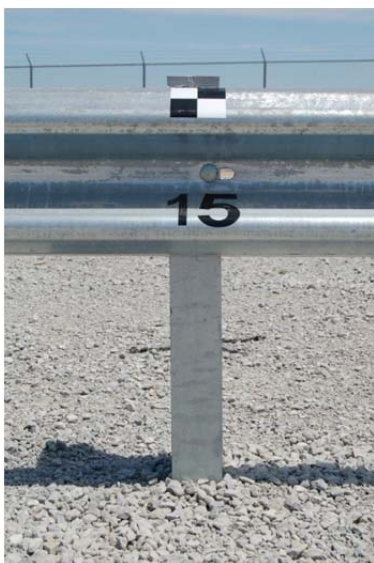
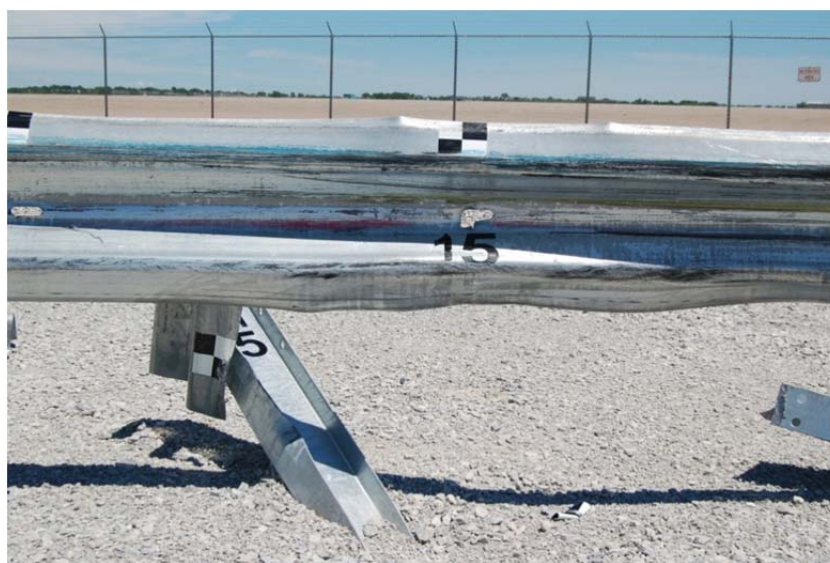
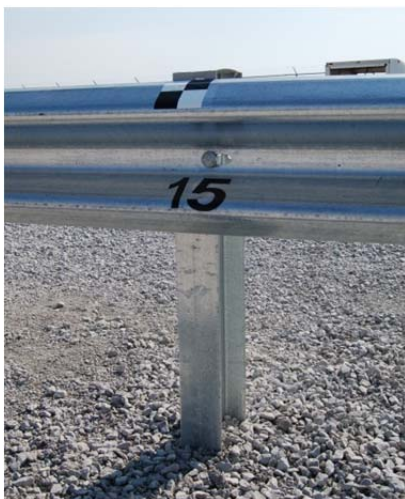
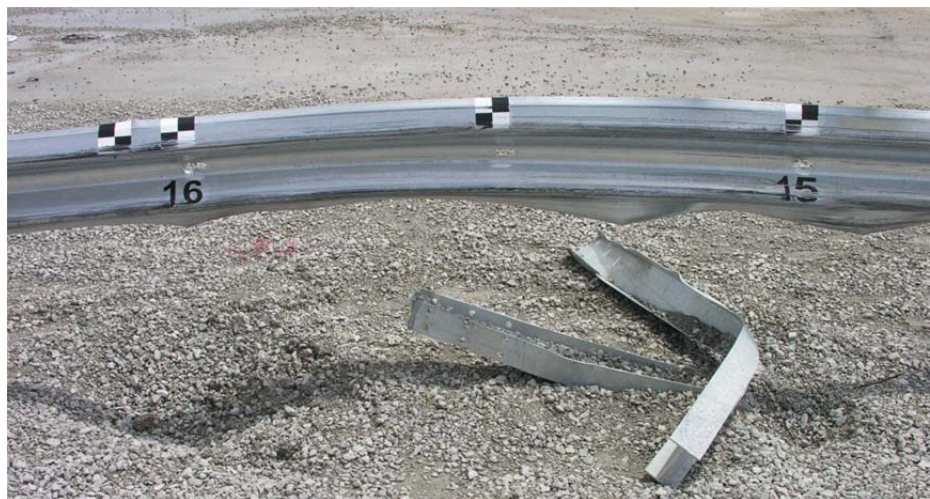
Figure 65. Bolt Located in Worst Case Location – Pull-Through Behavior Still Occurred

During test nos. MGSNB-1 and MGSNB-2, the locations of the post bolts were varied within the rail slots in order to investigate rail release away from the posts, as indicated in Figure 1 and shown in Figure 65. Post no. 15 was most likely the worst case scenario if the rail did not release from the post during impact. As a result, the post bolt was located at the downstream end of the rail slot. For both the pickup and small car tests, the guardrail detached from post no. 15 as the bolt head was pulled through the rail. Slight tearing of the rail was evident around the rail bolt hole, but nothing of significance was observed to cause concern for rail rupture. Video analysis also showed that the release of the rail occurred considerably before the post could pull the rail down as the posts rotated in the soil.

In order to prevent the rail from being pulled down as a post rotates in the soil as well as a possible vehicle override of the barrier during an impact event, the rail may need to detach away from the post. Fortunately, it has been shown that the bolt attachment mechanism used for the MGS, the same one used for standard W-beam guardrail systems for several decades, provides for satisfactory rail detachment.
