**WVDOT/DOH Report**

## **Evaluation of Weathering Steel Overhead Sign Structures in West Virginia**

June 2014

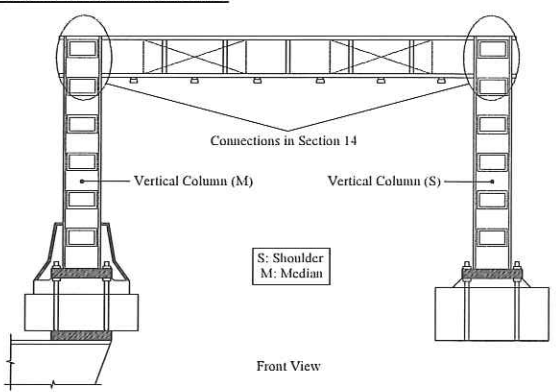
14. Connections between the Vertical Column and Horizontal Chords	<b>Locations of Connections:</b>		<b>Detailed Deficiency Comments:</b>

<b>Connections - Vertical Column (At Shoulder):</b> <b>Lower Chord</b> Misalignment <span style="float: right;"><input checked="" type="checkbox"/> No <input type="checkbox"/> Yes (specify):</span> L-Shaped Plate Damage <span style="float: right;"><input checked="" type="checkbox"/> No <input type="checkbox"/> Yes (specify):</span> U-Bolt Corrosion * <span style="float: right;"><input checked="" type="checkbox"/> No <input type="checkbox"/> Yes (specify level of corrosion):</span> U-Bolt Deterioration * <span style="float: right;"><input checked="" type="checkbox"/> No <input type="checkbox"/> Yes (specify level of deterioration):</span> Pack Rust Between Plates/Members <span style="float: right;"><input type="checkbox"/> No <input checked="" type="checkbox"/> Yes (specify level of rust):</span>
