*Experimental Construction Project ME 00-20
Third Year Interim Report on Experimental
Utilization of Tire Shreds to Enhance Highway
Drainage
April 2003*

Third Year Interim Report on Experimental Utilization of Tire Shreds to Enhance Highway Drainage

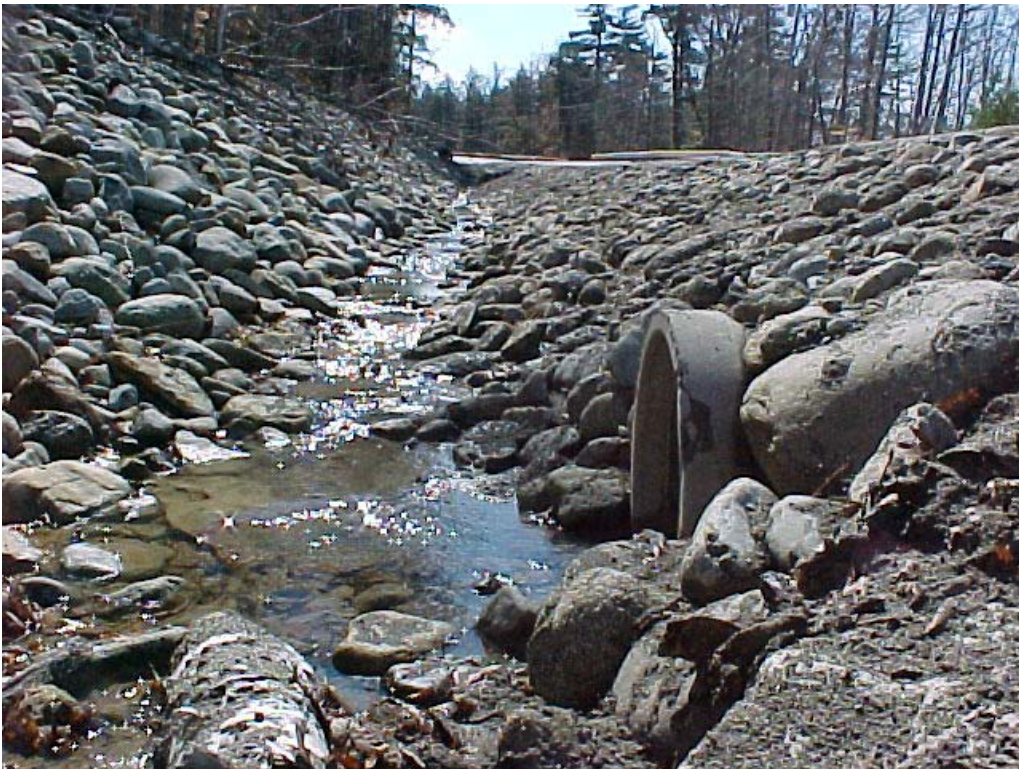
Figure 1.

In the summer of 2000 shredded tires were used in an experimental project on a full highway reconstruction project in the town of Rome. Shredded tires were used to construct a subgrade drain in the ditch profile. The picture at right shows the completed ditch and shoulder area during the spring of 2001. The French drain is located beneath the riprap on the road side of the ditch. This interim report documents temperature and water levels in the tire shred drain over time during the month of March 2003.

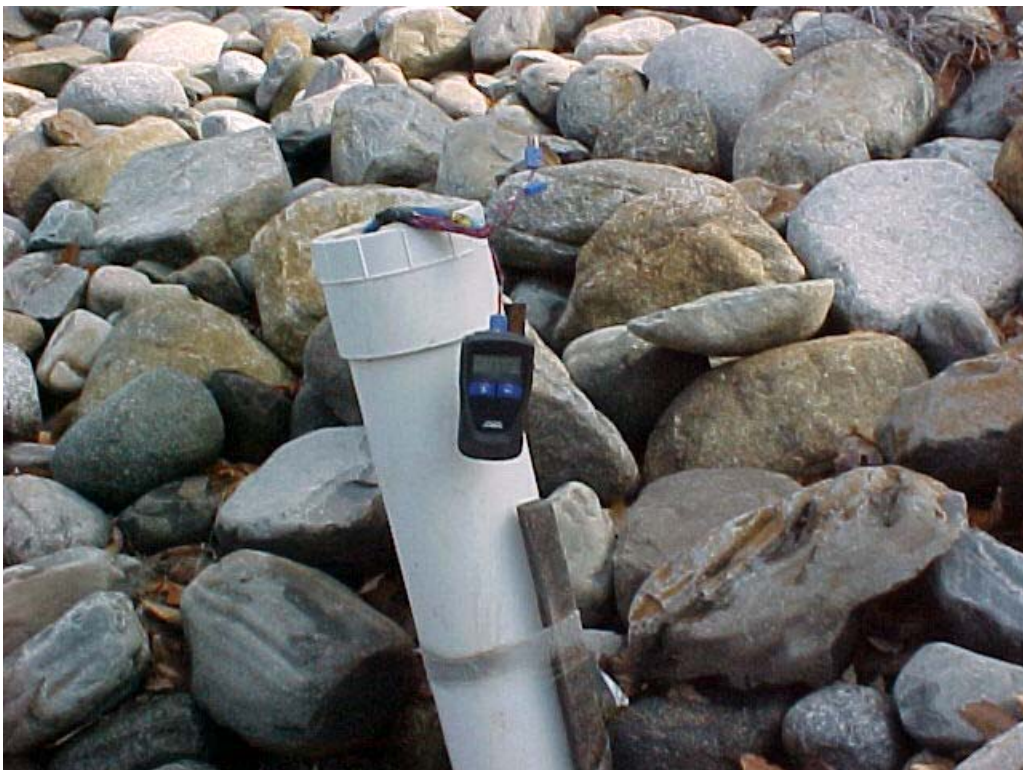
Figure 5. Digital Thermometer Connected to Thermocouple Leads

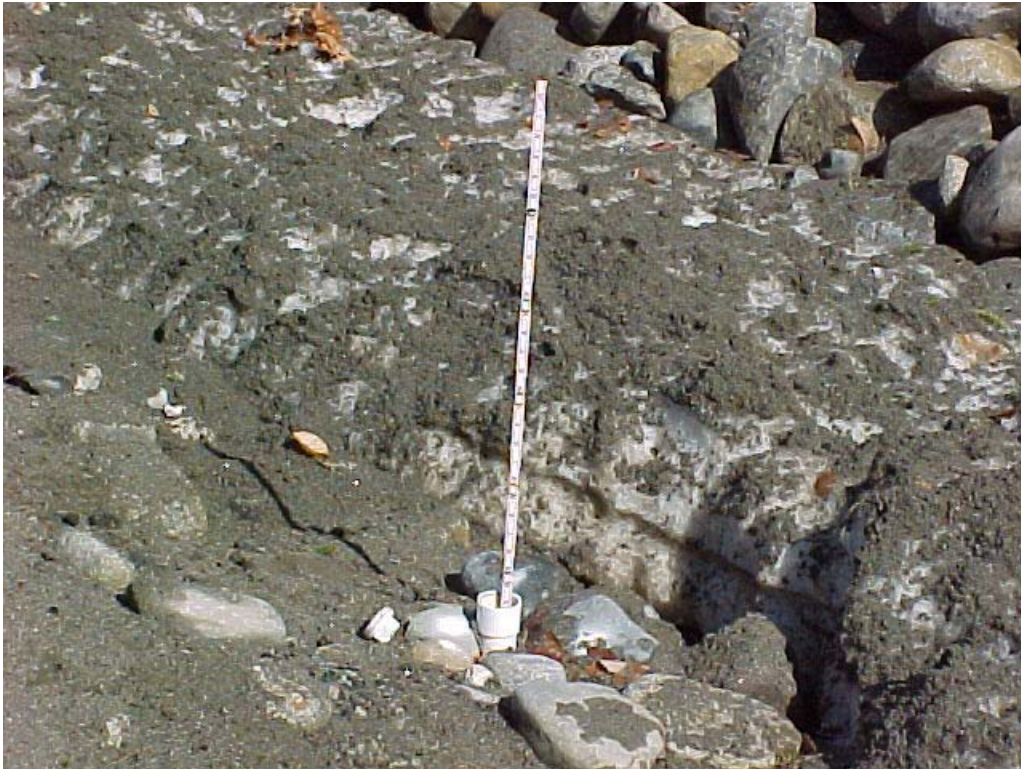
Figure 6. Measuring the Water Level in the Subsurface Drain

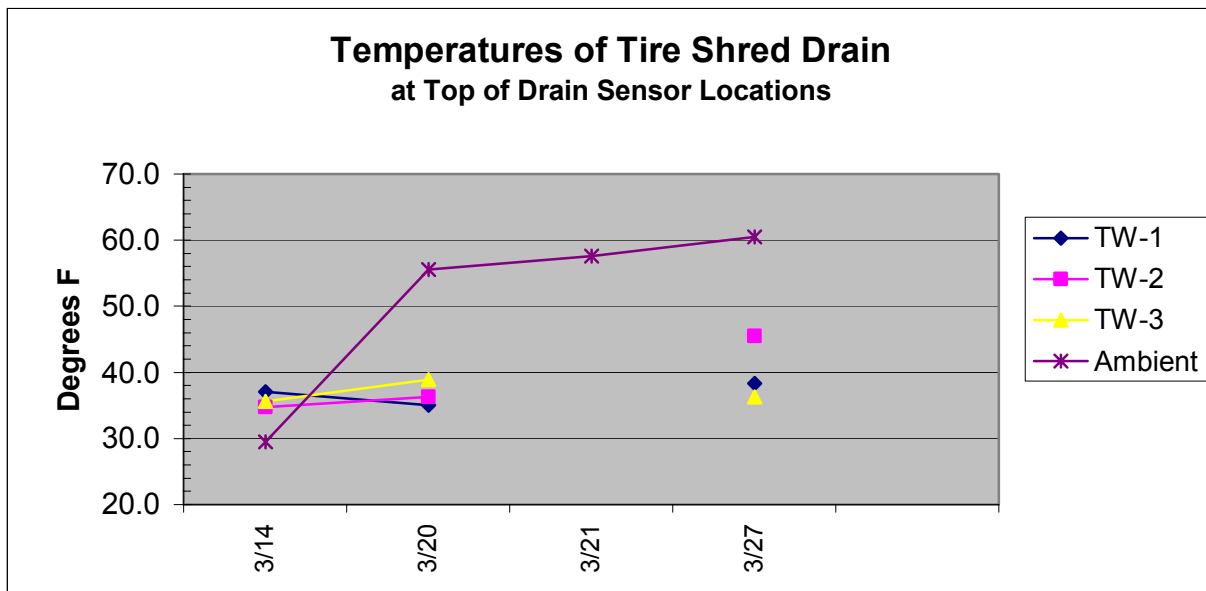
Figure 7.

The charts below show the results of the 2003 monitoring results. Despite generally deep frost penetration this past winter, the subsurface drain appeared to be functioning well during spring runoff.
