CRASH TEST AND EVALUATION OF LOCKING ARCHITECTURAL MAILBOXES

Test Report No. 9-1002-12-9

**TEXAS A&M TRANSPORTATION INSTITUTE
COLLEGE STATION, TEXAS**

TEXAS DEPARTMENT OF TRANSPORTATION

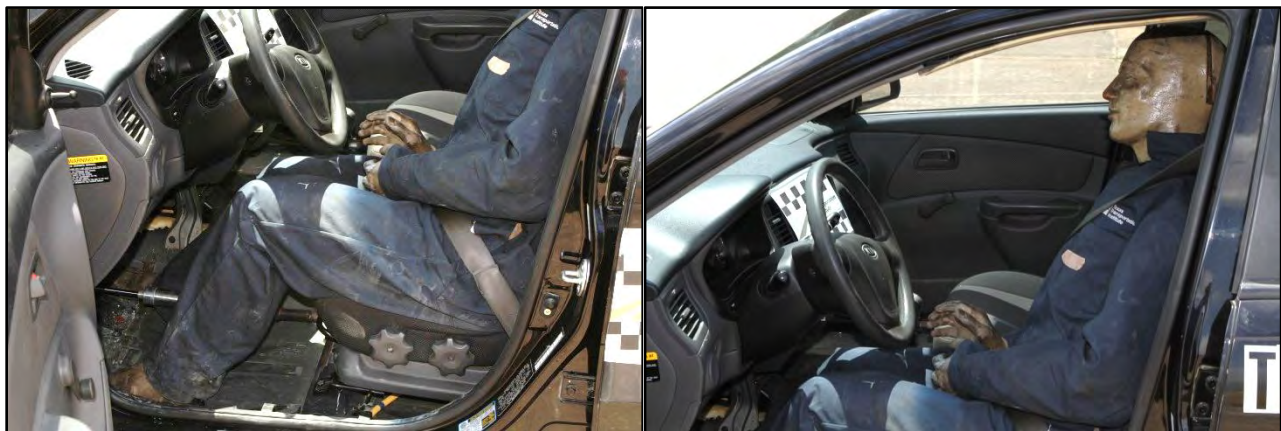
Figure 4.16. Interior of Vehicle after Test No. 490023-9-2.

Figure 4.15 shows damage to the exterior of the vehicle, and Figure 4.16 shows the interior of the vehicle. The vehicle sustained a small cut on the hood, and the hood was

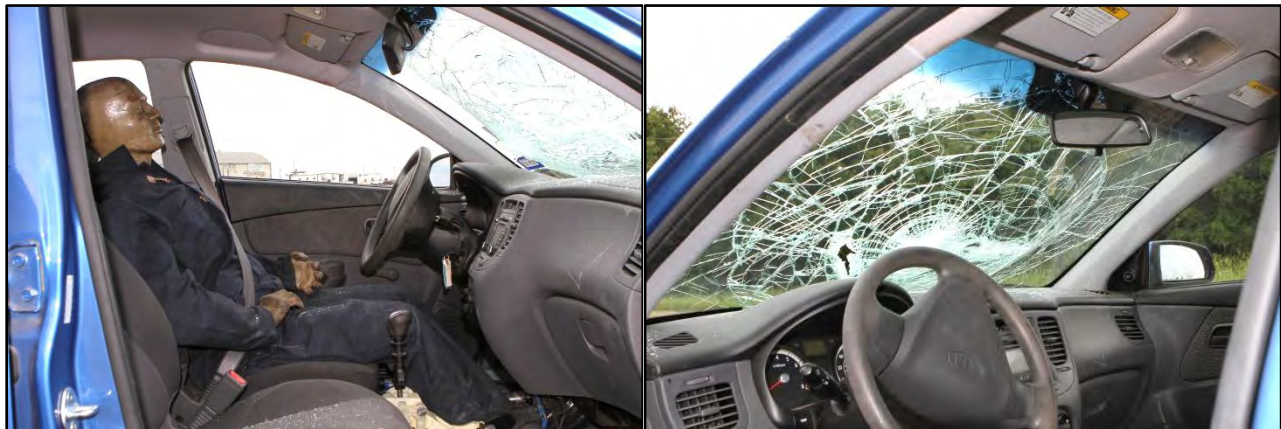
Figure 5.16. Interior of Vehicle after Test No. 490023-9-4.

The windshield sustained four cuts. One cut was 19 inches long, a second was 4.5 inches long, a third was 2 inches long, and the fourth was 3 inches long. The windshield was depressed 4.5 inches toward the occupant compartment over an area measuring 30 inches \times 36 inches. Figure 5.15 shows damage to the exterior of the vehicle, and Figure 5.16 shows the interior of the vehicle. Tables D2 and D3 in Appendix D provide exterior crush and occupant compartment measurements.

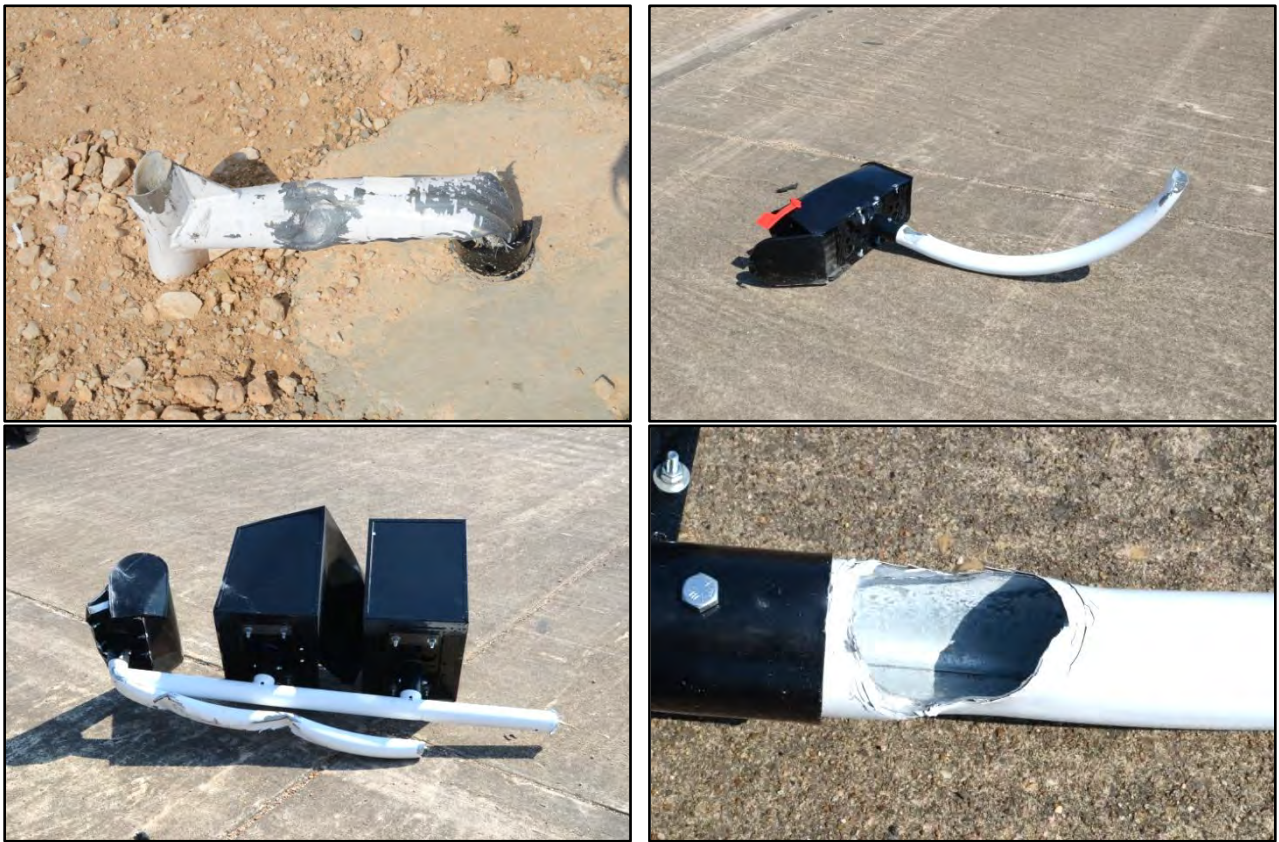
Figure 6.8. Installation after Test No. 490023-9-5.

Figures 6.7 and 6.8 show damage to the mailbox installation. The mailboxes remained attached to the support post; however, the support post fractured into three pieces. The support post pulled up inside the socket, but did not completely pull out of the socket. The piece remaining in the socket was deformed 90 degrees at ground level. One of the standard mailboxes and a piece of the support post came to rest 177 ft downstream of impact and 14 ft to the left of centerline of the vehicle path. The two locking architectural mailboxes, the second
