An Evaluation of TYFO S Fibrwrap

Final Report

Report 2013 – 05

Reporting on Work Plan 1994-R-7

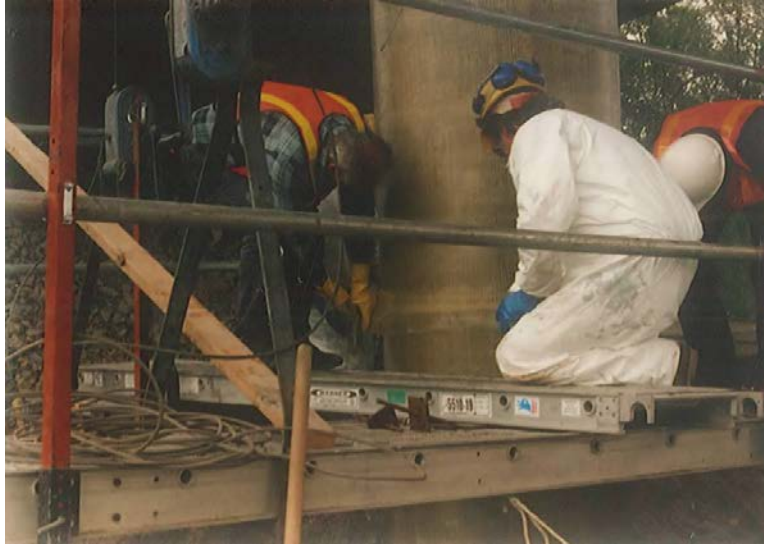
Figure 4 Applying the six inch strip to seal the butt joint (1994).

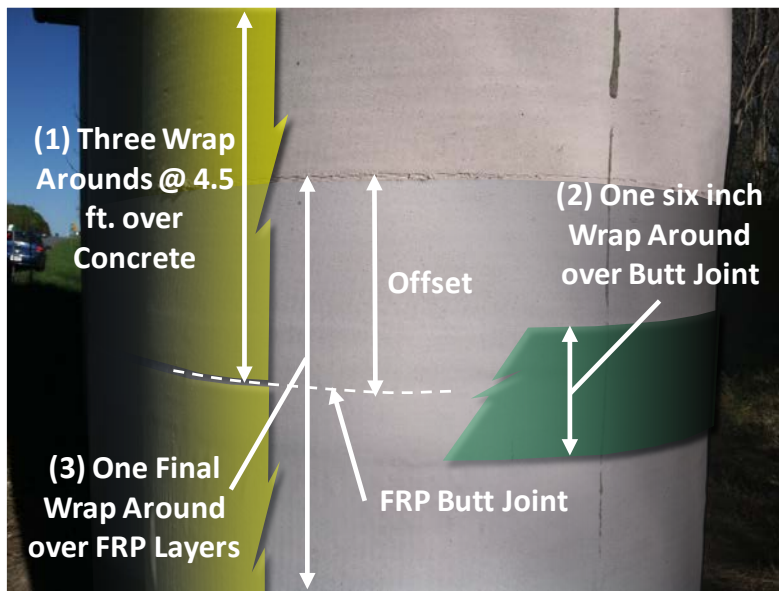
Figure 5 The primary wrap (1) was placed first in three wrap arounds. A 6” strip (2) was then wrapped around to seal the Butt Joint. Finally, a cover wrap (3) was applied at an offset of the Butt Joint covering the other wraps.
