**VERMONT AGENCY OF TRANSPORTATION**

**An Evaluation of Brifen Wire Rope Safety Fence**

**Final Report**

**Report 2013 – 06**

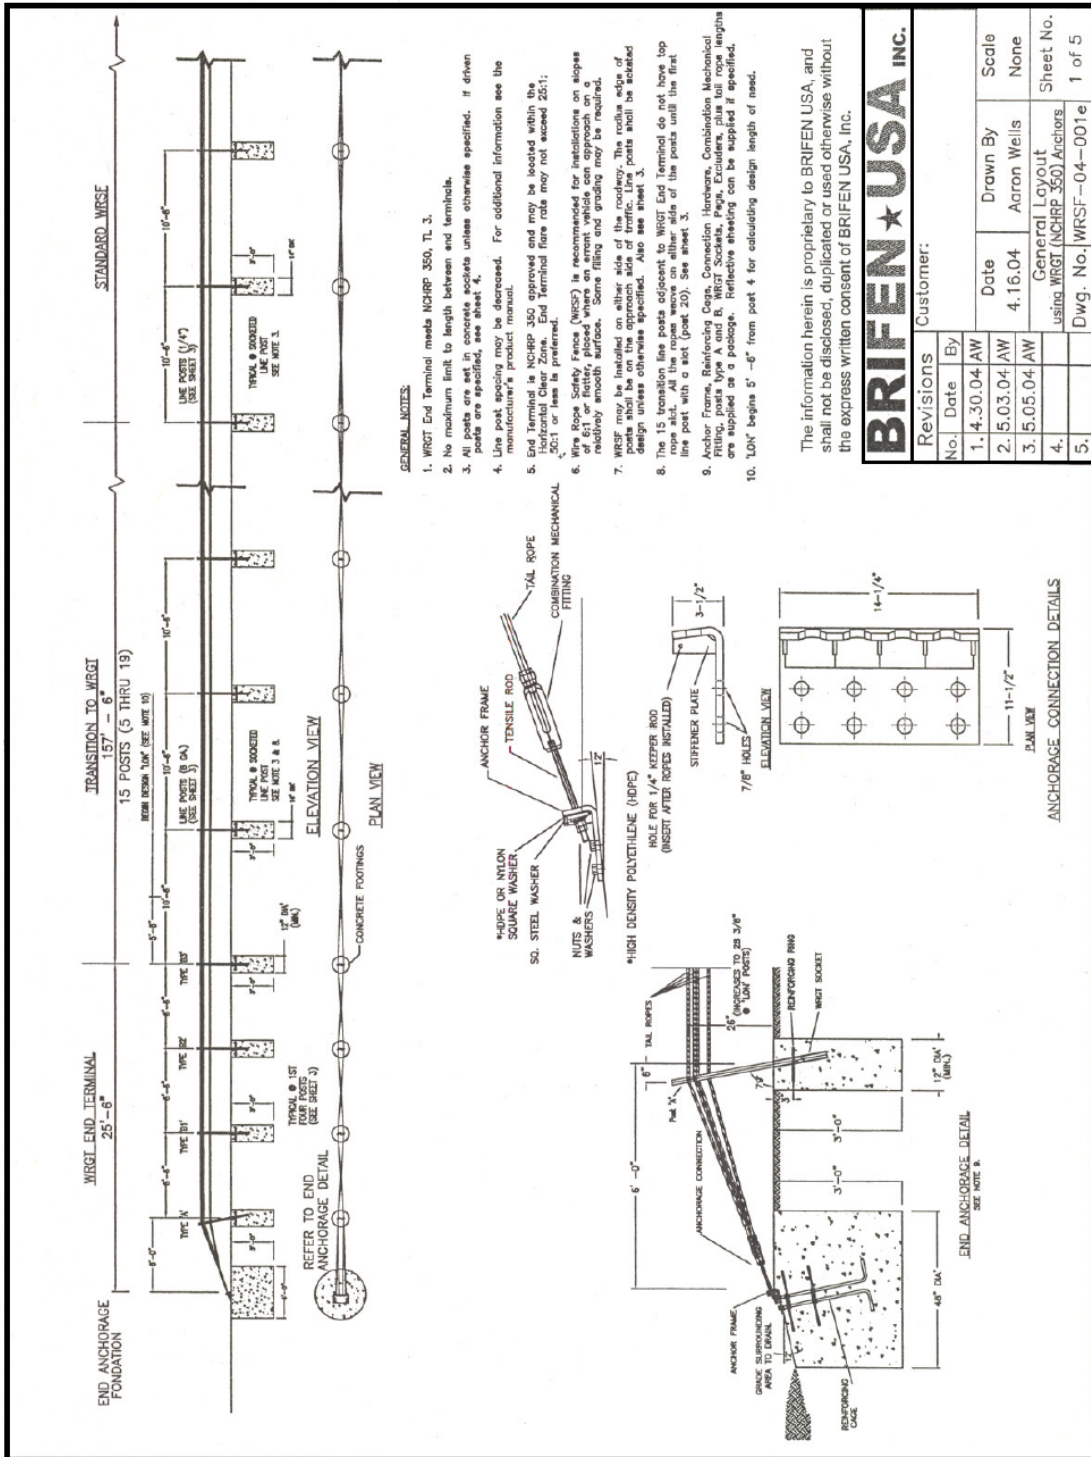
## Brifen Wire Rope Safety Fence Details.

Features of the Brifen System include slender posts and cables that can be powder coated to provide an unobstructed view from passenger cars. The posts are typically not driven; rather, they are set into concrete sockets. The wire ropes are anchored into concrete blocks at either end of their lengths, and then the wire ropes are tensioned between anchors. The cables are interwoven between the posts to prevent spreading. This highway restraint system can continuously span for miles. The system provides for simple and quick repair after a collision event. See appendix A for the Brifen Wire detail sheet.
