**ASSESSMENT OF TECHCRETE A CONCRETE REPAIR
MATERIAL AND JOINT SEALANT**

Report 2013 – 11

December 2013

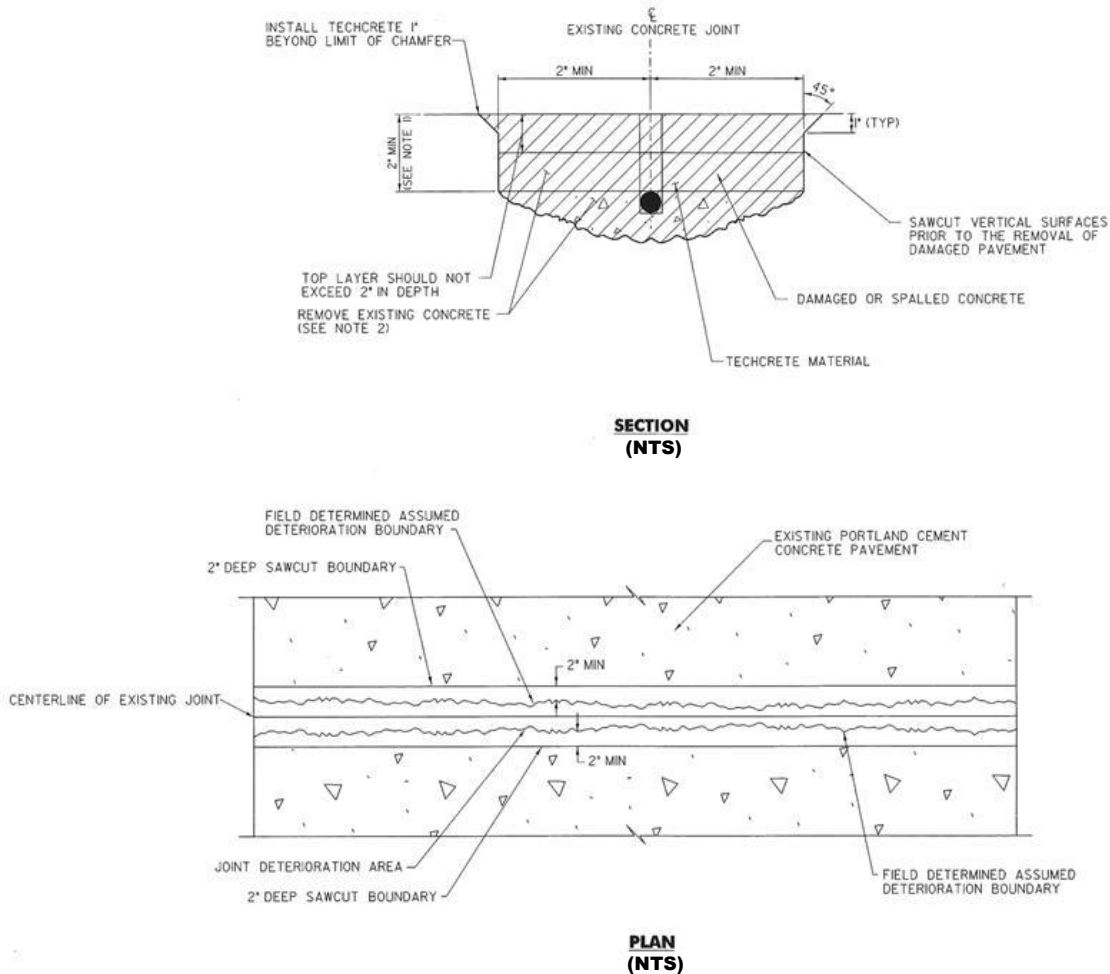
To determine which joints needed to be repaired for this project, professional judgment was employed by Project Engineers in their evaluation of the site prior to final design. An example of a selected joint in need of repair is shown in Figure 4. Per project specifications and contract, the installation of TechCrete was originally proposed to be limited to an 80-day project, with as many joints being repaired as possible in the timeframe, weather permitting. Additional days were to be added when needed to complete the necessary repairs. The time limit required a prioritization of cracks that would eventually be repaired. The 80 days was inclusive of both the Winooski and Burlington sections of concrete that needed to be repaired.

Figure 4 Typical concrete joint deterioration prior to repair

Prior to the 2008 pilot project with TechCrete, the concrete repair of 2002 had deteriorated significantly; with lengths of the concrete joint repair being fragmented. Figure 4 in this report gives an example of the state of that repair. Over the years since the repair, Winooski used asphalt patching material to seal the joints in places. In comparison, TechCrete has maintained a monolithic longitudinal integrity, and has maintained its position within the joint.
