VERMONT AGENCY OF TRANSPORTATION

Materials & Research Section
Research Report

CARGILL SAFELANE® HDX OVERLAY

Report 2014 – 04

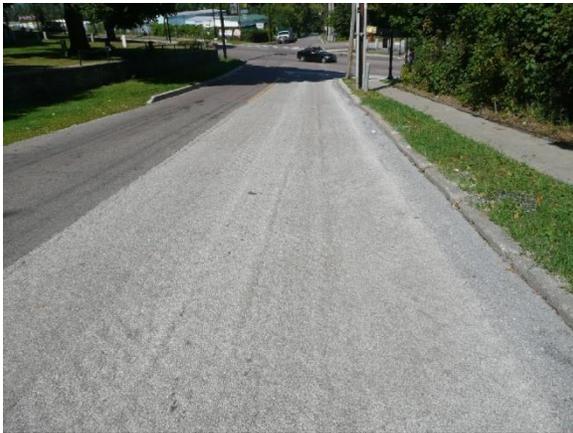
Figure 15 Overlay after application in 2008

apply the overlay. The first day involved milling the existing pavement to ensure the overlay would be flush with the surrounding pavement after completion. In the night after the milling process, a passing truck leaked oil onto the milled surface. As a result, the surface required shot blasting to ensure that the surface was clean in preparation of applying the overlay. Though the surface was properly prepared for the application of the material, the supplemental blasting left a ripple pattern on the surface of the overlay. Although the finish was not smooth and flat, the overlay was noted as being in good condition after placement. The site was visited periodically over the next 4 years. A considerable amount of cracking was noted in the last visit in March of 2012. No crashes or incidents have been reported between placement and the summer of 2012.

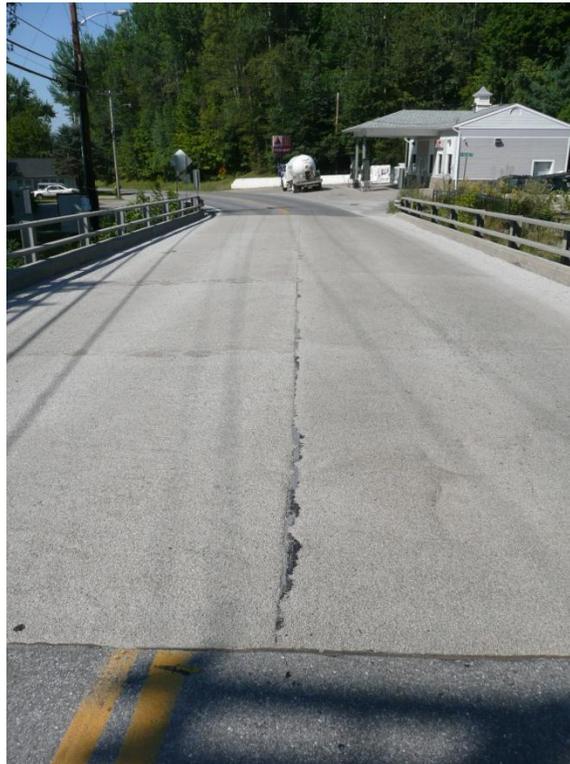
Figure 17 Application after installation in 2008

noted that the wheelpaths of the overlay were slippery. The surface was damp due to precipitation during morning hours. Upon furtherer examination, it was noted that within the wheelpaths, little aggregate remained on the surface of the experimental overlay. Instead, as shown in Figure 18, exposed epoxy was present in the majority of the surface of the overlay.

Cargill representatives were contacted and an onsite meeting to collect material and determine possible causes was conducted in September 2010. Attending were representatives from District 5, Cargill, and Materials and Research personnel. Ten cores of the overlay material were extracted to examine the current condition of the overlay and probable causes. Cargill personnel examined the cores at their central laboratory. They believed the loss of aggregate was due to studded tires. An earlier hypothesis was that the epoxy set up too quickly which did not allow enough time for the aggregate to bond properly to the epoxy. The analysis rebutted the earlier hypothesis. See Figure 19.
