1. Report No. FHWA/LA.14/526		2. Government Accession No.		3. Recipient's Catalog No.	
4. Title and Subtitle Data Collection and Evaluation of Continuity Detail for John James Audubon Bridge No. 61390613004101		5. Report Date October 2014

16. Abstract This report summarizes findings from monitoring data that was collected over a two-year period from Bridge No. 61390613004101 in the John James Audubon Project, which was formerly designated as Bridge #2 prior to construction completion. The bridge was instrumented as part of an earlier project (LTRC Project No. 08-1ST). Results from the first monitoring project warranted resuming data collection to monitor the performance of Bridge No. 61390613004101 over a longer period of time. The focus of the monitoring effort for both projects is on the employed continuity detail, which is based on the recommendation of the National Cooperative Highway Research Program (NCHRP) Final Report 519. Continuity details are typically used to eliminate the needs for high-maintenance joints that often lead to the acceleration of element deterioration near the joints. The employed positive moment continuity detail transfers forces between adjacent girder

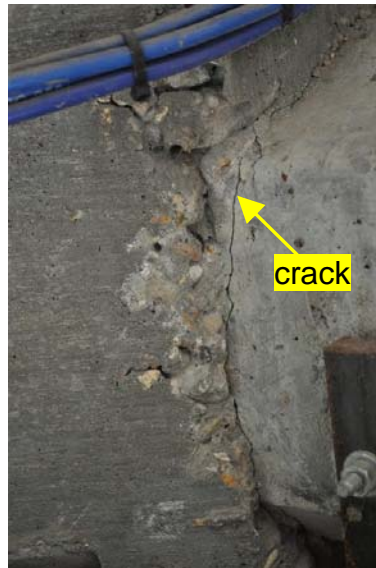
(b) October 22, 2010

Figure 14 shows the bottom flange of Girder G3 at six different times since bridge construction completion. Figure 14(a) and (b) show the crack as it was observed and documented in LTRC Final Report 477. It can be seen that the initial crack appeared about 6 months after establishing continuity, which coincides with the bridge getting exposed to hot weather conditions. The crack initially did not extend all the way to the soffit of the girder, but rather extended to only half the bottom flange height. In August 2012, it was clear that the crack grew and that the bottom flange was completely cracked. This crack helped explain the high strain readings in hairpin bars for Girder G3.

Figure 14
Observed crack at bottom flange of Girder G3 at Bent 24 – Span 24

This crack triggered the first attempt to seal the crack to avoid accelerated deterioration of the girder end. When the current project started in January 2012, the research team visited the bridge site on February 24, 2012. At that time, the crack was sealed using an epoxy-like material that entirely covered the crack, which could not be seen [Figure 14(c)]. Six months later, on August 6, 2012, the second visit to the bridge site took place. Figure 14(d) shows the conditions at that time, which revealed that the epoxy-like sealant has cracked along the same path of the original crack. This was not a surprise to the research team as the used sealant was brittle and could not withstand the large strains at this location due to the thermal gradient induced restraining moment that was discussed earlier. In other words, the brittle sealant failed after less than a year once the bridge was subjected to the first cycle of hot summer weather. On March 13, 2013, the research team visited the bridge site for the third time and the same crack could still be seen [see Figure 14(e)]. In between the third and fourth site visits (around June 2013), the second attempt to seal the crack was made. The sealant for this attempt was an elastomeric, crack-bridging coating (Sikagard[®] Elastic Base Coat + Sikagard[®] 550W Elastocolor), which can accommodate strains in excess of 300% [11, 12]. This product was chosen primarily because of its ability to elongate to these levels without rupture, which would definitely be needed as the thermal cycles opened and closed the crack. Figure 14(f) shows the same crack location on August 22, 2013, after applying the elastomeric coating. The crack could not be seen as it was completely covered by the new coating. Although only two months had passed since applying the new coating till the time of the last site visit, those two months (July and August) are when the most severe thermal cycles take place. Therefore, it can be said that the new coating had been exposed to the most demanding conditions that caused the crack to develop initially in May 2009, and the first epoxy like sealant to crack in August 2012. In both case, the crack developed after the bridge was exposed to the first hot thermal cycle. Therefore, the research team believes that the current conditions will last for an extended period of time. Therefore, it is recommended that

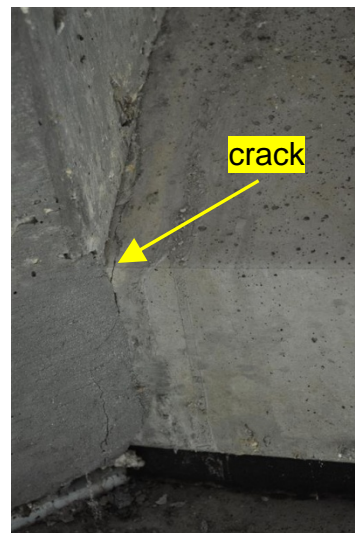
(b) Girder G4 – Span 24 - Bent 25

In addition to the old crack in Girder G3, the research team observed new cracks in Girder G4. The cracks can be seen in Figure 16. The crack features (location, width, and extents) were similar to those observed in Girder G3. This means that all girders are vulnerable to cracking like Girder G3 and G4. The crack in Girder G4 could not be correlated to any recorded strain readings as no sensors were installed at these locations.

New cracks observed in Girder G4
