Maine Department of  
Transportation  
**Transportation Research  
Division**

**Technical Report 02-3**  
*The Use of Micro-Surfacing for Pavement  
Preservation*

*Interim Report - Second, Third, Fourth Year, December, 2005*

## *The Use of Micro-Surfacing for Pavement Preservation*

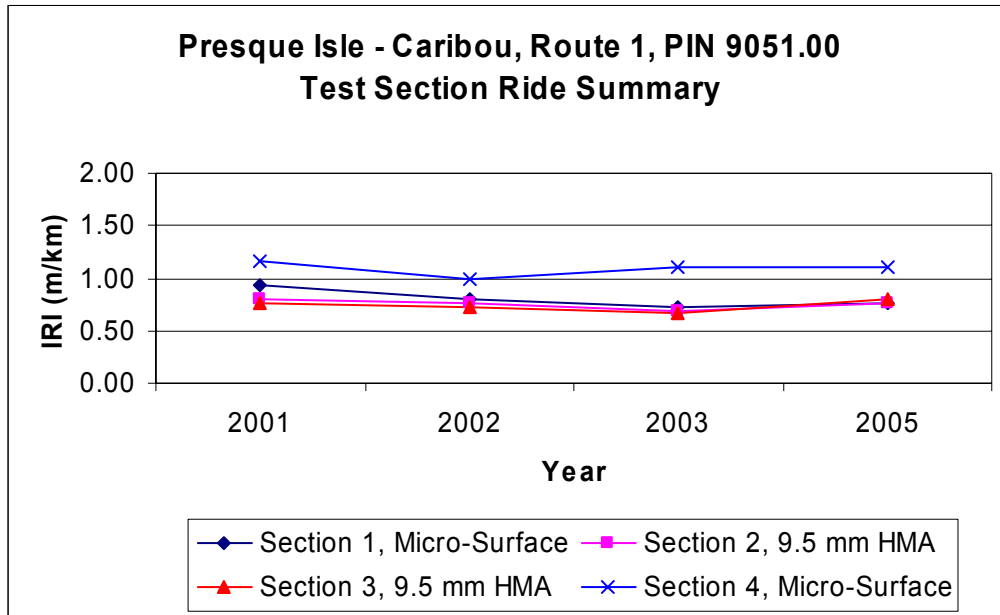
Figure 2: Presque Isle Test Section Level IRI Summary

Smoothness test results obtained from Sections 1, 2, 3, and 4 are displayed in Figure 2.

Micro-Surfaced portions of the project have a slightly rougher ride than HMA. IRI values for Micro-Surface treatments decreased 0.03 m/km (1.9 in/mi) in 2003 to an IRI of 1.01 m/km (64.0 in/mi) then increased 0.04 m/km (2.5 in/mi) to an IRI of 1.05 m/km (66.5 in/mi) in 2005.

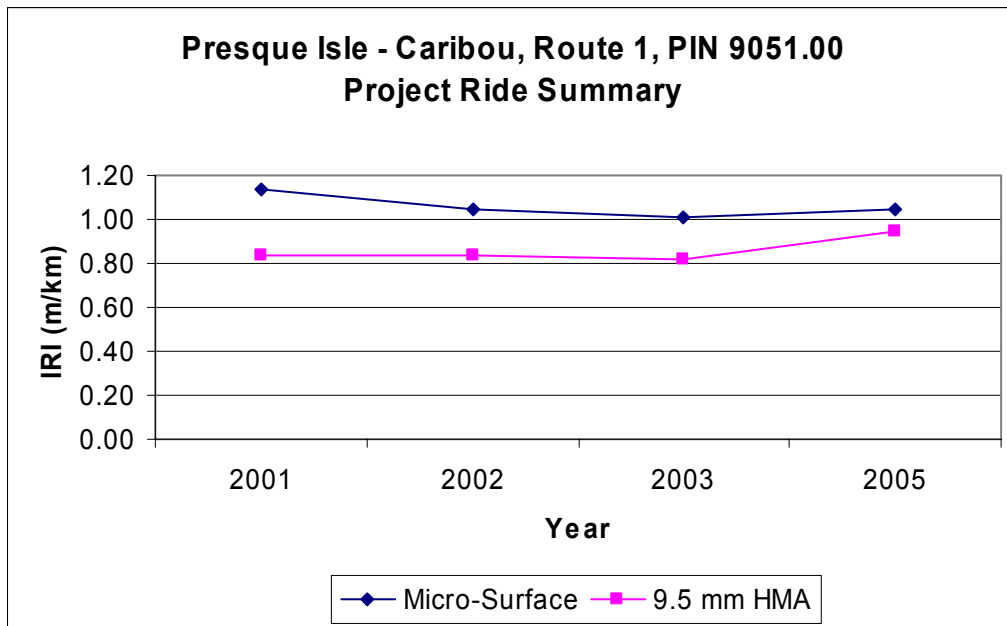
Figure 3: Presque Isle Project Level IRI Summary

For comparison the ARAN collected data on the entire length of the project. Figure 3 contains a summary of the test results.

HMA treatments decreased 0.02 m/km (1.3 in/mi) in 2003 with an IRI of 0.82 m/km (52.0 in/mi) then increased 0.13 m/km (8.2 in/mi) in 2005 to an IRI of 0.95 m/km (60.2 in/mi).

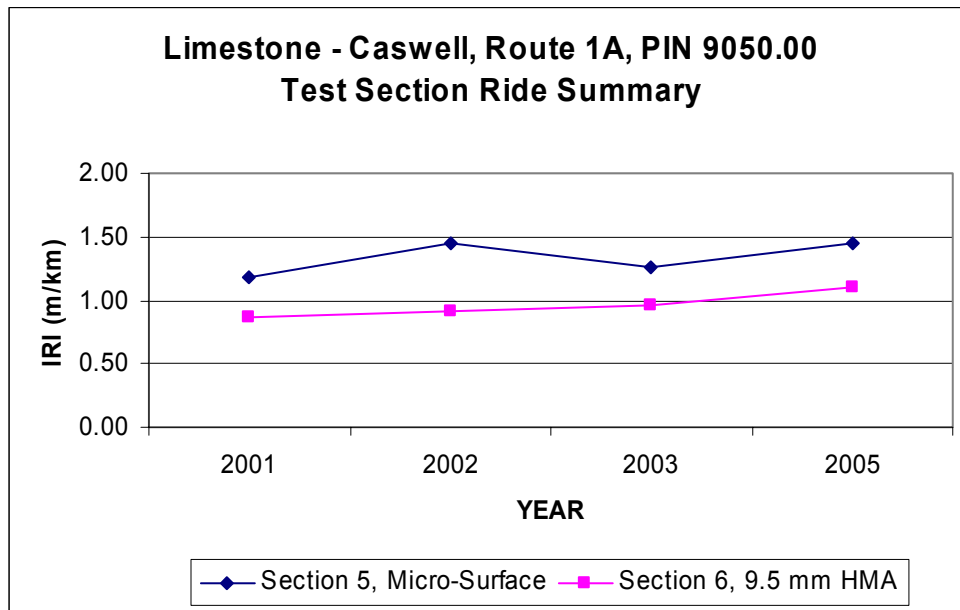
Figure 4: Limestone Test Section Level IRI Summary

Figure 4 contains smoothness test results for Section 5 and 6. Micro-Surfacing has higher IRI values than the HMA section.

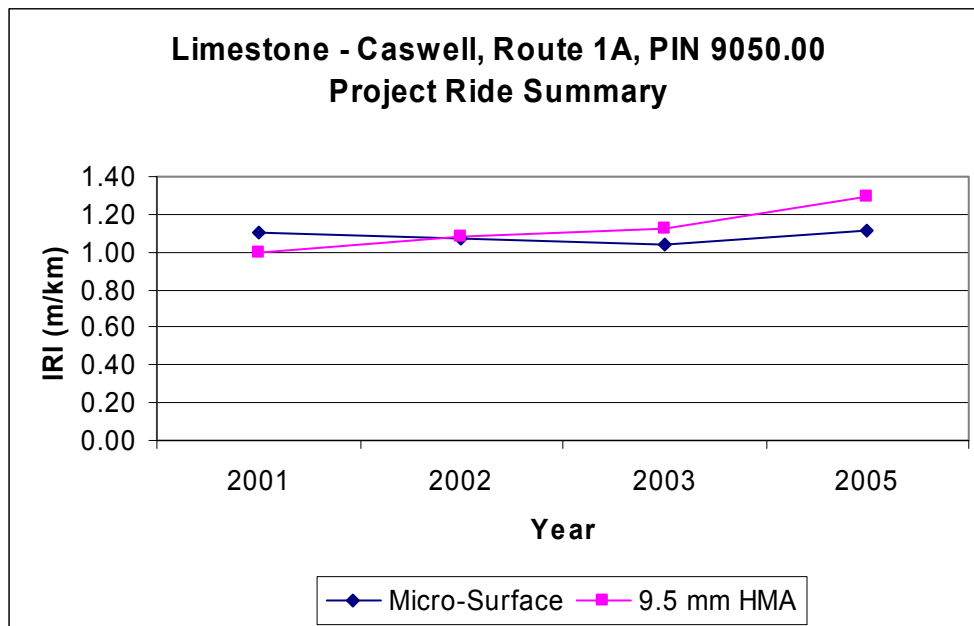
Figure 5: Limestone Project Level IRI Summary

The ARAN also collected data on the entire length of this project. Results are displayed in Figure 5.

IRI values have increased each year on the HMA portion of the project to a level that is rougher than the Micro-Surfaced portion. The ride increased 0.05 m/km (3.2 in/mi) in 2003 to an IRI of 1.13 m/km (71.6 in/mi) then increased an additional 0.17 m/km (10.8 in/mi) to an IRI of 1.30 m/km (82.4 in/mi) in 2005.

All IRI values remain in the smooth range of 1.02 – 1.57 m/km (65-99 in/mi).

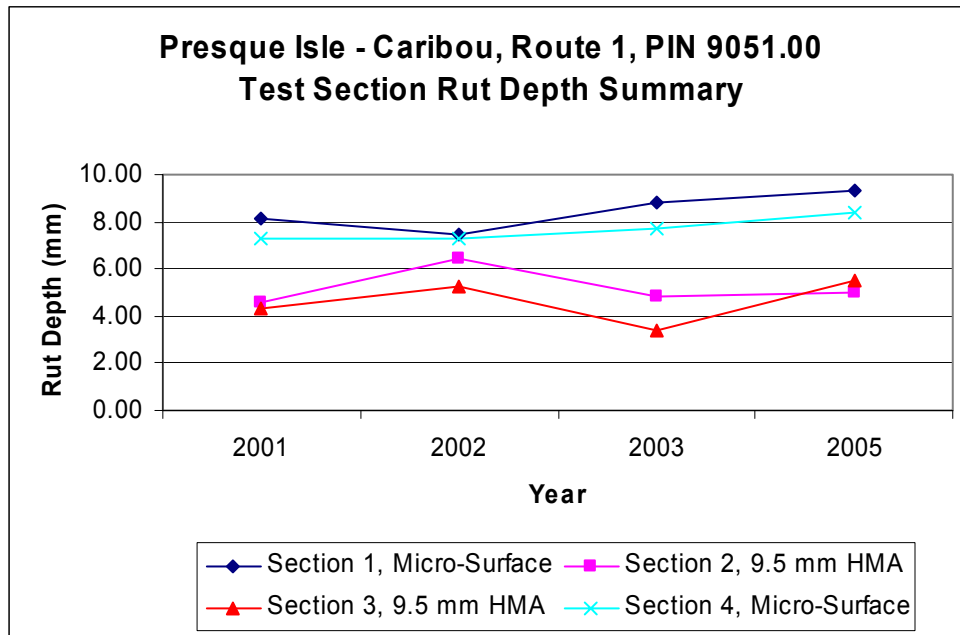
Figure 6: Presque Isle Test Section Level Rut Depth Summary

HMA rutting continues to be less severe than Micro-Surfaced areas. Figure 6 contains a summary of rut depth measurements for each test section.

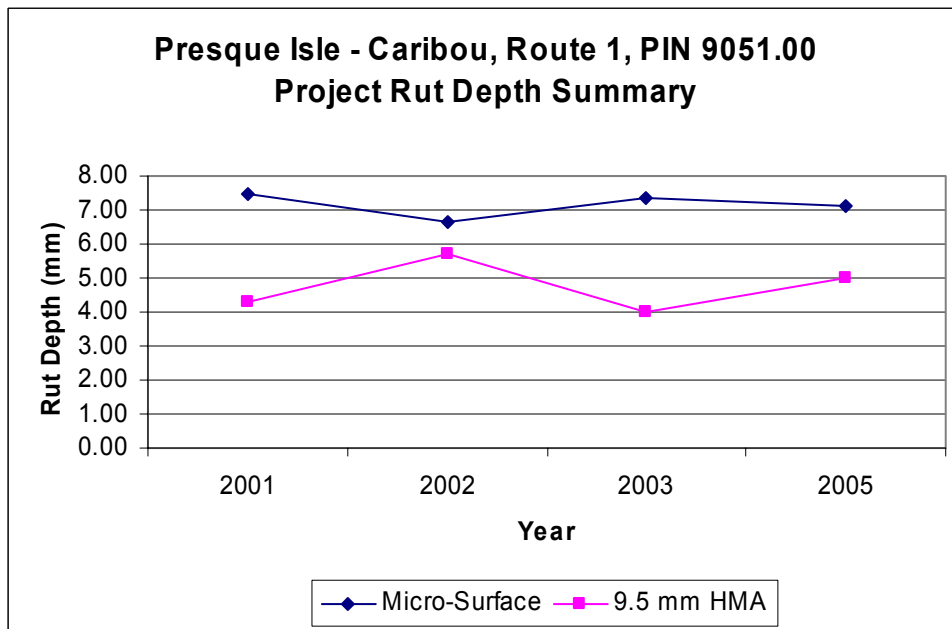
Figure 7: Presque Isle Project Level Rut Depth Summary

Figure 7 contains a summary of rut depth measurements collected on the length of the project. Micro-Surface portions increased 0.7 mm (0.03 in) in 2003 to a depth of 7.4 mm (0.29 in) then decreased 0.2 mm (0.01 in) to a depth of 7.1 mm (0.28 in) in 2005.

HMA portions decreased 1.7 mm (0.07 in) to a depth of 4.0 mm (0.16 in) in 2003 then increased 1.0 mm (0.04 in) to a depth of 5.0 mm (0.20 in) in 2005.

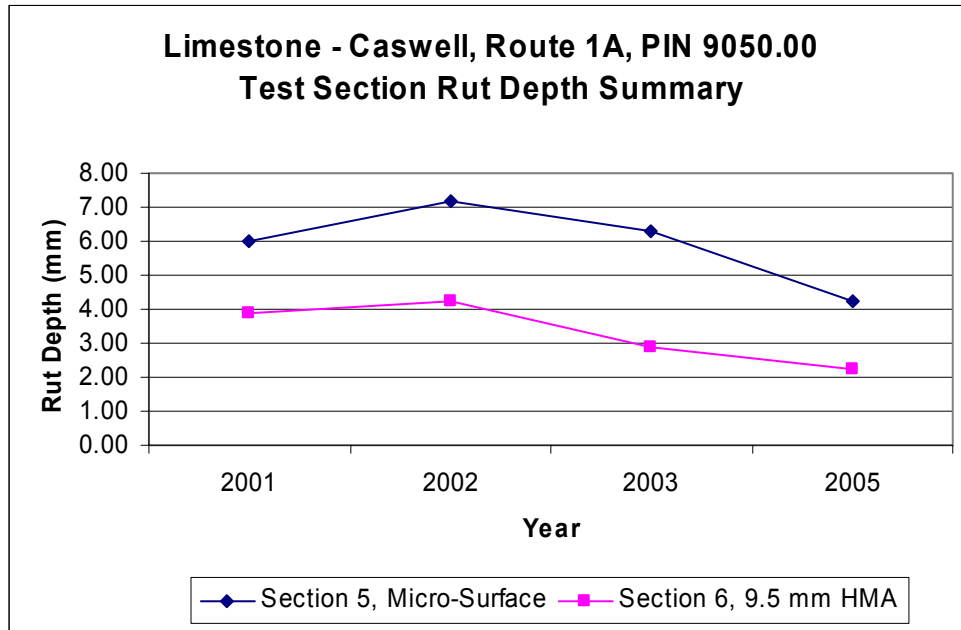
Figure 8: Limestone Test Section Level Rut Depth Summary

Rutting decreased on both sections in 2003 and 2005. Figure 8 contains a Rut Depth Summary of the test sections. Micro-Surface Section 5 decreased 12.2 % from 7.2 mm (0.28 in) to 6.3 mm (0.25 in) in 2003. Rutting decreased an additional 32.3 % in 2005 to a depth of 4.3 mm (0.17 in).

The decrease in rut depths could be attributed to the amount of plow wear on Micro-Surfaced sections, detailed in the Visual Inspection portion of the report, and heavy loads riding on centerline depressing centerline and between wheel path areas of Level 2 sections smoothing out the roadway profile.

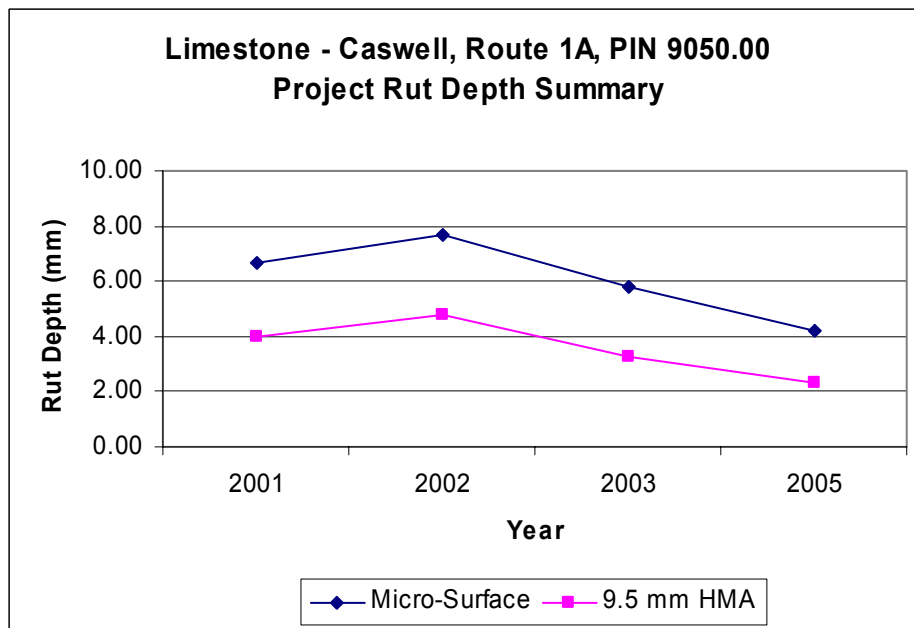
Figure 9: Limestone Project Level Rut Depth Summary

Average rut depths for the project also decreased in 2003 and 2005. Figure 9 displays a summary of the results. Micro-Surface treated portions of the project decreased 24.4 % from 7.7 mm (0.30 in) in 2002 to 5.8 mm (0.23 in) in 2003. Rutting decreased an additional 27.1 % to a depth of 4.2 mm (0.17 in) in 2005.

HMA portions of the project decreased 31.4 % from 4.8 mm (0.19 in) in 2002 to 3.4 mm (0.13 in) in 2003 then an additional decrease of 30.2 % to a depth of 2.3 mm (0.09 in) in 2005.

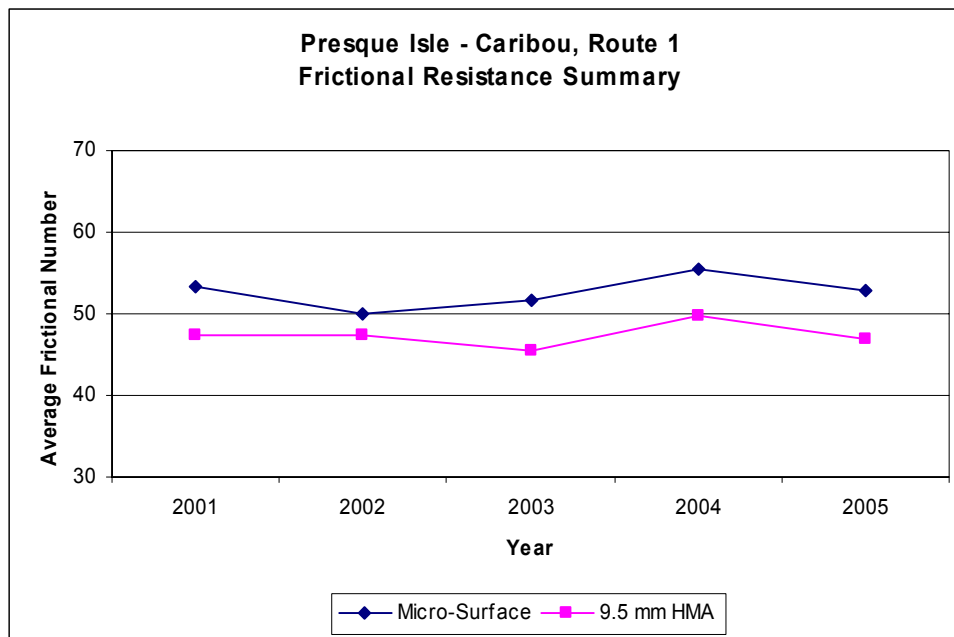
Figure 10: Presque Isle Frictional Resistance Summary

Figure 10 contains a summary of Frictional Numbers (FN) for the Presque Isle project. Frictional resistance increased from a FN of 49.9 in 2002 to 51.7 and 55.5 in 2003 and 2004. Frictional resistance decreased 4.86 % in 2005 to a FN of 52.8.

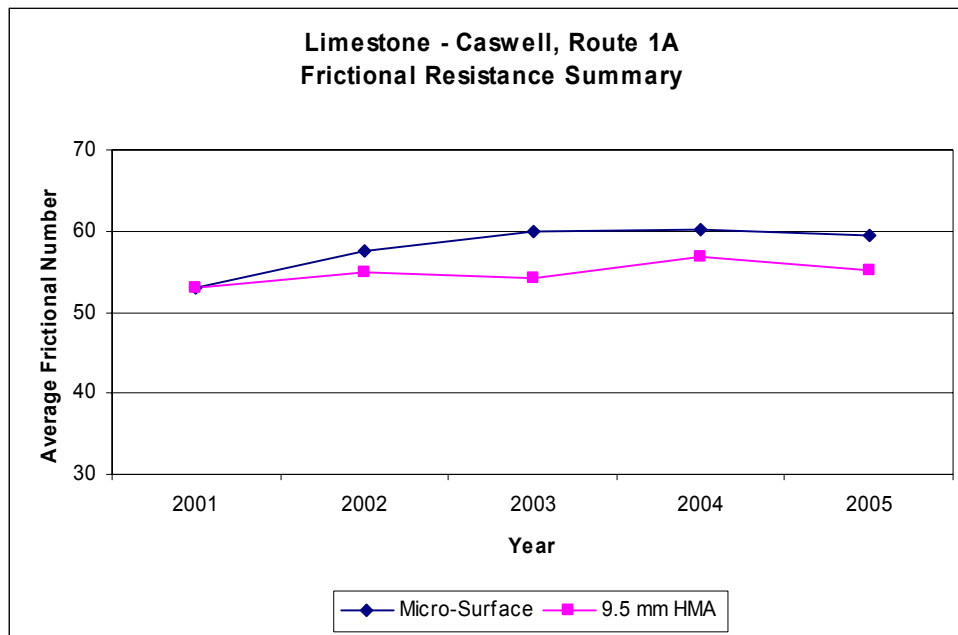
Figure 11: Limestone Frictional Resistance Summary

Figure 11 displays a summary of Frictional Numbers for the Limestone project. Micro-Surfaced portion increased in 2003 and 2004 to a FN of 59.9 and 60.3 respectively. Frictional resistance decreased 1.3 % to a FN of 59.4.

HMA Frictional Numbers decreased slightly from 54.8 to 54.3 in 2003 then increased 4.4 % to a FN of 56.8 in 2004. In 2005 there was another small decrease of 3.0 % to a FN of 55.1.
