VERMONT AGENCY OF TRANSPORTATION

**COLD IN-PLACE RECYCLED BITUMINOUS PAVEMENT
DORSET-DANBY, VT**

Report 2015 – 04

January 2015

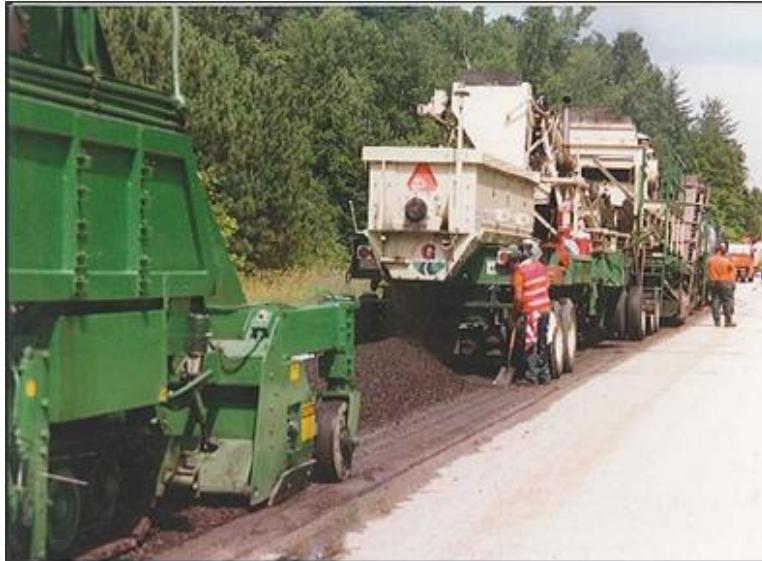
Cold-in-place recycling, shown in Figure 2, was performed during October 2006 and completed on October 10, to depths of 3 inches and 4 inches in four locations of the project. Asphalt emulsion at a rate from 1.0-1.5 gallons per square yard was added to the mix for all CIR locations. Due to seasonal constraints and sequencing of contracts, one lift of bituminous pavement was applied to all CIR locations in an effort to protect the treatment over winter months. A binder course was applied to two segments while the remaining two segments received only a wearing course. The binder course, consisting of a 1¾-inch Type II 75 blow Marshall Mix, was applied between October 23 and October 31. As stated on the approved design, the Type II mix contained 5% of performance graded (PG) 58-34 asphalt cement along with 0.5% Wetfix 312. According to historical weather data provided by Weatherunderground.com, the average ambient air temperature for this period was 47°F with an average minimum temperature of 38.5°F. A wearing course comprised of a 1½-inch Type III 75 blow Marshall Mix was placed on the remaining two CIR sections between November 6 and November 26. Similarly, this mix contained 4.8% of a PG 58-34 asphalt cement and 0.5% Wetfix 312. The average ambient air temperature for this period was 42°F with an average minimum temperature of 38°F, which is slightly elevated due to a 60°F day on November 8, 1996. The ambient air temperatures are somewhat of a concern during paving activities as they were below the specifications for placement. In accordance with the 1990 Vermont Agency of Transportation Standard Specifications for Construction, bituminous “*courses shall not be placed when the air temperature at the paving site in the shade and away from artificial heat is*

Figure 2 CIR process

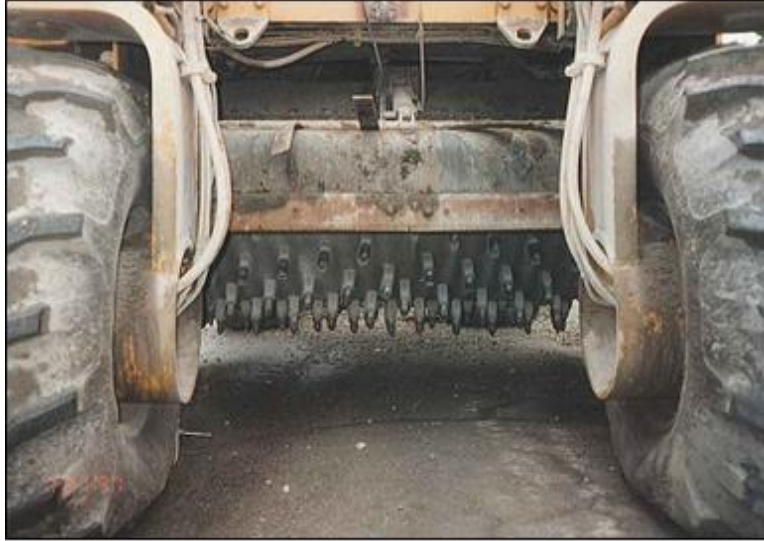
Figure 3 Reclaiming machine

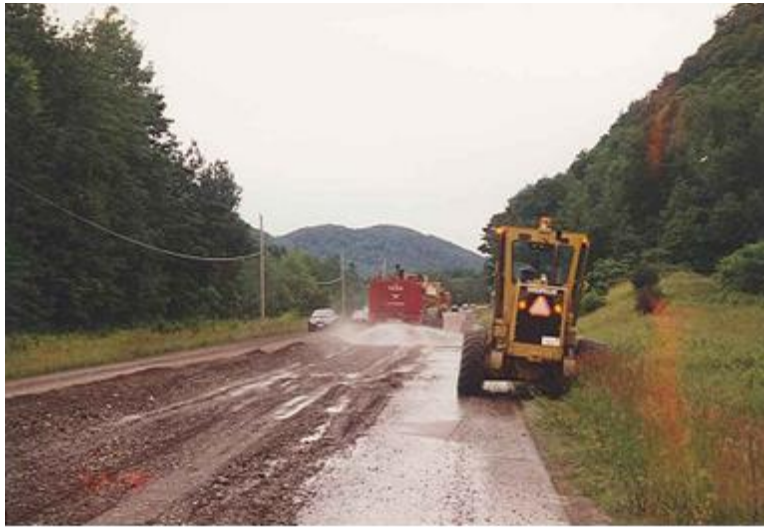
Figure 4 Water application during RSB construction

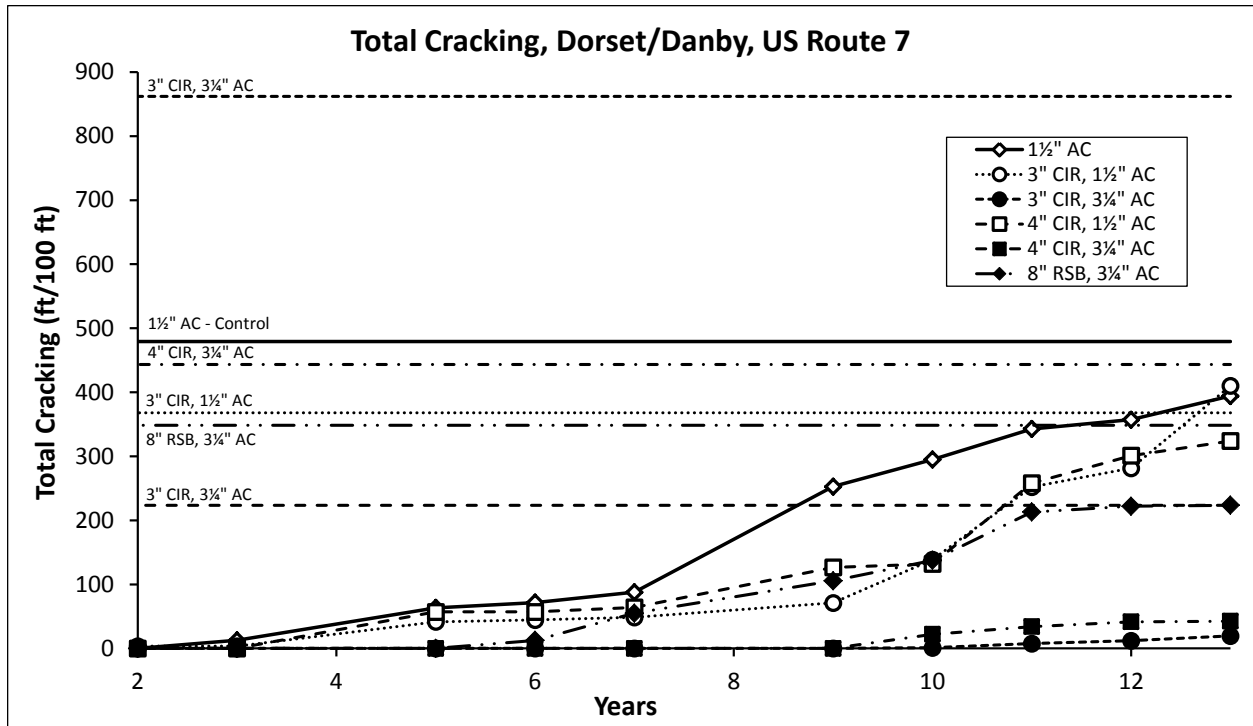
Cumulative total cracking in terms of average linear feet per treatment as a function of time is provided in Table 6 with the corresponding graphical representation in Figure 5. It is important to note that following 9 years of service, test site 11 (4-inch CIR with 1½-inch AC) was discontinued due to alligator cracking, which is indicative of deterioration and test site 13 was removed after year 12 due to the application of a shim course. All years following this were averaged amongst the remaining test sites for this treatment. For comparative purposes, the average preconstruction fatigue cracking in linear feet per treatment is also shown within the table. Through 13 years of service, only the 3-inch CIR with 1½-inch overlay has exceeded its preconstruction levels, meeting the project’s definition of failure with respect to total cracking. Both treatments utilizing the thicker ¾-inch overlay has shown only low amounts of cracking over their service life.

Figure 5 Total cracking in linear feet. Preconstruction values are shown as horizontal lines in corresponding line patterns.

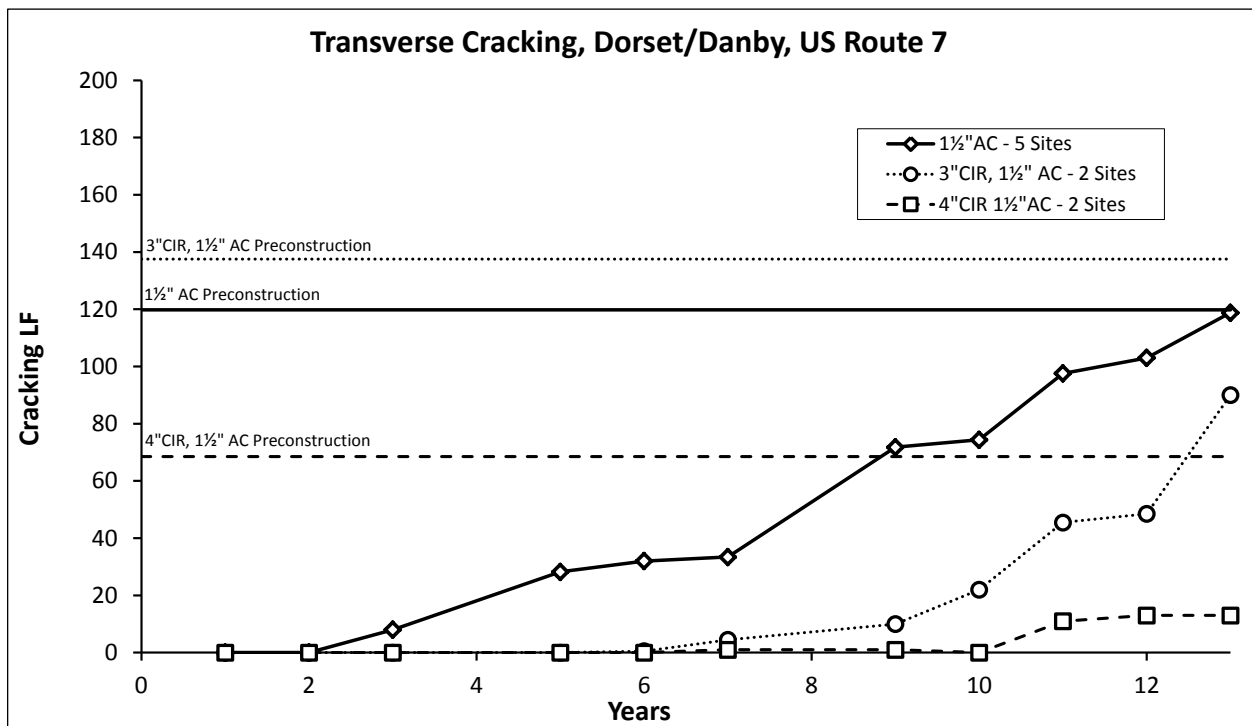
Cumulative transverse cracking in terms of average linear feet per treatment as a function of time is provided in Figure 9. Only treatments with greater than 5 feet of transverse cracking per 100-foot test section 13 years following construction have been included. These include standard overlay, 3-inch CIR with 1½-inch overlay, and 4-inch CIR with 1½-inch overlay. It is important to note that following nine years of service, test site 11 (4-inch CIR with 1½-inch AC) was discontinued due to alligator cracking, which is indicative of deterioration, and test site 13 was removed after year 12 due to the application of a shim course. All years following this were averaged among the remaining test sites for this treatment. For comparative purposes, the average preconstruction transverse cracking in linear feet per treatment is also shown.

Figure 9 Thermal cracking in linear feet. Preconstruction values are shown as dashed lines in corresponding colors.

Once again, the control sections displayed the greatest amount of transverse cracking on average (118 linear feet per 100-foot test section) as compared to all other sections. Comparatively, the other two treatments were found to have 90 and 13 linear feet of cracking for the 3 and 4-inch CIR depths, respectively, 13 years following construction. In examining Figure 9, none of the treatments have met or exceeded the amount of documented transverse cracking prior to construction. As of the summer of 2010, 99% of preconstruction transverse cracking on average had returned to the control treatment (1½-inch pavement overlay). These segments are anticipated to exceed these levels 14 years following construction. In the same timeframe, 65% of preconstruction transverse cracking has returned to the 3-inch CIR treatment with 1½-inch overlay. These segments are expected to provide a 16-year study life. Similarly, 19% of preconstruction transverse cracking had returned to the 4-inch CIR treatment and these segments are anticipated to exceed preconstruction levels around 19 years of service.

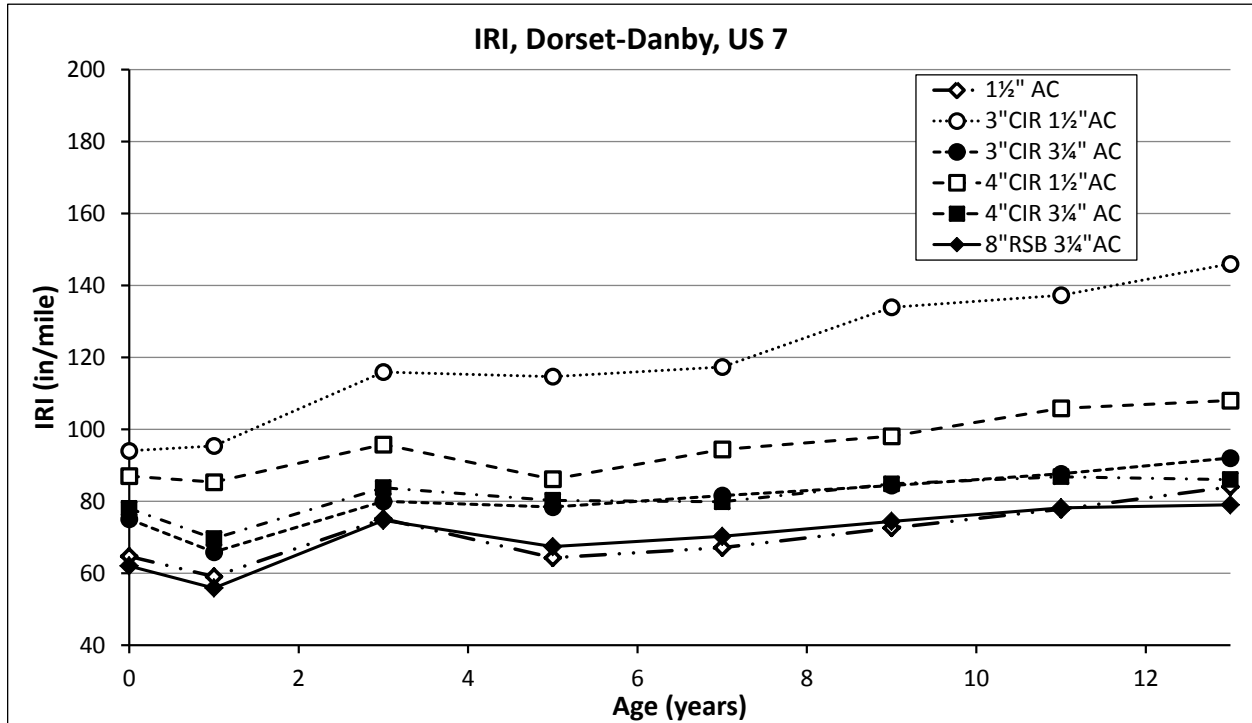
Figure 10 displays a graphical time series plot of comparative treatment performance, over time, with respect to average IRI values in terms of inches per mile.

Immediately following construction, all of the treatments were considered to be in good condition with respect to the Pavement Condition Scale. While many of the treatments remain in good condition following 13 years of service, both the 3 and 4-inch CIR with 1½-inch overlay treatments are in fair condition. Overall, IRI values for each of the six treatment types display a

mostly consistent increasing trend over time. At 13 years, the 3-inch CIR with 1½-inch overlay displays the highest IRI values as well as the largest increase in IRI over time. Surprisingly, the standard overlay appears to be outperforming the majority of the other pavement treatments. This is likely due to the condition of these roadway segments prior to construction as the associated IRI values were significantly lower than the IRI values addressed with cold recycled or reclaimed stabilized base treatments.

Figure 10 IRI plot for US 7 Dorset/Danby.

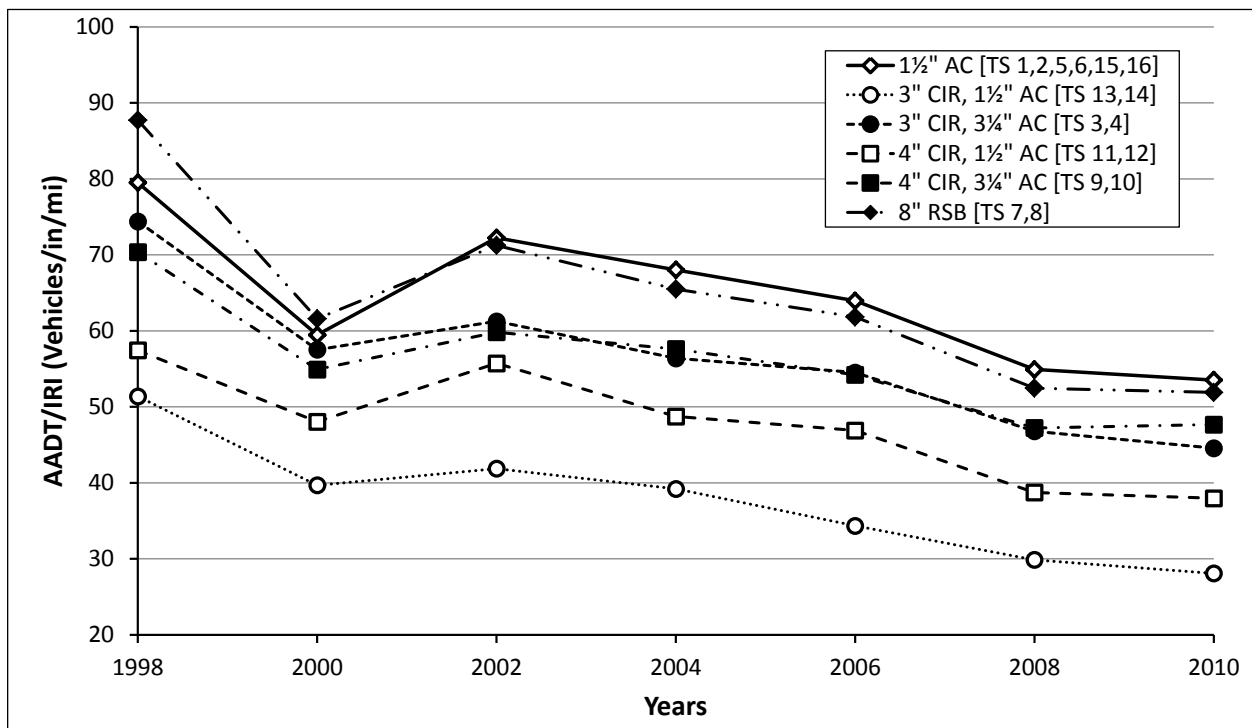
Another relationship was developed to estimate the benefit of the different treatment types with respect to the traffic characteristics (AADT) and roughness (IRI) of the roadway over time, which will be referred to as public benefit. It is a gauge of the perceived ride quality by the public in relation to the amount of daily traffic along this roadway segment. A larger value of the AADT/IRI quantity indicates a higher public benefit. Figure 11 displays the public benefit versus time for the six various treatments, using the IRI values in Table 10 and the AADT values from Table 3.

Interestingly the most and least comprehensive of the six pavement treatments, the RSB and the overlay only treatment, respectively, provide greater public benefit with respect to ride quality. The fact that the 1½-inch overlay was the optimum treatment in this analysis contradicts the previous rating system where the overlay was easily deemed the lowest quality of roadway based on cracking, rutting and IRI. This can be explained by the fact that the previous rating

system is based upon comparing current conditions to preconstruction conditions, while the public benefit displays only actual current conditions (per year). Being the least comprehensive (and cheapest) treatment, the overlay only treatment was placed on the sections of roadway that were in the best preconstruction condition, therefore this shows that this treatment type had degraded significantly over its service life as compared to its condition prior to construction (again cracking, rutting, and IRI), while still maintaining a smooth overall ride. The more comprehensive treatments, on the other hand, performed very well in both analysis methods, showing that although the driving public cannot perceive a large difference between the treatments, there is considerable long term structural and monetary benefits to a more extensively rehabilitated roadway.

Figure 11 Plot of public benefit (AADT/IRI) versus service years for all treatments.
