Evaluating Roadway Subsurface Drainage Practices – Phase II

Final Report
April 2015

IOWA STATE UNIVERSITY
Institute for Transportation

Sponsored by
Iowa Highway Research Board
(IHRB Project TR-662)
Iowa Department of Transportation
(InTrans Project 13-473)

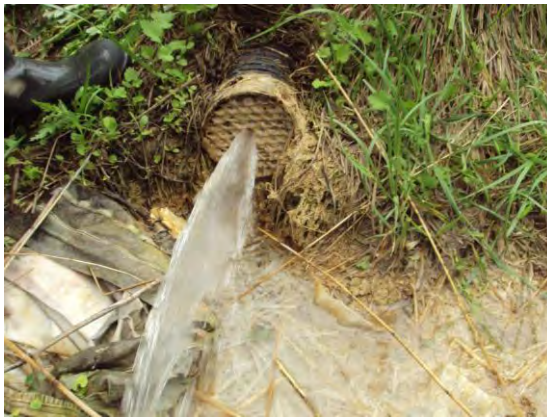
- Number of outlet pipe: 2
- Type of outlet pipe: Corrugated plastic
- Size of outlet pipe: 4 inch
- Condition of outlet pipe: 100% blockage (tufa blockage)
- Water present inside outlet pipe: Yes (standing)
- Type of rodent guard: Gate
- Tufa/Dead zone (due to tufa) present: Yes
- Embankment slop condition: Less than 30 degree

Water backup in pipe

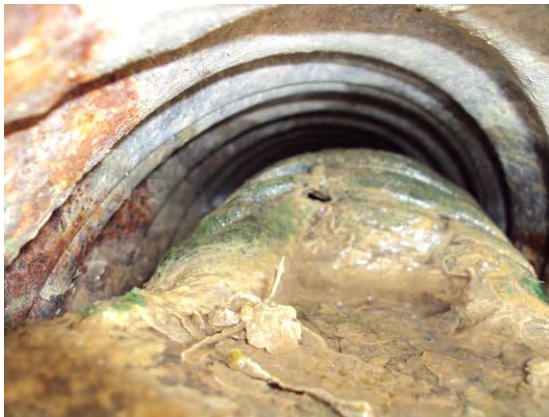
- Number of outlet pipe: 2
- Type of outlet pipe: Corrugated steel
- Size of outlet pipe: 6 inch
- Condition of outlet pipe: 80% blockage (tufa blockage and damaged)
- Water present inside outlet pipe: Yes (free flowing)
- Type of rodent guard: N/A
- Tufa/Dead zone (due to tufa) present: Yes
- Embankment slop condition: More than 30 degree

Tufa blockage extends back into the pipe

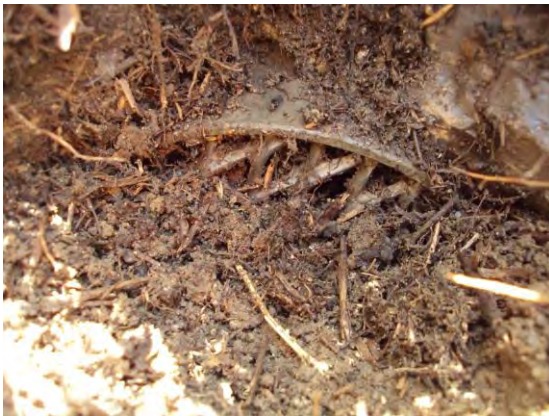
- Number of outlet pipe: 1
- Type of outlet pipe: Corrugated plastic
- Size of outlet pipe: 4 inch
- Condition of outlet pipe: 100% blockage (soil blockage)
- Water present inside outlet pipe: No
- Type of rodent guard: Gate screen
- Tufa/Dead zone (due to tufa) present: No
- Embankment slop condition: More than 30 degree

Had to dig to find drain

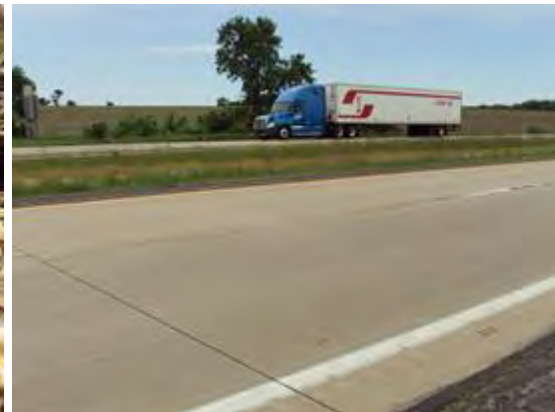
Longitudinal cracking along centerline

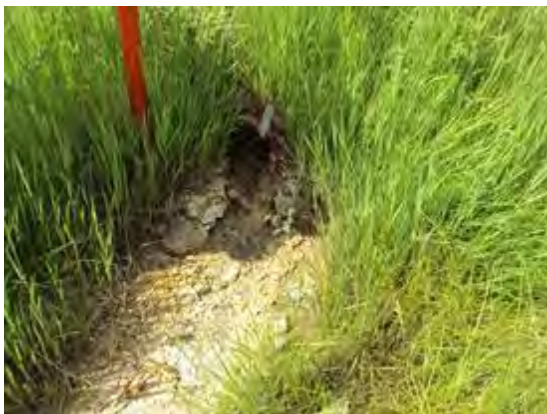
- Example of outlet damaged during tufa removal

Pipe damaged during tufa removal

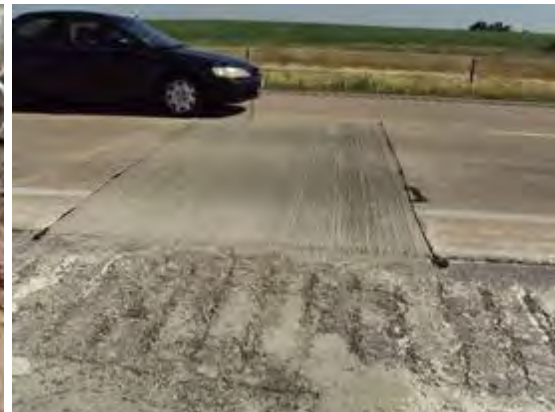
- Cracking and patching 50-ft. away

Pavement patching 50-ft. away

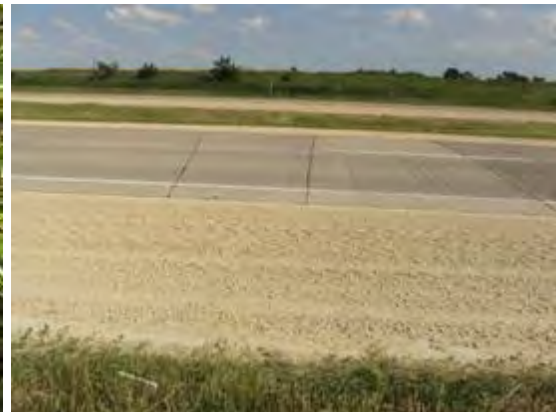
Pavement patching due to culvert

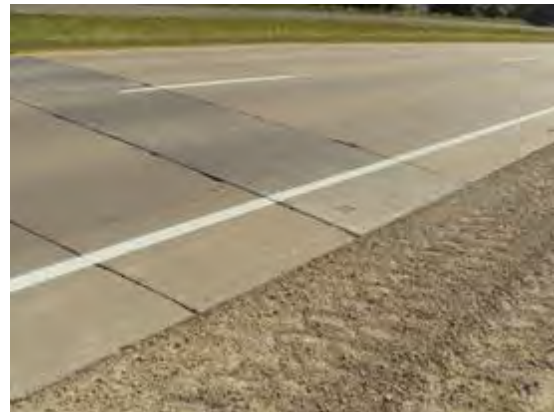
Pavement patching due to culvert

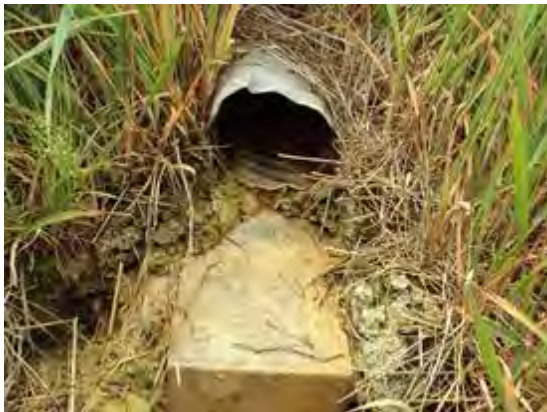
- Good drainage installation practice

Good drainage pad installation

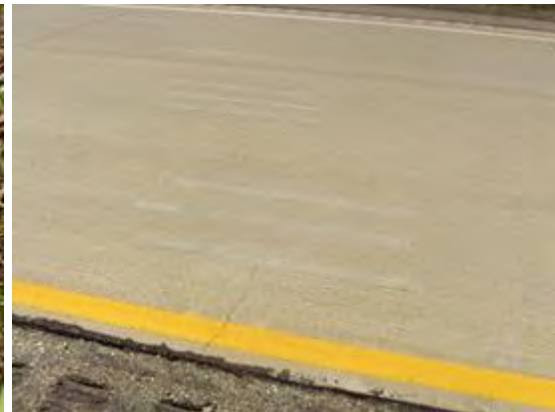
- Dowel bar installation

Dowel bar retrofit

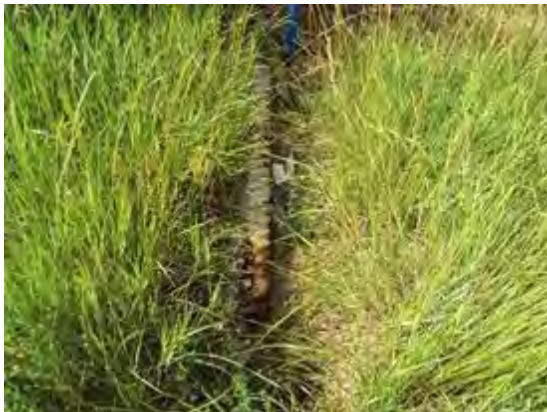
- Broken open 7-ft. up from opening; water is flowing from there

Tufa blockage and damage

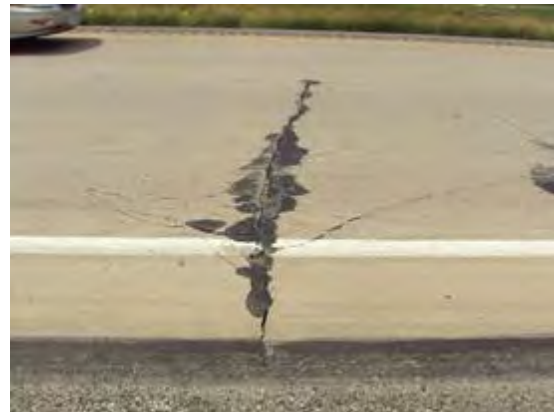
- Longitudinal/Transverse cracking

Longitudinal and transverse cracking

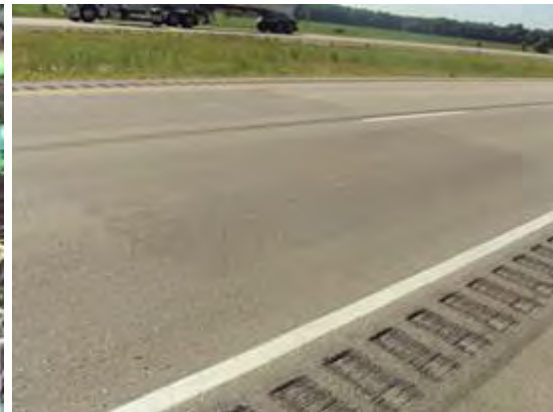
Pavement surface grinding

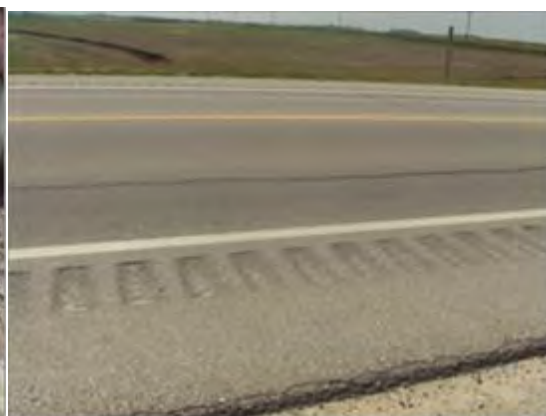
Longitudinal cracking patching

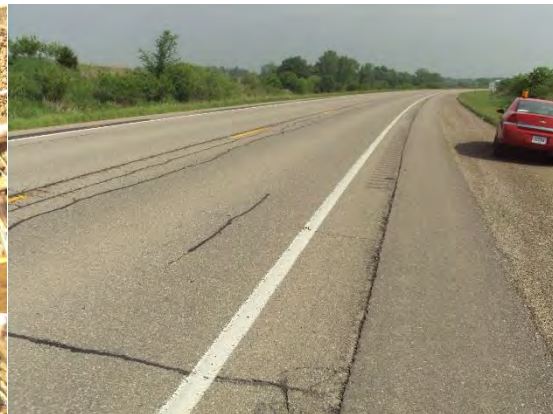
- Suggested by District 5 for investigation
- Cracked and sealed in 1990
- No load transfer in existing JPCP

Longitudinal and transverse cracking patching

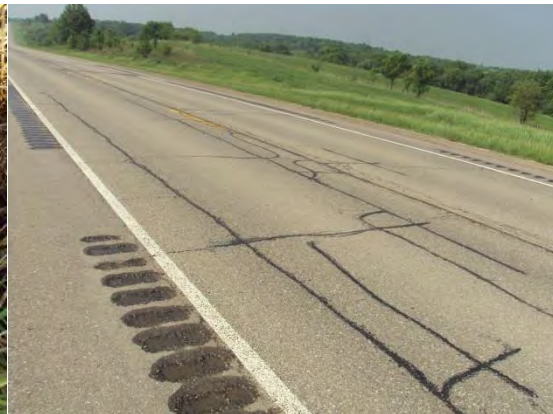
- Suggested by District 5 for investigation
- Cracked and sealed in 1990
- No load transfer in existing JPCP

Longitudinal and transverse cracking patching

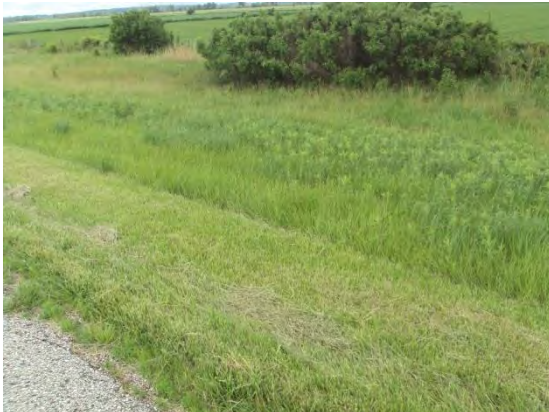
- Flooded by Missouri River in 2011
- Quartz aggregates
- This section has no drainage outlet

No drainage outlet

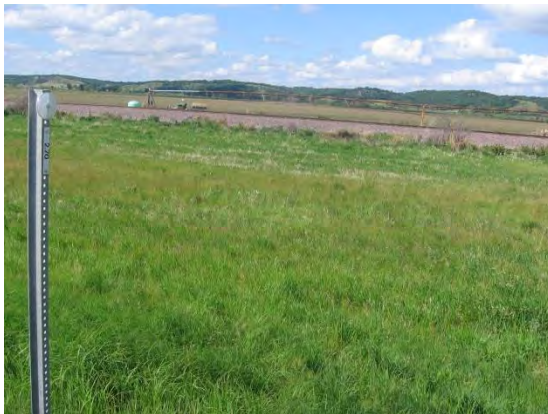
- Flooded by Missouri River in 2011
- This section has no drainage outlet.
- Cracking is related to drainage

No drainage outlet

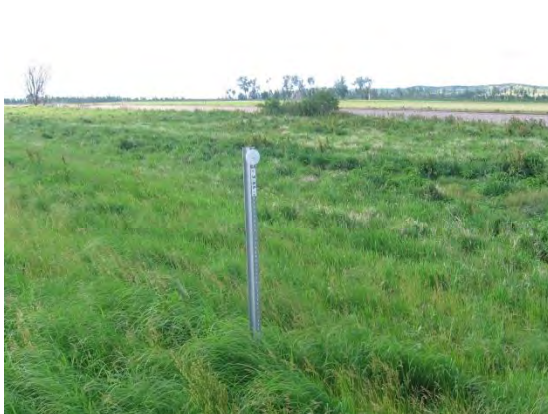
No drainage outlet

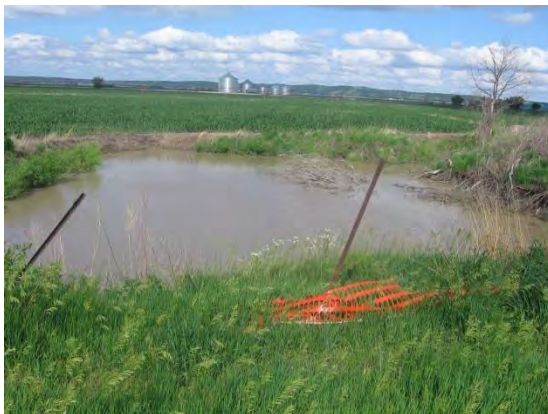
No drainage outlet

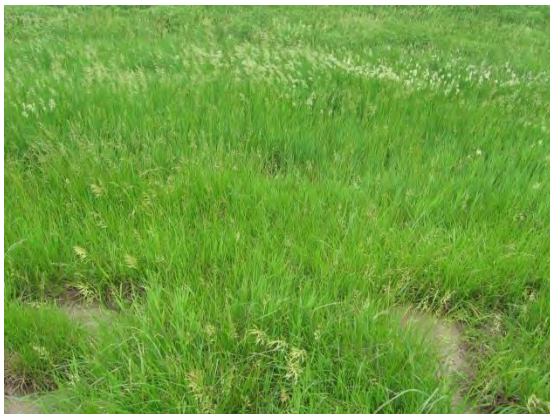
No drainage outlet

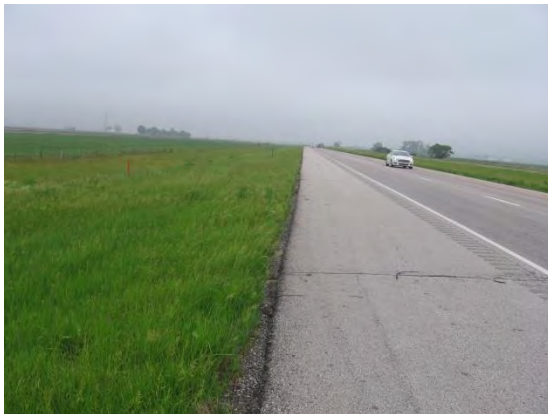
No drainage outlet

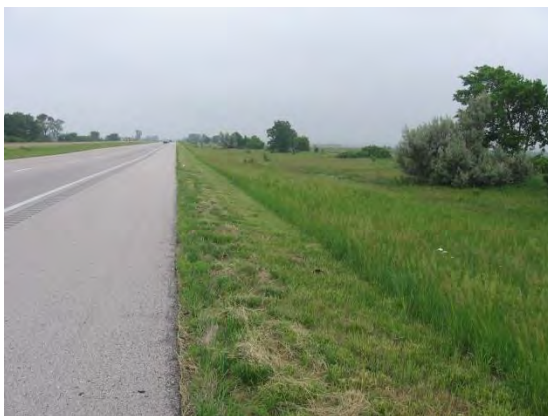
No drainage outlet

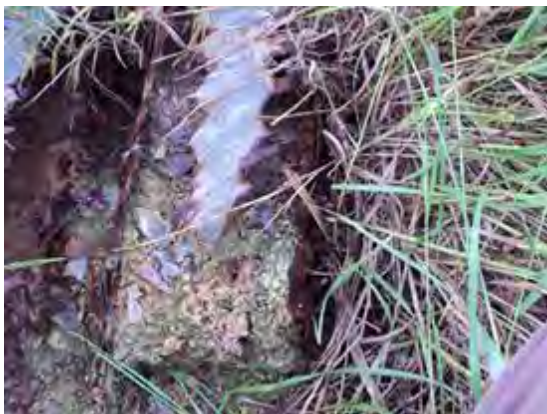
- Number of outlet pipe: 2
- Type of outlet pipe: Corrugated steel
- Size of outlet pipe: 6 inch
- Condition of outlet pipe: 80% blockage (tufa blockage and damaged)
- Water present inside outlet pipe: Yes (standing)
- Type of rodent guard: N/A
- Tufa/Dead zone (due to tufa) present: Yes
- Embankment slop condition: Less than 30 degree
- Slope condition at outlet: Parallel/Less than 1-ft. downhill

Tufa blockage/damaged outlet pipe

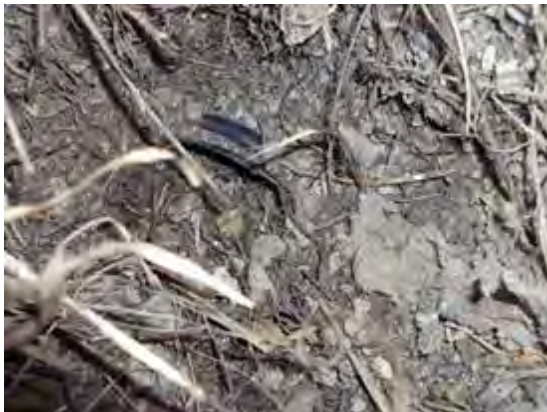
- Number of outlet pipe: 1
- Type of outlet pipe: Corrugated plastic
- Size of outlet pipe: 4 inch
- Condition of outlet pipe: 100% blockage (soil blockage and damaged)
- Water present inside outlet pipe: No
- Type of rodent guard: N/A
- Tufa/Dead zone (due to tufa) present: No
- Embankment slop condition: Less than 30 degree
- Slope condition at outlet: Uphill

Soil blockage/damaged outlet pipe
