4. Field Testing and Demonstrations

The objective of the field demonstrations of this research was to evaluate the performance of four non-destructive assessment techniques: BVRCS, 3DOBS, passive infrared thermography, and active infrared thermography. These remote sensing methods were used to assess the condition of selected bridge decks, a major element in a bridge that provides protection from the environment to the superstructure and substructure, indicates overall bridge health, and determines when preservation activities should be performed.

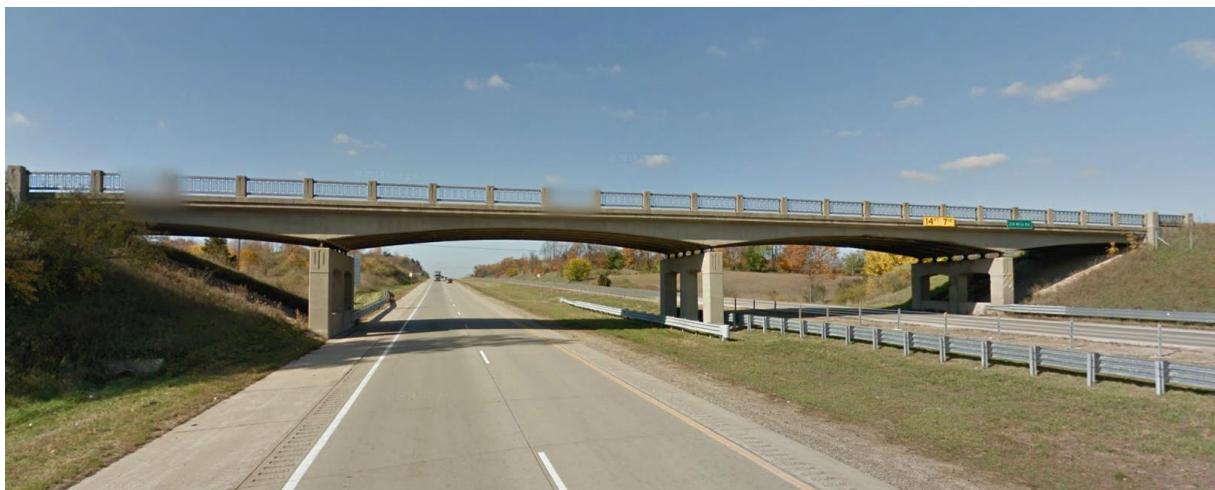
Figure 4-4: 24 Mile Road Bridge Selected as a Fall 2013 Deployment Site.

The concrete deck surface was assigned a poor condition NBI rating of 4 during the last inspection on August 14th 2013. With the assessment of the 3DOBS high-resolution system and passive infrared thermography being the main purpose of this deployment, the bridge deck was the main bridge component of interest. Only the surface of the bridge deck was evaluated for deficiencies, however, it should be noted that numerous spalls have left reinforcing steel exposed on many of the bridge beams reducing the superstructure to a rating of 5. Patching of these areas was recommended prevent further deterioration and extend the service life of the bridge.

The inspection report indicated various transvers and longitudinal cracks across the deck surface, some of which had been sealed with rubber. Various concrete patches were also present over the structure surface. A main area of interest was noted to be the unsealed longitudinal joint where cracking and scaling have contributed to wetness, exposed reinforcement steel from spalling, corrosion, and delaminations on the underside of the deck. To locate and quantify delaminations, the surface of the bridge deck was sounded on October 15th, 2013 revealing that 14% of the deck area contained these defected areas. Upon completion of the two inspections, recommendations

were made to seal construction joins and perform a shallow overlay to preserve the integrity of the bridge. An aerial image of the bridge deck can be seen in Figure 4-5.

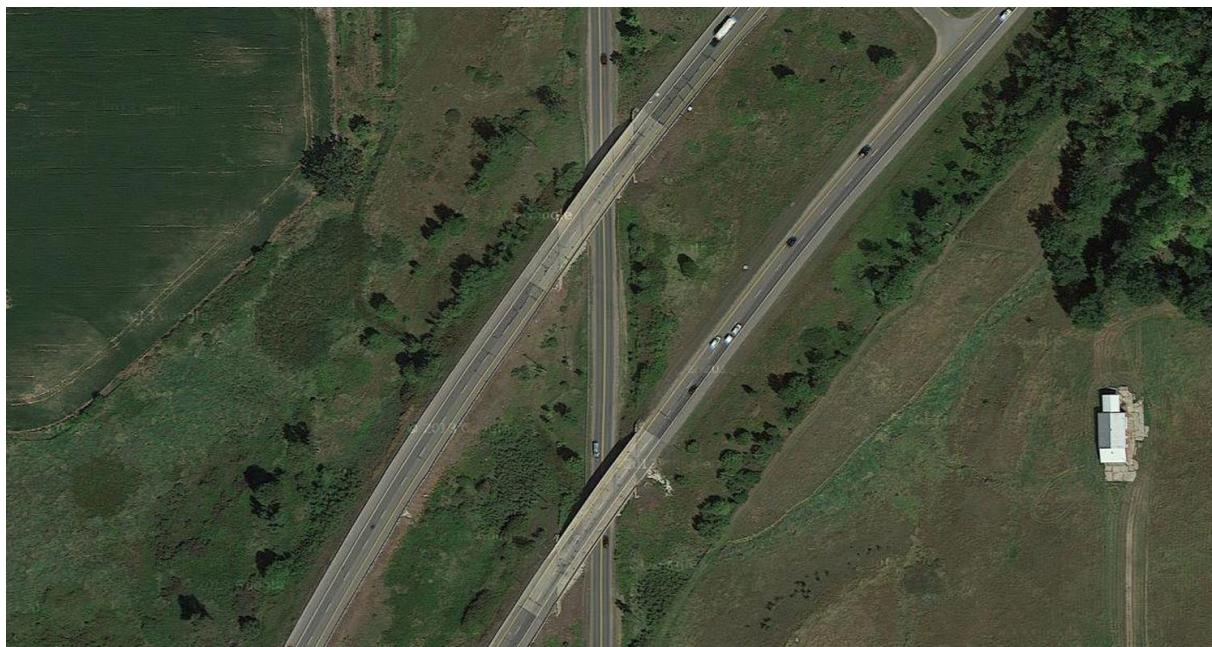
Figure 4-7: North and South Bound US-131 Bridges over White Creek Ave. near Cedar Springs, Michigan.

Although these two bridge structures are in close proximity, their levels of degradation are different which raises questions of construction inspection consistency and construction practices. The concrete deck surface of structure No. 5002 was assigned a fair condition NBI rating of 5 while the deck surface of No. 5003 was in poor condition and rated at a 4. The most

In the case of both bridges, it has been recommended that sealer be applied to expansion joints where deterioration has occurred. Concrete overlay on both bridge decks was also reported for consideration.

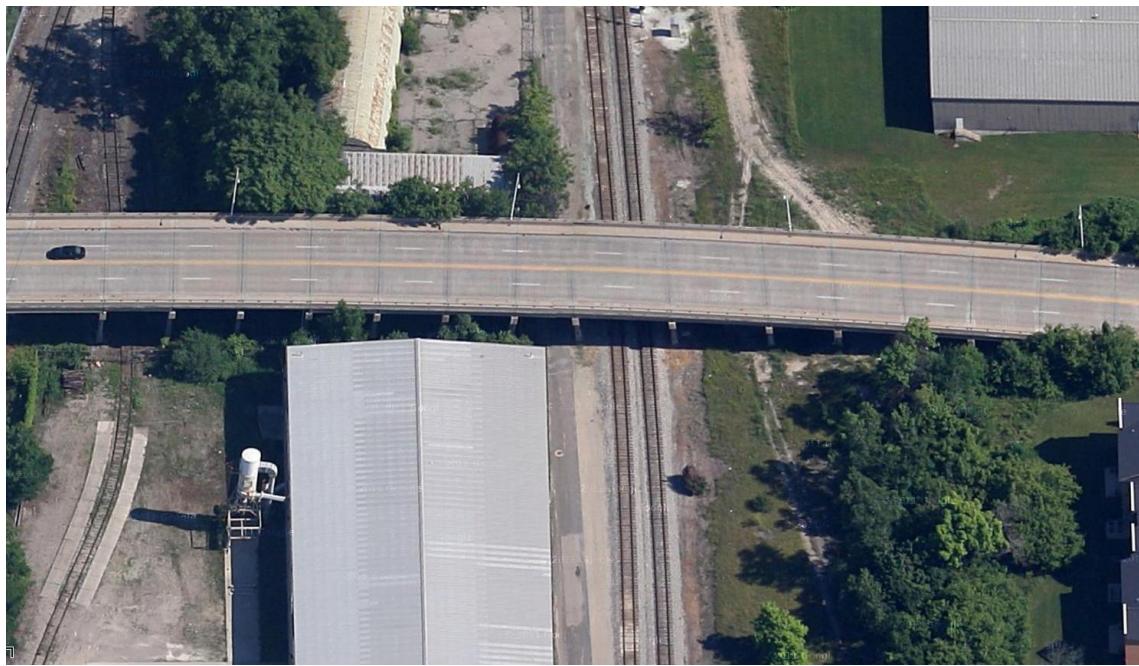
Figure 4-17: East Side of Franklin Street Bridge with Land Access to Underside.

The inspection report indicated various degrees of deterioration on the bottom deck surface. Replaced deck spans have remained in good condition but other spans contain considerable

amounts of spalling and cracking. In addition, soot buildup from locomotive exhaust was reported directly above the railroad line.
