# Experimental Study of Various Techniques to Protect Ice-Rich Cut Slopes

August 2014

Alaska Department of Transportation  
Statewide Research Office  
3132 Channel Drive  
Juneau, AK 99801-7898

**Number:** 4000(113)B

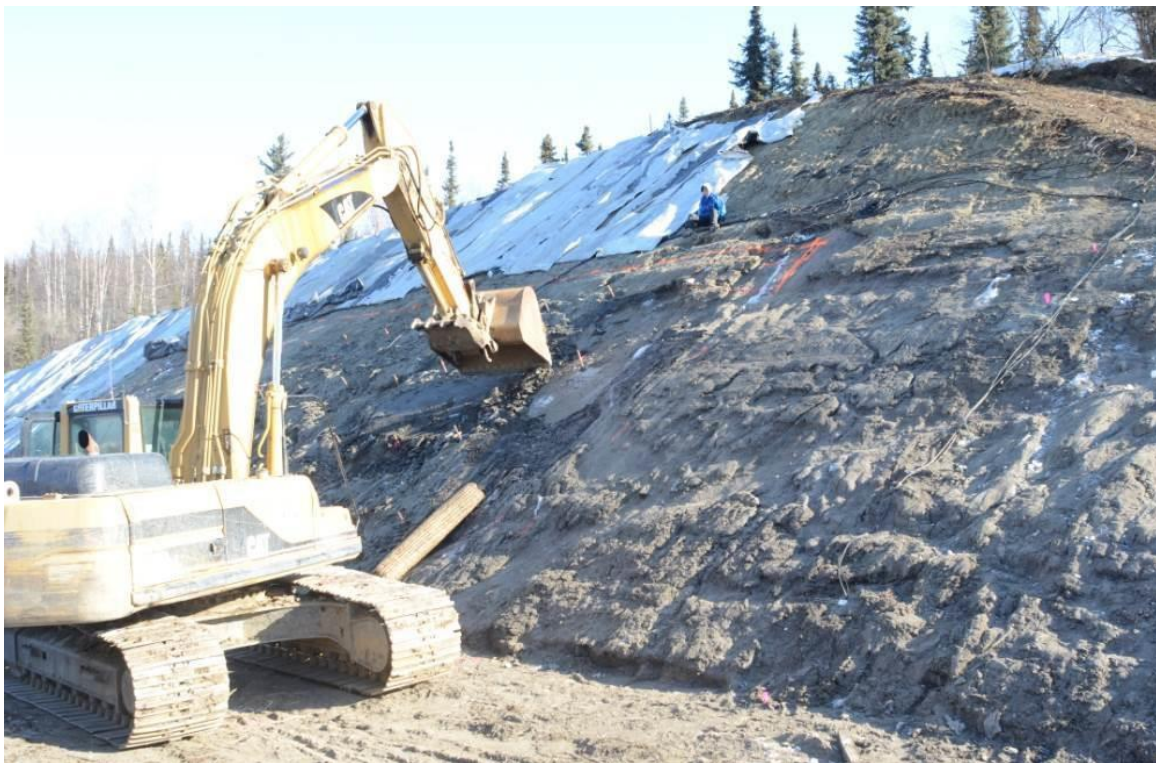
As mentioned previously (and shown in Figure 4.7), significant erosion was observed after the drilling process on the slope. The eroded, uneven slope surface quickly became unsuitable for placement of the coconut erosion control matting and the Tecco-mesh. It was necessary that both of these treatments be placed on a smooth ground surface to prevent air circulation between the treatment matting and the cut slope surface. Such air circulation would reduce the thermally protective effects of both treatment types. Therefore, prior to placement of the coconut matting (Section B) and Tecco-mesh (Section C) slope coverings, the bucket of a large backhoe excavator was used to smooth the uneven surface of the cut slope. This operation is shown in Figure 4.13. Then Sections B and C were seeded. Figure 4.14 shows a small area of the cut slope after seeding.

**Figure 4.13 Re-smoothing the cut slope surface**

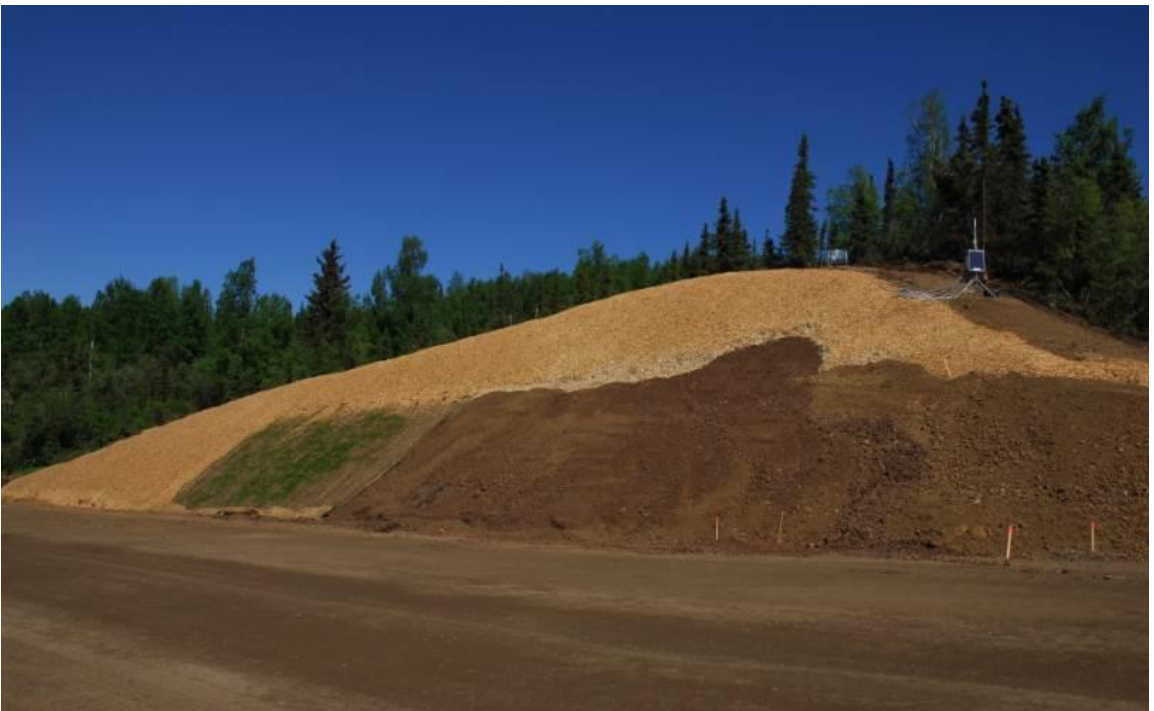
According to the recommendations listed above, on June 17, 2013, Tecco-mesh and the coconut erosion control blankets at Section C were removed (shown in Figure 6.5). The great loss of volume in cut slope soil at Section C can be seen in Figure 6.6, especially where massive ice is exposed. Crushed rock was hauled to the test site, and an excavator was used to cover Section C with crushed rock (see Figure 6.7). The hollow rebar anchors were left intact during these repairs to serve as survey and photogrammetric reference points. Figure 6.8 shows the cut slope after completion of repairs on June 17, 2013.

**Figure 6.8 Cut slope after construction on Section C**

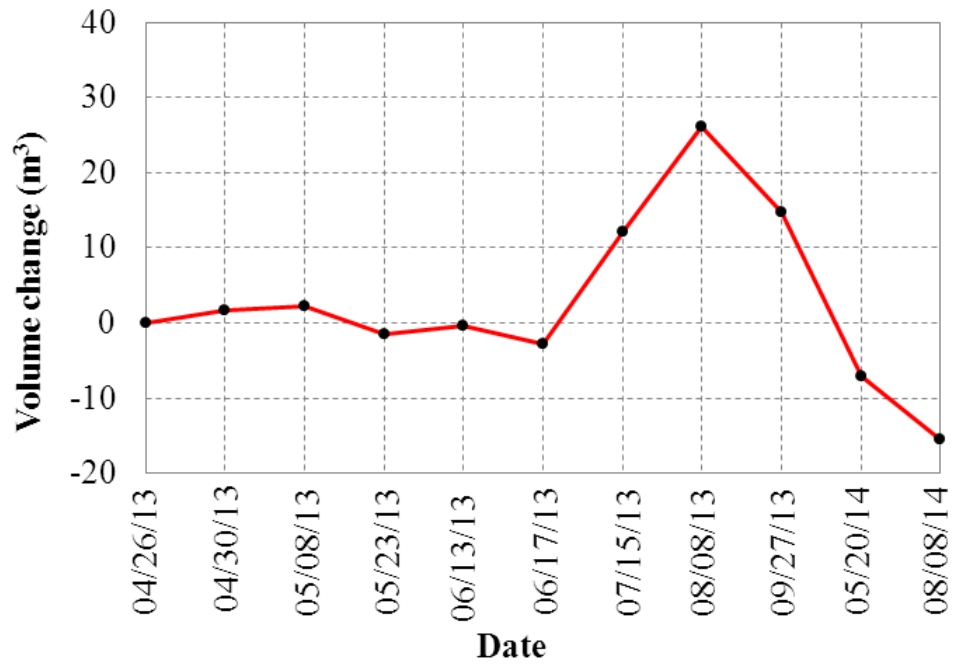
**Figure 7.28 Surface volume change on Section B**

Similar to Section A, no erosion on Section B (the coconut blanket section) was observed, which is consistent with the photogrammetric erosion measurement results shown in Figure 7.28. Before June 17, 2013, the volume change on the surface of Section B was not significant. Figure 7.29 presents a picture of this section on June 17, 2013, prior to the rapid growth of grass on the slope surface. After June 17, 2013, significant grass growth on this section was observed. Figures 7.30 and 7.31 are photos of this section captured on July 15 and August 8, respectively. Figure 7.31 is a photo showing the surface of Section B on September 27, 2013. This fall-time photo shows that the grass has wilted. This wilting process was detected as surface volume loss during the fall season, as shown in Figure 7.32. For two volume change measurement results in 2014 as shown in Figure 7.28, volume of Section B continuously decreased significantly which is similar to Section A. Part of the reason for this may be attributed to the melting of ground ice in the slope. The other two reasons is the grass grow in 2014, as shown in Figure 7.33, was not as good as that in 2013.

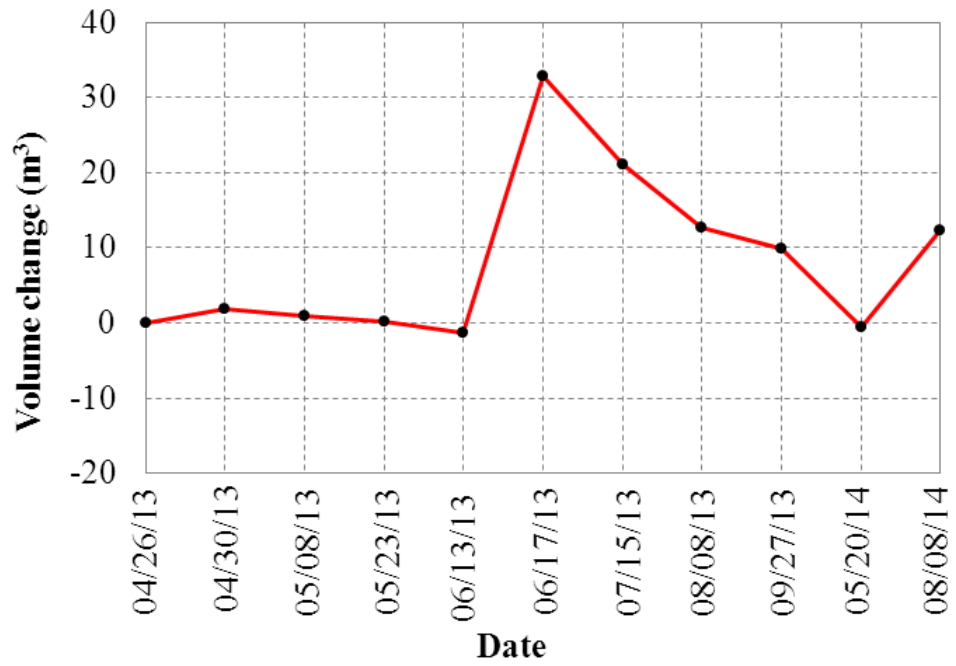
**Figure 7.34 Surface volume change on Section C**

As discussed previously, massive ground ice was found in Sections C and D. Erosion within these two sections was much greater than the erosion observed in Sections A and B. Figure 7.34 provides a very misleading record of total surface volume changes for Section C (Tecco-mesh and coconut blanket), because the photogrammetric process was only able to discern changes at the surface of the Tecco-mesh instead of at the underlying soil surface.

At the beginning of the photogrammetric record, April 26, measurements indicated a small surface volume increase due to the snow cover shown in Figure 7.35. During the period between about April 30 and June 13, 2013, a rather large volume of icy soil (and massive ice) materials, originally located beneath the Tecco-mesh slope cover, were lost to runoff and thaw-consolidation. Photogrammetric measurements, as indicated in Figure 7.34, keyed on the surface of the Tecco-mesh, and therefore provided no indication of the volume loss that was occurring under the Tecco-mesh. Figure 7.36 shows obvious signs of the actual condition of the cut slope face under the Tecco-mesh by June 13, 2013. Obviously, the deterioration process of the cut slope face under the Tecco-mesh was not detected by the photogrammetric process!

On June 17, the Tecco-mesh and coconut blanket on this section were removed and replaced by crushed rock as shown in Figure 7.37. This significant slope surface volume change (due to the added crushed rock) was captured by the subsequent set of photogrammetric measurements (indicated on the right-hand side of Figure 7.37). Figure 7.38 shows the appearance of Section C on September 27, 2013. Figure 7.34 indicates that an attenuation of thaw-related volume change was occurring in Section C prior to September 27, 2013. In 2014, slope surface volume continuously decreased till May 20, 2014 as shown in Figure 34. Figure 7.39 shows the appearance of Section C on May 20, 2014. However, after that, a volume increase change was captured on August 8, 2014. One reason for this volume increase was the grass grown as shown in Figure 7.40.

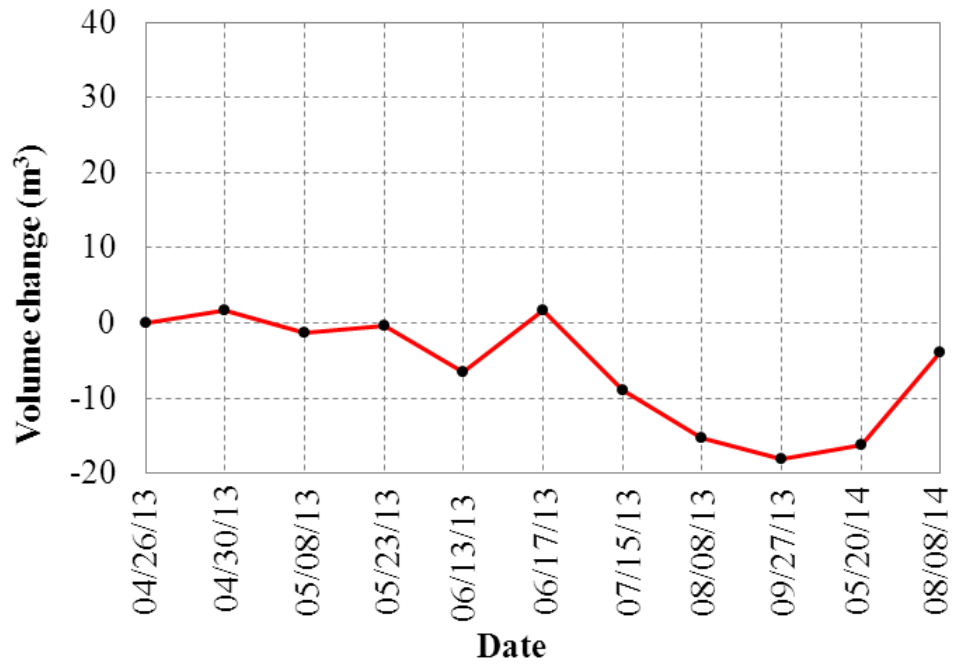
**Figure 7.41 Surface volume change on Section D**

Section D (originally constructed with a crushed rock blanket) serves as the control section for the Experimental Feature. Figure 7.41 indicates that a more or less continual loss of slope surface volume occurred through September 27, 2013. The initial small volume increase at the surface of Section D was because of the late April snowfall shown in the photo in Figure 7.42. Loss of surface volume (through erosion and/or thaw-consolidation) continued through June 13. Figure 7.43 shows the condition of the slope face on June 13, 2013. Then, on June 17, 2013, a volume of rock material was added to the surface of Section D during Section C repairs (see photo in Figure 7.44). The immediate surface volume increase due to this addition of material in Section D is plotted in Figure 7.41. After placement of additional crushed rock on June 17, 2012, the loss of surface volume continued through the end of this report's monitoring period, on September 27. The condition of the slope at that time is shown by the Figure 7.45 photo. Figure 7.41 indicates that the surface volume loss rate for Section D had not attenuated much prior to September 27, 2013. As shown in Figure 7.41, in 2014, surface volume of Section D increased. On May 20, 2014, no grass was shown at this section. However, grass grown was identified at Section D as show in Figure 7.42 on August 8, 2014.
