**EXPERIMENTAL PROJECTS CONSTRUCTION REPORT AND ANNUAL  
EVALUATION**

**SMART CUSHION INNOVATIONS (SCI) 100GM CRASH ATTENUATOR**

**Project Name:** Taft-West

**Project Number:** IM-90-1(84)0

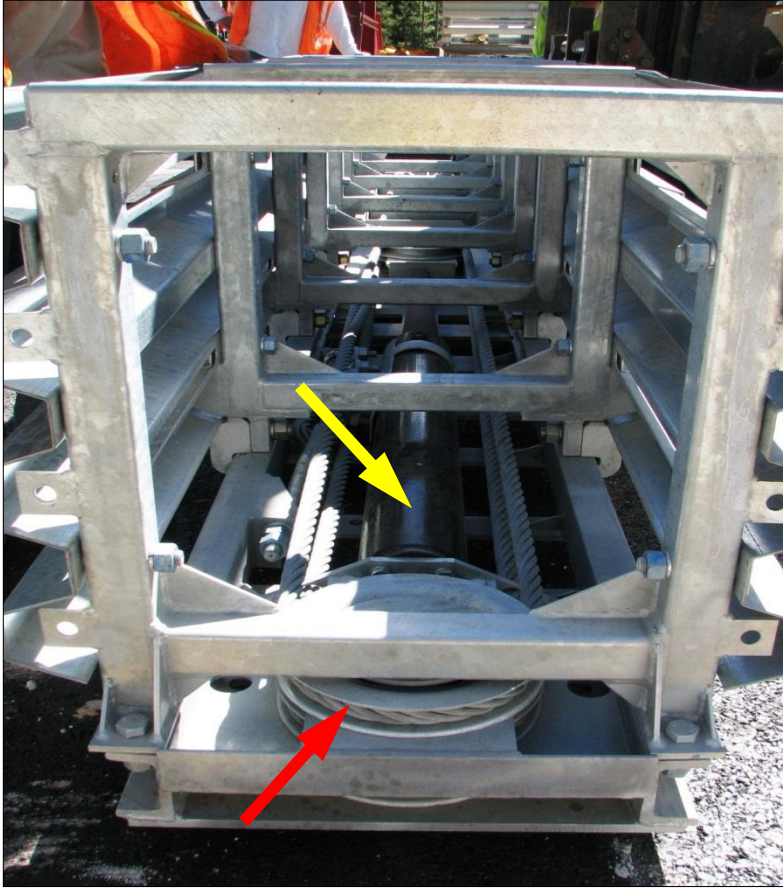
← Image shows the rear of the attenuator (prior to placing against the jersey barrier). Here you can see the rear sheave cable assembly (red arrow) and the hydraulic cylinder (yellow arrow).

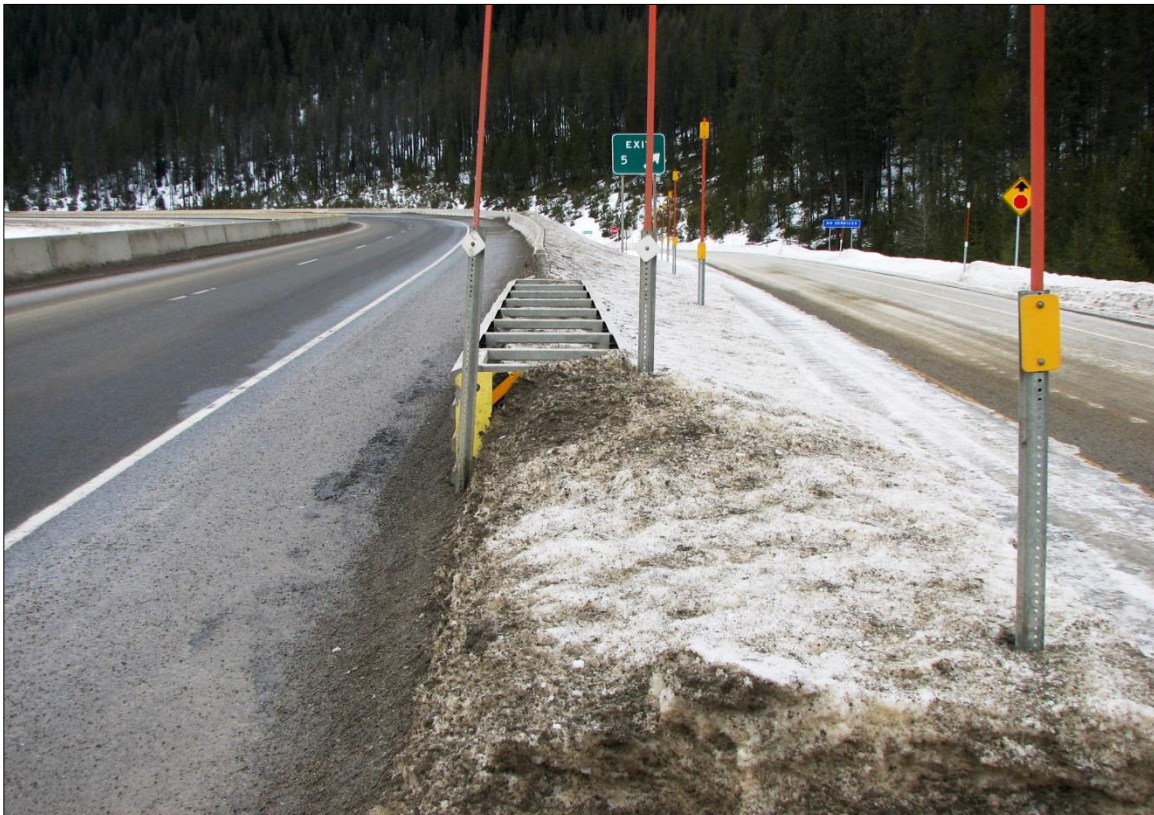
Note the level of snow and ice inside and in front of the attenuator.

As stated earlier it is uncertain how this condition would affect the performance of the cushion if struck by a vehicle.
