MASH TL-4 CRASH TESTING AND EVALUATION OF THE RESTORE BARRIER

MIDWEST ROADSIDE SAFETY FACILITY

MwRSF Research Report No. TRP-03-318-15

November 3, 2015

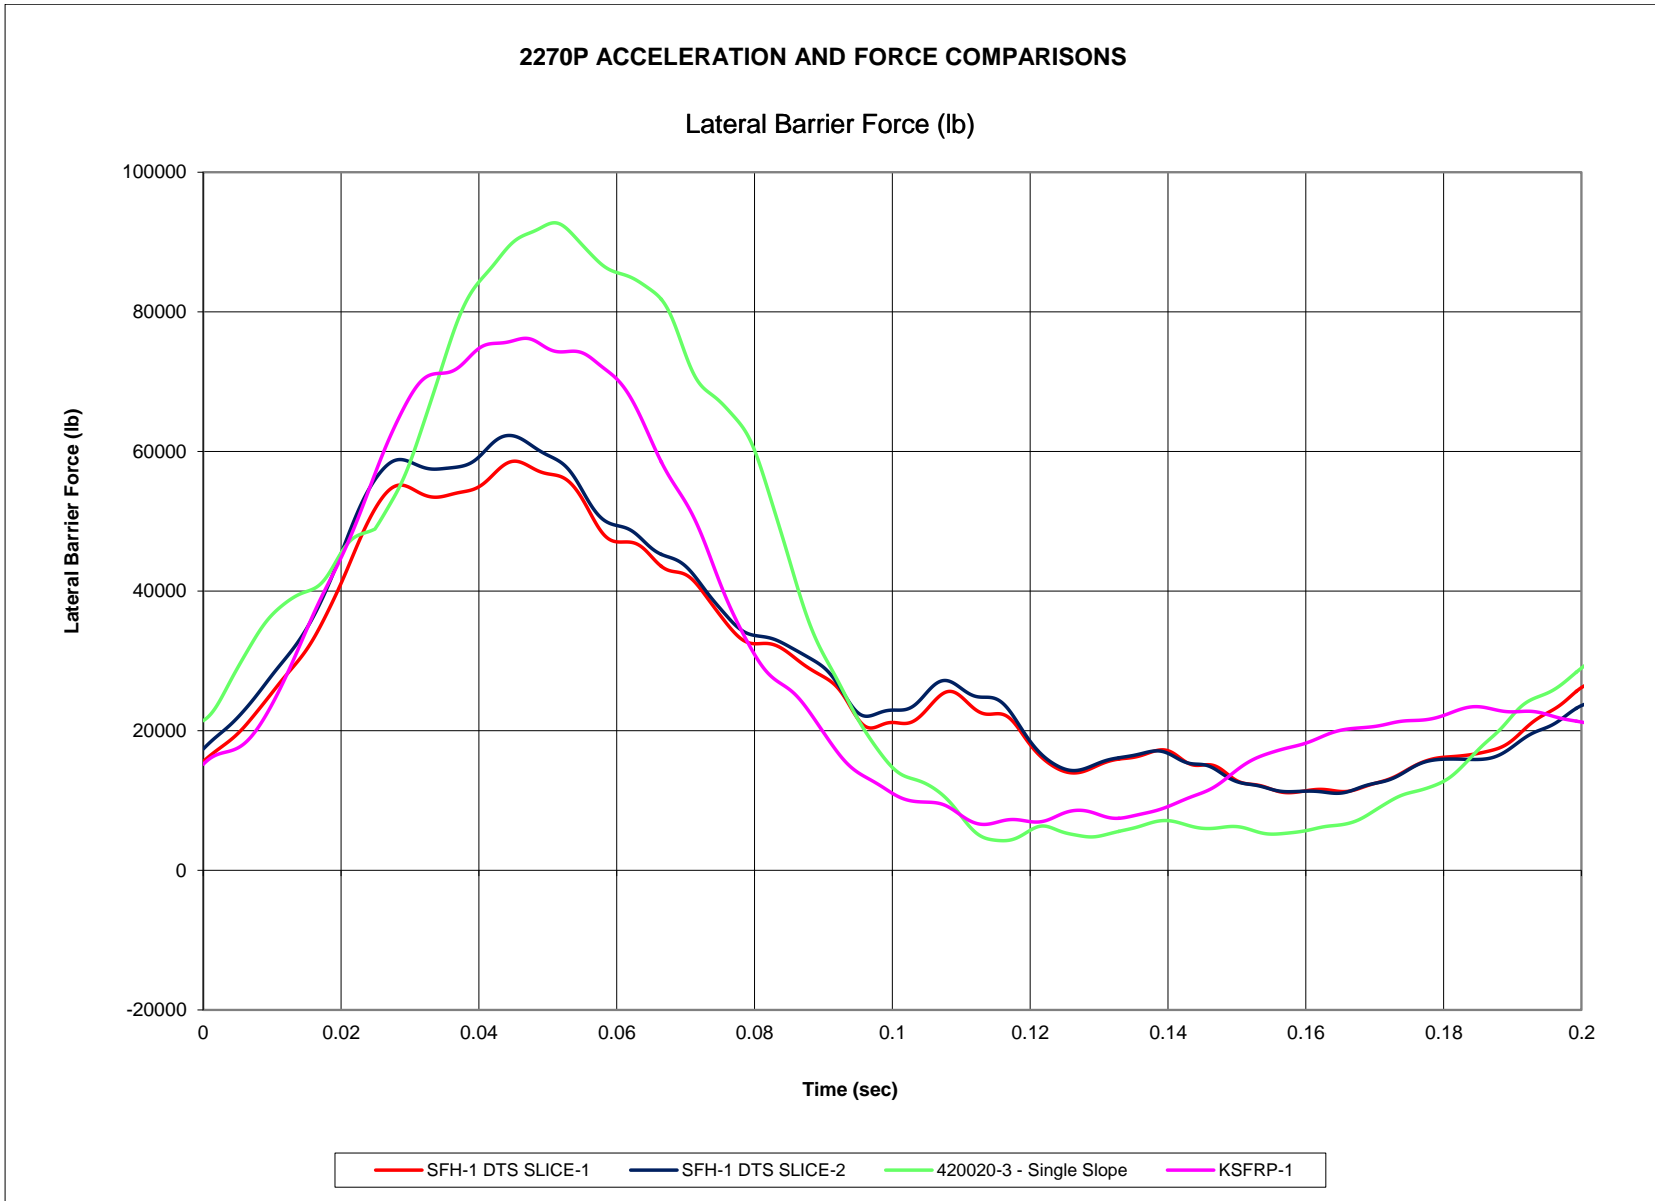
Figure 57. Force Comparisons, 2270P Vehicle

The results of test no. SFH-1 were compared to the results of two different MASH test designation no. 4-11 crash tests, test no. 420020-3 with a 2270P pickup truck impacting a single-slope barrier attached to a bridge deck [13] and test no. KSFRP-1 with a 2270P pickup truck impacting a vertical barrier attached to a fiber-reinforced polymer (FRP) deck [14]. The comparison tests and the force comparison plots for the 2270P vehicle are shown in Table 8 and Figure 57, respectively. The lateral barrier force was calculated in test nos. 420020-3 and KSFRP-1 using the same procedure as in test no. SFH-1's barrier force calculations. The peak lateral barrier forces were 33 to 38 percent less than those observed in the single-slope barrier impact and 17 to 23 percent less than those observed in the vertical barrier on FRP deck impact. The peak lateral acceleration was reduced by up to 47 percent and 25 percent when comparing test no. SFH-1 to test nos. 420020-3 and KSFRP-1, respectively. The lateral and longitudinal acceleration comparisons are shown in Figures 58 and 59, respectively. For test no. KSFRP-1, note that the barrier and FRP bridge deck deflected some during the impact event.

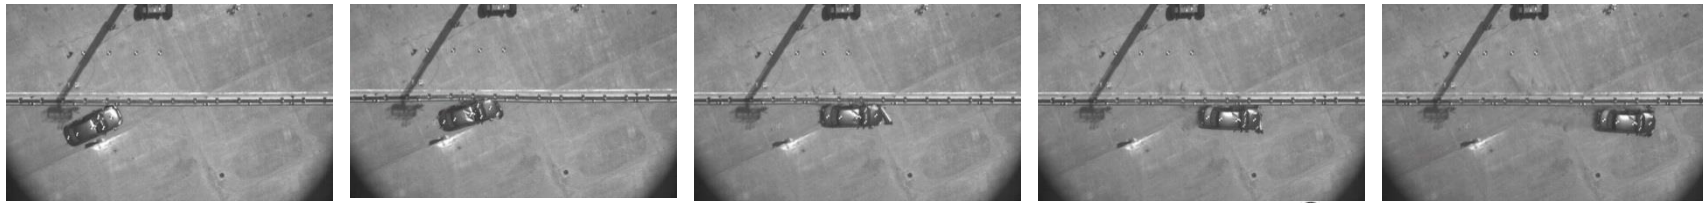
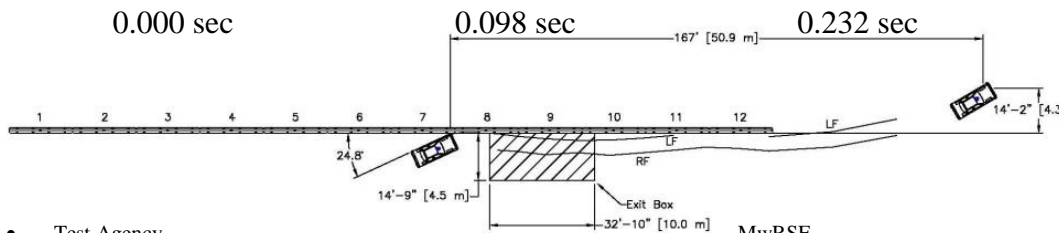
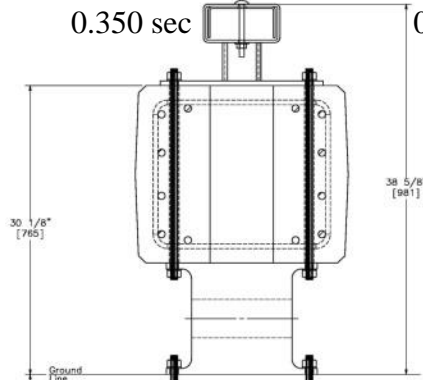
Figure 60. Summary of Test Results and Sequential Photographs, Test No. SFH-2

The 2,406-lb (1,091-kg) small car impacted the RESTORE barrier at a speed of 64.3 mph (103.5 km/h) and an angle of 24.8 degrees. A summary of the test results and sequential photographs are shown in Figure 60. Additional sequential photographs are shown in Figures 61 through 63. Documentary photographs of the crash test are shown in Figures 64 through 66.

of the joint between barrier nos. 7 and 8. A sequential description of the impact events is contained in Table 10. The vehicle came to rest 167 ft (50.9 m) downstream from the original impact point and 14 ft – 2 in. (4.3 m) laterally behind the system. The vehicle trajectory and final position are shown in Figures 60 and 68.

The calculated occupant impact velocities (OIVs) and maximum 0.010-sec occupant ridedown accelerations (ORAs) in both the longitudinal and lateral directions are shown in Table 13. Note that the OIVs and ORAs were within the suggested limits provided in MASH. The calculated THIV, PHD, and ASI values are also shown in Table 13. The results of the occupant risk analysis, as determined from the accelerometer data, are summarized in Figure 60. The

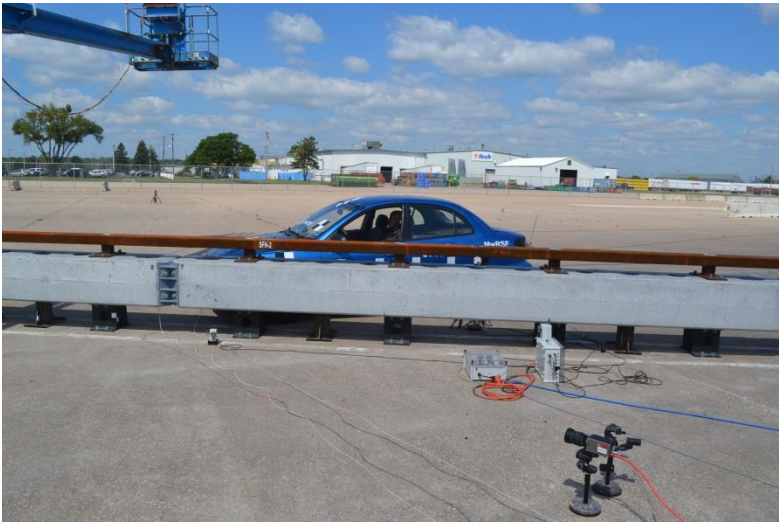
Figure 67. Impact Location, Test No. SFH-2

Initial vehicle impact was to occur 3.6 ft (1.1 m) upstream of the first post downstream of the joint between barrier nos. 7 and 8, as shown in Figure 67. This location was selected based on the recommendation for rigid barrier tests in MASH and verified through LS-DYNA simulation. The impact point was downstream from test no. SFH-1 so damage could be distinguished between the two tests. The actual point of impact was $8\frac{5}{16}$ in. (211 mm) upstream

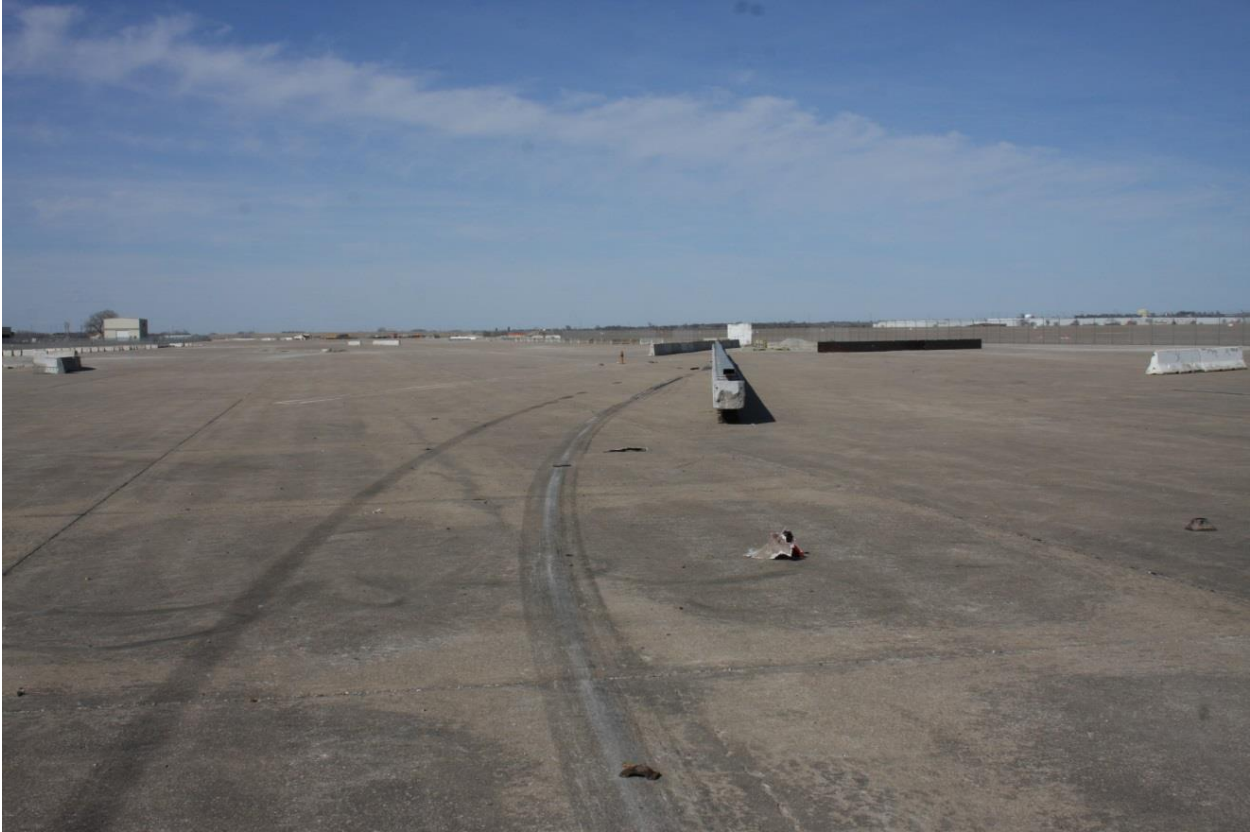
Figure 109. Impact Location, Test No. SFH-3

Initial vehicle impact was to occur 60 in. (1,524 mm) upstream from the joint between barrier nos. 5 and 6, as shown in Figure 109. This location was selected based on recommendation for rigid barrier tests in MASH and verified through LS-DYNA simulation. The actual point of impact was 55.75 in. (1,416 mm) upstream from the joint between barrier nos. 5 and 6, as determined from video analysis. A sequential description of the impact events is contained in Table 16. The vehicle came to rest 270 ft (82.3 m) downstream from the original impact point and 19 ft – 9 in. (6.0 m) laterally behind the system. The vehicle trajectory and final position are shown in Figures 104 and 110.

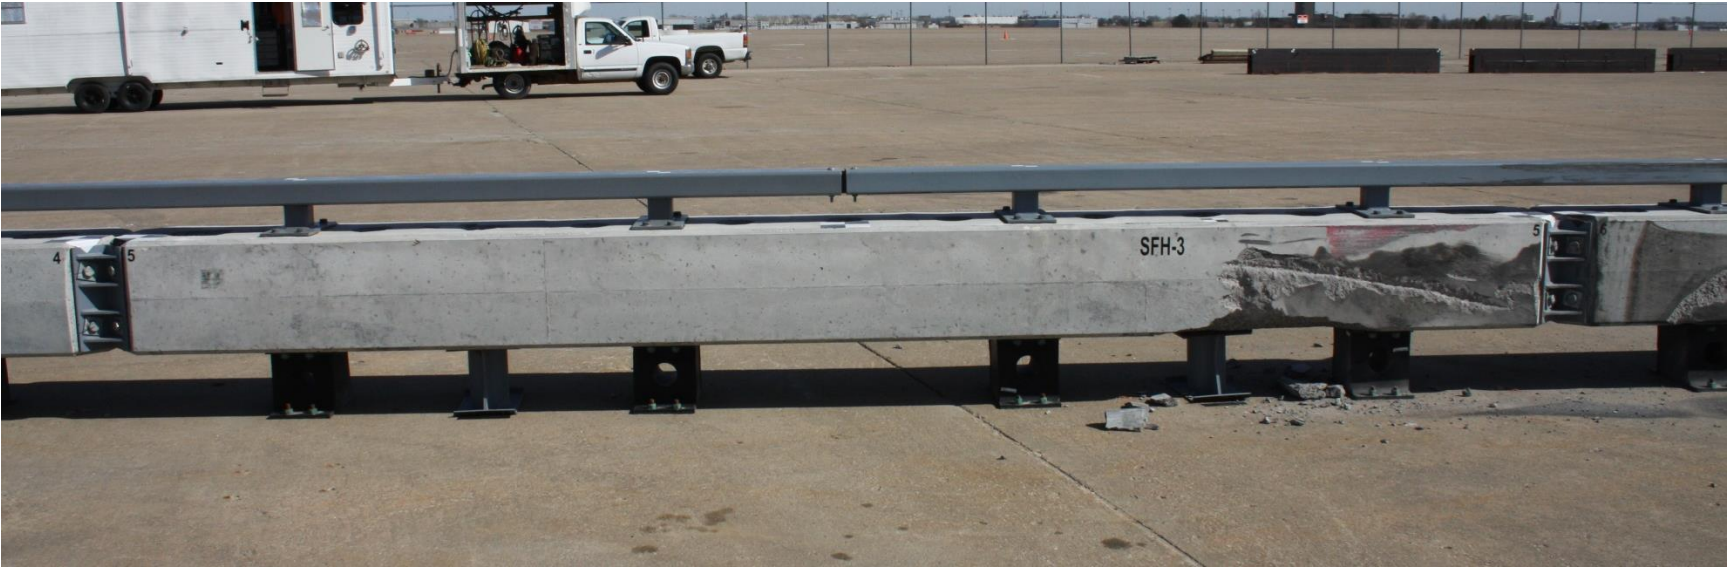
Figure 110. Vehicle Final Position and Trajectory Marks, Test No. SFH-3

Damage to the barrier was minimal, as shown in Figures 110 through 120. Barrier damage consisted of contact marks and gouging on the front face of the concrete beams, cracking and spalling at the joint connections, contact marks along the top of the concrete beams and along the upper tube assembly, and contact with the rubber posts. The length of the vehicle contact along the barrier was approximately 59 ft – 3 in. (18.1 m), which spanned from 60½ in. (1,537 mm) upstream from the joint between barrier nos. 5 and 6 to 29 in. (737 mm) upstream from the joint between barrier nos. 8 and 9. The majority of the contact marks were found on the front face of the concrete beam starting at the impact point and extending through the end of

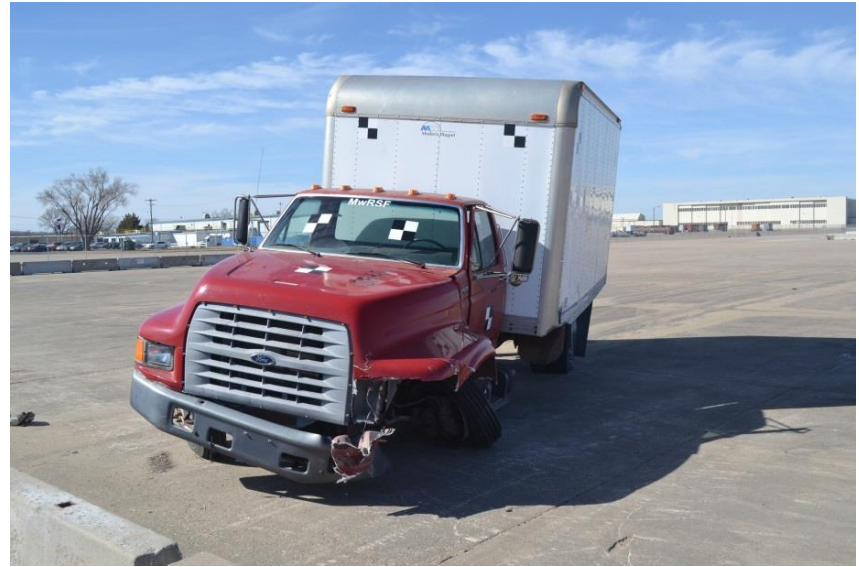
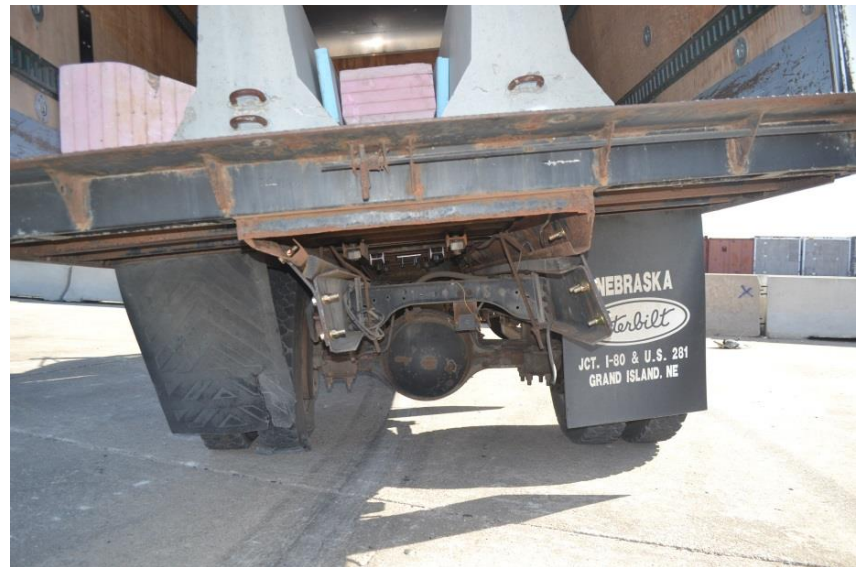
Figure 121. Vehicle Damage, Test No. SFH-3

The damage to the vehicle was moderate, as shown in Figures 121 through 123. The maximum occupant compartment deformations are listed in Table 18 along with the deformation limits established in MASH for various areas of the occupant compartment. Note that none of the MASH-established deformation limits were violated. Complete occupant compartment and vehicle deformations and the corresponding locations are provided in Appendix C.

The majority of the damage was concentrated on the left-front corner of the vehicle where the impact occurred and the frame under the cargo box. The left fender had multiple cracks and gouges starting at the left headlight and extending back along the fender to the back of the wheel well. The front bumper was separated 3½ in. (89 mm) from the grill and had a kink located 16 in. (406 mm) to the left of center. The left headlight was disengaged, and the left-front tire was deflated. Multiple gouges and dents were found along the left-front tire rim. The left-front U-bolts and centering pin were fractured, and the front axle displaced rearward 12 in. (305 mm) along the leaf spring on the left side. Similarly, the right-front U-bolts were fractured, and the front axle displaced 6 in. (152 mm) along the leaf spring on the right side. The top of the left door separated 2½ in. (64 mm) from the cab. The cargo box had multiple dents along the left-front corner, as well as scrapes extending the length of the box. The left-rear tire was deflated due to a gouge in the sidewall of the tire. A 3-in. (76-mm) wide tear occurred 100 in. (2,540 mm) longitudinally back from the front of the cargo box and 18 in. (457 mm) vertically above the bottom of the box. A steel angle disengaged from the lower left-front corner of the cargo box. The chassis frame twisted and displaced to the left, as shown in Figure 121. All of the additional U-bolts that were added to strengthen the box-frame connection were bent. Both the additional shear plates on the left side were bent at the connection between the frame and the sub-frame. The right-front shear plate was bent at the top, and the right-rear shear plate displaced with the
