## **MASH TEST NOS. 3-17 AND 3-11 ON A NON-PROPRIETARY CABLE MEDIAN BARRIER**

### **MIDWEST ROADSIDE SAFETY FACILITY**

MwRSF Research Report No. TRP-03-303-15

November 3, 2015

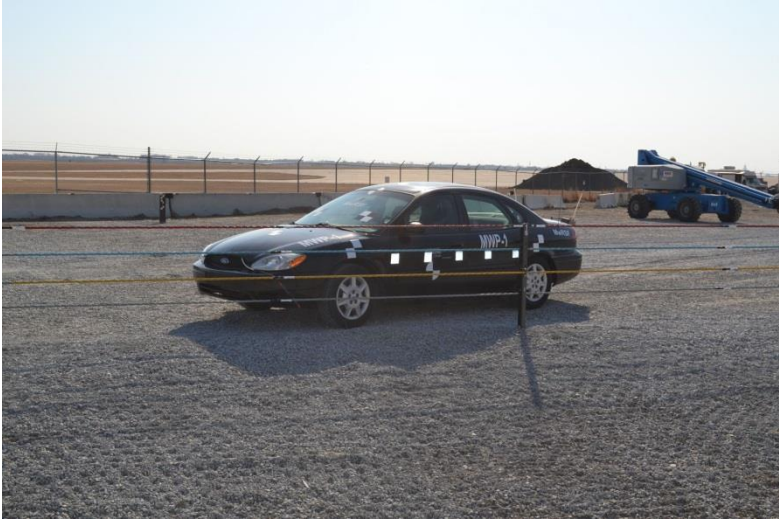
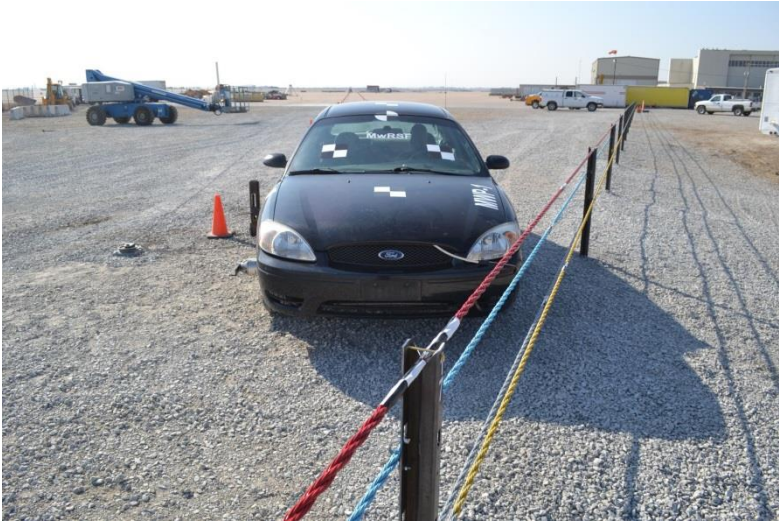
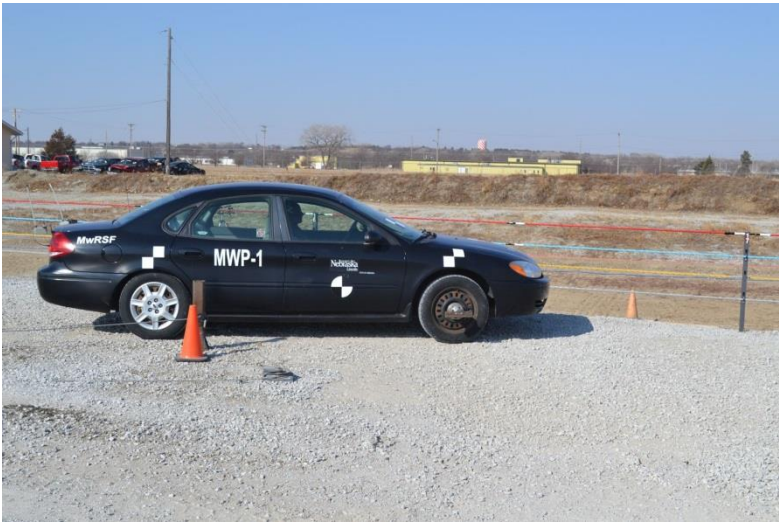
Figure 44. Impact Location, Test No. MWP-1

Initial vehicle impact was to occur 8 ft (2.4 m) downstream from post no. 16, as shown in Figure 44, which was selected according to MASH. The actual point of impact was approximately 9 in. (229 mm) downstream from the target impact point. A sequential description of the impact events is contained in Table 5. The vehicle came to rest in line with the system 180 ft – 3 in. (54.9 m) downstream from the point of impact between post nos. 27 and 28. The vehicle trajectory and final position are shown in Figures 40 and 45.

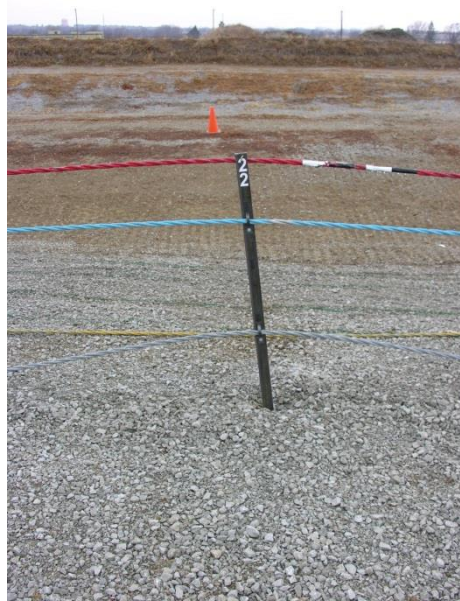
Post No. 22

Figure 48. System Damage, Post Nos. 21 through 23, Test No. MWP-1

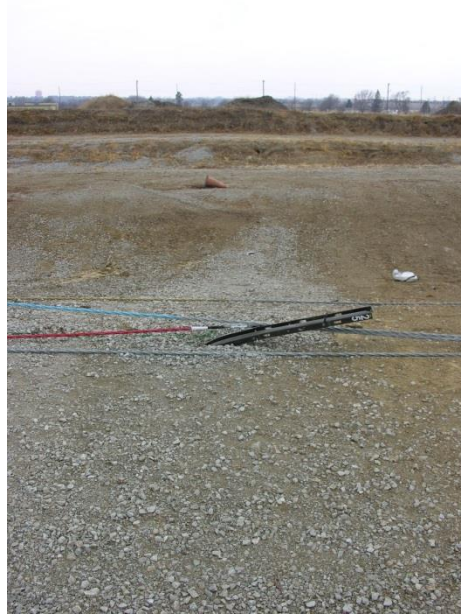
Post No. 25

Figure 49. System Damage, Post Nos. 24 through 26, Test No. MWP-1

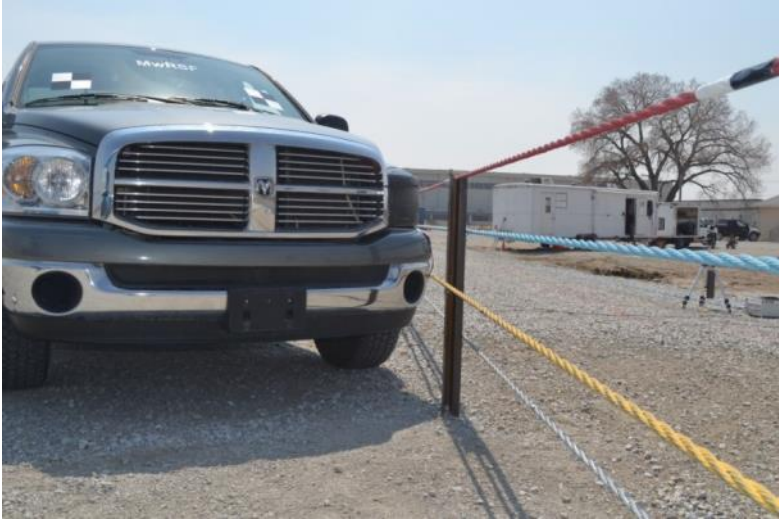
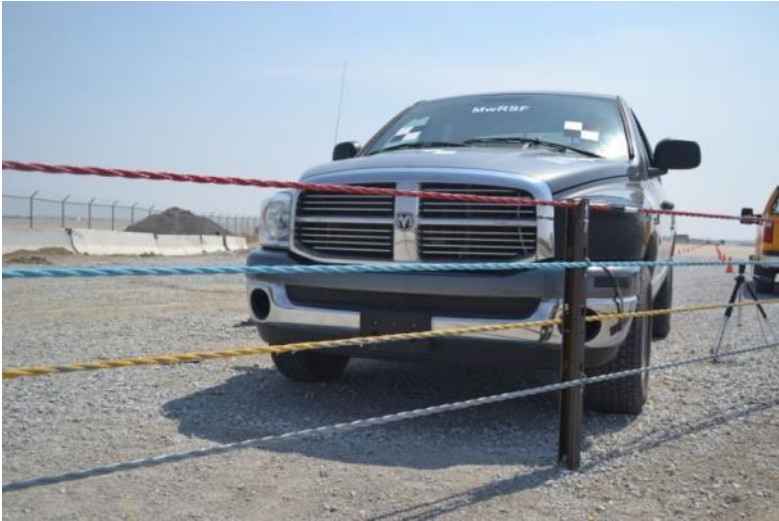
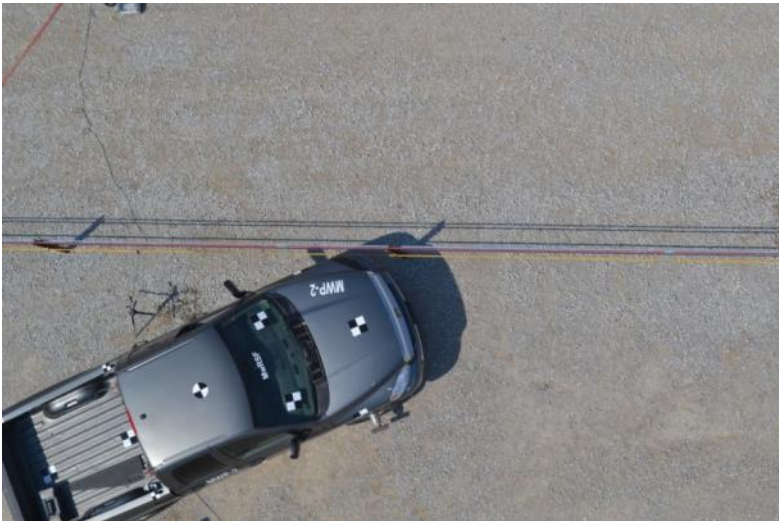
Figure 62. Impact Location, Test No. MWP-2

Initial vehicle impact was to occur 12 in. (305 mm) upstream from post no. 17, as shown in Figure 62, which was selected according to MASH. The actual point of impact was approximately 11 in. (279 mm) upstream from post no. 17. A sequential description of the impact events is contained in Table 10. The vehicle came to rest 187 ft – 1 in. (57.0 m) downstream from the point of impact and 4 ft – 1 in. (1.2 m) laterally behind the barrier’s initial position after successfully being captured by the barrier system. The vehicle trajectory and final position are shown in Figures 56 and 63.

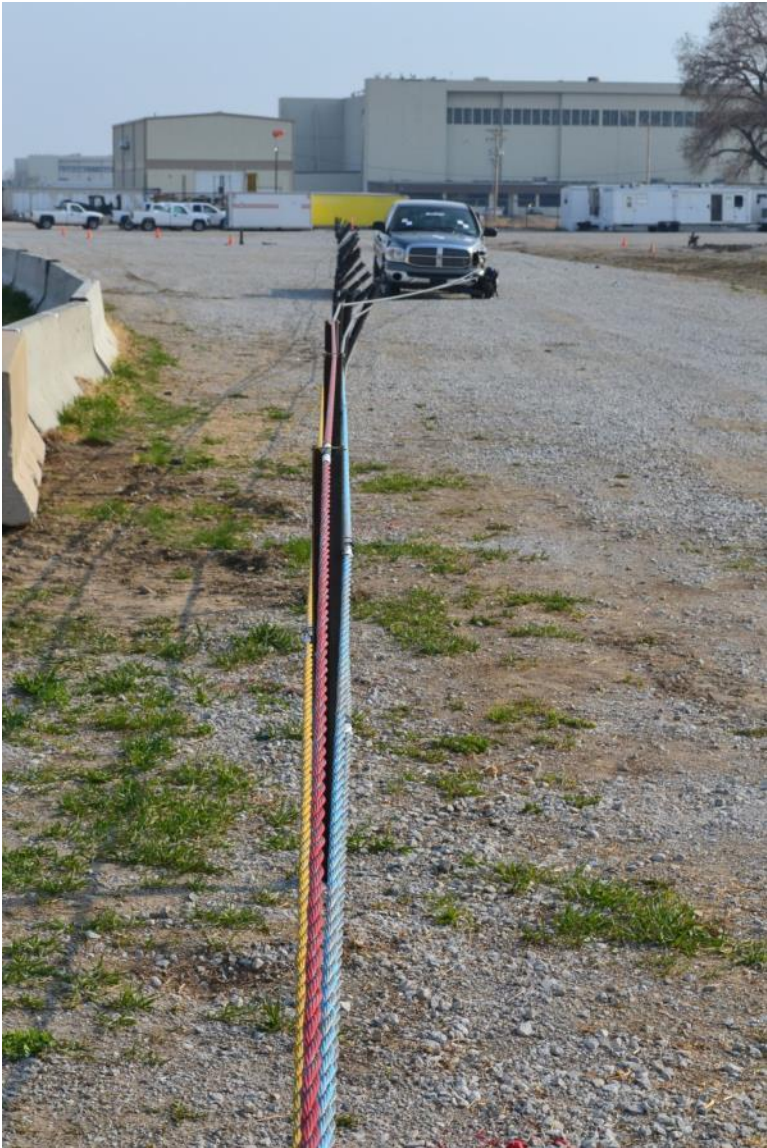
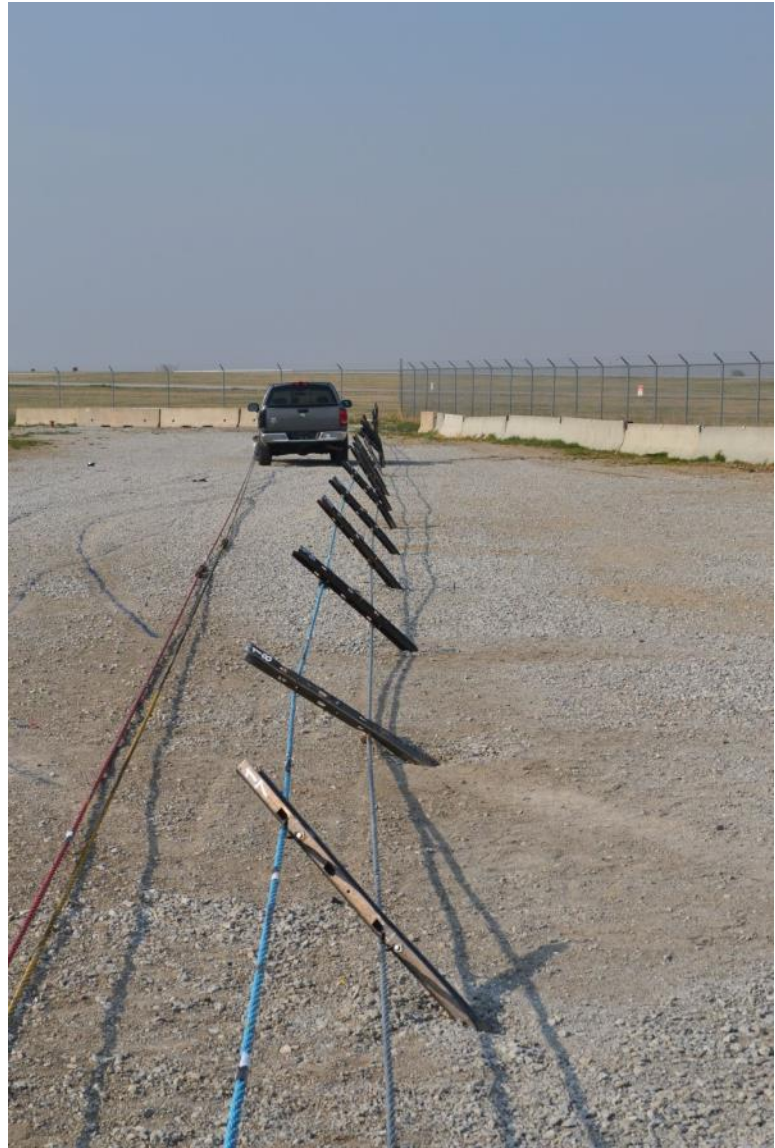
Figure 64. Damage to System, Test No. MWP-2

Damage to the barrier was moderate, as shown in Figures 63 through 66. Barrier damage consisted of bent posts, disengaged cables, deformed cable brackets, and movement of cable end anchor foundations. At the vehicle's final resting place it was still in contact with the system,

Post nos. 8 through 34 had varying degrees of bending and twisting. The posts typically bent backward and toward the initial impact location, except for post nos. 17 and 18, which were directly impacted and run over, causing bending downstream and backward. Furthermore, post nos. 27 through 32 tore in the post flange around the bottom keyway on the impact side of the post, as seen in Figures 66 and 67. The posts typically fractured on the impact side between the keyway and free edge while buckling occurred on the back side of these posts.

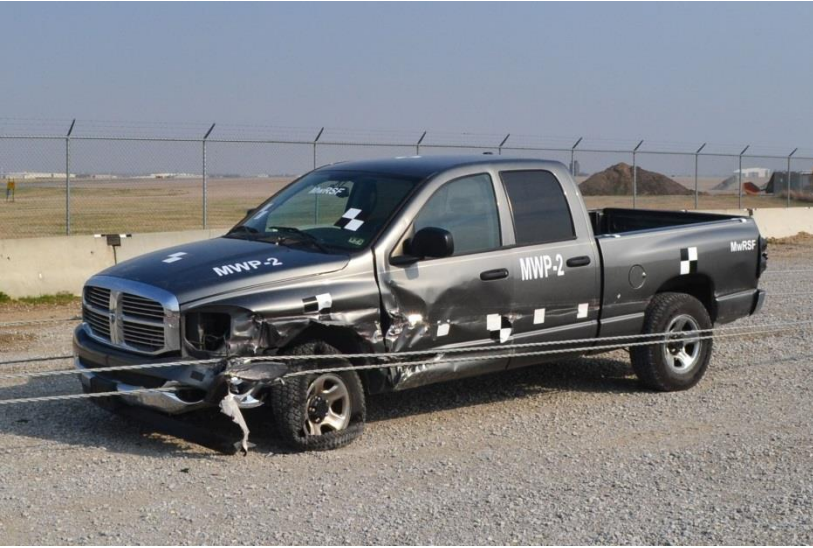
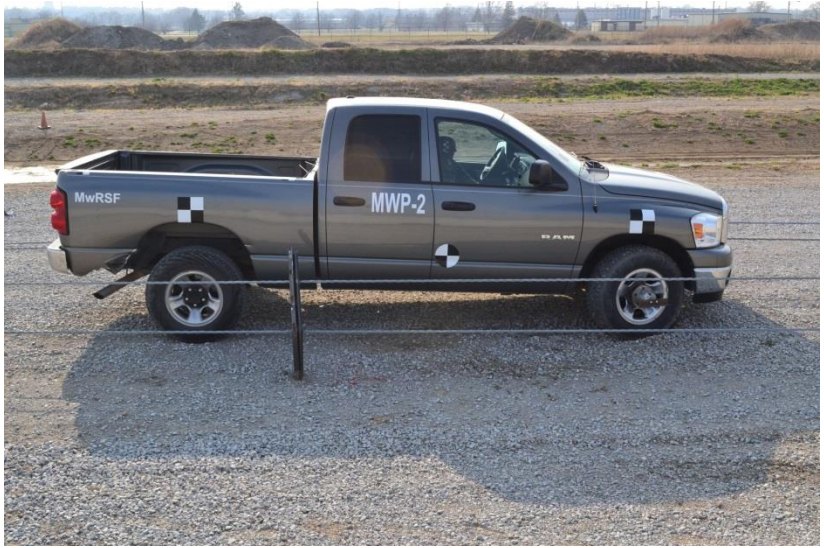
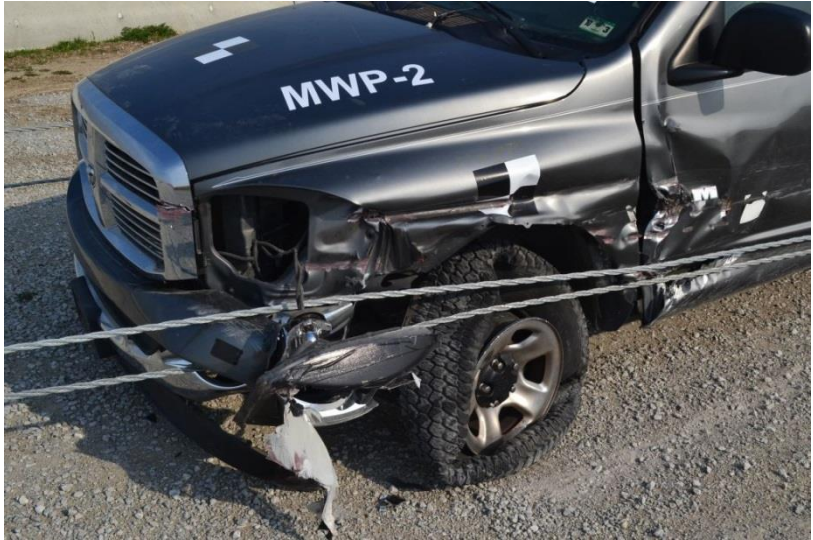
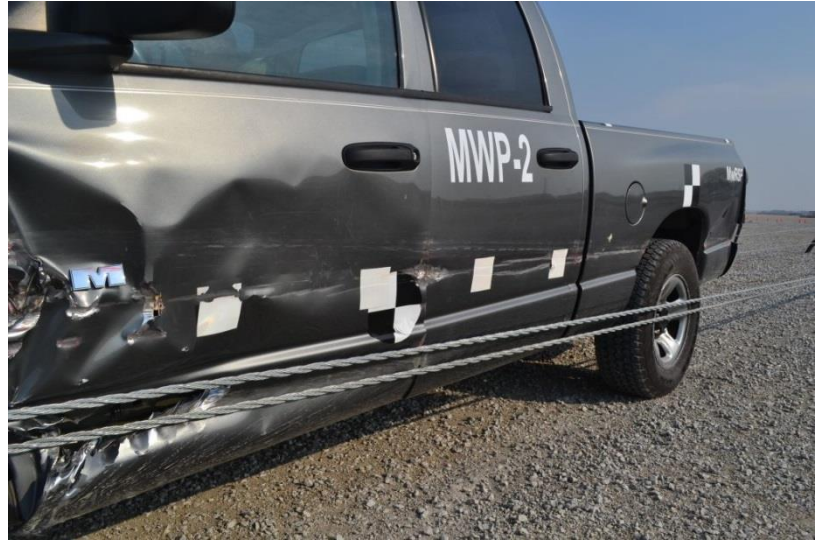
Figure 68. Vehicle Damage, Test No. MWP-2

The damage to the vehicle was moderate, as shown in Figure 68. The maximum occupant compartment deformations are listed in Table 11 along with the deformation limits established in MASH for various areas of the occupant compartment. Note that none of the MASH-established deformation limits were violated. Complete occupant compartment and vehicle deformations are provided in Appendix D.

- Vehicle Damage..... Moderate
  - VDS [14] ..... 11-LFQ-3
  - CDC [15]..... 11-LFEN-5
  - Maximum Interior Deformation ..... 3/4 in. (19 mm)

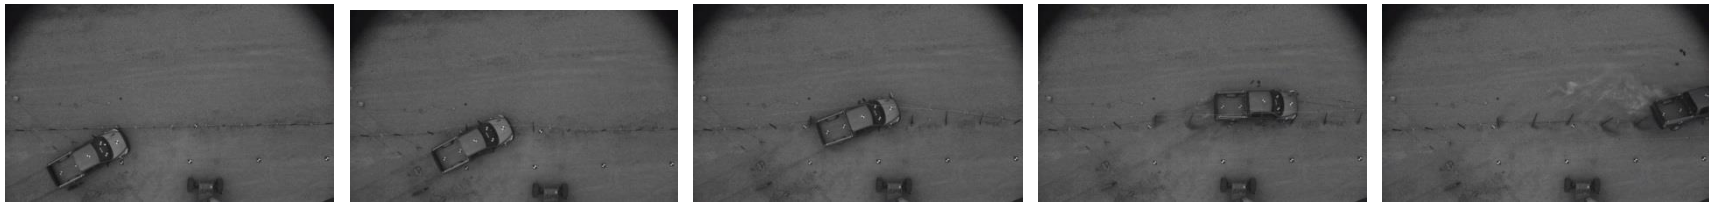
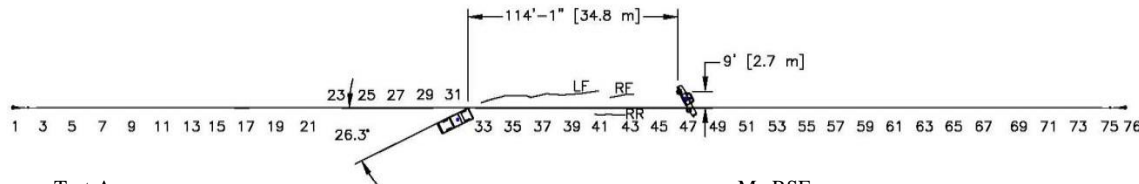
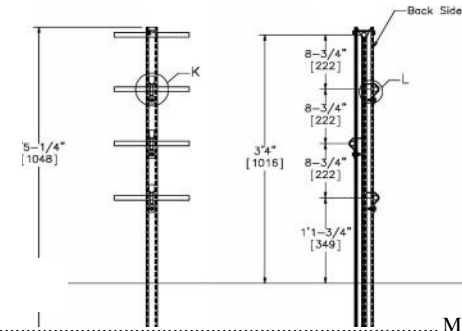
Figure 94. Summary of Test Results and Sequential Photographs, Test No. MWP-3

The analysis of the test results for test no. MWP-3 showed that the high-tension four-cable median barrier did not adequately contain and redirect the 2270P vehicle. A hole was found in the windshield, qualifying as penetration of the occupant compartment. Additionally, the test vehicle penetrated the barrier system and did not remain upright during the collision. Vehicle roll, pitch, and yaw angular displacements, as shown in Appendix I, were deemed unacceptable because the vehicle rolled over. Test no. MWP-3 conducted on the cable median barrier was determined to be unacceptable according to the MASH safety performance criteria for test designation no. 3-11.

- Vehicle Damage..... Extensive
  - VDS [14] ..... 11-L&T-4
  - CDC [15]..... 11-LDAO-9
  - Occupant Compartment ..... Penetrated and deformed

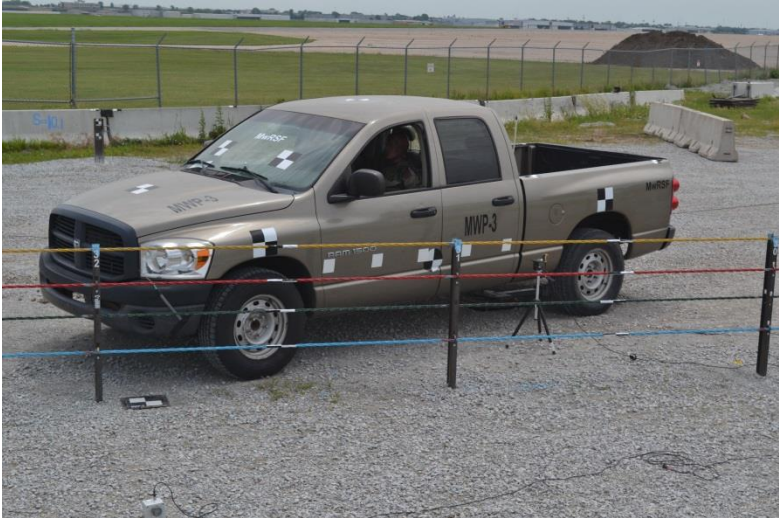
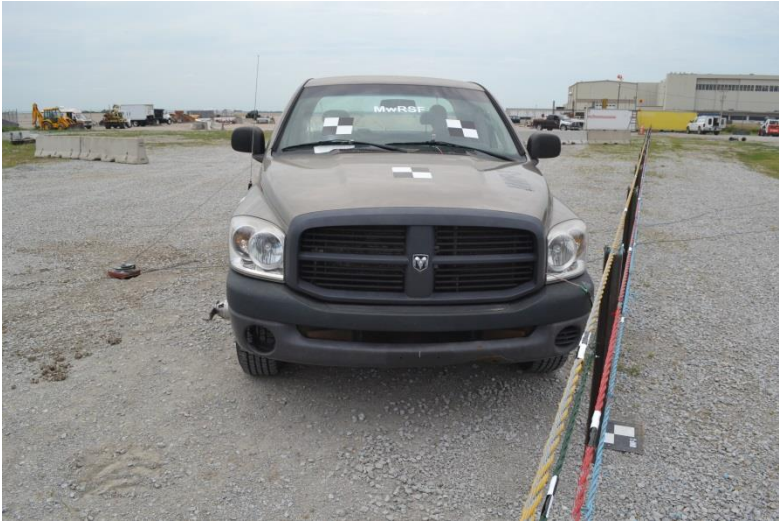
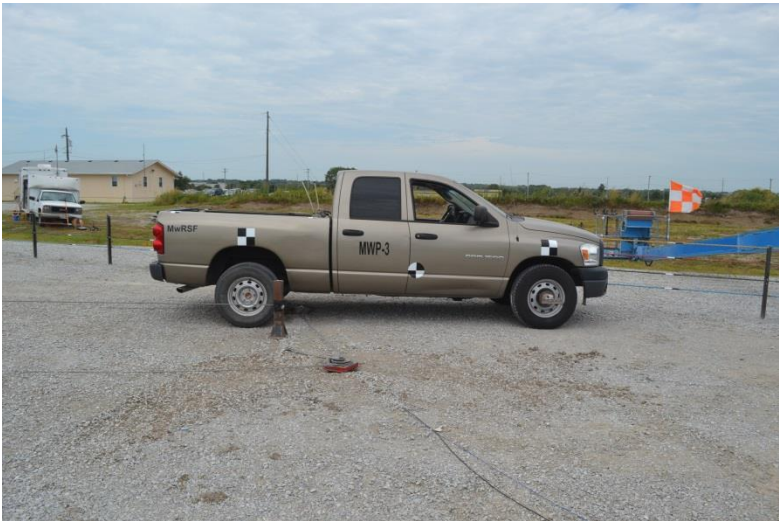
Figure 101. Impact Location, Test No. MWP-3

Initial vehicle impact was to occur 12 in. (305 mm) upstream from post no. 32, as shown in Figure 101, which was selected according to MASH. The actual point of impact was approximately 8 in. (203 mm) upstream from post no. 32. A sequential description of the impact events is contained in Table 15. The vehicle came to rest on its right side in line with the system 114 ft – 1 in. (34.8 m) downstream from the point of impact, with the system cables underneath it. The vehicle trajectory and final position are shown in Figures 94 and 102.

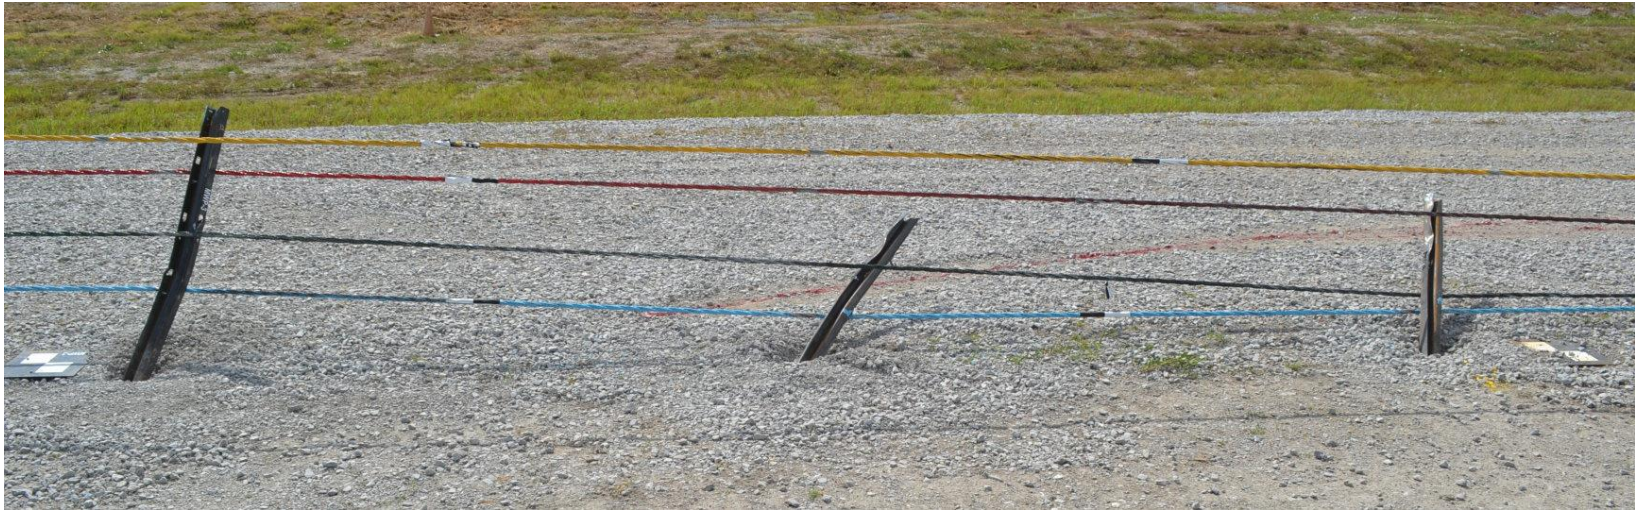
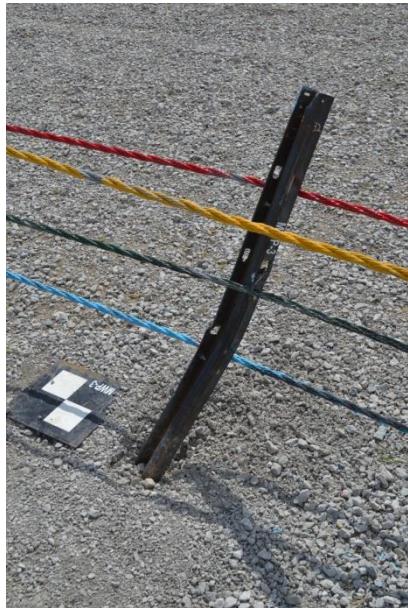
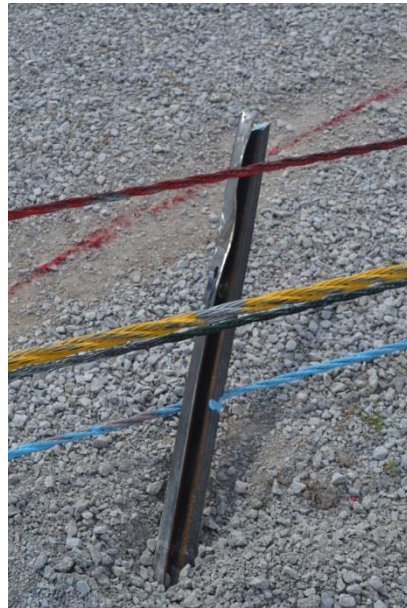
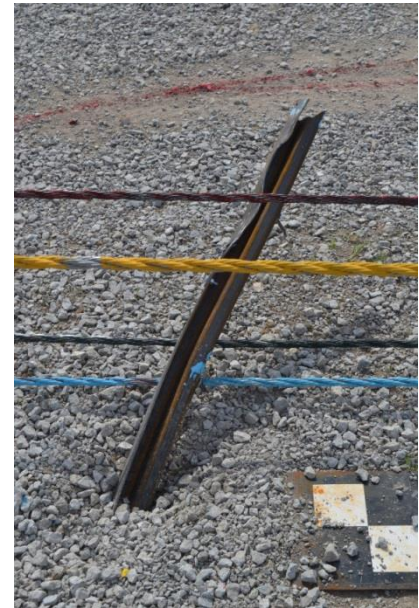
Figure 103. System Damage, Post Nos. 32 through 34, Test No. MWP-3

Damage to the barrier was moderate, as shown in Figures 103 through 108. Barrier damage consisted of bent posts, disengaged cables, and bent and fractured brackets. The concrete

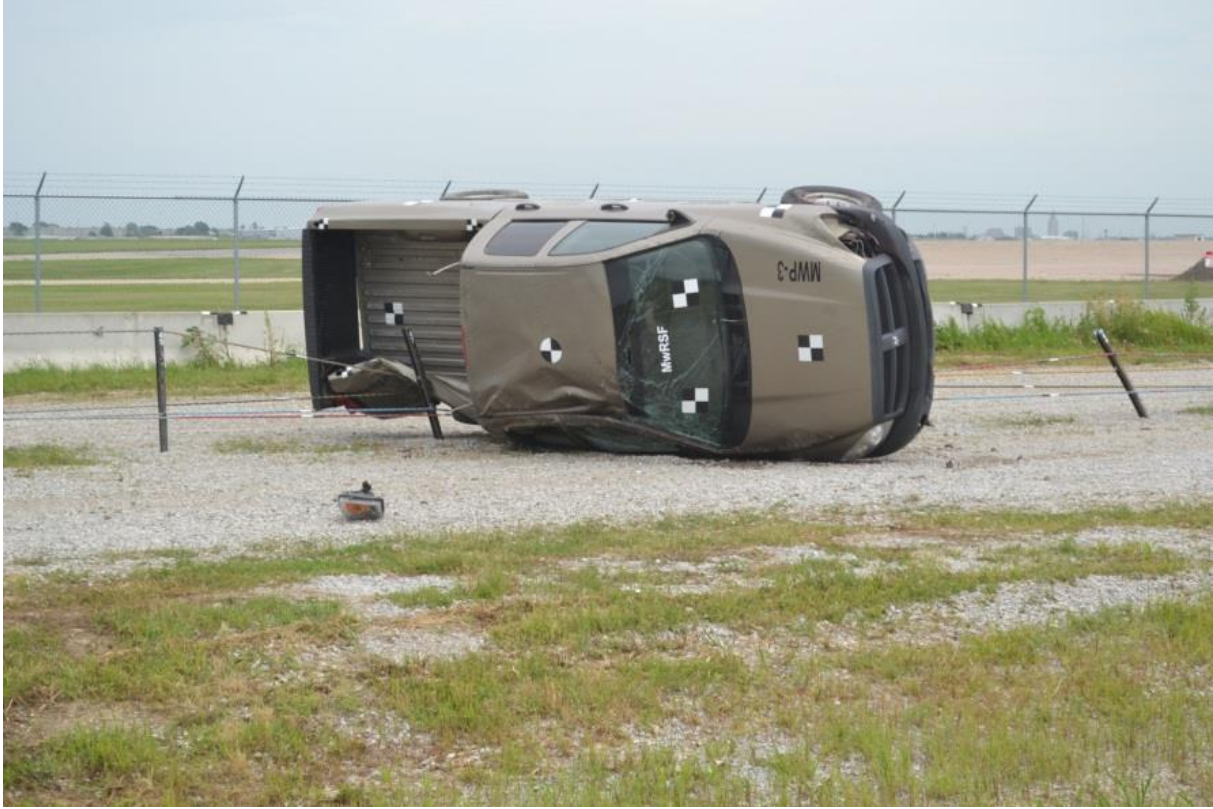
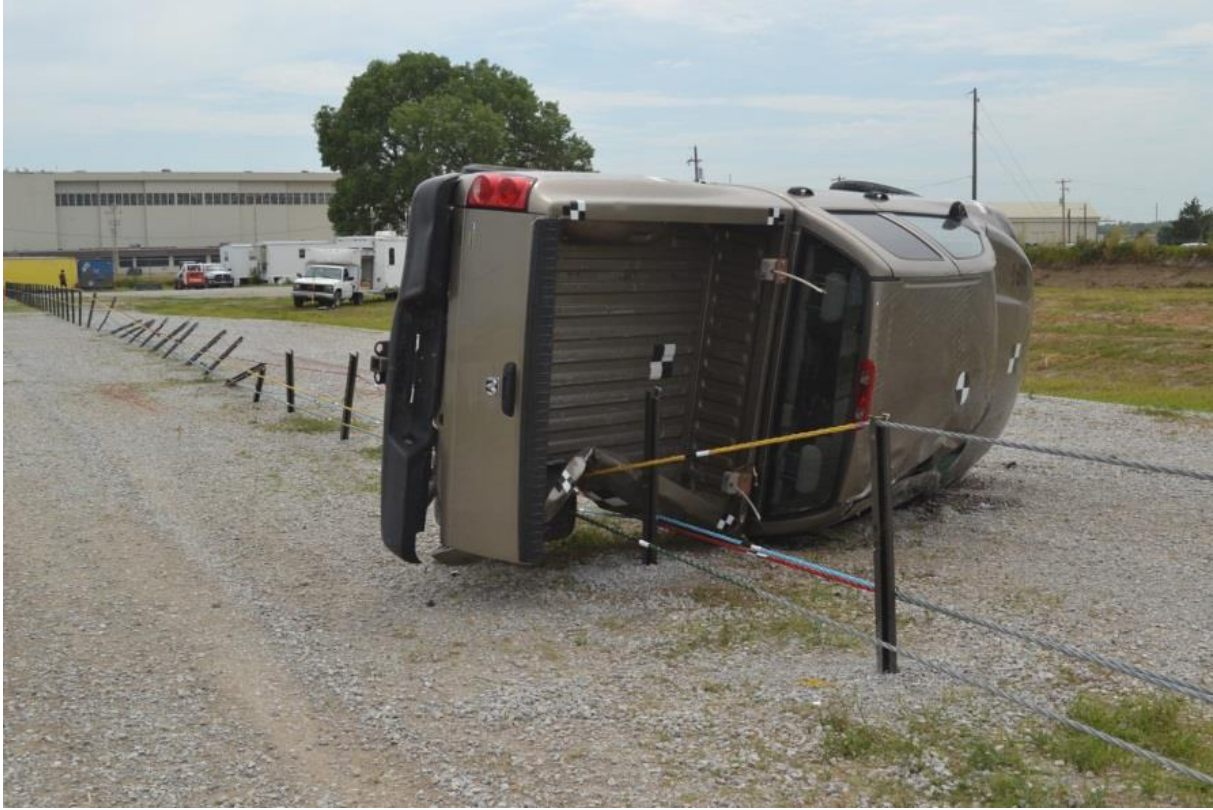
Figure 109. Vehicle Damage, Test No. MWP-3

The damage to the vehicle was extensive, as shown in Figures 109 and 110. The maximum occupant compartment deformations are listed in Table 16, along with the deformation limits established in MASH for various areas of the occupant compartment. Note that the MASH-established deformation limits for the roof were violated. Complete occupant compartment and vehicle deformations and the corresponding locations are provided in Appendix D.

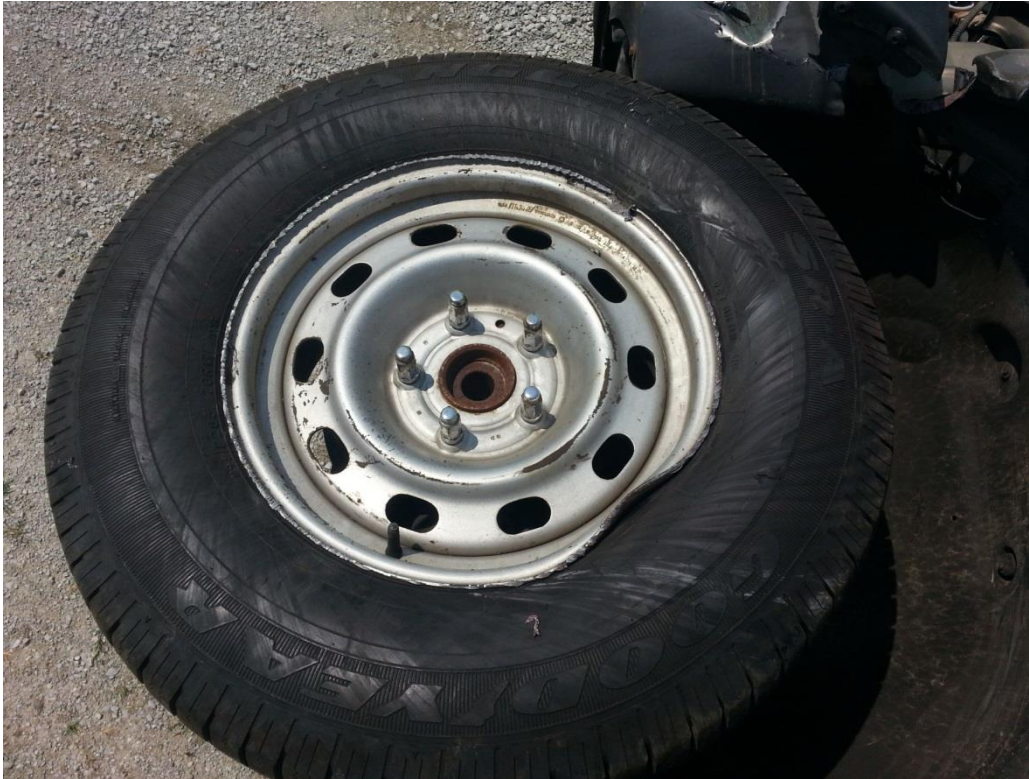
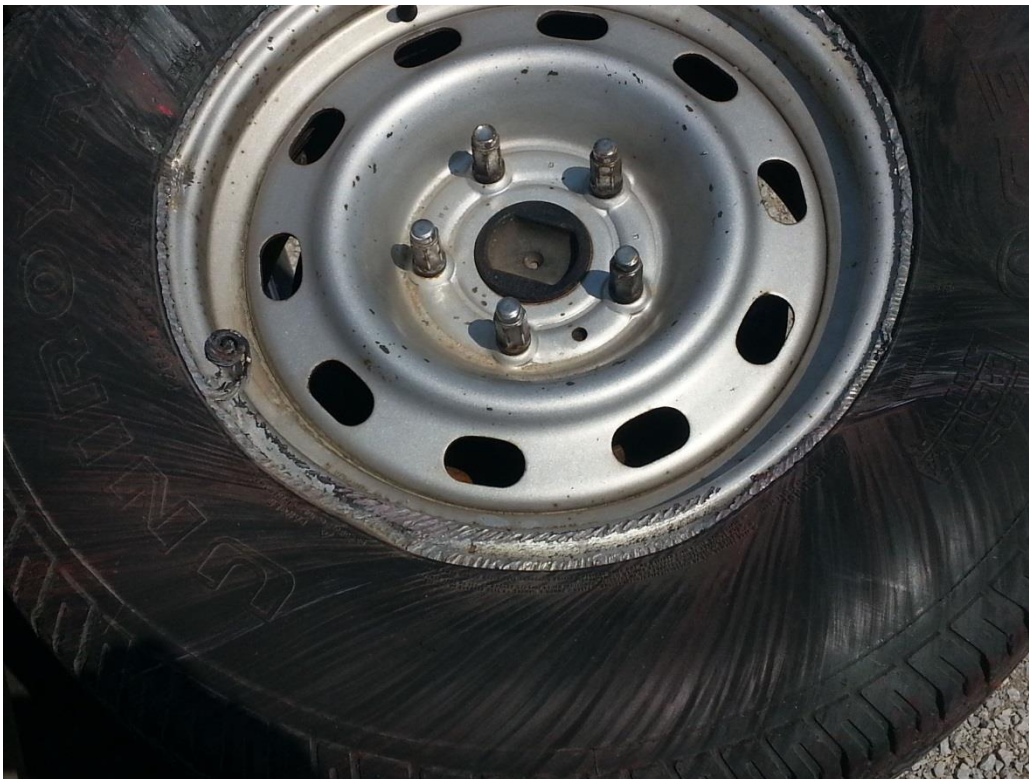
Figure 111. Cable Marks and Gouges on Left Side Wheel Assemblies, Test No. MWP-3

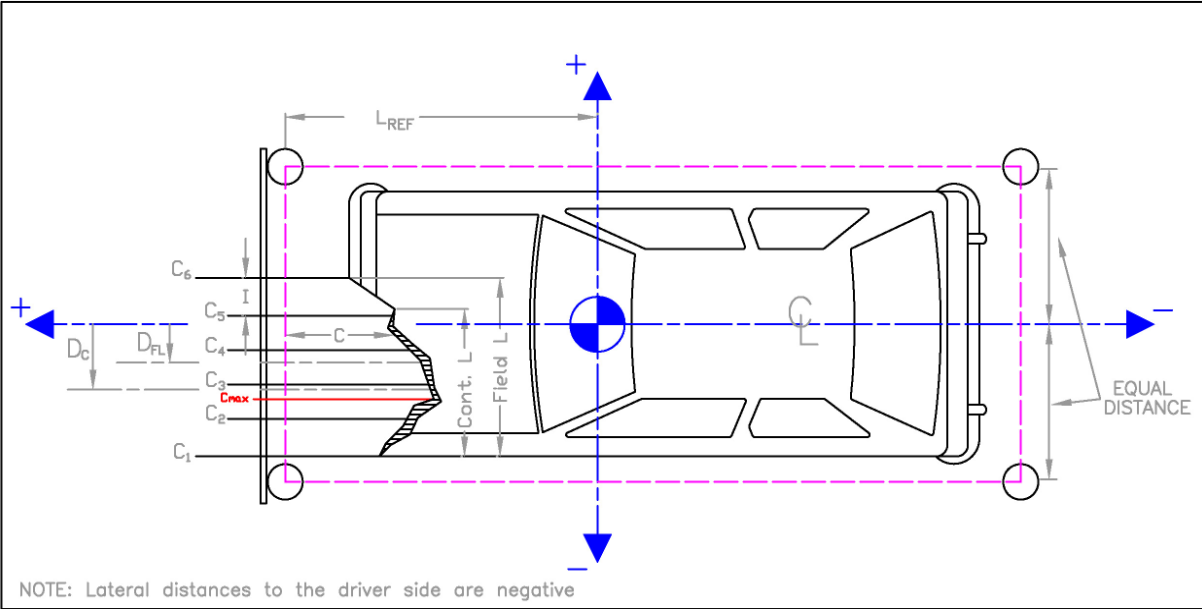
Figure D-5. Exterior Vehicle Crush (NASS) - Front, Test No. MWP-1

in.	(mm)
Distance from C.G. to reference line - L <sub>REF</sub> :	89	(2261)
Width of contact and induced crush - Field L:	68 3/4	(1746)
Crush measurement spacing interval (L/5) - I:	13.75	(349)
Distance from center of vehicle to center of Field L - D <sub>FL</sub> :	0	(0)
Width of Contact Damage:	68 3/4	(1746)
Distance from center of vehicle to center of contact damage - D <sub>C</sub> :	0	(0)
