No. FHWA/RD-80/502

SH TESTS OF SMALL HIGHWAY SIGN SUPPORTS

May 1980

Interim Report

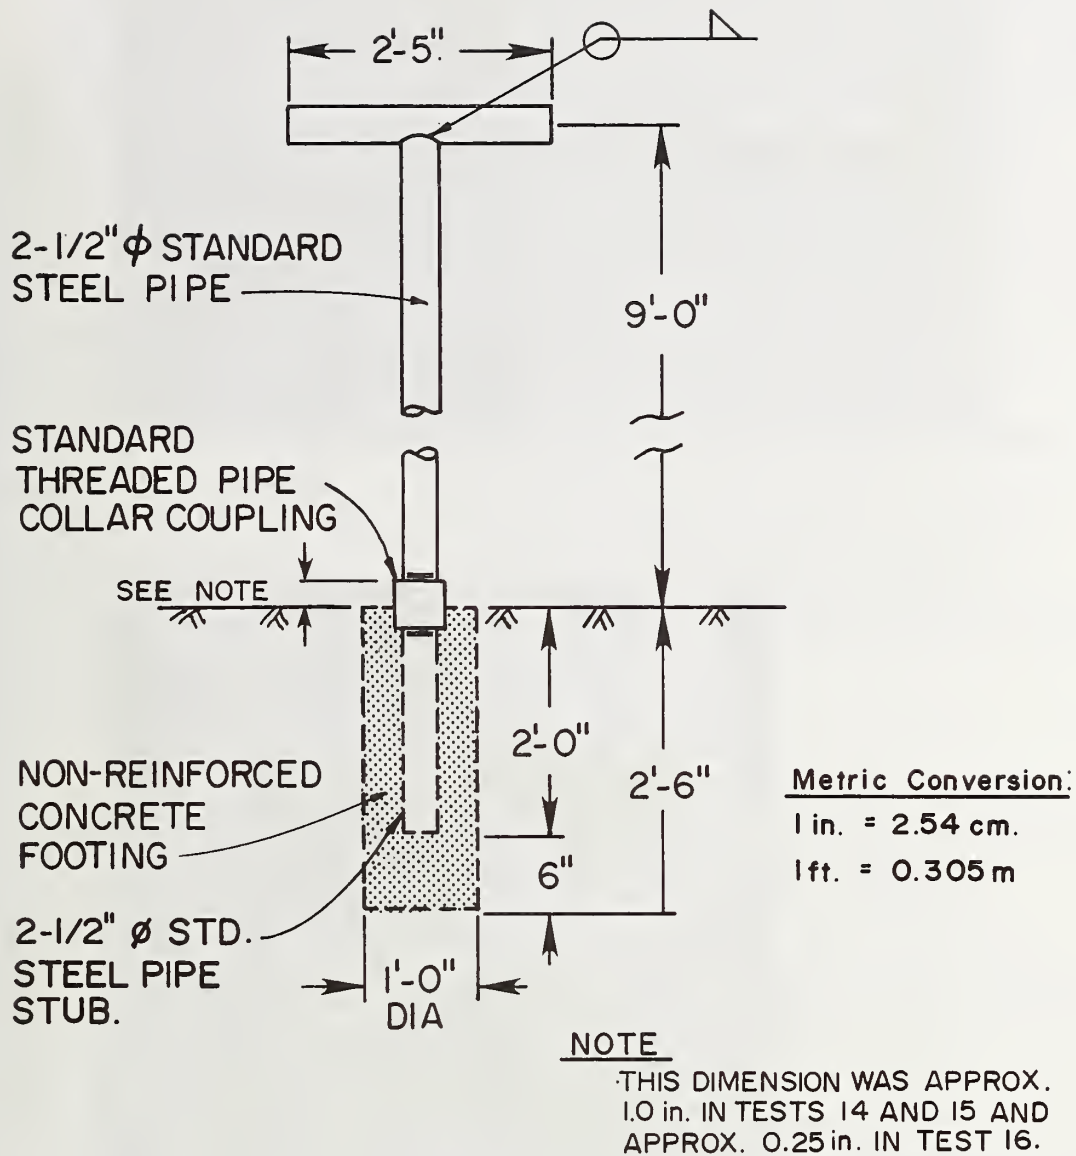
Figure 24. Steel pipe with breakaway coupling, tests 14, 15, and 16.

As noted in Figure 24, the collar was embedded to within approximately 1.0 in. (2.54 cm) of the top of the footing in tests 14 and 15 and to within approximately 0.25 in. (0.64 cm) in test 16. Also, in tests 14 and 15, the collar was greased prior to embedment so that the concrete would not bond to the collar. It was anticipated that upon impact either the signpost would fracture in the threaded portion at or just above the top of the collar, or, the

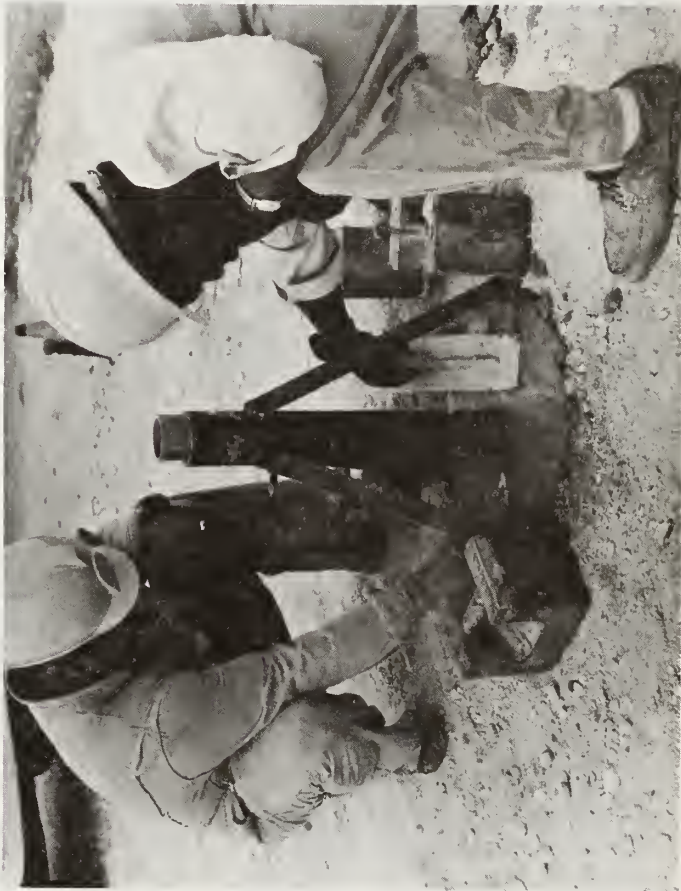
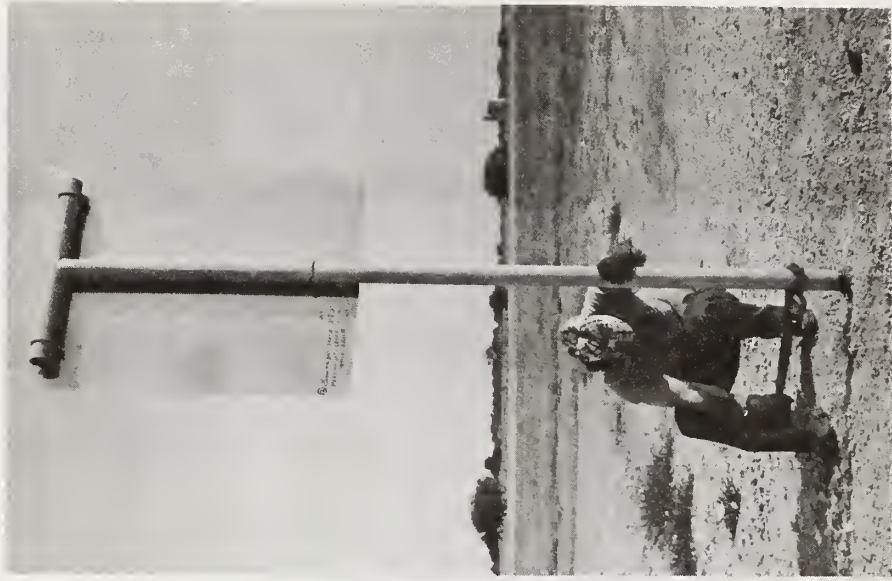
Figure 25. Installation of pipe with breakaway collar, tests 14, 15, and 16.

Installation is accomplished by first pouring a concrete footing with the stub and collar embedded in the concrete. Then, after the concrete has cured, the threaded post with panel attached is inserted and screwed into the collar. Photos of the installation are shown in Figure 25.

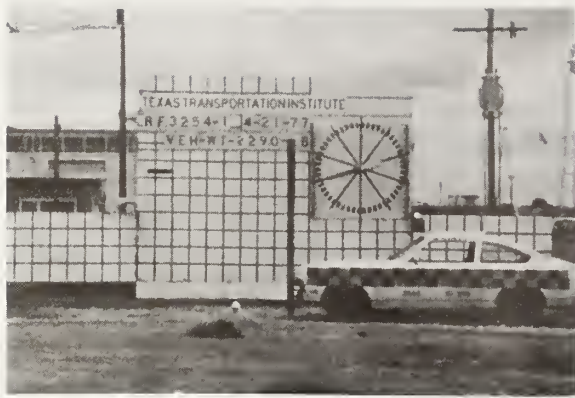
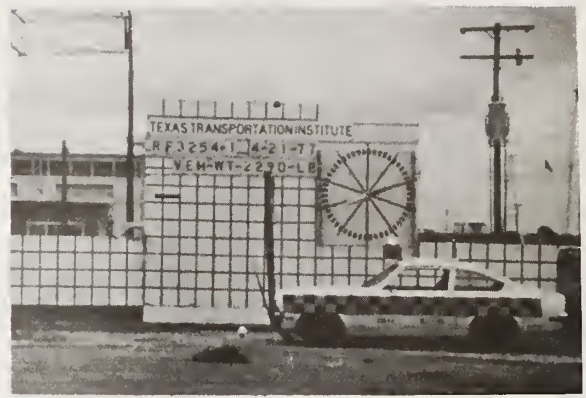
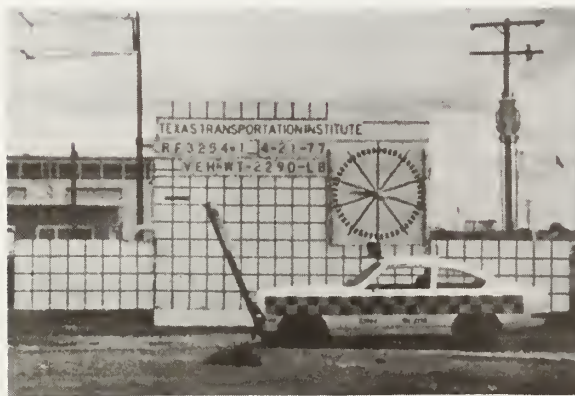
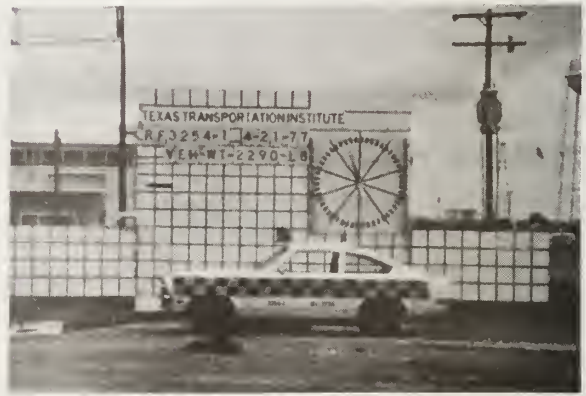
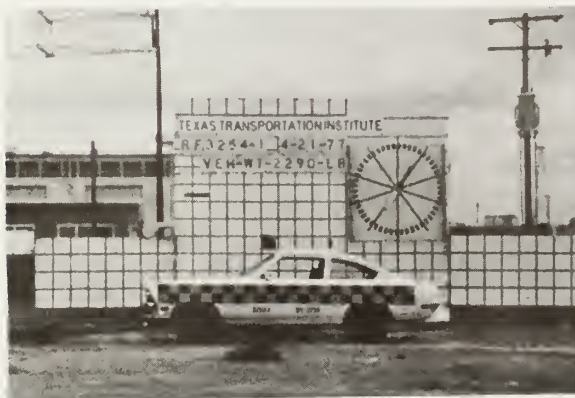
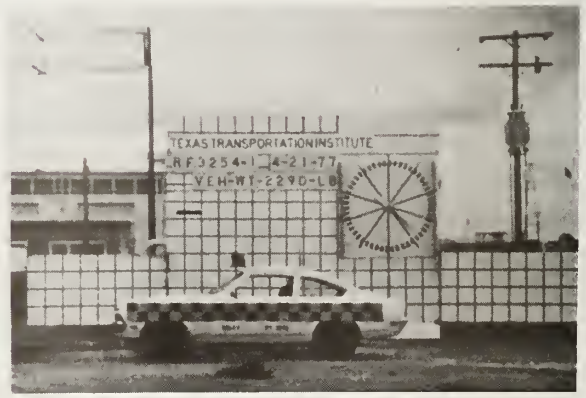
Figure 32. Sequential photos, test 1.

Table 9 summarizes the results of test 1. Figure 32 contains sequential photos from the high-speed film taken during impact, and Table 10 contains a time-displacement-event summary. Note that upon impact the wood post fractured at or near bumper height and at or near ground level. Also note that the panel and post were rotated down and projected out in front of the vehicle. Figures 33, 34, and 35 contain deceleration, change in momentum, and free missile travel versus time data. Figure 36 shows damage to the sign installation. Restoration would involve the installation of a new post. The panel and hardware were reusable after some refurbishment to the panel. Figure 37 shows the vehicle damage. Vehicle damage was assessed according to the TAD and SAE scales and is given in Table 9.

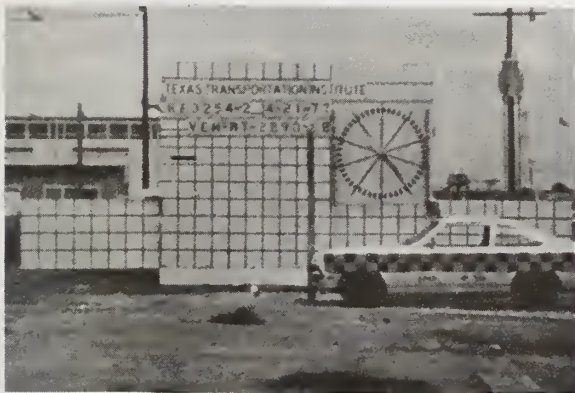
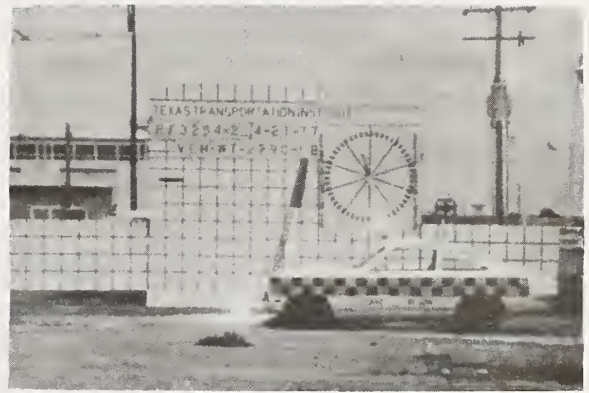
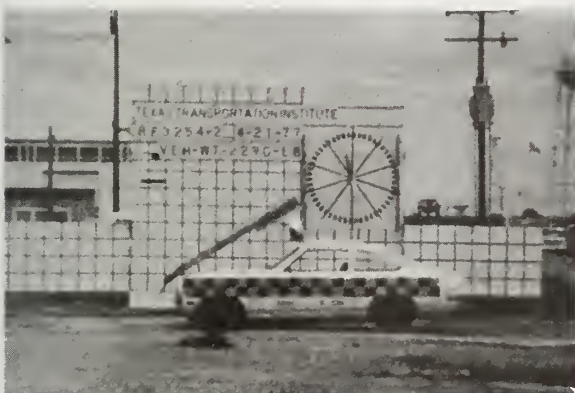
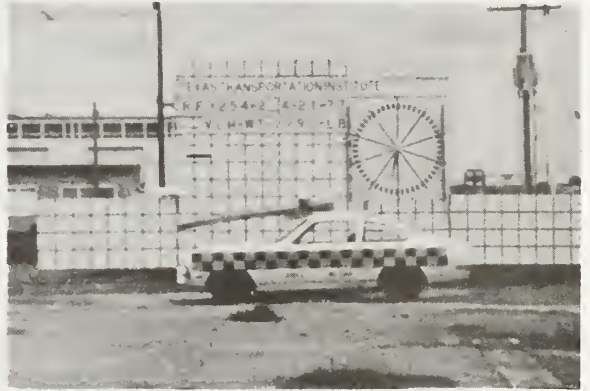
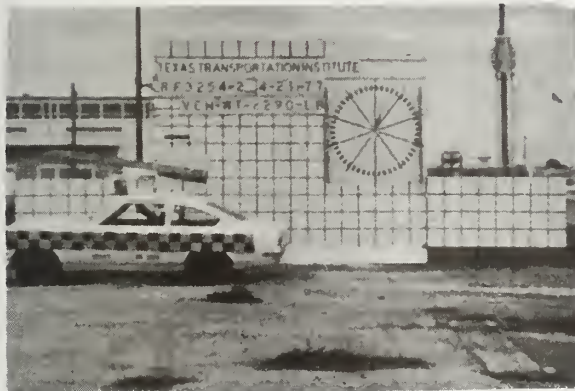
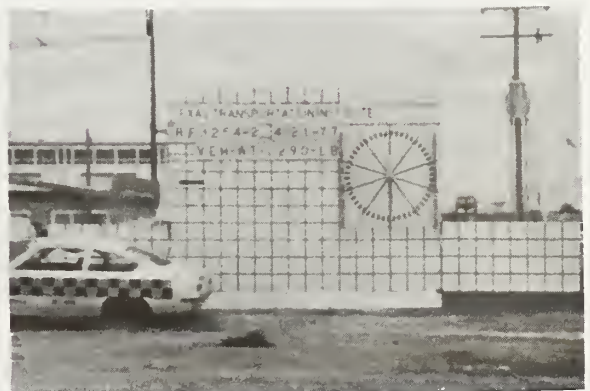
Figure 38. Sequential photos, test 2.

Table 11 summarizes the results of test 2. Figure 38 contains sequential photos from high-speed film taken during impact, and Table 12 contains a time-displacement-event summary. Note that upon impact the base of the post was kicked up and the panel rotated down on the roof. Although the panel appeared to move little in the horizontal direction until impact with the roof, the horizontal velocity of the post-panel combination was computed to be approximately 65 ft/sec (19.8 m/s). Vehicle velocity was about 89 ft/sec (27.2 m/s) when the panel hit the roof. During contact, friction between the panel and the roof slightly accelerated the post-panel combination in the horizontal direction. One can only speculate as to the results if a larger vehicle had hit the installation. The hood of a full-size automobile, which is higher than the Vega, would change the kinematics of the panel-post combination after impact, probably resulting in a larger longitudinal and rotational velocity. The length of the hood is longer on the full-size car, and this could increase the potential for windshield impact by the panel. However, after studying this test, and the other 21 tests in the project, it is the authors' opinion that although impact with the windshield may occur, test article penetration into the passenger compartment can be prevented to a large degree by making sure the panel remains on the post after impact. Design criteria for panel-to-post fasteners are given in Chapter III.

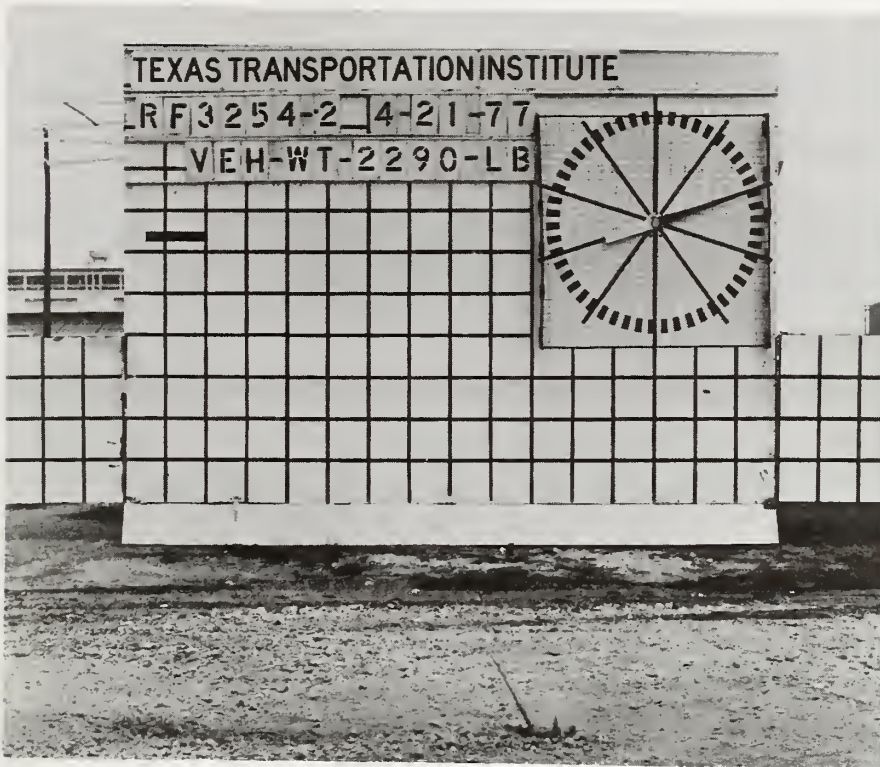
(a) SIDE VIEW

Figures 39, 40, and 41 contain deceleration, change in momentum, and free missile travel versus time data. Figure 42 shows the damage to the sign installation. Restoration would involve the installation of a new post. The panel and hardware were reusable after some refurbishment to the panel. Figure 43 shows the vehicle damage. Damage is that on the right side of the vehicle. (Damage on the left side was the result of test 1.) Vehicle damage was assessed according to the TAD and SAE scales and is given in Table 11.

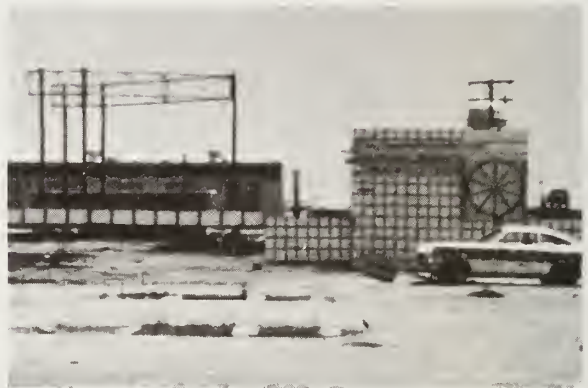
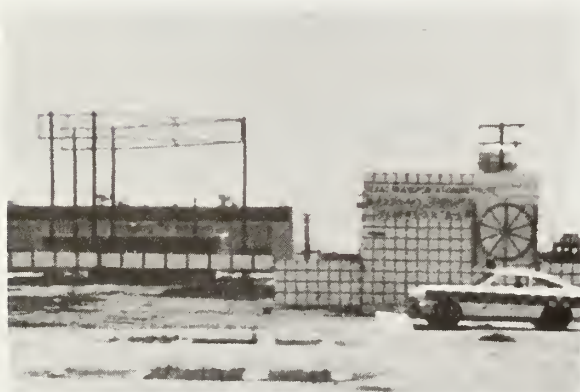
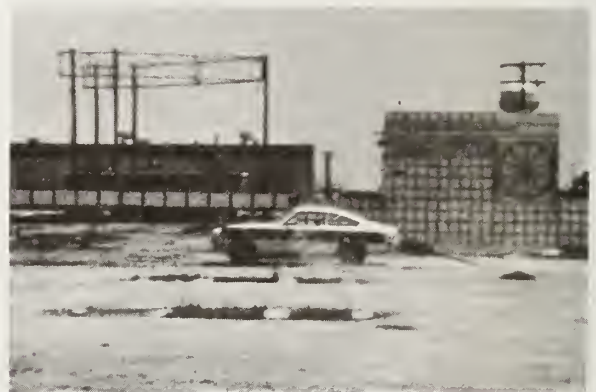
Figure 44. Sequential photos, test 3.

Table 13 summarizes the results of test 3. Figure 44 contains sequential photos from high-speed film taken during impact, and Table 14 contains a time-displacement-event summary. Upon impact, the post bent near the groundline and was ridden down by the vehicle. Figures 45, 46, and 47 contain deceleration, change in momentum, and free missile travel versus time data. Figure 48 shows damage to the sign installation. Restoration would involve the installation of a new post. The panel and hardware were reusable. As shown in Figure 49 there was little vehicle damage. Vehicle damage was assessed according to the TAD and SAE scales and is given in Table 13.

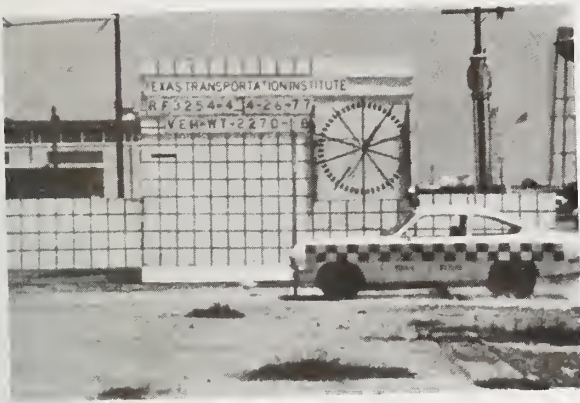
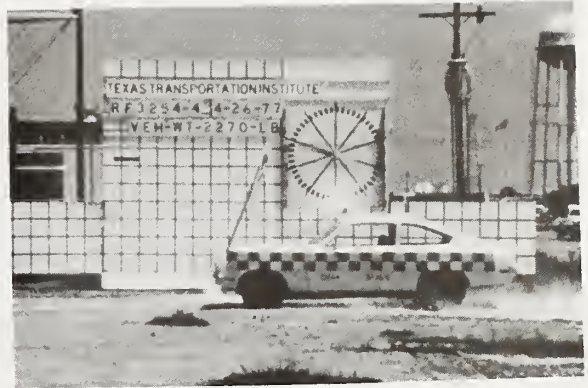
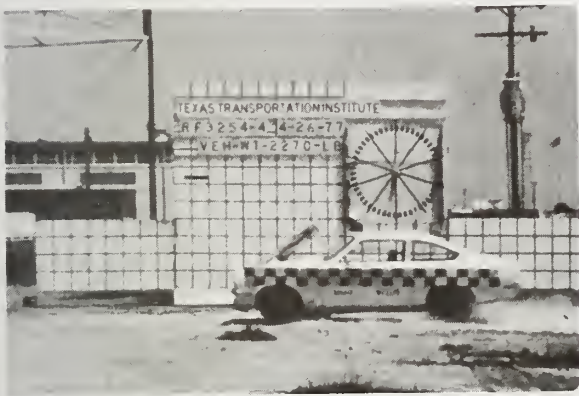
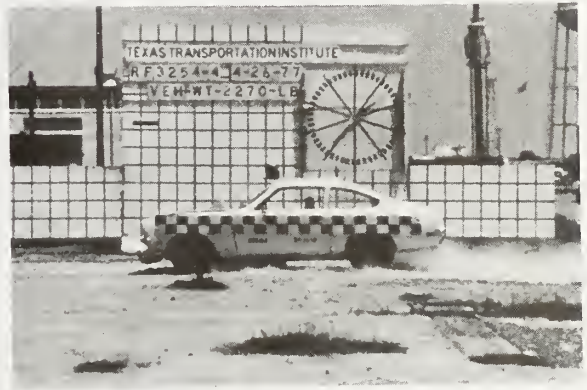
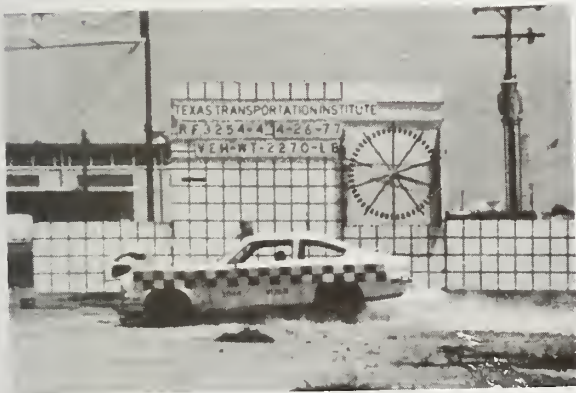
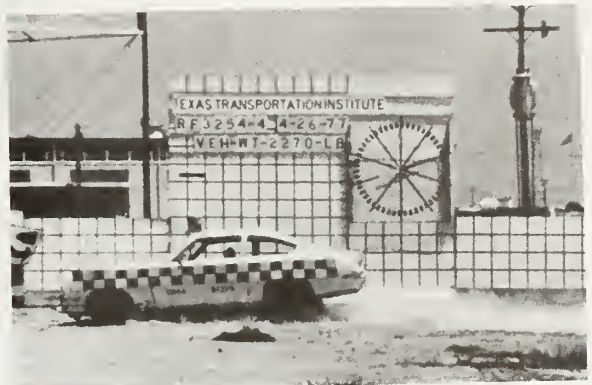
Figure 50. Sequential photos, test 4.

Table 15 summarizes the results of test 4. Figure 50 contains sequential photos from high-speed film taken during impact, and Table 16 contains a time-displacement-event summary. After impact, the post underwent considerable bending and momentarily wrapped around the hood of the vehicle. As the vehicle continued its forward motion, the post was straightened out and ridden down. Note that the panel was stripped from the post. Although the post was torn, it did not fracture. As a consequence of this action, the post imparted significant resistance to the vehicle's forward movement, producing a relatively large change in momentum. Although it did not occur, the vehicle appeared to be near rollover in test 4. After impact the vehicle began to yaw and roll. Then the cable guidance applied a steer correction which stabilized the yaw and roll motions and apparently prevented rollover. Further discussion of the impact performance of this type post is given in Section A-3-22.

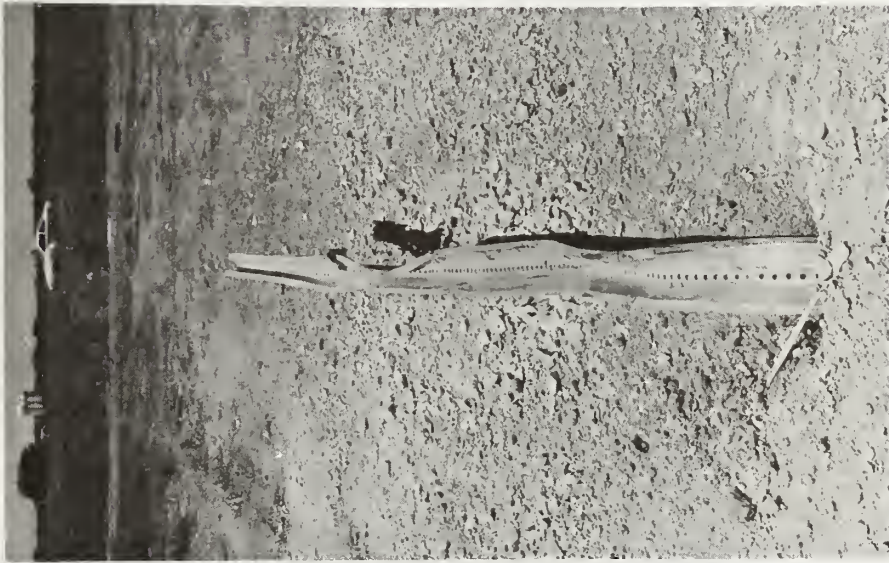
Figure 54. Sign installation damage, test 4.

Figures 51, 52, and 53 contain deceleration, change in momentum, and free missile travel versus time data. Figure 54 shows damage to the sign installation. Restoration would involve replacement of the complete installation. Figure 55 shows damage to the vehicle. Vehicle damage was assessed according to the TAD and SAE scales and is given in Table 15.

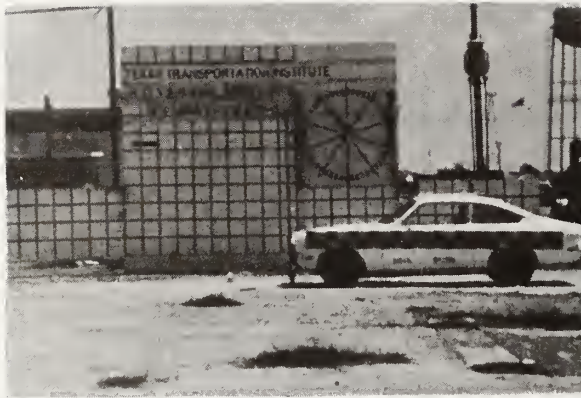
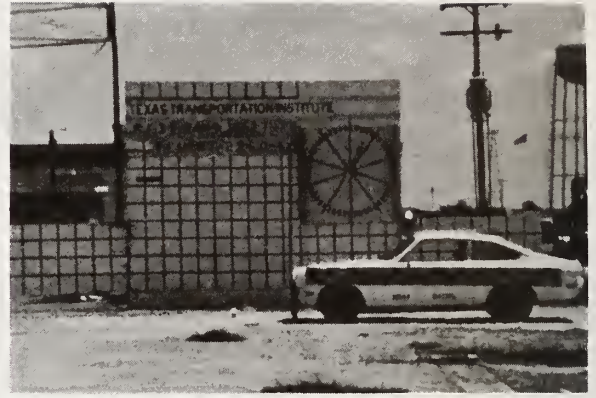
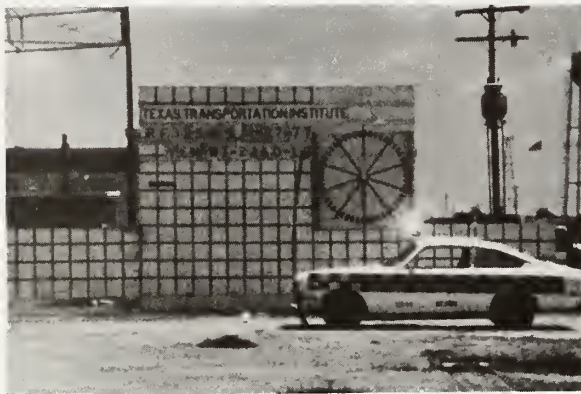
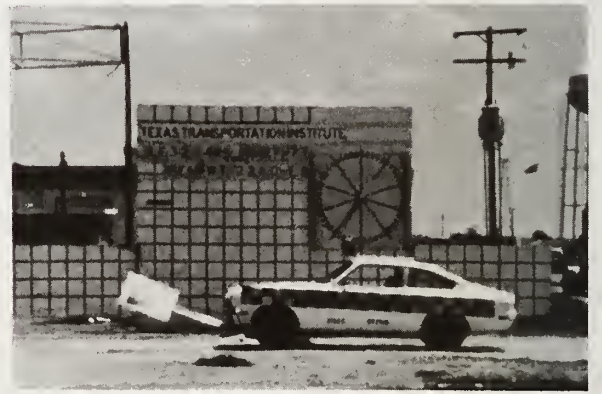
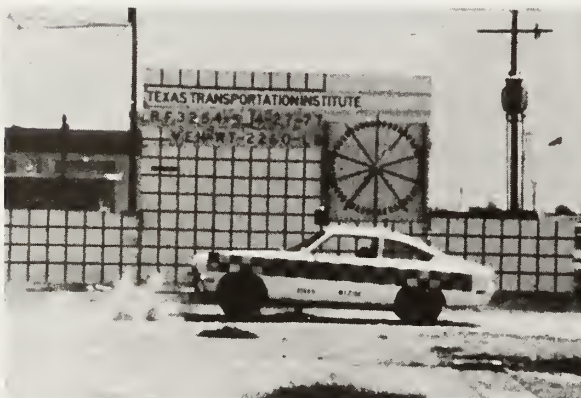
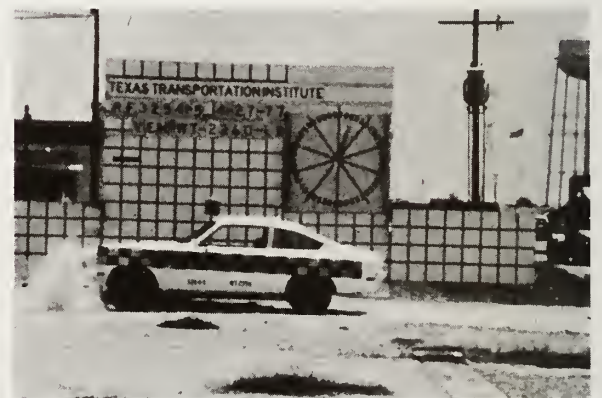
Figure 56. Sequential photos, test 5.

Table 17 summarizes the results of test 5. Figure 56 contains sequential photos from high-speed film taken during impact, and Table 18 contains a time-displacement-event summary. After impact, the post began to bend slightly at the bumper position. At about 0.023 sec after impact the coupling broke and the post began to move forward and rotate down. Then the two retaining straps bottomed out and held the base of the post for a short duration. This restraining action at the base along with the inertia resistance from the upper portion of the post and the panel combined to cause a relatively large bending moment in the post. The end result was a bent signpost and a slight bend in the stub post. It appears that removal of the retaining straps would reduce impact damage to both the signpost and the stub post. Also, the retaining ability of the straps, which was their intended purpose, seems doubtful since they fractured in this low-speed impact. Further testing is needed to evaluate the design without the straps.

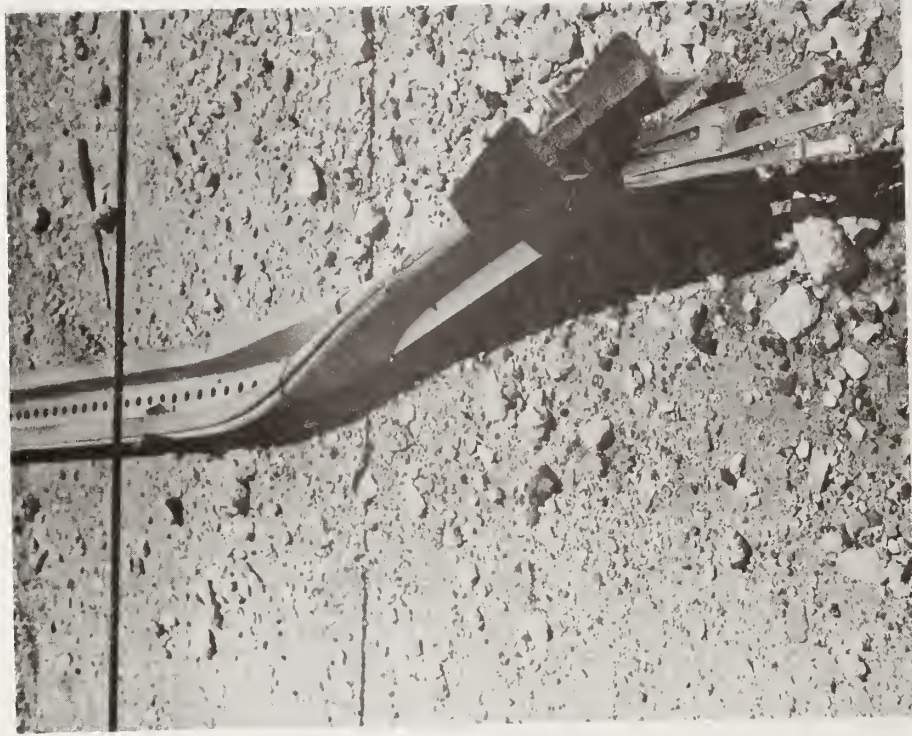
(b) POST AND COUPLING

Figures 57, 58, and 59 contain deceleration, change in momentum, and free missile travel versus time data. Figure 60 shows damage to the sign installation. Restoration would involve replacement of the signpost, coupling, and retaining straps. The stub could possibly have been straightened and reused. The sign panel was reusable. A noteworthy characteristic of this system is that the signpost, if damaged, will usually have salvage value. It can be cut and used as a stub(s). Figure 61 shows damage to the vehicle. Vehicle damage was assessed according to the TAD and SAE scales and is given in Table 17.

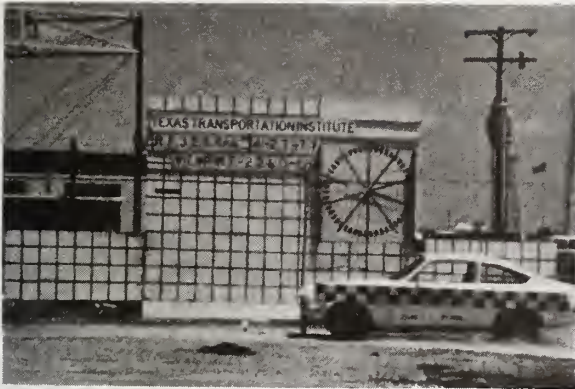
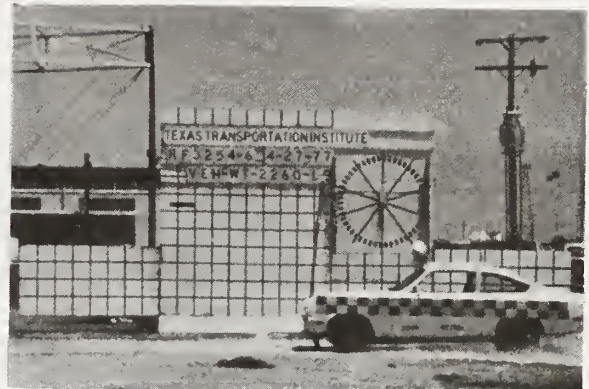
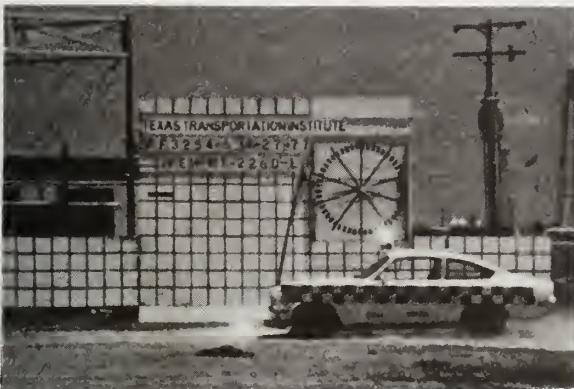
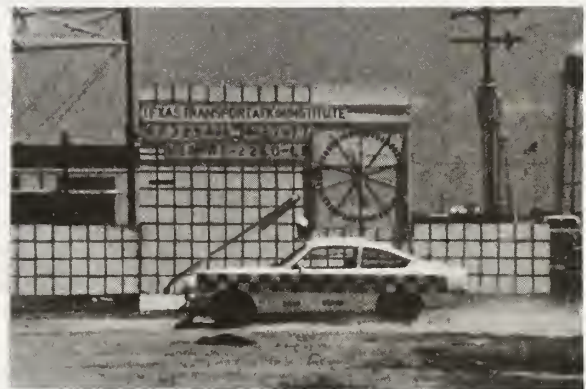
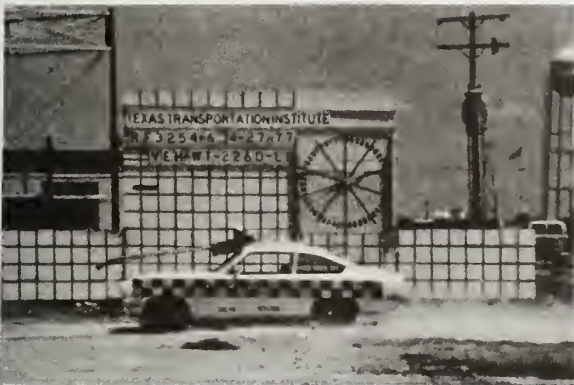
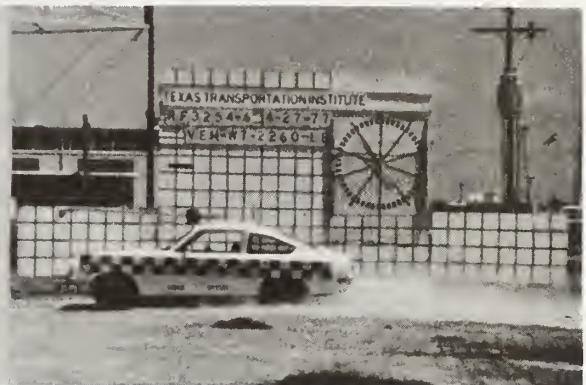
Figure 62. Sequential photos, test 6.

Table 19 summarizes the results of test 6. Figure 62 contains sequential photos from high-speed film taken during impact, and Table 20 contains a time-displacement-event summary. Shortly after impact the coupling and the retainer straps fractured. The post then rotated and was projected forward. The sign panel impacted the top edge of the windshield and the roof. After impact the velocity of the post and panel was only slightly less than that of the vehicle.

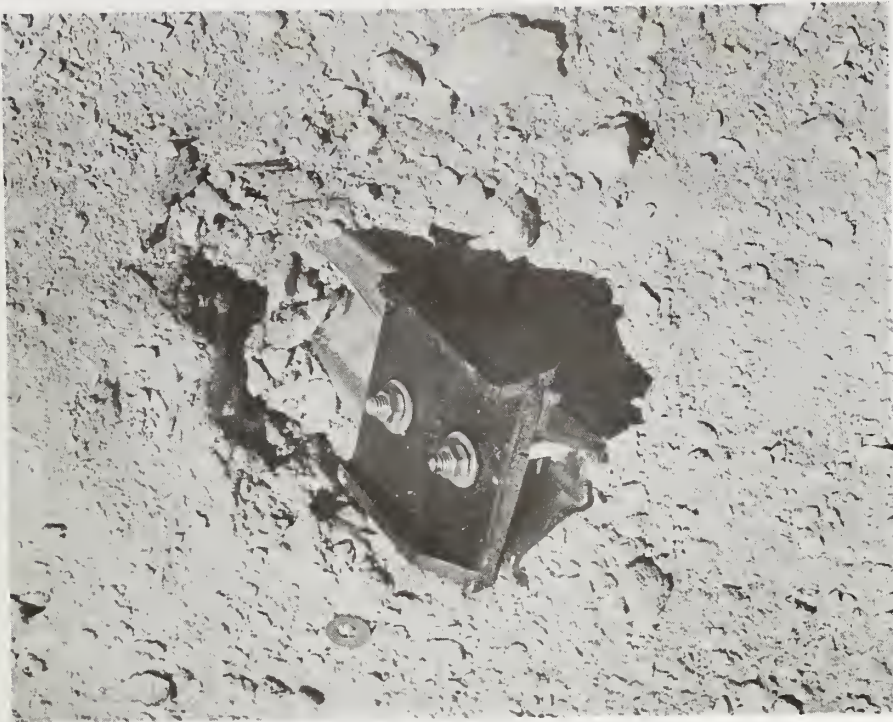
(b) CLOSE-UP VIEW

Figures 63, 64, and 65 contain deceleration, change in momentum, and free missile travel versus time data. Figures 66 and 67 show sign installation damage. Damage was similar to that in test 5. Although the signpost was not bent as much as the post in test 5, the stub post was bent more in test 6 than in test 5. Removal of the retainer straps would likely reduce the impact damage to the signpost and the stub. However, full-scale testing would be necessary to evaluate the design without straps. Restoration after the high-speed tests would involve replacement of the coupling, retainer straps, and the stub. It is questionable as to whether the signpost could have been straightened. If not, it would have had salvage value since it could have been cut and used as a stub(s).

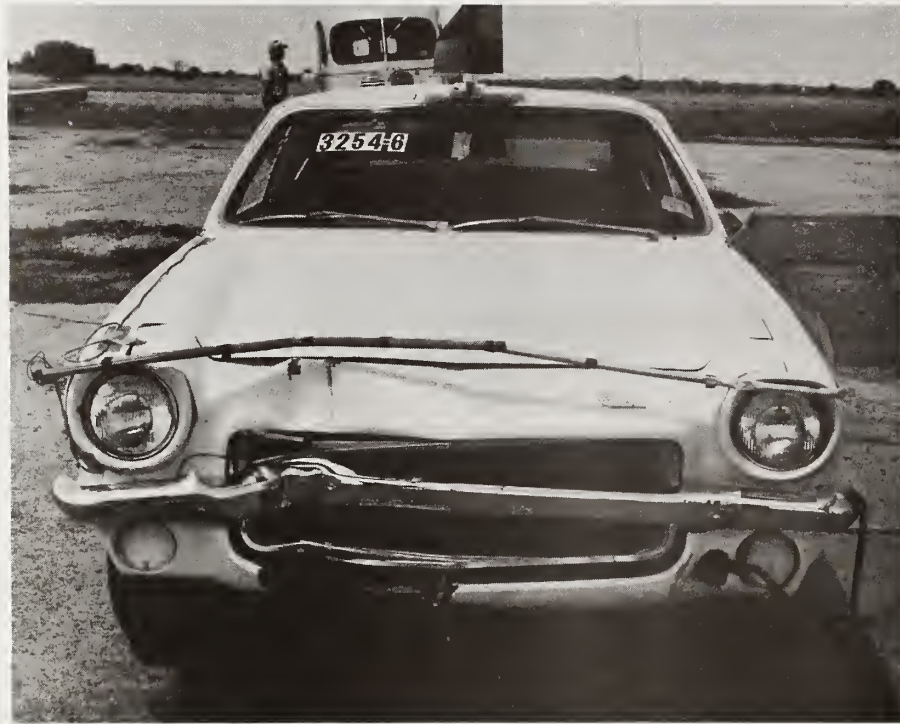
Figure 68. Vehicle damage, test 6.

Figure 68 shows damage to the vehicle. Damage to the right front of the vehicle was caused by test 6, and damage to the left front was caused by test 5. Damage caused by test 6 was assessed according to the TAD and SAE scales and is given in Table 19.

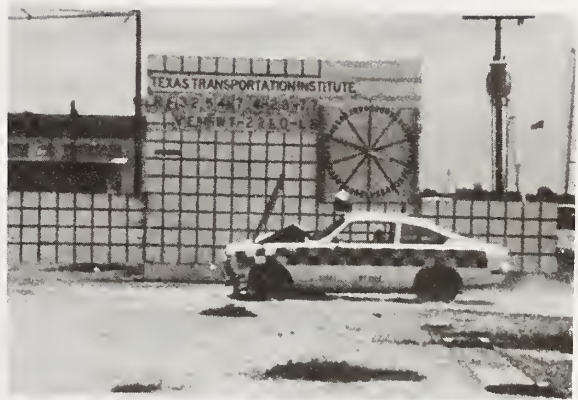
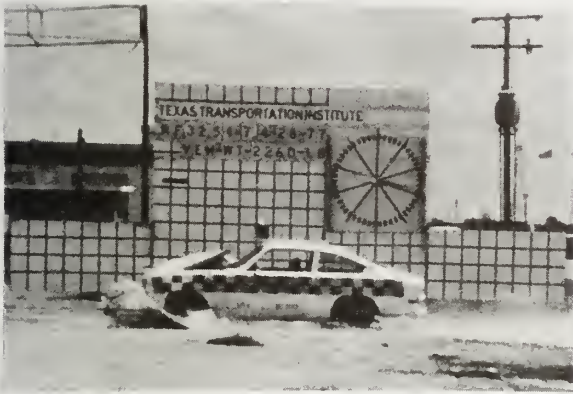
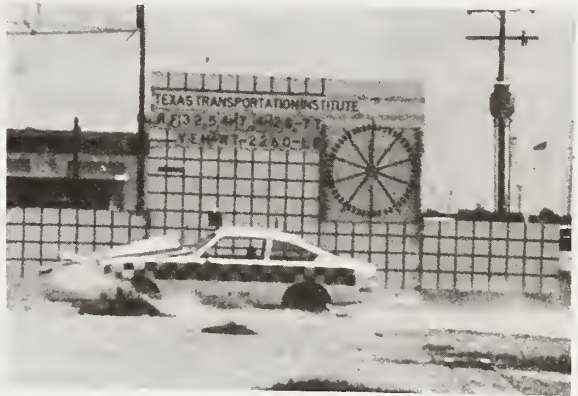
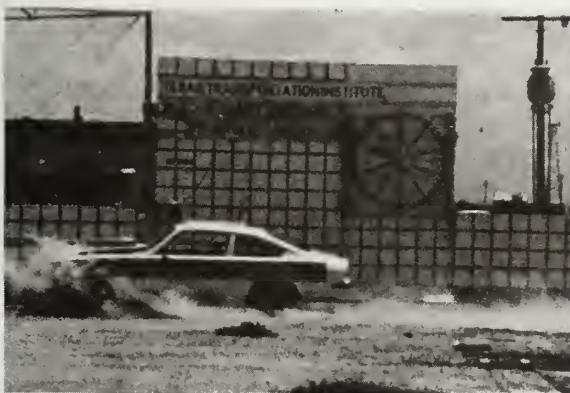
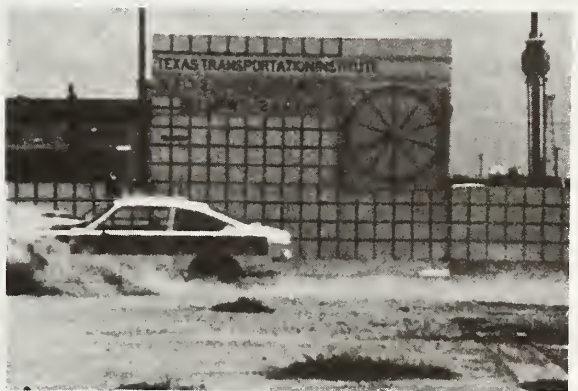
Figure 69. Sequential photos, test 7.

Table 21 summarizes the results of test 7. A 20 mph (32 km/h) test was not conducted on this system since recent tests by others had indicated satisfactory performance at low speeds (see Table B-6 of Reference 1). Figure 69 contains sequential photos from high-speed film taken during impact, and Table 22 contains a time-displacement-event summary. Upon impact the post began to bend at bumper height. Continued vehicle movement caused the post to fracture at its juncture with the stub. The post continued to wrap around the hood of the vehicle, pushing the hood into the windshield. Although the windshield was broken, the hood did not penetrate through to the passenger compartment. The post and panel remained with the vehicle for about 75 ft (22.9 m) before falling to the ground.

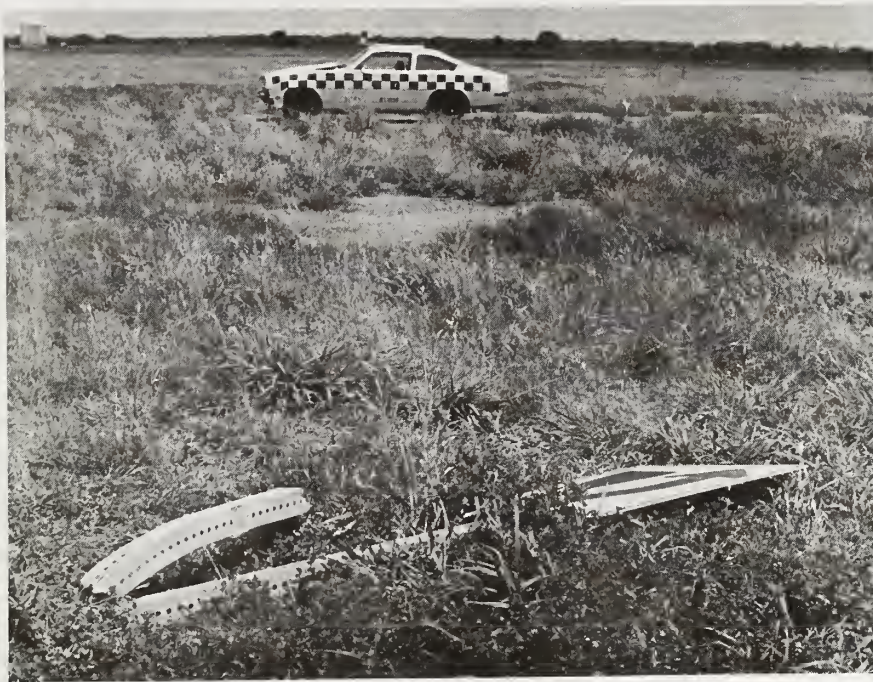
Figure 73. Sign installation damage, test 7.

Figures 70, 71, and 72 contain deceleration, change in momentum, and free missile travel versus time data. Figure 73 shows the sign installation damage. Restoration would involve replacement of the signpost. The panel, stub, and hardware were reusable. It should be noted that in most cases the signpost will have salvage value in that it can be used as a stub for a smaller signpost.

(a) POST AND PANEL

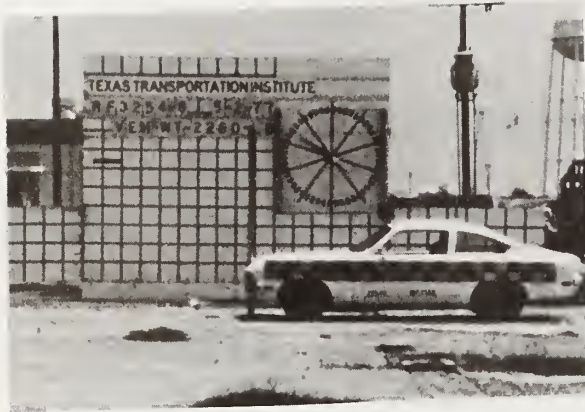
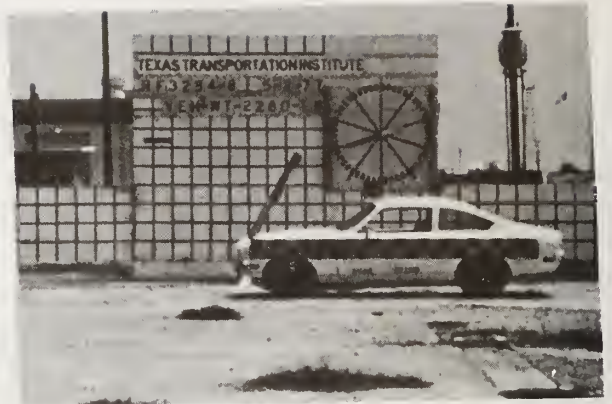
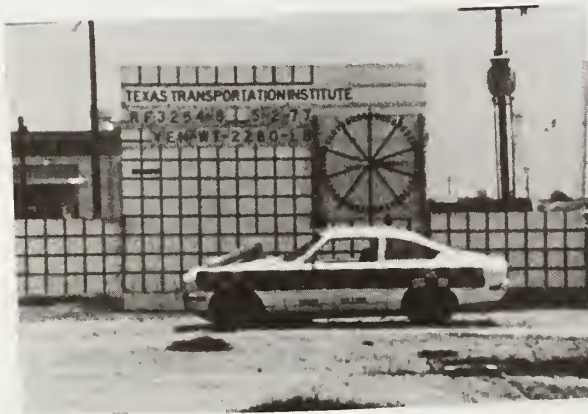
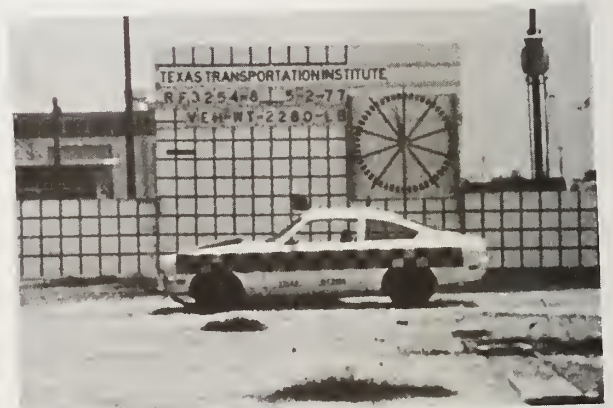
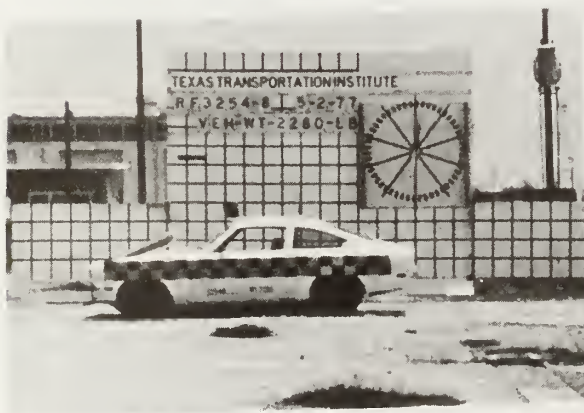
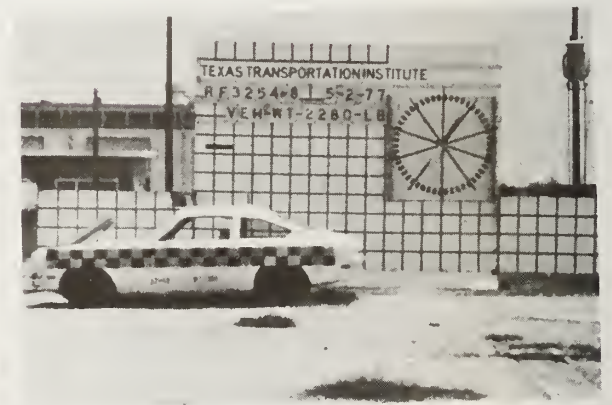
Figure 75. Sequential photos, test 8.

Table 23 summarizes the results of test 8. Based on results of tests 3 and 4, it was concluded that a high-speed impact with yielding or base bending supports was more severe than a low-speed impact. The aluminum type 3X post was therefore impacted at a high speed only. Figure 75 contains sequential photos from high-speed film taken during impact, and Table 24 contains a time-displacement-event summary. After impact the post wrapped around the hood and then the post fractured at ground level. The post and panel were carried along with the vehicle until it stopped. It can be seen that the panel and post were never in any danger of impacting the windshield. Impact performance of the system was considered to be very good.

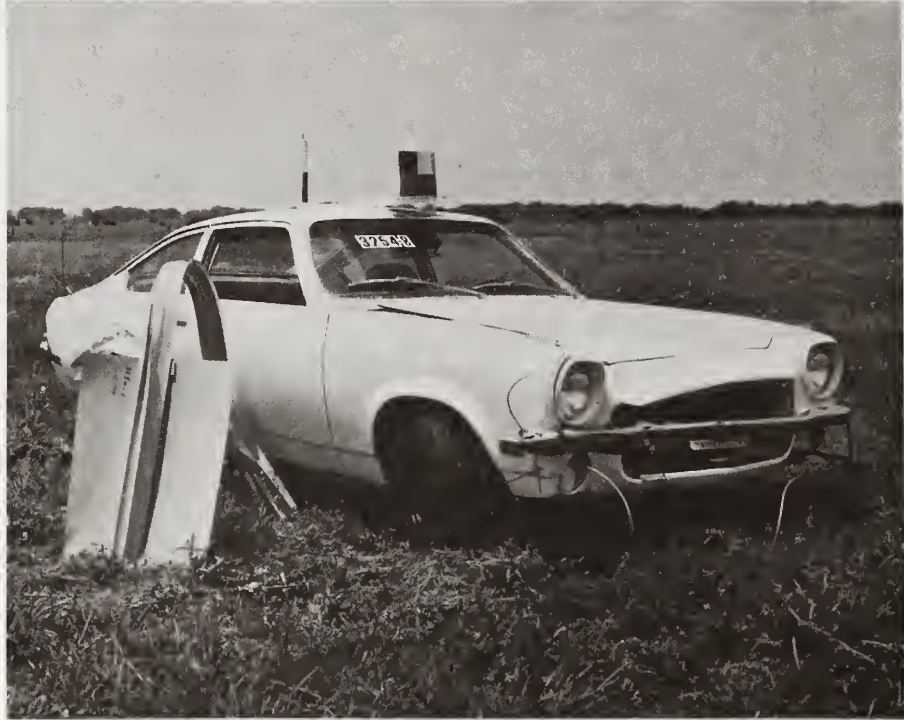
Figure 79. Sign installation damage, test 8.

Figures 76, 77, and 78 contain deceleration, change in momentum, and free missile travel versus time data. Figure 79 shows sign installation damage. Restoration would involve replacement of the signpost. The panel could probably have been straightened and reused.

(a) PANEL AND POST

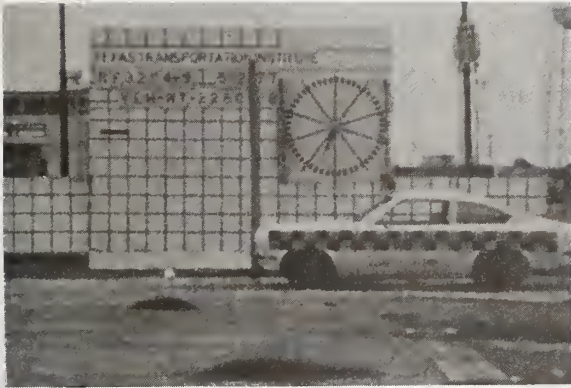
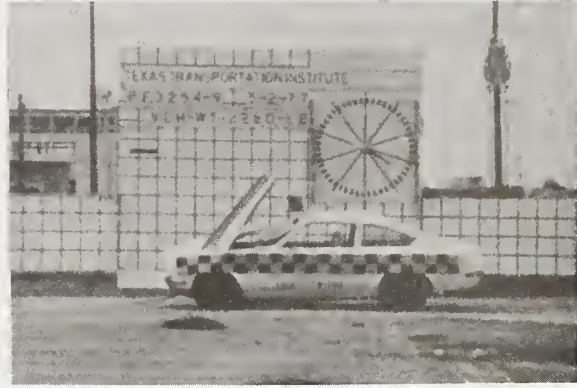
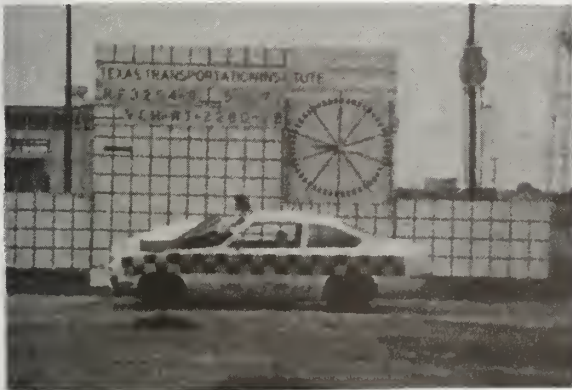
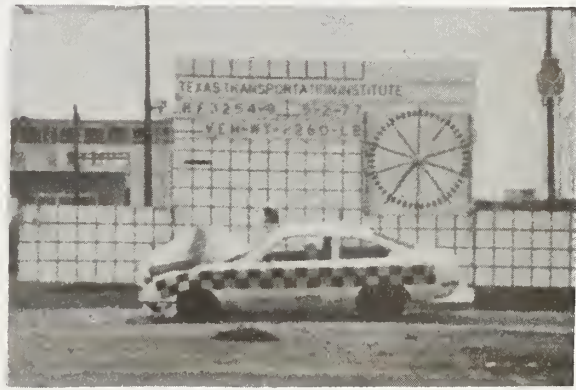
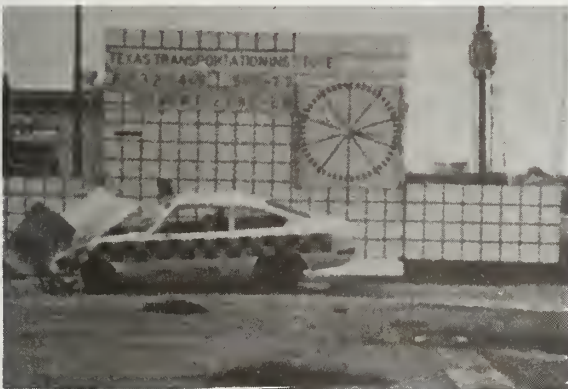
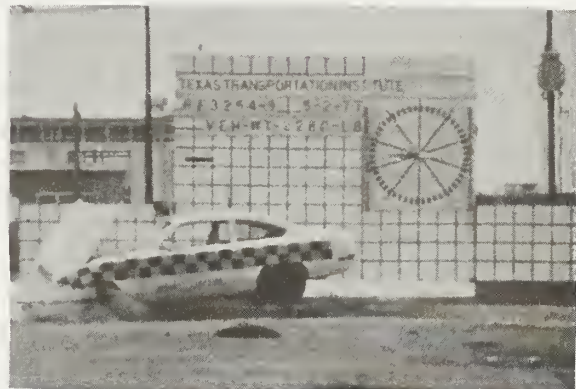
Figure 81. Sequential photos, test 9.

Table 25 summarizes the results of test 9. Based on results of tests 3 and 4, it was concluded that a high-speed impact with this system would be more severe than a low-speed impact. Hence, the system was tested at the high speed only. Figure 81 contains sequential photos from high-speed film taken during impact, and Table 26 contains a time-displacement-event summary. After impact the post wrapped around the hood and imparted relatively high forces to the vehicle. The hood was pushed back into the windshield but did not penetrate into the passenger compartment. Continued forward movement of the vehicle stripped the panel off the post and straightened out the post. Neither of the 3 lb/ft (4.5 kg/m) posts fractured. The bolts used to fasten the two posts in a back-to-back configuration were sheared off. After impact the vehicle spun about 200 degrees and almost rolled over. It came to rest about 50 ft (15.3 m) beyond the point of impact. Further discussion of the impact performance of this type post is given in Section A-3-22.

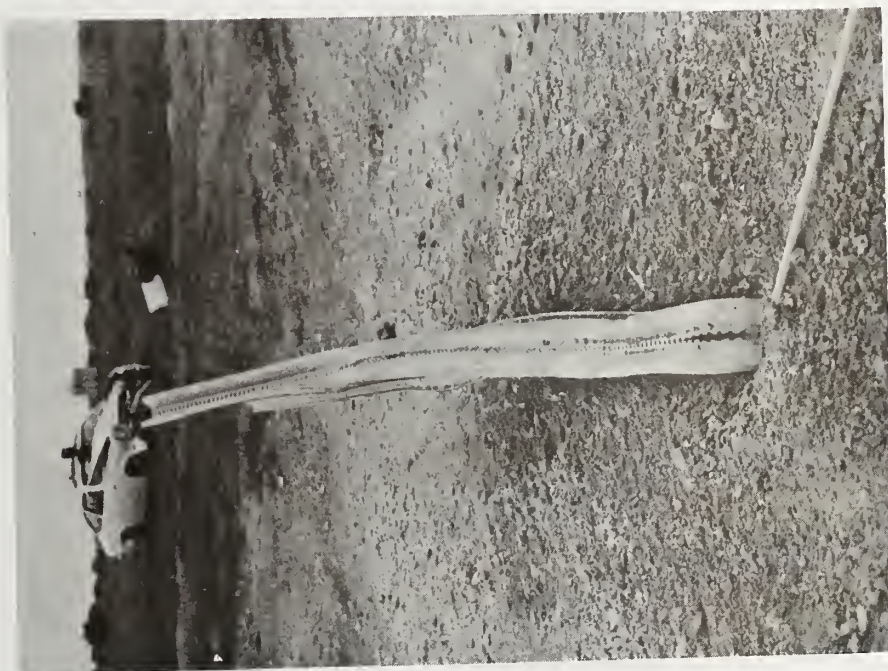
Figure 85. Sign installation damage, test 9.

Figures 82, 83, and 84 contain deceleration, change in momentum, and free missile travel versus time data. Figure 85 shows damage to the sign installation. Restoration would involve replacement of the complete installation. Figure 86 shows damage to the vehicle. Damage was assessed according to the TAD and SAE scales and is given in Table 25.

(a) FRONT VIEW
