No. FHWA/RD-80/502

SH TESTS OF SMALL HIGHWAY SIGN SUPPORTS

May 1980

Interim Report

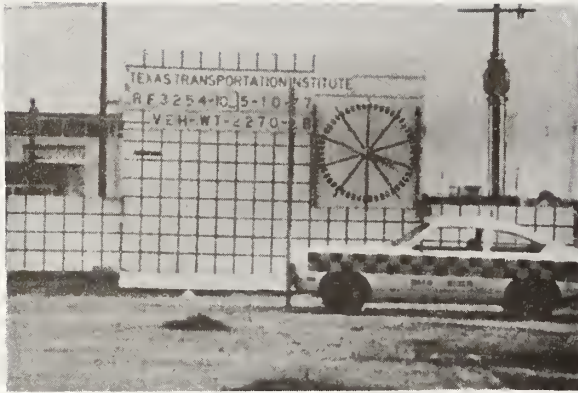
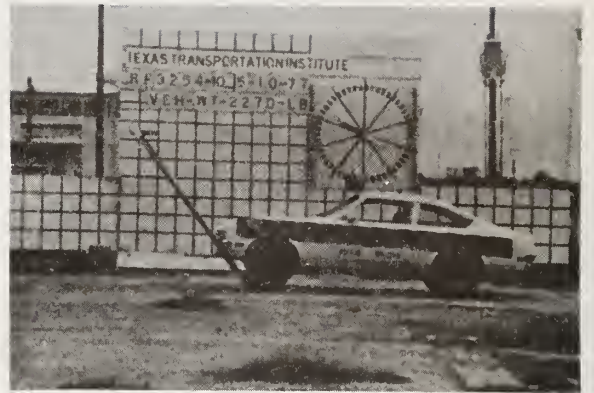
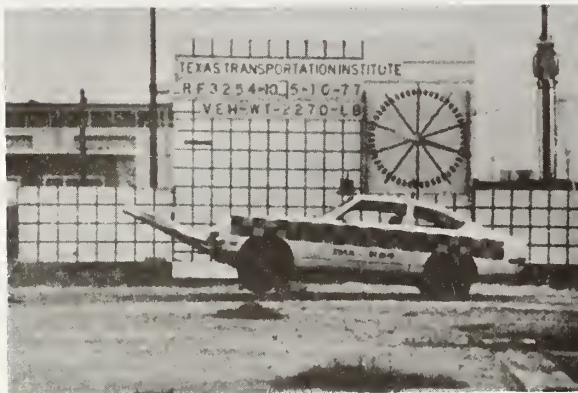
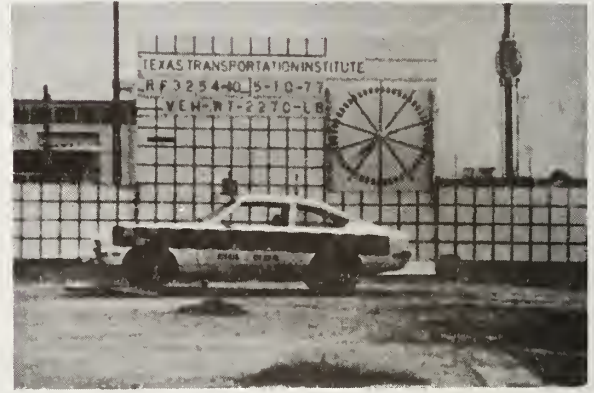
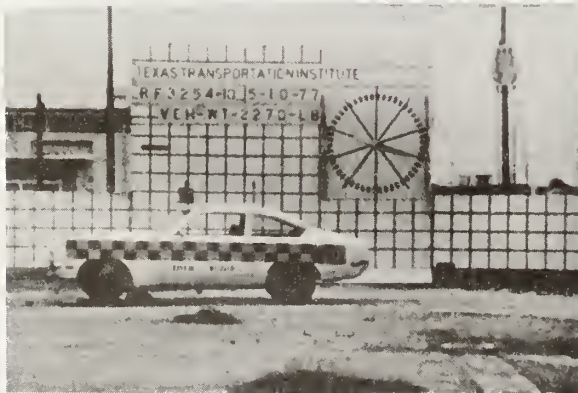
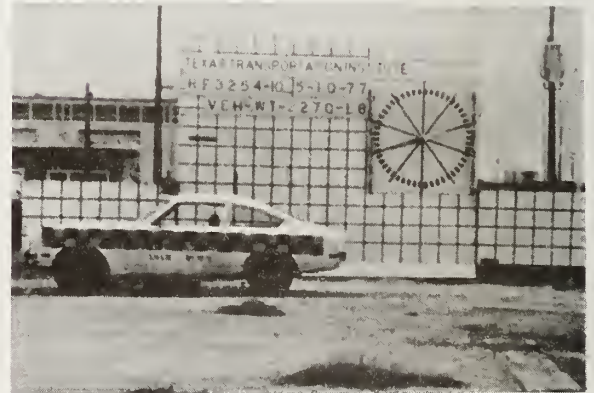
Figure 87. Sequential photos, test 10.

Table 27 summarizes the results of test 10. Figure 87 contains sequential photos from high-speed film taken during impact, and Table 28 contains a time-displacement-event summary. As shown in the photographs, the vehicle pitched up as it rode the post down. As the vehicle continued to move forward, the post and panel contacted the bottom of the vehicle, which impacted additional retarding forces.

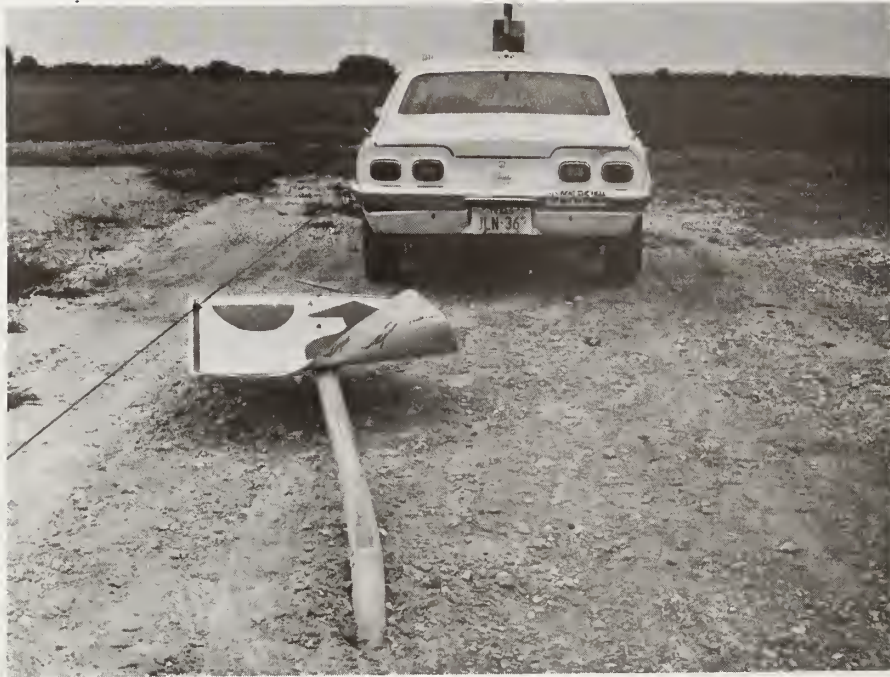
Figure 91. Sign installation damage, test 10.

Figures 88, 89, and 90 contain deceleration, change in momentum, and free missile travel versus time data. Figure 91 shows damage to the sign installation. Restoration would involve replacement of the signpost and repair to the sign panel.

(a) FRONT VIEW

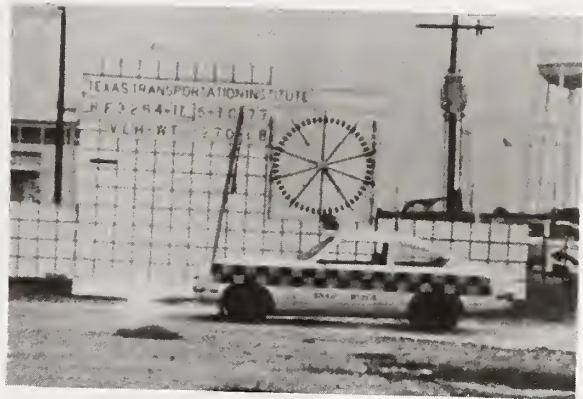
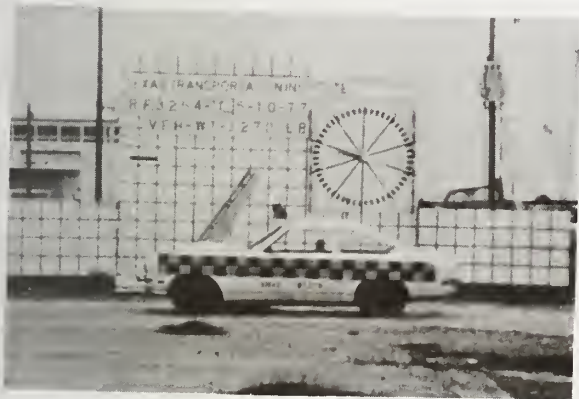
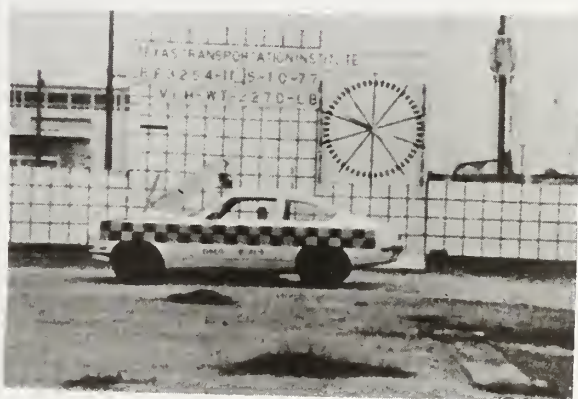
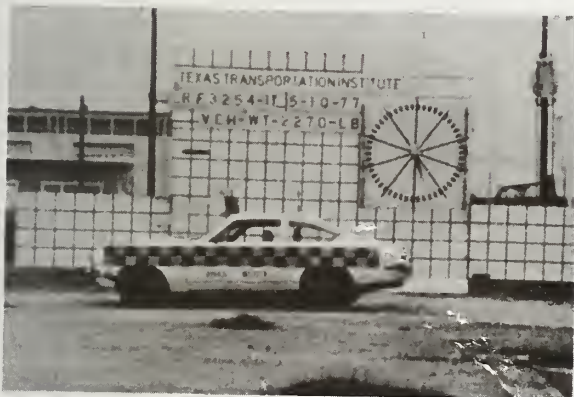
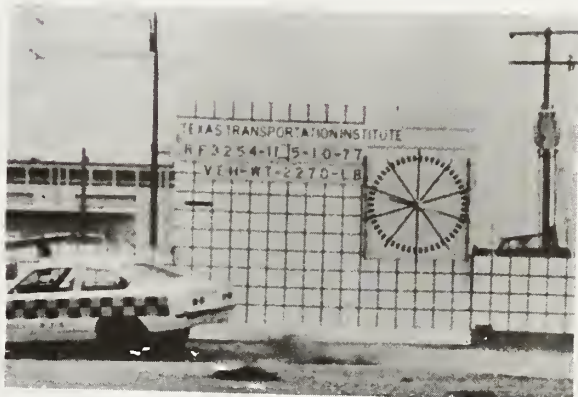
Figure 93. Sequential photos, test 11.

Table 29 summarizes the results of test 11. Figure 93 contains sequential photos from high-speed film taken during impact, and Table 30 contains a time-displacement-event summary. After impact, the post wrapped around the hood and imparted significant restraining forces to the vehicle. Continued forward motion of the vehicle straightened the post out and stripped the panel from the post. The post did not fracture. During contact the vehicle began to pitch down, yaw, and roll. After loss of post contact, the vehicle obtained a significant yaw and roll motion which resulted in complete loss of stability. The vehicle rolled over three times and was a total loss.

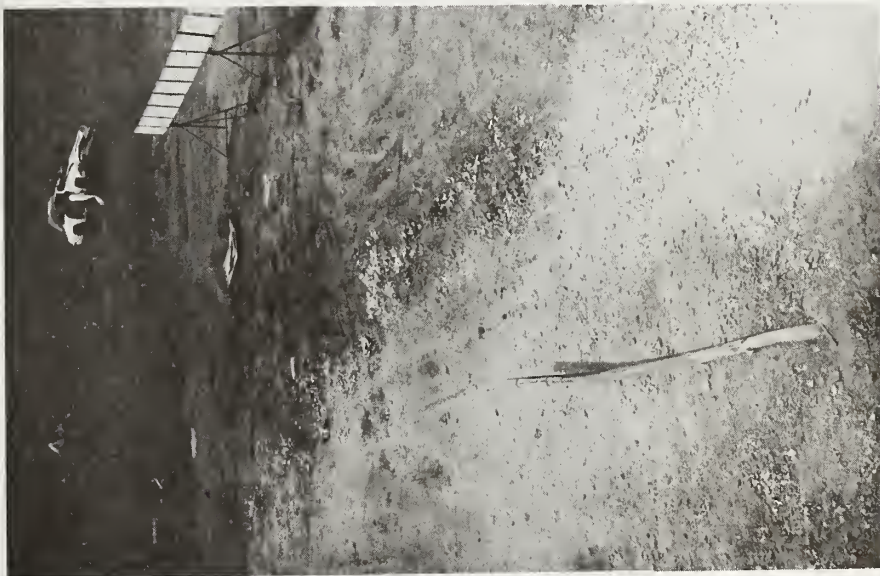
Figure 97. Sign installation damage, test 11.

Figures 94, 95, and 96 contain deceleration, change in momentum, and free missile travel versus time data. Figure 97 shows damage to the sign installation. Restoration would involve replacement of the post. The panel could have possibly been repaired.

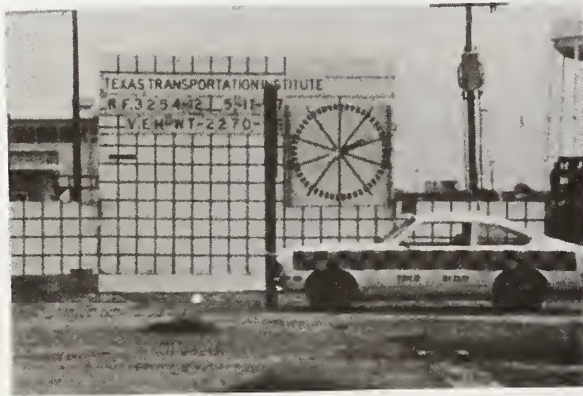
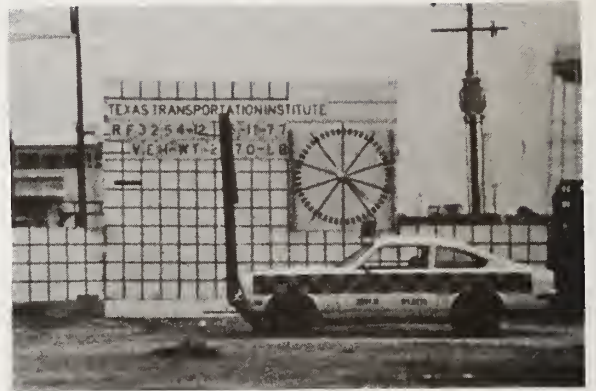
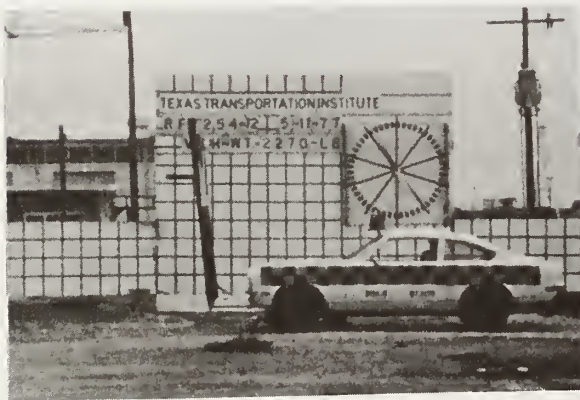
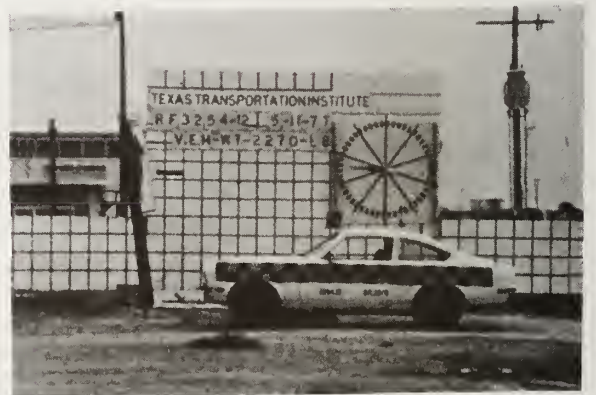
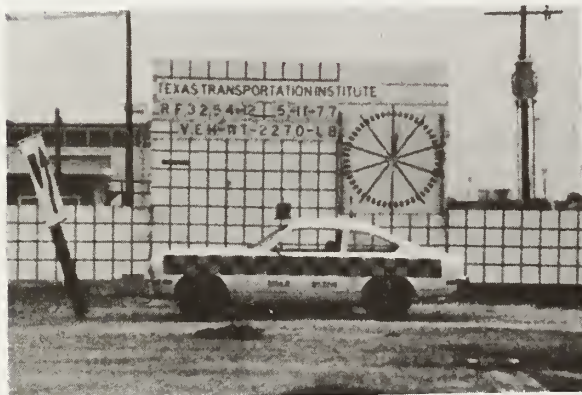
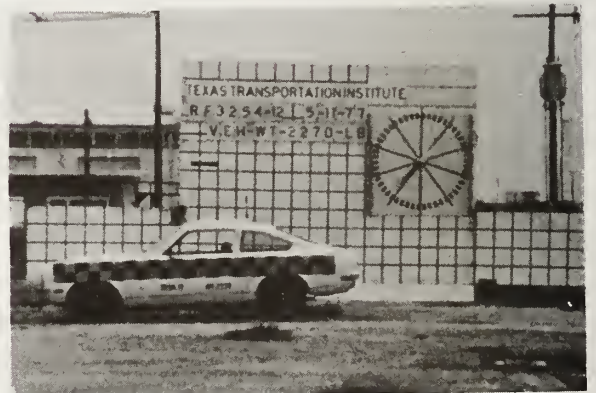
Figure 99. Sequential photos, test 12.

Table 31 summarizes the results of test 12. Figure 99 contains sequential photos from high-speed film taken during impact, and Table 32 contains a time-displacement-event summary. It can be seen that the post fractured near the bumper contact point and near the ground. The post and panel were then projected out in front of the vehicle.

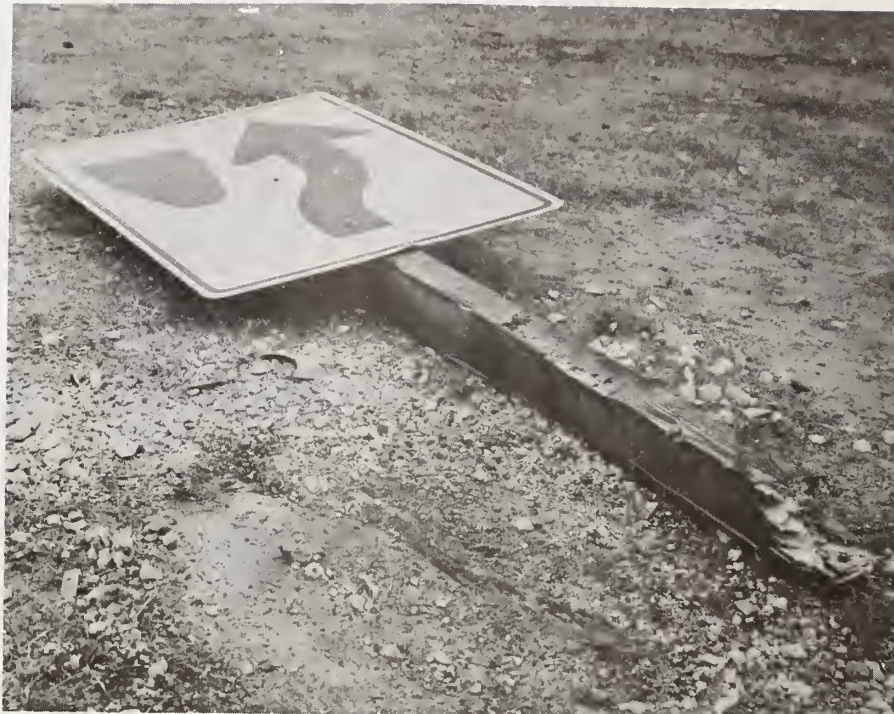
Figure 103. Sign installation damage, test 12.

Figures 100, 101, and 102 contain deceleration, change in momentum, and free missile travel versus time data. Figure 103 shows damage to the sign installation. Restoration would involve replacement of the signpost.

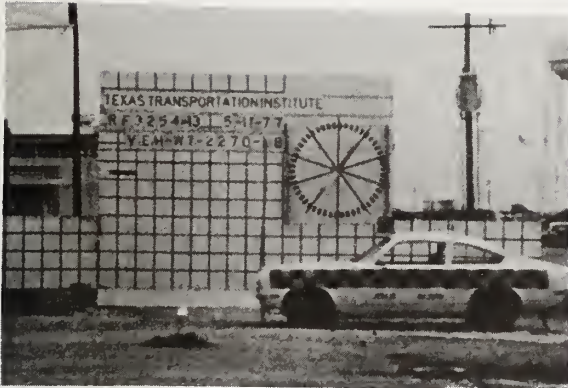
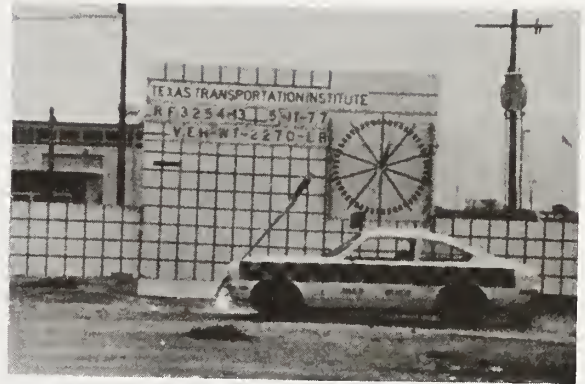
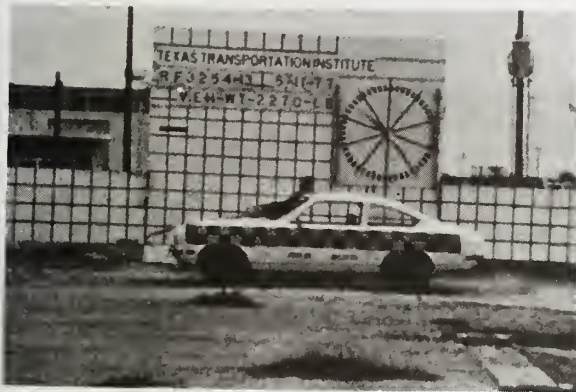
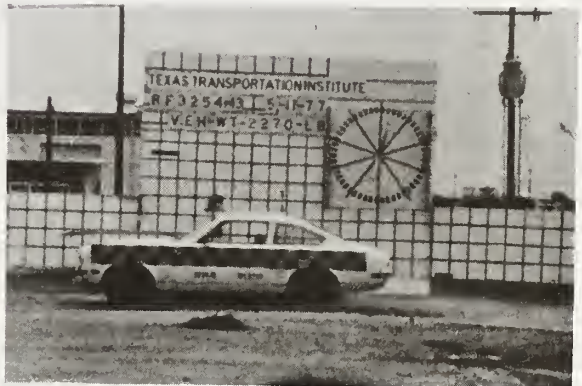
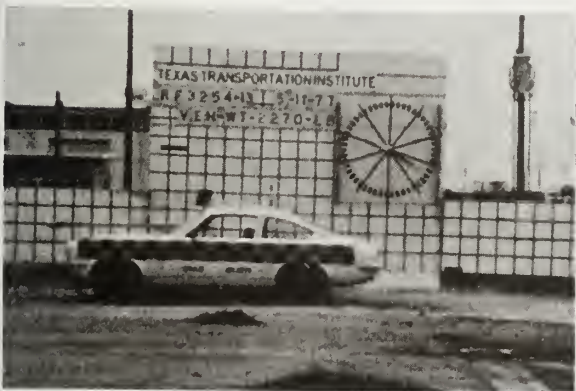
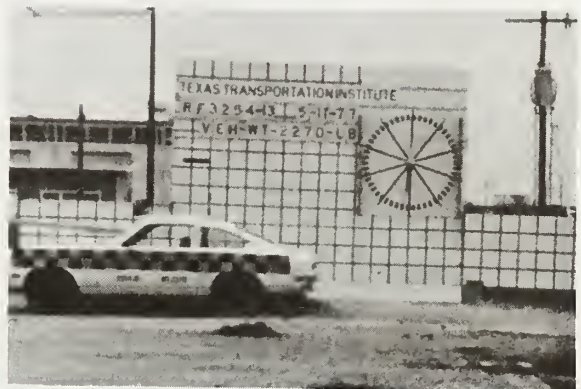
Figure 105. Sequential photos, test 13.

Table 33 summarizes the results of test 13. Figure 105 contains sequential photos from high-speed film taken during impact, and Table 34 contains a time-displacement-event summary. It can be seen that immediately after impact the post fractured near the bumper contact point. The post was then projected forward, and the panel was rotated down into the windshield. Although the windshield was broken and dished considerably, the panel did not penetrate through into the passenger compartment. Subsequent to impacting the windshield, the post and panel were projected along with the vehicle. Reference should be made to Section A-3-2 for comments regarding the trajectory hazard of the small sign installations.

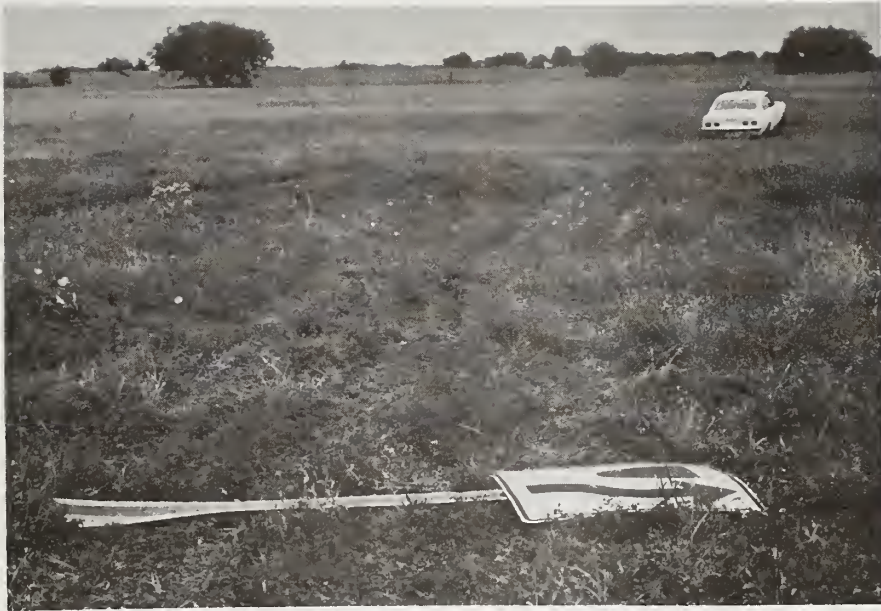
(a) POST AND PANEL

Figures 106, 107, and 108 contain deceleration, change in momentum, and free missile travel versus time data. Figure 109 shows damage to the sign installation. Restoration would involve the replacement of the signpost. The panel and hardware were reusable.

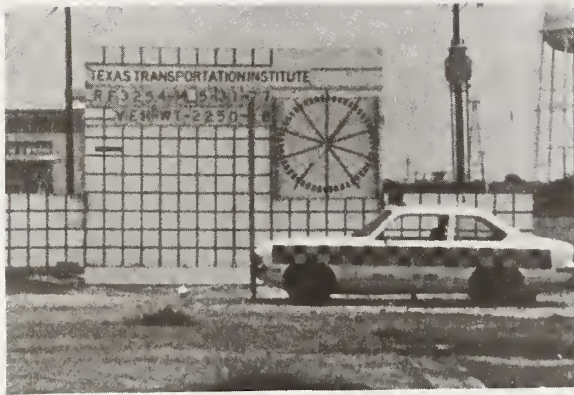
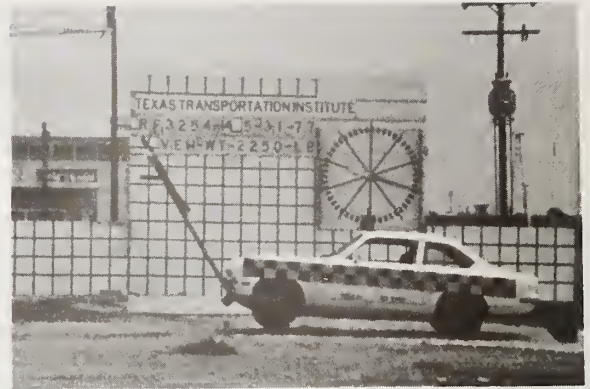
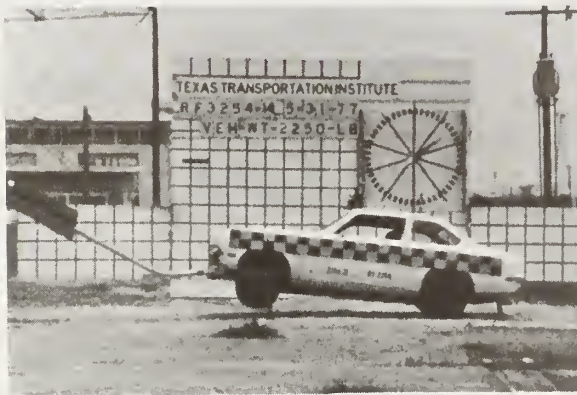
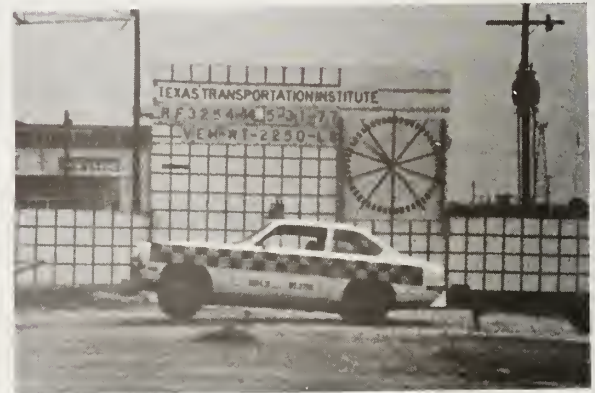
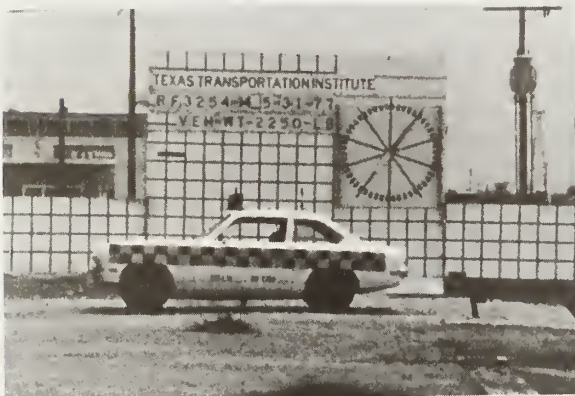
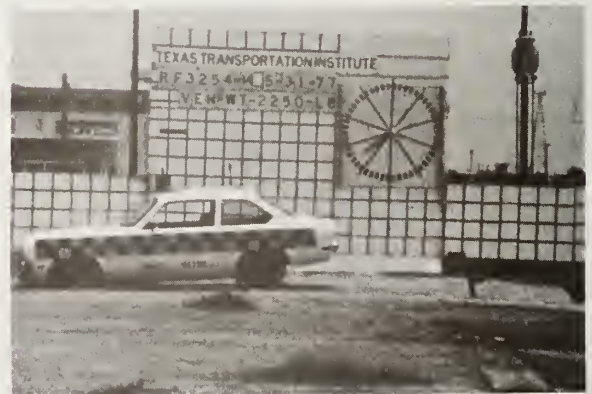
Figure 111. Sequential photos, test 14.

A summary of test 14 is given in Table 35. Figure 111 contains sequential photos from high-speed film taken during impact, and Table 36 contains a time-displacement-event summary. After impact the vehicle began to pitch upward, and the post was deflected downward. Then the stub post fractured just below the coupling and the post and panel were projected forward.

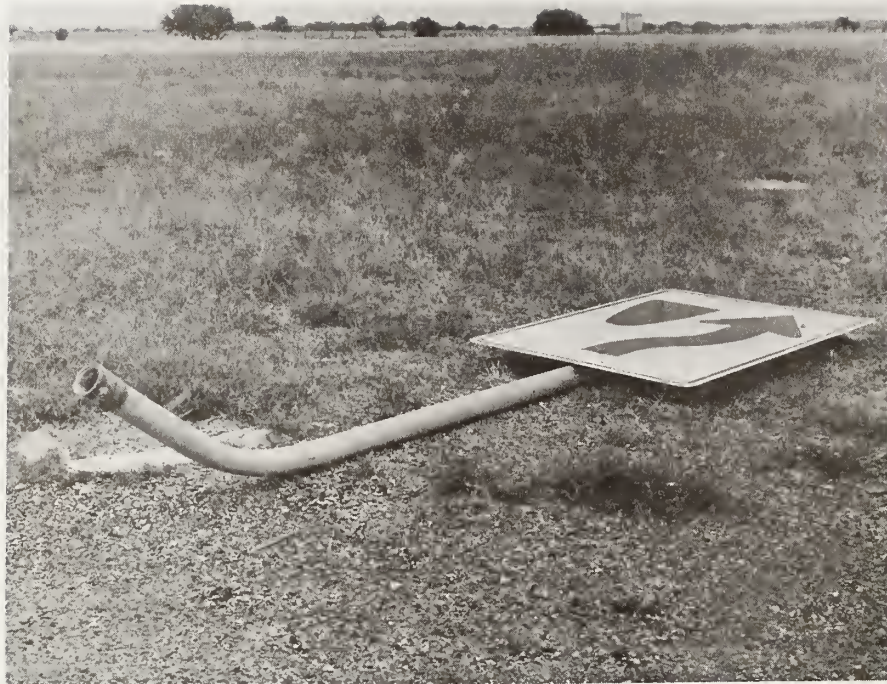
(a) POST AND PANEL

Figures 112, 113, and 114 contain deceleration, change in momentum, and free missile travel versus time data. Figure 115 shows damage to the sign installation. Restoration would involve replacement of the stub and concrete footing. The signpost could have possibly been straightened. The panel and hardware were reusable. Reference should be made to the discussion in Section A-2-5 regarding this design and the changes made in test 16 to reduce impact damage.

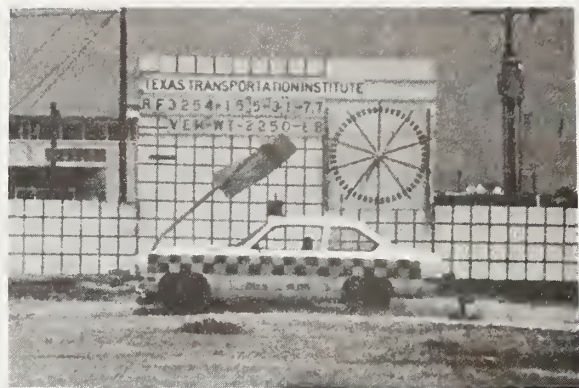
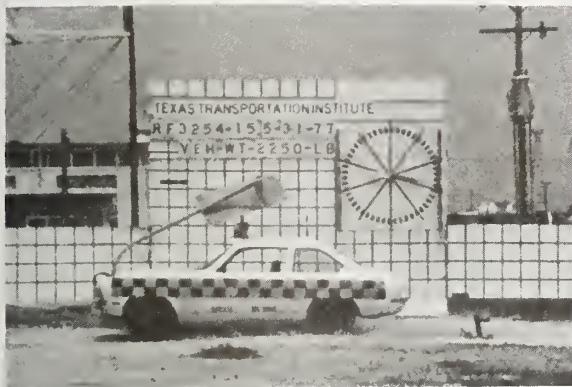
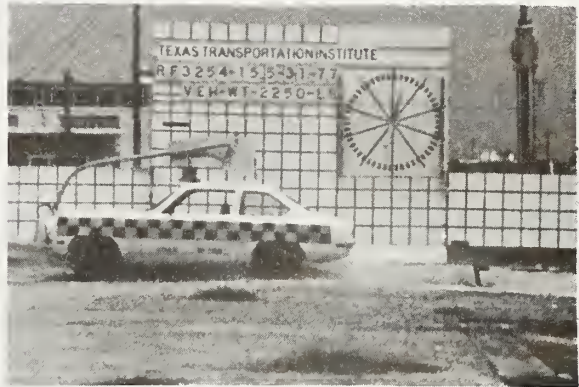
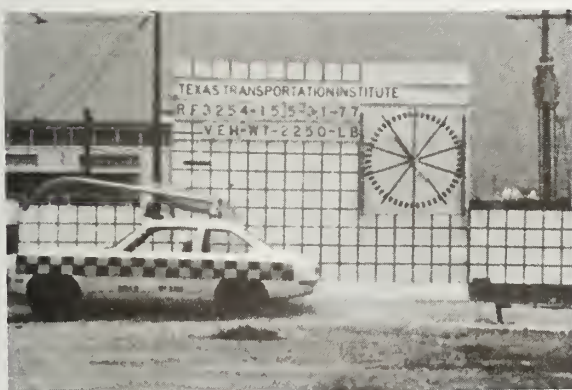
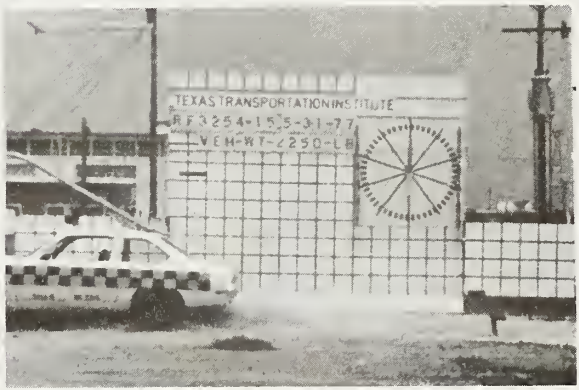
Figure 117. Sequential photos, test 15.

A summary of test 15 is given in Table 37. Figure 117 contains sequential photos from high-speed film taken during impact, and Table 38 contains a time-displacement-event summary. Shortly after impact the stub post broke just below the coupling. The post was then projected forward and upward, and the panel contacted the rear portion of the roof.

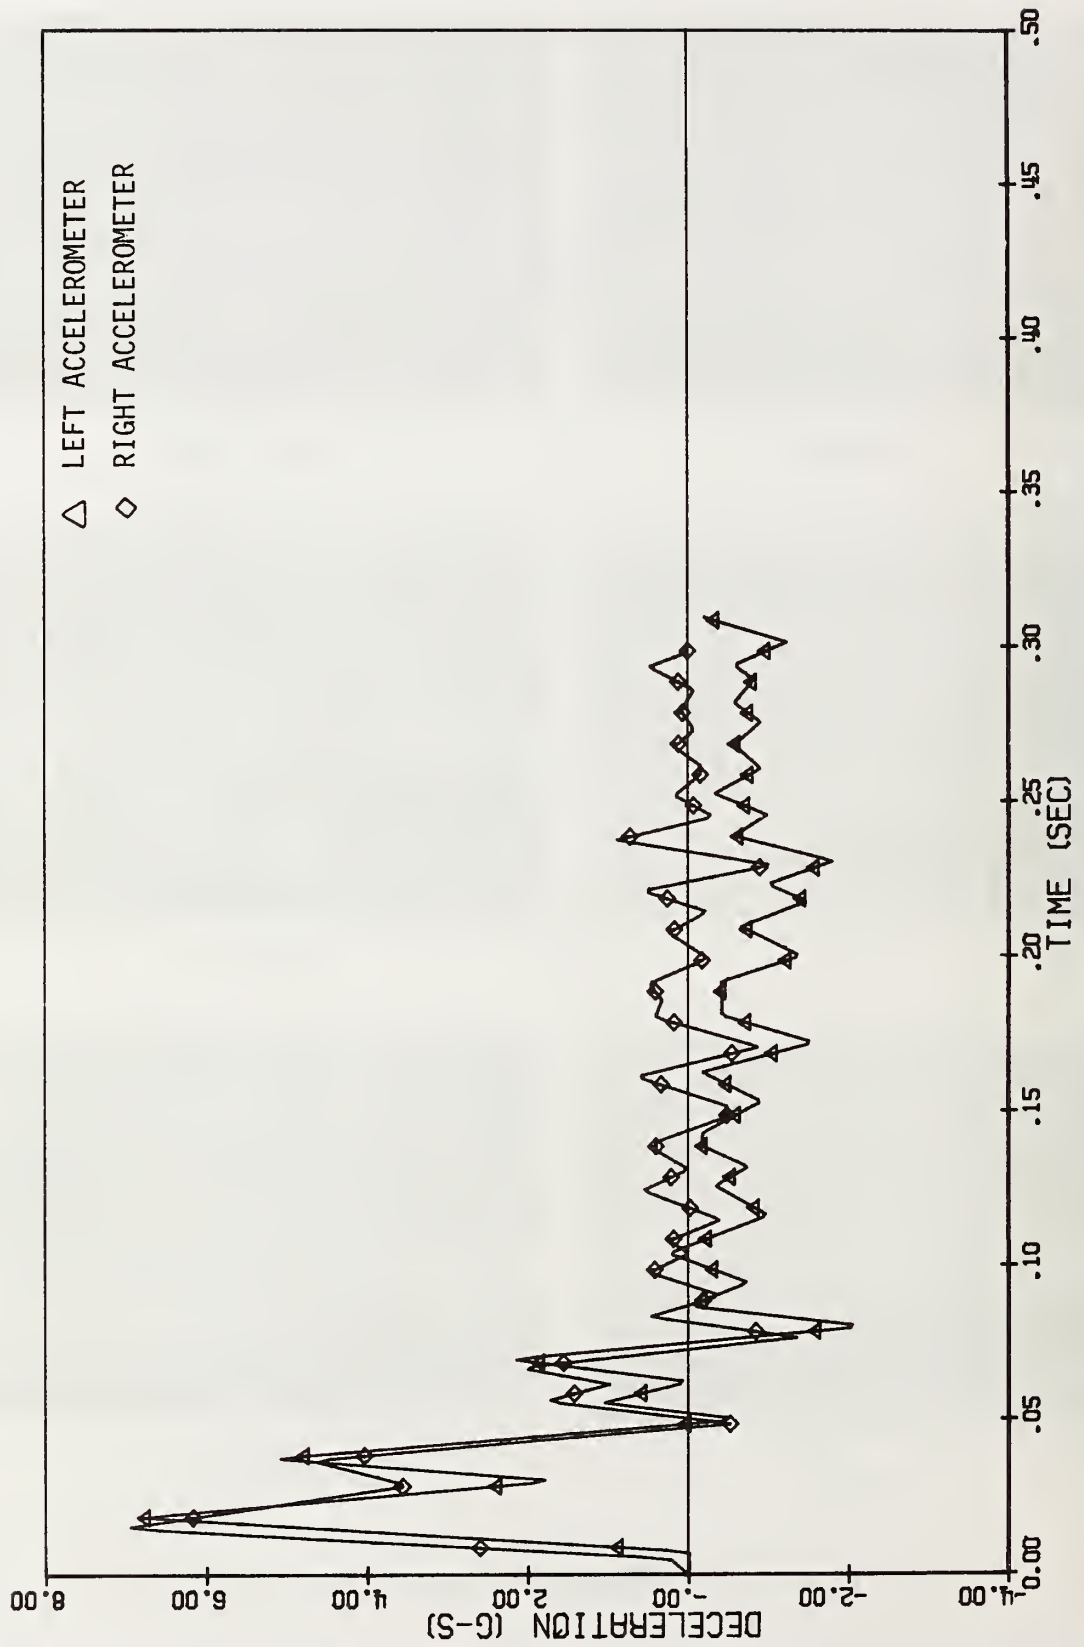
Figure 118. Deceleration vs. time, test 15.

Figures 118, 119, and 120 contain deceleration, change in momentum, and free missile travel versus time data. Sign installation damage is shown in Figure 121. Restoration would involve replacement of the stub and the concrete footing. The signpost could have possibly been straightened, and the panel was reusable. Reference should be made to Section A-2-5 regarding this design and the changes made in test 16 to reduce impact damage.

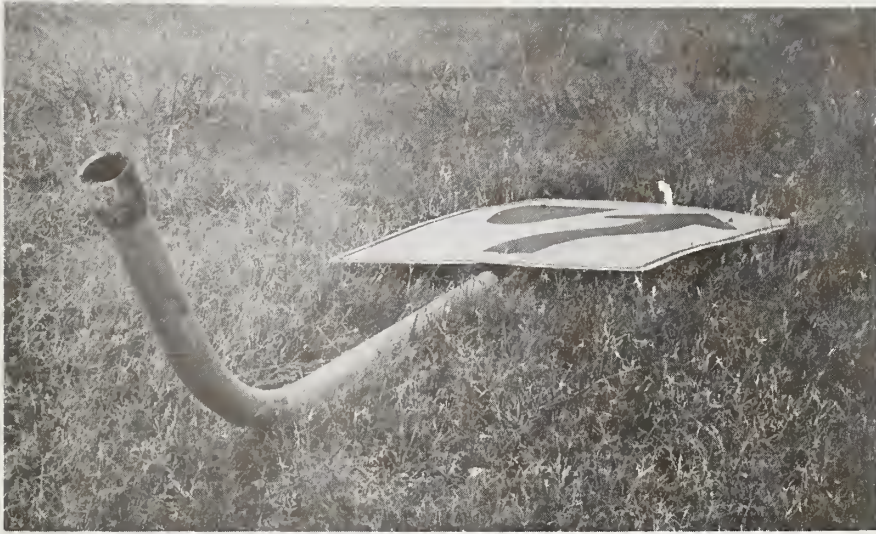
Figure 121. Sign installation damage, test 15.

(a) POST AND PANEL

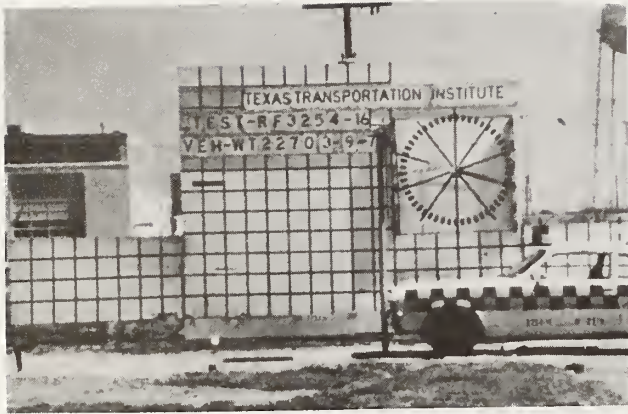
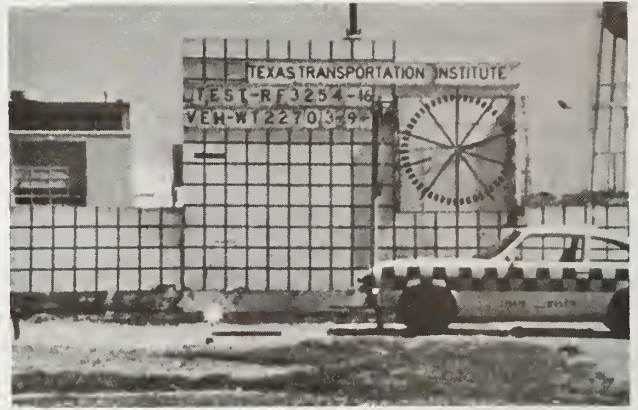
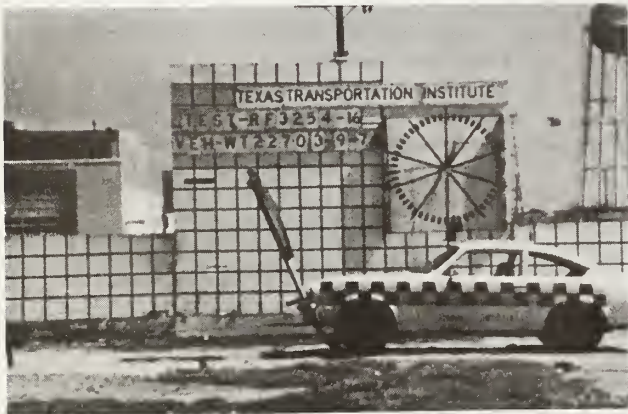
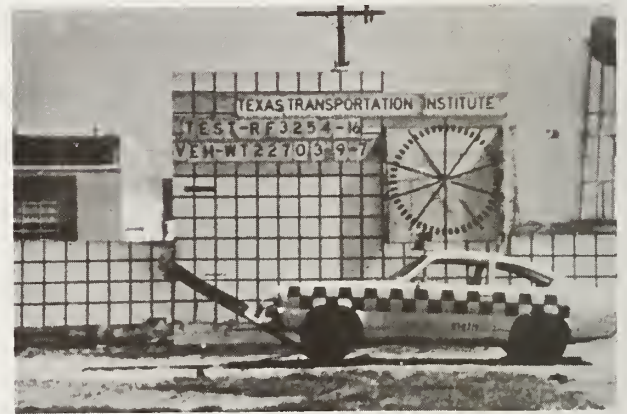
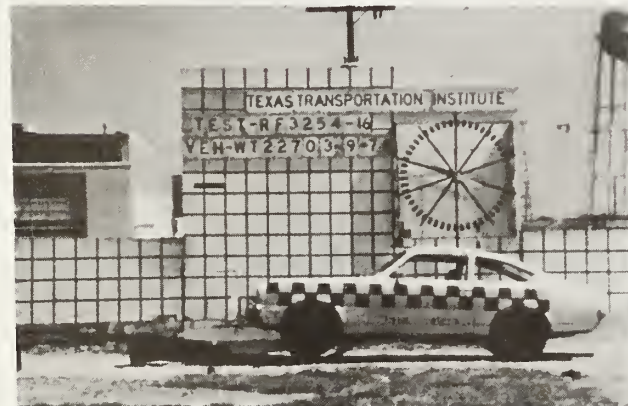
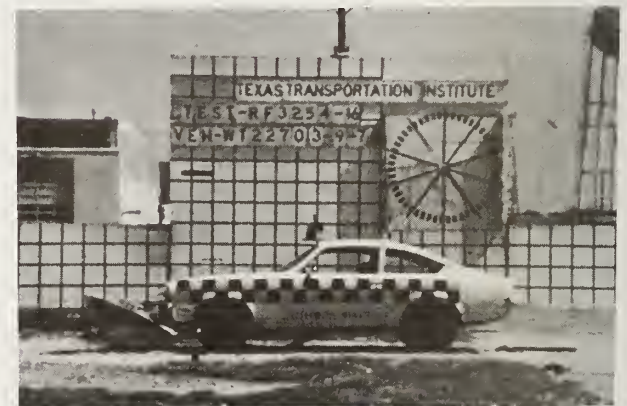
Figure 123. Sequential photos, test 16.

Table 39 contains a summary of test 16. Figure 123 contains sequential photos from high-speed film taken during impact, and Table 40 contains a time-displacement-event summary. Impact behavior was similar to that observed in test 14. However, in this test the post broke just above the coupling, as desired.

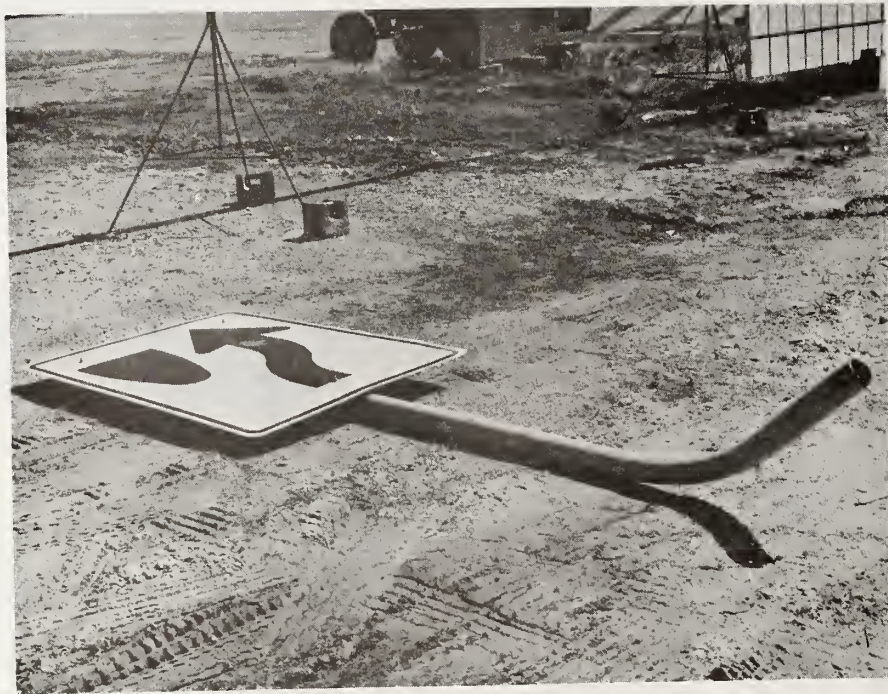
Figure 127. Sign installation damage, test 16.

Figures 124, 125, and 126 contain deceleration, change in momentum, and free missile travel versus time data. Figure 127 shows damage to the sign installation. At most, restoration would involve replacement of the signpost. Restoration could probably have been accomplished by straightening and rethreading the post. The threaded part of the post remaining in the coupling could be easily removed. The panel and stub were reusable.

(a) POST AND PANEL

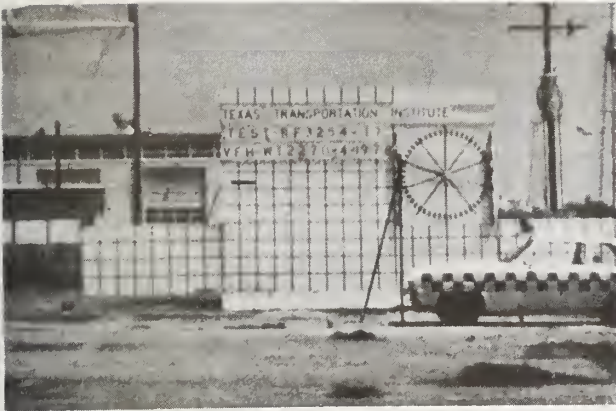
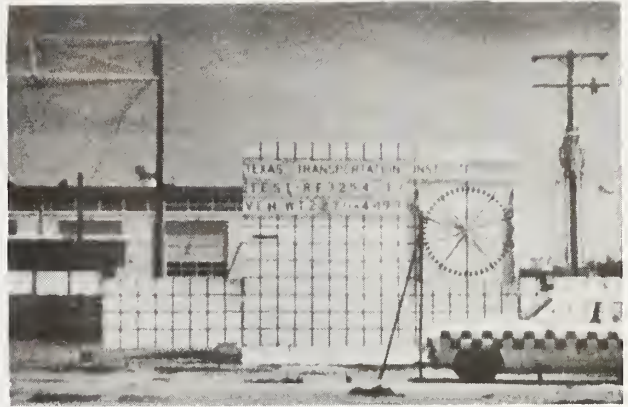
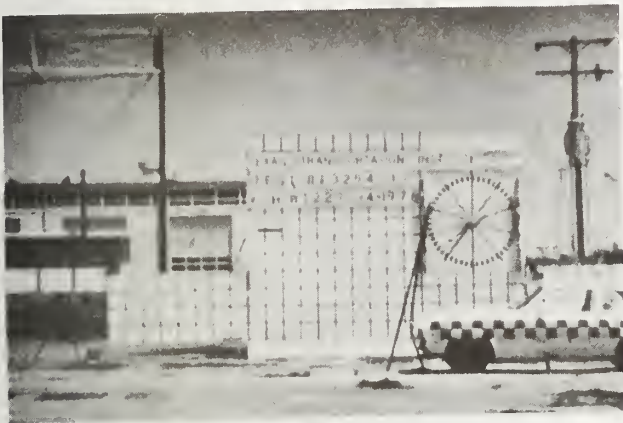
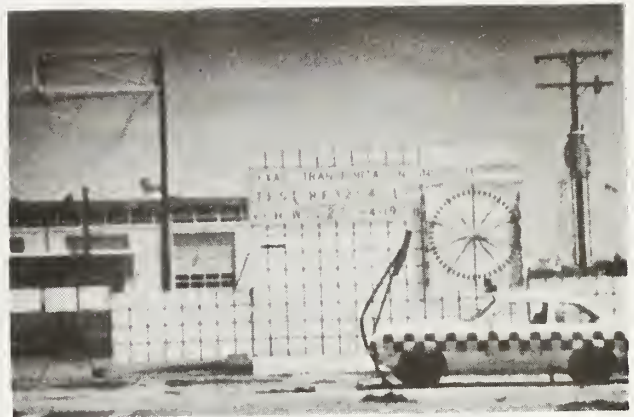
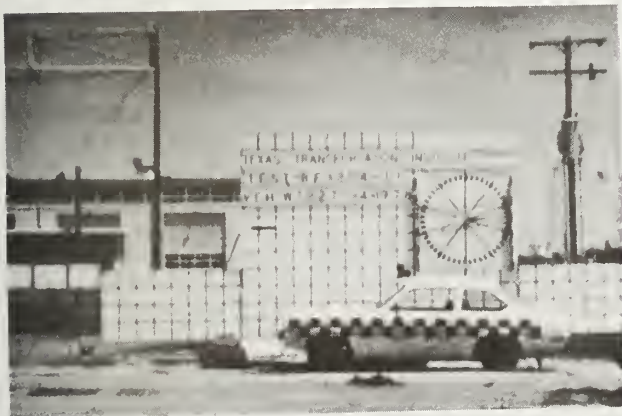
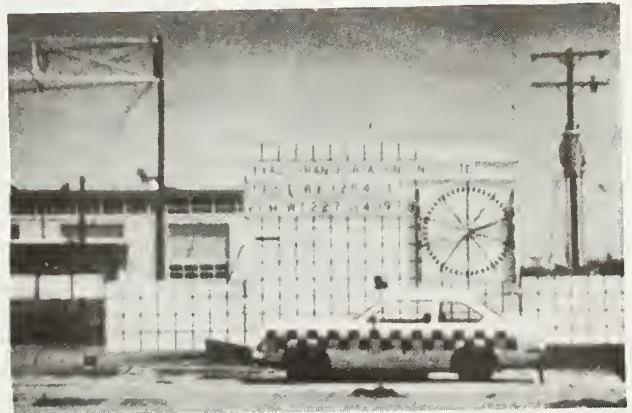
Figure 129. Sequential photos, test 17.

A summary of test 17 is given in Table 41. Figure 129 contains sequential photos from high-speed film taken during impact, and Table 42 contains a time-displacement-event summary. Upon impact, the vertical post began to bend. Continued movement of the vehicle caused increased loading on the back brace as the vertical member was deflected and pulled down. At about 0.125 sec the back brace collapsed, and the installation was then ridden down. Although damage to the vehicle would not indicate it, the change in momentum was relatively high. By comparing the deceleration versus time plot of test 17, Figure 130, with that of a similar test with a 3 lb/ft (4.5 kg/m) full length post, Figure 45, it can be seen that the back brace design causes higher decelerations of longer duration than the 3 lb/ft (4.5 kg/m) post.

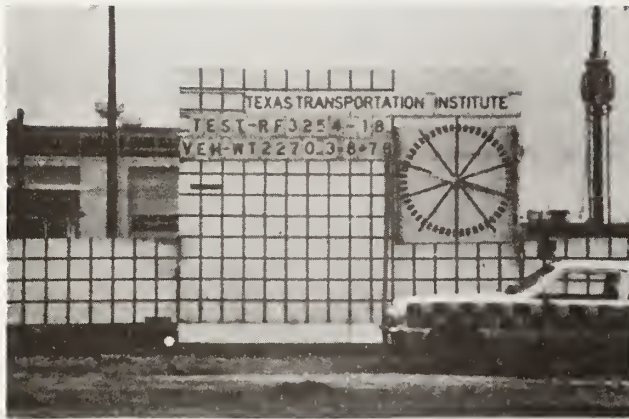
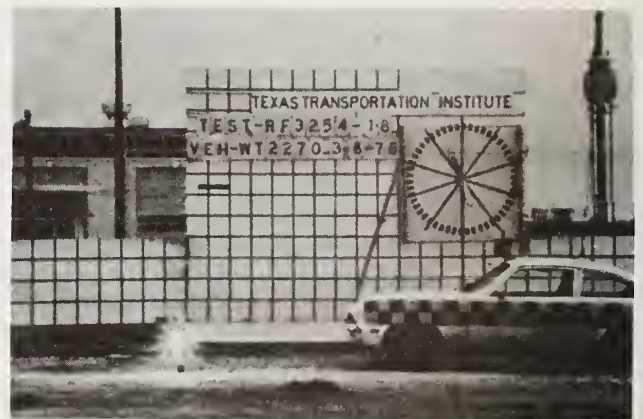
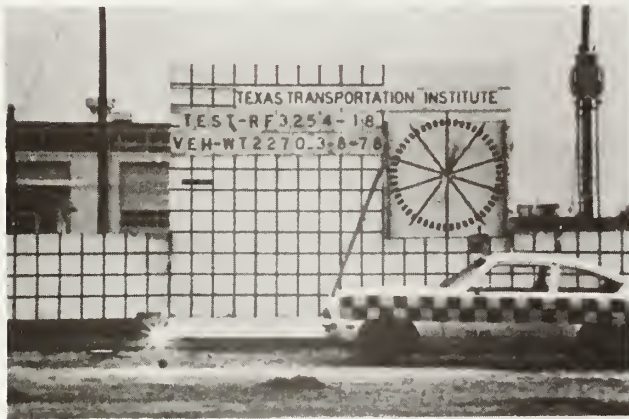
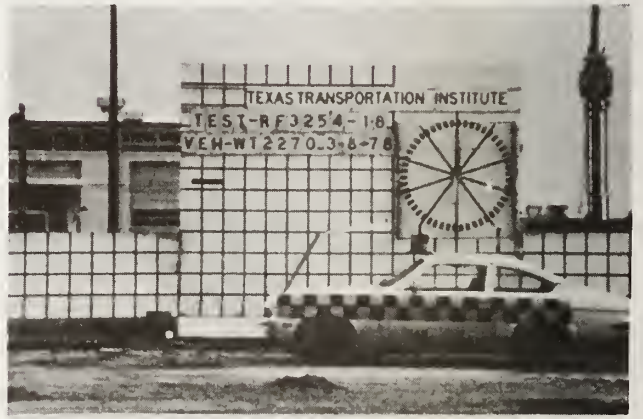
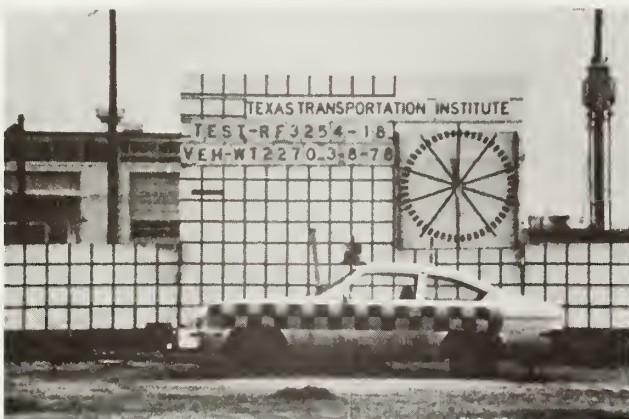
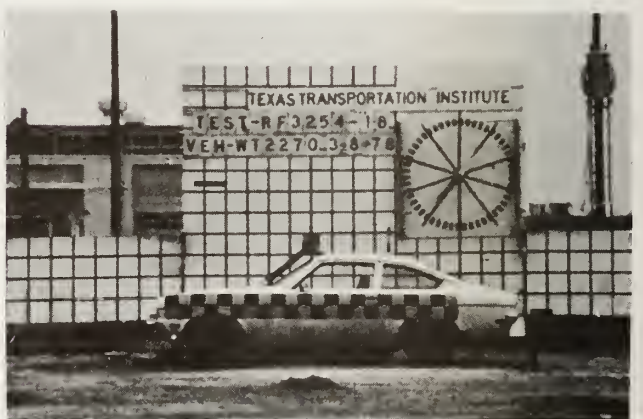
Figure 135. Sequential photos, test 18.

A summary of test 18 is given in Table 43. Sequential photos from the high-speed film are shown in Figure 135. Table 44 contains a time-displacement-event summary. After impact, the post began to bend and rotate down toward the hood. However, the post was straightened and ridden down before it contacted the hood. This contrasted with the behavior of the larger pipe in test 11 in which the post wrapped around the hood and imparted considerably higher forces to the vehicle. Another factor which reduced the severity of test 18 (versus test 11) was the smaller panel size, 5 ft² (0.47 m²) versus 12 ft² (1.12 m²). Inertia forces and wind resistance would be larger for the larger panel. In addition, it can be seen in Figure 135 that the panel slipped off the post during impact. It is possible that the pipe clamps (see Figure 22) were not securely fastened to the pipe. It can be seen in Figure 139 that the clamps were still fastened to the panel. A "friction cap", placed on the top of the pipe, did little to prevent the clamps from slipping off the post. The friction cap, composed of 24 gauge (0.061 cm) sheet metal, is designed primarily to keep rainwater out of the pipe.

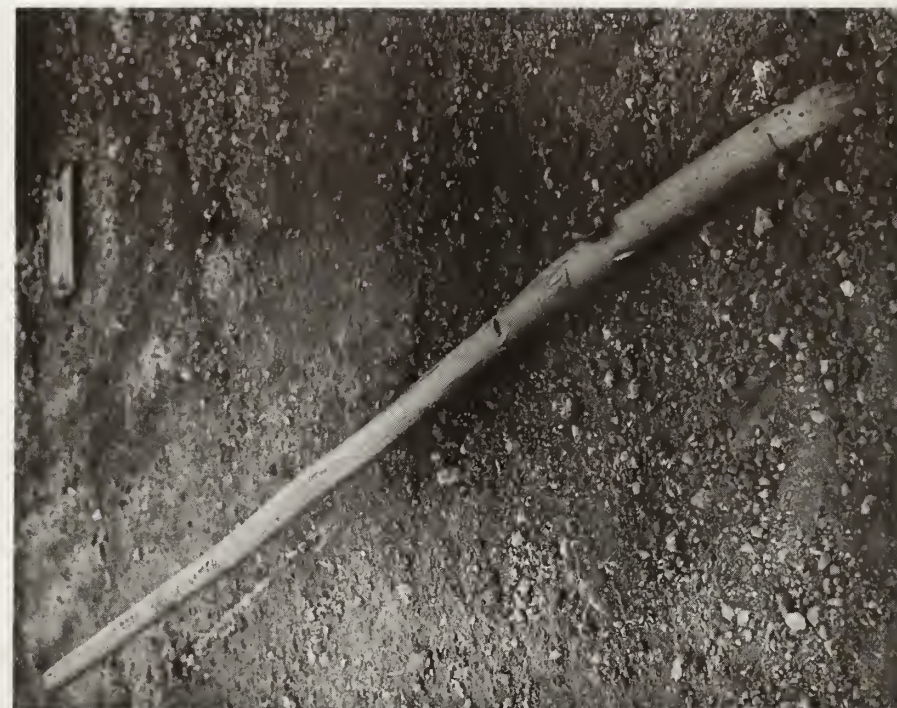
(a) POST

Figures 136, 137, and 138 contain deceleration, change in momentum, and free missile travel versus time data. Sign installation damage is shown in Figure 139. Restoration would involve replacement of the signpost.

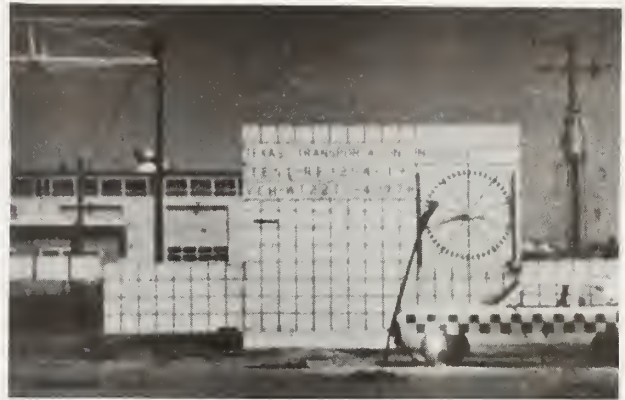
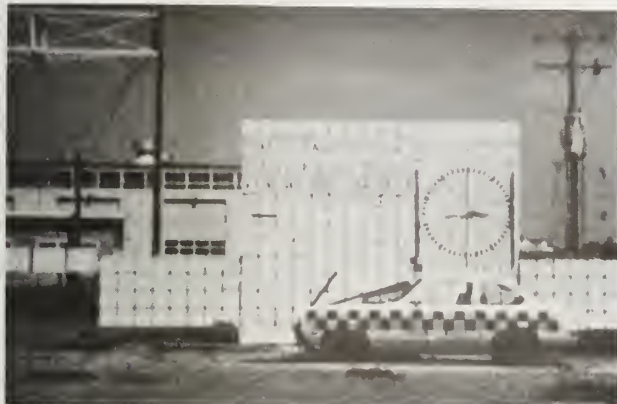
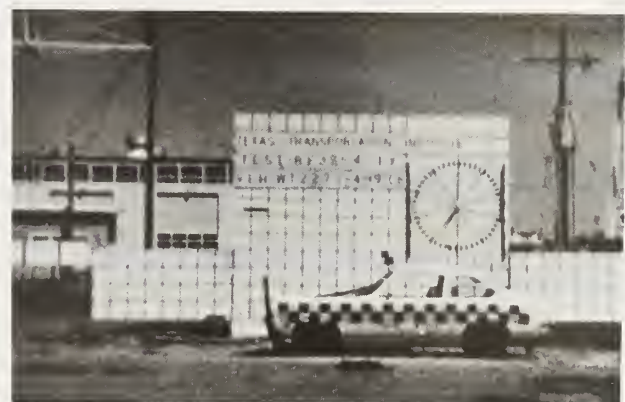
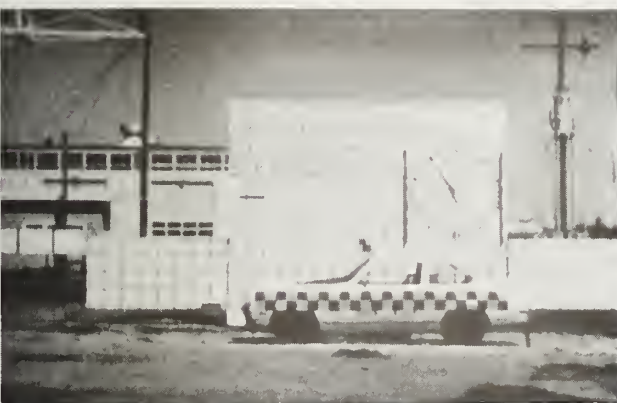
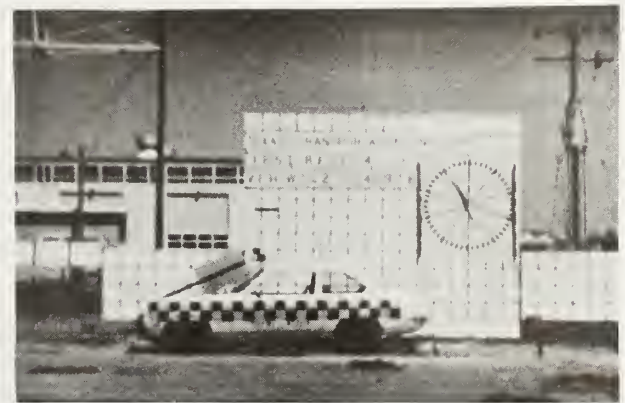
Figure 141. Sequential photos, test 19.

A summary of test 19 is given in Table 45. Figure 141 shows sequential photos from high-speed film taken during impact, and Table 46 contains a time-displacement-event summary. After impact, the vertical post was bent and pulled down. At about 0.02 sec, the bolt between the back brace and the vertical post sheared. The post and panel then rotated down into the windshield. Although the windshield was dished considerably, the panel did not penetrate through to the passenger compartment. Continued movement of the vehicle pulled the post out of the ground, and the post and panel remained with the vehicle. The back brace was ridden down but was not pulled from the ground.
