No. FHWA/RD-80/502

SH TESTS OF SMALL HIGHWAY SIGN SUPPORTS

May 1980

Interim Report

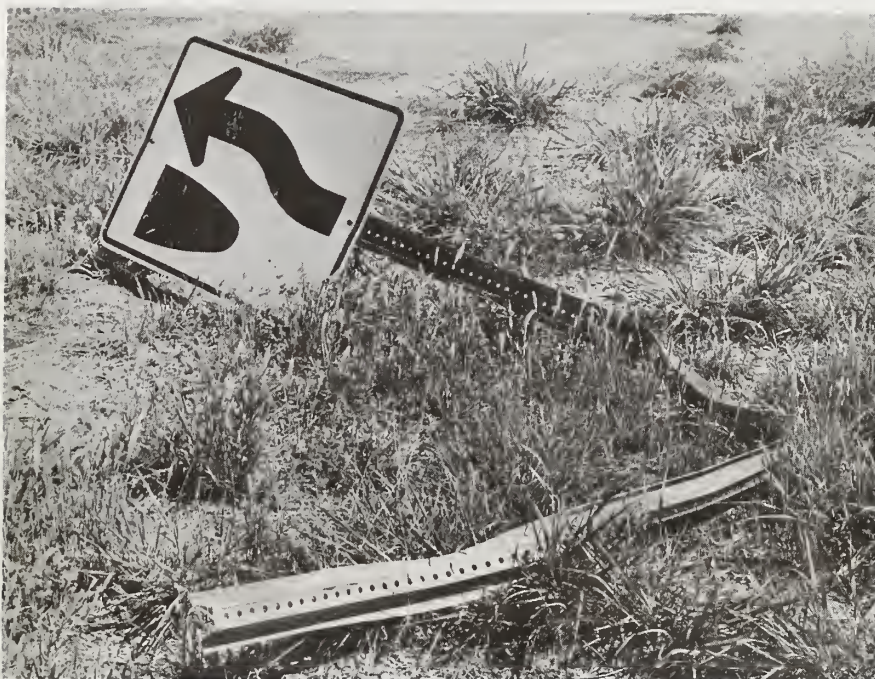
Figure 145. Sign installation damage, test 19.

Figure 142, 143, and 144 contain deceleration, change in momentum, and free missile travel versus time data. Figure 145 shows damage to the sign installation. Restoration would involve replacement of the vertical post and back brace. The sign panel was reusable.

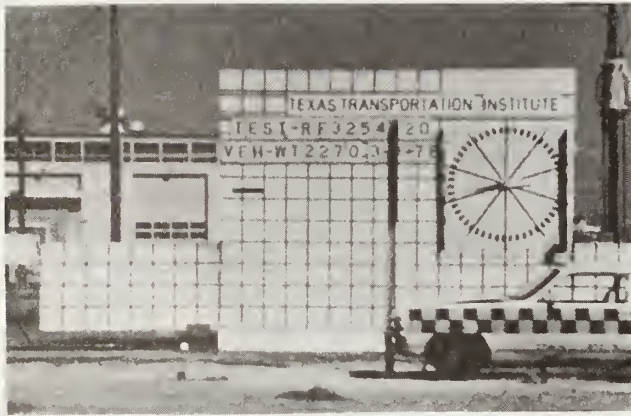
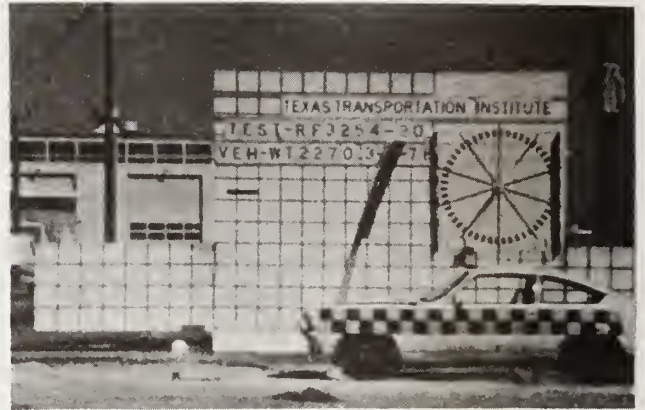
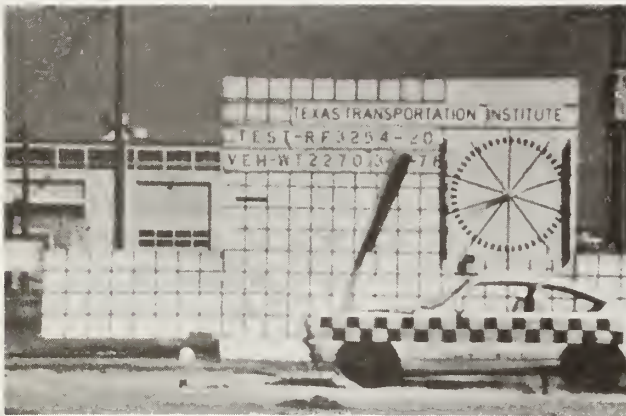
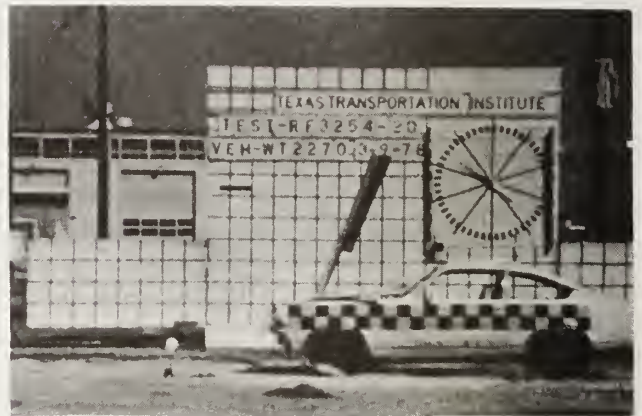
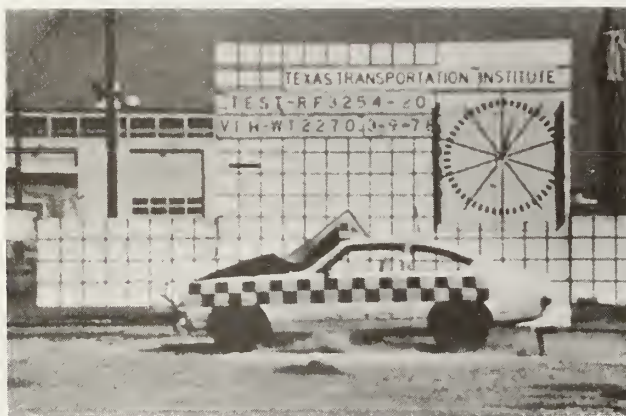
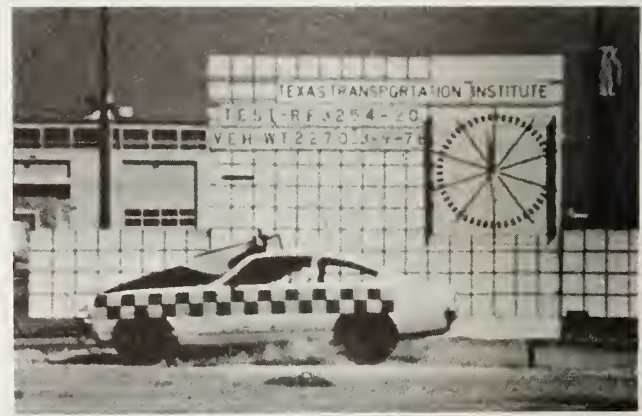
Figure 147. Sequential photos, test 20.

A summary of test 20 is given in Table 47. It should be noted that the impact speed was 67.3 mph (108.3 km/h), somewhat higher than the intended speed of 60 mph (96.5 km/h). Figure 147 contains sequential photos from high-speed film taken during impact, and Table 48 contains a time-displacement-event summary. Upon impact the post penetrated through the bumper, grille, and front vehicle sheet metal. At about 0.035 sec after impact the post fractured. Then the post and panel began to move forward and rotate down onto the hood, windshield and roof, which produced a relatively large dent in the roof and broke the windshield.

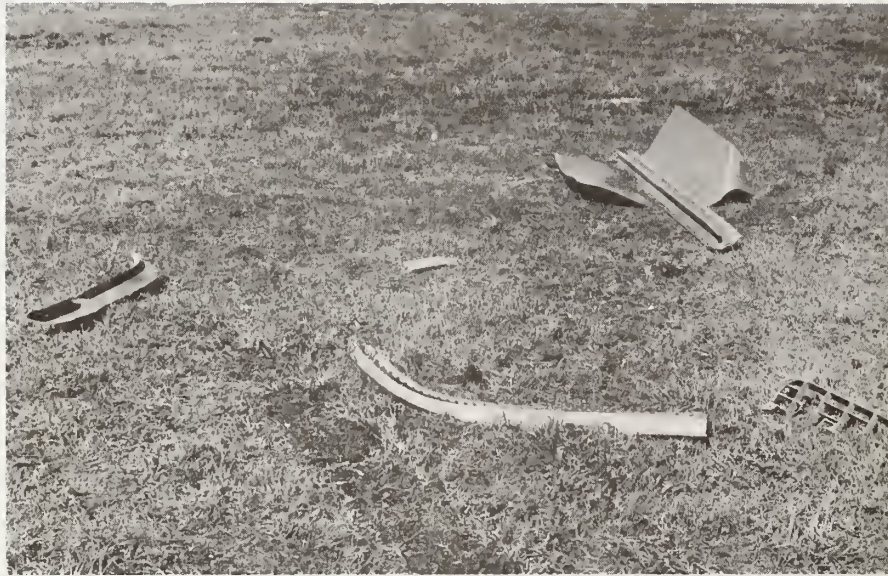
Figure 151. Sign installation damage, test 20.

Figures 148, 149, and 150 contain deceleration, change in momentum, and free missile travel versus time data. Figure 151 shows damage to the sign installation. Restoration would involve replacement of the posts. The panel could probably have been repaired and reused.

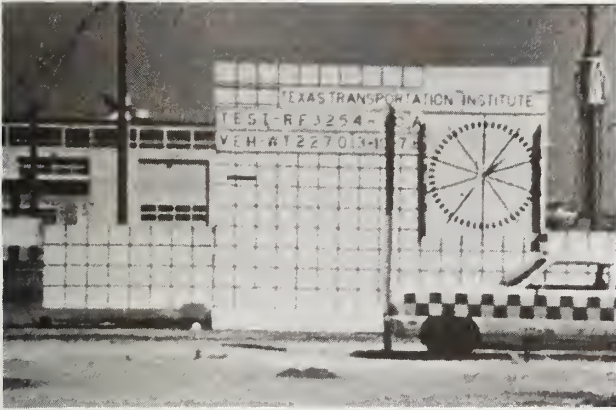
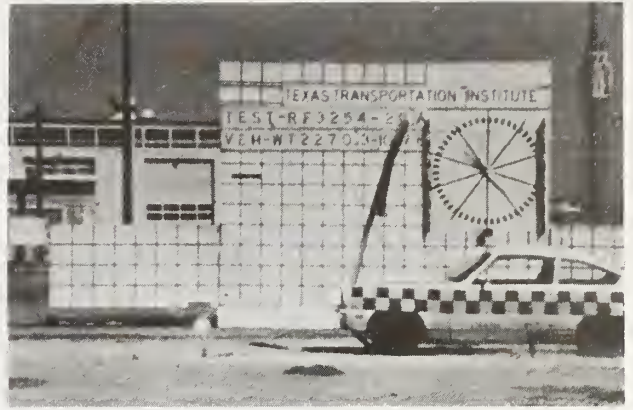
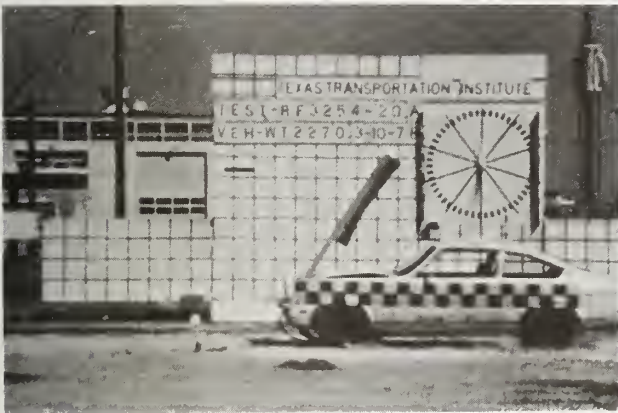
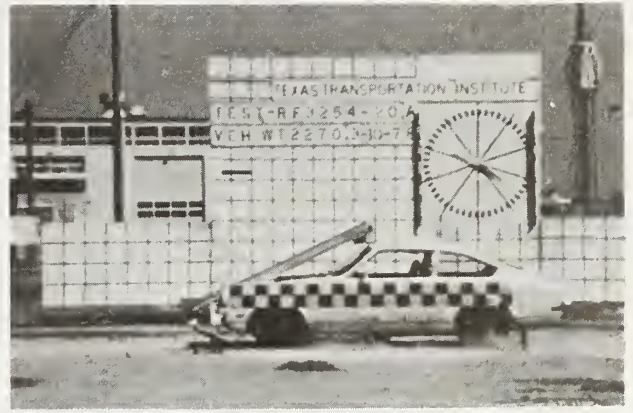
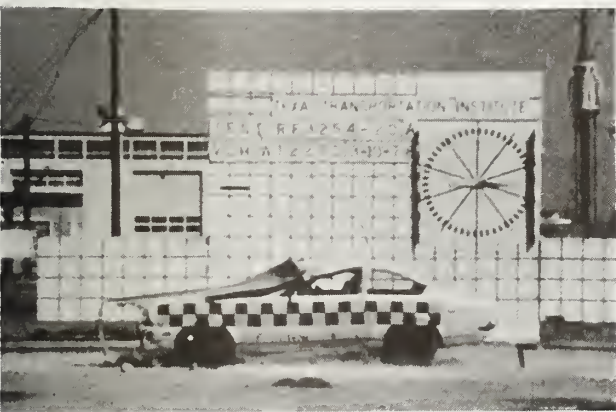
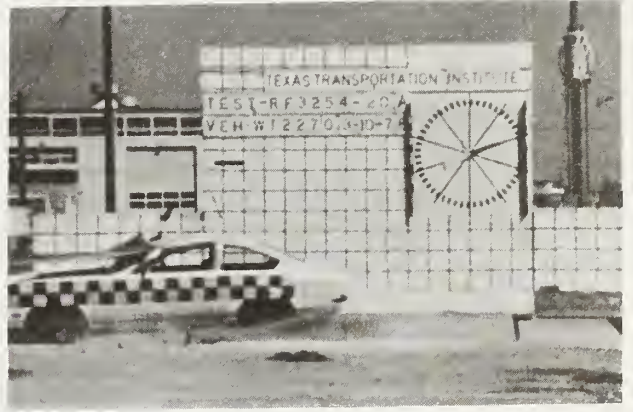
Figure 153. Sequential photos, test 20A.

Test 20A was a repeat of test 20 but at a lower speed. A summary of the test is given in Table 49. Sequential photos of the impact are presented in Figure 153, and a time-displacement-event summary is given in Table 50. Impact behavior of the post in this test was similar to that of test 20. However, the post penetrated considerably less into the front vehicle structure in test 20A (compare Figures 152 and 158). Also, the post and panel did not rotate as far back on test 20A. Panel contact with the roof and windshield produced a dent and broke the windshield. After impacting the roof, the post and panel were carried along with the vehicle for about 50 ft (15.2 m). At that point the brakes were applied to the vehicle causing the panel to slide off the hood onto the ground in front of the vehicle. Application of the brakes also produced a yawing motion to the vehicle. When the panel and post hit the ground the panel dug into the soil (see Figure 157). Then the vehicle hit the post and panel, tripped, and rolled over two times. One can only speculate as to the probability of such an occurrence; however, it is believed to be small.

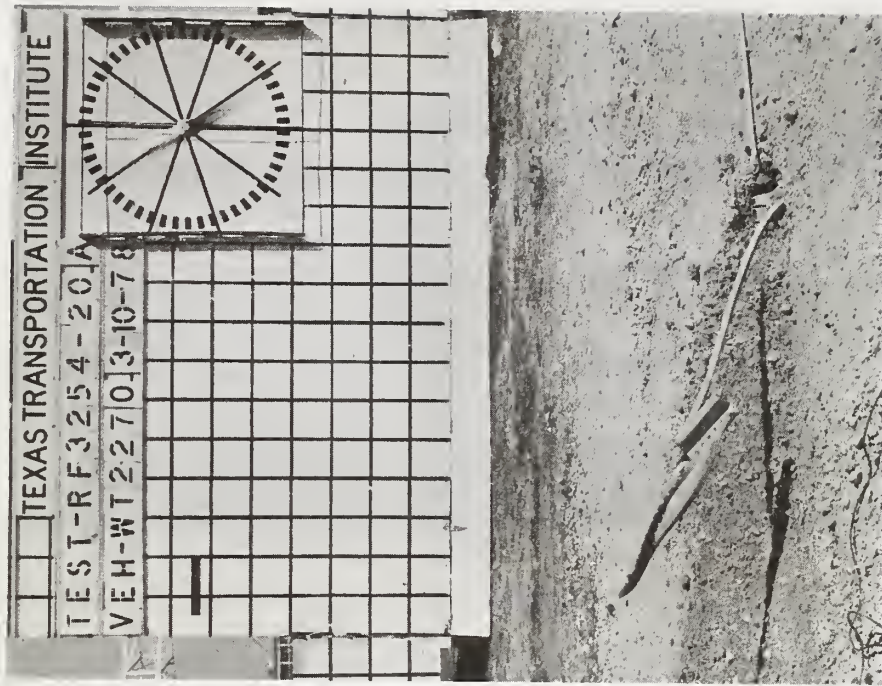
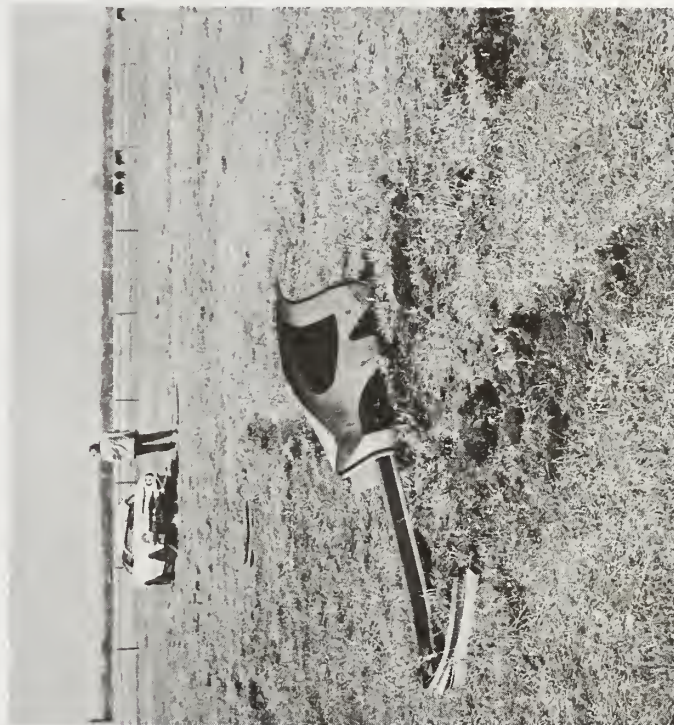
Figure 157. Sign installation damage, test 20A.

Figures 154, 155, and 156 contain deceleration, change in momentum, and free missile travel versus time data. Damage to the sign installation is shown in Figure 157. Note the soil penetration produced when the panel tripped the vehicle. Restoration would involve replacement of the complete sign installation.

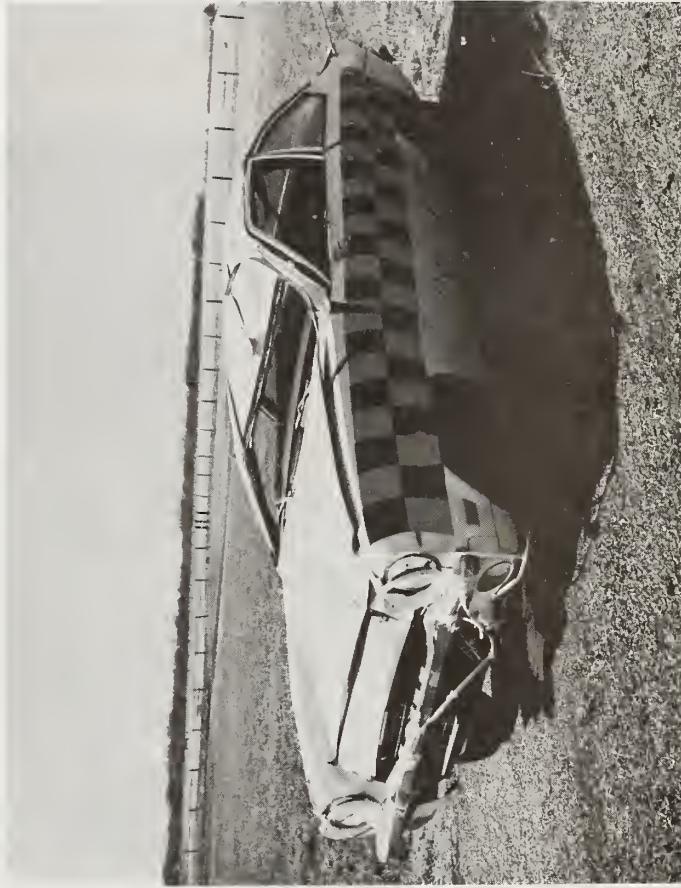
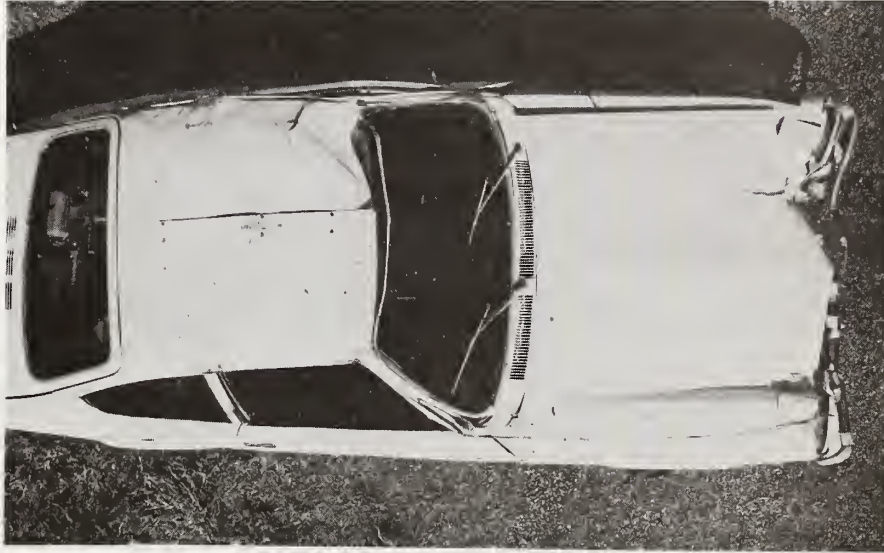
Figure 158. Vehicle damage, test 20A.

Damage to the vehicle is shown in Figure 158. Damage was assessed according to the TAD and SAE scales and is given in Table 49.

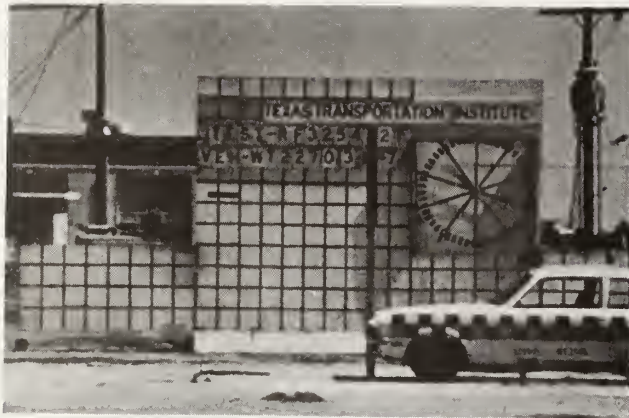
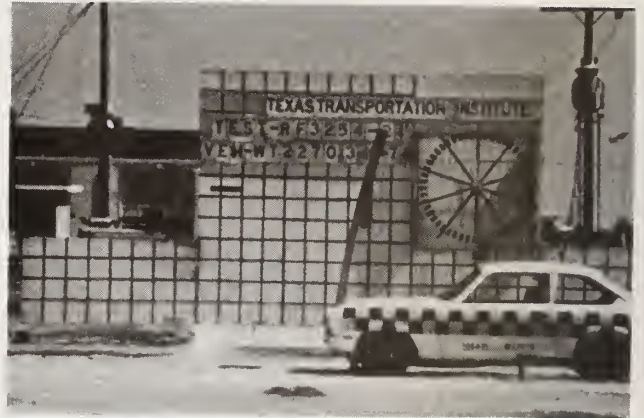
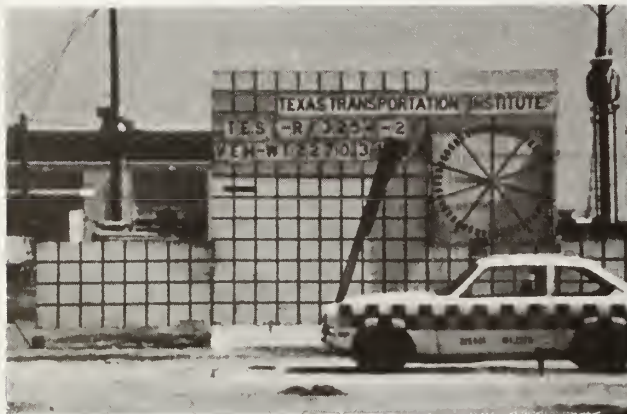
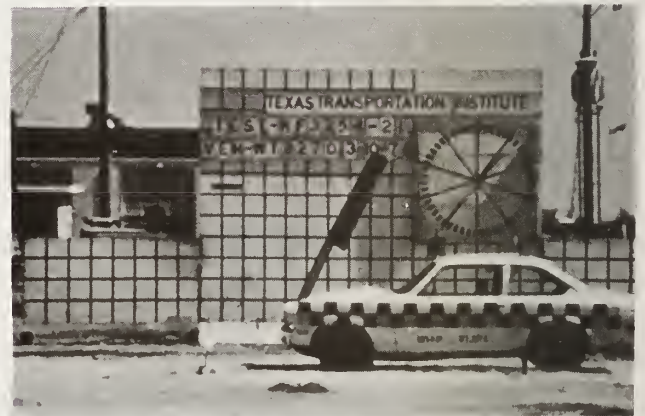
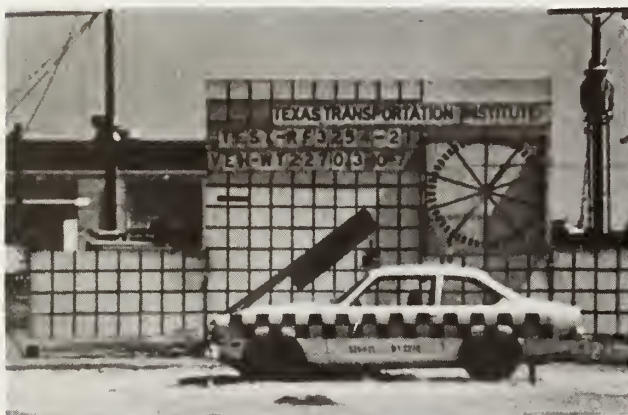
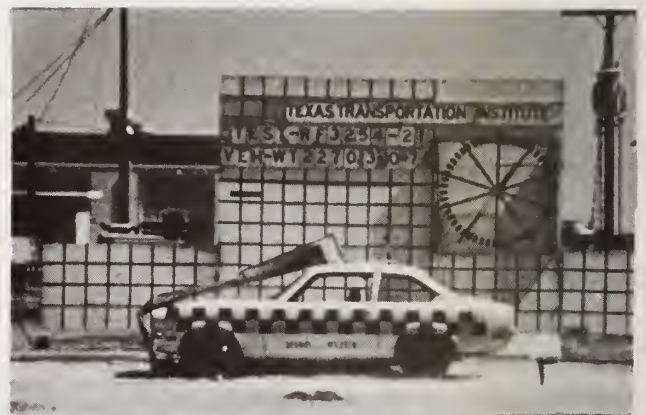
Figure 159. Sequential photos, test 21.

A summary of test 21 is given in Table 51. Photos taken during impact are presented in Figure 159. A time-displacement-event summary is given in Table 52.

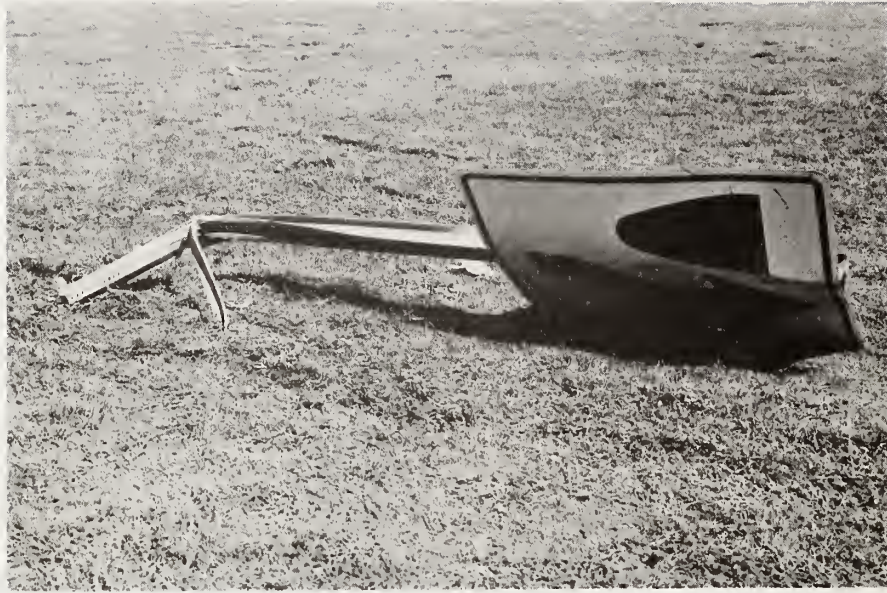
(a) POST AND PANEL

Figure 163. Sign installation damage, test 21.

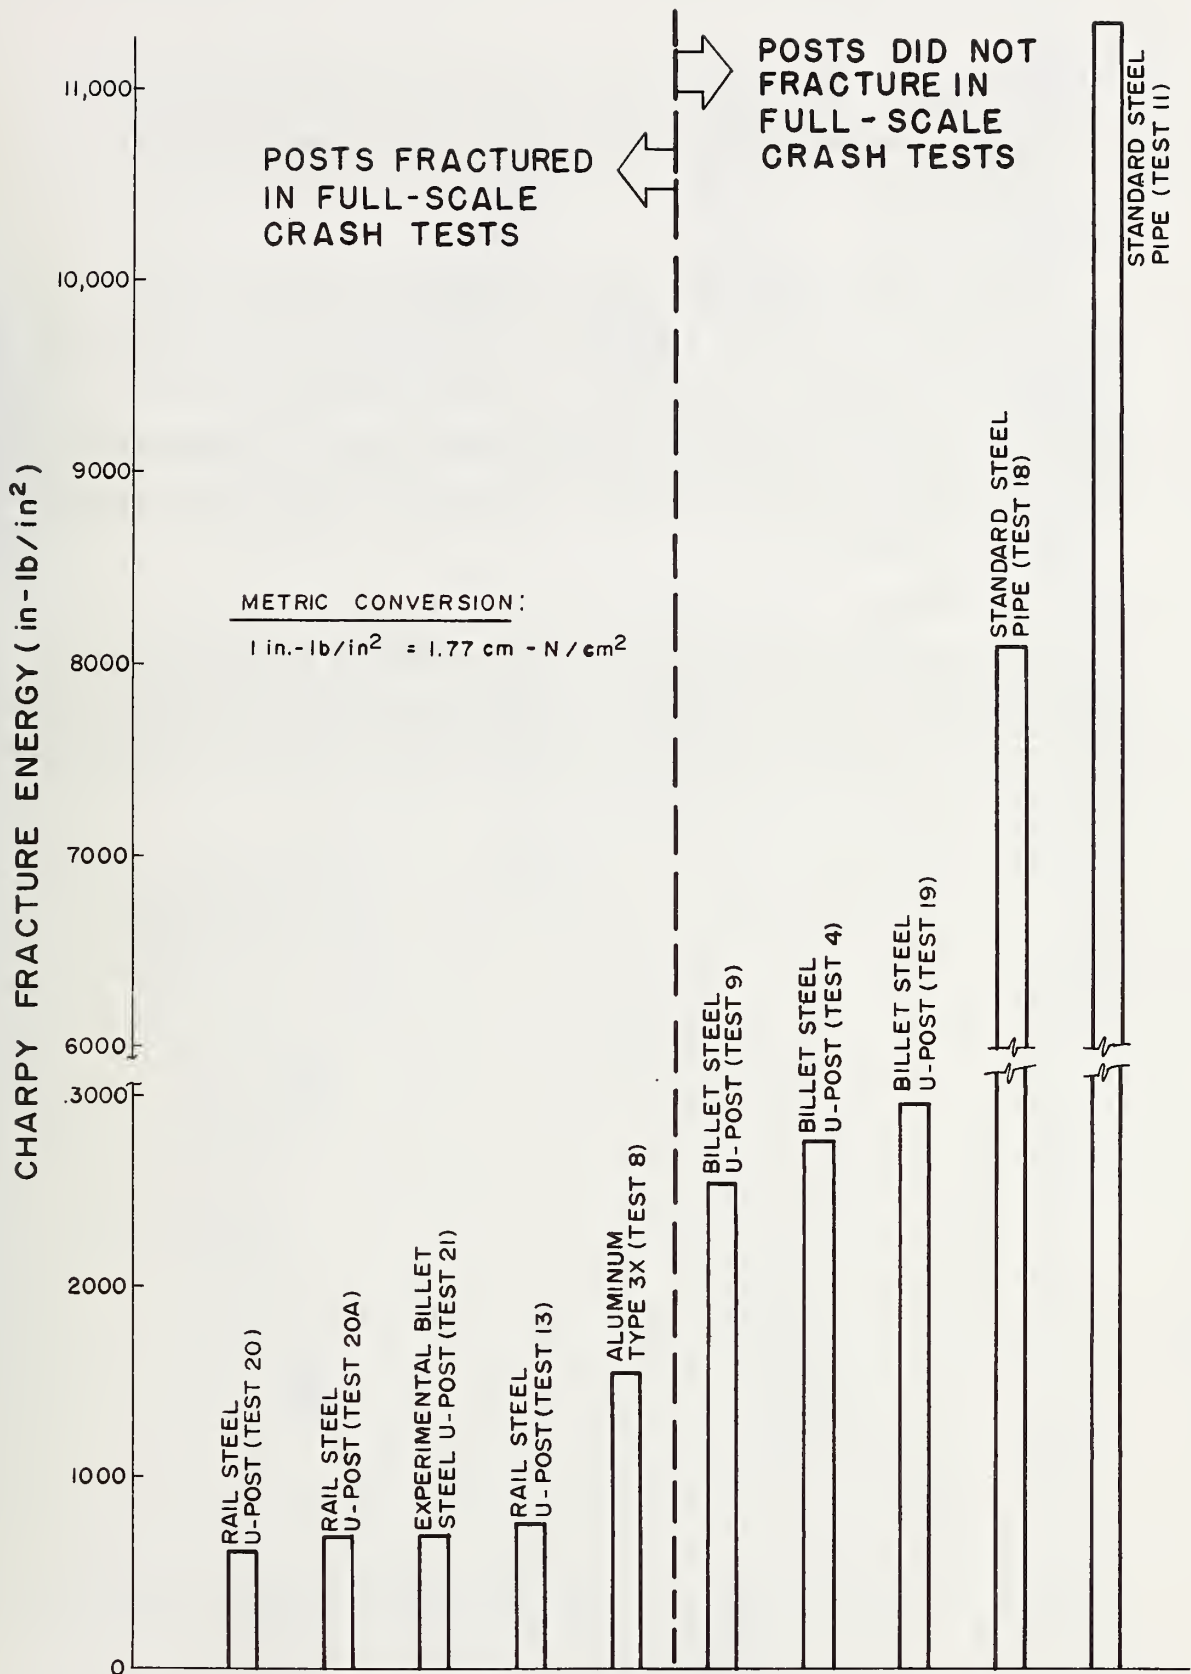
Figure 165. Fracture energy at 150°F (65.6°C) of metal post.

Figure 165 was prepared to further illustrate the Charpy results in relation to full-scale test results. Fracture energy values shown are averages for the respective posts at 150⁰F (65.6⁰C). As shown, posts which fractured during full-scale impacts had fracture energy values below 1600 in.-lb/in.² (2832 cm-N/cm²) and those that did not had energy values above 2500 in.-lb/in.² (4425 cm-N/cm²).
