Report No. FHWA-RD-79-133

# FATIGUE OF CURVED STEEL BRIDGE ELEMENTS

## Fatigue Tests of Curved Plate Girder Assemblies

April 1980  
Interim Report

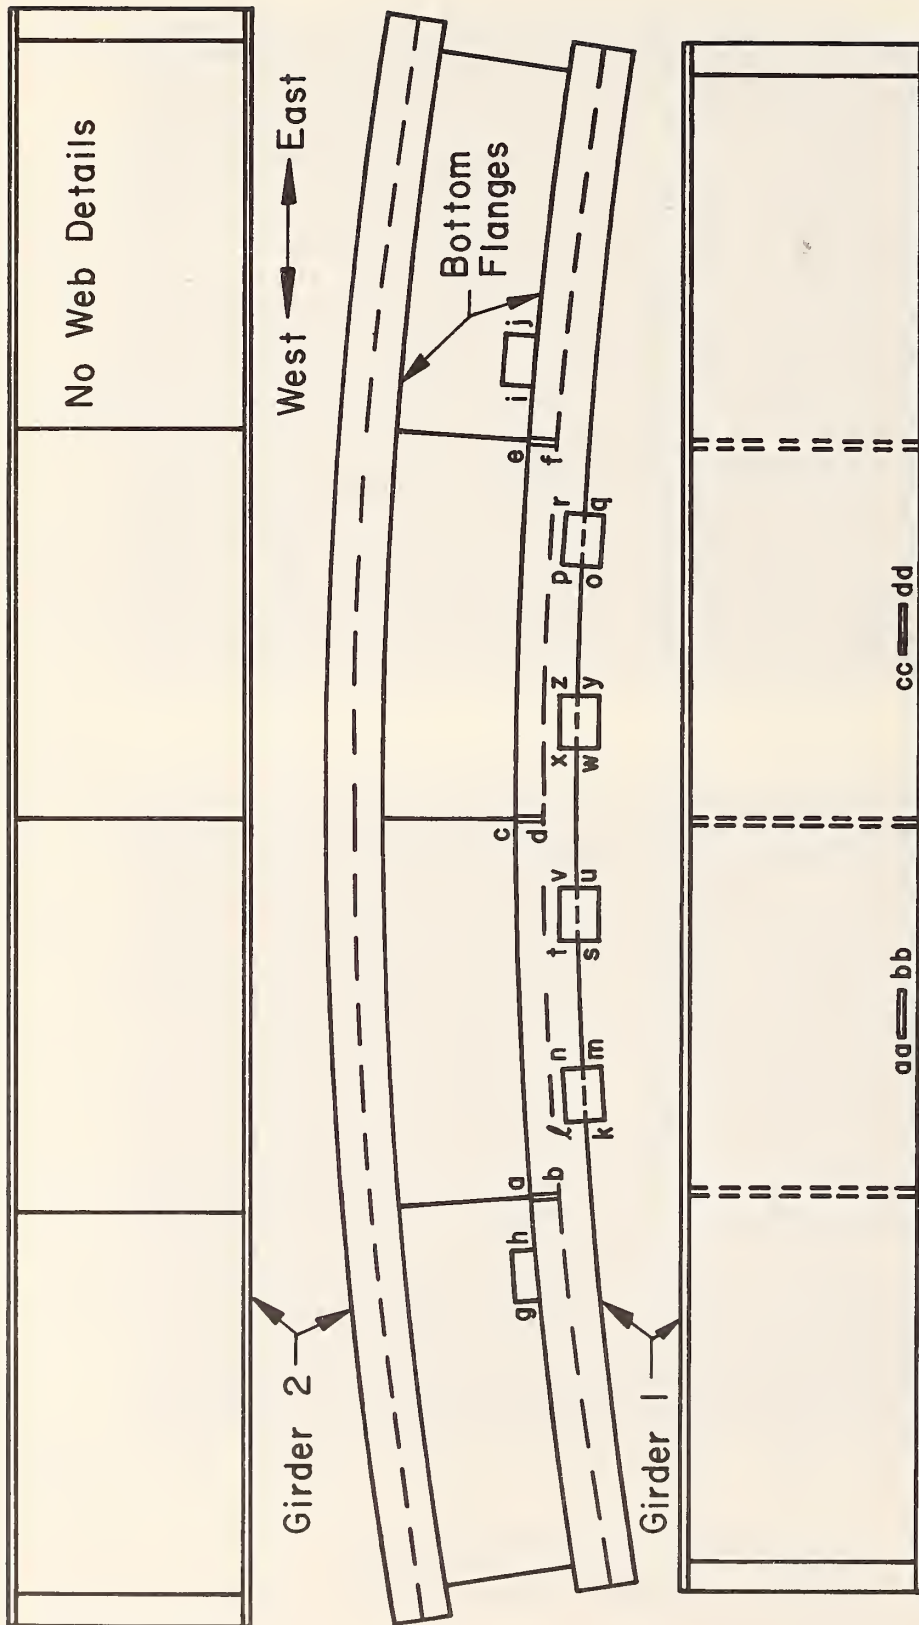
Fig. 53 Group 1 and Group 2 welded Details on Assembly 1

Figures 53 through 57 are schematic diagrams showing the Group 1 and Group 2 welded details on each assembly. The side view of each girder is the south side. Each potential primary fatigue crack location is assigned a letter or letters. The Group 2 details in Figs. 53 through 57 are positioned as shown on the stress range profiles (Figs. 42 through 50) with the exception of two type  $V_{ob}$  details on Assembly 3. The  $V_{ob}$  details in Fig. 55 with potential crack locations u through bb were welded on the wrong edge of the flange and remained there during the fatigue tests.

Table 6 Measured Nominal Stress Ranges at All Potential Crack Locations and Cycles to Visible and Through Cracks - Assembly 1

AASHTO Fatigue Category	Detail Type	Potential Crack Location	Measured $S_r$		Cycles ( $10^6$ )		
			(MPa)	(ksi)	Visible Crack	Through Crack	
C	I <sub>o</sub>	a	100.7	14.6	1.61		
		b	71.7	10.4			
		c	83.4	12.1			
		d	<69.0	<10			
		e	100.7	14.6			
		f	71.7	10.4			
E	V <sub>oa</sub>	g	57.2	8.3	1.45	0.76 0.95	
		h	79.3	11.5	0.64		
		i	79.3	11.5	0.64		
		j	57.2	8.3	2.03		
E	V <sub>ob</sub>	k	77.9	11.3	*0.95	0.95 1.61	
		l	59.3	8.6			
		m	73.8	10.7	*0.64		
		n	73.1	10.6			
		o	73.8	10.7	0.64		
		p	Interference from crack at o				
		q	73.1	10.6	1.45		
		r	59.3	8.6			
		s	81.4	11.8	0.95		
		t	Interference from crack at s				
		u	64.1	9.3			
		v	64.8	9.4			
		w	64.1	9.3	*0.64		
		x	64.8	9.4			
y	81.4	11.8	0.95				
z	67.6	9.8					
E	III <sub>ob</sub>	aa	58.6	8.5	2.03		
		bb	51.7	7.5			
		cc	51.7	7.5			
		dd	58.6	8.5

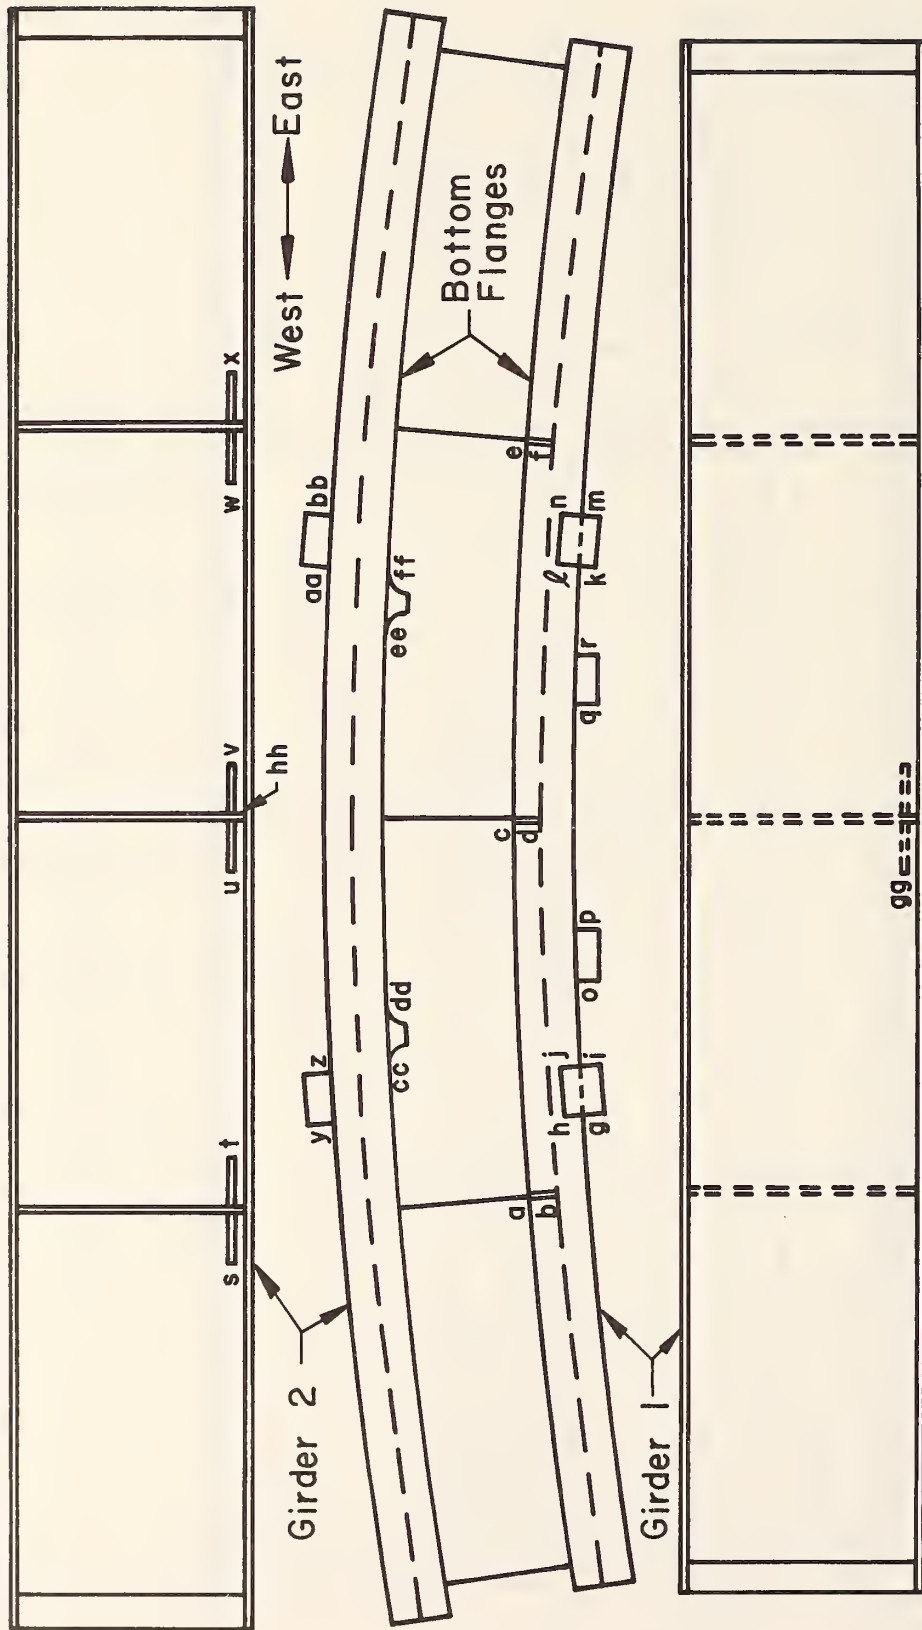
Fig. 57 Group 1 and Group 2 Welded Details on Assembly 5

Table 10 Measured Nominal Stress Ranges at All Potential Crack Locations and Cycles to Visible and Through Cracks - Assembly 5

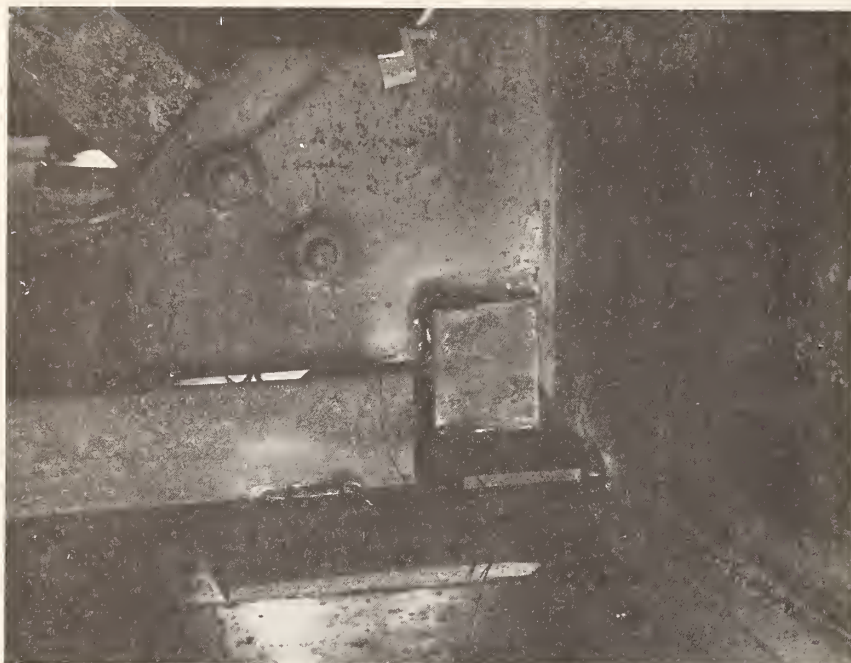
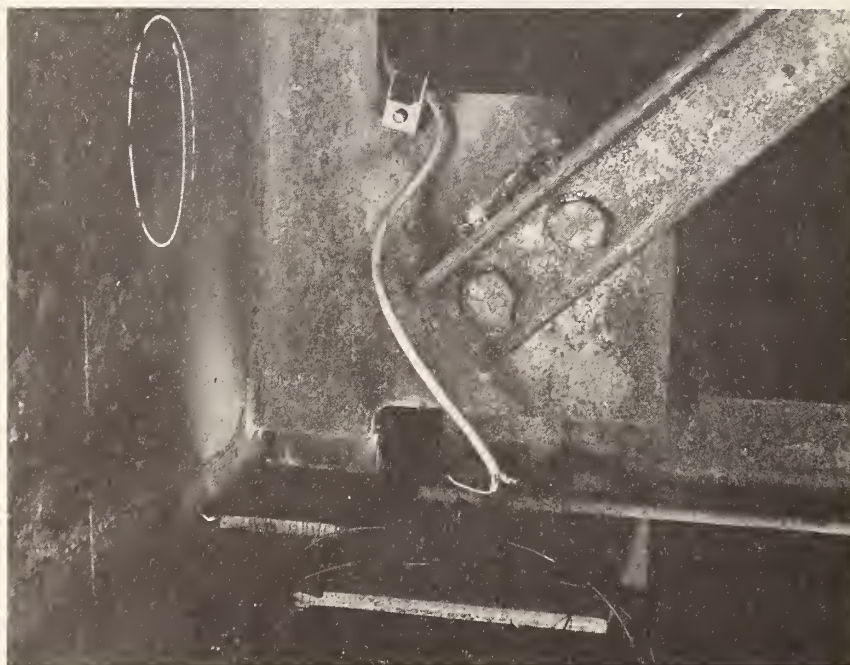
Fig. 62 Trial  $\perp$ -Type Connection to Join  
Type II<sub>o</sub> Detail to Bottom Flange

Figure 62 shows two views of a L-type connection to join cut-short transverse stiffeners to the bottom flange. The connection was

used on the type  $II_o$  details at joints 3, 4, 7, and 8 on Assembly 2. In Fig. 62 the horizontal and diagonal diaphragm members are not connected at the joint thus allowing lateral out-of-plane motion of the type  $II_o$  stiffener before installation of the  $\perp$ -type connection. The horizontal leg of the  $\perp$  is welded to the web-to-flange junction. The vertical leg is then welded to the stiffener. Such a connection may be practical only when the flange tip stress range is too large to consider extending the web stiffener and welding it directly to the flange, as is done for type  $I_o$  details. The  $\perp$ -type details used at joints 4 and 8 on Assembly 2 (ee and ff in Table 7) have approximately 4 inch long horizontal plates, placing them into a Category D detail. Although  $\sigma_r$  varied from 13.7 to 13.9 ksi at these details no visible cracks were observed at the end of the test ( $2.03 \times 10^6$  cycles).

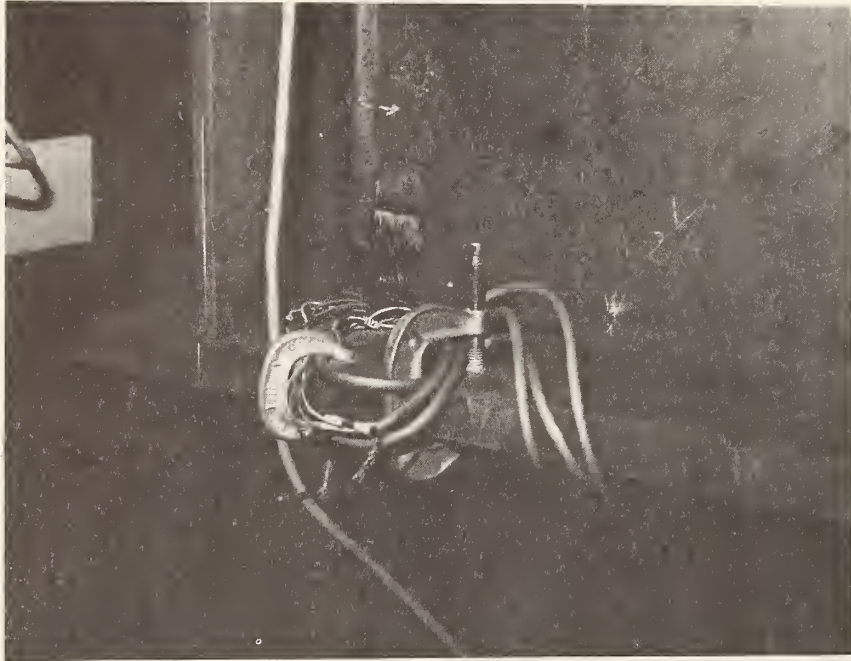
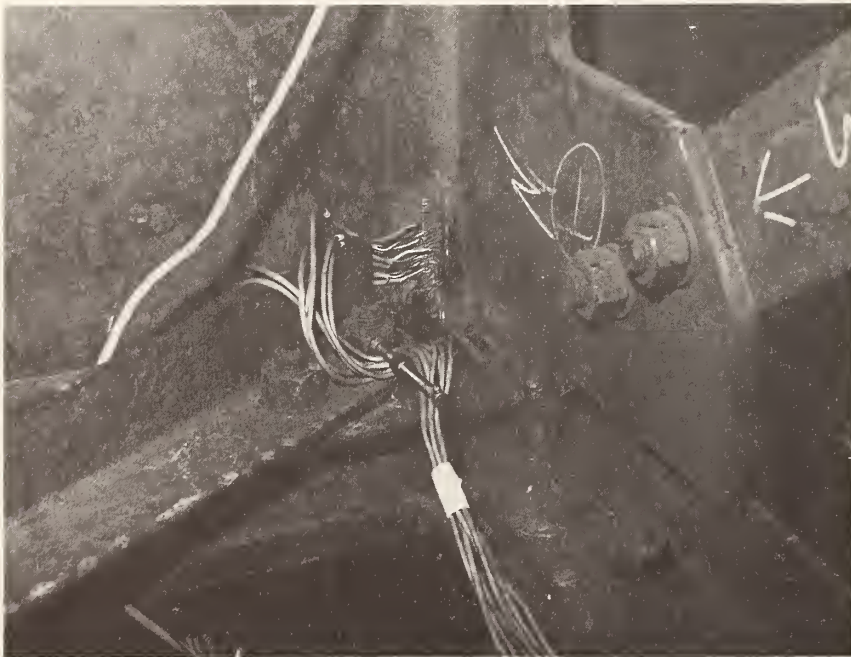
Fig. 63 Strips of Ten Strain Gages Mounted on  
North and South Faces of Web -  
Midspan - Assembly 4 - Girder 2

Out-of-plane displacement induced stresses in the web can also be significant in the cope of the type  $III_{oa}$  detail (Table 2). One midspan type  $III_{oa}$  detail on Girder 2 of Assembly 4 was modified by disconnecting the detail from the transverse stiffener by flame cutting. Again a strip of ten strain gages was mounted on each face of the web. This time the gages were oriented horizontally. Figure 63 shows each side of the web on Girder 2 where the strain gages are mounted horizontally at the level of the type  $III_{oa}$  detail. The figure also shows wires leading to the oscillograph recorder. Forces in the bottom lateral bracing member and the diaphragm contribute to the out-of-plane bending of the web. Web fatigue cracks developed after 790,000 cycles with out-of-plane bending stresses measured as high as 222 MPa (32.2 ksi). Repairs consisted of drilling holes at the crack tips and rewelding the gusset plate to the transverse stiffener.

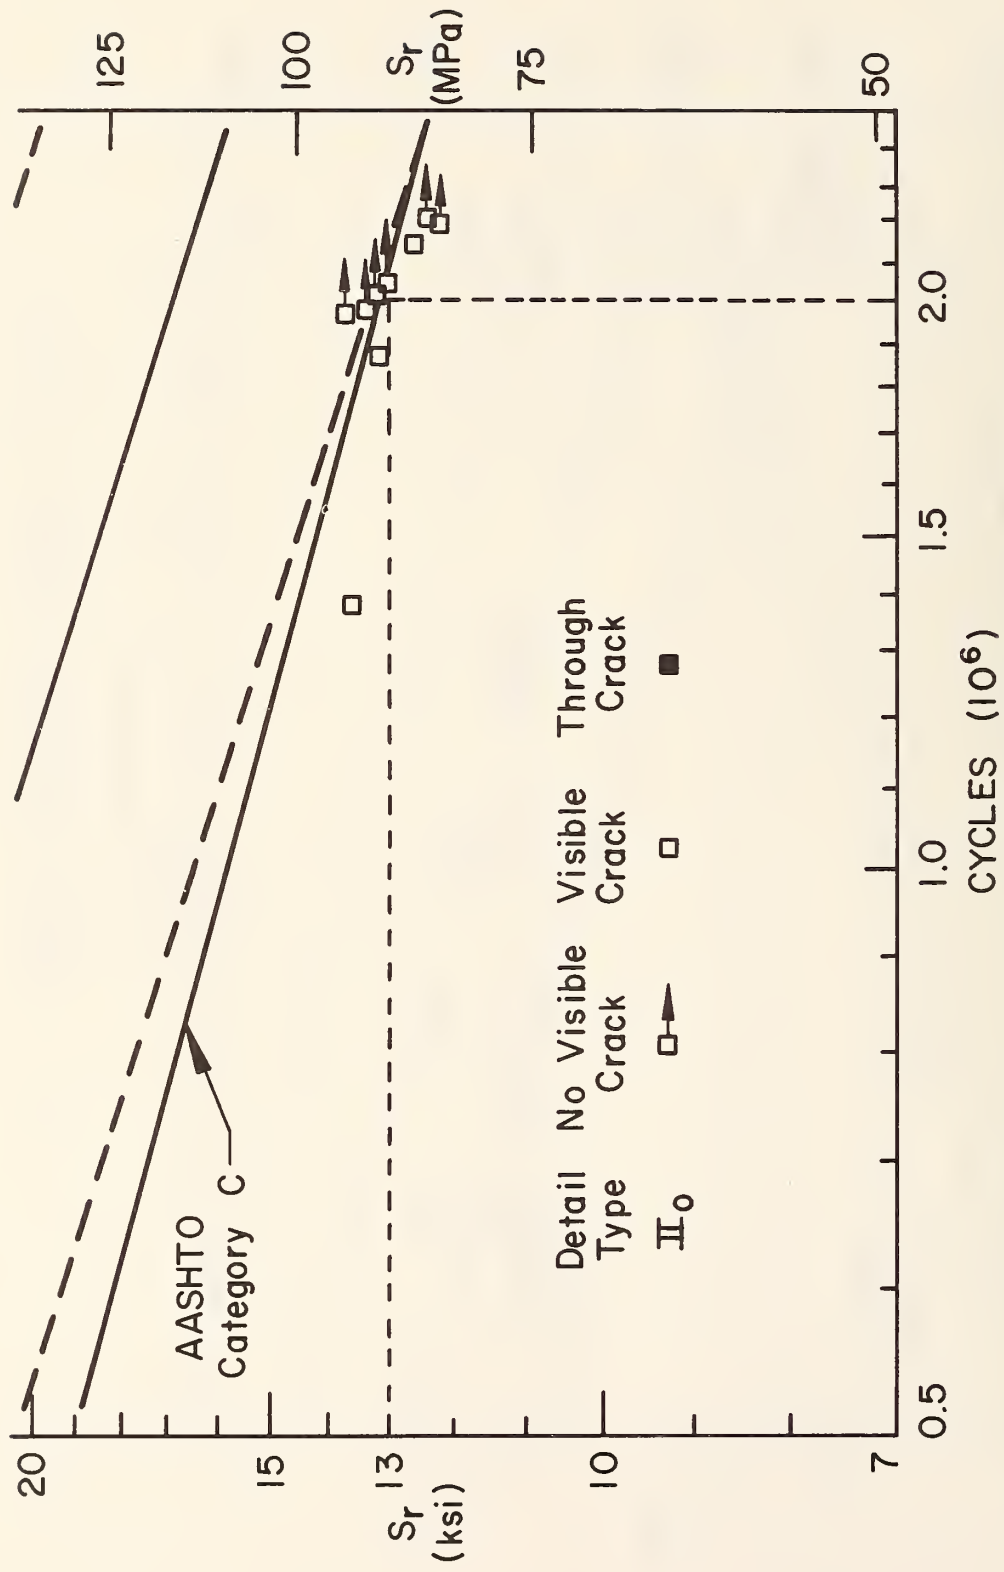
Fig. 76 Fatigue Results - Type II<sub>0</sub> Details

The fatigue results for type II<sub>o</sub> details on all five assemblies are presented in Fig. 76. The type II<sub>o</sub> detail is not affected by torsion normal stresses introduced by the curvature when a curved girder is loaded because the detail is welded only to the web. Thus the behavior of a type II<sub>o</sub> detail on a curved girder should not differ from its behavior on a straight girder. Fatigue cracks due to out-of-plane bending of the web (Art. 6.2) are not included in the figure.

Six of the type II<sub>o</sub> details in Fig. 76 are Group 2 details with no diaphragm members attached to them. Each of these cut-short stiffeners had a 25.4 mm (1 in.) gap between the detail and the bottom flange. Two of these stiffeners had visible fatigue cracks. They did not develop into through-thickness cracks during the two million load cycles.

Three type II<sub>o</sub> details in Fig. 76 are Group 1 details with diaphragm members attached. The bottoms of these transverse stiffeners were flush with the top surface of the bottom flange. Only one developed a visible fatigue crack after two million load cycles.

The three Group 1 type II<sub>o</sub> details discussed in Art. 6.2 experienced high bending stresses out of the plane of the web. The out-of-plane deformation of the web took place in the 25.4 mm (1 in.) gap between the detail bottom and the top surface of the bottom flange. The diaphragm member forces (Table 4) causing the out-of-plane deformation are higher than would be expected on curved girder assemblies with larger curvature radii or when a concrete slab is present<sup>(8)</sup>. Nevertheless, the early fatigue cracking on Assemblies 2 and 3, and an analytical study on the cut-short transverse stiffeners on curved box girder assemblies indicate that early fatigue cracking can be expected to occur whenever lateral displacement is allowed to occur between the cut-short stiffener and the flange<sup>(14)</sup>.

In the curved plate girder assembly tests a type II<sub>o</sub> detail lacking either the gap or the connection to diaphragm members exhibits a fatigue strength comparable to the straight girder Category C. Thus the AASHTO straight girder Category C is applicable to type II<sub>o</sub> details not experiencing secondary fatigue cracking on curved plate girders.

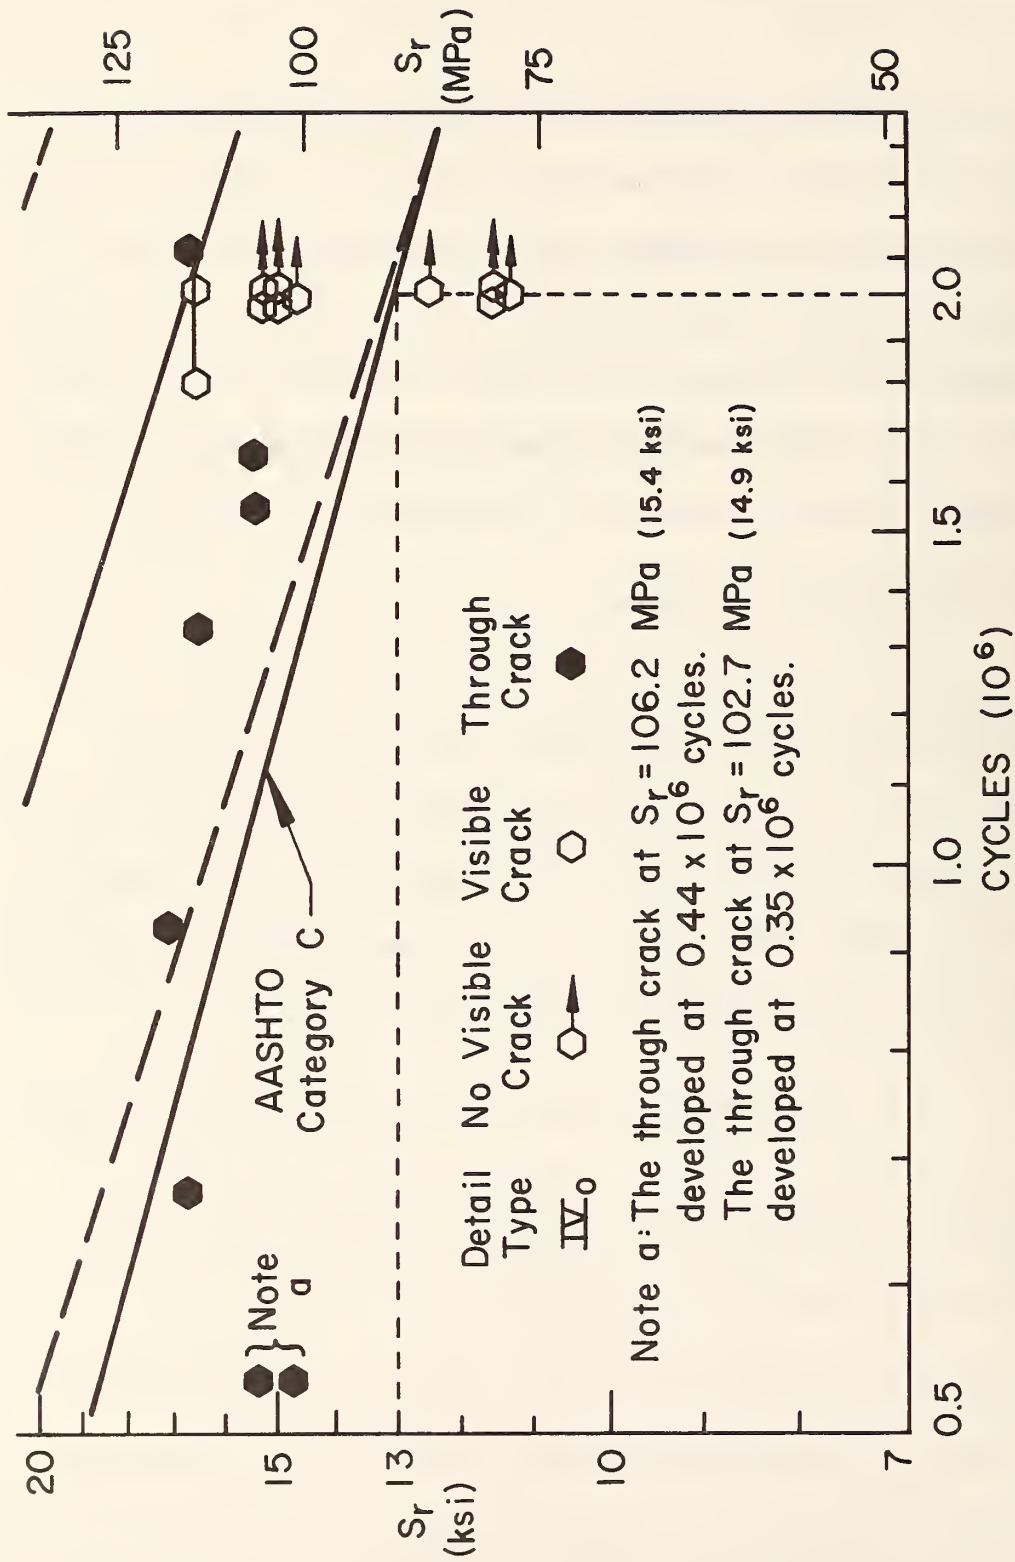
Fig. 78 Fatigue Results - Type IV<sub>0</sub> Details

Fatigue test results for all type IV<sub>o</sub> details are plotted in Fig. 78. These groove-welded gusset plates with circular transitions

All but three of the visible or through-thickness cracks lie within the 95 percent confidence limits in Fig. 78. The three fatigue cracks falling below the AASHTO Category C allowable stress range curve are at locations a and f on Assembly 4 and location cc on Assembly 5 (Figs. 56 and 57). The fatigue life of two of the three early fatigue cracks is only a small fraction of the expected life. This is cause for further investigation and discussion.

Table 12 contains the calculated estimates of initial crack size,  $a_i$  and  $b_i$ , for two different crack growth shapes at four type IV<sub>0</sub> details. Location ee is included because it falls almost directly on the 95 percent confidence limit curve in Fig. 78. The assumed crack

Analytical studies of groove-welded gusset plates with circular transition radius  $r$ , have shown that the maximum stress concentration occurs a distance of about  $r/5$  from the point-of-tangency<sup>(17, 20)</sup>. The fatigue cracks in Fig. 78 which are not a result of visible flaws are all located 25.4 mm (1 in.) to 38.1 mm (1.5 in.) from the point-of-tangency for the transition radius of 152.4 mm (6 in.). The visible flaws discussed previously also happened to be located near this region of maximum stress concentration which thus compounded the severity of the flaws.

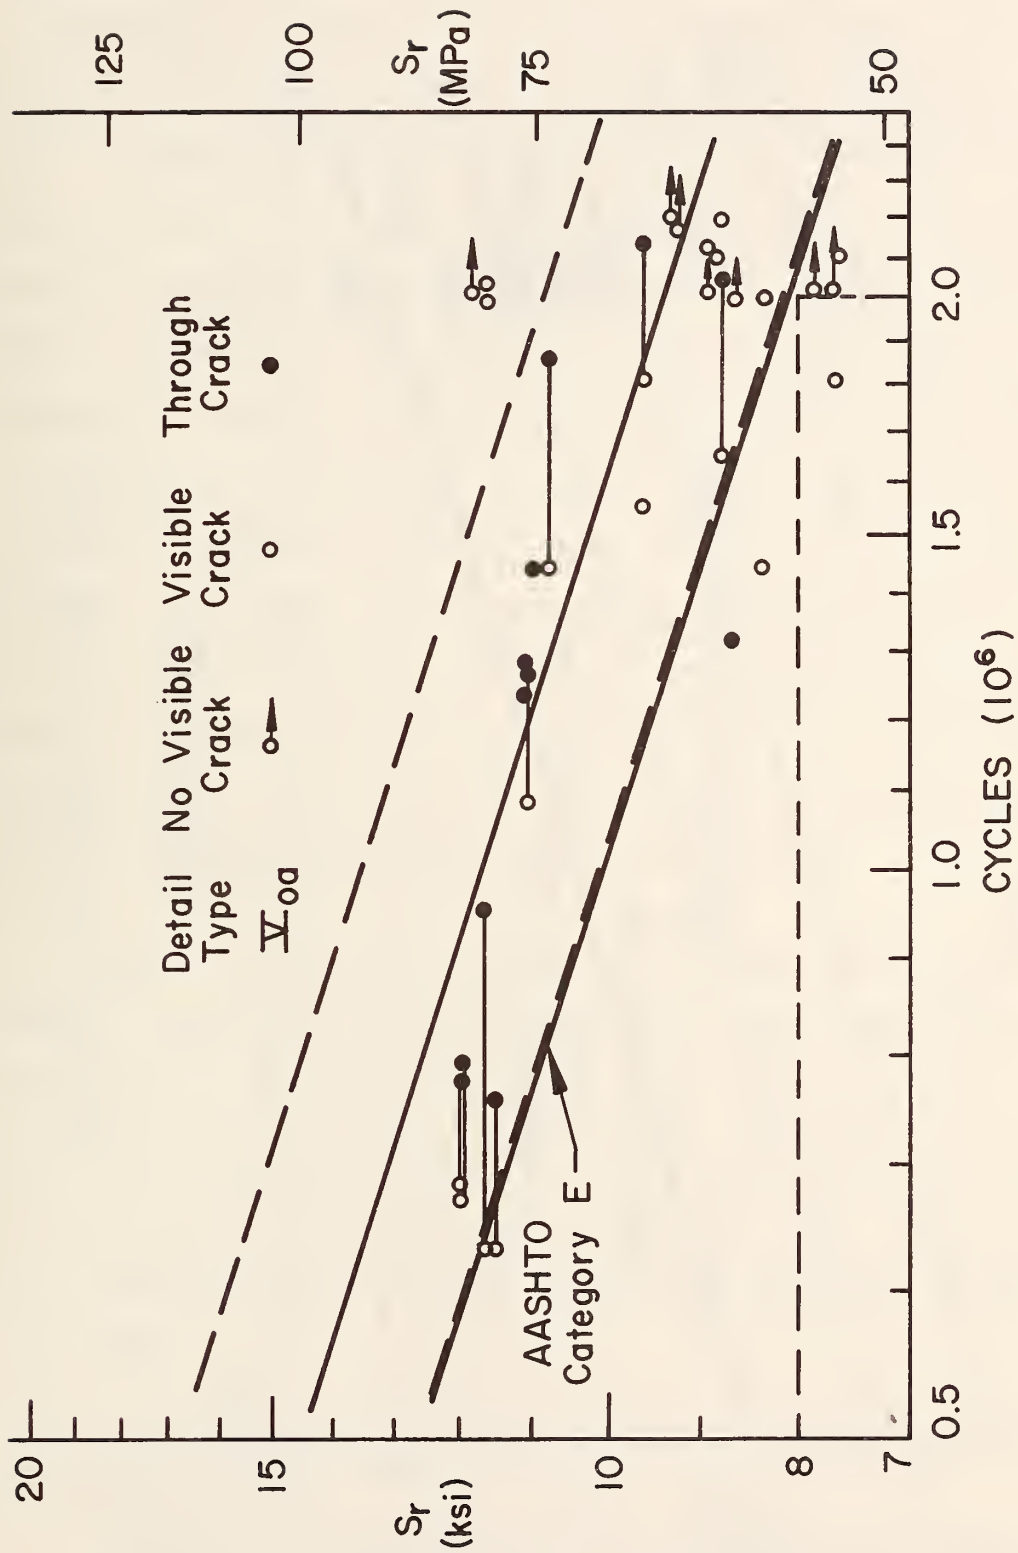
Fig. 79 Fatigue Results - Type  $V_{oa}$  Details

Fatigue test results for all the type V<sub>oa</sub> details are plotted in Fig. 79. Only three visible fatigue cracks and one through-

thickness crack are below the straight girder AASHTO Category E allowable stress range curve. The through-thickness crack falling below the Category E curve developed at location j on Assembly 4 (Fig. 56). A close visual inspection of the crack location reveals no apparent surface flaw from which the crack grew. No strain gage was mounted adjacent to location j but the symmetric location g on the west end of Assembly 4 was gaged. The measured stress range at g is assigned to location j in plotting the fatigue crack. The actual stress range at j could have been higher than the measured stress range at g. Thus the through-thickness crack at location j could have actually experienced a stress range above the allowable stress range curve or it could be one of the fatigue failures which statistically does not lie above the 95 percent survival line. In either case the AASHTO straight girder Category E is applicable to the type  $V_{oa}$  details on the curved plate girder test assemblies.

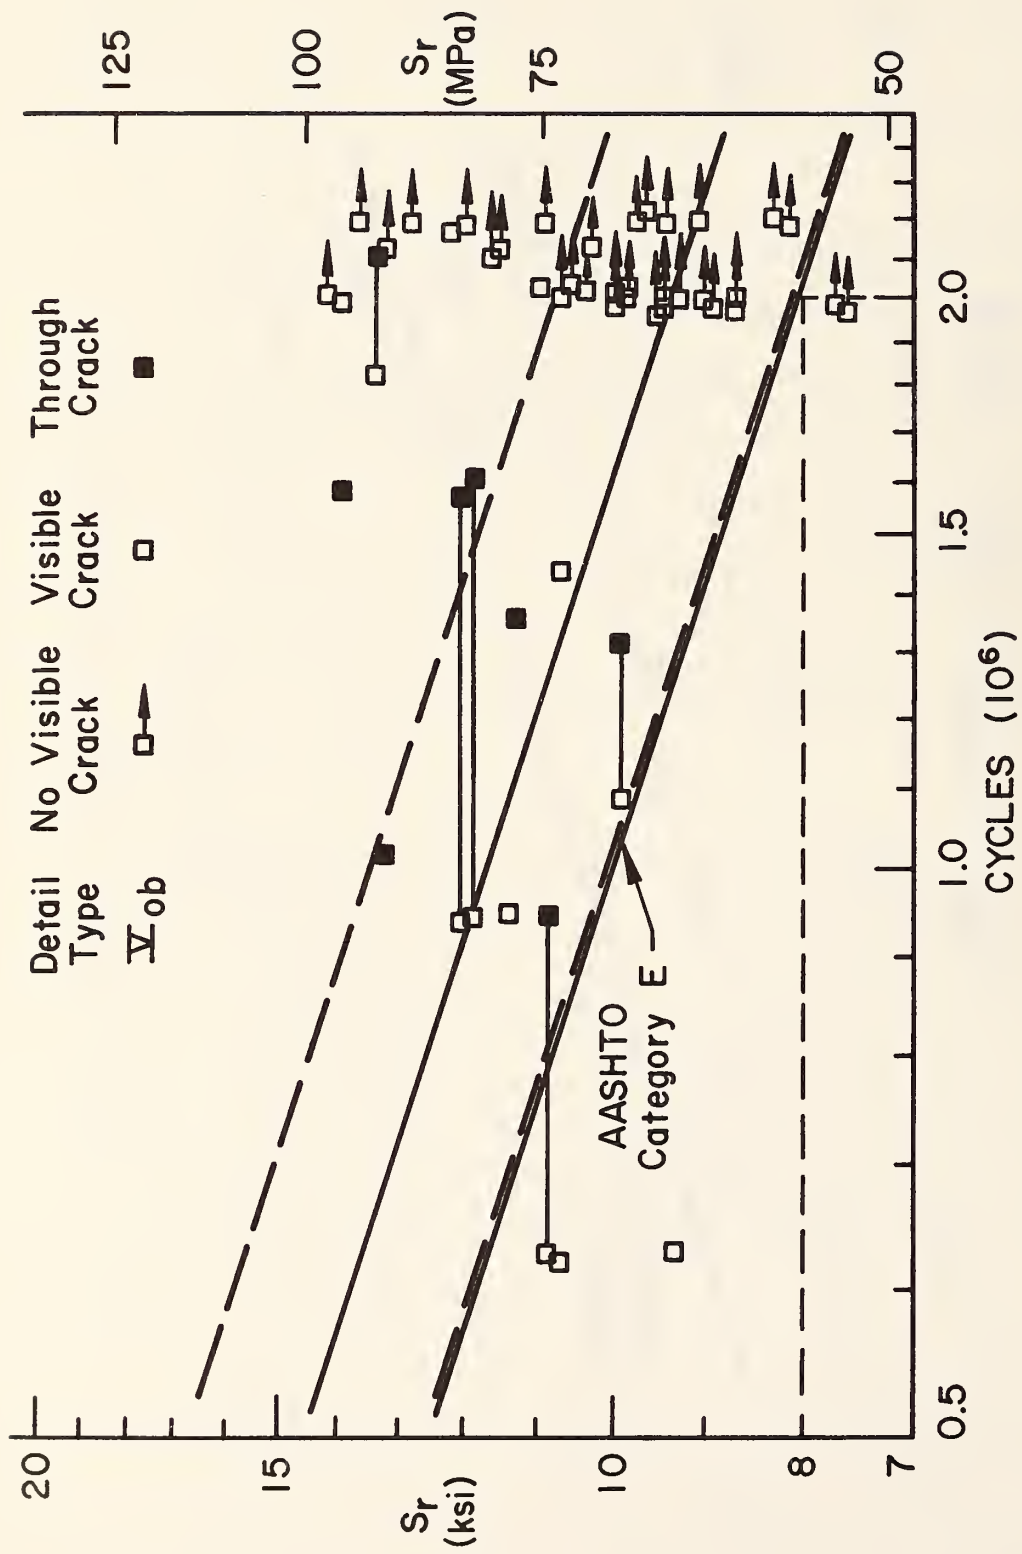
Fig. 80 Fatigue Results - Type  $V_{ob}$  Details

Fatigue test results for all type  $V_{ob}$  details are plotted in Fig. 80. A large percentage of the potential crack locations either

The two visible cracks at 640,000 cycles in Fig. 80 were located in the fillet weld metal and not in the flange metal. Apparently a flaw existed in the weld metal such that its stress concentration overshadowed the usually critical stress concentration at the fillet weld toe. The weld metal cracks did not visibly increase in surface length during the remainder of the fatigue testing.
