NATIONAL PARTS RETURN PROGRAM

Kappa Systems, Inc.
1501 Wilson Blvd.
Arlington, Virginia 22209

Final Report
January 1978

Technical and Summary Report
National Parts Return Program
June 1977
Final Report

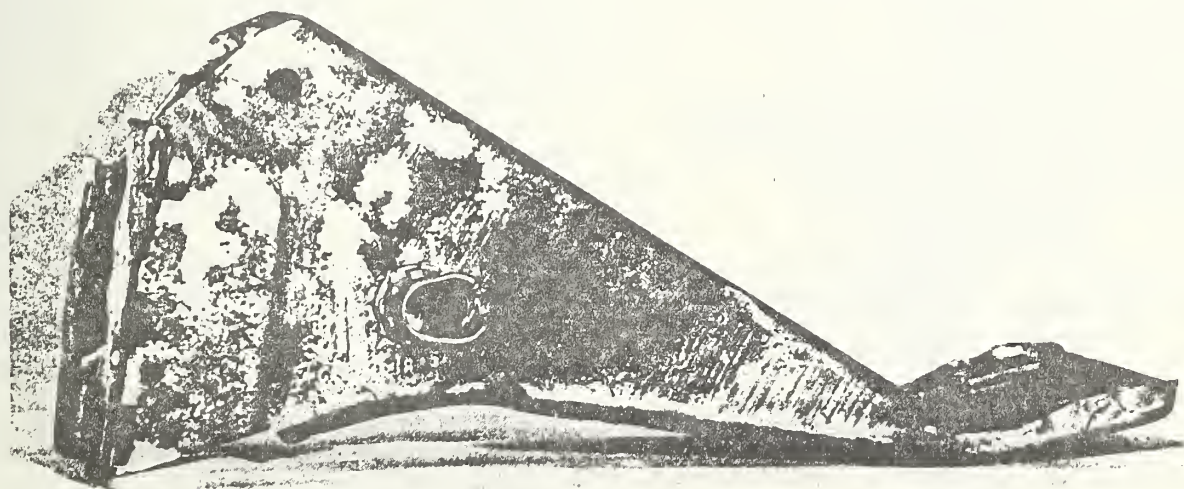
Figure 1

The bushing which supports the brake pedal swing shaft on the right side of this bracket is elongated and split (see figure 1). The hole in the bracket thru which the bushing fits is also elongated, approximately $\frac{3}{8}$ of an inch, and the bracket has a light coating of rust. Reportedly, the failed bushing can prevent the brake pedal from returning, possibly resulting in brake lock-up, or cause enough resistance to require excessive effort to apply the brakes.

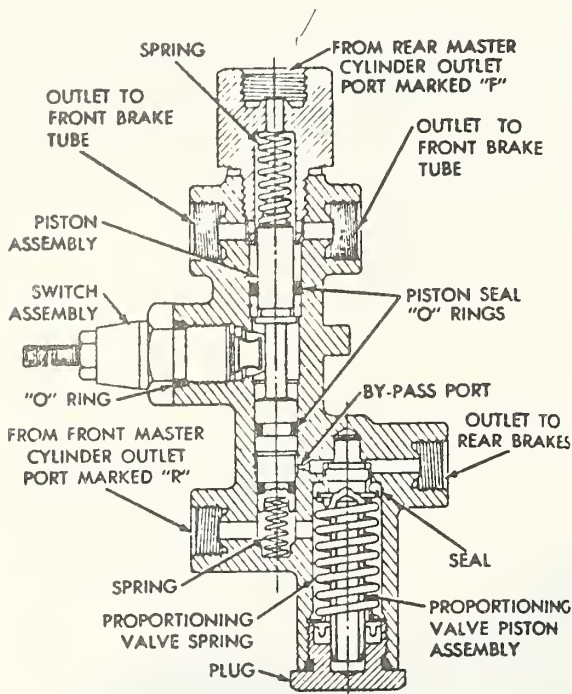
Figure 2

A warning system consists of an illuminated "brake" display sign in the vehicle's instrument panel, a special switch, and a proportioning valve. The switch is operated by *differential* pressure on the ends of a sliding rod. When the brake pedal is pressed and one of the brake lines is open, the rod will be forced to move. It is designed to provide cam operation of the switch which operates the brake warning light (see figure 2).

Combination brake warning switch and proportioning valve assembly (sectional)

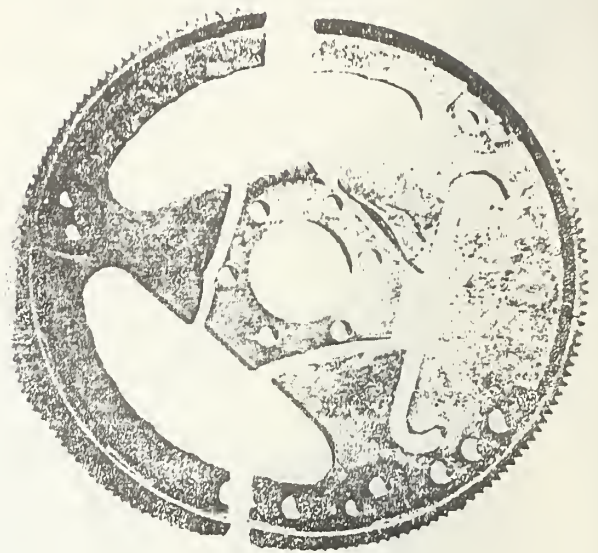
J. GARTNER'S AUTO SERVICE in Chicago, Illinois has returned a converter flex-plate that was removed from a 1973 Buick Century station wagon with a mileage of 49,548. The vehicle was equipped with a 350 CID engine and a 350 Turbo Automatic transmission. The hub apparently broke out of the flex-plate, suddenly, while the vehicle was being driven on the highway. As shown in the photograph, the outer mounting holes of the plate are elongated and worn, and the hub is broken away from the spokes. The part was too large to fit in a PRP mailbag, so the rim has been cut in two. The driver of the car reportedly experienced loss

of drive power as a result of the failure. The vehicle was allowed to coast to the side of the road and out of the path of traffic. Special thanks to J. GARTNER'S for sending in the part. If your shop has encountered a similar failure please let the PRP know.

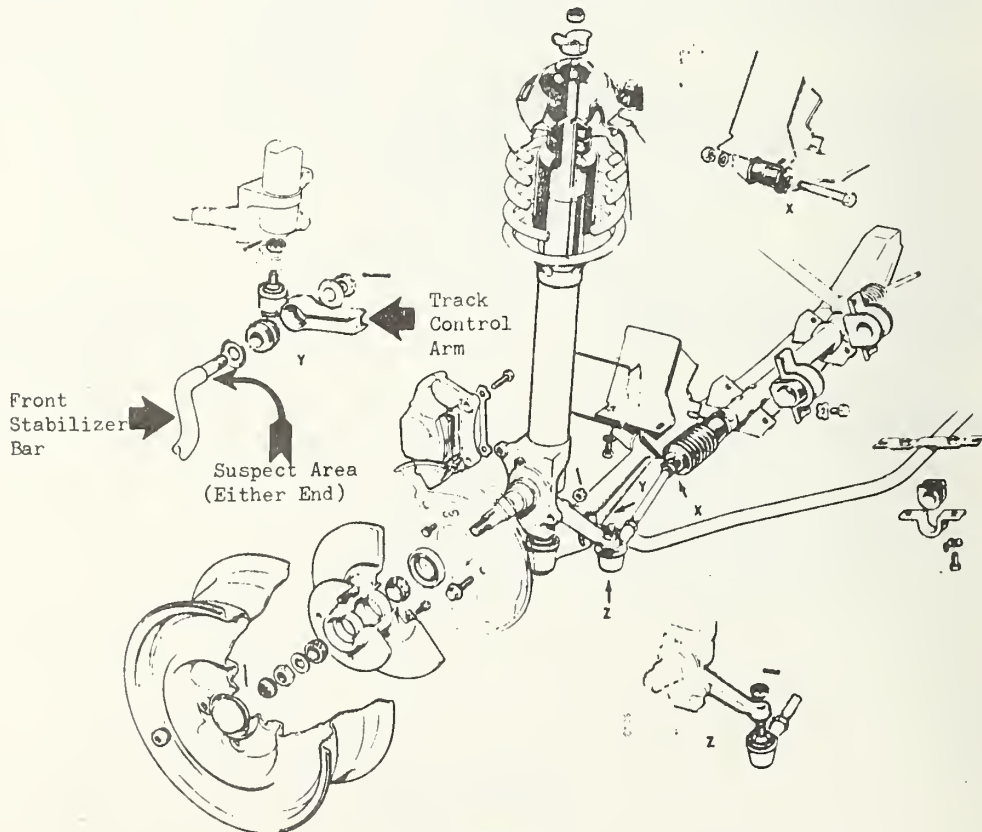
The front stabilizer bar and the track control arm to which it is attached by a steel sleeve and rubber bushing insulator are components of the vehicle suspension system (see accompanying diagram). Together they regulate front wheel movements. The control arm regulates lateral movements. The stabilizer bar regulates fore and aft movements, and together with the control arm reduces shock-loading stresses on the steering linkage from road surface irregularities. However, its principal function is to counter the vehicle tendency to roll or lean in cornering maneuvers. The centrifugal forces created in turning place a downward stress load on one end of the stabilizer bar and an upward stress load on the other end. The stabilizer bar resists these loads, thereby impeding vehicle roll or lean and maintaining vehicle side-to-side equilibrium.

Allegedly, stabilizer bar failure is due to metal fatigue through crack initiation and propagation, with final fracture resulting from overload. The apparent and primary contributing factor to fatigue crack initiation is a small radius fillet between the machined shank and the as-formed stabilizer bar. Other apparent contributing factors reportedly are metal impurities, environmental attack, and failure to properly finish the shank ends. There are no known prefailure symptoms. Investigation was initiated to determine whether the alleged problem constitutes a potential safety-related defect within the meaning of the National Traffic and Motor Vehicle Safety Act of 1966.
