NATIONAL PARTS RETURN PROGRAM VOLUME II

OCTOBER 1980
FINAL REPORT

1. Report No. DOT-HS-805-638		2. Government Accession No.		3. Recipient's Catalog No.	
4. Title and Subtitle National Parts Return Program Final Report - Volume II				5. Report Date 1 October 1980

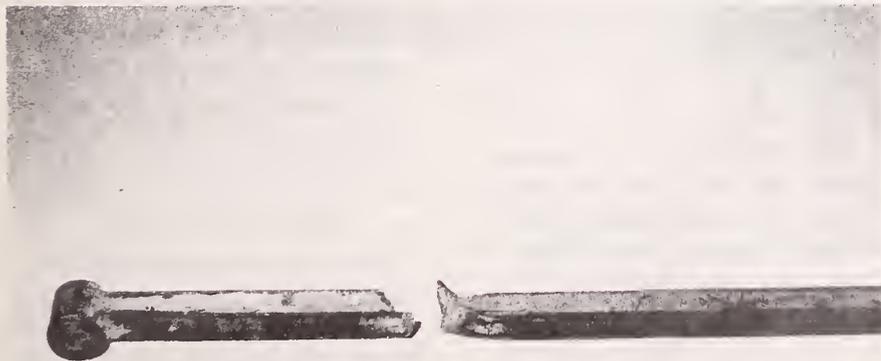
The rod in the photo below, taken from a 1978 Fiesta with 29,000 miles, shows a typical failure. The rod was submitted by **PROTANO'S SERVICE STATION, INC.** PRP members should note that indications of bending often precede breaking.

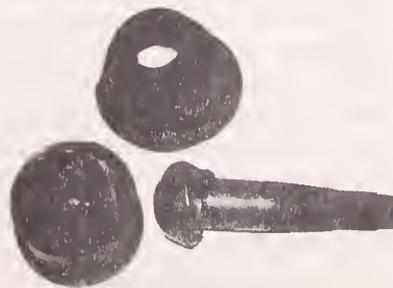
Pictured below is the right front lower ball joint from a 1977 Dodge Van with approximately 66,000 miles. As shown, the part has completely separated. It exhibits signs of abnormal wear at the taper end of the ball.

According to **RED'S AUTOMOTIVE** of Abilene, Texas, the vehicle was moving at between 30 and 40 mph when the failure occurred, resulting in partial loss of steering and other vehicle control. Fortunately, the failure did not cause an accident. The shop further

stated that the vehicle was in good condition, had been serviced regularly, and was not abused.

In the September 1978 Newsletter, similar ball joint breakage in Dodge Vans was reported. In contrast, it was speculated at that time that the failure was due to mismatched tapers on the ball joint and spindle, causing the stud to break. The PRP is interested in hearing from members regarding Dodge Van suspension problems. Any further information would be appreciated.

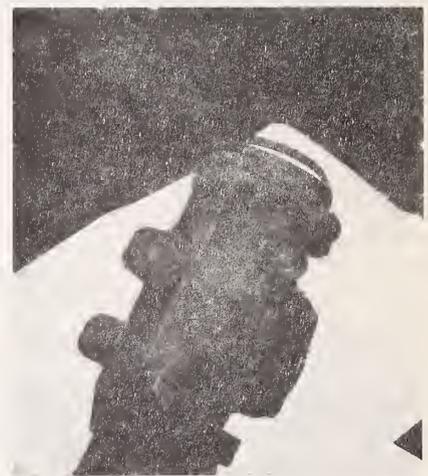
power assist. The cause of the failure is not clearly known.

Vehicle mileage was 56,000 at the time of failure.

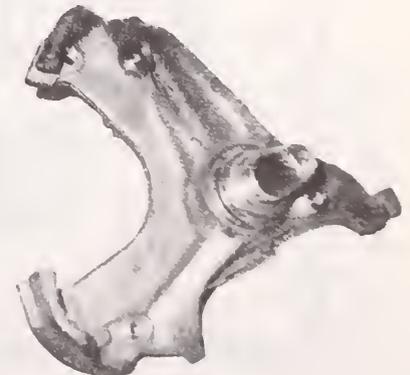
The day before this spindle was removed, the shop uncovered a similar problem on a 1973 full sized Chevrolet with 21,000 miles. While the Chevrolet spindle did not break, the wheel bearing race is seized to it in a similar manner and extensive

bluish discoloration indicated intense heat build-up.

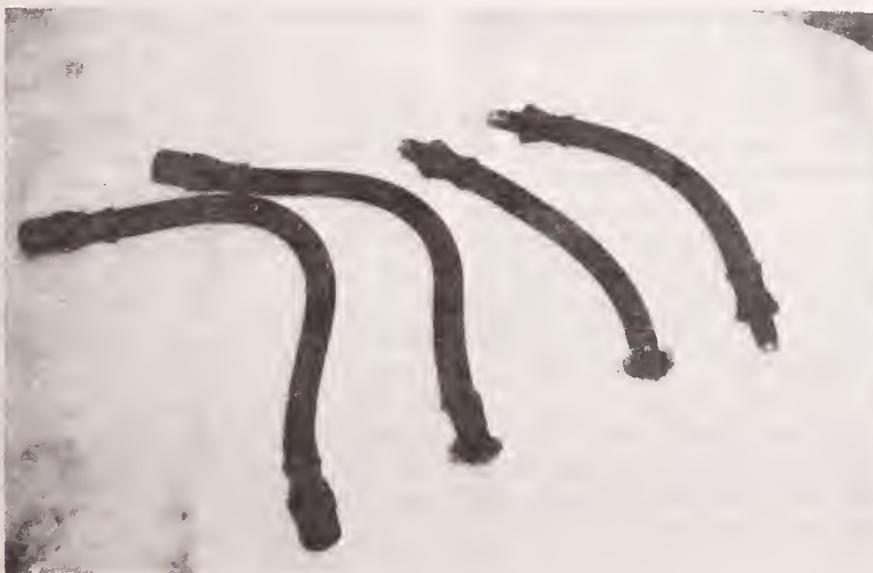
All four hoses show signs of leakage at or near the area where the threaded coupler is crimped around the flexible hose. In two cases, the coupler has been separated from the hose itself. Some of the hoses show cracks and other deterioration, yet even in the case where the hose and fitting are intact, traces of a fluid leak can be seen around the coupler.

The shop reports this is a common problem among late model Toyota Corollas and Coronas. The PRP is interested in hearing from other members who have encountered this or similar problems.

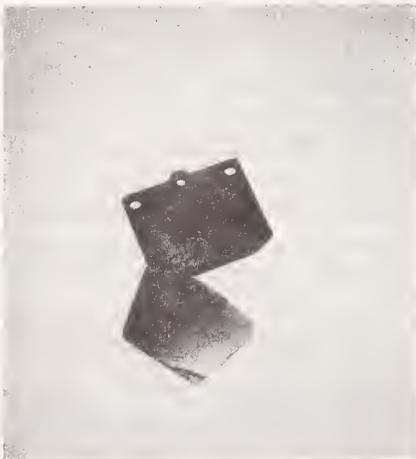
Close inspection indicates the failure may have been caused by the bonding agent, as the pad itself is intact. It is unclear whether the part was original equipment on the vehicle or an after-market replacement. As a result of the failure, the pad was twisted on the backing plate and has worn unevenly. The owner complained of brake noise, but apparently did not experience any brake pull.

The vehicle had just over 19,000 miles showing when the repair was made.

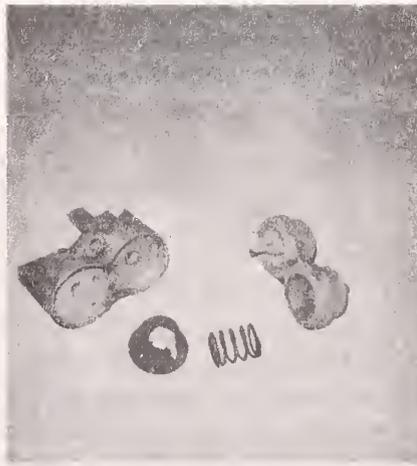
The PRP received 7 spark advance units from 1975 and 1976 model AMC vehicles equipped with 6 cylinder engines and the BID ignition system. In each case the vacuum advance diaphragm was ruptured. The **STATE OF WISCONSIN** in Madison, Wisconsin, reports that a potential safety problem exists in that, when this diaphragm breaks, the plastic chamber can fill up with a mixture of air and fuel. If the vehicle backfires, as it is prone to do when this diaphragm breaks, a small explosion can occur, resulting in blowing the distributor cap off, stalling the vehicle, and causing damage to the advance unit as shown in the photo below.

FELD GARAGE of Kenosha, Wisconsin submitted 4 advance units with the same problem. Vehicle mileage on these components ranged from 32,000 to 68,000 miles.

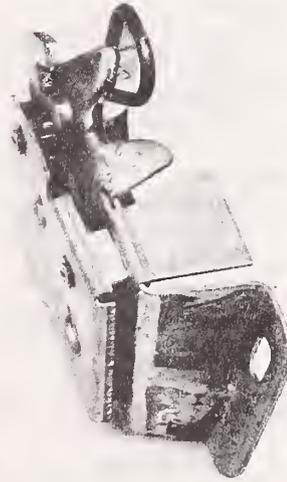
The photo below shows the tailgate latch from a 1977 Plymouth Volare Station wagon. As can be seen, the striker guide plate near the latch jaw is bent and torn, restricting the movement of the jaw and hampering the engagement of the ratchet. The result is, of course, the failure of the latch to hold closed. The vehicle was not involved in a collision, and no other explanation for the failure was evident. The latch was submitted by **WALE'S GARAGE** of Ft. Lauderdale, FL. Mileage at failure was approximately 30,000.

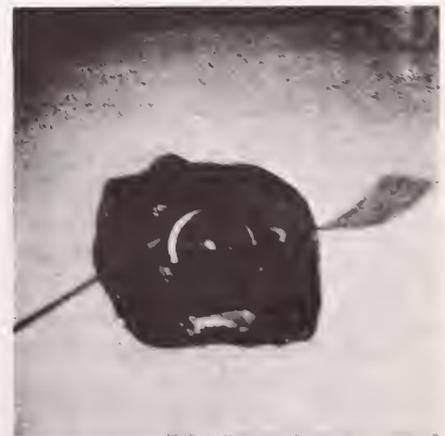
CHEVETTE SHOCK MOUNT FAILURE

While the total extent of the damage is not clearly visible in the photo, the failure caused a definite lack of stability of the vehicle due to the resultant erratic operation of the shock absorber.

The part was submitted by the **STATE OF CONNECTICUT DEPARTMENT OF TRANSPORTATION**, of Hartford, CT. They maintain several similar vehicles in their fleet. Fortunately, this was the only vehicle inspected that exhibited the problem.

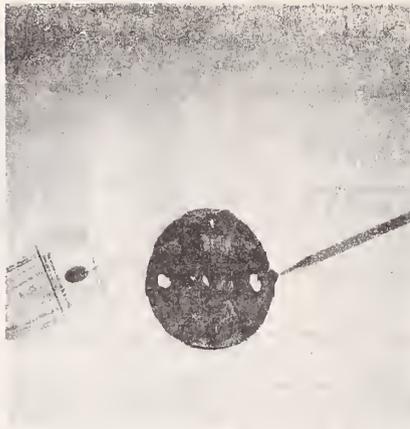
CORVETTE STEERING COUPLER FAILURE

Pictured above is the rubber steering column coupler removed from a 1977 Chevrolet Corvette equipped with power steering. The part was submitted by **WAYNE'S GARAGE** of Eugene, OR.

As can be seen in the photo, the screen reinforced flexible rubber coupler has torn near one bolt hole. This failure, in turn, caused excessive wear on the two steel guide pins. The end result is excessive play in the steering, and, more importantly, directional control problems.

The vehicle involved had approximately 51,000 miles showing when the failure was identified and corrected.

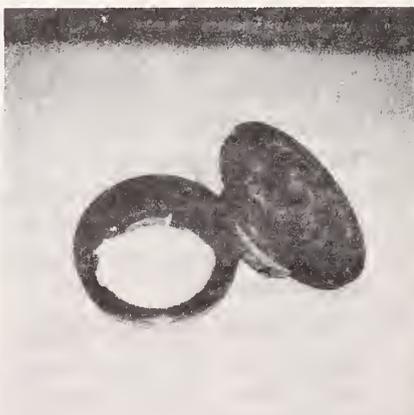
MORE PULLEY FAILURES

The crankshaft pulley shown below was removed from a 1975 Chevrolet Monte Carlo with approximately 48,000 miles. This particular failure shows the complete separation of the outer pulley from the hub.

The PRP has seen a number of similar failures on different vehicles in recent months. With the summer season upon us, the increased use of vehicle air conditioners places increased loads on components such as these pulleys. Because of the relative inaccessibility of the crankshaft pulley, it is often overlooked in a cooling system/air conditioner check up.

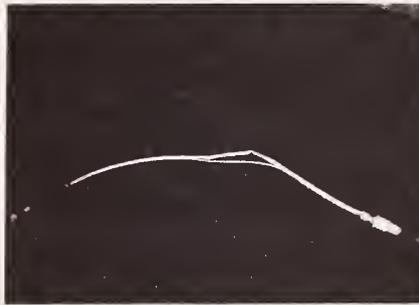
Pictured below is the clutch cable removed from a 1978 Volkswagen Rabbit Diesel with approximately 24,000 miles. As can be seen, the stainless steel inner cable has worn through the outer sheathing, resulting in erratic clutch operation and only partial disengagement. The outer casing is made of a material like ABS plastic. The cause of the failure is not known. There is no evidence of abrasive material in the cable and the cable appears to be adequately lubricated.

The cable was submitted by **ISE AUTOMOTIVE** of Hollywood, CA.
