Final Report 552

## **Repair of Morganza Spillway Bridge Bent Pile Cap Using Carbon Fiber Reinforcement (CFR)**

1. Report No. <b>FHWA/LA.15/552</b>		2. Government Accession No.	3. Recipient's Catalog No.
4. Title and Subtitle  <b>Repair of Morganza Spillway Bridge Bent Pile Cap Using Carbon Fiber Reinforcement (CFR)</b>		5. Report Date <b>April 2016</b>

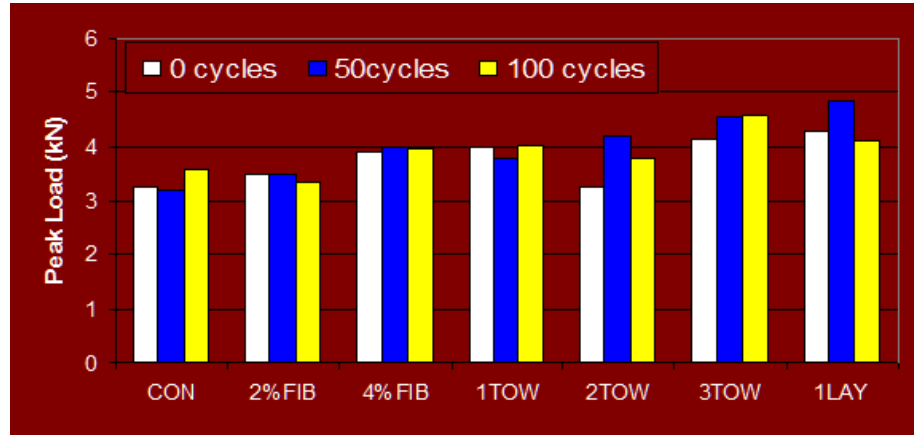
**Figure 5**  
Peak loads after wet-dry exposure

results, summarized in Figures 5 and 6, show that the system is durable both under wet-dry and scaling cycling conditions with the decrease in peak loads at 50 and 100 cycles not exceeding 10% for both conditions.

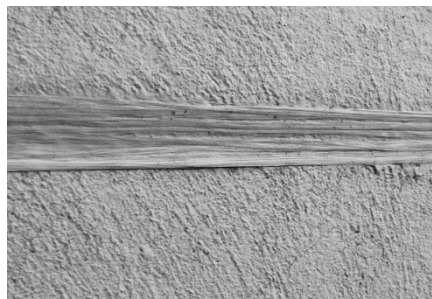
**Coating and Adhesion of Carbon Tows in the Laboratory.** For this project, tests were conducted using the same materials and compositions that were utilized in the field. The key parameters were attaching the high modulus carbon tows and coating color coordination. The resin consisted of liquid and powder parts mixed with high shear mixers. Once mixed the pot life was 3 hours at 70°F. A concrete slab was used to attach the carbon tow shown in Figure 7. A 2-in. bond length was needed to develop the strength of the carbon tow. Since more than 24 in. of adhesion length were available in the field, developing the strength of carbon was not an issue. Samples coated with different color formulations are shown in Figure 8. From these samples, a light gray shade that closely matches the bridge color was chosen for the field application.

**Figure 7**  
**High modulus carbon fiber tow attached to concrete slab**

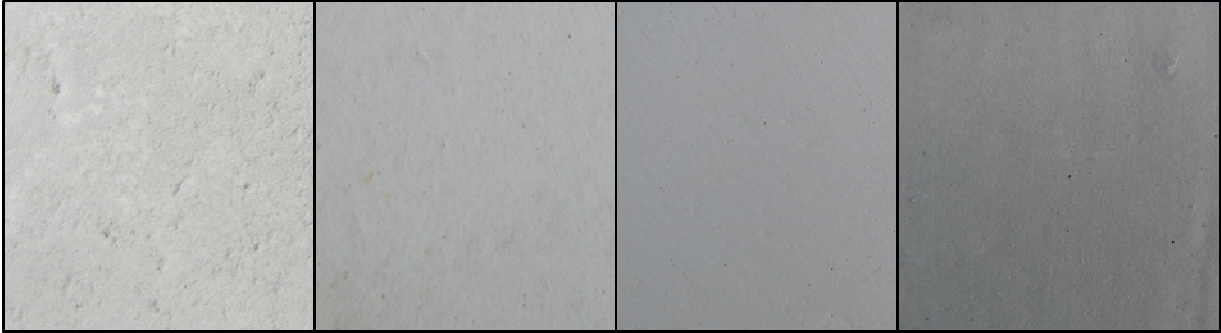
**Figure 8**  
**Inorganic composite color samples**
