**ALTERNATIVE AGGREGATES AND MATERIALS FOR HIGH  
FRICTION SURFACE TREATMENTS**

Final Report  
Project BDR74-977-05

Performed in cooperation with the  
Florida Department of Transportation  
and the  
Federal Highway Administration

Published May 2016

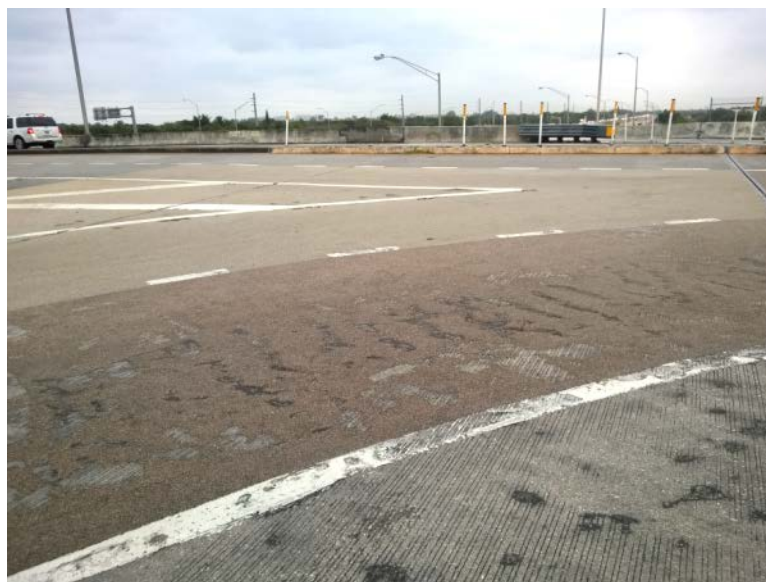
The most common type of failure is aggregate loss, or raveling. Skid resistance can be significantly compromised depending on how much aggregate is lost. This can occur within the wheel path (Figure 2.6) or across the whole application (Figure 2.7). Aggregate dislodgement under traffic is a result of one of two problems:

**Figure 2.7 – Aggregate loss over concrete, single HFST application (I-95 to Congress)**

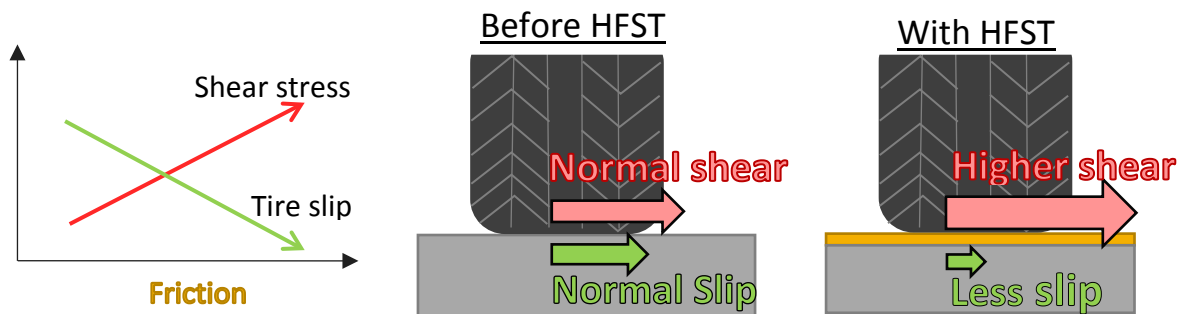
The exact mechanism is not proven but theorized in Figure 2.14. As a vehicle turns, brakes, and accelerates, the tires generate shear forces on the pavement surface. There is also a small amount of slipping that occurs, especially when turning. On an aggressive high-friction surface, the amount of slipping is reduced, and as a consequence, the shear stress between the tire and surface increases. These higher shear stresses can accelerate the deterioration of weak substrates.

**Figure 2.14 – Theoretical mechanism of substrate tearing**

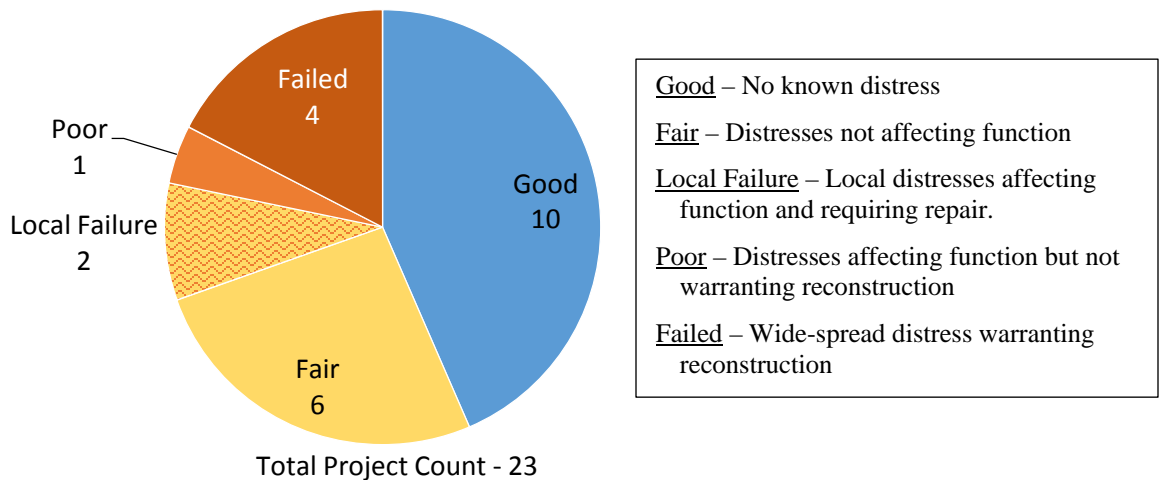
The general distress condition of all projects is summarized in Figure 3.5. Ten out of 23 projects (43 percent) are in good condition and 16 projects (nearly 70 percent) are in fair or better condition. Two projects had localized failures but were otherwise in fair or good condition. One project was in poor condition and four projects had severe wide-spread distress. The poor and failed projects constitute 22 percent of all the HFST projects.

**Figure 3.5 – Distress condition of HFST projects (Subjective rating)**

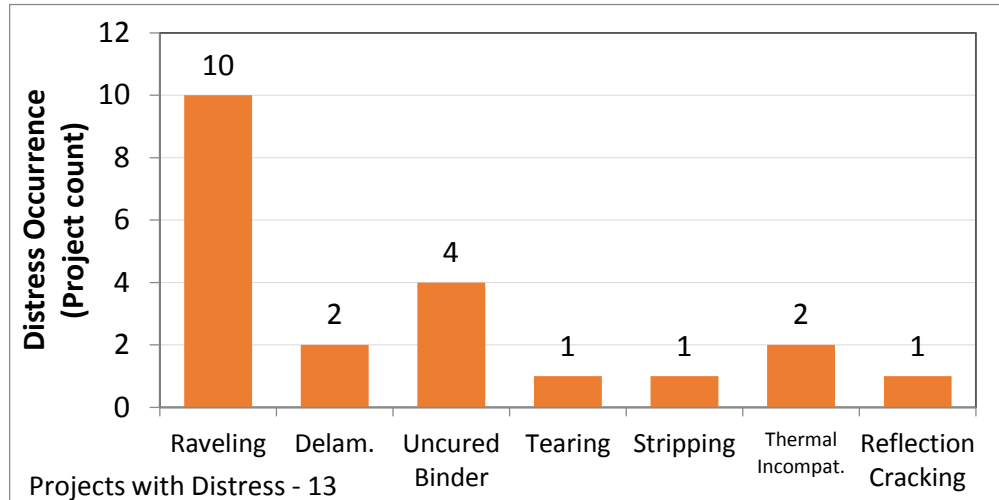
The frequency of specific distresses types is summarized in Figure 3.6. Descriptions and examples of each distress described in the Chapter 2 under HFST Failure Mechanisms. Raveling

was the most frequent problem, occurring on 10 projects, and is usually caused by inadequate binder film thickness. The next most frequent problem (four projects) was uncured binder failure, which happens if the binder is improperly mixed, proportioned, or has an incorrect formulation. Delamination occurred on three projects and a potential thermal incompatibility issue on two projects. Substrate tearing, substrate stripping, and reflection cracking occurred on one project each.

**Figure 3.6 – Occurrences of HFST distress**

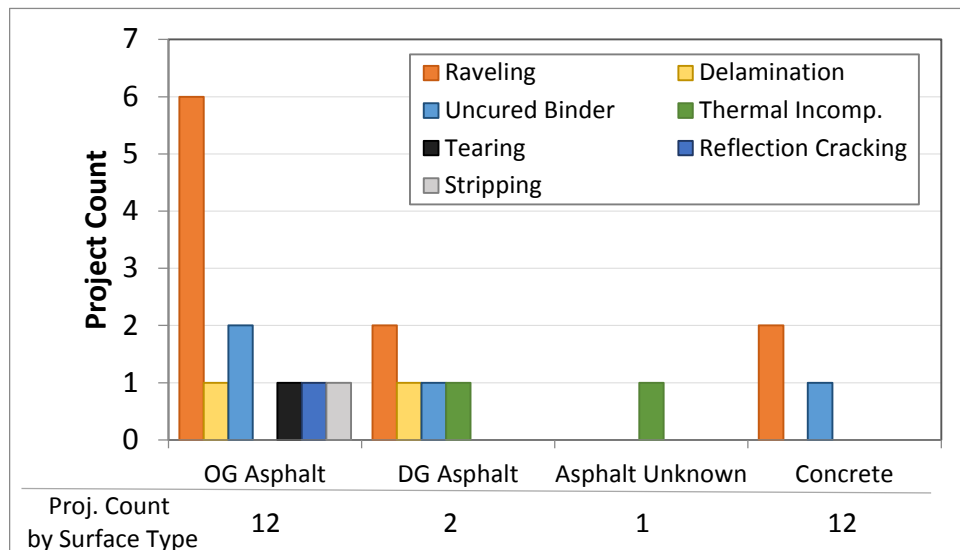
Figure 3.7 shows the distribution of these distresses by surface type. Of the 12 projects with open-graded surfaces, six (or 50 percent) of these had raveling. Five other distress types were noted over OGFC's. Both of the dense-graded asphalt projects had raveling, and had delamination, uncured binder failure, and thermal incompatibility. Of the 12 concrete sections, two had raveling and one had uncured binder failure.

**Figure 3.7 – Distribution of HFST distress by surface type**

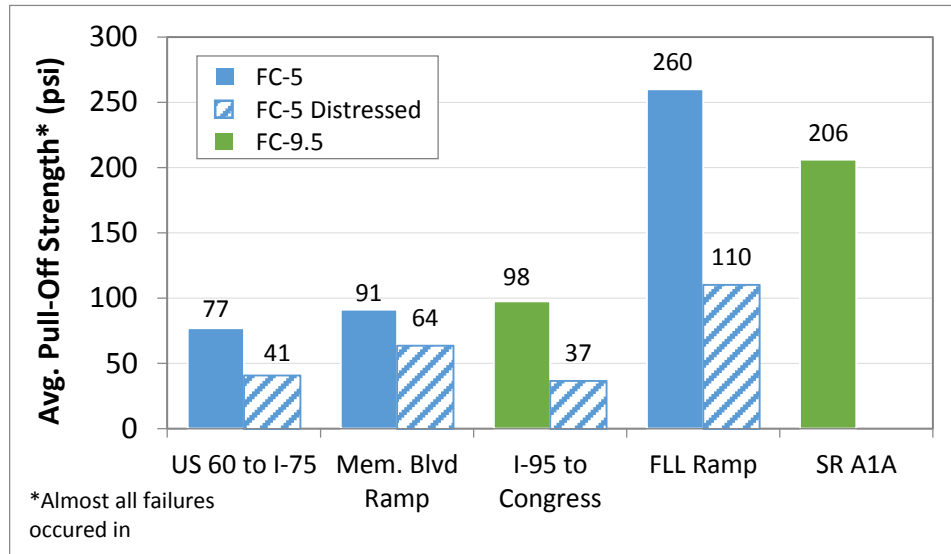
Figure 4.3 is a simplified representation of all the pull-off results. The first bar is the average of “higher strength” and intact HFST locations. The second bar generally represents the average at locations with observed distresses. Most sections were over FC-5 with two FC-9.5 sections. Average values for the good locations ranged from 77 to 260 psi. The distressed sections ranged from 37 to 110 psi, including some cores that failed during sample preparation. Most tests failed within the substrate but a few failed at the HFST bond. These were a heavily distressed sample on I-95 to Congress (just after the stop bar), one reading on SR A1A, and one reading on FLL Ramp in the un-distressed area.

Though the field tests on concrete sections were unsuccessful, the researchers noted that the strength when the test failed was between 100 and 250 psi. They also noted that the bond strength over splotchy areas on the I-95 off-ramp at 6<sup>th</sup> Ave S was very weak and the material was even removable by hand.

**Figure 4.3 – Summary of pull-off test results**

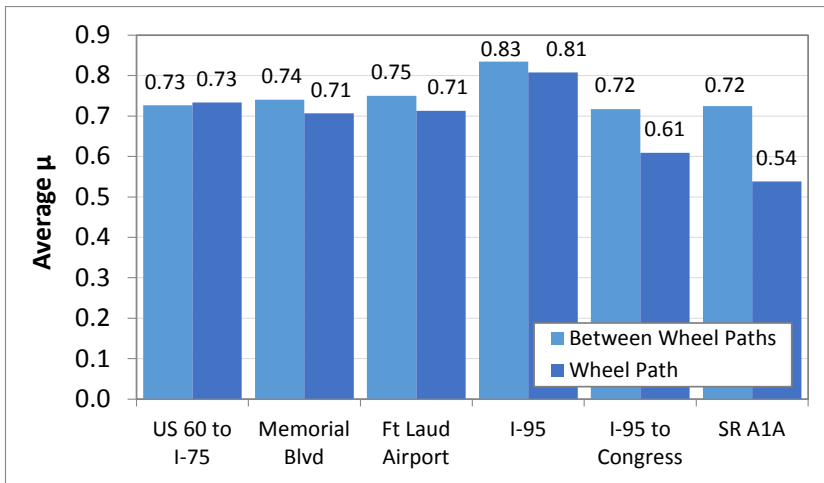
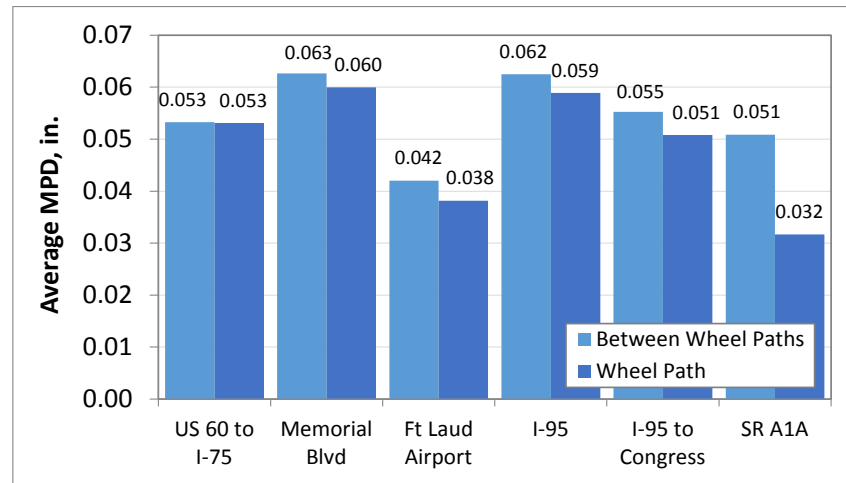
The friction results for between and inside the wheel paths are shown in Figure 4.4. Friction consistently decreased in the wheel path under traffic for both the DFT and CTM readings. The average friction coefficient,  $\mu$ , without traffic was 0.75 and dropped to 0.69 (9 percent decrease) with traffic. For the CTM, the average mean profile depth (MPD) changed from 0.054 to 0.049 inches (11 percent decrease). This is after an average of 3 years.

(a) (b)  
**Figure 4.4 – Friction results between and in the wheel paths: (a) DFT and (b) CTM**

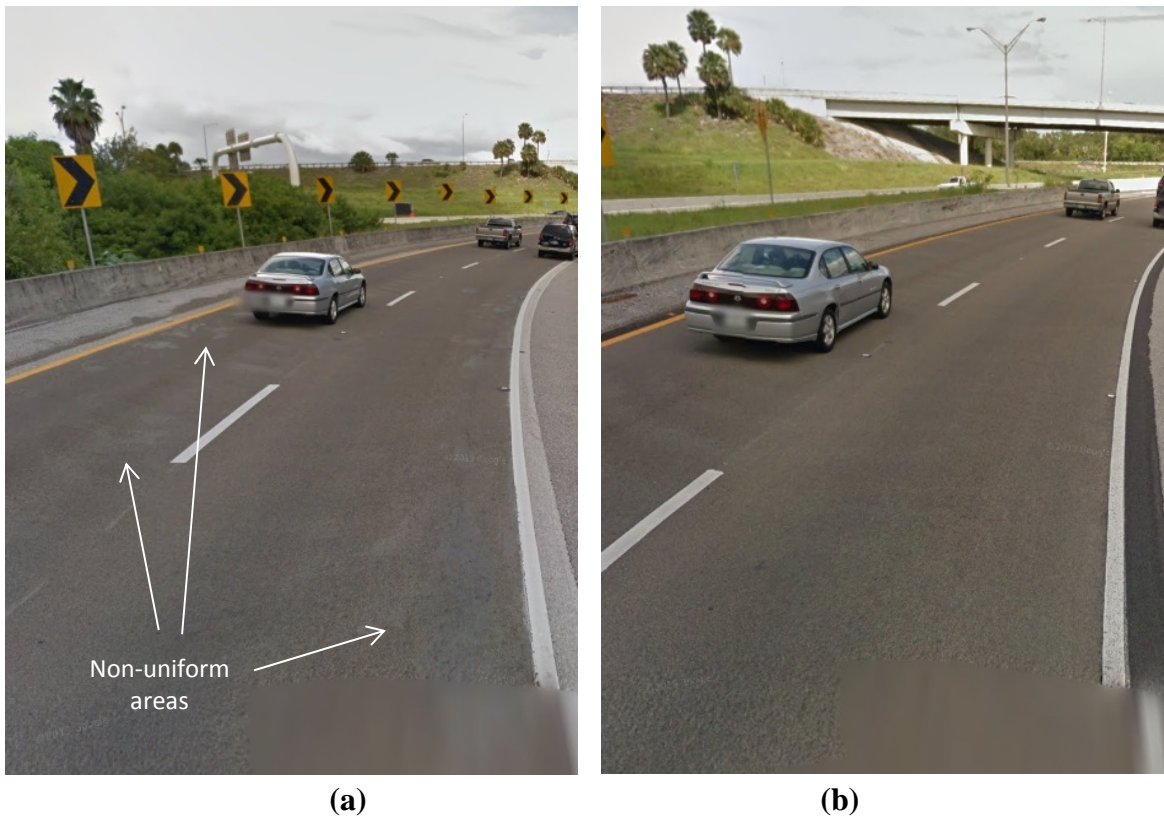
The final surface in Figure C.2 shows with locations without and with milling/resurfacing, respectively. The HFST in Part A was non-uniform and splotchy, a result of poor epoxy mixing and possibly incorrect binder thickness. The image in Part B is notably more uniform.

**Figure C.2 – Completed HFST (July 2012): a) over existing surface, b) over milling/resurfacing.**  
 (www.google.com/maps/)

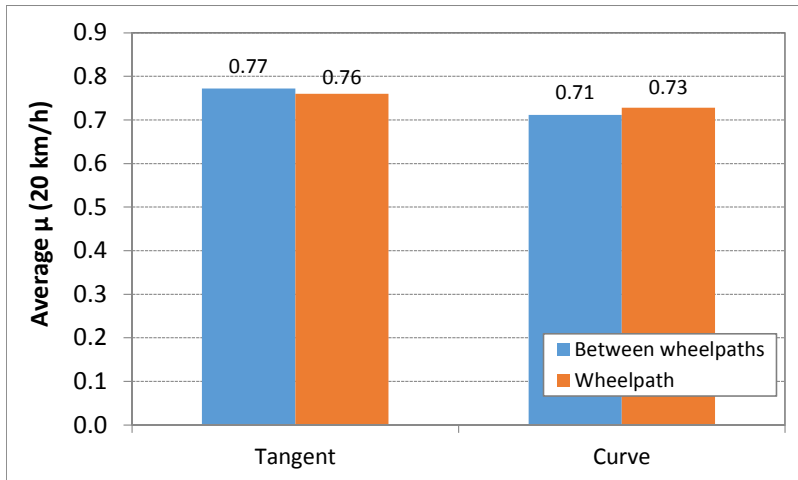
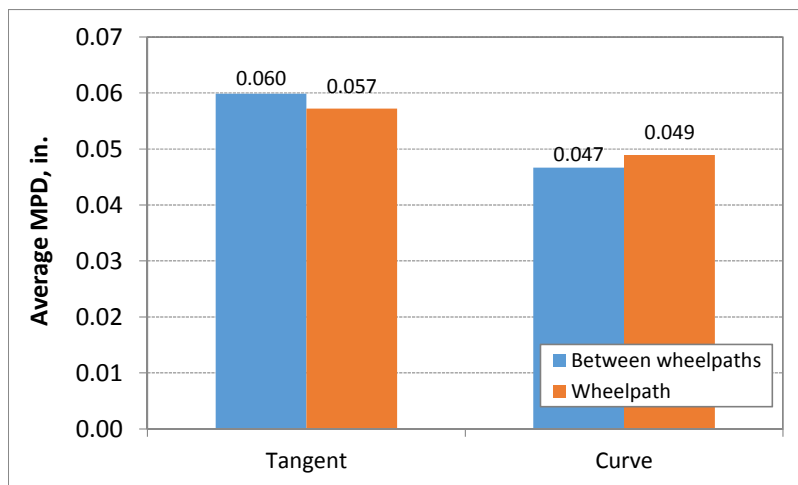
**Figure C.8 – Results of DFT and CTM testing: a) Friction and b) texture.**

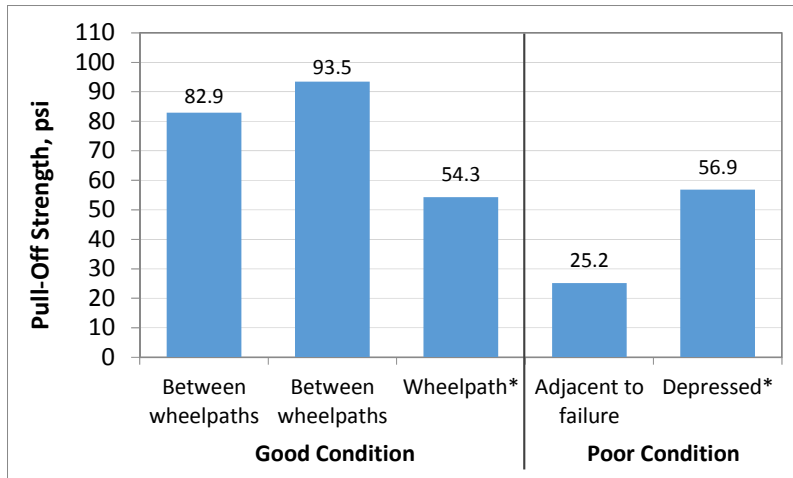
Three cores were taken in good locations and two from poor locations for pull-off testing. The results of the test are shown in Figure C.9. All results are the average of three readings, except those marked by an asterisk which experienced some failures during sample preparation. “Good Condition” samples between the wheel paths had high bond strengths above 80 psi. The “Good” sample in the wheel path had low strength, under 55 psi, and also had two readings that failed in sample preparation. The “Poor Condition” samples had average strengths around 25 and 55 psi. All failures were in the FC-5 substrate.

**Figure C.9 – Pull-off test results.**

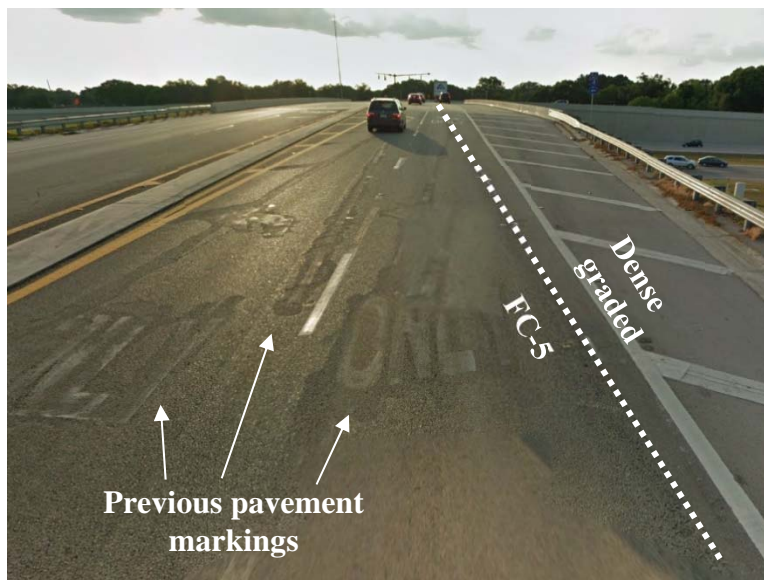
**Figure C.11 – Uneven texture of existing surface before bridge deck (May 2011).**  
 (www.google.com/maps/)

The project is generally performing well. Most of the HFST is intact with uniform texture. There is a 190 ft portion just before the bridge that is raveling and corresponds to the preexisting area with pavement marking removal. It is likely that the uneven texture made it difficult to achieve the correct epoxy thickness, which lead to the aggregate loss. Portions of the shoulder are also raveled, which was likely caused by lower attention to construction quality in a non-critical area. The double application on the bridge is performing very well, even under heavy turning traffic.

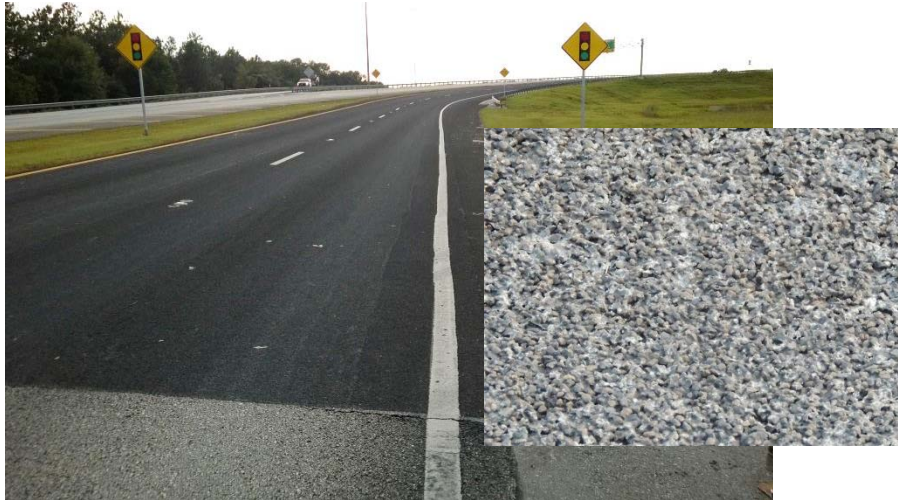
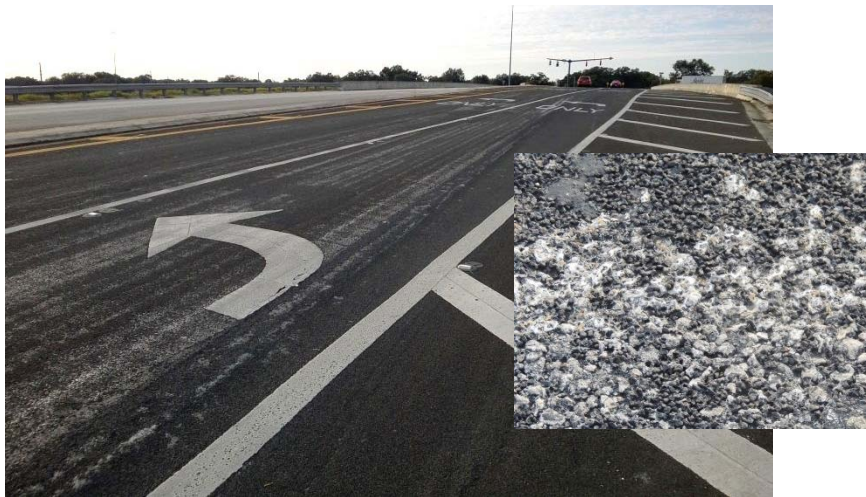
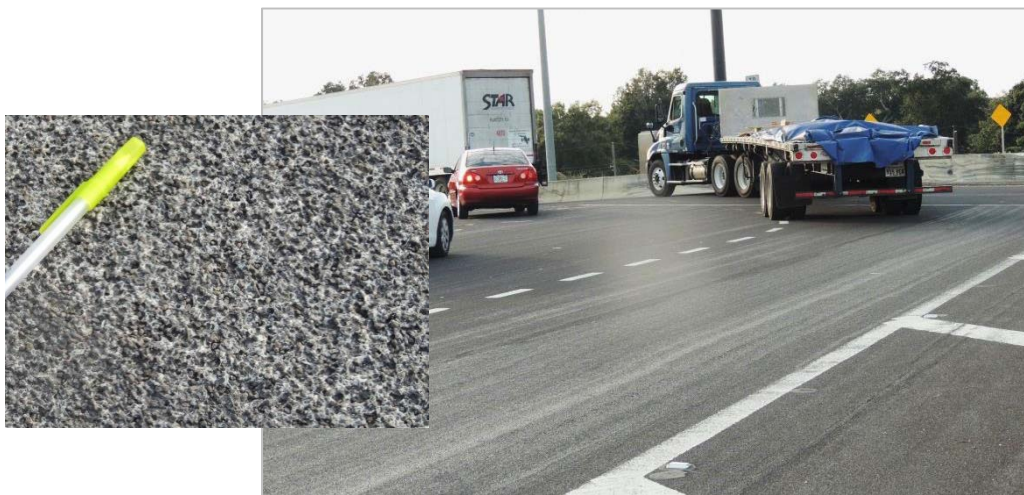
**Figure C.12 – In-service HFST (November 2014): a) Intact over asphalt, b) raveling over asphalt, c) intact over concrete.**

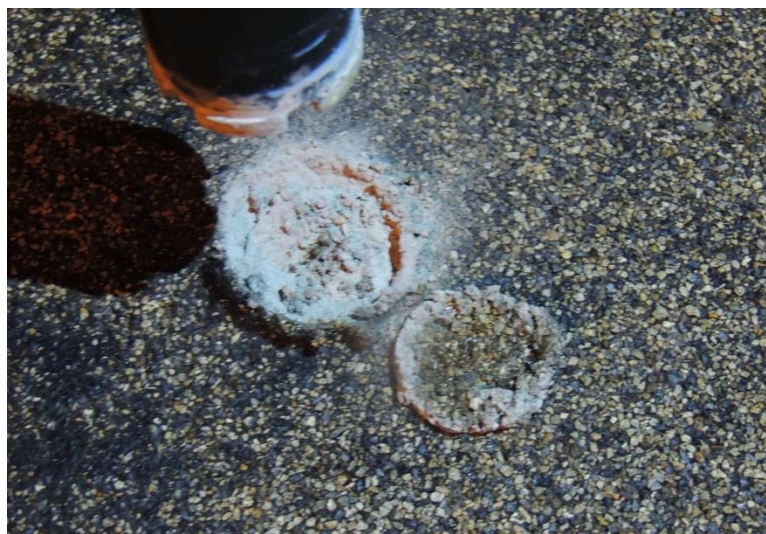
Construction was done with an automated epoxy mixer and applicator followed by hand distribution with serrated squeegees. The aggregate was spread using a mechanical blower. Construction went smoothly for most part except for an epoxy mixing malfunction on the southbound exit ramp. This left random splotchy areas that did not set up, as will be discussed shortly

**Figure C.17 – Weak bond of splotchy area.**

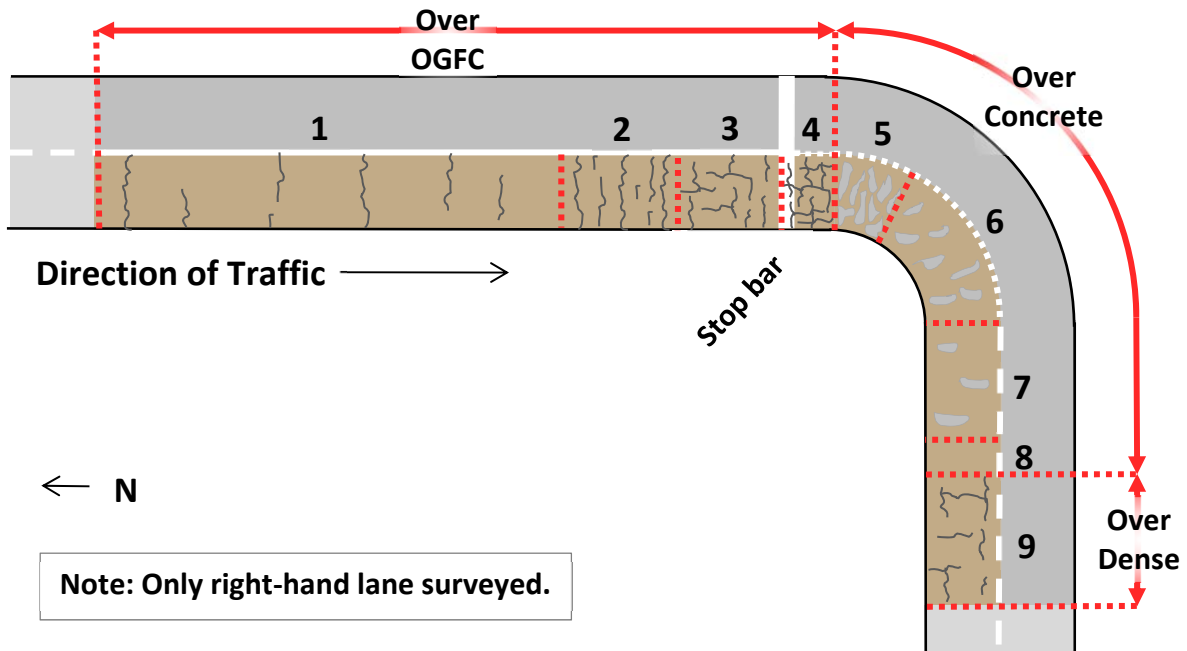
The HFST approaching the stop light is transversely cracked, with crack severity and frequency greatest near to the stop bar (Figure C.21). The cracking pattern becomes more block-like after the stop bar, heading into the turn. Before the HFST, there is no sign of cracking, except an occasional longitudinal crack. To confirm that the distress was not reflective cracking from the existing pavement, cores were taken at the edge of developing cracks to see if the cracks originated from the top or bottom. Pull-off strength tests on the approach broke within the OGFC and failed during sample preparation, confirming the very weak condition of the substrate. After the stop bar, where distress was more severe, the average strength was 74 psi. These samples, however, failed at both the epoxy-asphalt interface and in the OGFC. This was not expected but suggest the repeated high-shear forces at the intersection have also weakened the HFST bond.

Around the turn, traffic moves onto the concrete bridge deck. The first section here has significant HFST raveling and wearing away (Figure C.22); roughly 30% of the HFST is gone. This is only apparent in the right-hand lane, which has a tighter turning radius and more traffic. Initially, the aggregate is raveled/plucked out of the epoxy, after which the exposed epoxy also wears away. After the turn, the wearing away of the HFST on the bridge deck is much less severe. We believe this problem was caused by 1) using a single-lift HFST, and 2) possibly no shot-blasting. This does not appear to be a traditional delamination issue.

Figure C.20 – Distress map.

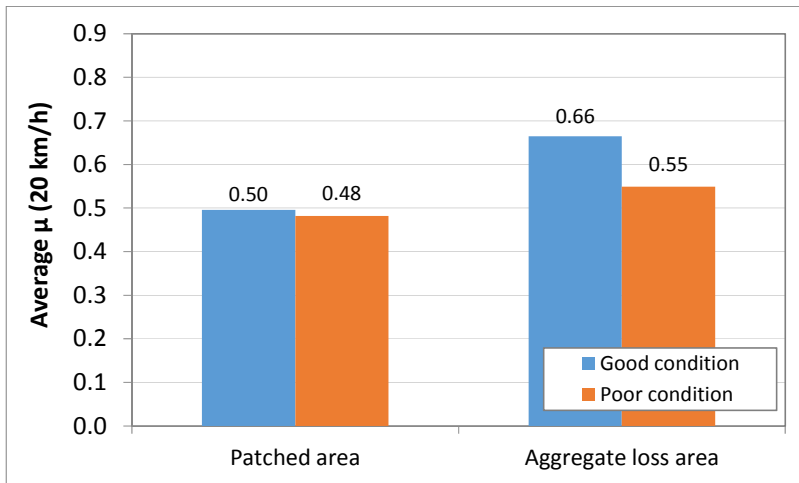
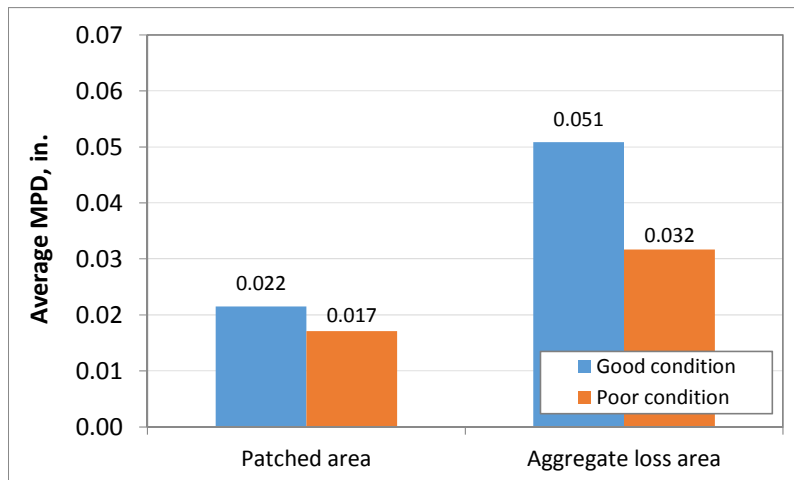
The average skid number (FN30R) before construction was 36. In 2012, a few months after construction, the SN was 69. The following year, the SN was 57 and the MPD was 0.028 (quite low for an HFST). In the 2014 site visit, the friction and texture were measured with the DFT and CTM (Figure C.25). Measurements were made on an area with patching and on an area with aggregate loss. In both cases, tests were made on “good” and “poor” condition surfaces. Friction was highest (0.66) where the aggregate was intact and not patched. This spot was also outside the wheel paths. Areas with patching and experiencing aggregate loss had a friction

coefficient around 0.5. Texture was also much higher in the “good” non-raveled area (0.051 inches). The patched areas had low texture (~ 0.02 inches).

**Figure C.25 – Results of DFT and CTM testing: a) friction and b) texture.**

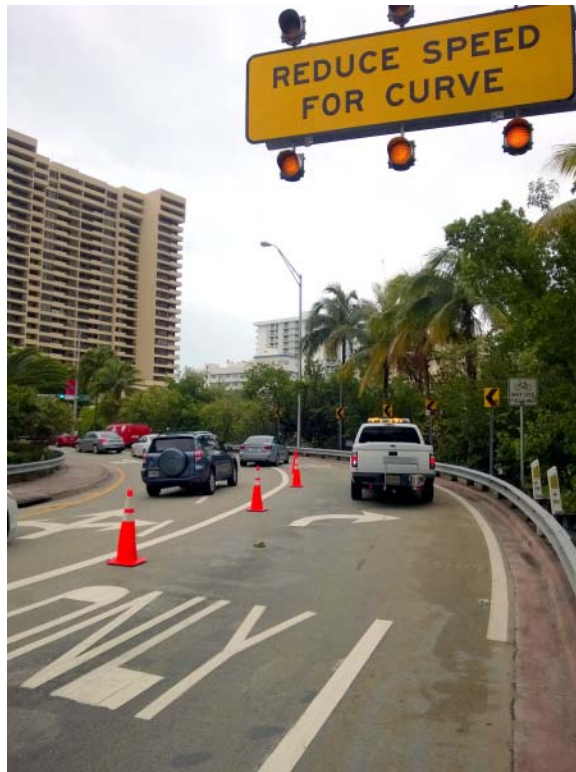
**Figure C.26 – Project overview.**

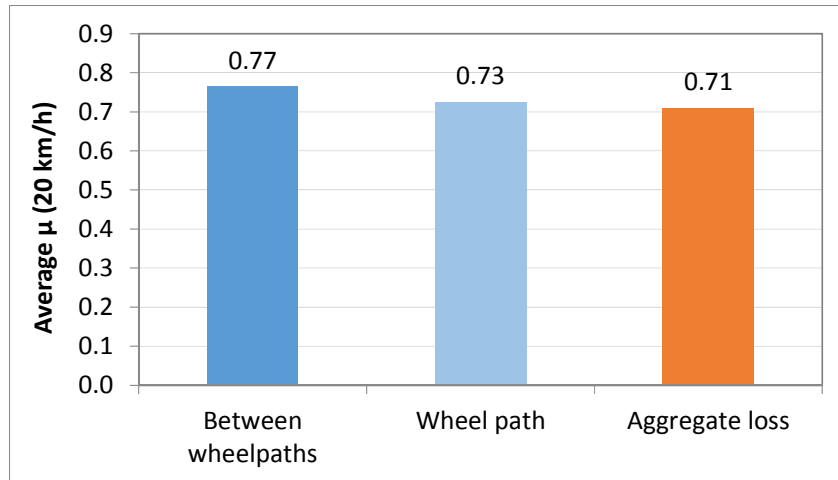
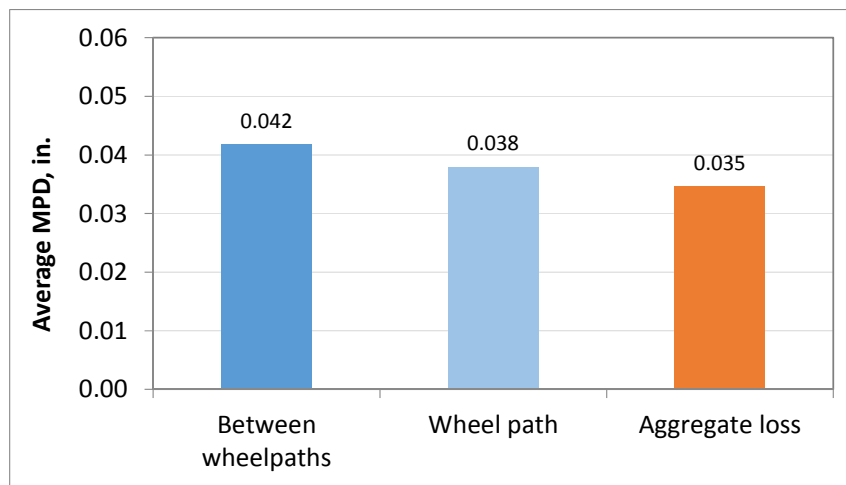
The average skid number (FN40R) in 2008 was 44. Immediately after construction, the average SN was 88 and the MPD was 0.047 inches. The following year (2013), the SN was 77 and MPD was 0.043 inches, and in 2015 FN40R was 69. In the 2014 site visit, the friction and texture were measured with the DFT and CTM. Measurements were made on an asphalt section in a good area and an area with aggregate loss. More measurements were made over the bridge in and between the wheel paths. The highest friction (0.77) was located between the wheel paths. Locations in the wheel path and experiencing aggregate loss had lower friction (0.73 and 0.71, respectively). This is still exceptional. Texture depth was greatest between the wheel path (and also over the asphalt) (0.042 inches). The lowest texture was in an area with aggregate loss (0.035 inches). These trends are reasonable and expected.

**Figure C.30 – Results of DFT and CTM testing: a) friction and b) texture.**

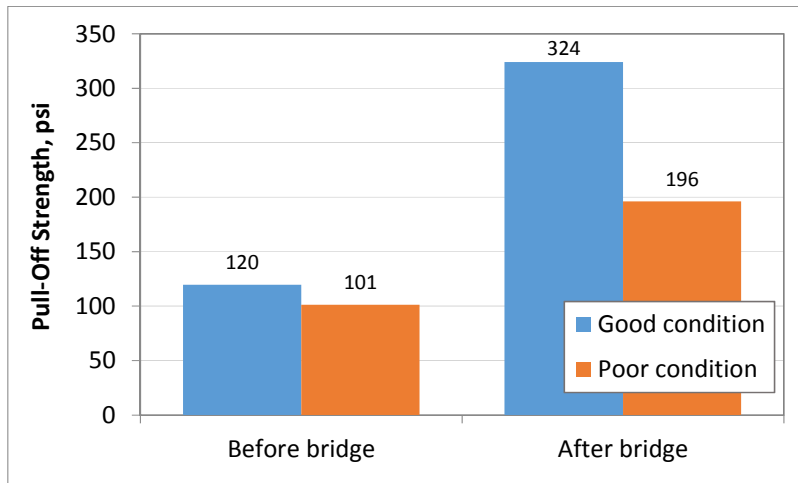
Pull-off testing was attempted in the field on concrete sections and done on asphalt cores in the lab. Field testing was not successful due to precipitation and cold temperatures. The pull-off results from the asphalt sections are shown in Figure C.31. In nearly every case, the FC-5 substrate failed before the HFST bond. Before the first bridge, the average strength was between 100 and 120 psi. After the bridge, the strength was much higher, between 200 and 325 psi. These values help us understand what kind of tensile strengths we can expect from FC-5.

**Figure C.31 – Pull-Off Strength Results.**

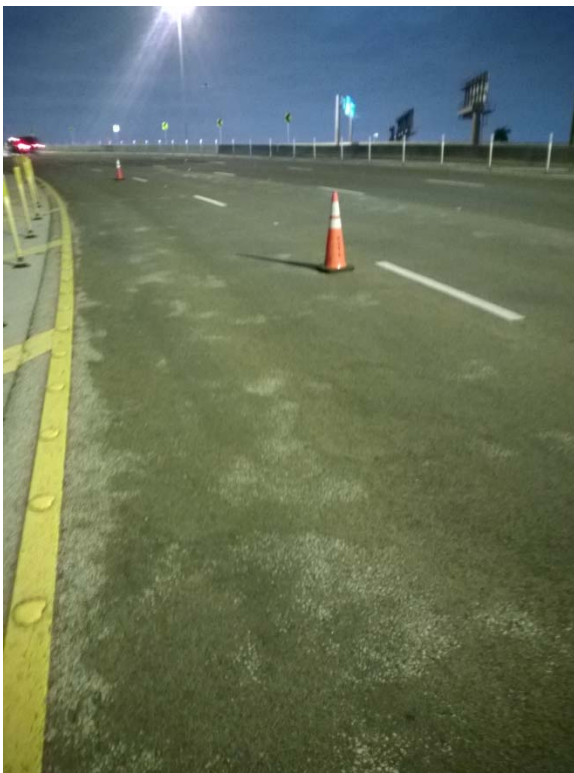
**(a)**

There were two distress types apparent on this project: raveling and irregular depressions Figure C.32. The raveling was an issue during construction, inadequate film thickness, and is still apparent. The irregular depressions were noted at the lane edge and in some random locations within the lane, not necessarily associated with the wheel path. These depressions appear similar to the areas that potholed out on the Bradenton WB US 60 to NB I-75 ramp. Those potholes were caused by 1) poor epoxy mixing and 2) substrate stripping. Though not certain, we think these sections may be a result of stripping. Perhaps moisture is getting trapped beneath the HFST

**Figure C.32 – Surface distress: a) Aggregate loss and b) irregular depressions.**

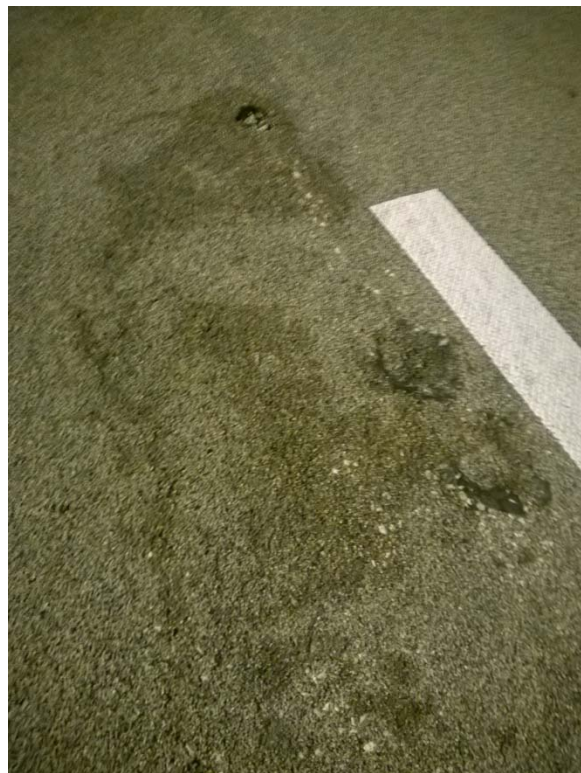
**(b)**

and in the summer heat is causing the problem shown here. The researchers believe these sections may pothole in the near future.
