Field Testing of Hand-Held Infrared Thermography, Phase II TPF-5(247) Final Report

Project No. TPF-5(247)

Field Testing of Hand-Held Infrared Thermography, Phase II

Final Report Volume II: New Technologies

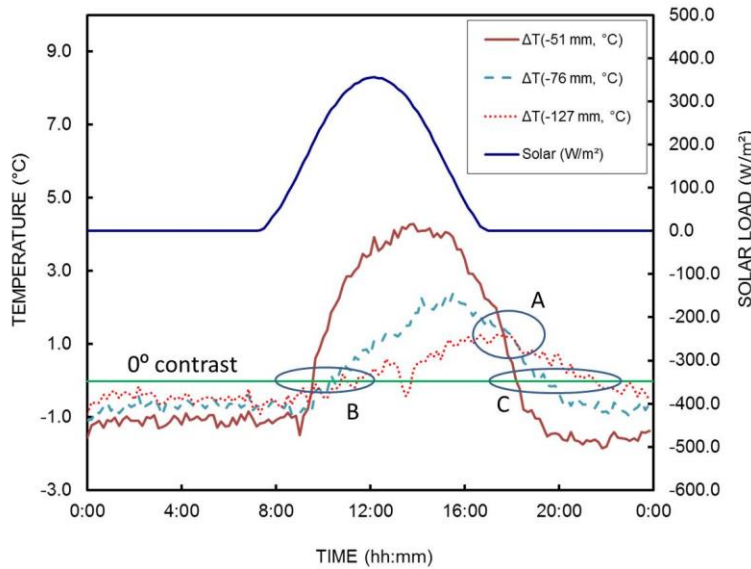
Figure 2 shows a selected result from the study for a single day for a surface exposed to solar loading. This image shows the thermal contrast for the Styrofoam targets at different depths in the concrete block. The thermal contrast is the temperature difference between the surface above an embedded Styrofoam sheet and a surface area above intact concrete. The horizontal axis of the figure shows a single 24 hour period from midnight (0:00) to midnight the next day. The left vertical axis shows the thermal contrast developed at the target and the right vertical axis shows the solar exposure in watts/m^2 . This figure illustrates how the thermal contrast for a subsurface target develops over the course of the day. In the overnight period, the thermal contrast is negative, meaning the target area appears as a cold spot on the concrete surface. During the daytime, the sun rises, increasing the solar loading on the deck.

During this period, the thermal contrast at the targets changes from a negative value to a positive value, i.e., the surface above the target appears as a hot spot. Several notable features in this figure illustrate key characteristics of thermal imaging of subsurface damage in concrete:

1. The magnitude of thermal contrast depends on the depth of the target, with more shallow targets developing a greater maximum thermal contrast than deeper targets.
2. The time at which the maximum thermal contrast develops depends on the depth of the target, with deeper targets reaching their maximum much later in the day than shallow targets.
3. There is a point in time (marked A in the figure) when the contrast magnitude is essentially the same, regardless of the depth of the target.
4. There are two time periods during the day (marked B and C in the figure) during which there is no thermal contrast between the target areas and the sound concrete.
5. The rate at which thermal contrast develops between the target areas and the sound areas of the block is a function of the target depth, with shallow targets displaying a higher rate than deeper targets.

Figure 2. Graph showing thermal contrast for subsurface targets in concrete, and the solar loading during a 24 hour time interval.

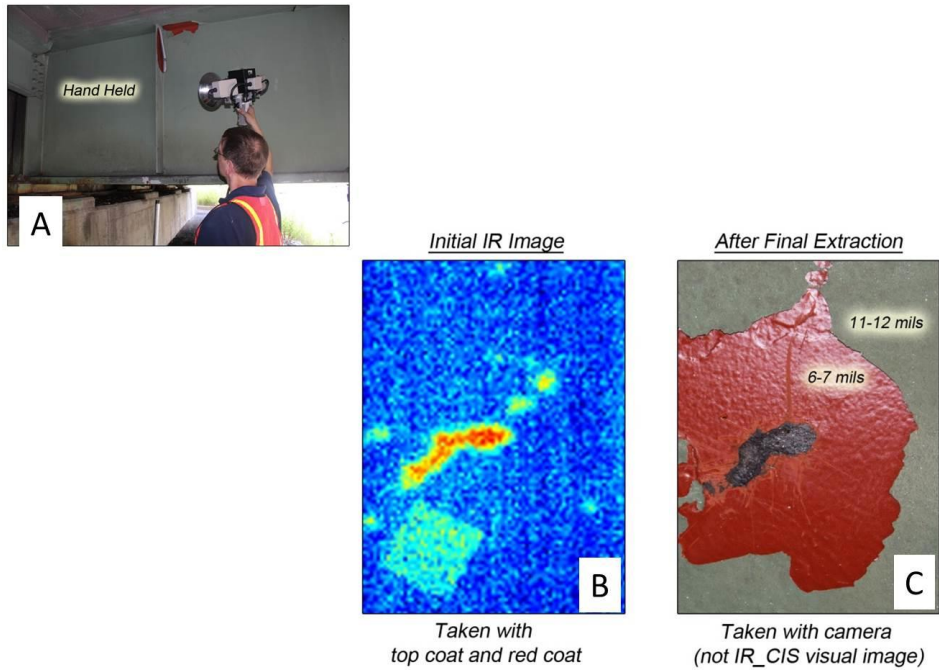
This technology is applied to detect defects, such as corrosion, that are under coatings so they are not visually observable. Figure 4 provides an example of the application of the IR-CIS technology for detection of corrosion on a steel bridge. Figure 4A shows the hand-held prototype instrument being used to image an area of the surface of a steel bridge. Figure 4B shows the IR-CIS results from an area of intact coating that has corrosion beneath the coating. Figure 4C shows the defect following extraction, i.e., the intact coating was removed to verify the results shown in the image [19].

Figure 4. Figure showing the application of active IR system for detecting corrosion under coatings on a steel bridge. Photograph of the instrument being used in the field (A), image of a defect in the intact coating system (B), and the defect after extraction of the coating (C).

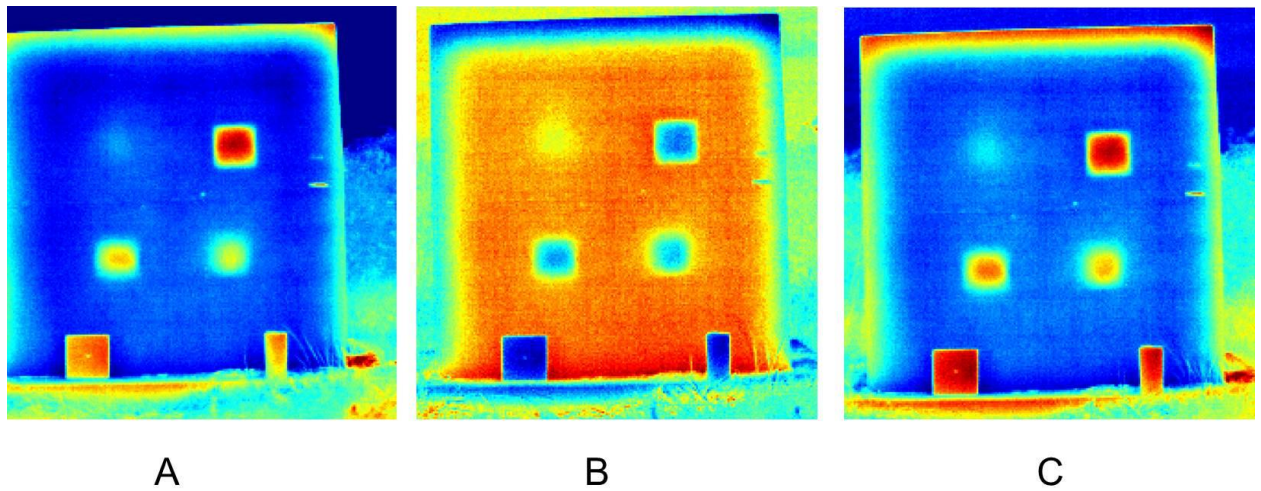
The IR-UTD data was analyzed during cooling and heating cycles throughout the testing interval. Figure 16 shows the results of data processing during the heating cycle (Figure 16A), cooling cycle (Figure 16B), and the difference between the heating and the cooling cycle (Figure 16C). A 2 in. thick concrete paver and a 6 in concrete cylinder placed on the block’s footing are also shown in the image. These objects were placed on the block’s footing to investigate how the objects would appear in the processed IR-UTD image as compared with test block. The most notable feature of these images is that the Styrofoam target at a depth of 5 in. in the concrete could be observed in the images, although the edges of the target are less defined than the targets located at depths of 1, 2, or 3 inches. Generally, the definition of the edges of the targets is diminished with increasing depth of the targets, such that the 1 in. deep target is more clearly defined than the 2 in. deep target, etc. It is also notable that the color representations of the images correspond to the depth of the target and the temperature cycle analyzed. For example, for the heating cycle (I), the 1 in. deep target is a more intense red than the 2 in. deep target, and the 5 in. deep target is mostly blue, indicated a low thermal inertia relative to the more shallow targets. In the image created from the cooling cycle, the targets appear blue, indicating a negative ROC. In the differential image, which shows the difference

between the inertia in the heating and cooling cycle, the 5 in. deep target is better defined than in either the heating or the cooling cycle.

Figure 16. IR-UTD images showing the thermal inertia during the heating cycle (A), the cooling cycle (B), and the difference between heating and cooling (C).

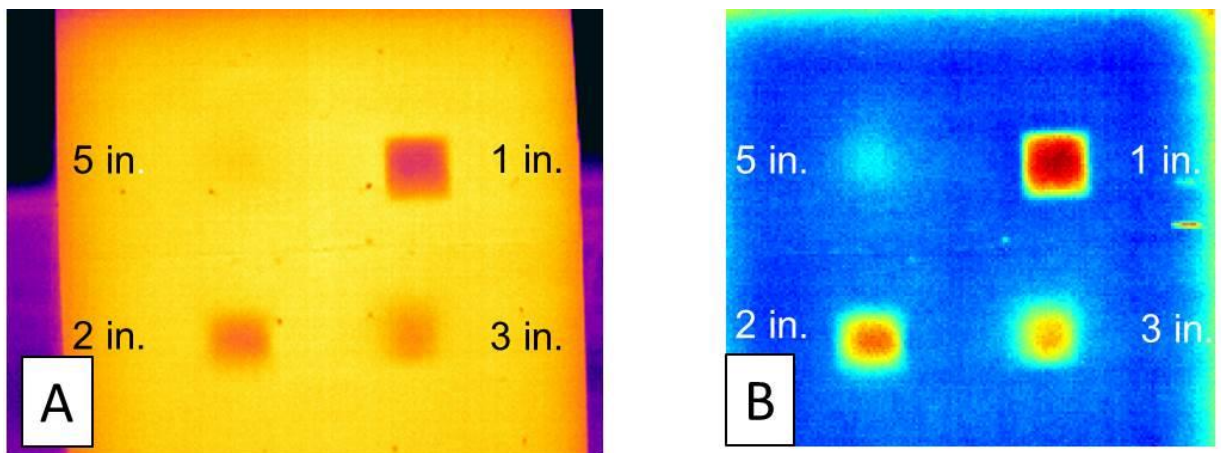
These data were compared with images collected during phase I of the research, during which time an IR camera was used to collect individual images of the test block over a period of three months. Because the north side of the test block was not exposed to solar loading, the target at a depth of 5 in. was not typically detected in the thermal images collected during that portion of the research. Figure 17A shows a single IR image captured during phase I of the research, and figure 17B shows the IR-UTD data for that portion of the block. As this figure illustrates, the IR-UTD system has an improved ability to image the target at a depth of 5 in. relative to conventional IR imaging.

Figure 17. Comparison of conventional IR thermography (A) and IR-UTD imaging (B).

The results of these tests indicated that IR-UTD had an improved ability to image targets at a depth of 5 in. in the concrete, relative to conventional IR imaging. The results also confirmed that the results of the IR processing produced images in which the depth of the target corresponded with the magnitude of the thermal inertia.

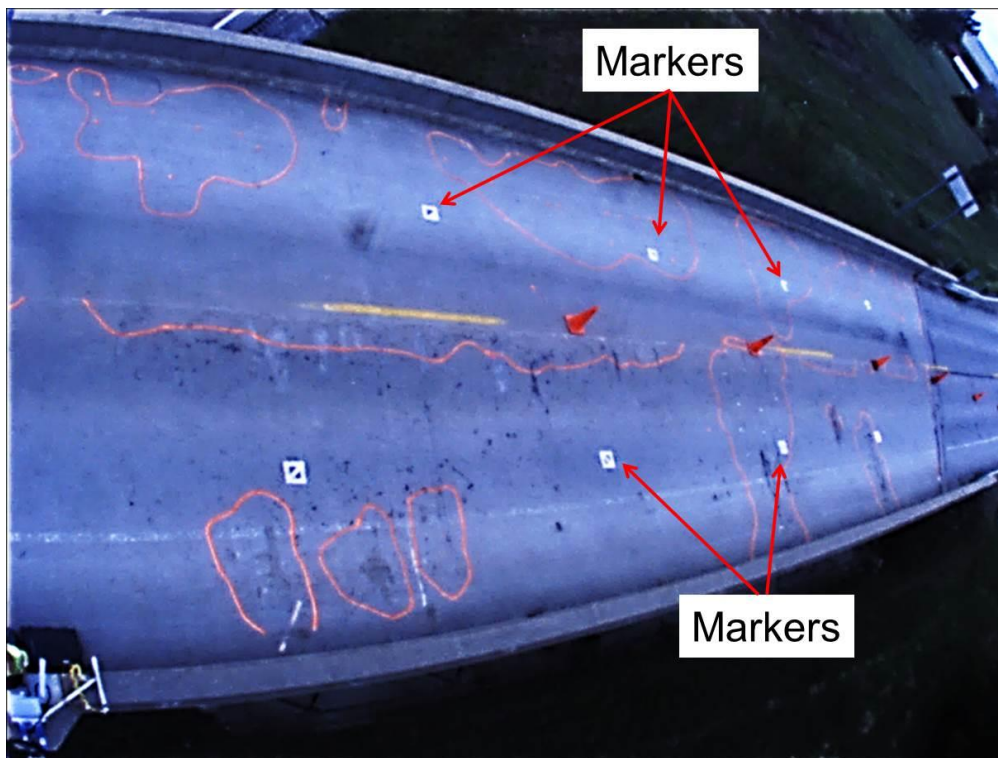
Figure 25. Image of the bridge deck captured by the IR-UTD visual camera.

Figure 25 shows a visual photograph of the bridge deck captured by the IR-UTD. This image was captured near the completion of testing, after the delaminations in the bridge deck had each been outlined with orange paint to improve their visibility. Shown in the photograph are the IR markers placed on the deck to provide a spatial reference in the IR-UTD images. The photograph also shows dark areas on the deck that resulted from spillage of epoxy materials on the surface of the deck and traffic control cones placed on the deck during the daytime hours.

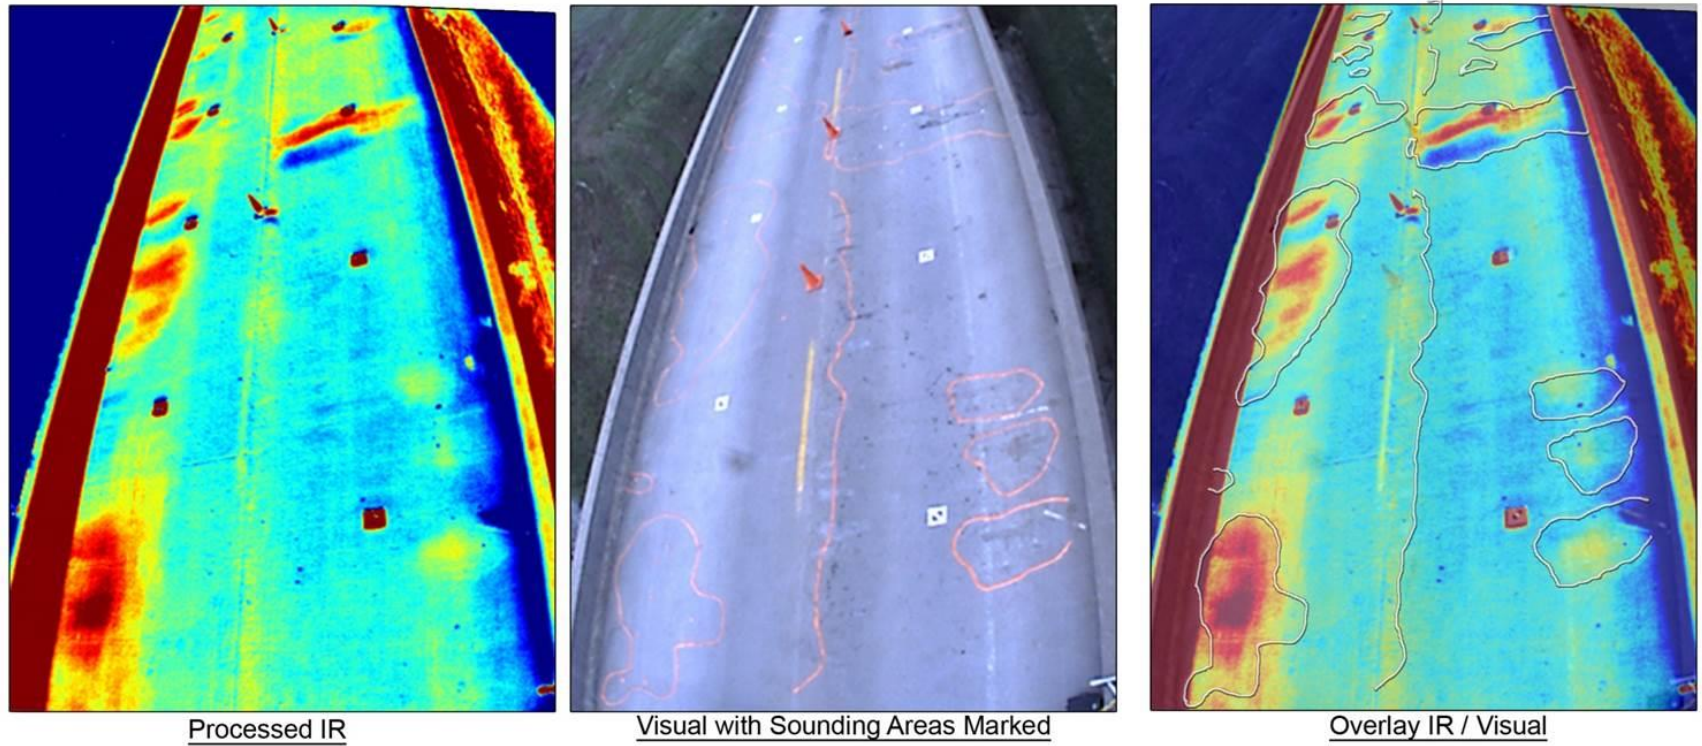
To verify the results shown in the IR-UTD image, an overlay of the IR-UTD data and the hammer sounding results was produced. This overlay consisted of placing the data shown in Figure 25, which shows the outline of delaminated areas determined using sounding, over the IR-UTD image shown in Figure 26. The overlay was trimmed slightly to remove the area of the deck obscured by the weather shield. Figure 27 shows the results of this overlay procedure. The overlay of these data provides a verification that the IR-UTD results match well with the sounding results. Both the location and spatial extent (i.e., size) of the delaminations correlate

with the location and extent identified through hammer-sounding. These data also demonstrate that the IR-UTD data contains information not included in the hammer sounding, namely the relative depth of the delamination.

3
4 **Figure 27. Overlay of IR-UTD image and hammer sounding results, showing IR-UTD results (left), hammer sounding results (center), and**
5 **an overlay showing IR-UTD data over hammer sounding results.**

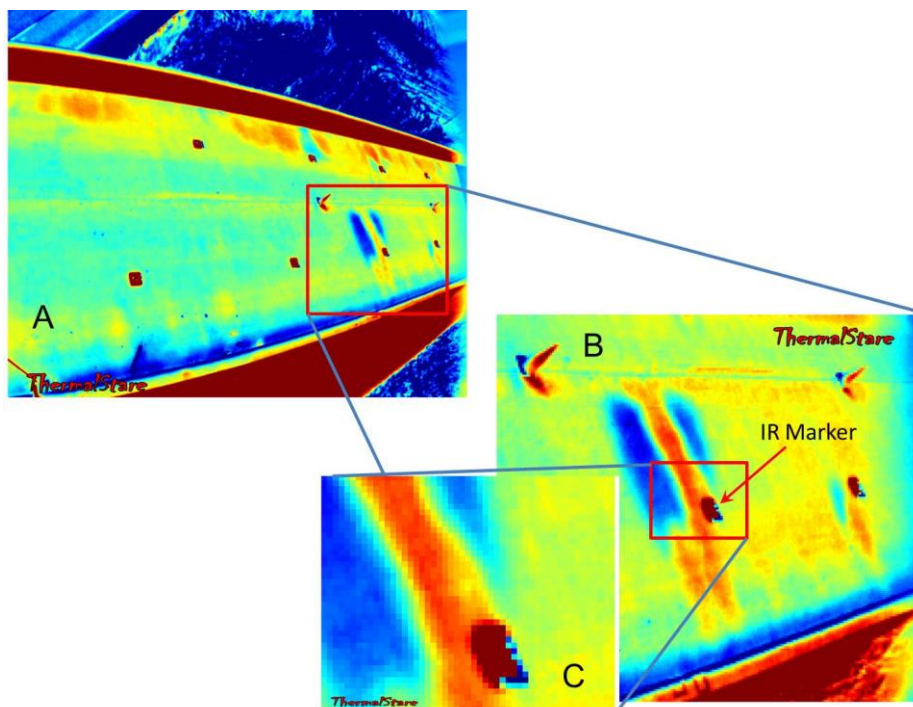
Figure 28. IR-UTD image demonstrating resolution of the image.

To illustrate this effect, Figure 28 shows a delamination that has deep portions shown in red to yellow on the image and shallow areas shown in blue. Figure 28A shows the overall view of the deck, Figure 28B shows a closer view, and Figure 28C shows an even closer view of these data. A marker that was placed on the deck is also shown in this image; this marker represents one sq ft. These data illustrate that IR-UTD data has very high spatial resolution for imaging delaminations in the bridge deck.

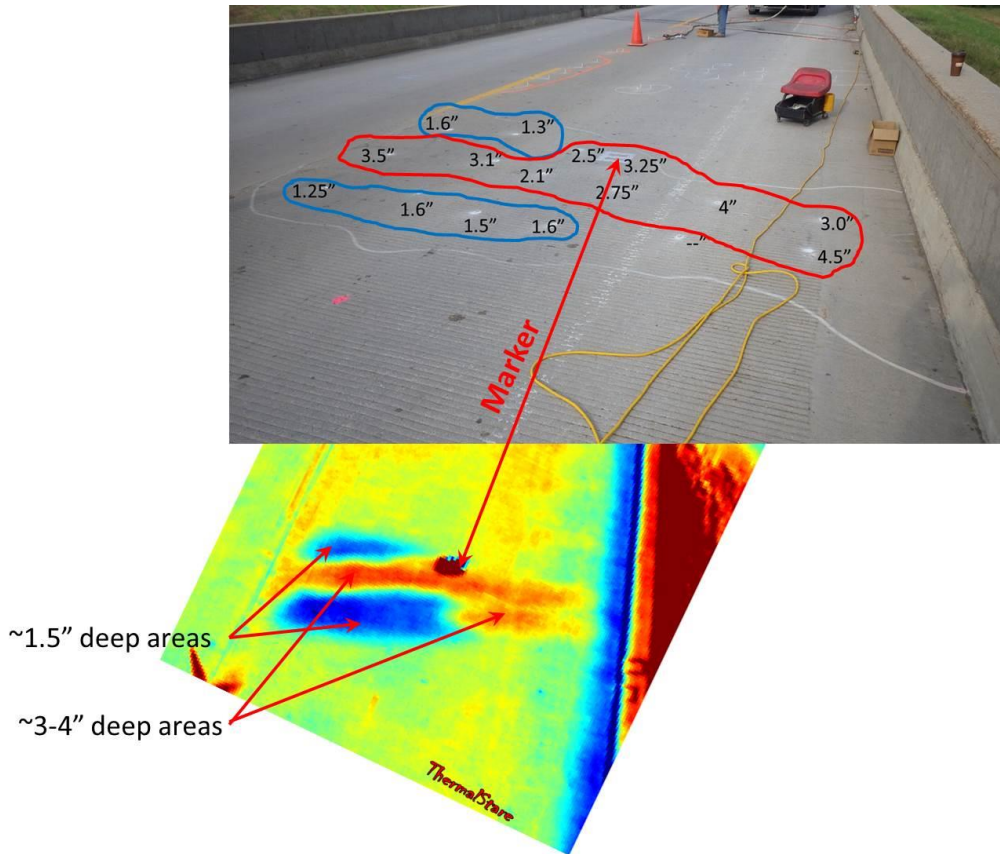
Figure 29. Visual image showing depth measurements and the IR-UTD image of a delamination with varying depths.

To better understand the depth measurements shown in the IR-UTD data, a borescope was used to measure the depth of several delaminations. Figure 29 shows the results of the depth measurements superimposed on a delaminated area of the bridge deck shown in the IR-UTD image. As shown in the figure, the different depths of the delamination are represented in IR-UTD by different colors, with red to yellow showing deeper portions of the delamination and blue areas representing shallow areas of the delamination. These data illustrate the contrast in thermal inertia between sound areas of the deck, where there are no delaminations, and damaged areas of the deck. Also, since delaminations at different depths will change temperature at different rates, as previously shown in the research, the different depths of the delamination areas are also differentiated in the IR-UTD data. The correlation between the exact depth of a delamination and the IR-UTD results is still a subject of research, due to the complexity of the interaction between the IR-UTD imaging technology and the environmental conditions surrounding a given test. However, these data provided empirical evidence that damage at different depths can be differentiated qualitatively by the IR-UTD technology.

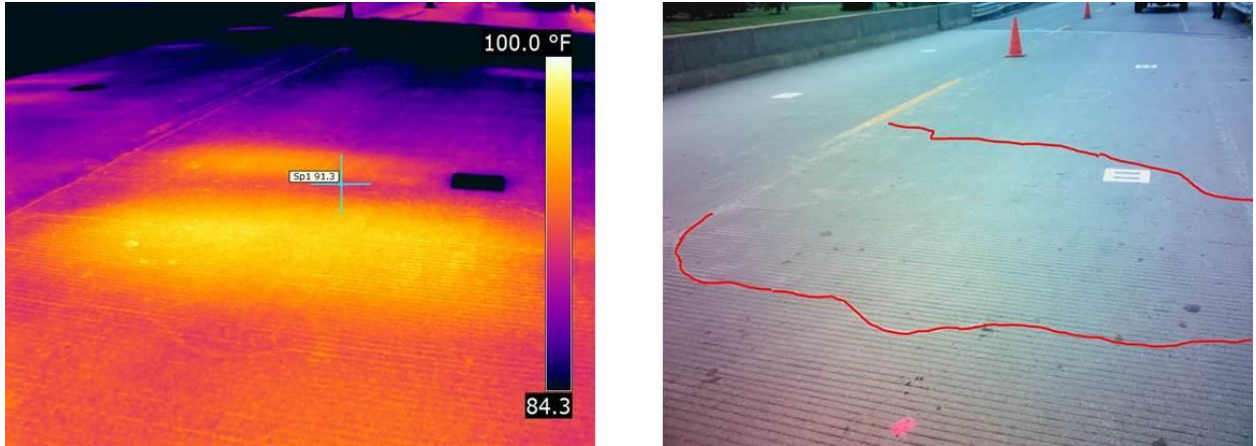
Figure 30. Thermal data from a hand-held FLIR 620 IR camera (left) and visual image of the area showing an outline of the delaminated area (right).

Figure 30 compares the IR-UTD result for this delamination with data collected using a FLIR 620 hand-held thermal camera. The thermal image was captured near the optimum time for capturing subsurface delaminations, approximately 1 p.m. in the afternoon. The figure illustrates the challenge of hand-held thermal cameras when imaging a deep subsurface defect. The hand-held cameras collect only a single image at a particular point in time, which may or may not be the optimum time for inspection. In this case, the shallow areas of the delamination are captured in the IR data and appear as two separate defects because the deeper area of the delamination is not shown. In contrast, the IR-UTD data shows the entire area as a single defect, but with varying depth.

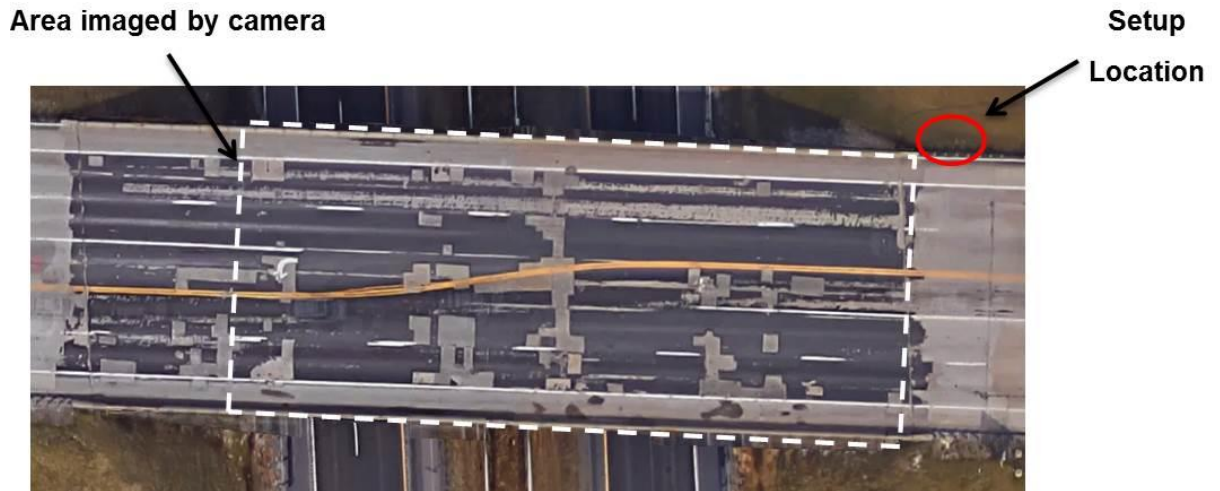
Figure 32. Aerial view of the Grindstone Bridge.

The Grindstone Bridge is located in Columbia, MO, over Highway 63. The roadway carries Grindstone Parkway. The bridge is a four-span voided slab. The deck carries five lanes of traffic. The surface of the deck has an asphalt chip seal overlay that has variations in thickness. The surface of the deck has a number of patch repairs, as can be seen in Figure 32.

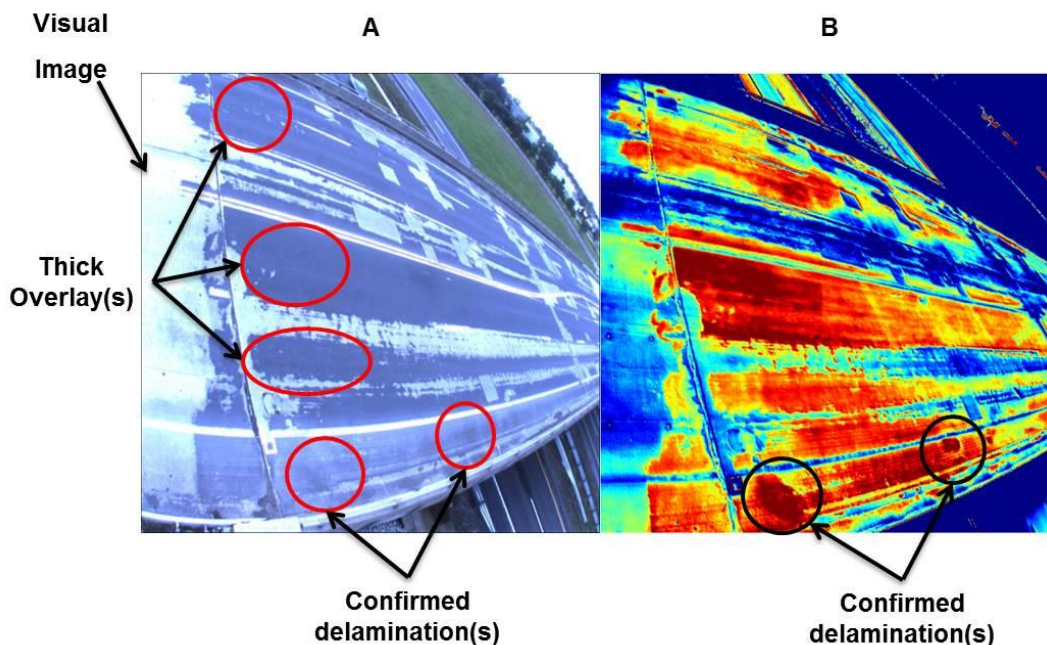
Figure 35. IR-UTD images of the Grindstone Bridge showing the visual image (A) and processed IR-UTD data (B).

Figure 35 shows two images of the bridge deck. Figure 35A is the visual image captured by the IR-UTD from its position on the mast. Figure 35B is a processed IR-UTD image based on the temperature variations during the heating and cooling cycle shown as shown as period 1 in Figure 33. Several features are identified in Figure 35A. First, the overlay on the bridge deck was distributed irregularly across the deck, which resulted in some areas having a thick overlay while other areas have little or no overlay; areas where the overlay appeared to be thickest are identified in the image. The thickness of the overlay was assessed qualitatively using sounding. Several patches are also shown in Figure 35A.

The locations of two delaminations are also shown in the image; these delaminations were confirmed with sounding. These variations in overlay thickness affected the IR-UTD images produced because these areas demonstrated a different thermal inertia than areas of the deck with thin or no overlay. This is due to the material properties and the color characteristics of the material (black), which absorbs radiant energy from the sun more efficiently than bare concrete.

Figure 35B shows the processed IR-UTD image. Delaminations in the shoulder area of the deck are identified in this image. However, generally these images are difficult to analyze to identify delaminations, because the variable nature of the overlay produced variations in the IR-UTD image produced from analyzing period 1.

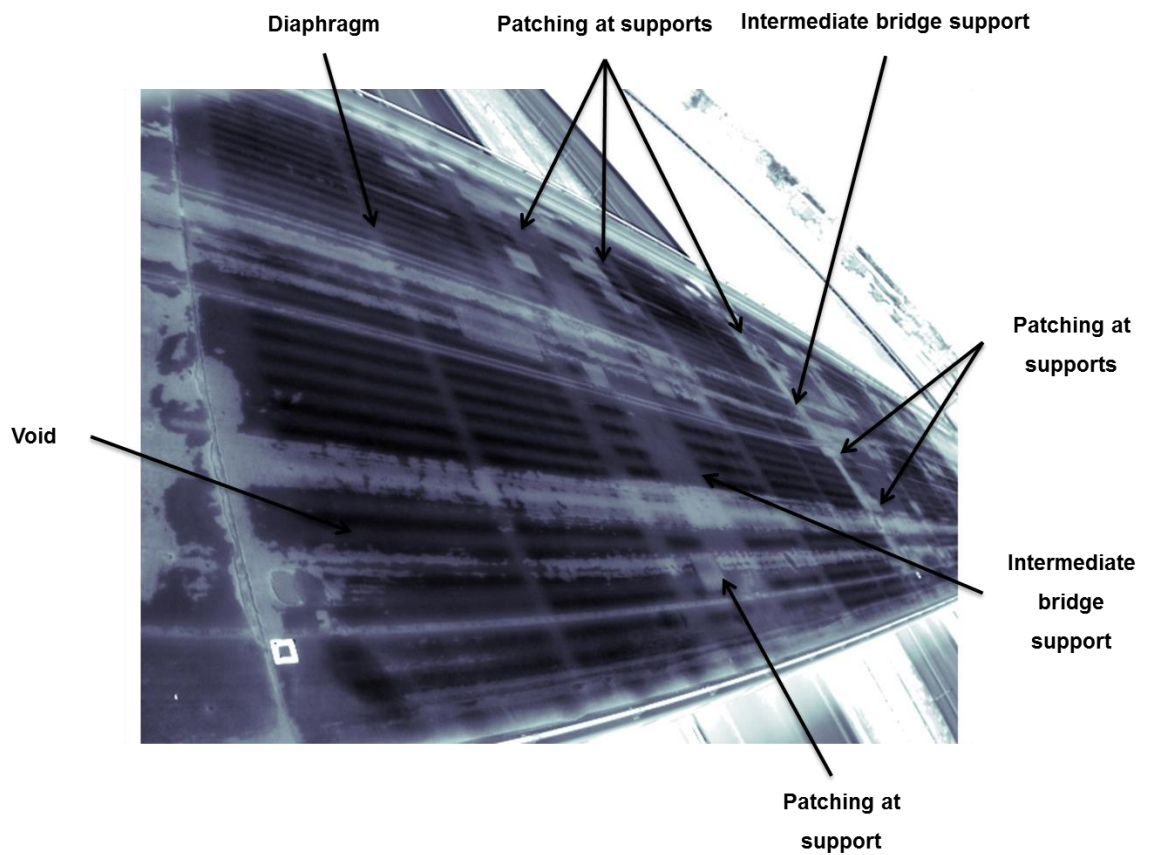
Figure 36. IR-UTD processed data showing structural features and patches above the support.

By processing these data through different time intervals, different IR-UTD images were produced that provided images that were more easily analyzed to identify damage in the deck. One of the outcomes of the processing can be seen in Figure 36, where the structural features and patches of the bridge are visible. This image was produced from period 1 to emphasize the

structural features of the bridge, rather than delaminations in the deck. It can be observed that the majority of the patches on the bridge deck are located above or near the bridge supports.

The location of these patches near the negative moment region above the support suggests that the negative moments may be creating tensile stresses in the concrete. These stresses may result in the concrete cracking which then provides a pathway for deicing chemicals to penetrate more rapidly to the level of the reinforcing. As a consequence, these areas have deteriorated more rapidly than other portions of the deck, causing delamination and spalling that have subsequently been repaired. These data illustrate the unique capability of imaging the structural features of the bridge using transient thermal data collected by the IR-UTD.

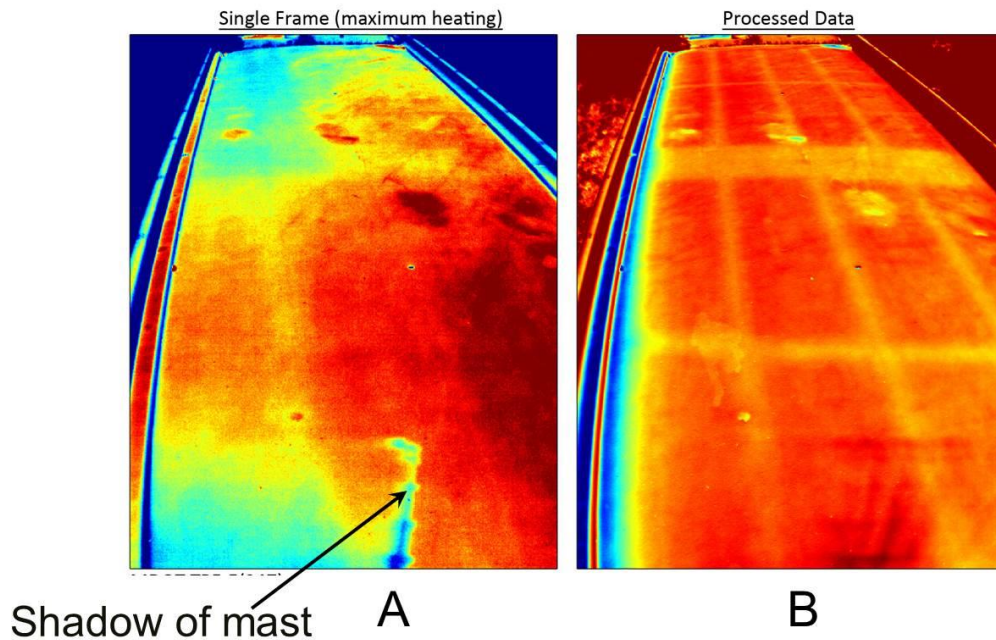
Figure 41. Data from test 2 showing single-frame IR image (A) and IR-UTD processed image (B).

The delaminations shown in Figure 40 were subsequently imaged during Test 2. Data was collected over an 11 hr. period during Test 2. Figure 41 provides a comparison between the processed IR-UTD data and a typical, single-frame IR image. Figure 41A shows a single

frame of IR data collected by the IR-UTD system. This frame was selected because it was captured at a point in time when the thermal contrast of the delaminations on the deck was maximized. The delaminations can be observed in the image as well as the shadow of the mast. Since the IR-UTD system collects data periodically over time, individual images such as that shown in Figure 41A can be selected from the overall dataset; these data are essentially the same as IR data collected by a hand-held thermal camera. As shown in the figure, variations in the IR energy emitted from the surface of the deck create “noise” in the image, i.e., different areas of the deck appear as different colors. These variations in emitted energy may be caused by variations in exposure to solar loading, material properties, moisture content in the deck, or some combination of these factors.

Figure 41B shows the processed data from the IR-UTD system. The internal structure of the bridge (diaphragms and webs) can be seen in the image, as well as the delaminations in the bridge deck. In comparison with Figure 41A, the “noise” in the image of the deck is eliminated by the IR-UTD processing. This is because the processed IR-UTD data measures the thermal inertia, as represented by varying rates of change of IR energy emitted from the deck, which is much less sensitive to surface variations in solar loading, material properties, or moisture.

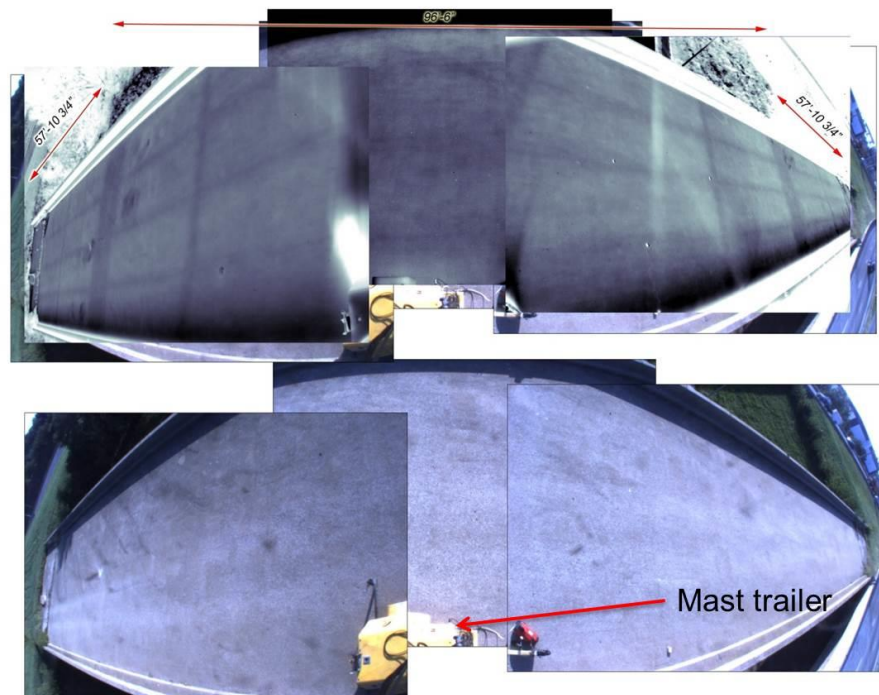
Figure 42. IR-UTD image showing structure features of the bridge (top) and visual images captured by the IR-UTD camera.

Figure 42 shows data from the IR-UTD system captured from Bridge A0295. As shown in the figure, the entire bridge deck was imaged from a single location near the center of the bridge. The IR-UTD data shown in the figure (top) are optimized to show the structural features of the bridge, including the internal webs and diaphragms of the bridge. The visual images captured by the IR-UTD camera head are also shown in the figure (bottom). The mast trailer is shown in these images because the mast was positioned on the deck of the bridge.

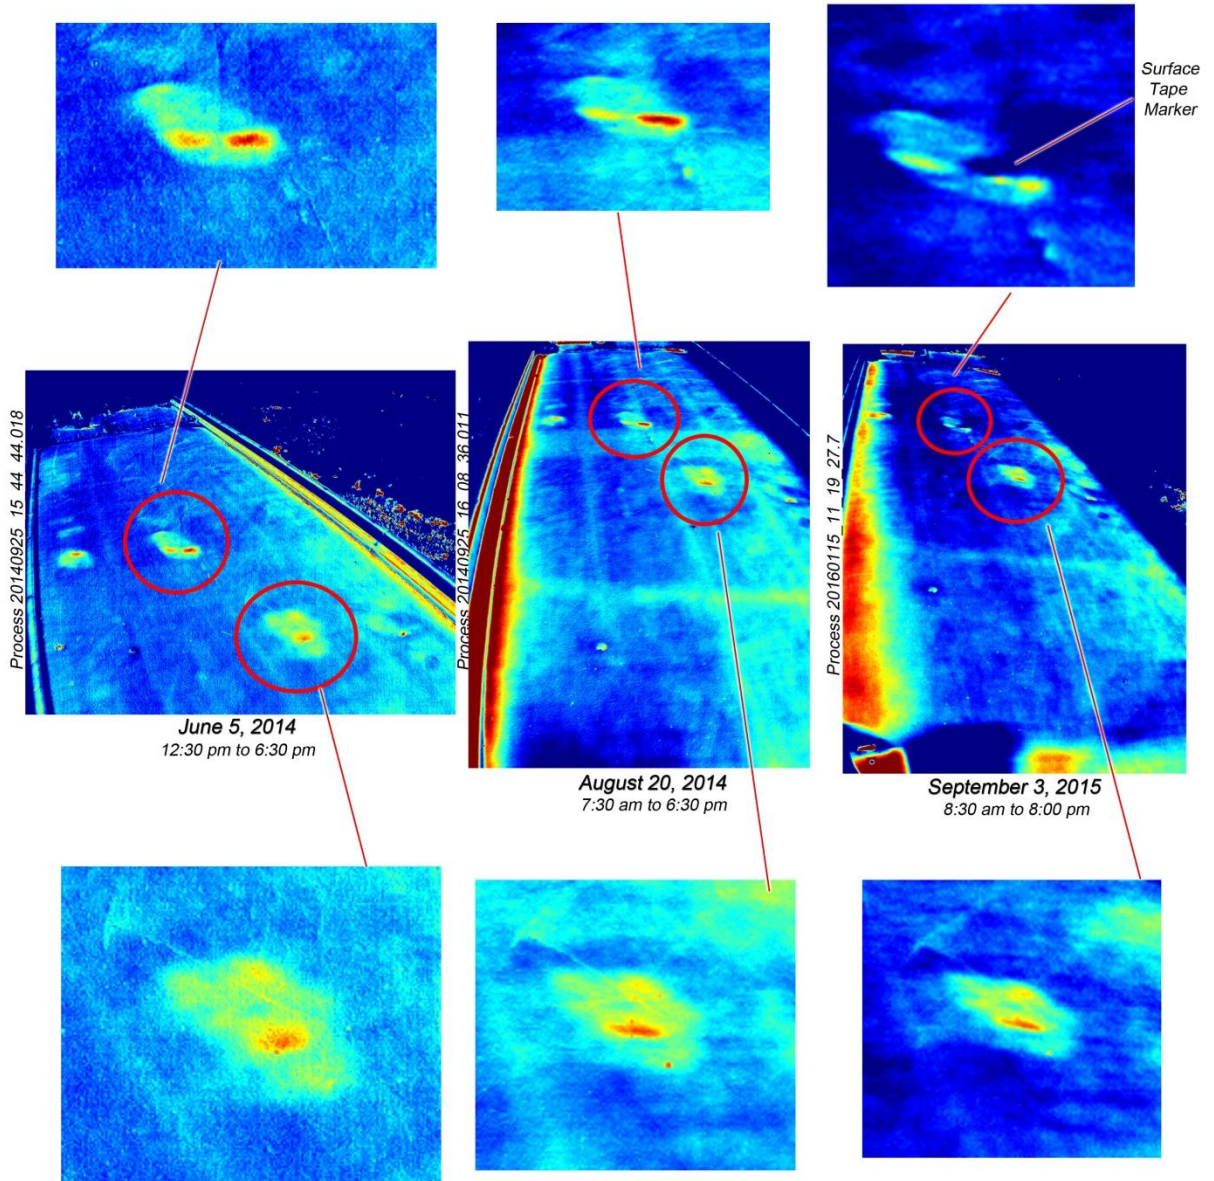
Figure 44. IR-UTD images of the north span of the Kansas City Bridge from three different tests

Figure 44 shows a comparison between the three different tests for the delaminations identified in the north span of the bridge. In this figure, call-outs show an expanded view of each of the defects such that these can be compared between each test. The position of the IR-UTD camera head was different for each of the three tests, such that the delaminations are shown from a slightly different perspective. The time interval over which data was collected was also different for each test, and obviously the weather was different for each of the tests. Regardless, these data indicate that the same delaminations were detected in each test and the size of the delaminations was consistent.

It should be noted that for one of the delaminations, a marker was inadvertently placed on the surface of the bridge during Test 3. This marker was placed on the surface of the deck as a fiducial mark for other testing that was occurring during the same time period. Because the delamination is not visible from the surface of the deck, the marker was inadvertently placed where the subsurface delamination was located. This affects the quality of this particular image. These data illustrated that the IR-UTD results were reproducible across three different tests involving different test set-ups, different data collection intervals, and different weather conditions.

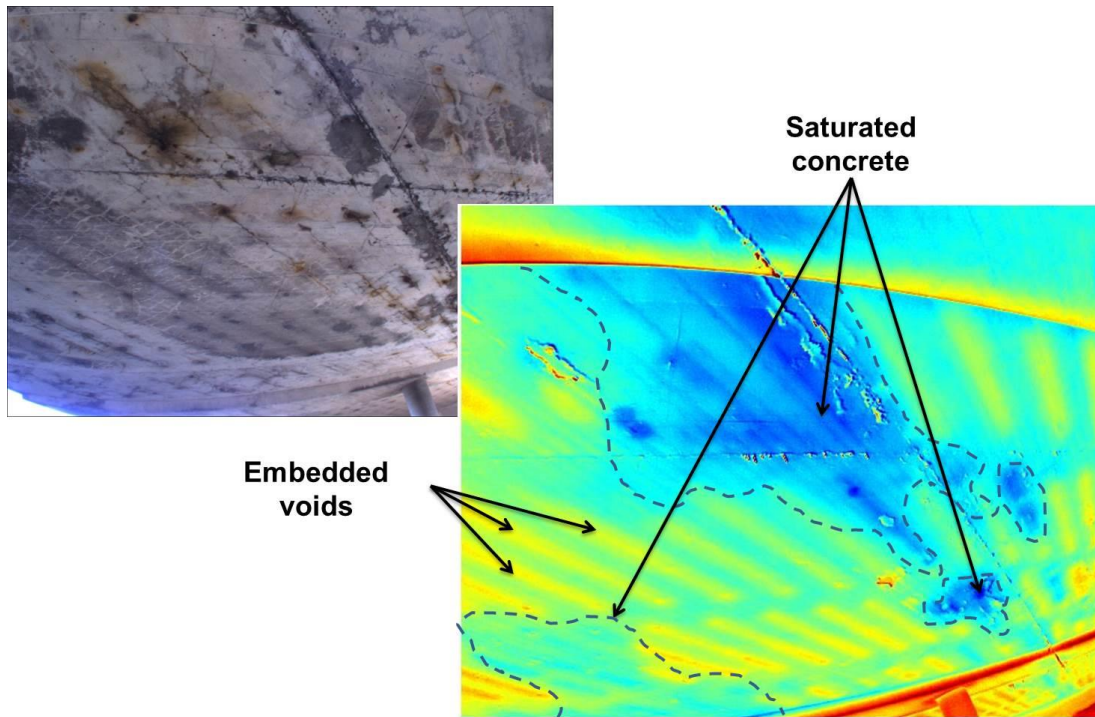
Figure 49. Image showing saturated portions of the soffit area of the bridge deck.

The results of processing the IR-UTD data indicate a large area of saturation as shown in Figure 49. As a result of the water saturation, there was very little temperature change in the saturated area, resulting in an anomaly in the IR-UTD data. The saturated areas of the concrete are enclosed in dashed lines in the figure. In other areas of the image, the signature of the voids is shown in the IR-UTD data, appearing as areas where the thermal inertia is reduced relative to area between the voids, where concrete is continuous through the thickness of the slab. The indication of the voids in the image indicates that heat transfer was occurring normally in these areas. In contrast, the voids are not apparent in the areas that are saturated, indicating that heat transfer was not occurring normally in these areas.

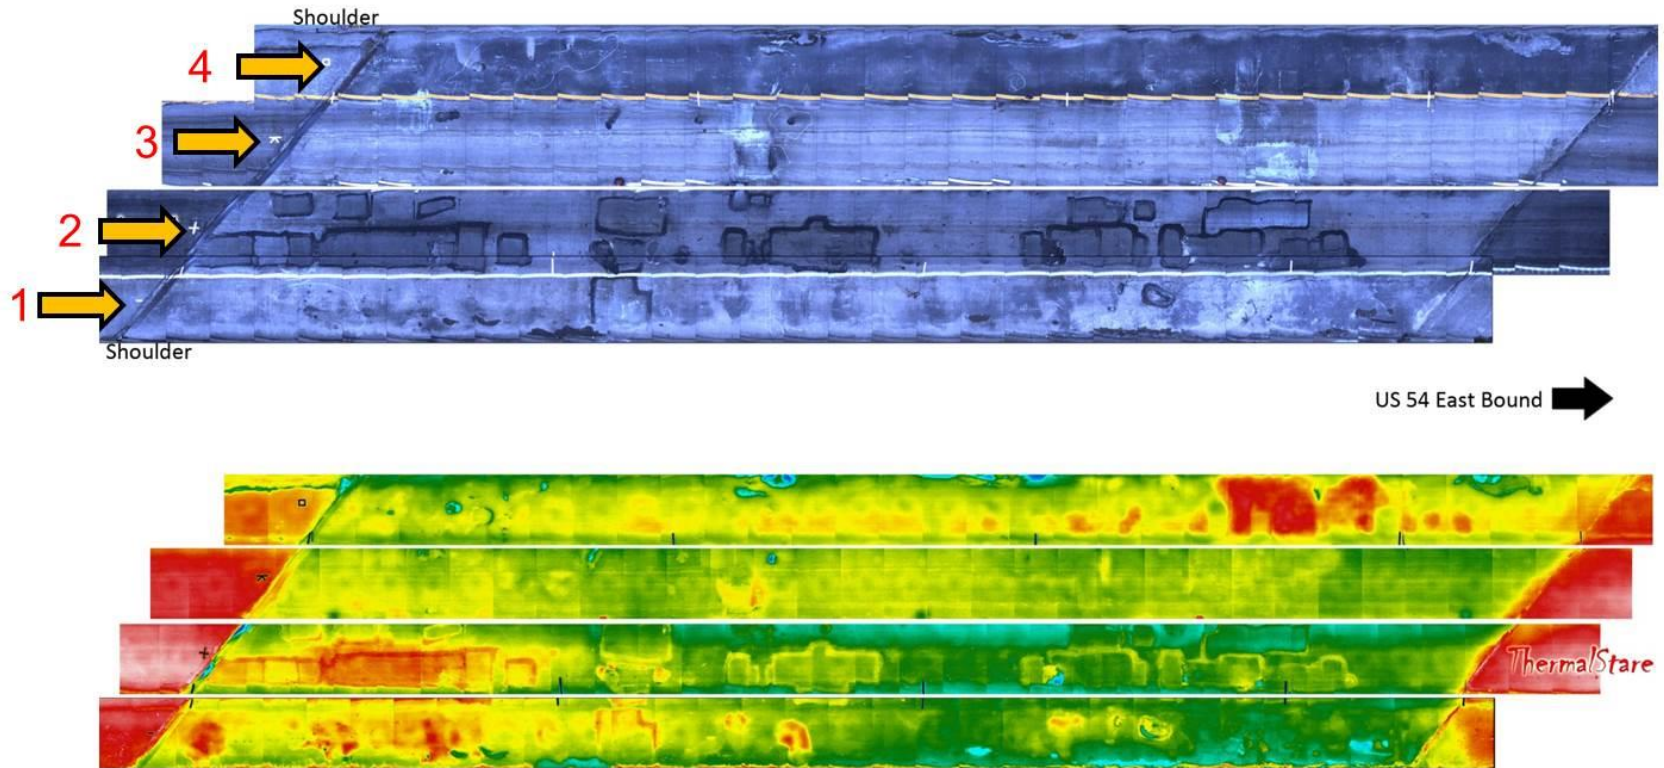
Figure 55. Plan view image of the bridge deck showing IR-DSS visual images (top) and thermal images (bottom).

The results of the testing are summarized in Figures 55 thru 58 below. Figure 55 shows an overall plan view image of the bridge deck including the visual images (top) and the thermal images (bottom). The visual images are captured by the IR-DSS visual camera and show the deck patches on the bridge. The thermal images (bottom) show a number of delaminations in the bridge deck. Figures 56 and 57 provide the results for each lane of data captured separately, with expanded views of individual delaminations to demonstrate the resolution and spatial precision of the data captured by the IR DSS. Figure 56 shows delaminations in lane 1 as well as a spalling patch area with moisture on the surface. The moisture appears blue in the image. Lane 2 also shows delaminations in the deck including delamination developing around an area that has been patched. Figure 57 shows lanes 3 and 4, including a very large area of delamination in lane 4. Generally, the quality of data produced from lanes 3 and 4 was lower than data produced from lanes 1 and 2 due to the weather conditions, as previously mentioned.

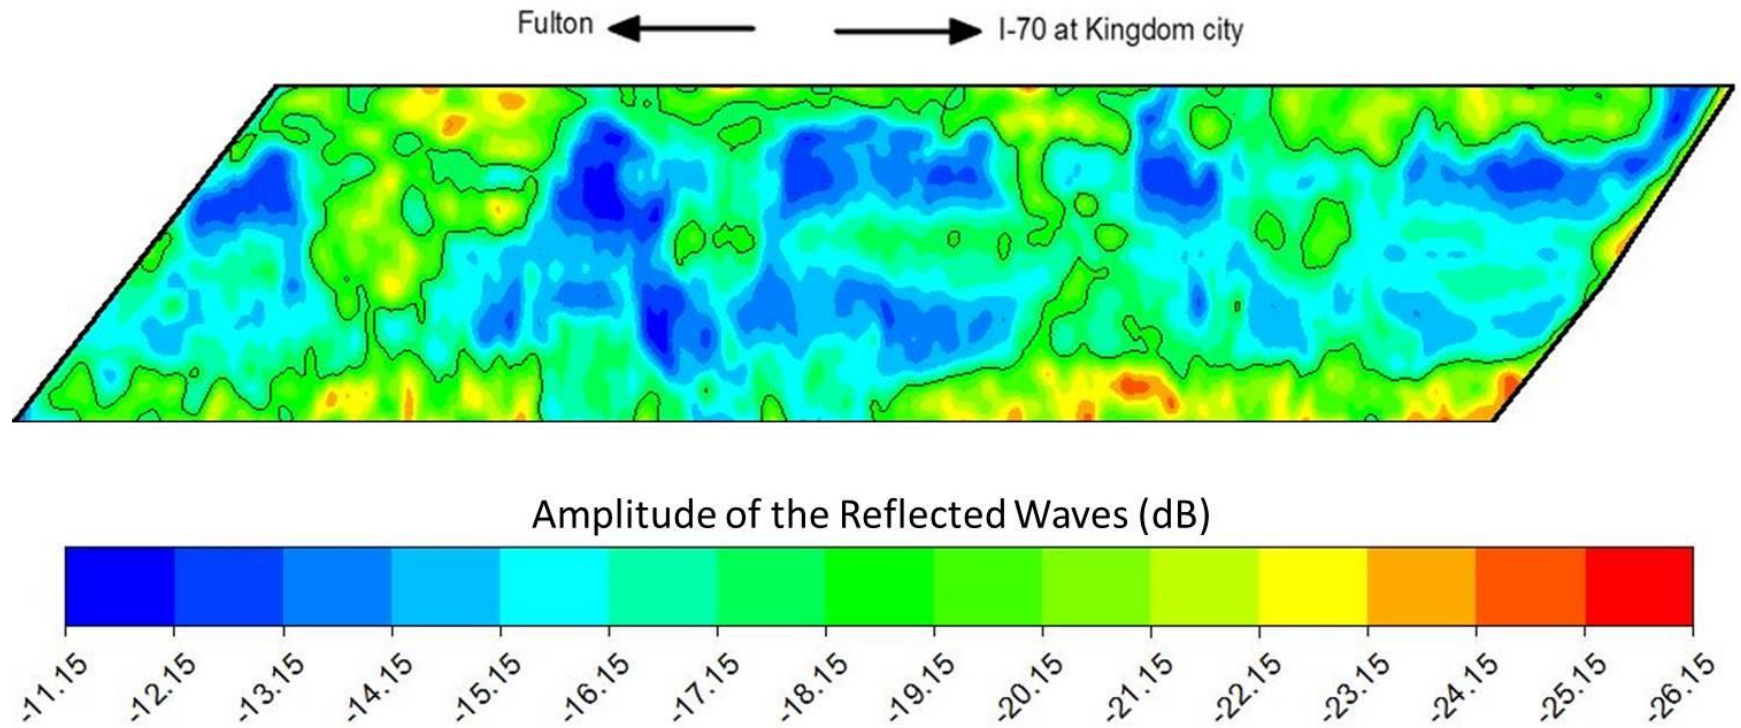
Figure 59. Image showing GPR scanning results of Bridge A2111.

The IR-DSS results were compared with GPR scans that were completed during the field test. The results of the GPR scanning are shown in Figure 59. In this figure, areas shown in blue have a low likelihood of corrosion damage, areas shown in green, red and yellow exhibit increased attenuation associated with increased likelihood of corrosion damage. To provide a comparison between the IR-DSS results and the GPR scan, a subjective threshold attenuation of -7 dB was applied to the GPR image. The threshold value of -7 dB was determined from an analysis of the recommended values in the ASTM standard for applying GPR to bridge decks [27]. This standard indicates that a threshold value of signal amplitude loss of -6 to -8 dB (relative to the maximum signal amplitude measured for a given test) typically corresponds with deterioration [27]. These threshold values were analyzed to determine the area of bridge deck (in %) that would be determined to have a high likelihood of corrosion damage for each threshold value. Figure 60 shows results for threshold values of -6 (top) and -8 dB (bottom) threshold applied to the GPR data from bridge A2111. The areas of low likelihood are shown in black/grey in the figures.

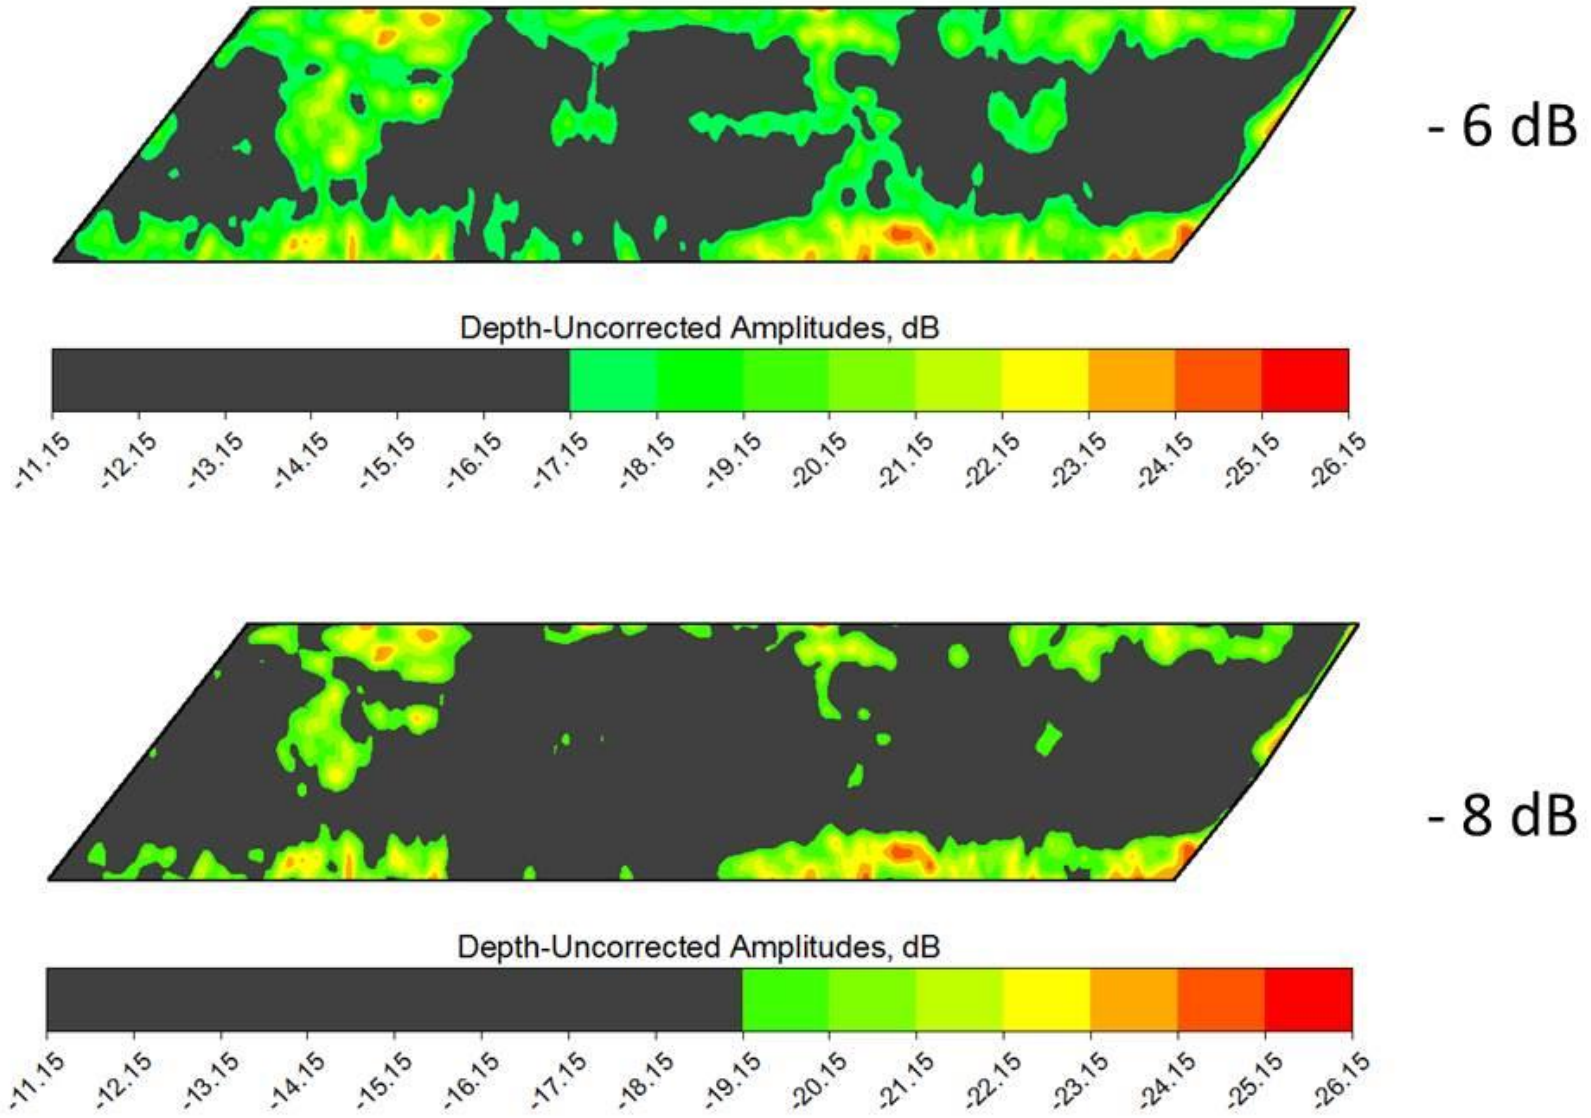
Figure 60. GPR scanning results showing threshold of -6 dB (top) and -8 dB (bottom).

Significantly different results in terms of deck area are found between these two different threshold values. For example, using a threshold attenuation of -6 dB results in approximately 43% of the deck area indicated as having a high likelihood of corrosion damage. Using a threshold value of -8 dB results in approximately 22% of the deck area indicated as having a high likelihood of corrosion. This means that the deck area measured by GPR as having a high likelihood of corrosion damage varies by a factor of almost 2 (1.96) between the recommended threshold values. A threshold value of -7 dB was selected as a nominal value that “split the difference;” using a threshold of -7 dB results in approximately 31% of deck area.
