Field Testing of Hand-Held Infrared Thermography, Phase II TPF-5(247) Final Report

Project No. TPF-5(247)

Field Testing of Hand-Held Infrared Thermography, Phase II

Final Report Volume II: New Technologies

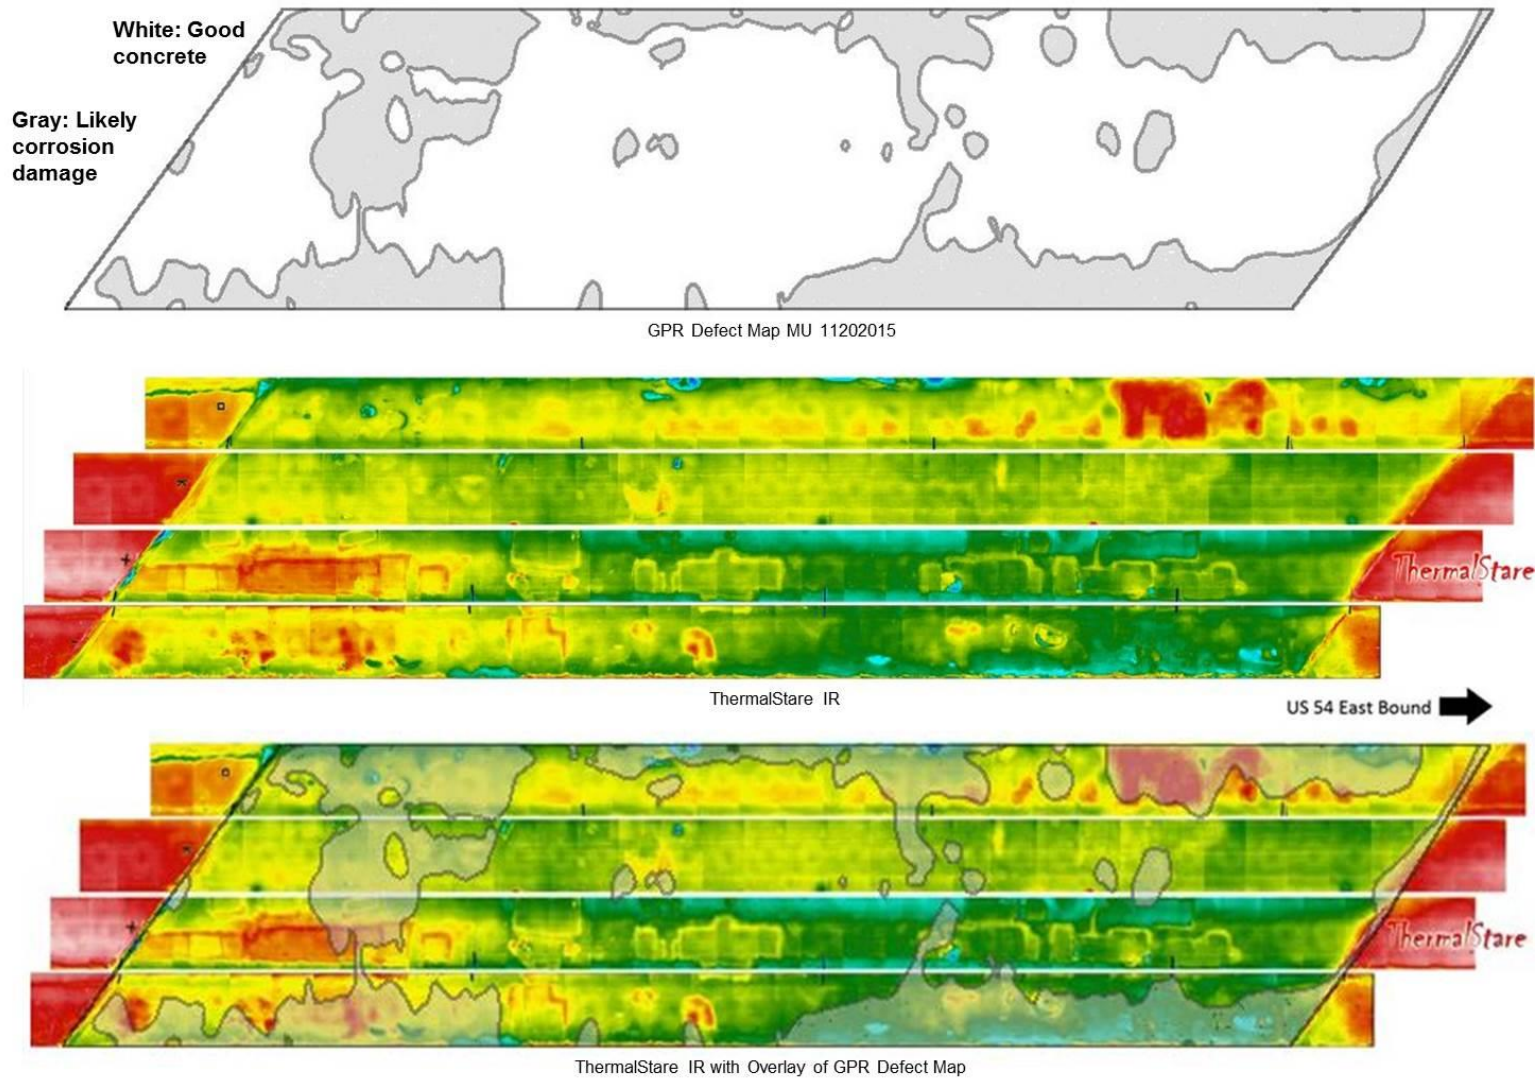
Figure 61. GPR data (top), IR-DSS data (middle) and the overlay showing the GPR data on the IR-DSS data (bottom).

Figure 61 shows three plan-view images of the bridge deck. The top image is the GPR results with the -7 dB threshold and the modified color map applied. Areas shown as clear in this image have a low likelihood of corrosion damage based on the GPR results. The second

figure shows the IR-DSS results, and the third image shows an overlay of the GPR data with the IR-DSS data.

This comparison is useful for understanding the differences between the type of information provided by IR results and GPR results. The GPR results show general information on areas of the deck where corrosion damage is more likely, relative to other areas of the deck. This likelihood is based on the presence of moisture and chloride ions that affect the polarizability of concrete which manifest in signal attenuation and delay. GPR results do not by themselves provide information regarding the area of the deck that is delaminated, patched or has obvious spalls in the surface. In contrast, the IR results provides data on the specific areas that are damaged (delaminated), providing the location and extent of each individual area that is delaminated. Sound and unsound patches were detected and differentiated from the IR-DSS data. In addition, the visual image produced by the IR-DSS shows patches and spalling in the bridge deck.

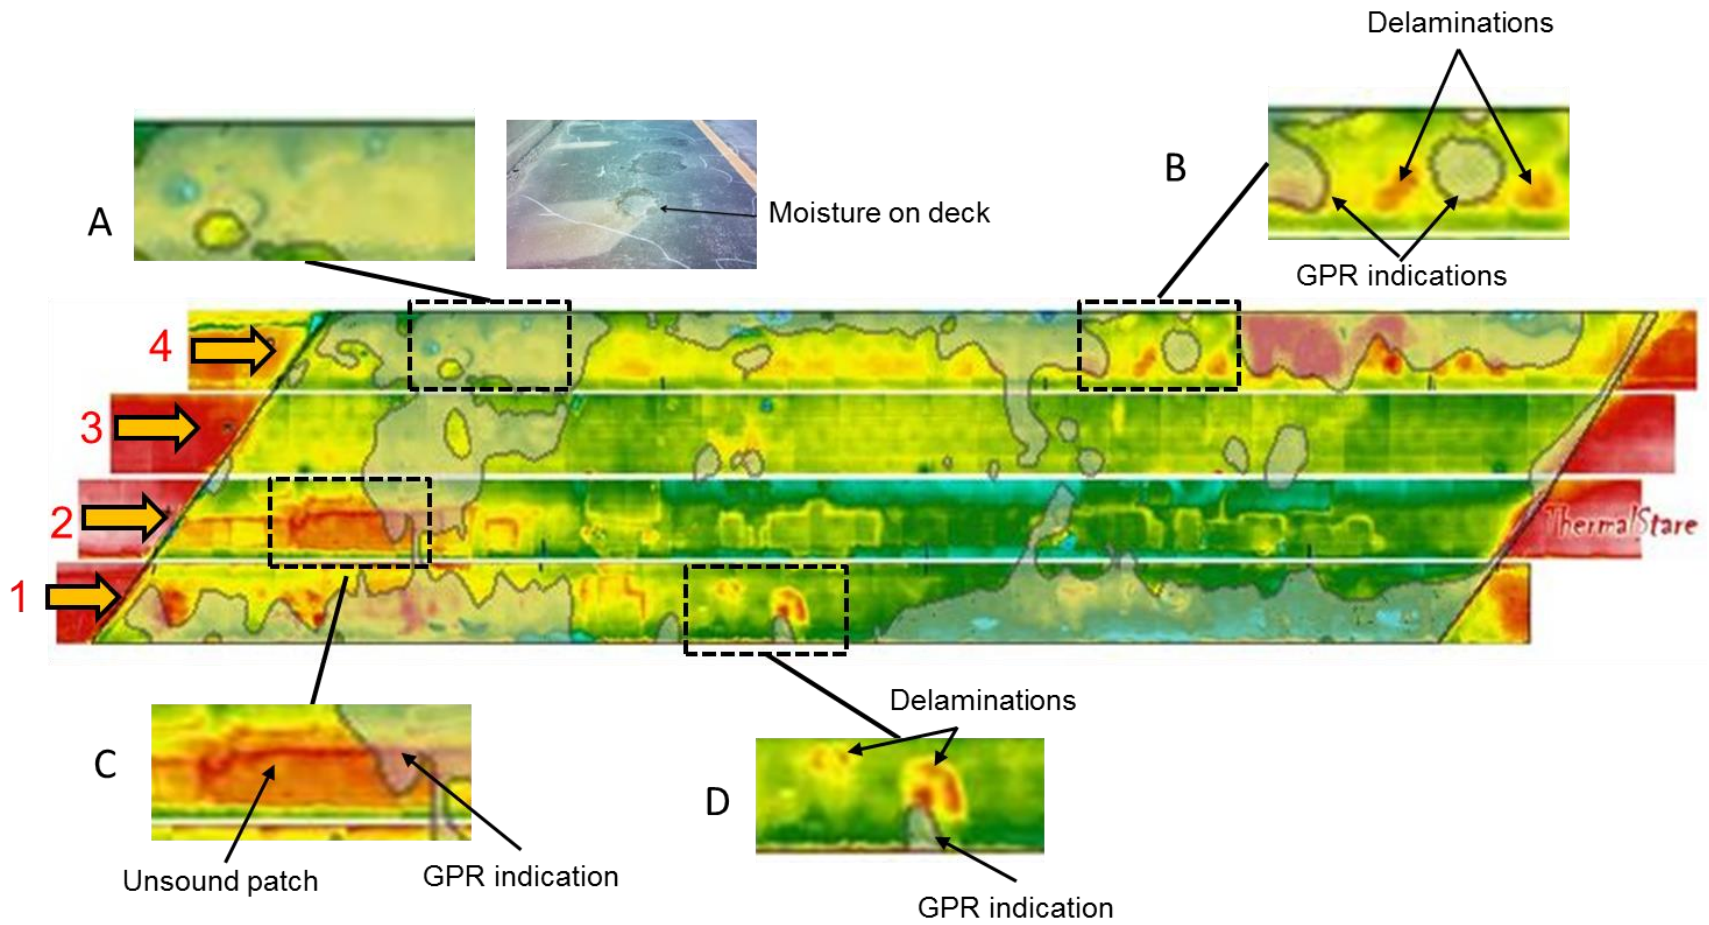
Figure 62. Overlay of GPR data and IR-DSS data showing plan view of bridge A2111 showing expanded view of several areas.

Specific areas of the deck are highlighted in Figure 62 to further describe the differences between GPR results and IR-DSS results. Four areas have been highlighted in the figure and these areas have been labeled A, B, C, and D. The following paragraph provides analysis of each of the highlighted areas.

Area A illustrates an area of the deck where the GPR data indicated a high likelihood of corrosion damage, but the IR-DSS results did not show a delamination. A delamination in this area was confirmed with hammer sounding. This area of the deck was saturated, with water emerging from the delamination in the area of a pothole as shown in the photograph in the figure. This moist area of the deck is captured in the IR-DSS data as a blue area that is located where the moisture can be observed in the photograph. GPR is sensitive to moisture and chloride solutions and as such this area exhibits a large attenuation (see Figure 59). However, moisture in a delamination will cause the heating and cooling of the deck in the area to be slowed, such that a thermal contrast with the intact deck does not appear in the IR image, as previously discussed. Rain prior to the testing resulted in this saturated deck area. The saturation of the delamination was verified by drilling a ½ hole into the deck in this area. The material removed by the drill from the depth of the delamination was saturated.

Area B shows an area where the GPR scan indicated an area with low likelihood of corrosion damage, but in fact there are delaminations in this area as indicated by the IR-DSS scanning and verified with hammer sounding. Area C indicates an area where there are unsound patches detected by the IR-DSS, while the GPR scan indicates that this is an area with a low likelihood of corrosion damage. It may be that the damage in the partial-depth patch is not corrosion-related, but rather a debonding of the patch with the substrate. The GPR technology is sensitive to the presence of chloride ions and moisture; the technology is generally insensitive to dry delaminations. This may explain why the IR-DSS detected this unsound patch while the GPR did not indicate damage was likely in this area. Finally, area D illustrates delaminated areas of the deck where the GPR results indicate a low likelihood of corrosion damage, but the IR-DSS indicates a delamination. This delamination was confirmed with sounding and impact echo. It should also be noted that there are many areas of the bridge deck that GPR indicated a high likelihood of corrosion damage, but there are no delaminations detected in the IR-DSS data.

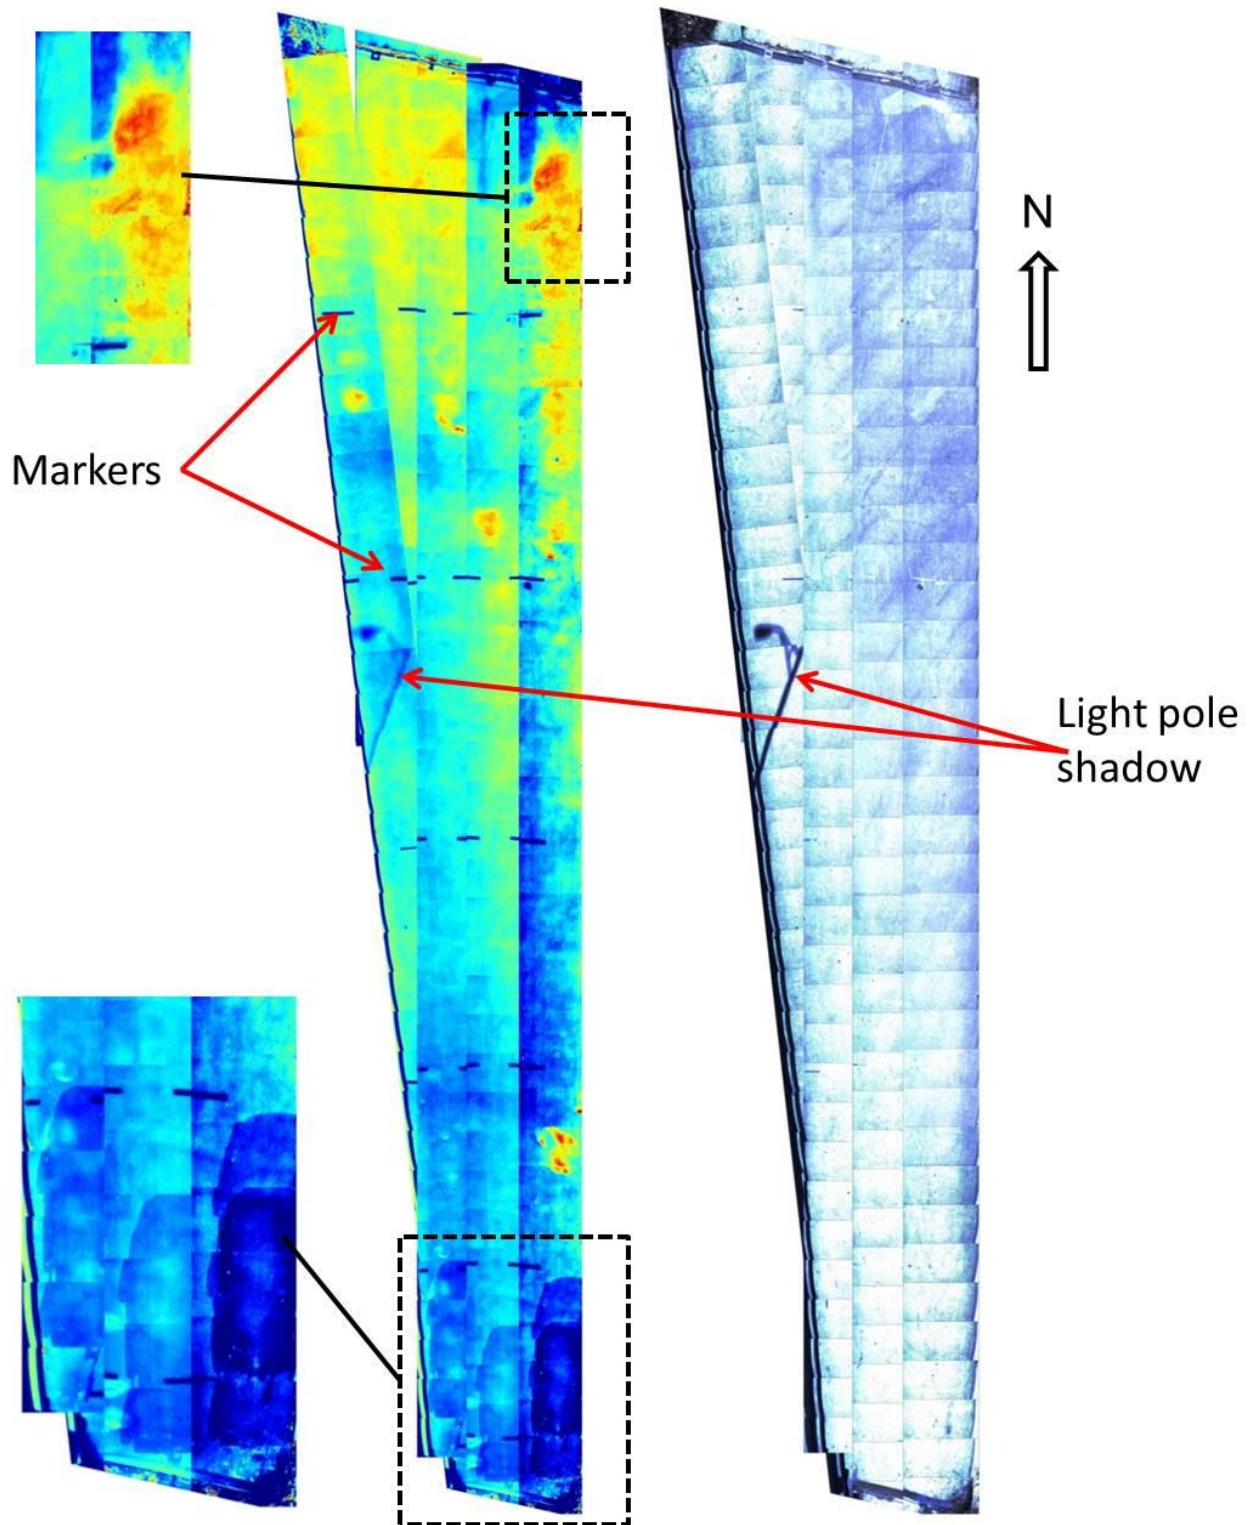
Figure 65. Plan view images of bridge A0295 showing visual image (right) and IR-DSS image (left).

Figure 65 shows the results of scanning the Kansas City bridge deck with the IR-DSS system. There are several features identified in this image. First, metal tape markers were placed on the bridge to provide reference marks for research purposes, and these appear as dark lines in the IR-DSS data. Second, there is the shadow of a light pole on the bridge, and this appears in both the IR-DSS and visual image of the deck surface. Third, there is an area in the north east corner of the deck where the IR-DSS scan appears to show a delamination. This is possibly a false indication; a delamination in this area has not been confirmed with previous hammer sounding. A very faint indication in this area appears in the most recent IR-UTD image of this area of the deck; it is possible that a delamination in this area has developed since the chain drag was completed in 2013. Efforts are ongoing to verify this area. Generally, the north end of the bridge demonstrates “noisy” data such that there appears to be a greater thermal output from this area than other areas of the deck. This phenomena has also appeared in single-frame data collected when testing the IR-UTD system, as was shown in Figure 41. The cause of the increased noise on this portion of the bridge may be related to a variation in material properties or surface conditions. Fourth, on the south end of the bridge, the IR-DSS data is obscured by shadows that were created from a vehicle used during the test. The vehicle had to be positioned on the deck itself prior to the start of each test, creating an area of shadowing on the deck; this was a result of the bridge not having any approaches,

Individual delaminations in the bridge deck are also shown in the image, represented by red areas in the figure.

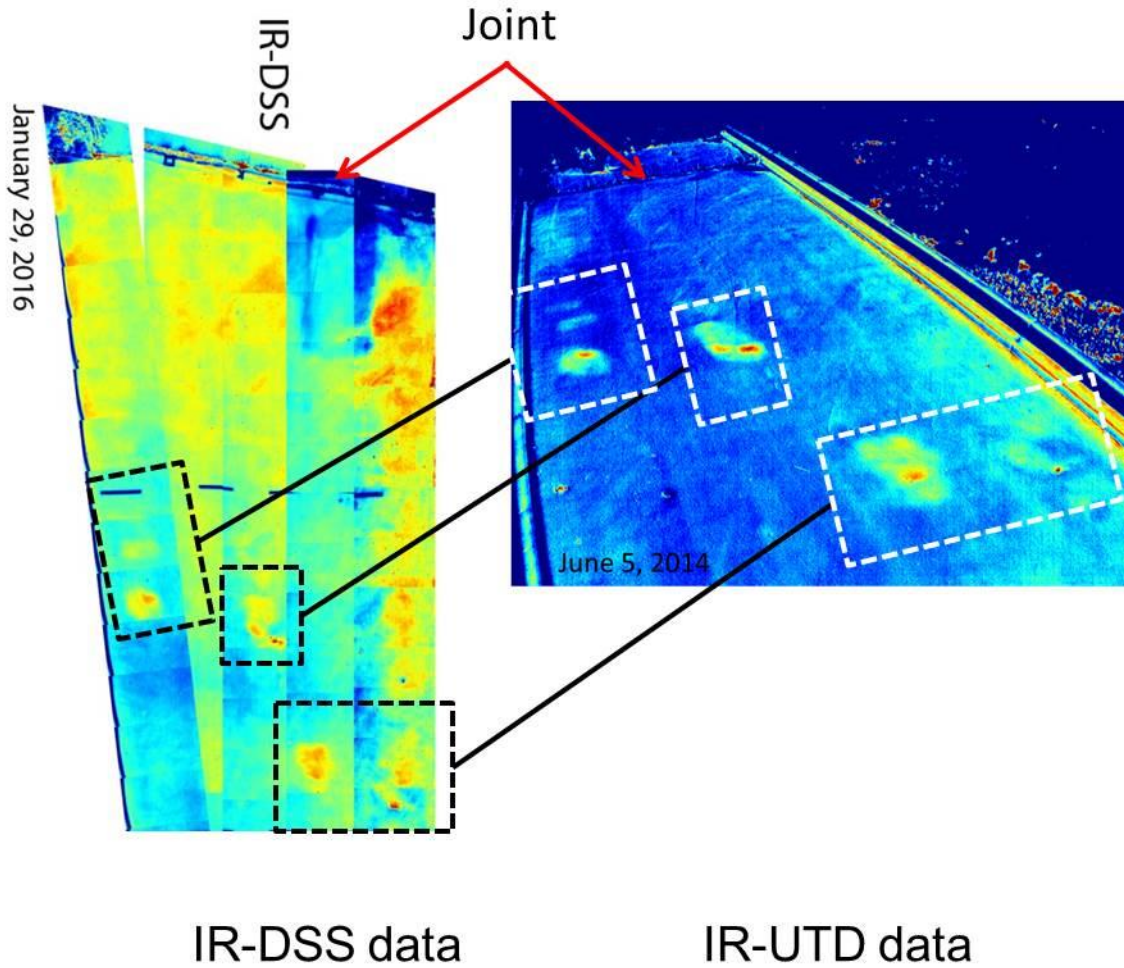
Figure 66. Images showing comparison between IR-UTD and IR-DSS images of bridge A0295.

Figure 66 shows a comparison between the IR-DSS system results and the IR-UTD system results for the north end of the bridge. Qualitatively it can be observed that the IR-UTD data has much less noise in the image such that the deck appears more uniform in color. As a result, the spatial extent of the delamination is unambiguous in the IR-UTD image. In the IR-DSS image, variations in the IR energy emitted from the surface create background noise that makes determining the spatial extent of a delamination difficult. Also, delaminations are detected by each of the systems, in the same area and sharing similar characteristics in terms of magnitude variations across the delamination (i.e., variations of red and yellow color). These variations result from variations in depth of the delamination from the surface. In other areas of the deck that are intact (no delamination), the IR-DSS shows thermal variations of a similar magnitude to areas that are known to be delaminated. These areas are false indications caused by the noise in the data.

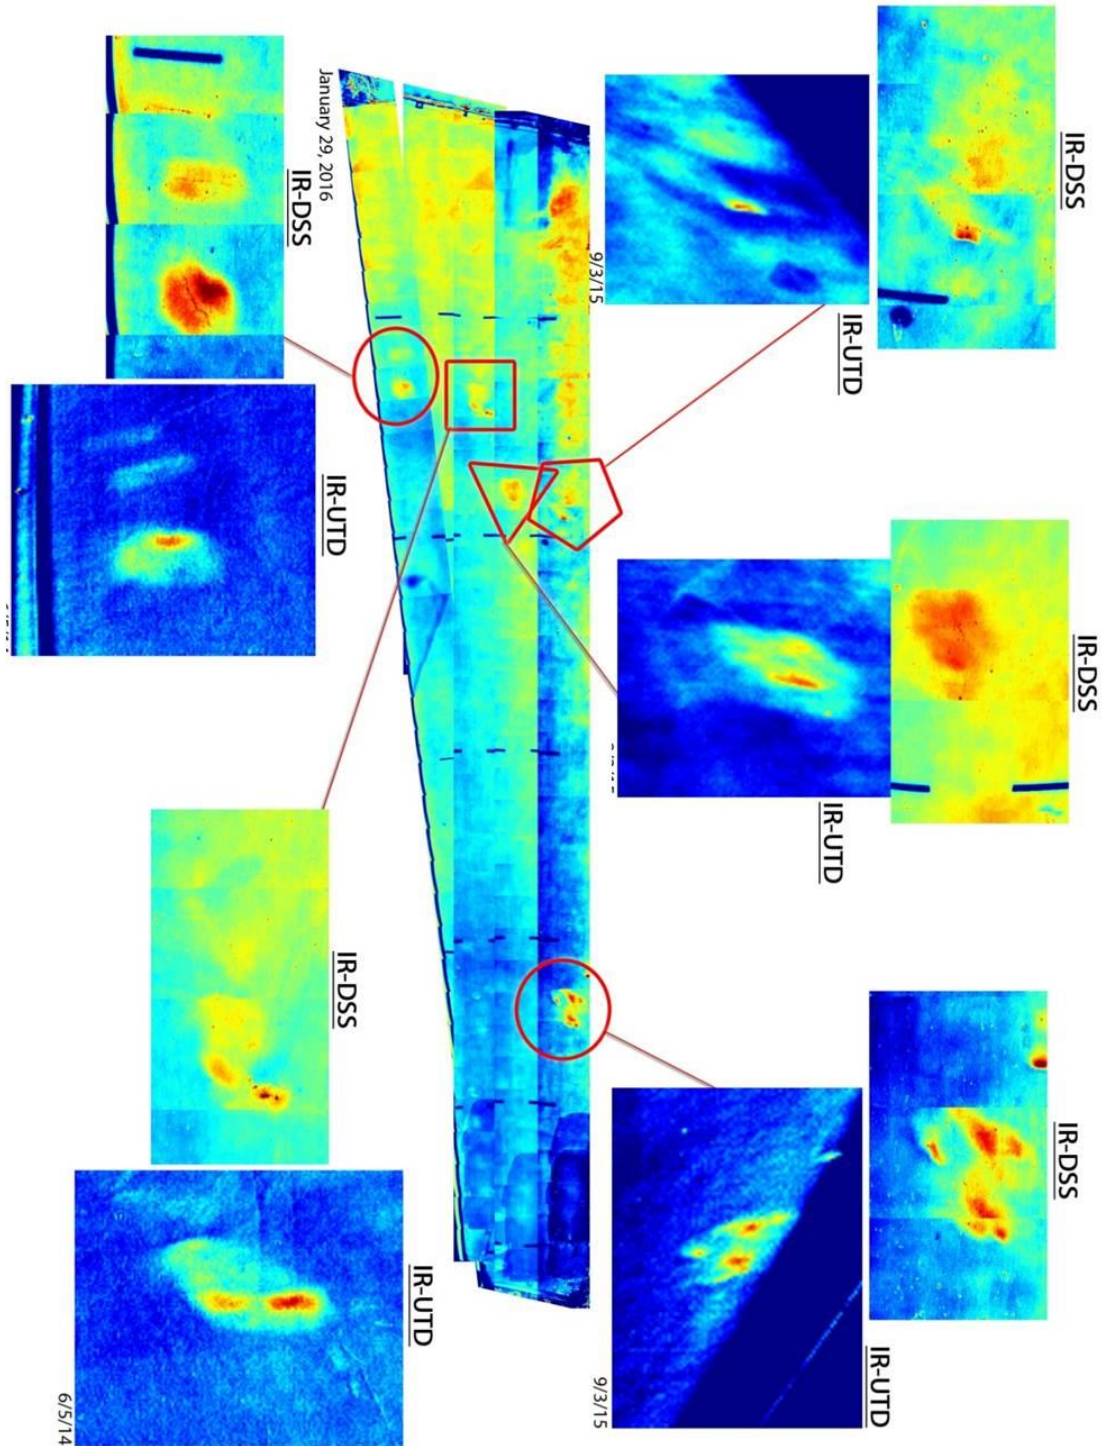
Figure 67. Image showing expanded view of delaminations imaged by the IR-UTD and the IR-DSS systems.

Figure 67 shows a comparison of the IR-DSS results with the IR-UTD results for the entire length of the bridge. As shown in the figure, the correlation between the IR-DSS results and the IR-UTD results was very good. This is not surprising, since the ambient weather conditions were very favorable during the IR-DSS testing.
