Final Report No. 605601 Report Date: July 2016

Development of Delineator Material/Impact Testing Specific to Managed Lane Use for Optimization of Service Life

Test Nos.: 605601-1-6

State of Florida Department of Transportation

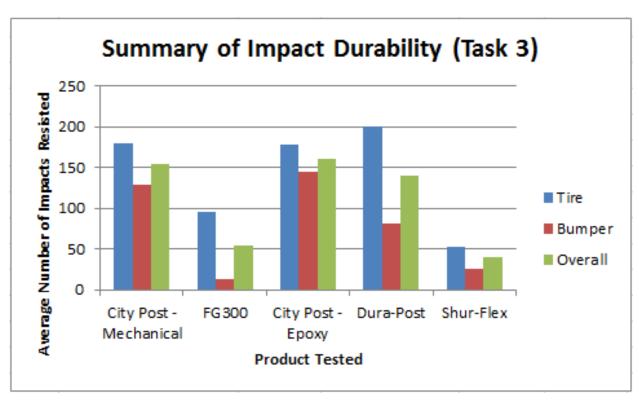
Figure 32. Summary of Impact Durability (Task 3).

Recent impact testing under this project has produced data indicating the current durability of many top performing delineator products. The data include durability with respect to both a vehicle's tire and front bumper. A total of seven different delineators have been evaluated. Two of these products were preliminarily evaluated under Task 1 of the study and only represent a reasonable approximation of their performance. Figure 32 and Figure 33 compare the average number of tire impacts resisted, the average number of bumper impacts resisted, and the combined overall average number of tire and bumper impacts resisted for each delineator. Figure 32 shows a summary of the average number of impacts resisted for the delineators that were evaluated under Task 3. Figure 33 shows a summary of the average number of impacts resisted for the two delineators that were evaluate under Task 1.

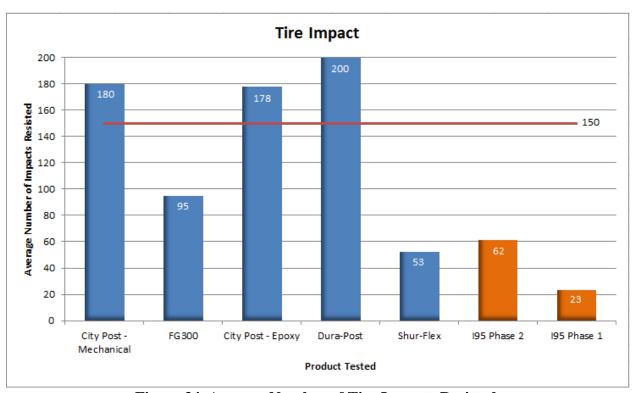
Figure 34. Average Number of Tire Impacts Resisted.

When determining the minimum average number of tire impacts, the researchers looked at the performance of the test samples under Task 1 and Task 3. After looking at the data, there was a large gap between product performances. This created a reasonable and scientific reason to set a minimum performance level for tire impacts that separates the two performance levels. The researchers recommend that a minimum value of 150 impacts be used as a minimum average number of impacts to be resisted by an impacting vehicle tire. Figure 34 shows the average number of tire impacts resisted for each delineator compared to the recommended minimum value. The City Post (mechanically anchored), City Post (epoxy anchored), and Dura-Post (epoxy and mechanically anchored) samples all meet the minimum. The FG300, Shur-Flex, I95 Phase 1, and I95 Phase 2 products do not meet the minimum requirement.

After an extensive evaluation of the data, the researchers recommend setting a minimum average of 150 tire impacts and a minimum average of 45 bumper impacts resisted. These minimum values would serve as an additional requirement that a product must meet in order to be considered for a managed lane marker application. These recommended values come directly from the data obtained while testing the products under Task 3 and represent the state of the possible.

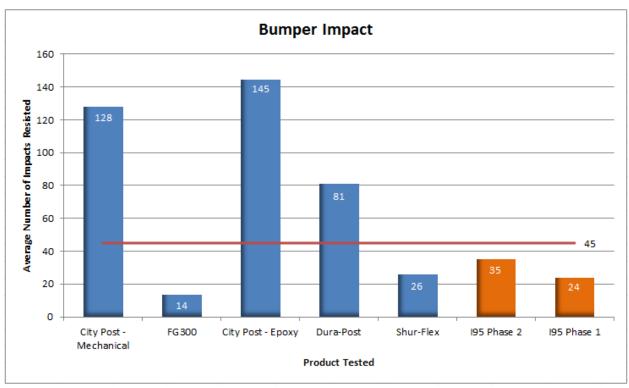
Figure 35. Average Number of Bumper Impacts Resisted.

each product compared to the recommended minimum value. Again the City Post (mechanically anchored), City Post (epoxy anchored), and Dura-Post (epoxy and mechanically anchored) samples all meet the minimum requirement. The FG300, Shur-Flex, I95 Phase 1, and I95 Phase 2 products do not meet the minimum requirement.

During the process of evaluating the results, FDOT expressed a need to have a minimum of two manufactures products that meet the minimum performance level to maintain competitive bids. To address FDOT's requirements, the researchers recommend that a minimum average of 45 bumper impacts be used. Figure 35 shows the average number of bumper impacts resisted by

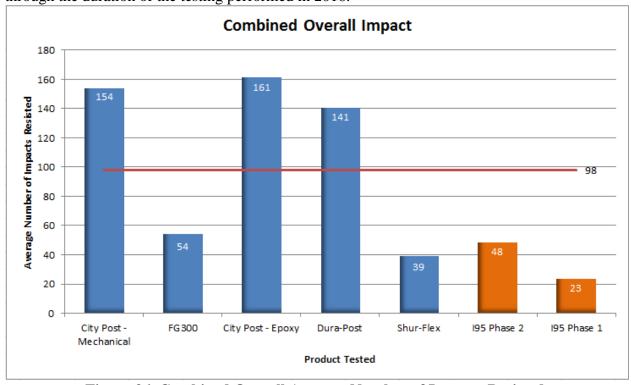
Figure 36. Combined Overall Average Number of Impacts Resisted.

Finally, the average overall impact performance of the delineator should exceed 98 impacts resisted. This value represents the average of the tire (150) and bumper (45) impacts resisted. Figure 36 shows the overall average number of impacts resisted for each product compared to the secondary limit of 98 impacts. As expected the City Post (mechanically anchored), City Post (epoxy anchored), and Dura-Post (epoxy and mechanically anchored) samples all meet the secondary limit. The FG300, Shur-Flex, I95 Phase 1, and I95 Phase 2 products do not meet the secondary limit.

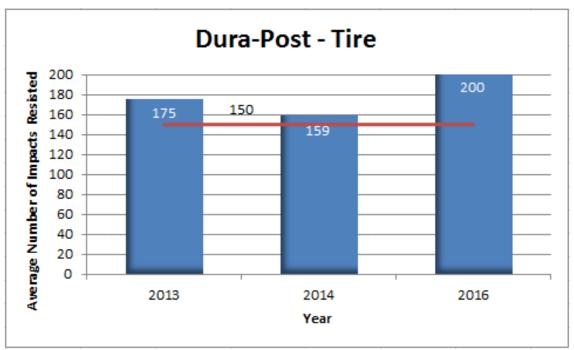
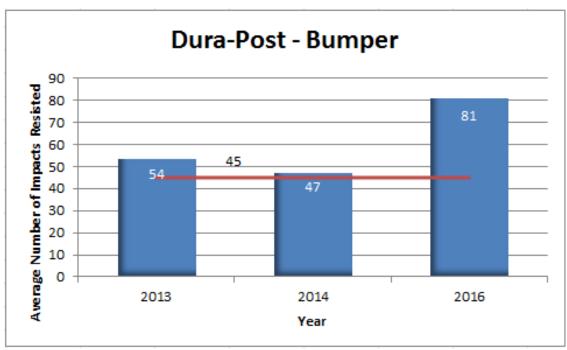
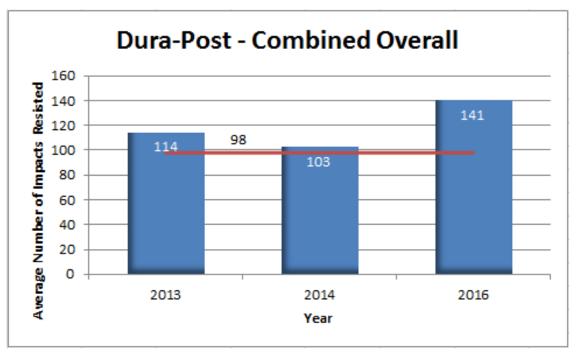
Figure 37 through Figure 39 show the average number of tire, bumper, and overall impacts resisted by the Dura-Post during each of these tests. It is shown that the number of impacts resisted in the 2013 and 2014 tests are significantly lower than the number of impacts resisted in the 2016 test. This shows variability in the performance of the products tested based on ambient temperature that has to be considered.

To address this inherent variability, the minimum average number of impacts resisted was shifted lower to accommodate the variability in testing conditions. Figure 37 through Figure 39 indicate how the minimum values were selected to ensure that the Dura-Post and City-Post meet the minimum requirement within a reasonable temperature range for testing under this standard. Additionally, Figure 39 indicates why the minimum value for the average number of bumper impacts resisted is recommended to be much lower than the values witnessed in the 2016 testing.

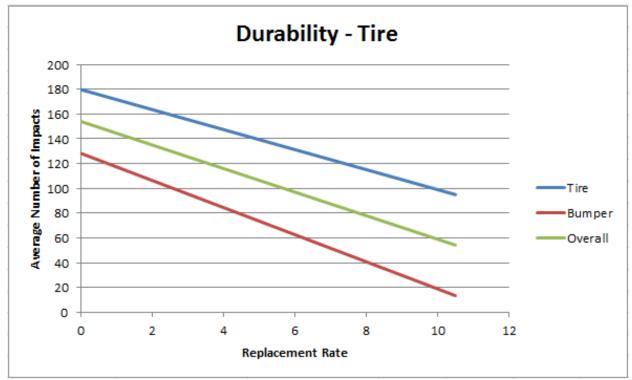
Figure 40. Durability of Delineators.

The durability of delineators should be considered when selecting a product. Table 14 shows data from three different projects where Pexco delineators were installed on various tollways. The data was taken from presentations provided by Pexco to FDOT district management. TTI did not request similar data from other manufactures as this was not a primary focus of the research tasks. Results may vary depending on product design, cost, and location of installation. Table 14 compares the replacement rate (calculated by dividing the number of posts replaced per year by the total number of posts installed) and the average annual cost to replace damaged delineators. As the number of posts needed to be replaced increases, the annual cost to replace damaged delineators increases as well. Figure 40 shows the replacement rate compared
