Louisiana Transportation Research Center

Technical Assistance Report 16-03TA-C

Evaluation of Cores from Jefferson Highway Near Airline Highway

Petrographic Investigation of Concrete Cores Extracted from Cracked
Pavement Slabs on Jefferson Highway in Baton Rouge, Louisiana
(RE: LTRC Project 16-1TA-C)

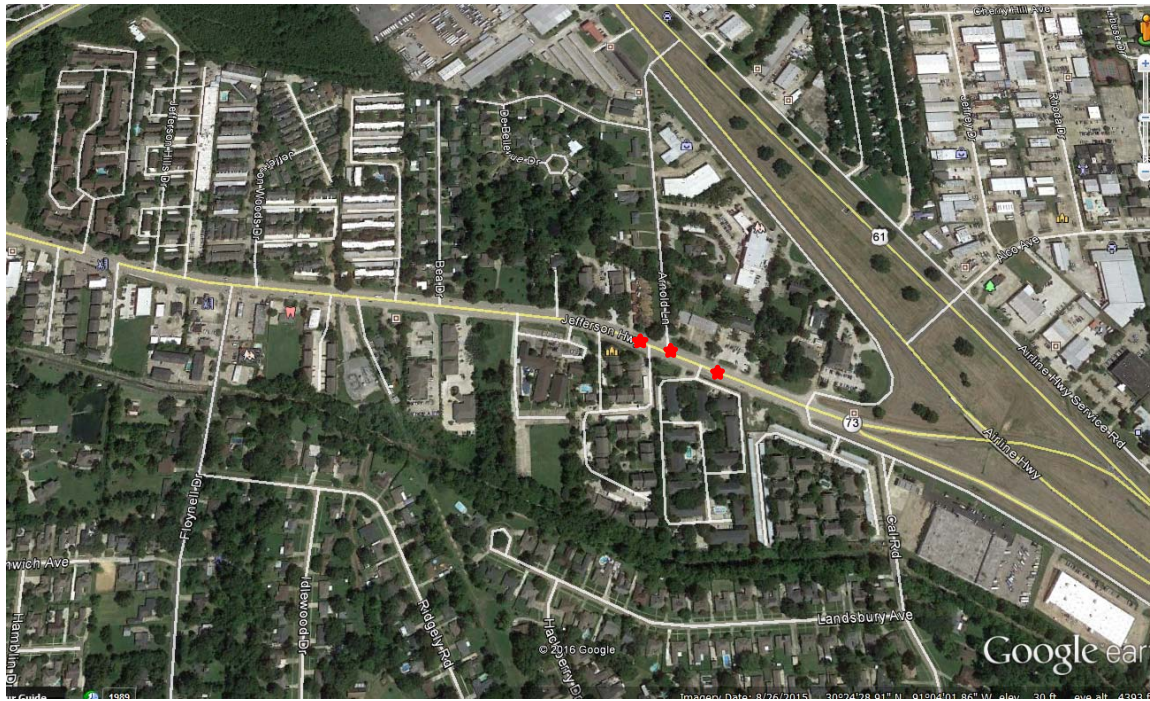
Figure 1
Core locations

LTRC Concrete Research Laboratory personnel obtained three cores (see Figure 1) with assistance of District personnel in March 2016. The cores were photographed and sent to the petrographer for analysis. A petrographic analysis was conducted according to ASTM C856 and ASTM C1723. The full report from the petrographer can be found in the Appendix.

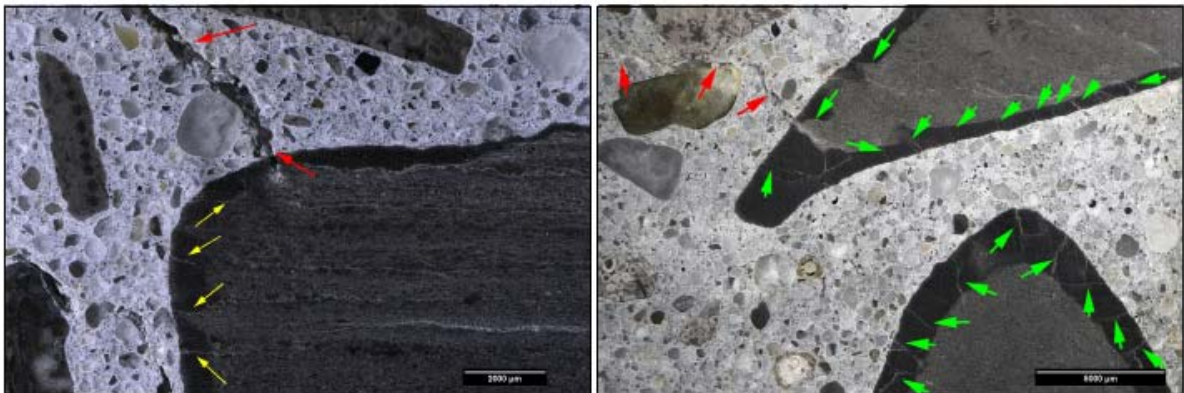
All three cores showed evidence of ACR, but the most advanced evidence was exhibited in Core 3. Numerous limestone particles show microcracking around the perimeter of the aggregate particle (See Figure 2). Yellow and green arrows indicate the microcracking around the perimeter of the aggregate with the red arrows showing cracks cutting from the aggregate into the paste. Figure 3 shows another image of Core 3 with the microcracking and cracking occurring in the paste. Note that the purple arrows show the thickness of the reaction rim of an ACR aggregate.

Figure 2
Images of Core 3 showing perimeter microcracking and cracks cutting into the paste

Being that the evidence strongly indicates that this pavement section is affected by ACR, possible remedies include continued patching efforts and a full-depth replacement of the affected section since ACR cannot be mitigated with an overlay.

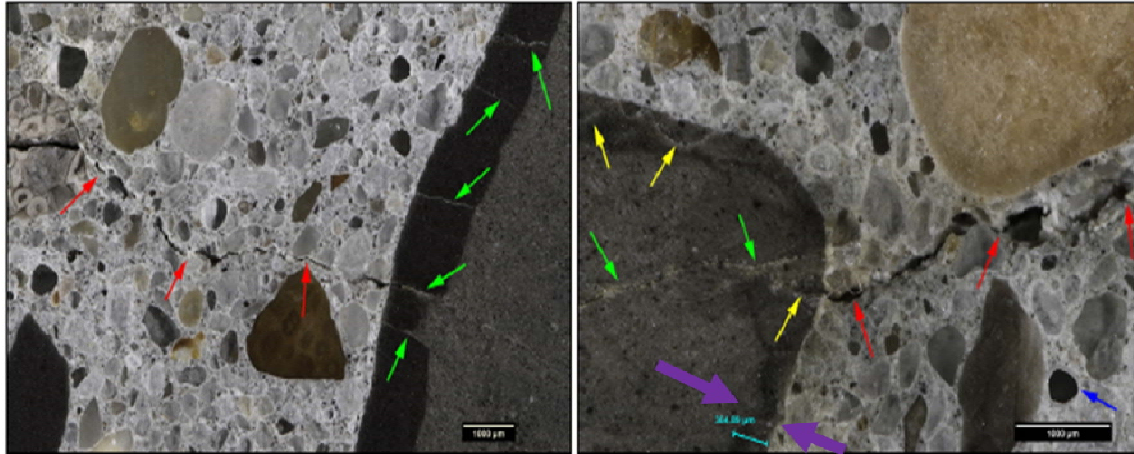
Figure 3
Core 3 showing perimeter cracking and reaction rim

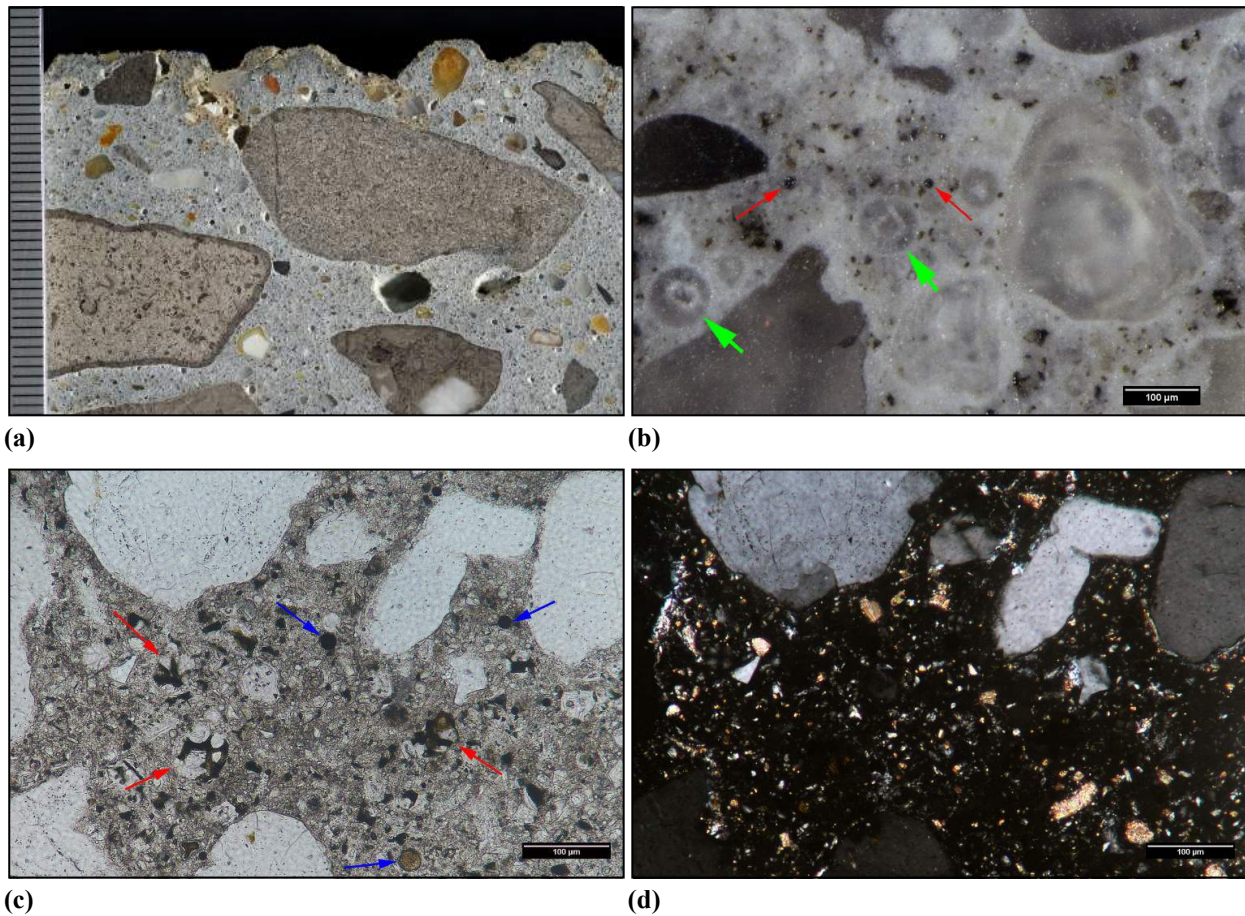
3.2 Components: Paste The paste fraction of all the cores consists of hydrated cement with fly ash; no slag cement or other supplemental cementitious materials were observed (**Figure 4, Figure 5**). The hydration is normal with relict and residual cement grains that consist primarily of belite rimmed by interstitial aluminate and ferrite observed most commonly. Calcium hydroxide is fine to medium-grained and distributed fairly evenly throughout the paste. Very fine fragments of calcite were observed in the paste, suggesting that limestone was blended with the cement. EDS analysis of fly ash particles in all of the cores showed relatively high calcium peaks, which is typical of Class C fly ash (**Figure 5c**). The physical and optical properties of the paste observed in all the cores indicate broad consistency in the proportioning of water and cementitious materials. The cores show layers at the top of the cores that are 1-2 mm (40-80 mil) where the paste is slightly darker than in the rest of the core below.

Figure 4. Examples of paste properties in Core 1. (a) Photograph of the polished surface showing overview of paste at the top of the core; the scale is in millimeters. (b) Reflected light photomicrograph of polished surface showing paste texture and luster in the middle of the core. The red arrows indicate grains of fly ash and the green arrows indicate deposits of ettringite in voids. Transmitted light photomicrographs of thin section showing detail of paste in (c) plane-polarized and (d) cross-polarized light. The red and blue arrows in (c) indicate relict and residual cement grains and fly ash, respectively.

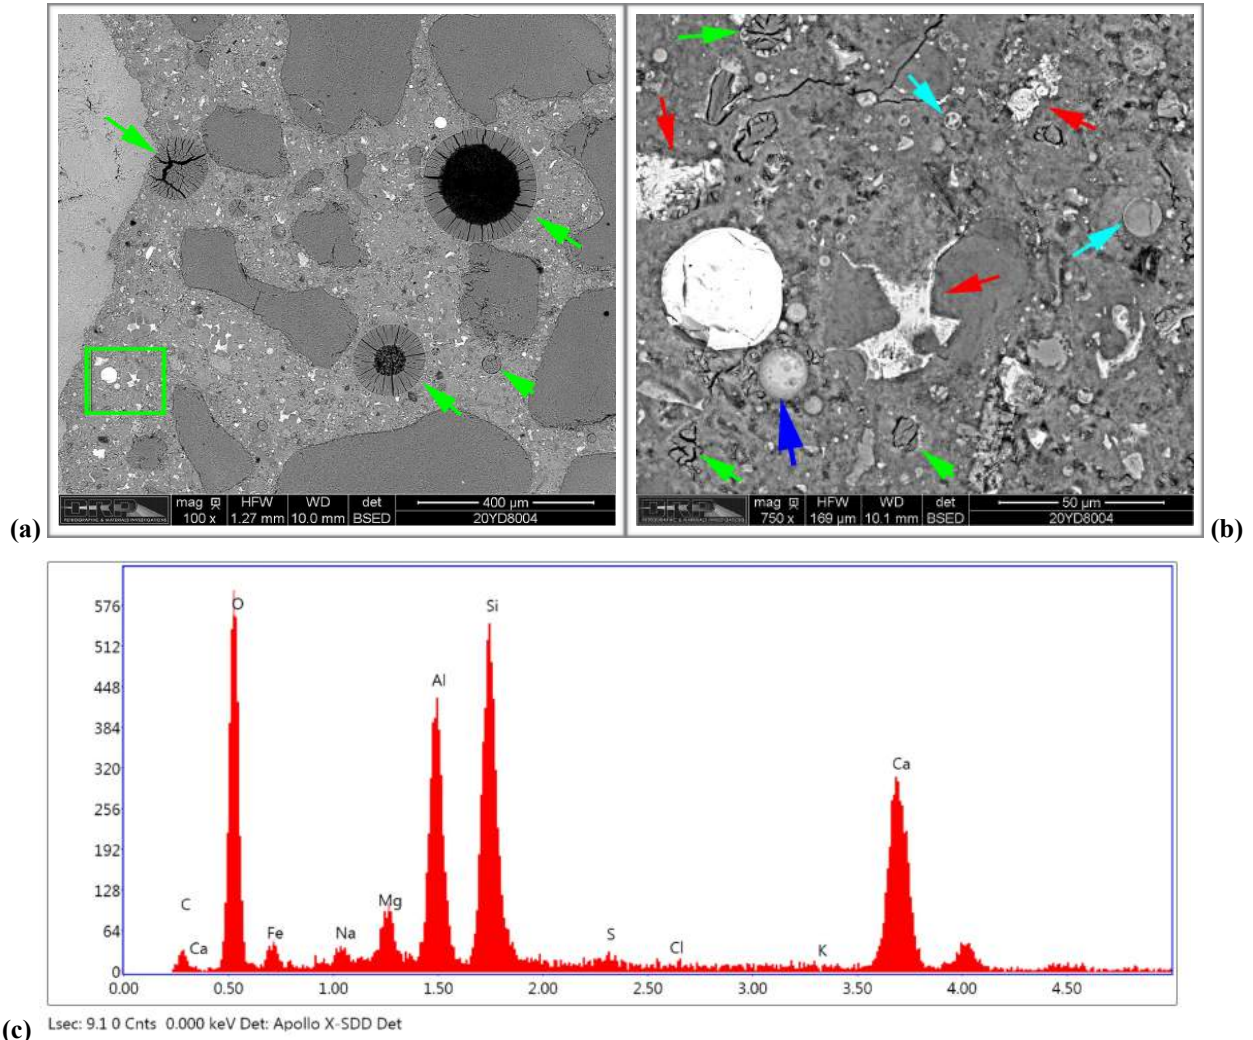
Figure 5. Backscatter electron (BSE) micrographs of paste from Core 3. The green box in (a) shows the area of (b). The green arrows indicate deposits of ettringite in both micrographs and the red and blue arrows in (b) indicate relict and residual cement grains and fly ash, respectively. (c) EDS spectrum obtained from fly ash particle indicated by the darker blue arrow in (b). Note the high peak for calcium (Ca), which is typical of Class C fly ash.

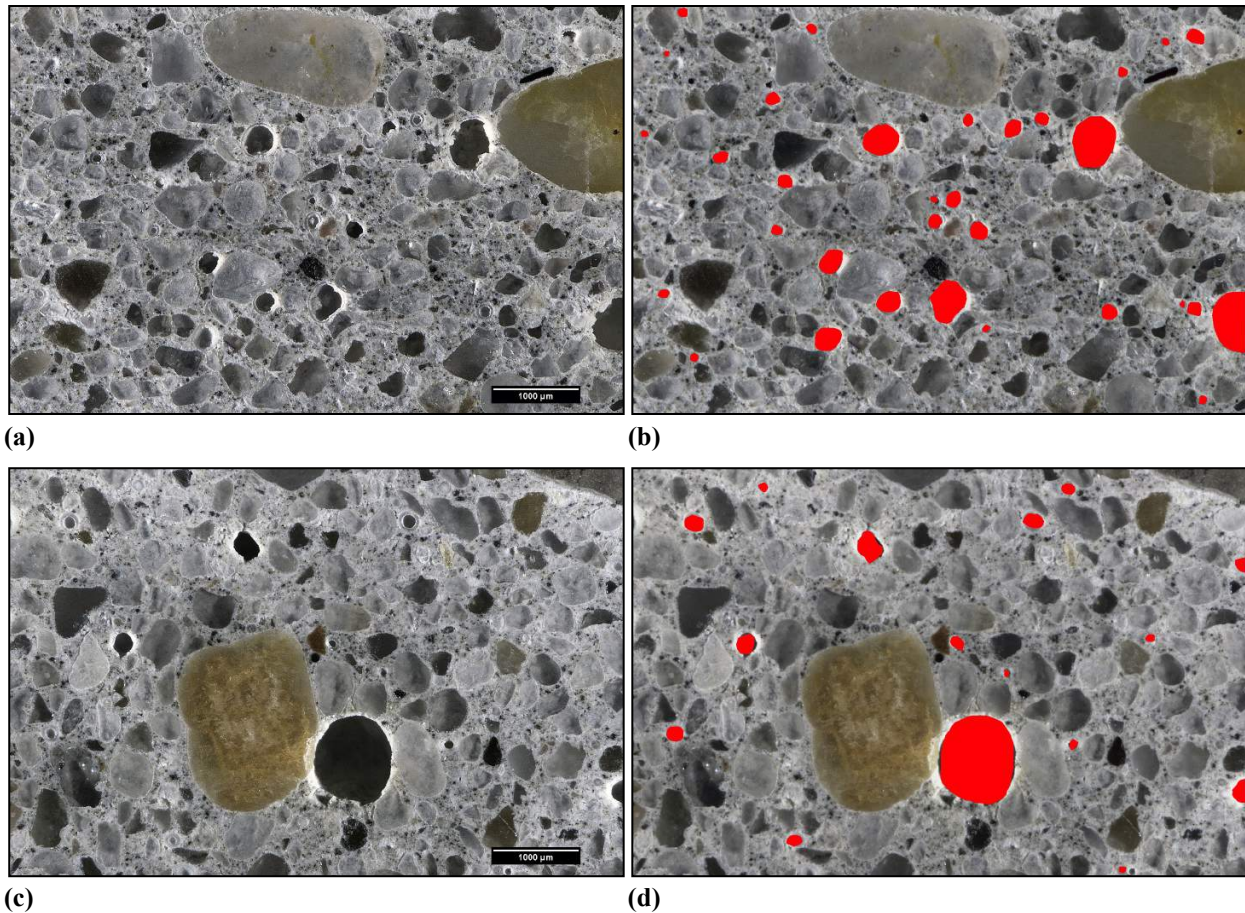
3.3 Components: Air Core 1 and Core 3 show marginal entrainment of air voids where most voids are spherical in shape and less than 1 mm (40 mil) across (**Figure 6**). However, the total air contents, which were estimated at 3-4% from visual and microscopical observations, are well below those typically observed in purposefully air-entrained concrete. Core 2 showed markedly lower air content estimated at less than 2%. However, none of the cores are subjects of a quantitative measurement of hardened air per ASTM C457 [3]. All three cores were well consolidated with no major entrapped air voids, water voids or consolidation voids observed.

Figure 6. Air voids. (a) and (b) are reflected light photomicrographs of the same are of the polished surface of Core 1 showing air voids, which appear as black areas in (a), were filled in with a red marker as shown in (b). The image in (b) was then subjected to image analysis and the red areas make up ~ 4% of the area. (c) and (d) are reflected light photomicrographs of the same are of the polished surface of Core 3. The air voids, which appear as black areas in (c), were filled in with a red marker as shown in (d). The image in (d) was then subjected to image analysis and the red areas make up ~ 3% of the area.

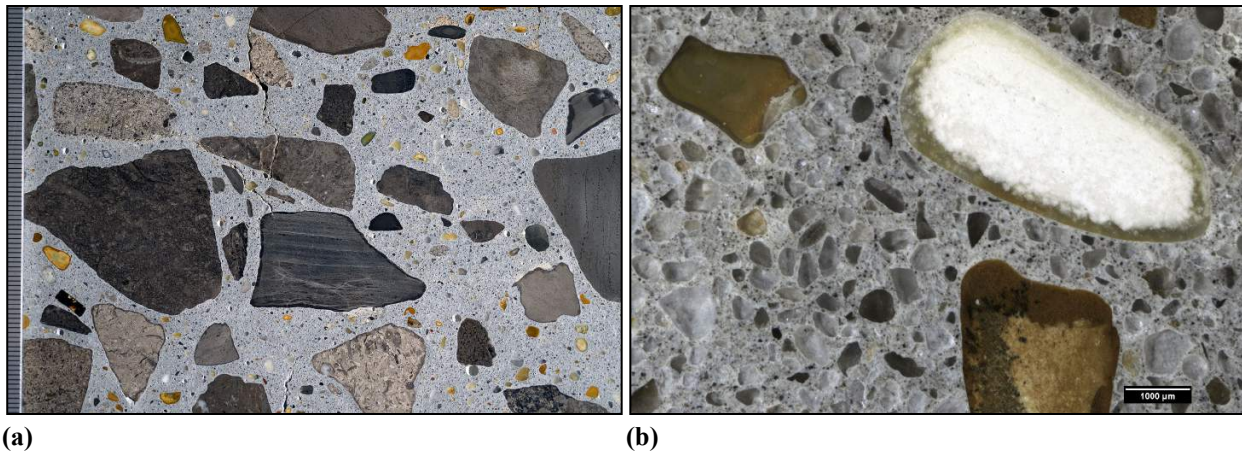
3.4 Components: Aggregates The cores contains similar aggregates. The coarse aggregate is a limestone gravel with a 38 mm (1 ½ in.) nominal top size and the fine aggregate is a natural sand that consists primarily of siliceous rocks with minor amounts of carbonate rocks (limestone) similar to those observed in the coarse aggregate (**Figure 7**). The coarse aggregate shows significant gap grading in all three cores, with a paucity of particles below 25 mm (1 in.) observed such that the sand content of the concrete is high and the distribution of coarse aggregate is somewhat uneven. The coarse aggregate consists of a variety of different limestones that range from dark brown micritic (very fine-grained lime mud) rocks to pale tan oolitic limestones to brown fossiliferous jackstones to brown dolomitic limestones. Many of these particles show well-developed reaction rims, particularly the oolitic limestones and the dolomitic limestones. Examination of the oolitic and fossiliferous limestones in thin section revealed the presence of interstitial quartz and chert, which was commonly chalcedonic. Such rocks are potentially susceptible to alkali-silica reaction (ASR). As discussed below, some of the dolomitic limestones showed evidence of alkali-carbonate reaction (ACR). The natural sand consists primarily of quartz and quartzite with minor amounts of chert and traces of feldspar. Chert is potentially susceptible to ASR and particles of chert commonly showed well-developed reaction rims and occasional microcracks with gel that cut into the paste. Alkali-aggregate reactions (AAR) in the cores is discussed in detail below. The aggregates did not show deleterious coatings or incrustations. Occasional low w/cm mortar coatings were observed on coarse aggregate particles.

Figure 7. (a) Photograph and (b) reflected light photomicrograph of polished surface of Core 2 showing coarse and fine aggregate, respectively. The scale is in millimeters in (a).

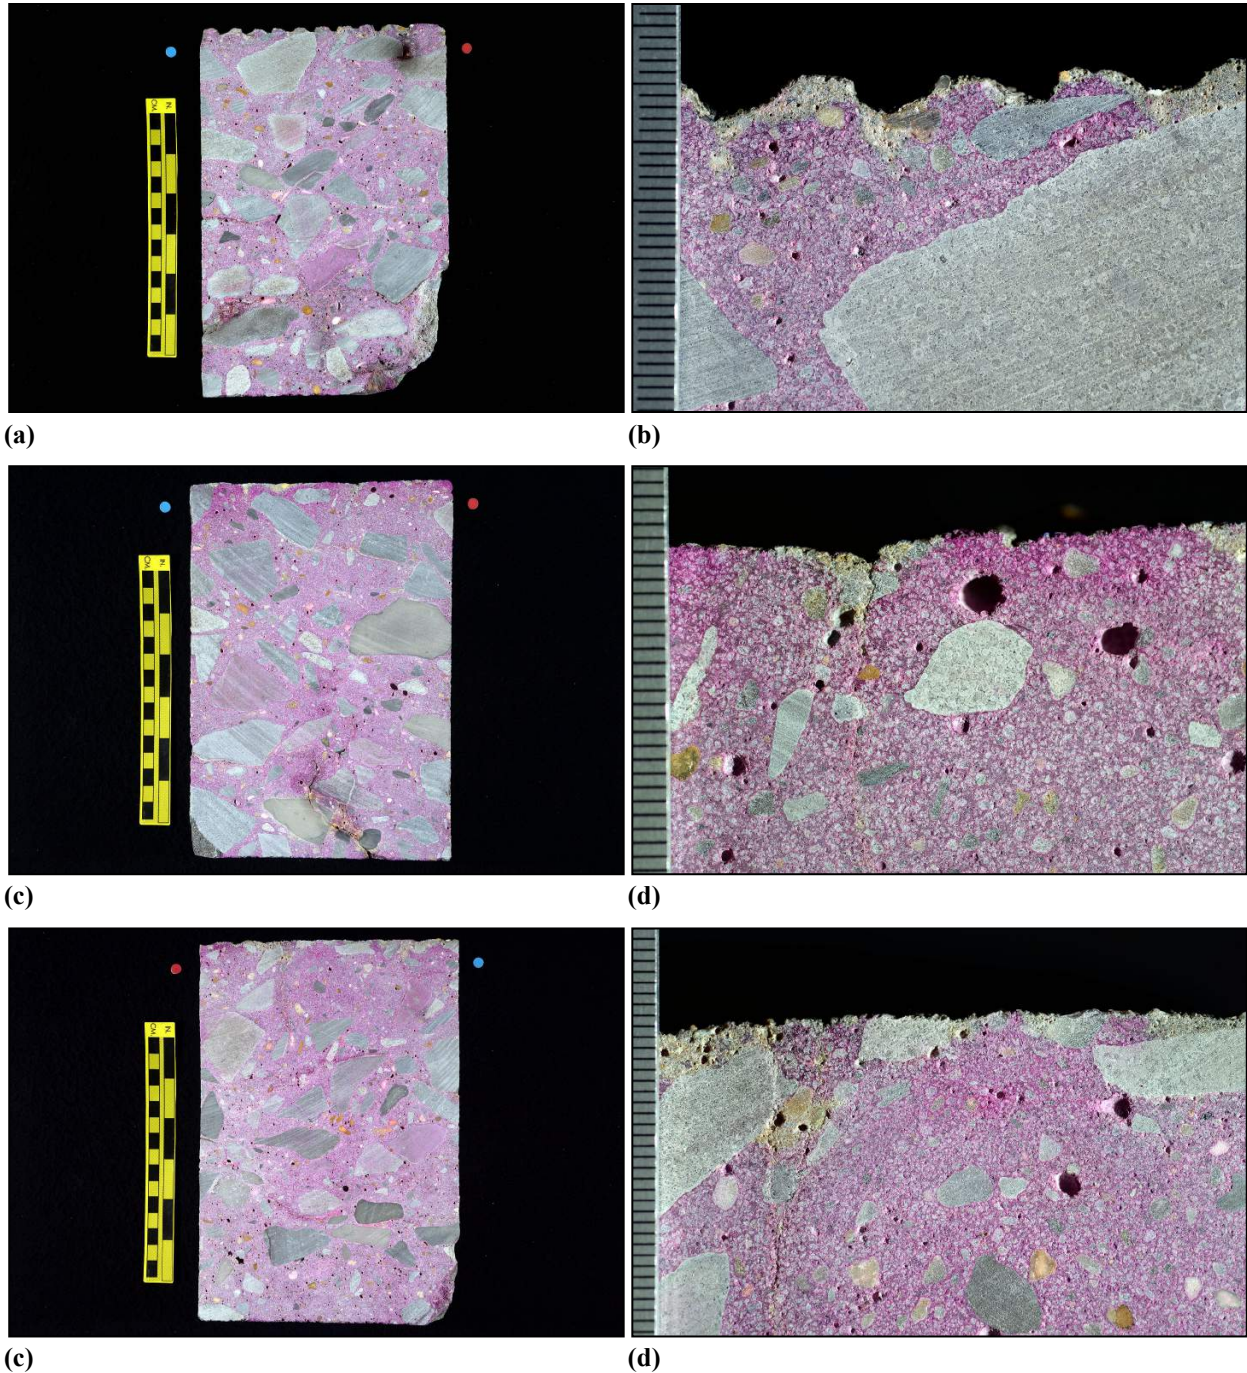
3.6 Secondary Deposits—Carbonation No significant carbonation was detected by phenolphthalein staining or thin section microscopy; which indicate negligible carbonation (< 1 mm or 40 mil; **Figure 11**).

Figure 11. Photographs of the phenolphthalein stained surfaces. (a), (b) Core 1. (c), (d) Core 2. (e), (f) Core 3. The yellow scale bar is ~ 150 mm (6 in.) long; the scale is in millimeters in (b), (d) and (f).

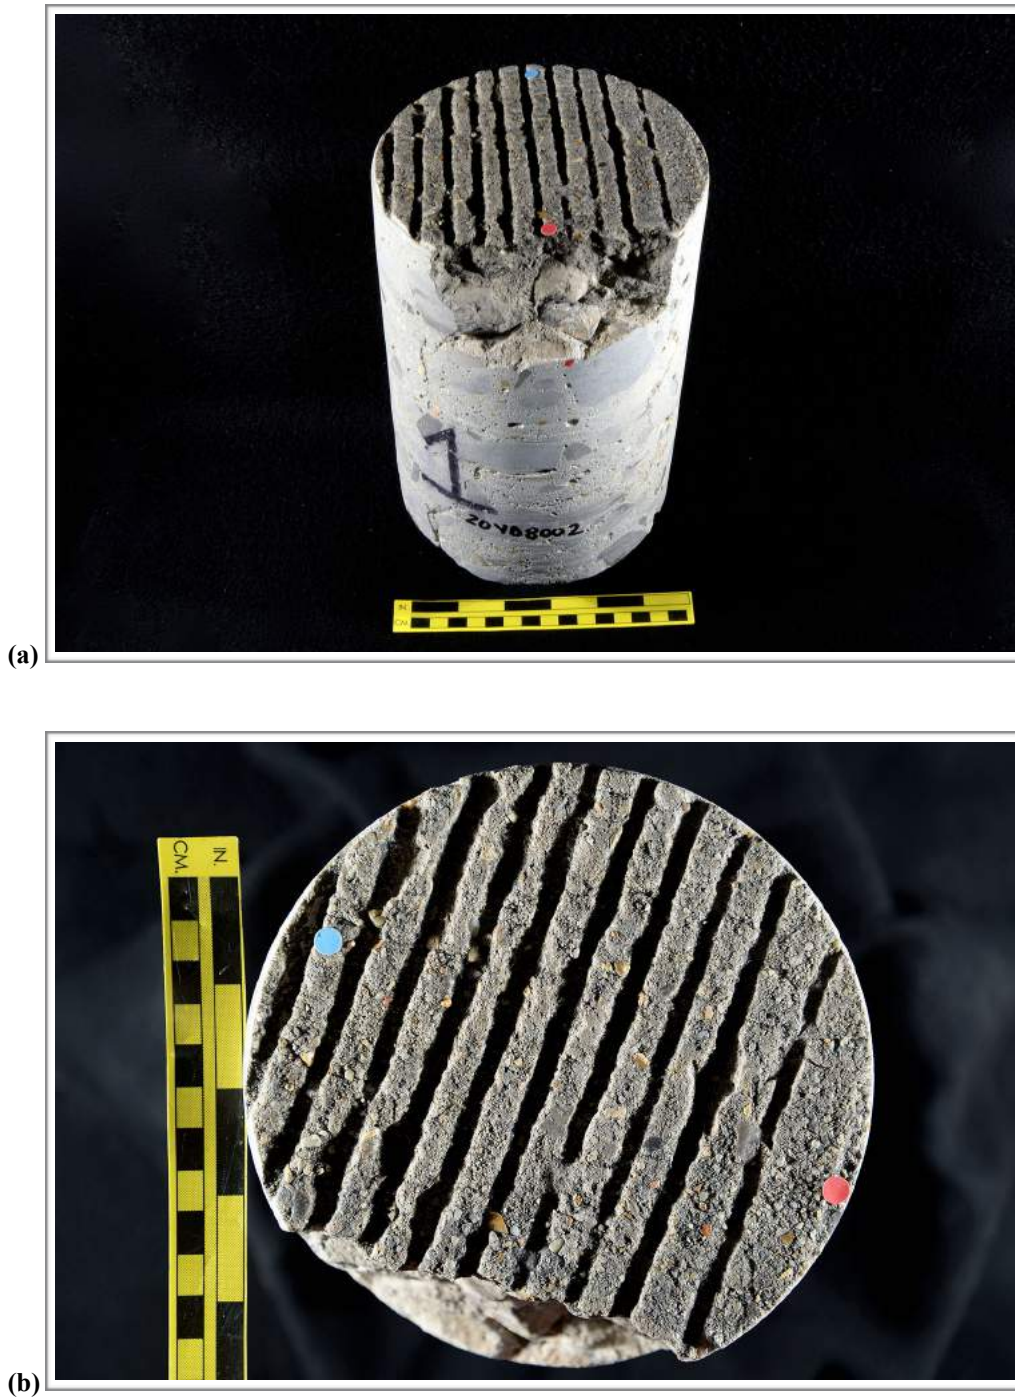
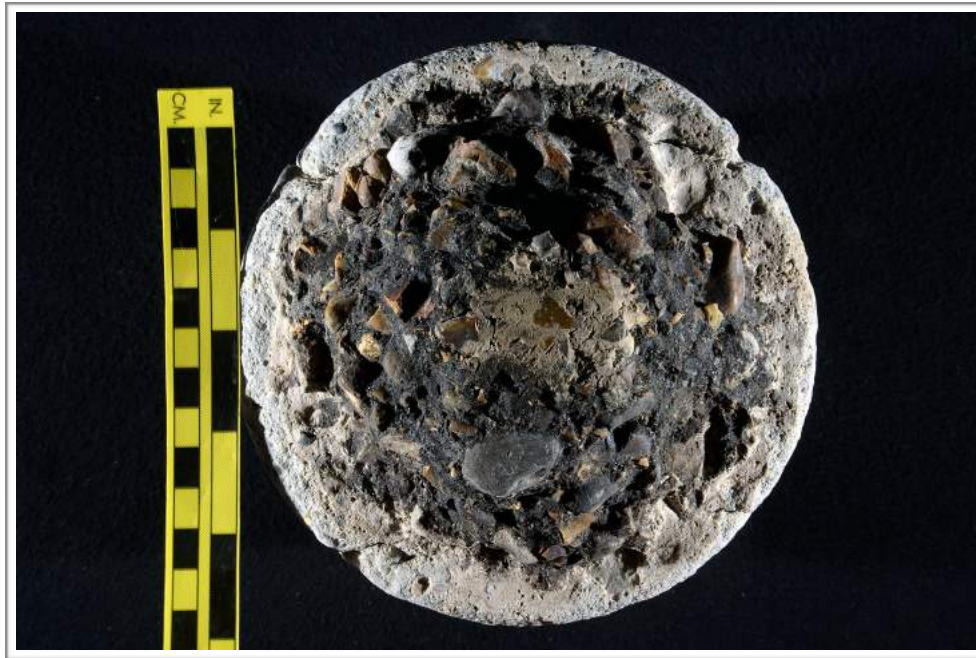
1. RECEIVED CONDITION	
ORIENTATION	Vertical core through pavement slab measures 150 mm (6 in.) in diameter and 220 mm (~ 8 5/8 in.) in length (Figure A1, A2).
SURFACES	The top surface is tined (Figure A3) and the lower surface is cast on asphalt such that the core represents the full thickness of the portland cement concrete pavement.
GENERAL CONDITION	The concrete is hard and compact and rings lightly when sounded with a hammer. A section of the core is missing from the top surface; the missing section reaches down to 55 mm (2 1/8 in.) below the top surface (Figure A4).

Figure A1. Photographs showing (a) oblique view of the top and side of the core with identification labels and (b) the top of the core. The red and blue dots in (b) show the orientation of the saw cuts used to prepare the sample. The yellow bar is ~ 150 mm (6 in.) long.

Figure A1 (cont'd). (c) Photograph showing the bottom surface of the core.

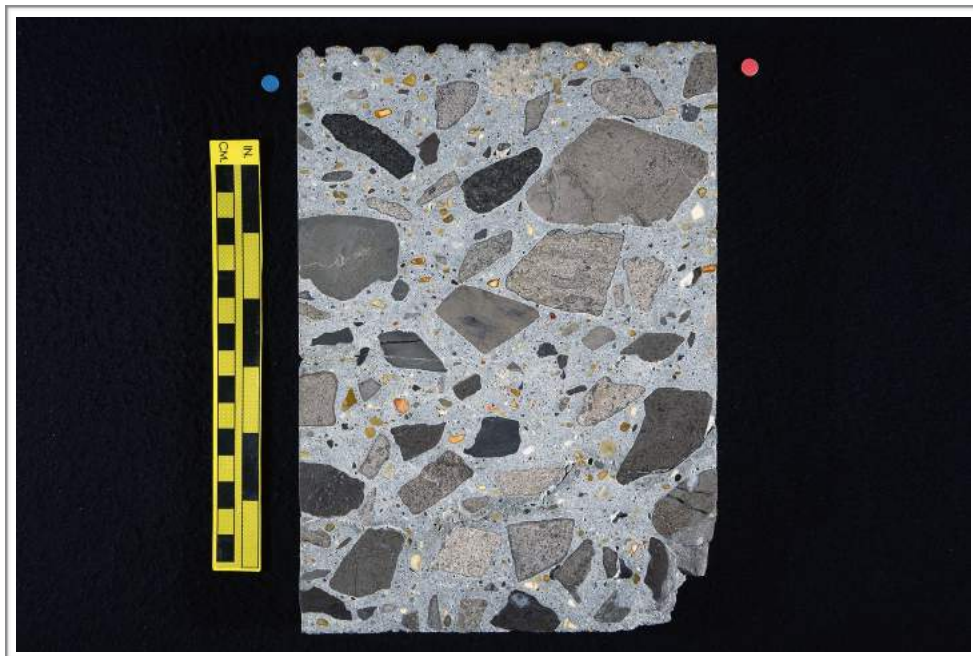
Figure A2. Photograph showing one of the polished surfaces of the core; both sides of the slab were polished. The yellow bar is ~ 150 mm (6 in.) long.

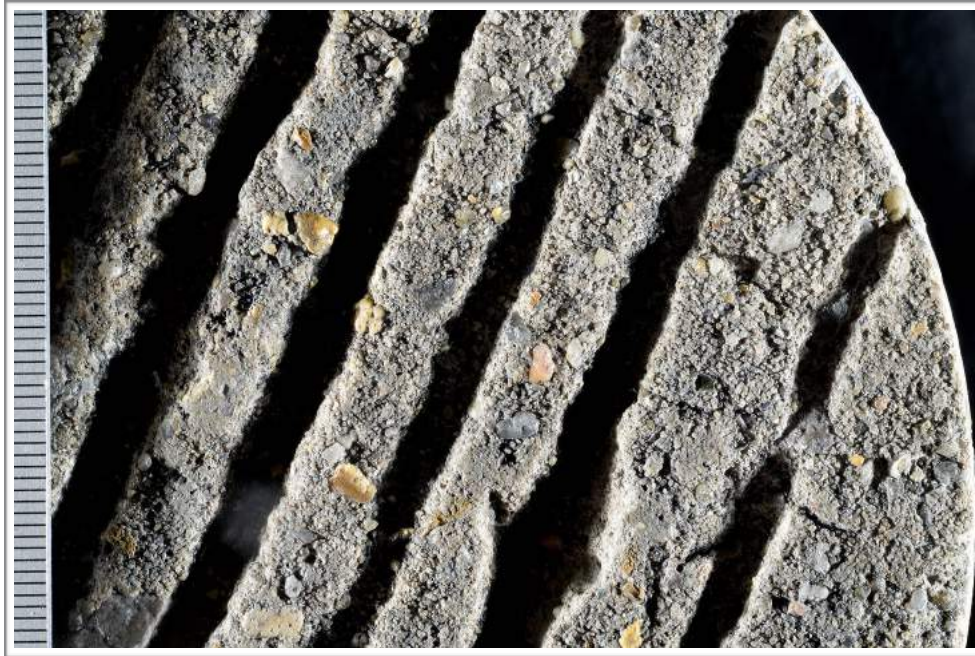
Figure A3. Photograph showing detail of tined top surface; scale in millimeters.

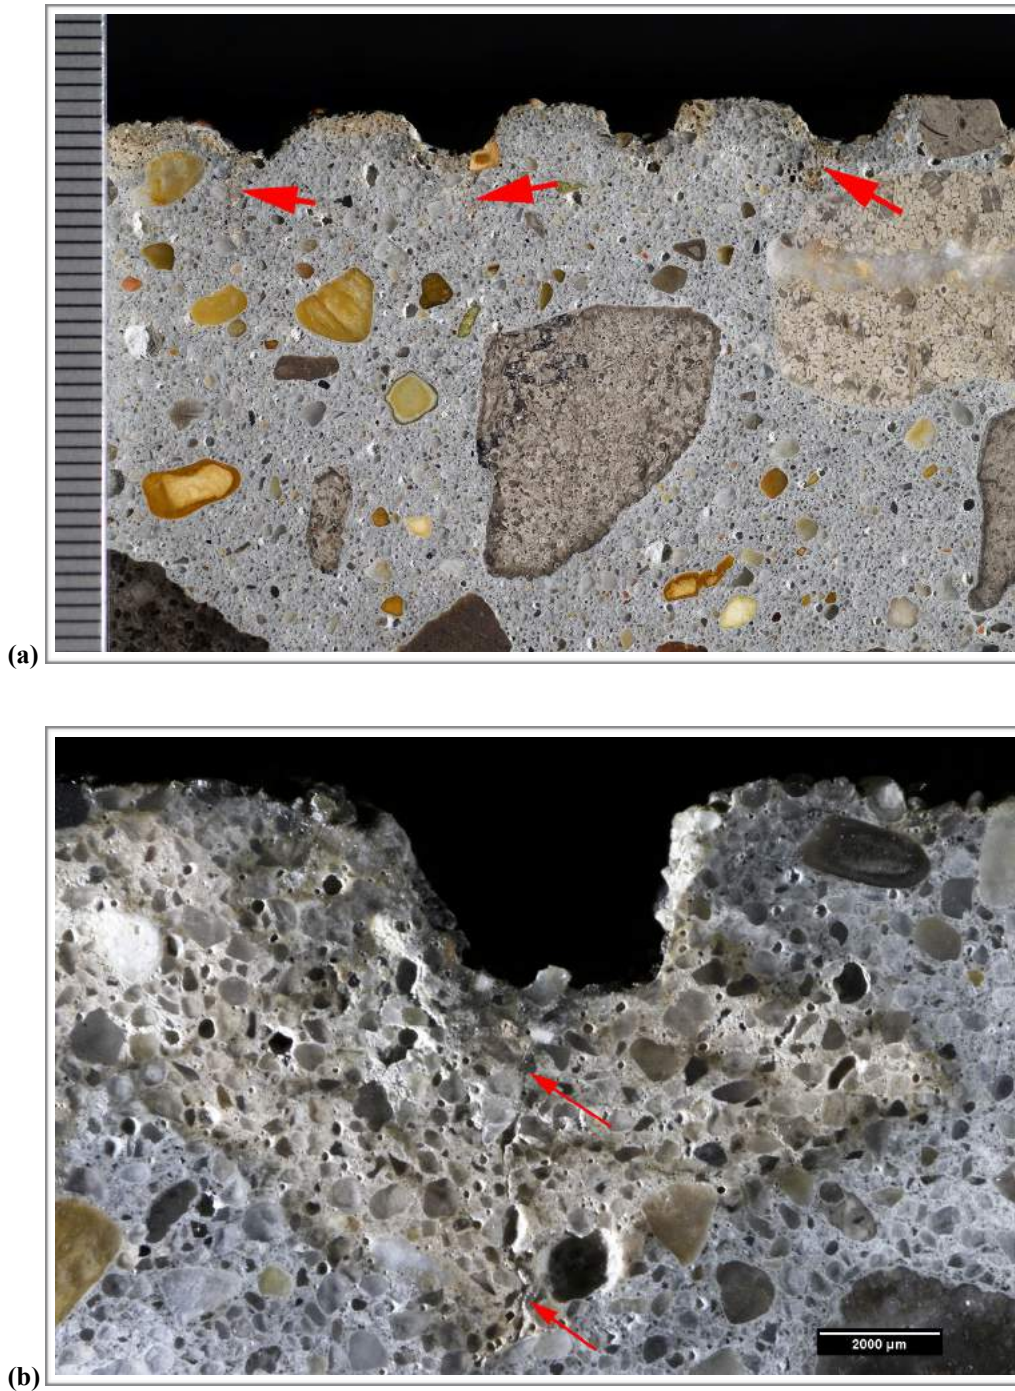
Figure A9. (a) Photograph showing overview of polished surface at the top of the core where red arrows highlight discolored paste in walls of sub-vertical microcracks. The scale is in millimeters. (b) Reflected light photomicrograph of the polished surface showing detail of sub-vertical microcrack (red arrows) at the top of the core.

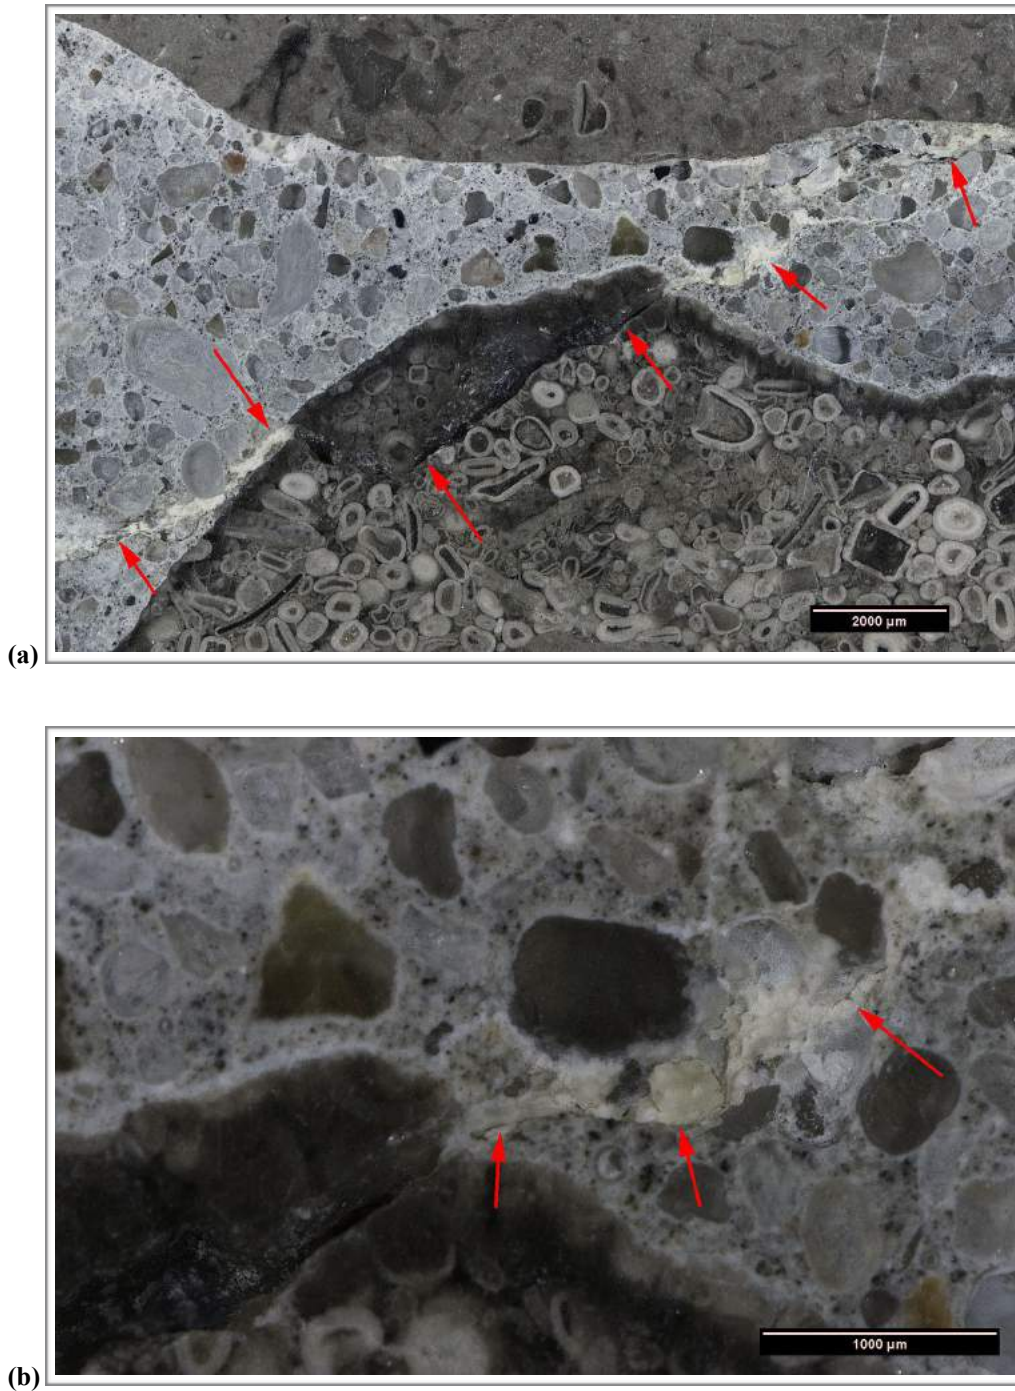
Figure A10. Reflected light photomicrographs of polished surface showing (a) overview and (b) detail of microcracks (red arrows) that cut from oolitic limestone particle into the paste about 65 mm (2 ½ in.) below the top surface. In (b) the red red arrows highlight deposits of gel.

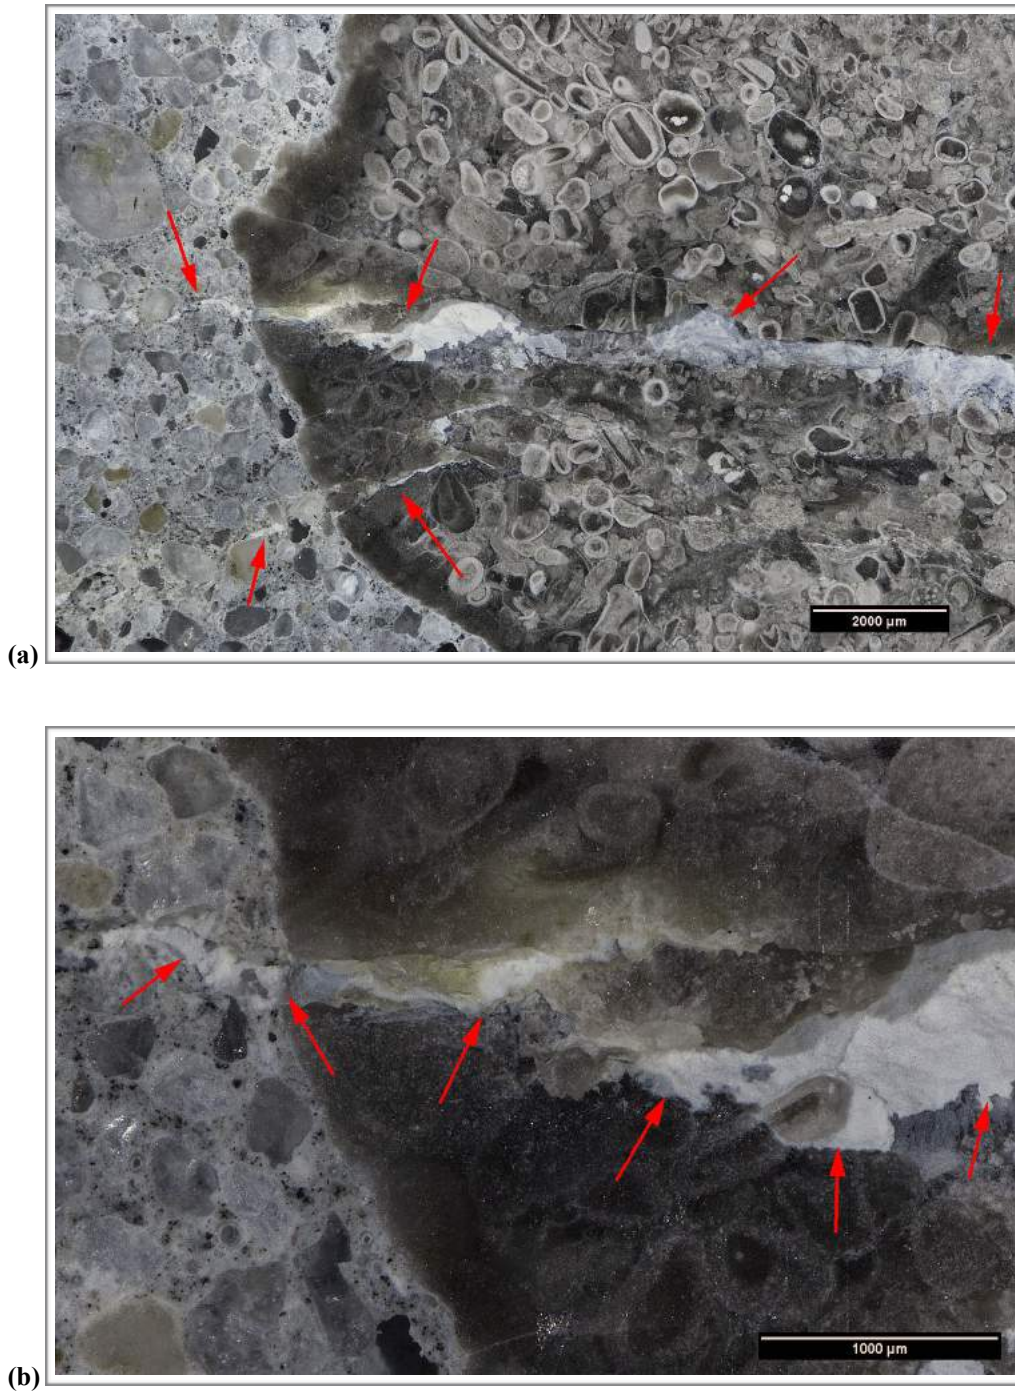
Figure A11. Reflected light photomicrographs of polished surface showing (a) overview and (b) detail of microcracks (red arrows) that cut from oolitic limestone particle into the paste about 150 mm (6 in.) below the top surface. In (b) the red red arrows highlight deposits of gel within the particle and in the microcrack in the paste.

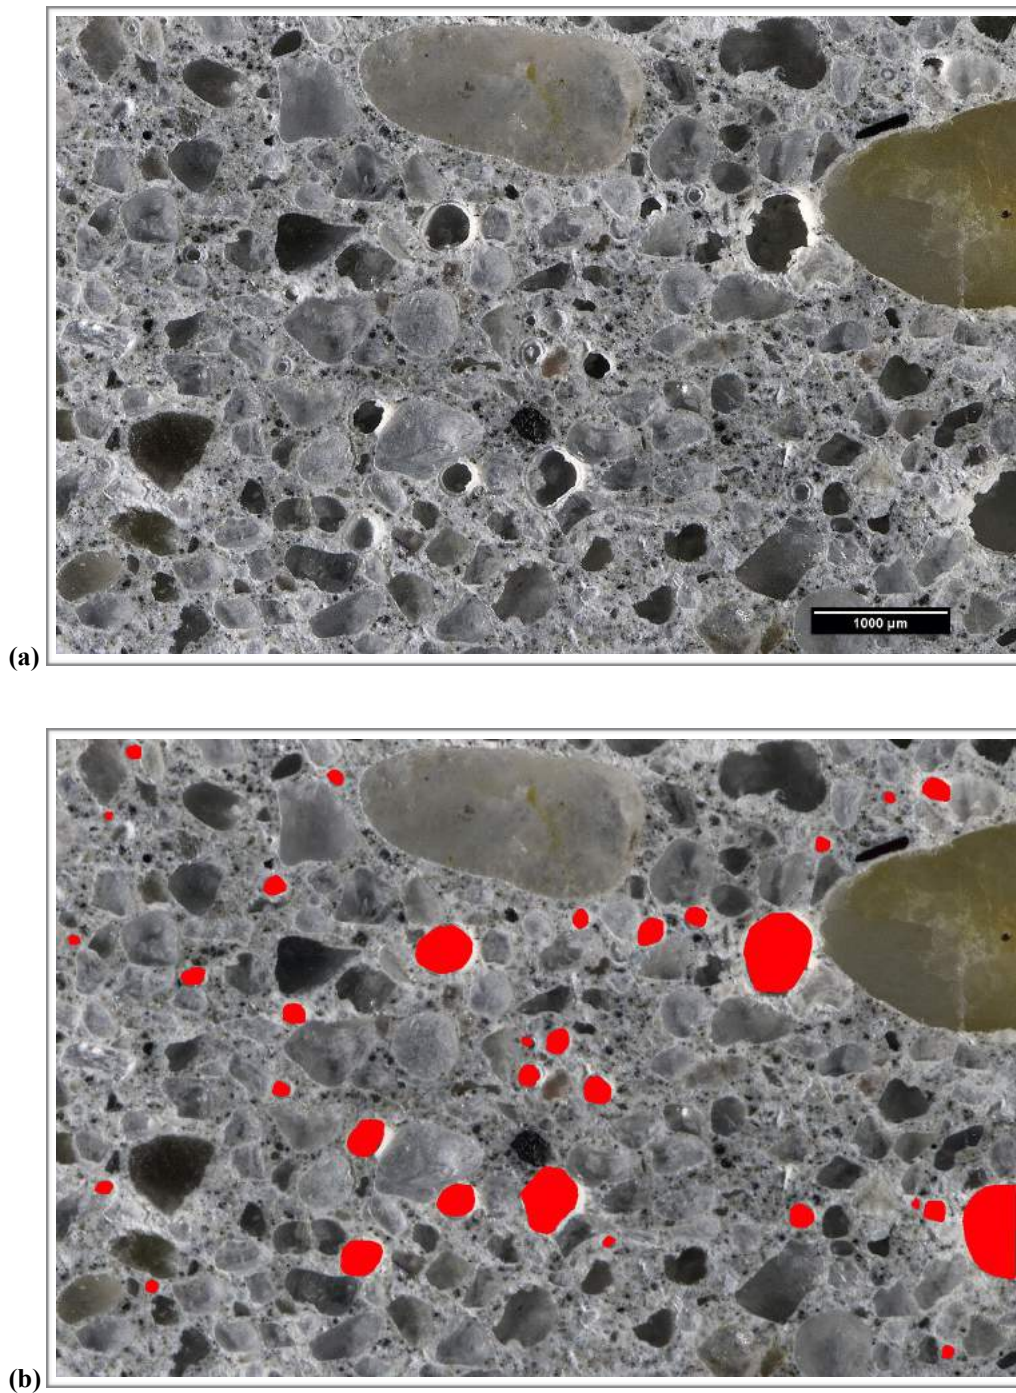
Figure A12. (a) Oblique reflected light photomicrographs of polished surface showing voids (dark circles). (b) Image of same area as (a) where red circles indicate voids. This image was analyzed and found to contain ~ 4% air.

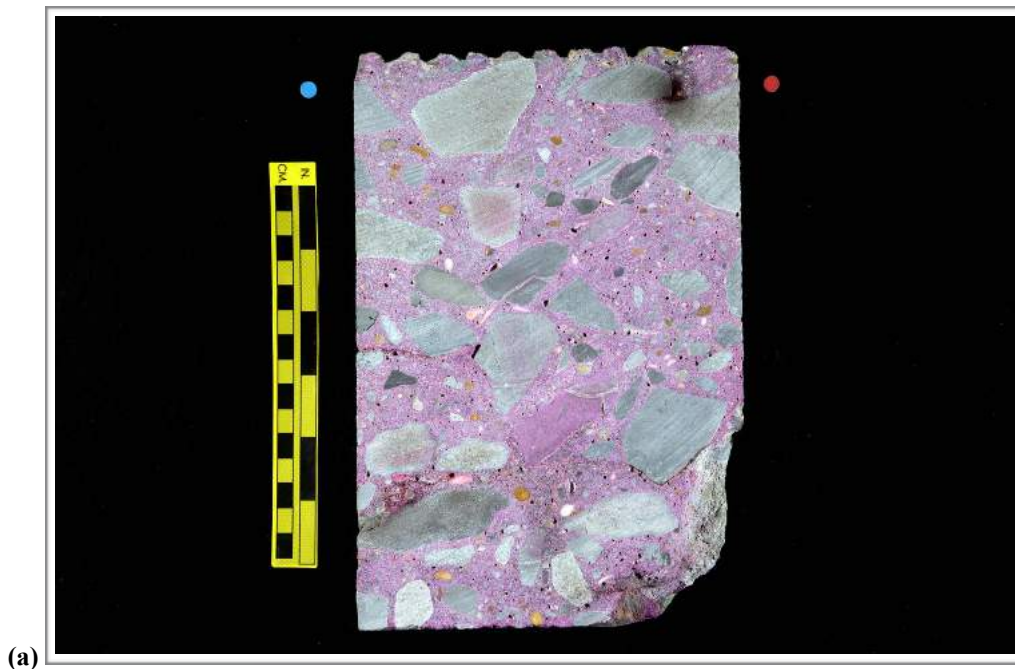
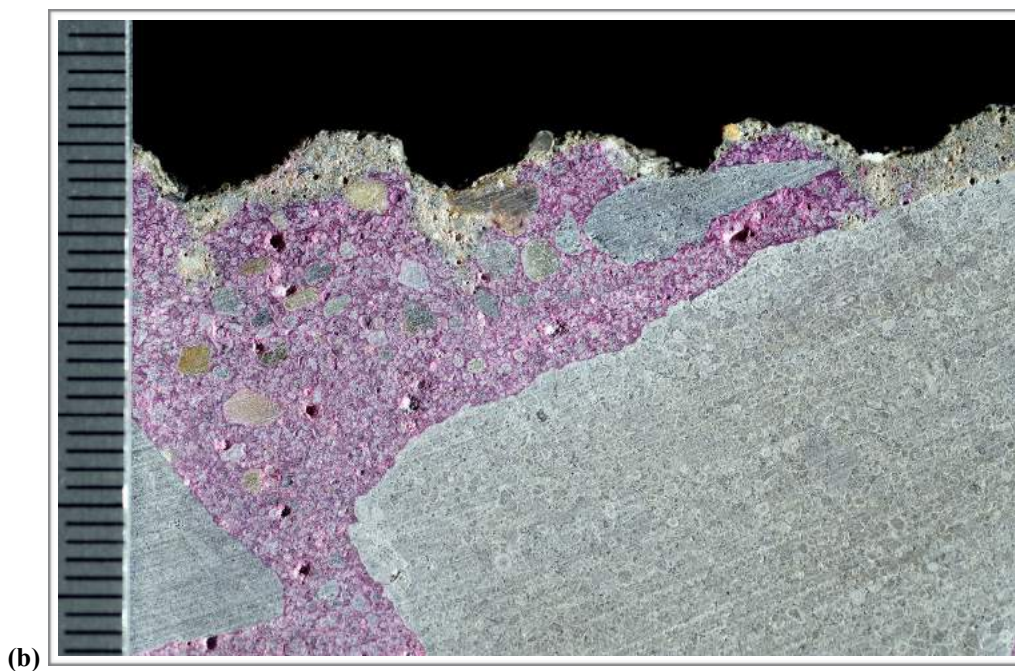
8. SECONDARY DEPOSITS	
PHENOLPHTHALEIN	Entire surface stains purple except along irregular zones (microcracks) at the top of the core where not staining was observed to 6 mm (¼ in.) depth (Figure A19).
DEPOSITS	No significant carbonation observed. Deposits of ettringite observed commonly in voids throughout core and in microcracks that cut through the paste and in the ITZ along aggregate particles (Figure A20). Deposits of ASR gel observed in occasional microcracks, commonly in association with coarse aggregate particles. Occasional cracks and numerous microcracks filled with gel observed cutting from chert particles into the paste (Figure A8, A10, A11, A21). SEM/EDS analysis indicates the gels are richer in calcium than alkali, suggesting they are mature (Figure A22, A23).

Figure A19. Photographs showing (a) overview of phenolphthalein stained surface and (b) detail of surface near the top of the core. Scale in millimeters in (b).

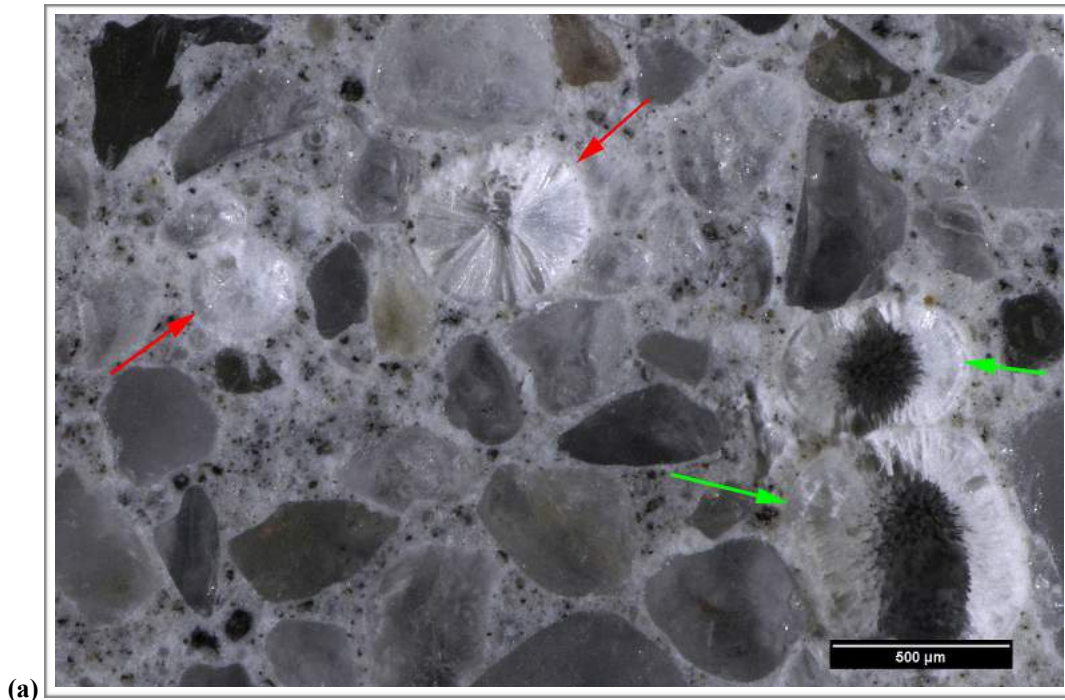
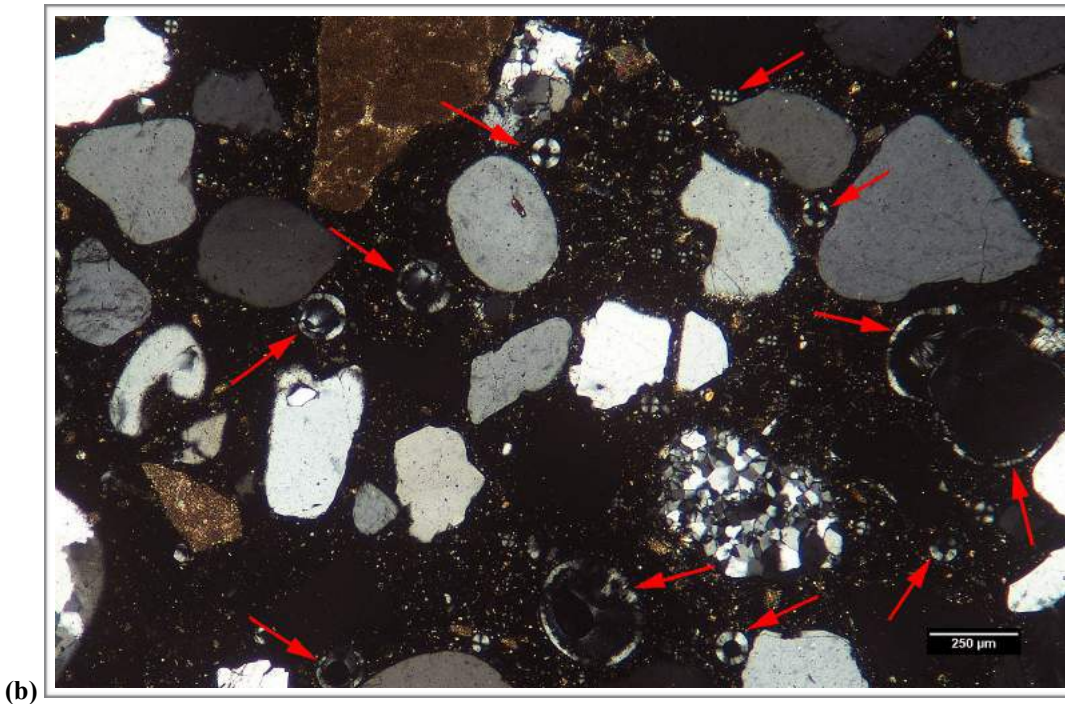
Figure A20. (a) Reflected light photomicrograph of the polished surface showing deposits of ettringite filling voids (red arrows) and lining voids (green arrows). (b) Cross-polarized transmitted light photomicrograph of thin section showing voids lined and filled with ettringite (red arrows).
