Louisiana Transportation Research Center

Technical Assistance Report 16-03TA-C

Evaluation of Cores from Jefferson Highway Near Airline Highway

Petrographic Investigation of Concrete Cores Extracted from Cracked
Pavement Slabs on Jefferson Highway in Baton Rouge, Louisiana
(RE: LTRC Project 16-1TA-C)

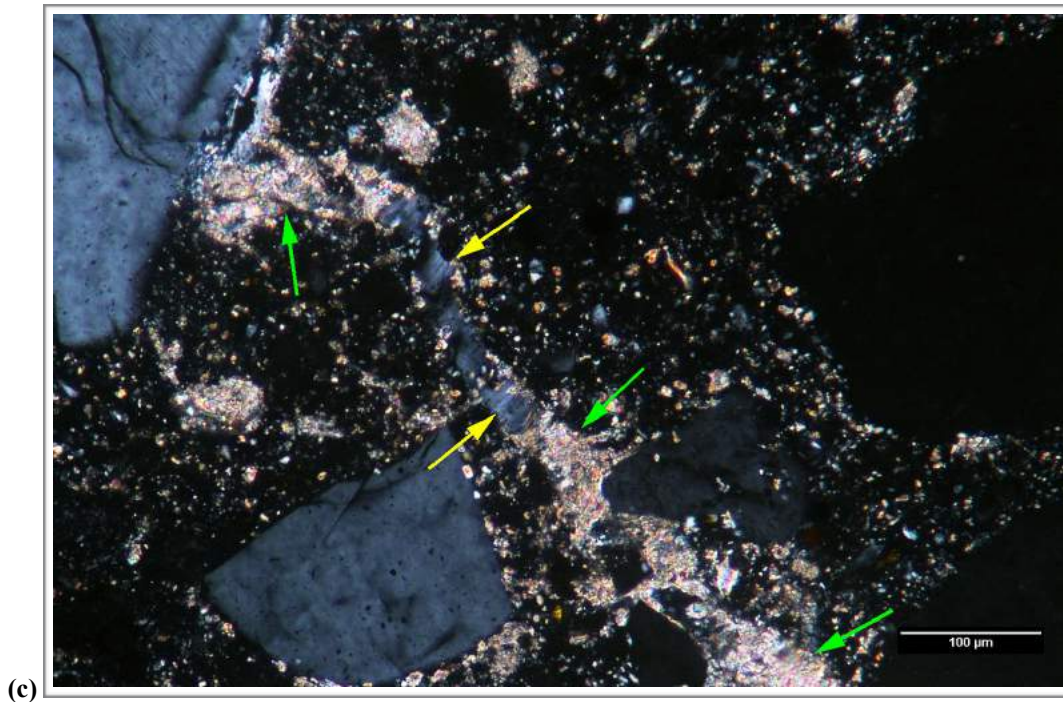
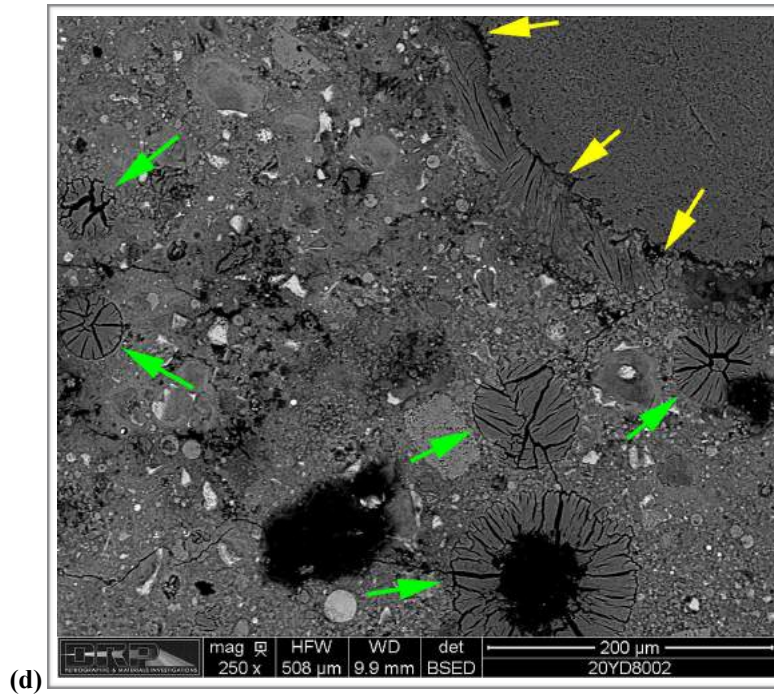
Figure A20 (cont'd). (c) Cross-polarized transmitted light photomicrograph of thin section showing microcrack with deposits of ettringite (yellow arrows) being replaced by calcium carbonate (green arrows). (d) BSE micrograph of polished surface showing ettringite in voids (green arrows) and along the ITZ of an aggregate particle (yellow arrows).

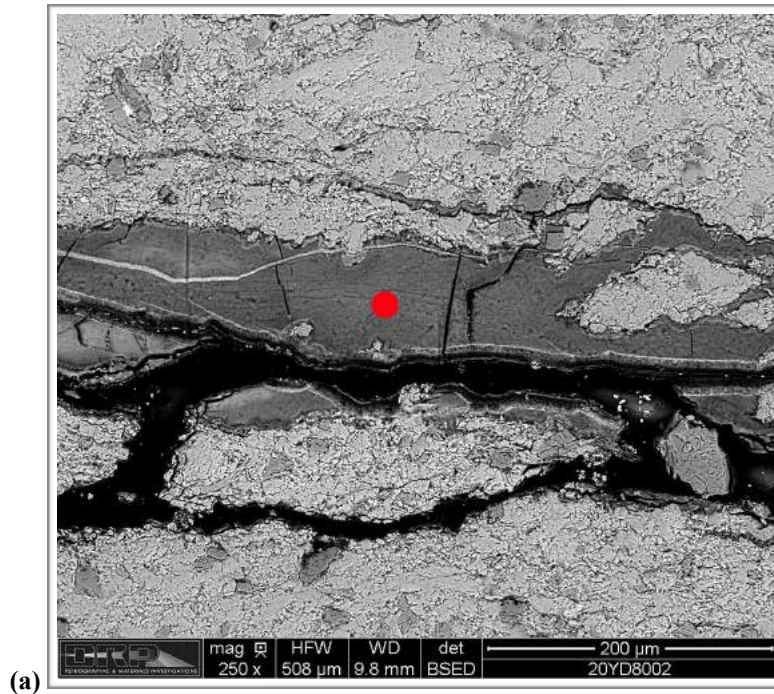
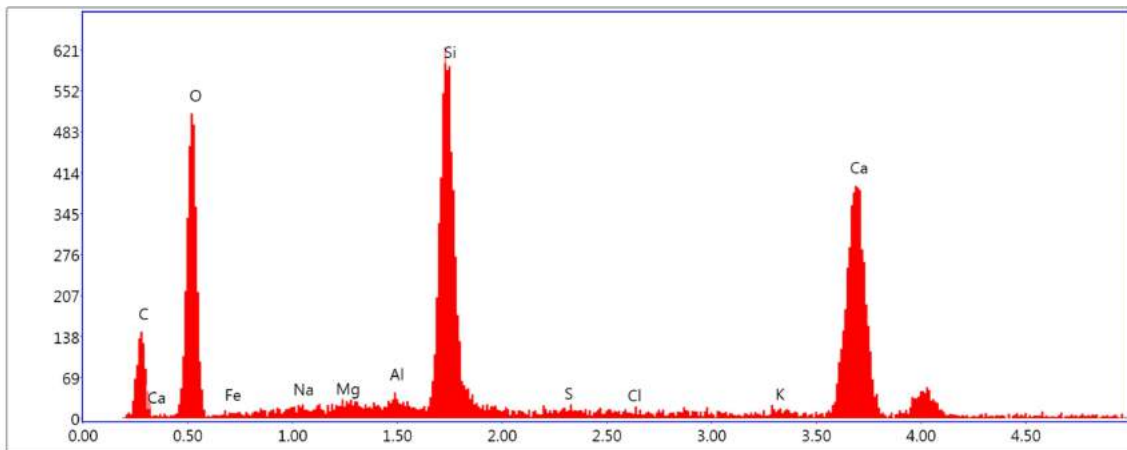
Figure A21. (a) BSE micrograph of gel in microcrack shown in Figure A8. The red dot in (a) shows area subject to EDS analysis that produced the spectra shown in (b). Similar spectra were obtained for the gel when it was scraped from the surface and analyzed separately. Note the high calcium content of the gel.

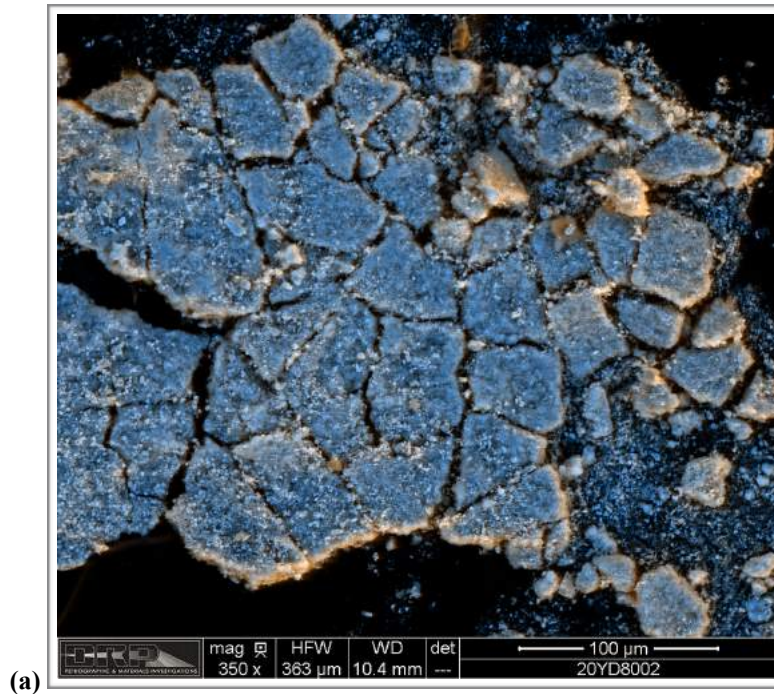
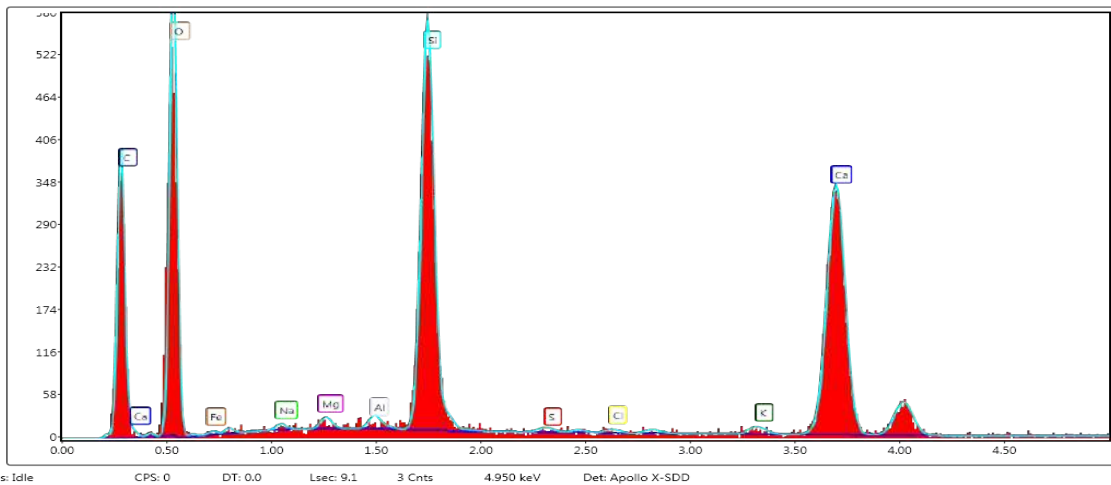
Figure A22. (a) Combined BSE and secondary electron micrograph of gel that was scraped from microcrack shown in Figure A10 and placed on a carbon tape for EDS analysis. (b). EDS spectra obtained for the gel. Note the high calcium content of the gel.

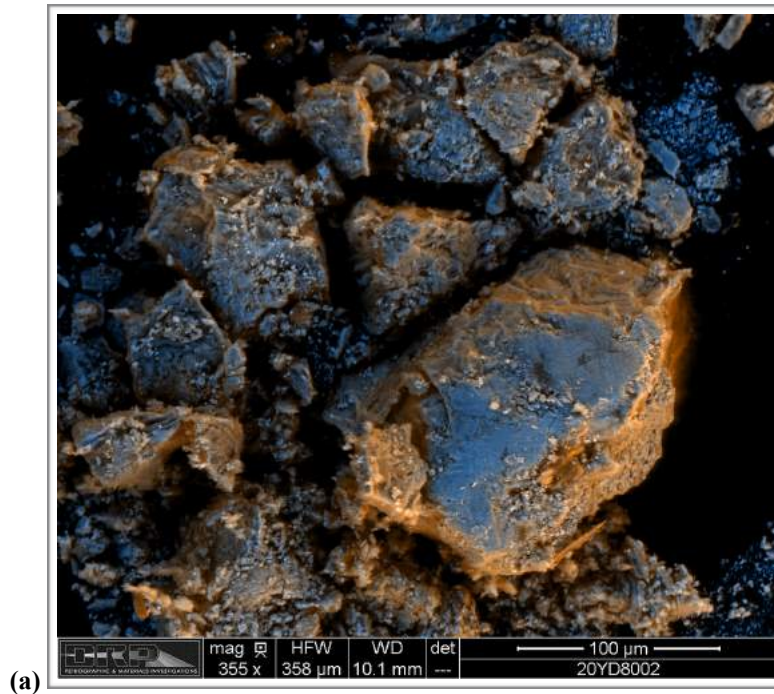
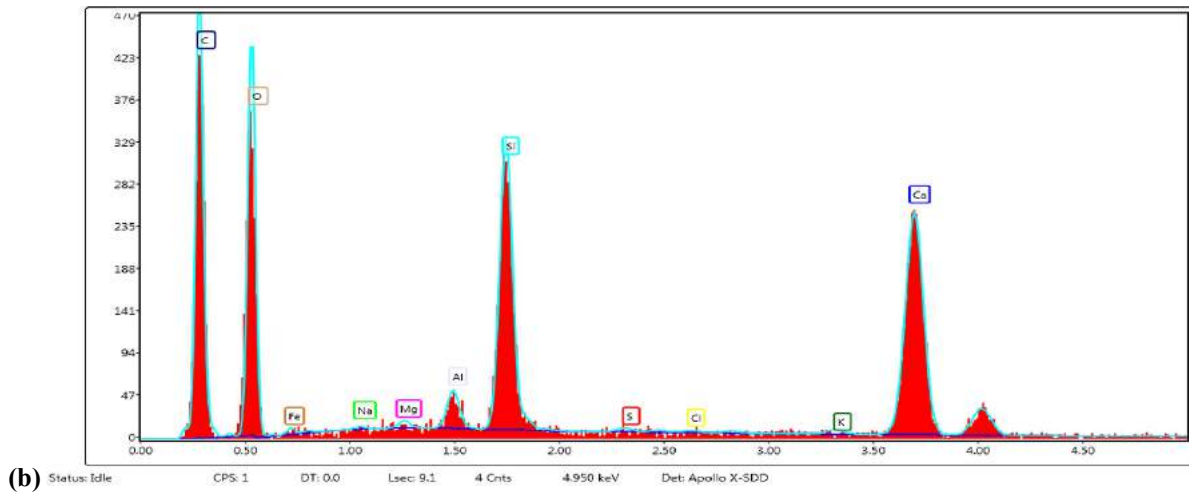
Figure A23. (a) Combined BSE and secondary electron micrograph of gel that was scraped from microcrack shown in Figure A11 and placed on a carbon tape for EDS analysis. (b). EDS spectra obtained for the gel. Note the high calcium content of the gel.

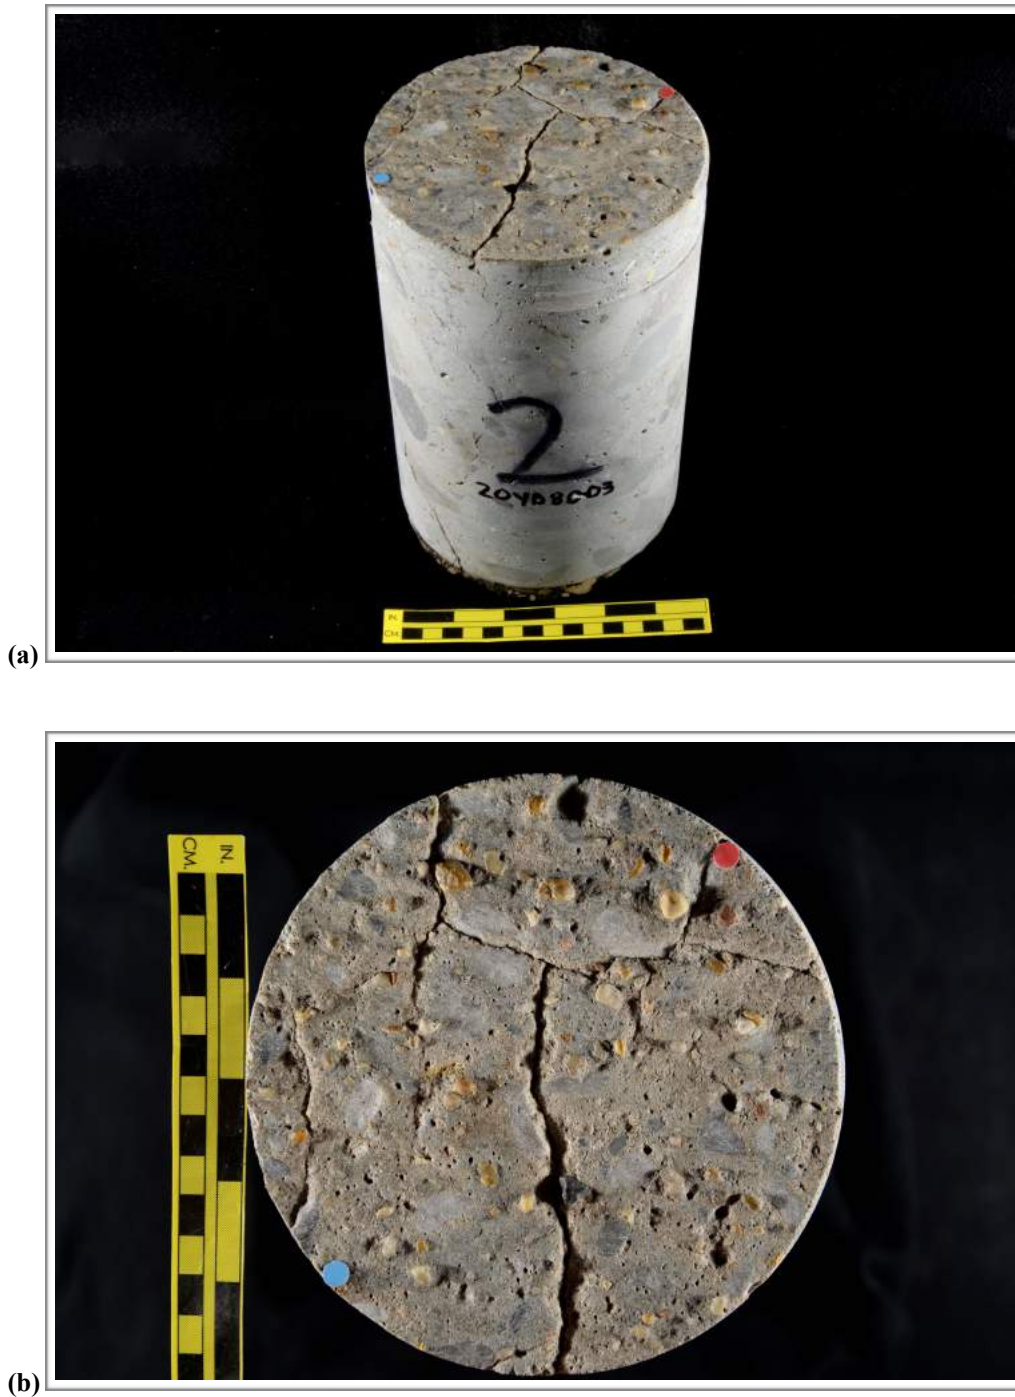
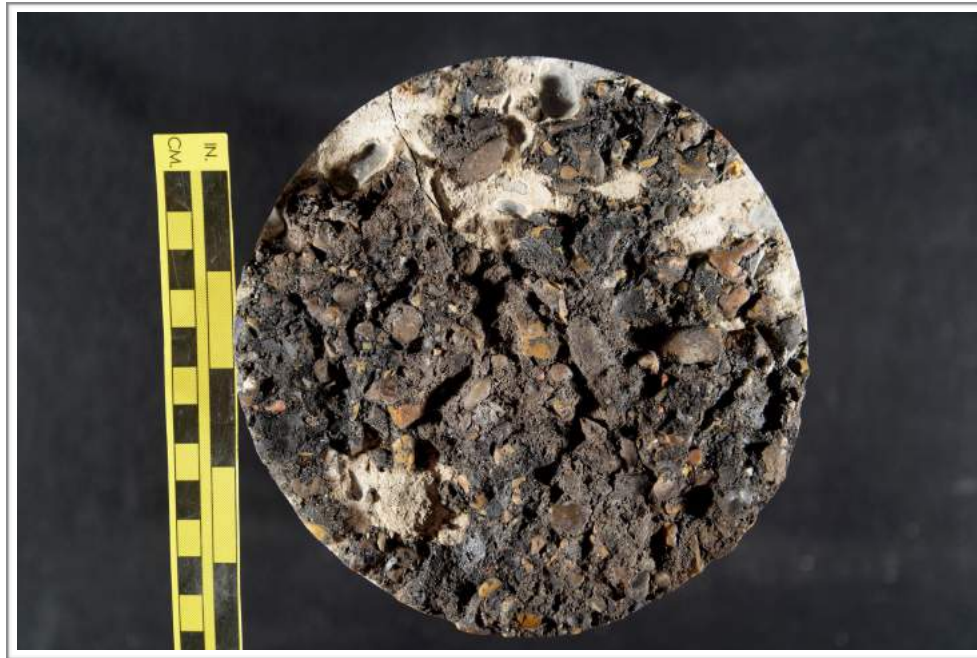
1. RECEIVED CONDITION	
ORIENTATION & DIMENSIONS	Vertical core through pavement slab measures 150 mm (6 in.) in diameter and 220 mm (~ 8 5/8 in.) in length (Figure B1, B2).
SURFACES	The top surface is quite worn with no remnant of an original texture and exposed, polished coarse aggregate particles (Figure B3) and the lower surface is cast on asphalt such that the core represents the full thickness of the portland cement concrete pavement.
GENERAL CONDITION	The concrete is hard and compact and rings lightly when sounded with a hammer.

Figure B1. Photographs showing (a) oblique view of the top and side of the core with identification labels and (b) the top of the core. The red and blue dots show the orientation of the saw cuts used to prepare the sample. The yellow bar is ~ 150 mm (6 in.) long.

Figure B1 (cont'd). (c) Photograph showing the bottom surface of the core.

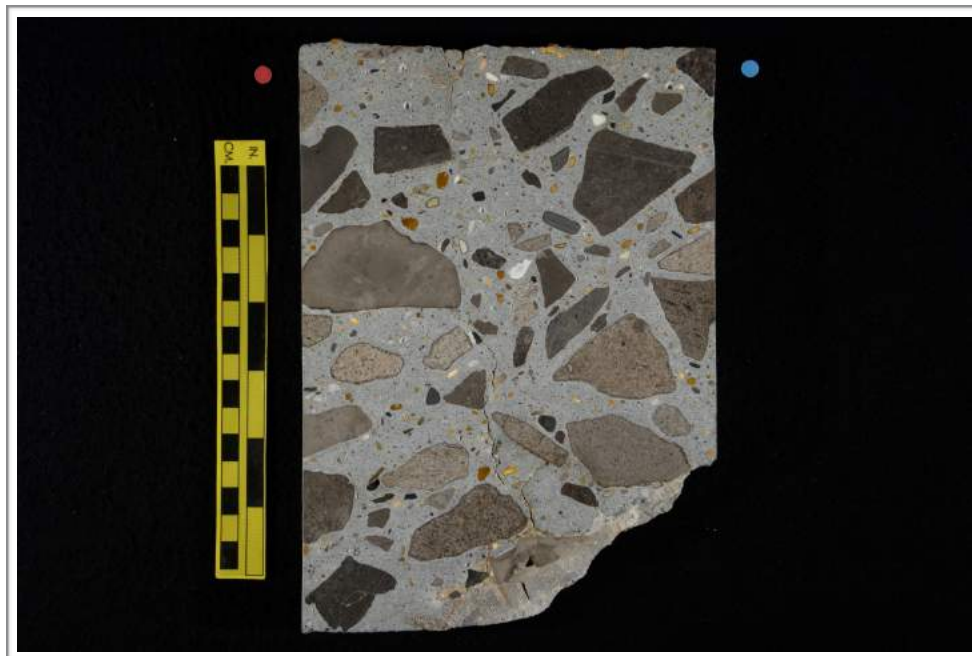
Figure B2. Photograph showing one of the polished surfaces of the core; both sides of the slab were polished. The yellow bar is ~ 150 mm (6 in.) long.

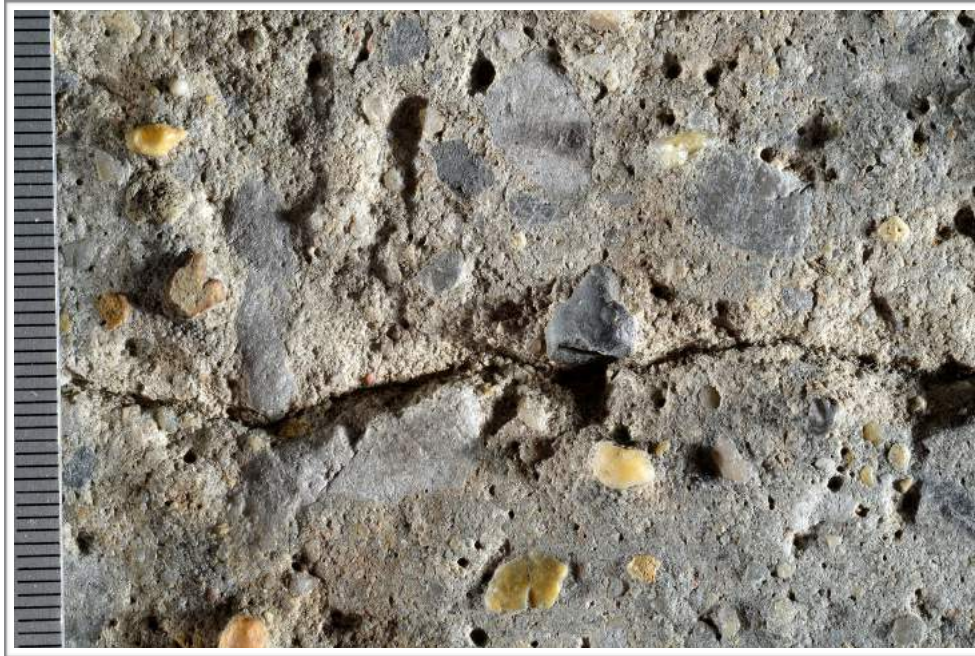
Figure B3. Photograph showing detail of top surface; scale in millimeters.

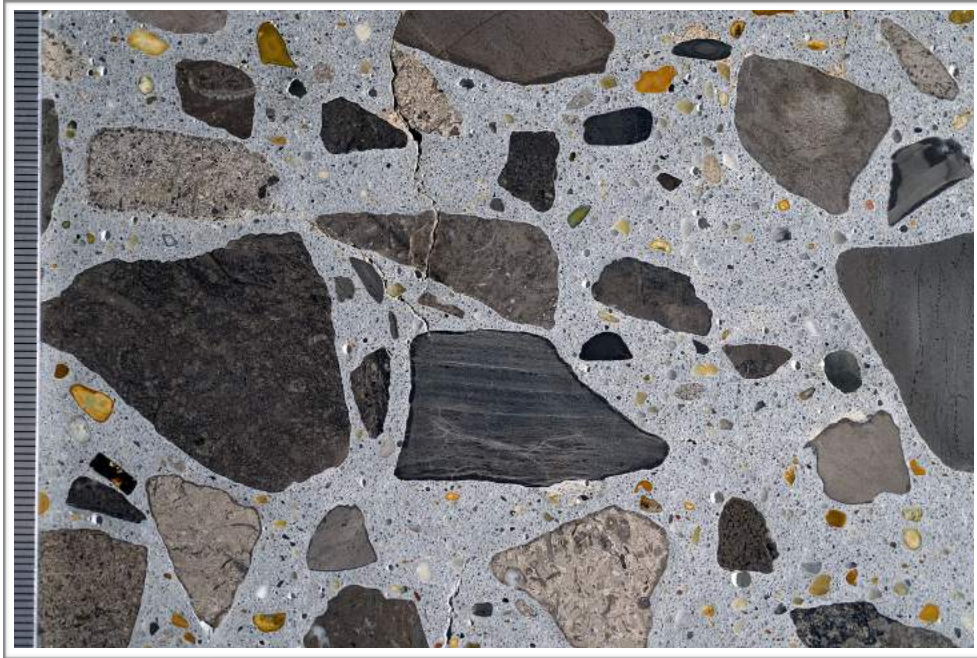
5. COARSE AGGREGATE	
PHYSICAL PROPERTIES	The coarse aggregate is a limestone gravel with a nominal top size of 38 mm (1 ½ in.; Figure B11). The rocks are hard and competent. The particles are sub-equant to oblong in shape with sub-rounded to sub-angular edges. The aggregate shows gap grading with few particles below 19 mm (¾ in.) across observed but the gradation is more even than Core C-1
ROCK TYPES	The aggregate is carbonate in composition and consists of various types of limestone that range from dark brown micritic rocks to pale tan oolitic limestones to brown fossiliferous packstones and brown dolomitic limestones. Many particles show well-defined reaction rims and some appear to contain fine-grained siliceous material. Examination of some particles in thin section shows that deposits of chalcedonic chert are present in some of the limestone particles (Figure B12 ; chalcedonic chert is highly susceptible to alkali-silica reaction (ASR).

Figure B11. Photograph of the polished surface showing overview of coarse aggregate; scale in millimeters.

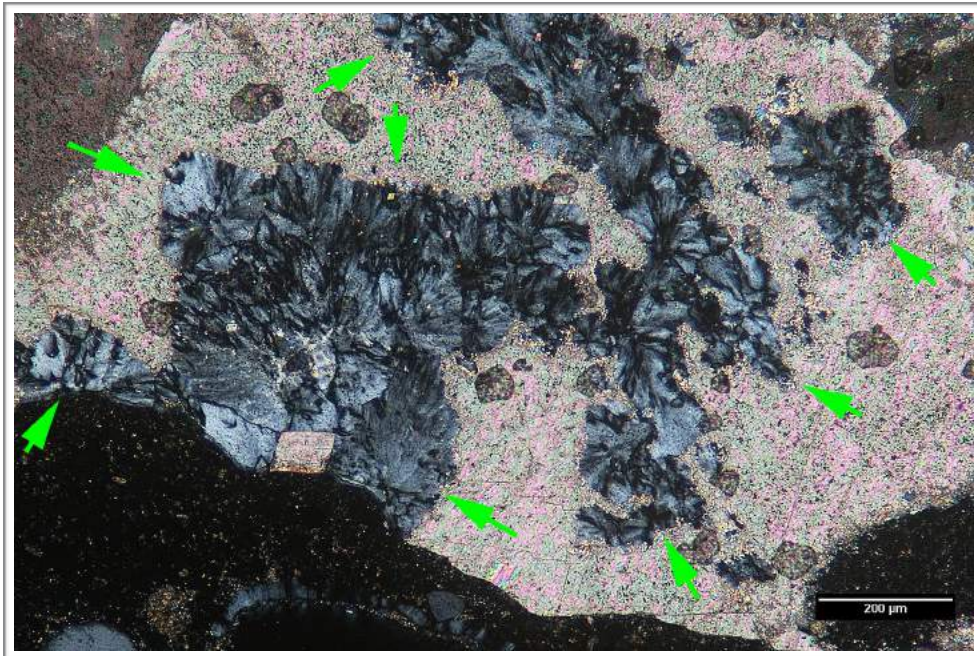
Figure B12. Cross-polarized transmitted light photomicrograph of thin section showing detail of limestone particle. The green arrows highlight area where chalcedonic chert is present.

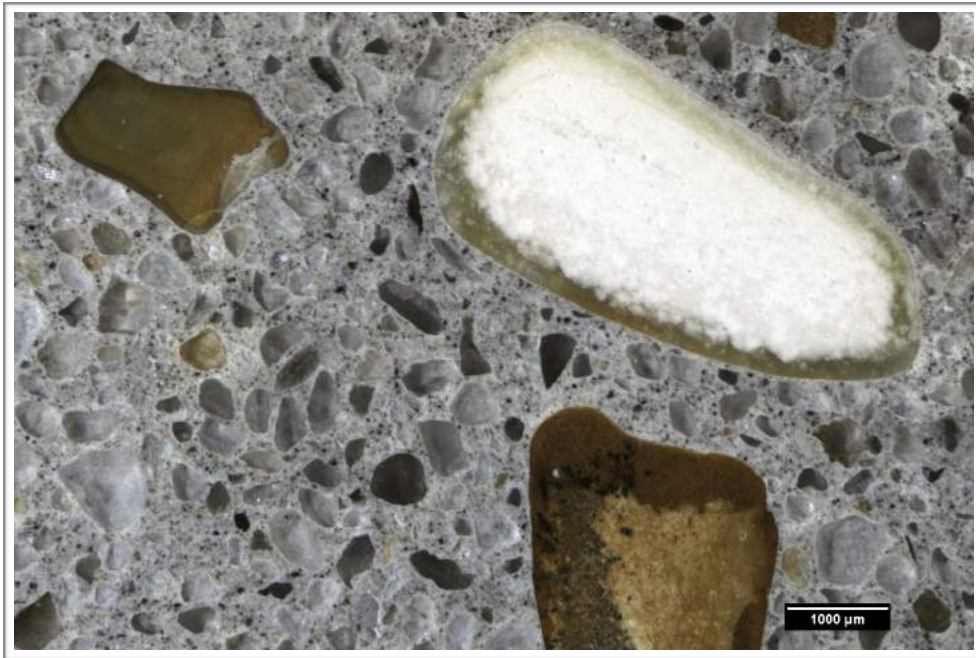
6. FINE AGGREGATE	
PHYSICAL PROPERTIES	The fine aggregate is a natural sand that consists of rocks that are hard and competent (Figure B13). The sand consists primarily of siliceous rocks but minor amounts of limestone (carbonate) similar to those in the coarse aggregate were observed. The particles are sub-equant to oblong in shape with rounded to sub-angular edges. The grading and distribution are even.
ROCK TYPES	The consists primarily of quartz and quartzite; chert is a minor component and limestone is also present. Seams of chalcedonic chert were observed in limestones.
OTHER FEATURES	No deleterious coatings or incrustations observed and no low w/c mortar coatings observed. The chert commonly shows well-developed reaction rims; the quartz and quartzite particles are intact. Occasional particles of limestone show peripheral microcracking (Figure B14).

Figure B13. Reflected light photomicrographs of the polished surface showing overview of the sand. The larger particles consist of chert.

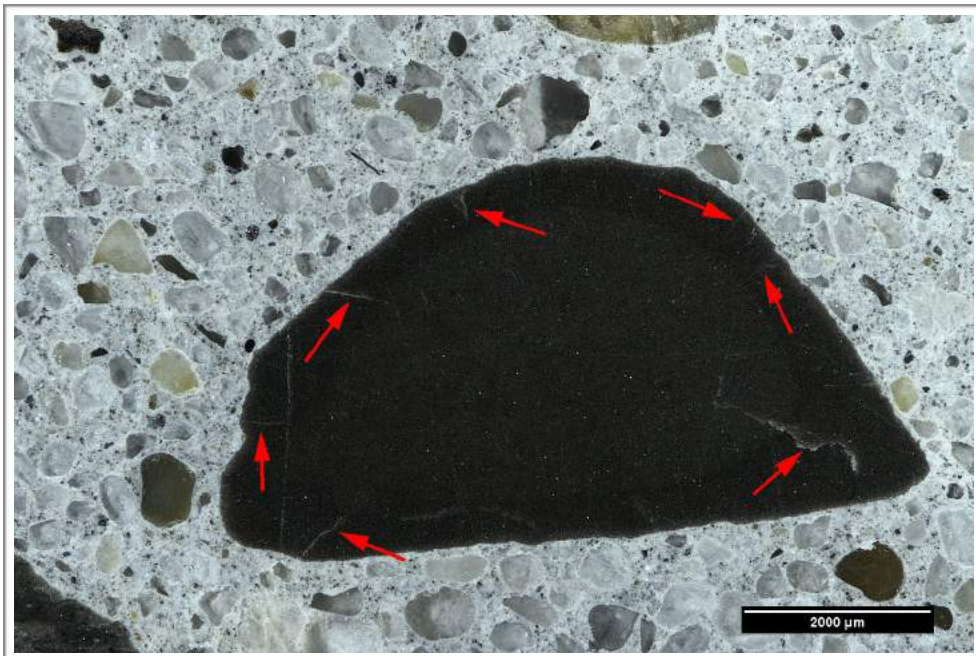
Figure B14. Reflected light photomicrographs of the polished surface showing limestone particle with internal microcracks (red arrows).

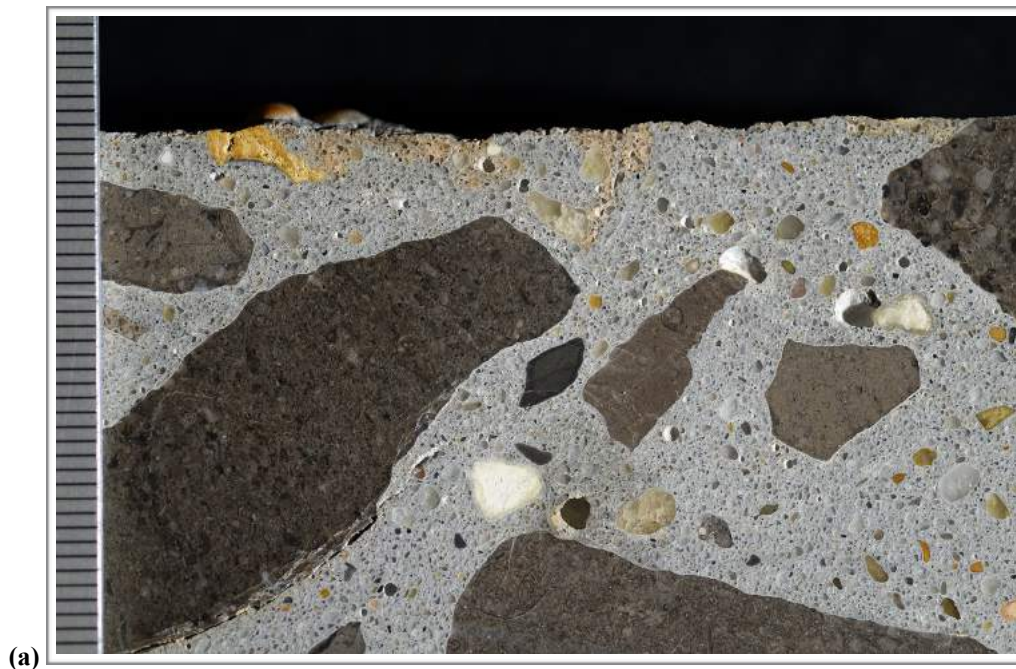
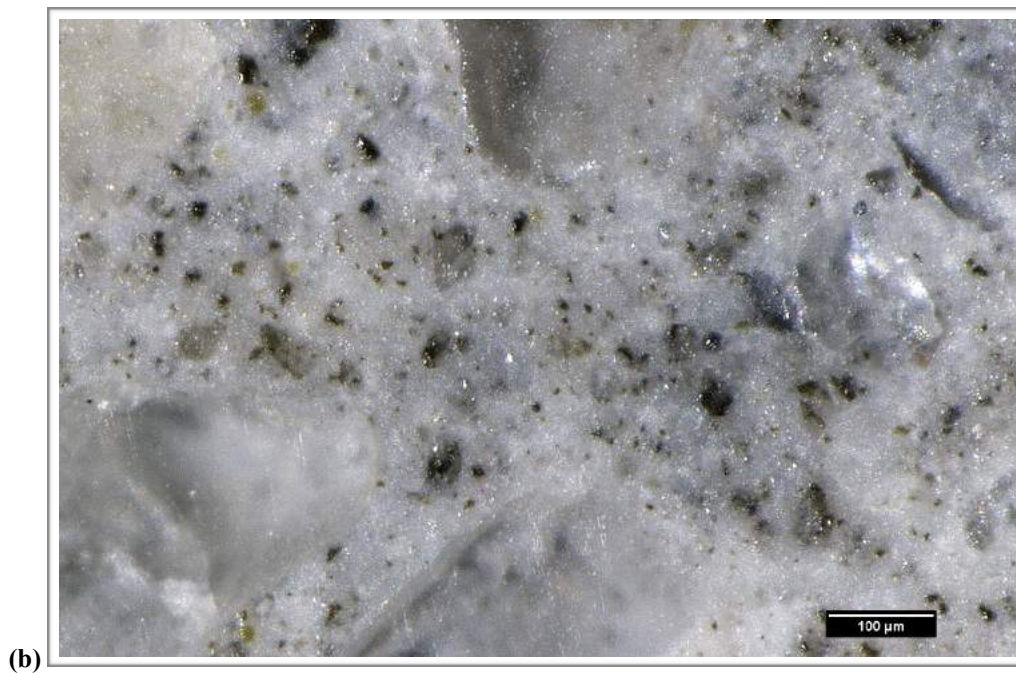
7. PASTE OBSERVATIONS	
POLISHED SURFACE	Paste is light gray (Munsell 10YR/7/1), has a smooth texture and weakly sub-vitreous luster (Figure B15). The paste is moderately hard (Mohs 3-3.5). The paste is gray (10YR/6/1) for 1-2 mm (40-80 mil) from the top surface and irregularly distributed zones of yellow (2.5Y/7/4) to light red (2.5YR/7/4) paste are present for up to 3 mm (¼ in.) from the top surface.
FRESH FRACTURE	Fracture surface is gray, has a hackly texture and a sub-vitreous luster (Figure B16). The fracture cuts through coarse aggregate particles. Significant deposits of ASR gel were observed on the surface.
THIN SECTION/ SEM*	The paste contains hydrated portland cement and fly ash; no slag cement or other SCM were observed. The hydration is normal with 5-10% RRCG that consist mostly of belite and interstitial ferrite and aluminate (Figure B17, Figure B18). Minor amounts of very fine crystals of calcite are present in the paste. CH makes up 8-15% of the paste, is fine grained and evenly distributed.

Figure B15. (a) Photograph of polished surface showing overview of paste in the middle of the core. The scale is in millimeters. (b) Reflected light photomicrograph of polished surface showing detail of paste texture and luster.

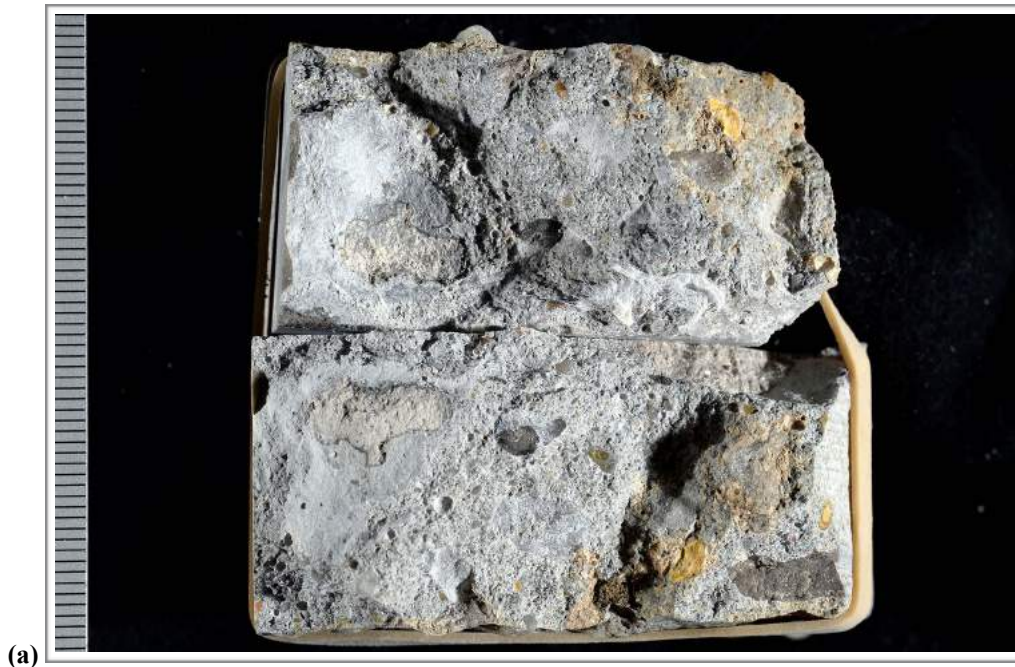
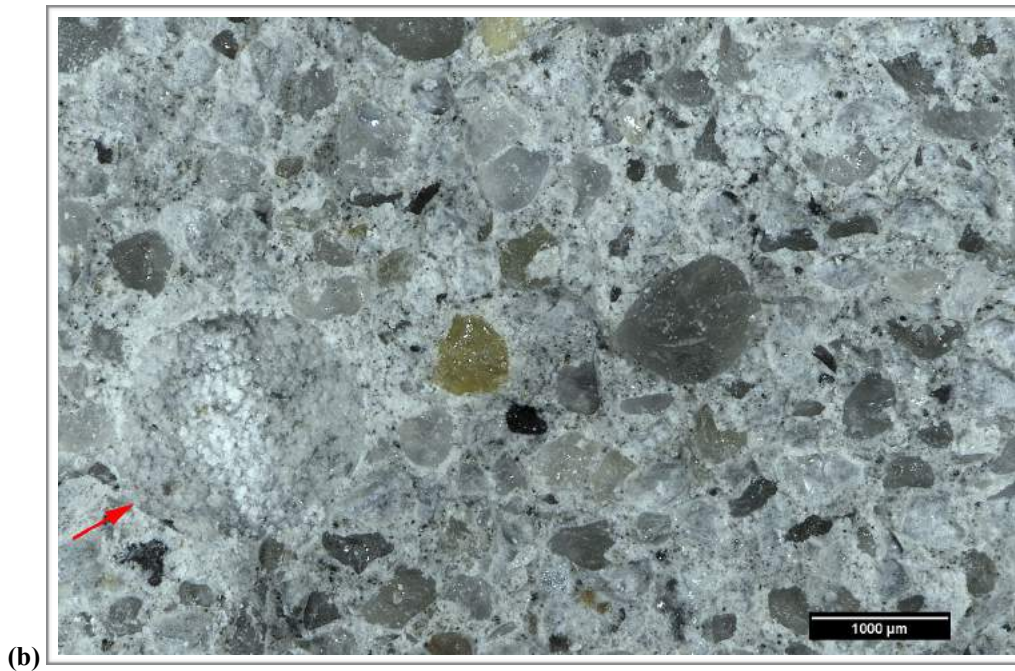
Figure B16. (a) Photograph and (b) reflected light photomicrograph of fresh fracture surface. The scale is in millimeters in (a). In (b) the red arrow shows a void with ettringite.

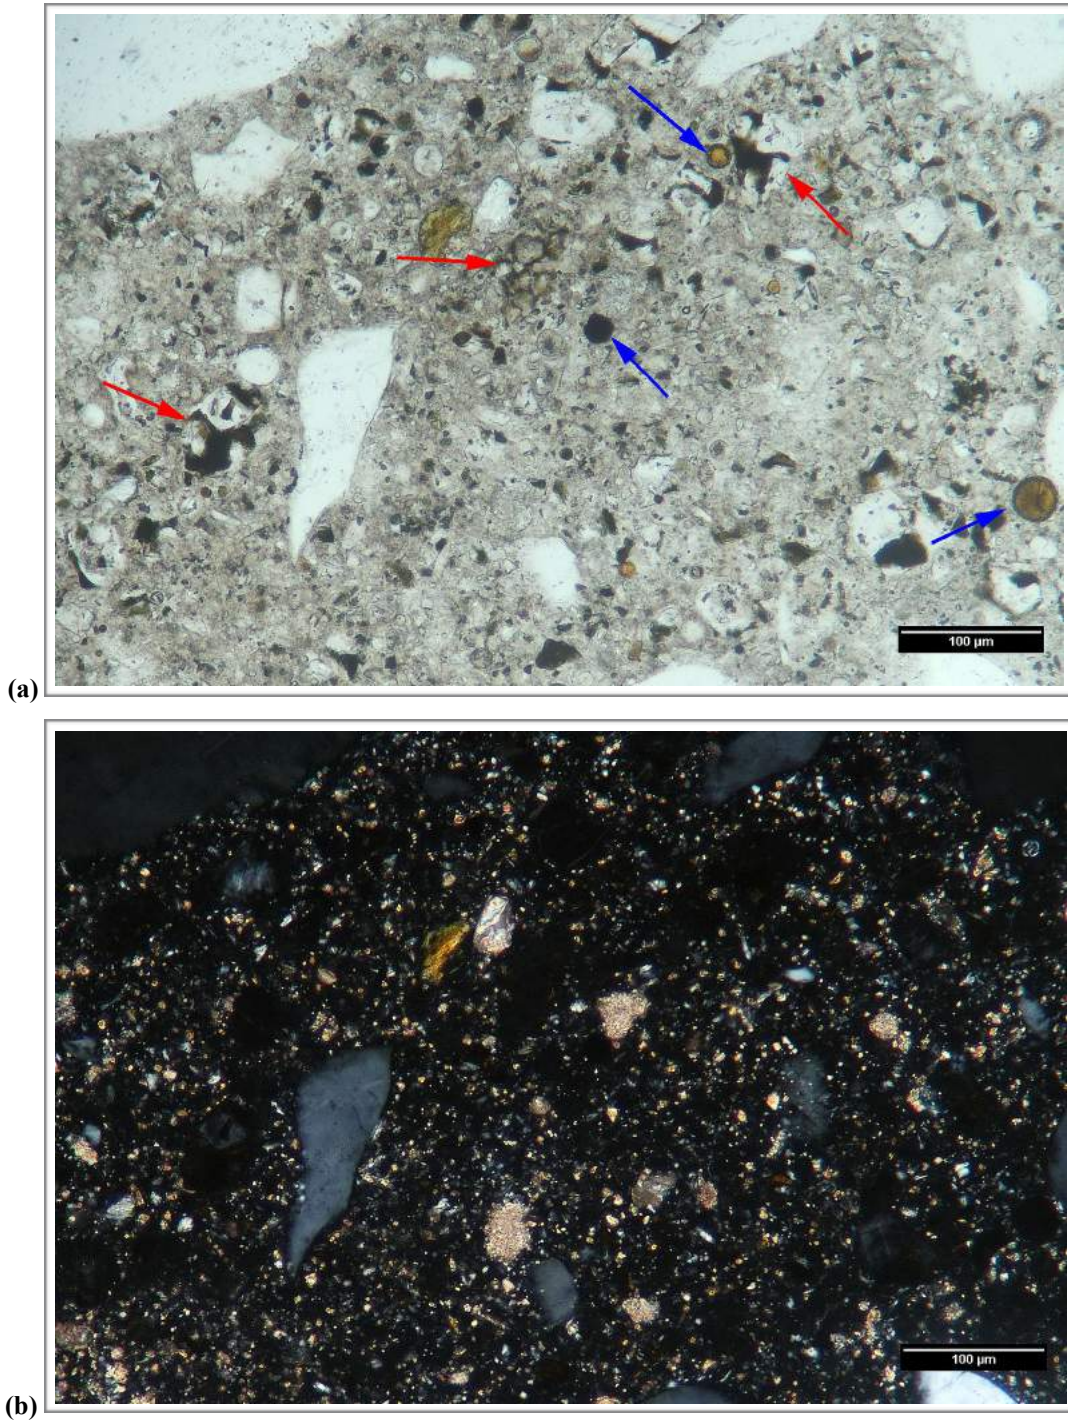
Figure B17. Transmitted light photomicrographs of thin section showing detail of paste in (a) plane-polarized and (b) cross-polarized light. The red and blue arrows in (a) indicate RRCG and fly ash, respectively.

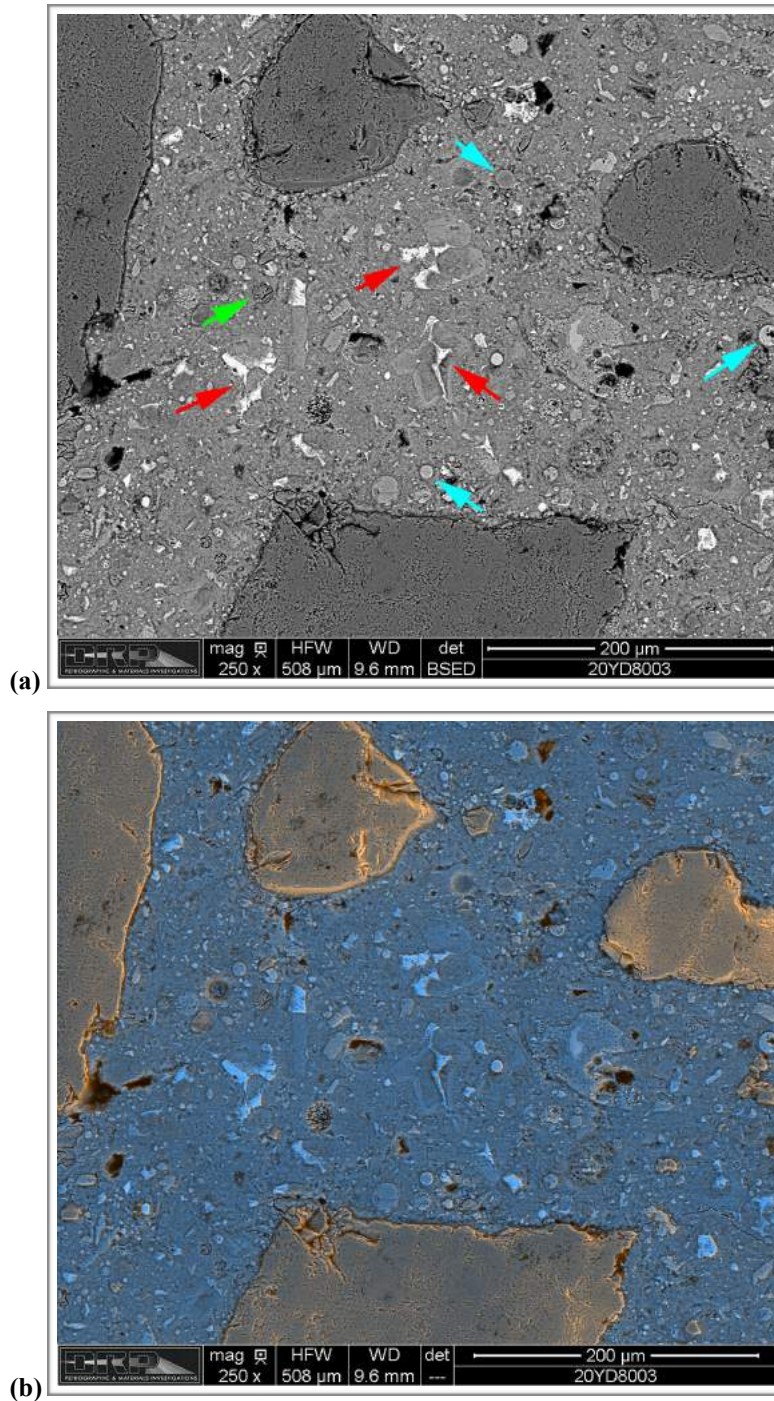
Figure B18. Backscatter electron (BSE) and combined BSE/secondary electron (SE) micrographs of polished surface showing detail of paste. The red and blue arrows in (a) indicate RRCG and fly ash, respectively and the green arrow indicates ettringite in a void.

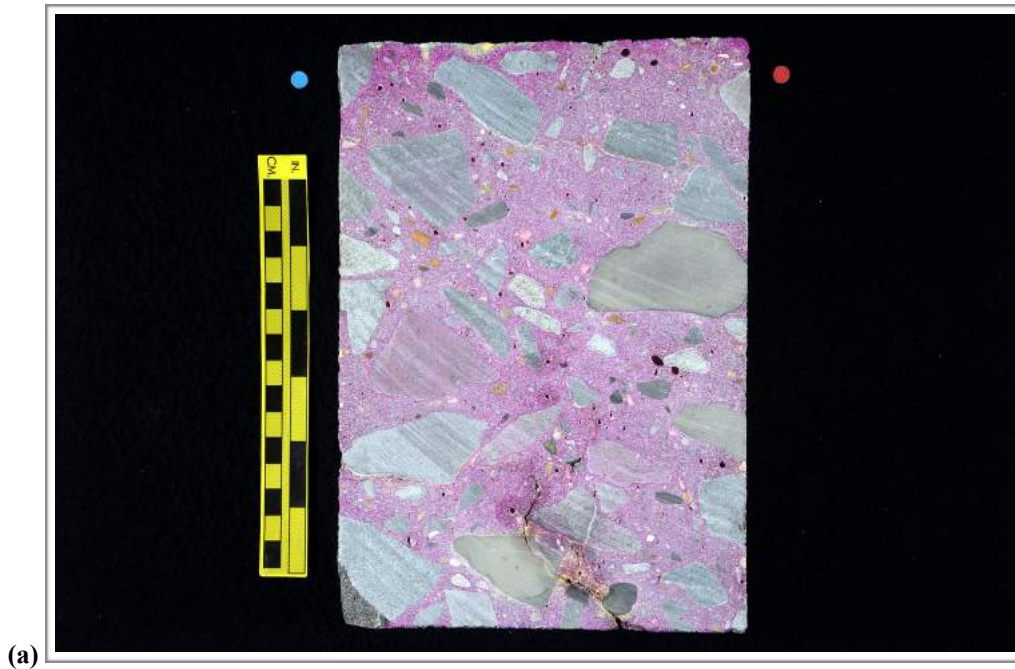
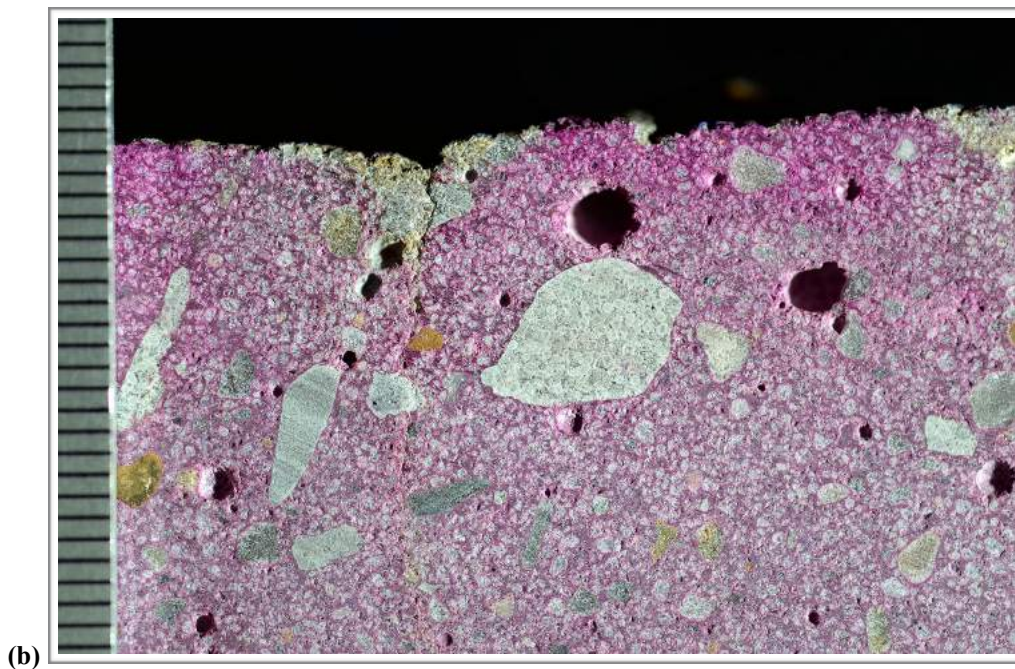
8. SECONDARY DEPOSITS	
PHENOLPHTHALEIN	Entire surface stains purple except along irregular zones (microcracks) at the top of the core where not staining was observed to 6 mm (¼ in.) depth (Figure B19).
DEPOSITS	No significant carbonation observed. Minor deposits of ettringite observed in occasional voids and microcracks (Figure B20). Traces of gel observed but much less gel than in Core C-1. A few cracks cut from limestone particles with peripheral microcracking into the paste (Figure B21). Minor deposits of Mg-rich material detected by EDS around some limestone particles with peripheral microcracking (Figure B22).

Figure B19. Photographs showing (a) overview of phenolphthalein stained surface and (b) detail of surface near the top of the core. Scale in millimeters in (b).

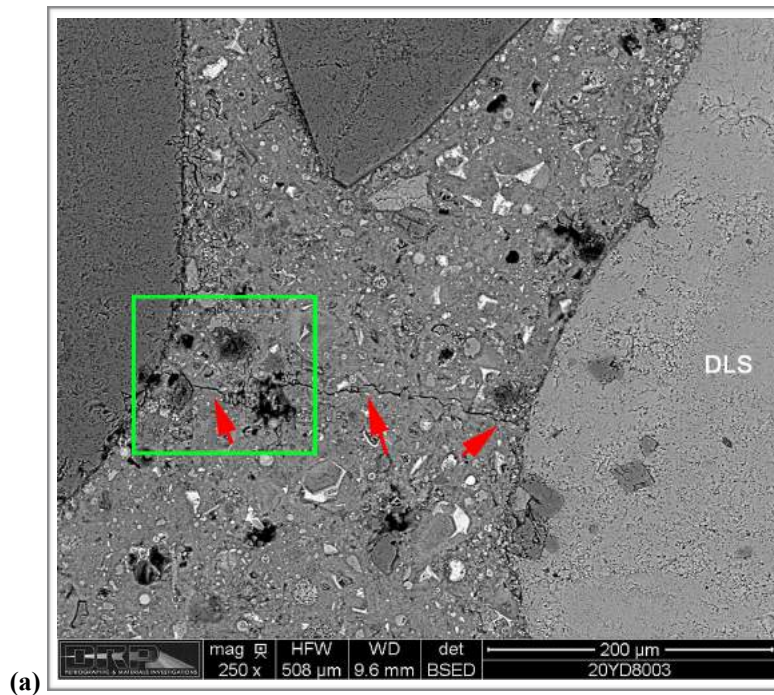
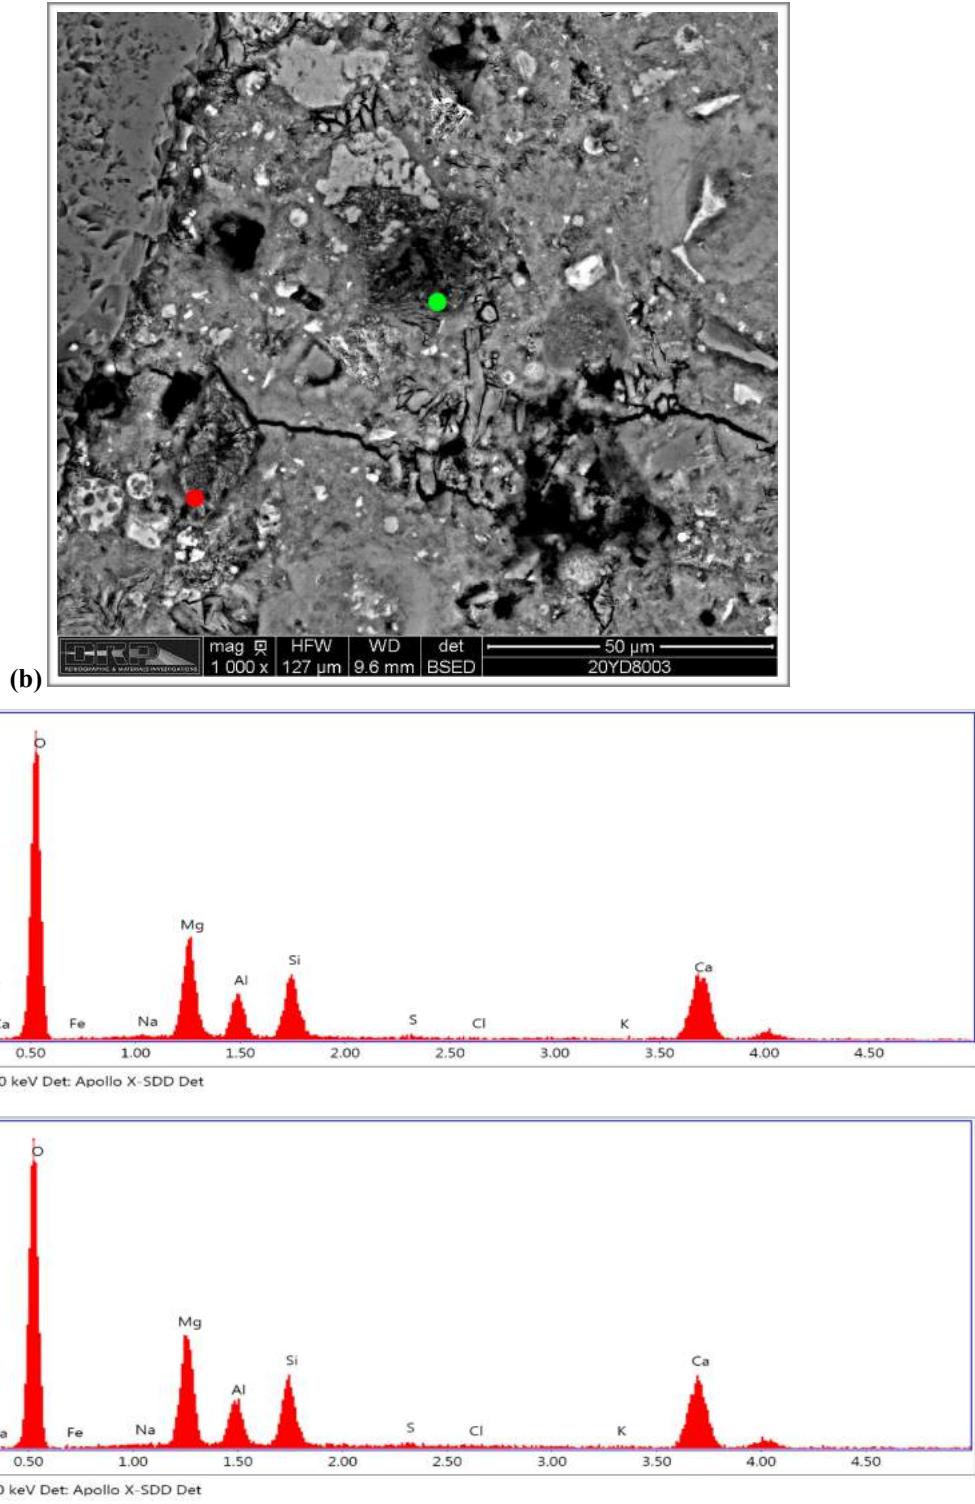
Figure B22. (a) BSE micrograph of polished surface showing location of area where EDS analyses were performed. The green box shows the area of (b). The red arrows indicate a microcrack that cut from the dolomitic limestone particle (DLS) on the right side of the image.

Figure B22 (cont'd). (b) BSE micrograph of polished surface showing location of EDS analyses. (c) and (d) are EDS spectra obtained from areas indicated by the red and green dots, respectively. These spectra show much higher concentrations of magnesium (Mg) than other areas, suggesting mobilization of Mg consistent with alkali-carbonate reaction.
