Louisiana Transportation Research Center

Technical Assistance Report 16-03TA-C

Evaluation of Cores from Jefferson Highway Near Airline Highway

Petrographic Investigation of Concrete Cores Extracted from Cracked
Pavement Slabs on Jefferson Highway in Baton Rouge, Louisiana
(RE: LTRC Project 16-1TA-C)

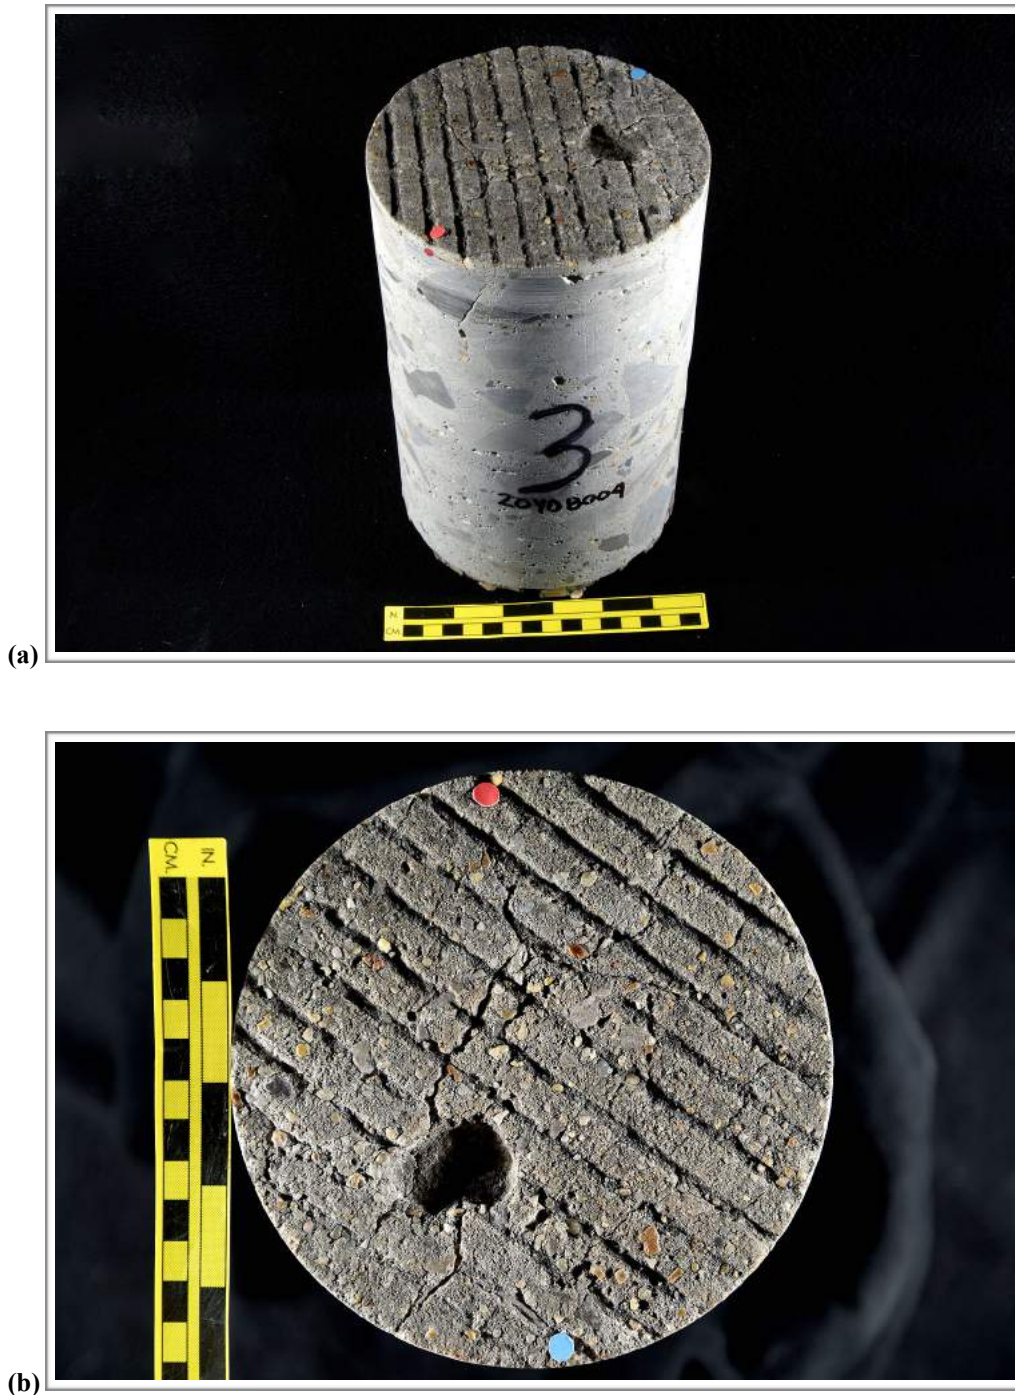
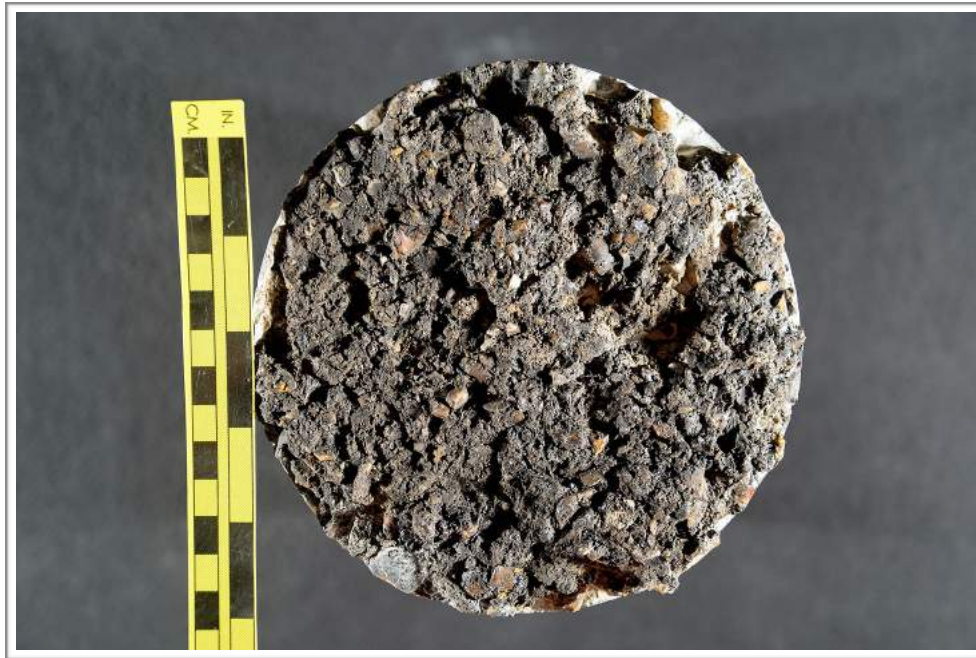
1. RECEIVED CONDITION	
ORIENTATION	Vertical core through pavement slab measures 150 mm (6 in.) in diameter and 225 mm (~ 9 in.) in length (Figure C1, C2).
SURFACES	The top surface is tined and worn with exposed fine aggregate particles on the surface (Figure C3) and the lower surface is cast on asphalt such that the core represents the full thickness of the portland cement concrete pavement.
GENERAL CONDITION	The concrete is hard and compact and rings lightly when sounded with a hammer. A pit measuring ~ 19 x 35 mm ($\frac{3}{4}$ -1 $\frac{3}{8}$ in.) in area is present on the top surface (Figure C4).

Figure C1. Photographs showing (a) oblique view of the top and side of the core with identification labels and (b) the top of the core. The red and blue dots in (b) show the orientation of the saw cuts used to prepare the sample. The yellow bar is ~ 150 mm (6 in.) long.

Figure C1 (cont'd). (c) Photograph showing the bottom surface of the core.

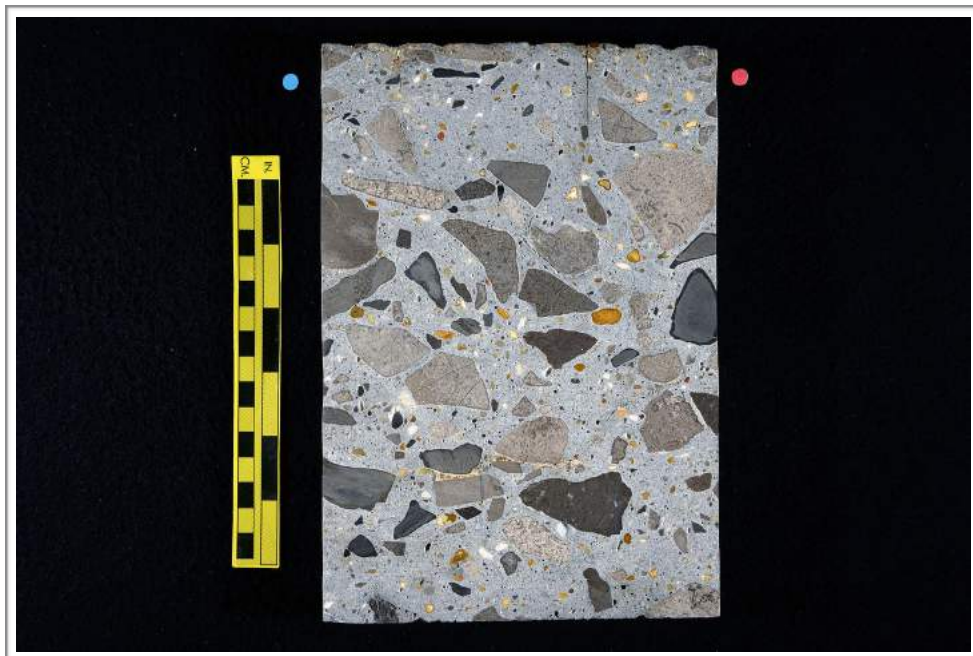
Figure C2. Photograph showing one of the polished surfaces of the core; both sides of the slab were polished. The yellow bar is ~ 150 mm (6 in.) long.

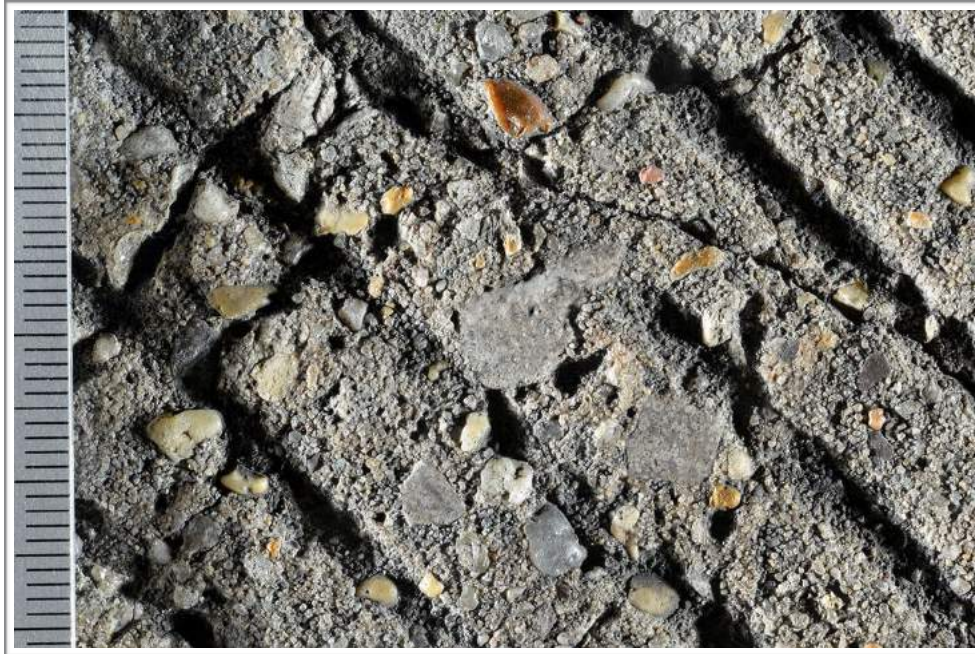
Figure C3. Photograph showing detail of top surface; scale in millimeters.

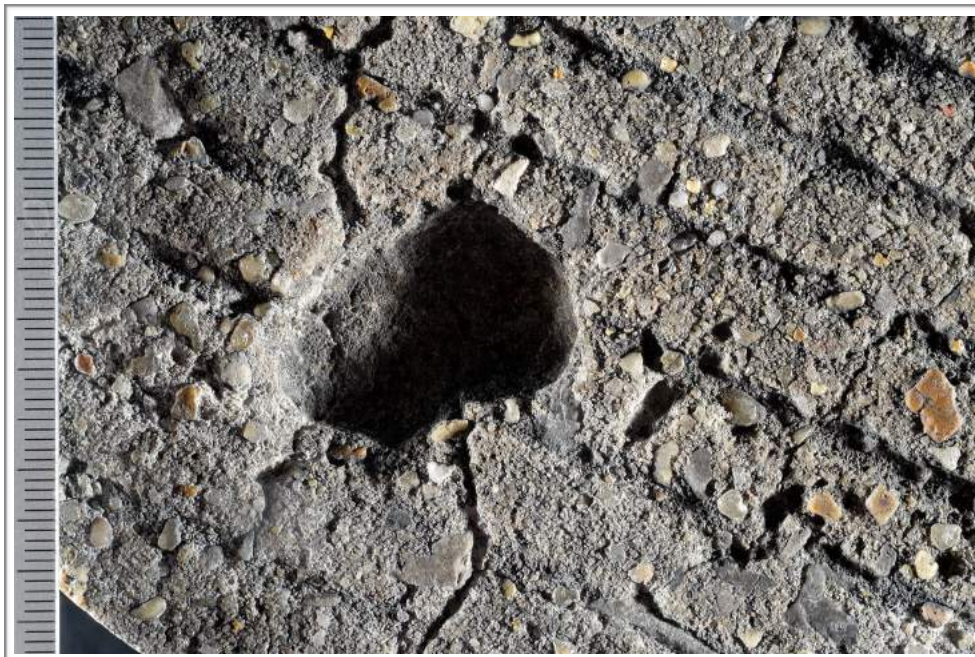
Figure C4. Photograph of top of core showing pit; scale in millimeters.

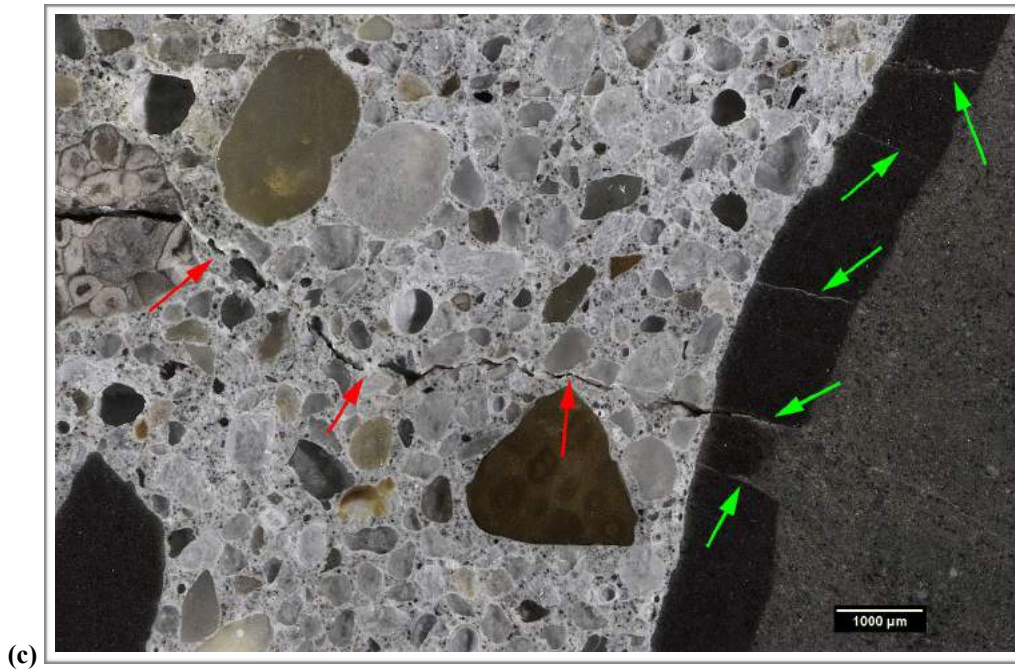
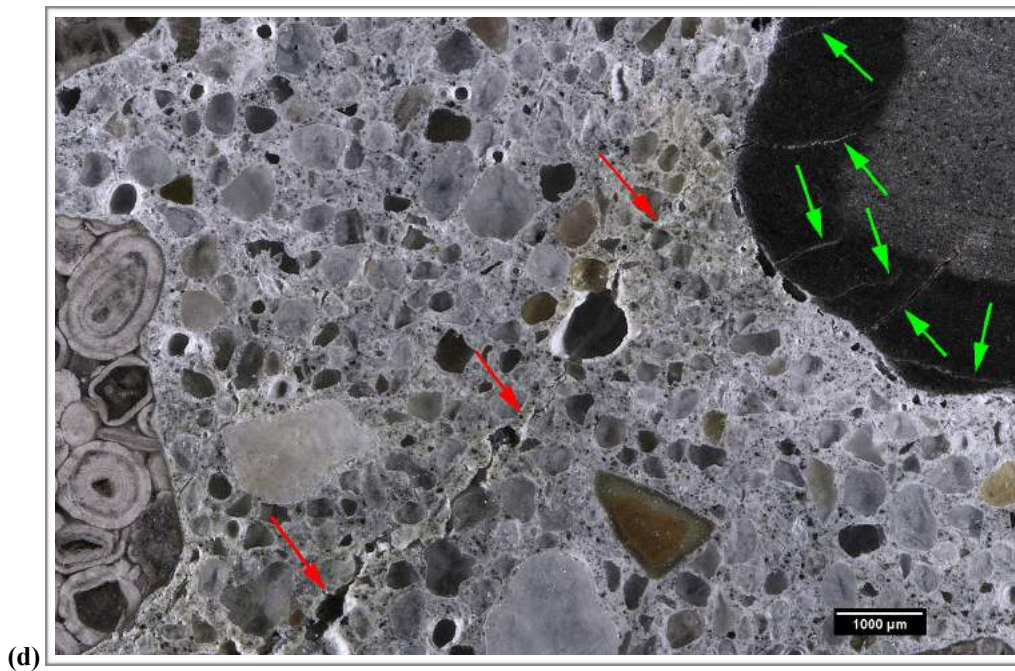
MICROSCOPIC	<p>A few microcracks ranging up to 100 μm (4 mil) wide cut from the top surface to 3-6 mm ($\frac{1}{8}$-$\frac{1}{4}$ in.); these cut around aggregates and are mostly free of secondary deposits.</p> <p>Extensive peripheral microcracking was observed in occasional particles of dolomitic limestone (Figure C9). Many of these microcracks are orthogonal to the perimeter of the particles and some cut into the paste where they cut mostly around but occasionally through aggregate particles. Most of these microcracks are free of secondary deposits but some contain deposits of ettringite.</p>

Figure C9 (cont'd). Reflected light photomicrographs of the polished surface showing peripheral microcracking (green arrows) in dolomitic limestone particles about (c) 85 mm (3 3/8 in.) and (d) 110 mm (4 3/8 in.) below the top surface. The red arrows in both photos indicate microcracks that cut from the limestone into the paste.

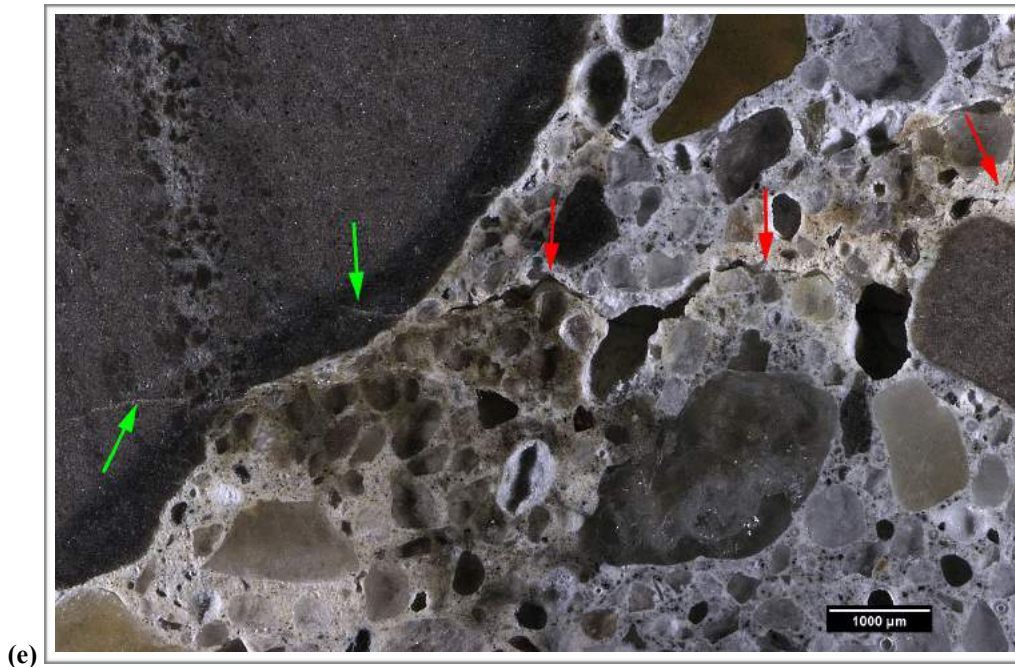
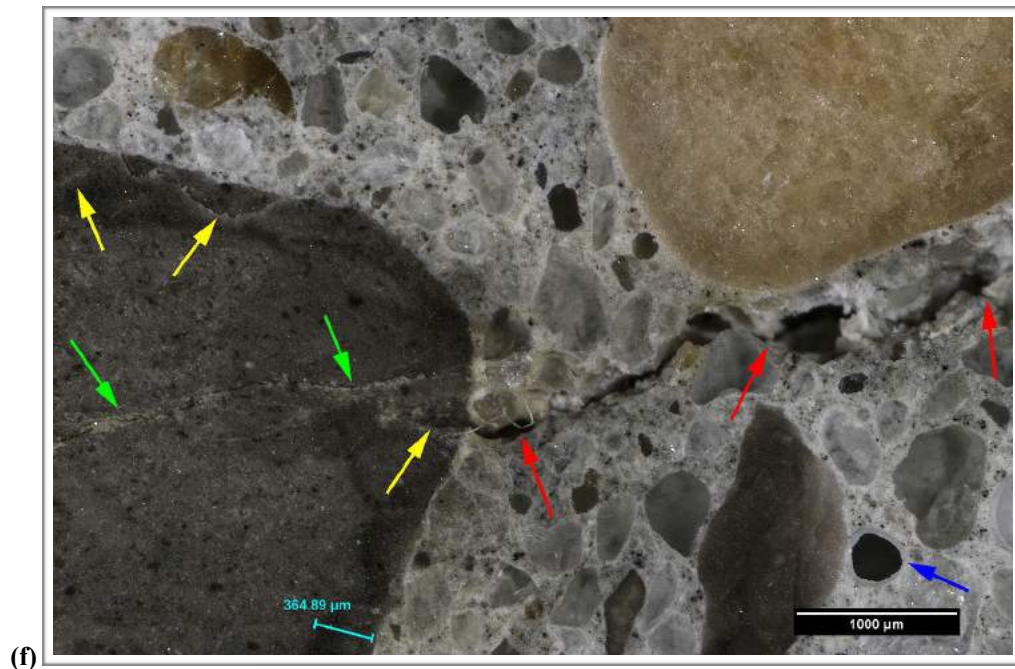
Figure C9 (cont'd). Reflected light photomicrographs of the polished surface showing microcracks (red arrows) that cut from dolomitic limestone particles into the paste about (e) 150 mm (6 in.) and (f) 165 mm (6 ½ in.) below the top surface. In (e) green arrows indicate peripheral microcracks that are mostly orthogonal to the perimeter of the particle. In (f) the yellow arrows indicate peripheral microcracks and the green arrow indicates an internal microcrack. The blue bar in (f) measures the width of a reaction rim and the blue arrow highlights a void lined by ettringite.

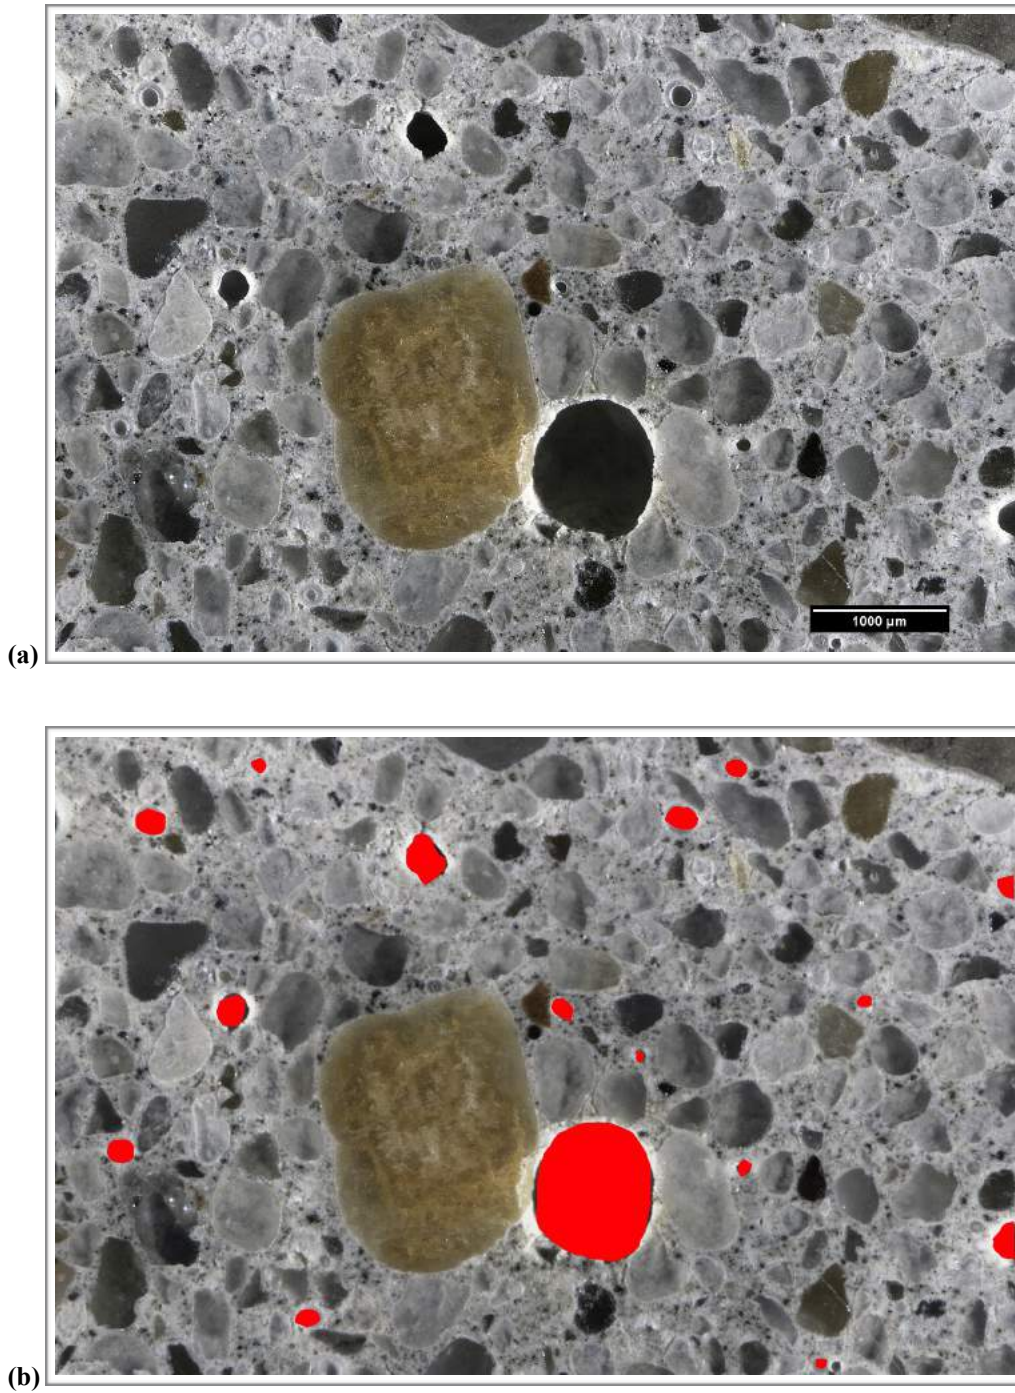
4. VOIDS	
VOID SYSTEM	Concrete is marginally air-entrained and contains ~ 3% total air as estimated from visual and microscopical observations (Figure C10). The concrete is well consolidated with no significant entrapped voids or water voids observed.
VOID FILLINGS	Voids commonly contain deposits of ettringite that rim and fill the voids.

Figure C10. (a) Oblique reflected light photomicrographs of polished surface showing voids (dark circles). (b) Image of same area as (a) where red circles indicate voids. This image was analyzed and found to contain ~ 3% air.

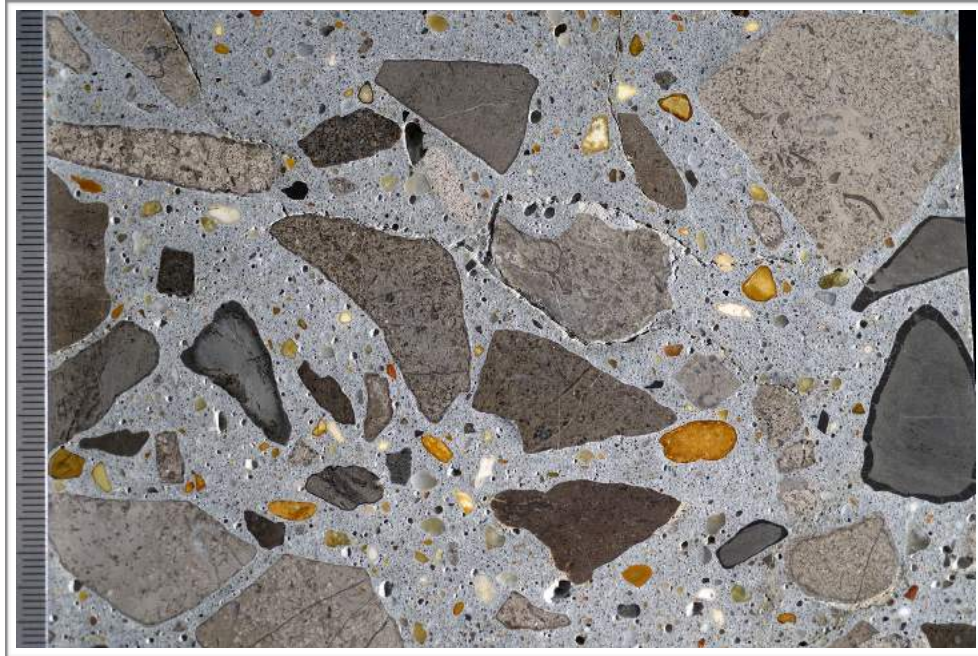
Figure C11. Photograph of polished surface showing overview of coarse aggregate; scale in millimeters.

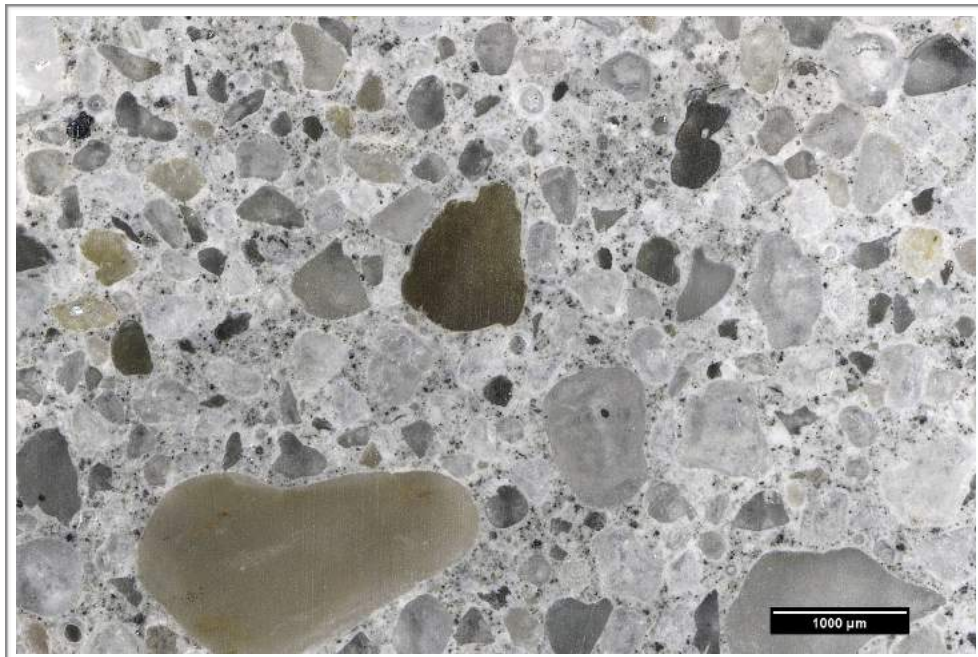
6. FINE AGGREGATE	
PHYSICAL PROPERTIES	The fine aggregate is a natural sand that consists of rocks that are hard and competent (Figure C12). The sand consists primarily of siliceous rocks but minor amounts of limestone (carbonate) similar to those in the coarse aggregate were observed. The particles are sub-equant to oblong in shape with rounded to sub-angular edges. The grading and distribution are even.
ROCK TYPES	The consists primarily of quartz and quartzite; chert is a minor component and limestone is also present. Seams of chalcedonic chert were observed in limestones.
OTHER FEATURES	No deleterious coatings or incrustations observed and no low w/c mortar coatings observed. The chert commonly shows well-developed reaction rims; the quartz and quartzite particles are intact.

Figure C12. Reflected light photomicrograph of polished surface showing fine aggregate.

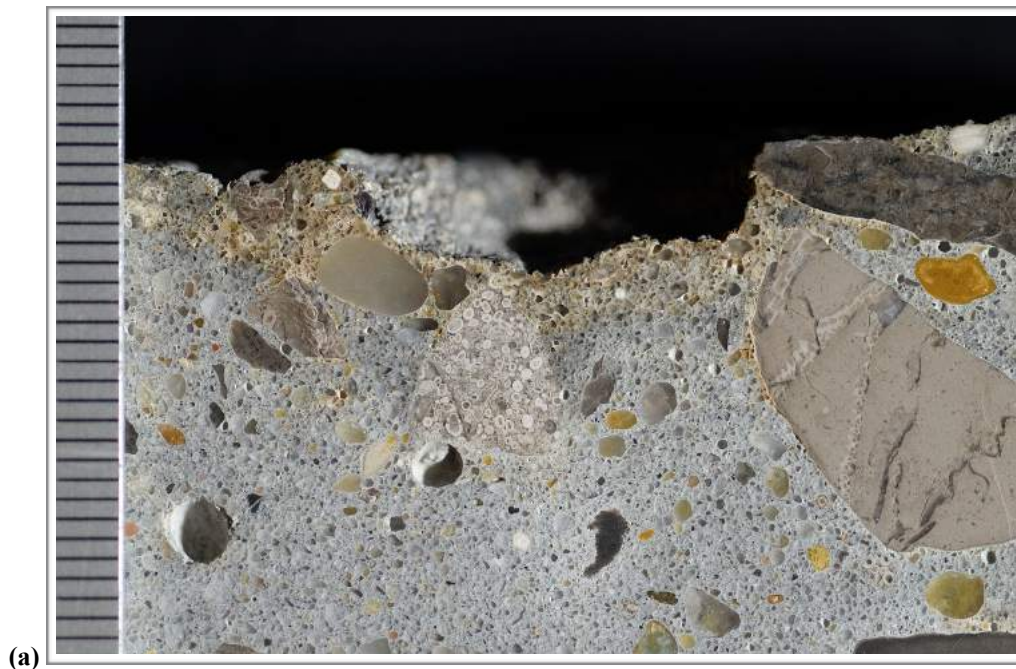
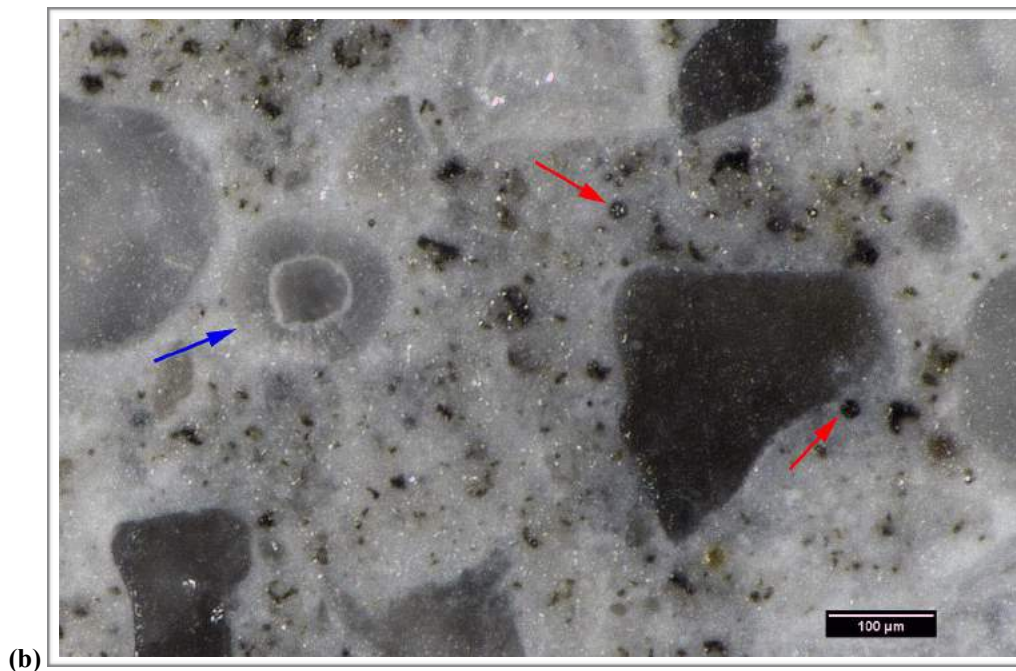
7. PASTE OBSERVATIONS	
POLISHED SURFACE	Paste is light gray (Munsell 10YR/7/1), has a smooth texture and weakly sub-vitreous luster (Figure C13). The paste is moderately hard (Mohs 3-3.5). The paste is gray (10YR/6/1) for 1-2 mm (40-80 mil) from the top surface and irregularly distributed zones of yellow (2.5Y/7/4) to light red (2.5YR/7/4) paste are present for up to 12.5 mm (½ in.) from the top surface along microcracks and cracks.
FRESH FRACTURE	Fracture surface is gray, has a hackly texture and a sub-vitreous luster (Figure C14). The fracture cuts through coarse aggregate particles. Deposits of ettringite were observed on the surface.
THIN SECTION/ SEM*	The paste contains hydrated portland cement and fly ash; no slag cement or other SCM were observed. The hydration is normal with 3-6% RRCG that consist mostly of belite and interstitial ferrite and aluminate (Figure C15, Figure C16). Minor amounts of very fine crystals of calcite are present in the paste. CH makes up 8-15% of the paste, is fine to medium grained and distributed fairly evenly.

Figure C13. (a) Photograph of polished surface showing overview of paste at the top of the core. The scale is in millimeters. (b) Reflected light photomicrograph of polished surface showing detail of paste texture and luster. The red arrows indicate fly ash and the blue arrow indicates a void filled ettringite.

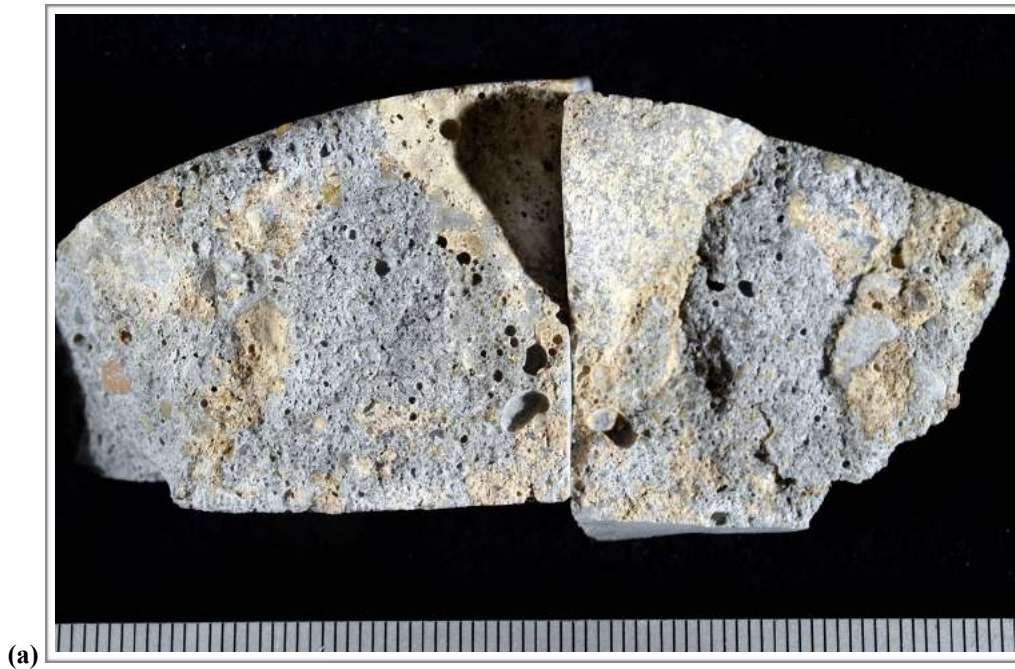
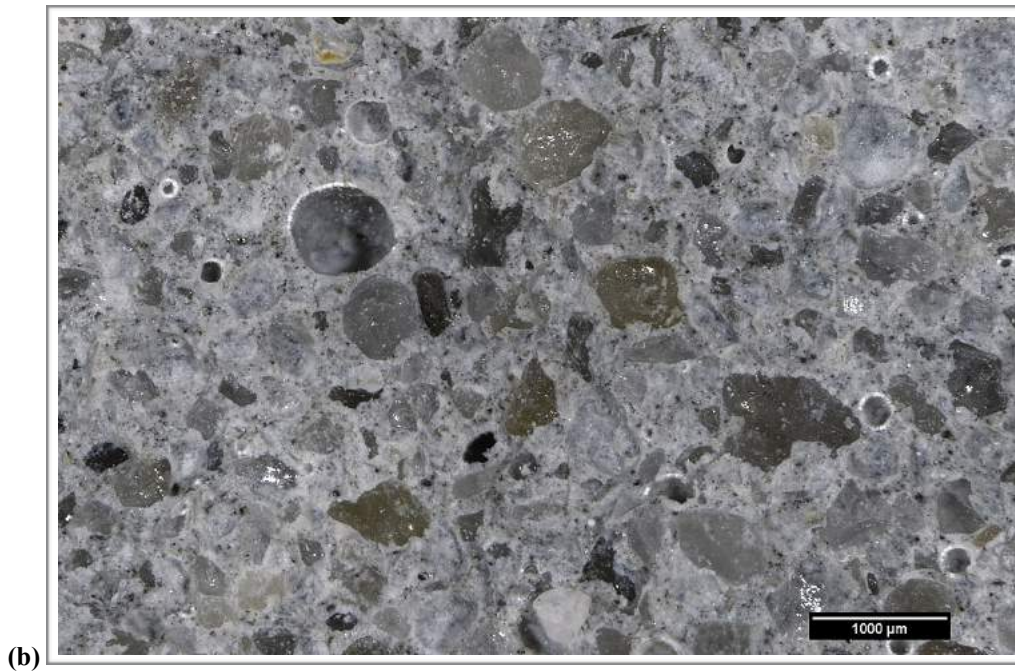
Figure C14. (a) Photograph and (b) reflected light photomicrograph of fresh fracture surface. The scale is in millimeters in (a).

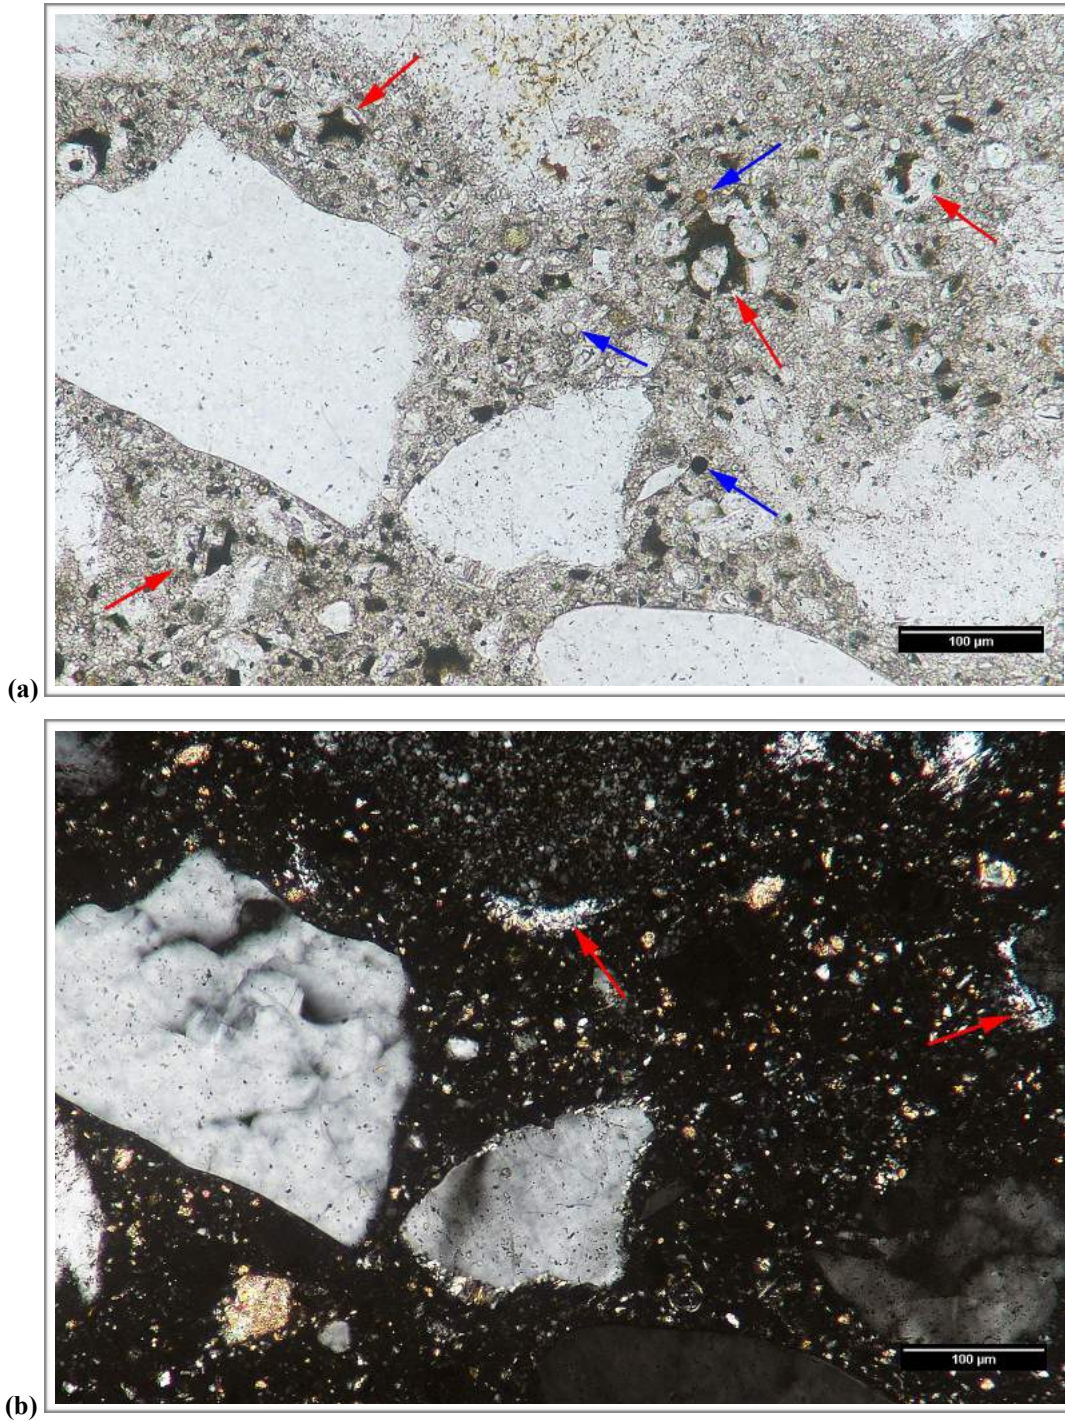
Figure C15. Transmitted light photomicrographs of thin section showing detail of paste in (a) plane-polarized and (b) cross-polarized light. The red and blue arrows in (a) indicate RRCG and fly ash, respectively. In (b) the red arrows indicate CH.

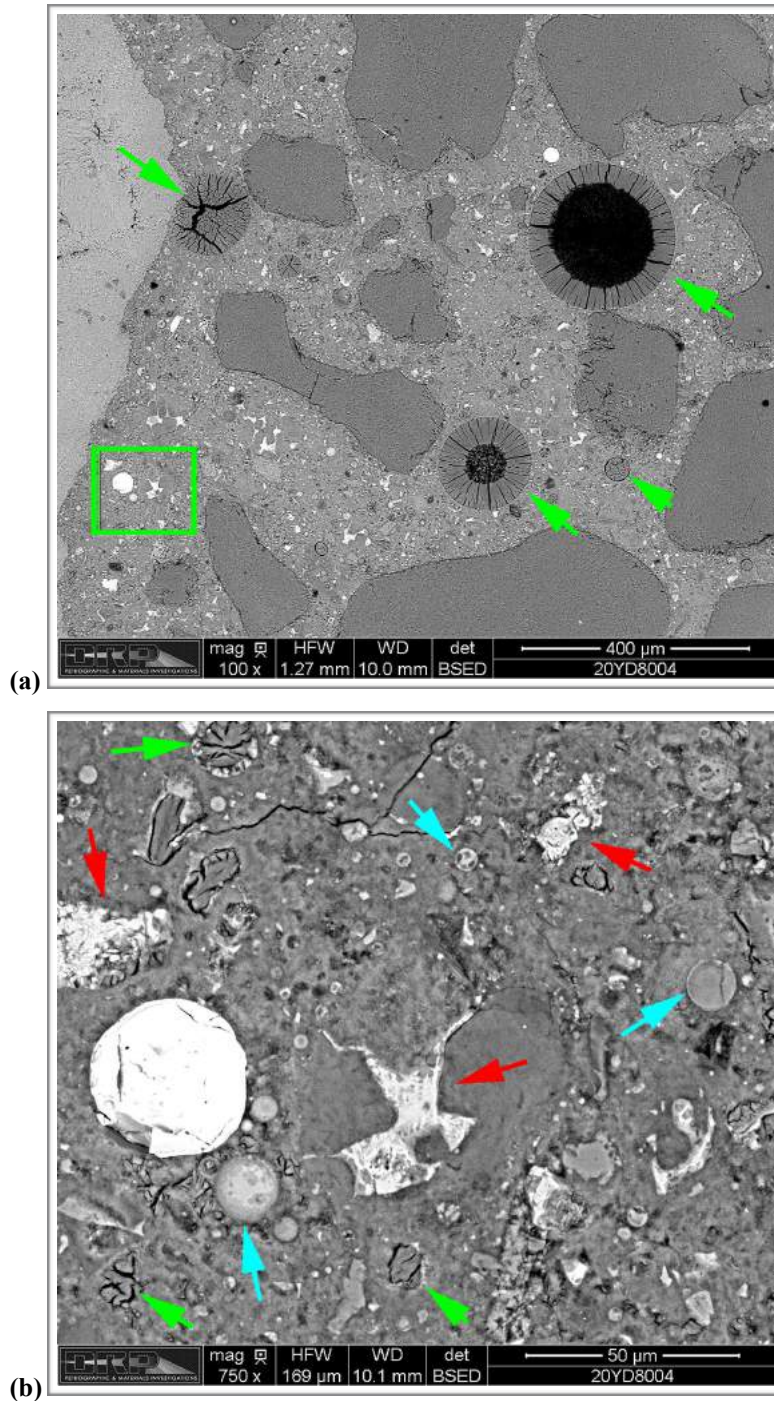
Figure C16. Backscatter electron (BSE) micrographs of polished surface showing (a) overview and (b) detail of paste. The green box in (a) shows the area of (b) and the green arrows in (a) indicate voids with ettringite. The red and blue arrows in (b) indicate RRCG and fly ash, respectively and the green arrows indicate deposits of ettringite.

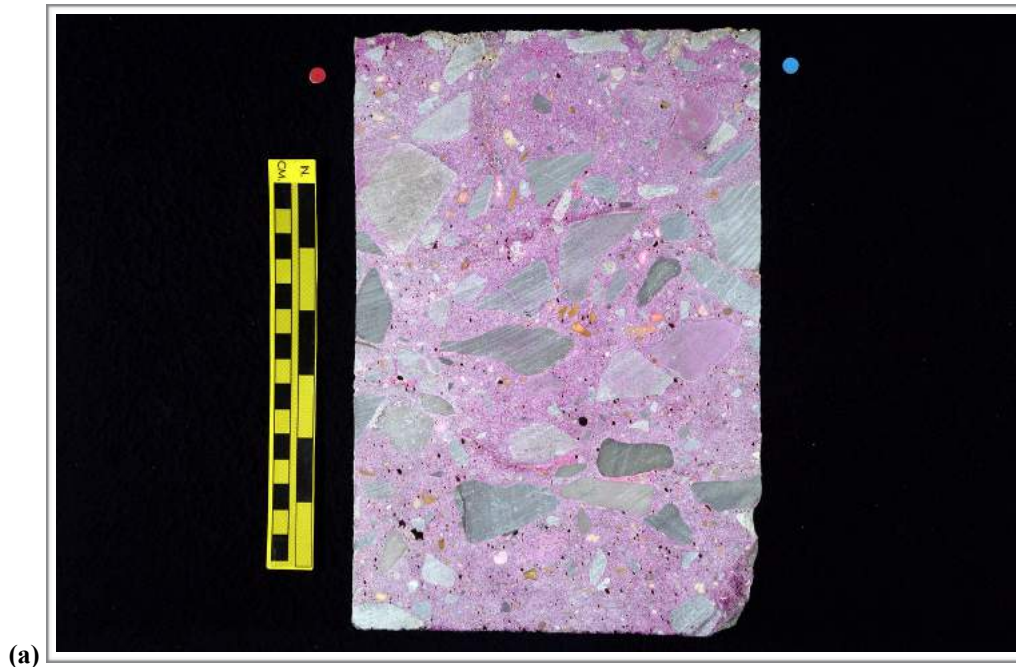
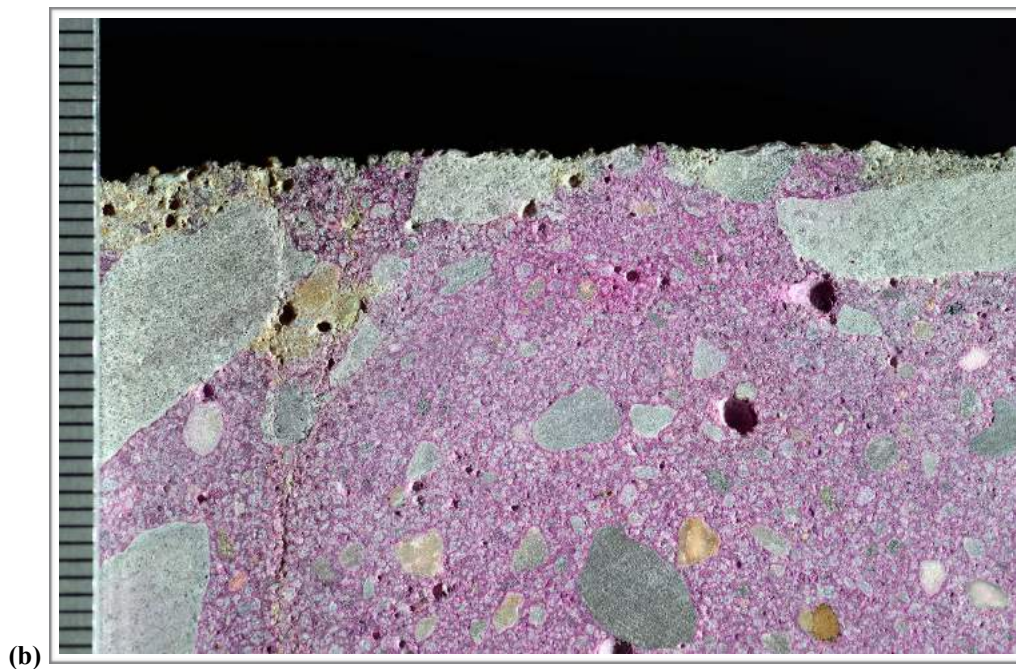
PHENOLPHTHALEIN	Entire surface stains purple except along irregular zones (microcracks) at the top of the core where not staining was observed to 6 mm (¼ in.) depth (Figure C17).
DEPOSITS	No significant carbonation observed. Minor deposits of ettringite observed in occasional voids (Figure C18). Deposits of ASR gel observed in ITZ of occasional aggregate particles and in occasional voids (Figure C19, Figure C20).

Figure C17. Photographs showing (a) overview of phenolphthalein stained surface and (b) detail of surface near the top of the core. Scale in millimeters in (b).

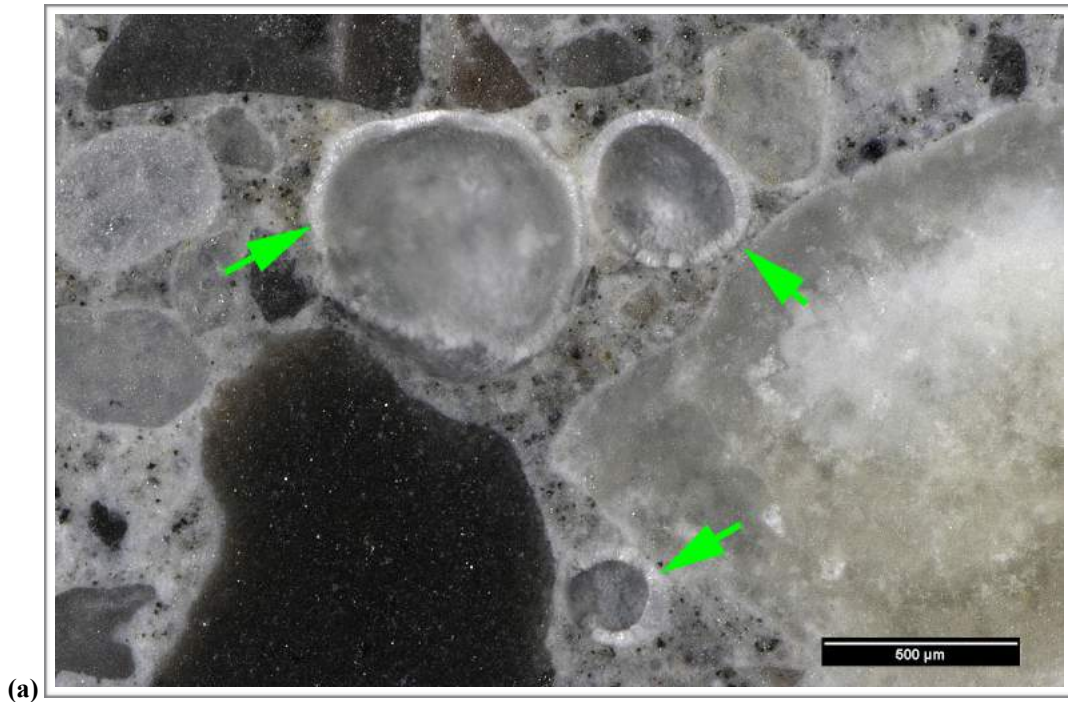
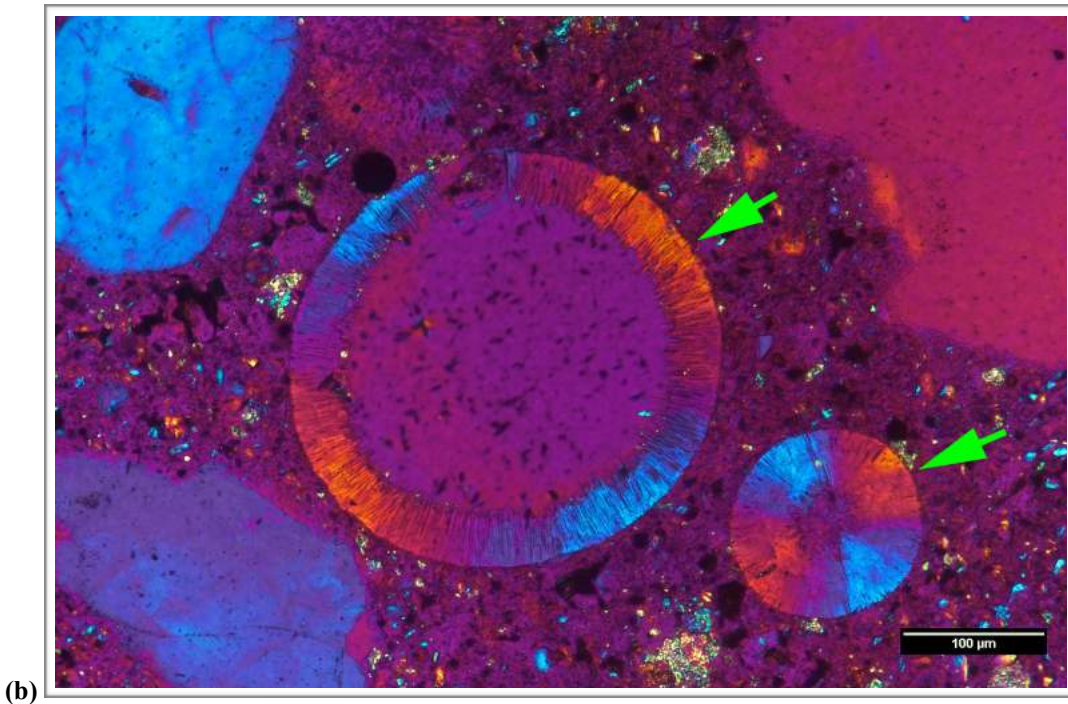
Figure C18. (a) Reflected light photomicrograph of the polished surface showing deposits of ettringite lining voids (green arrows). (b) Cross-polarized transmitted light photomicrograph of thin section with gypsum plate inserted showing voids lined with ettringite (green arrows).

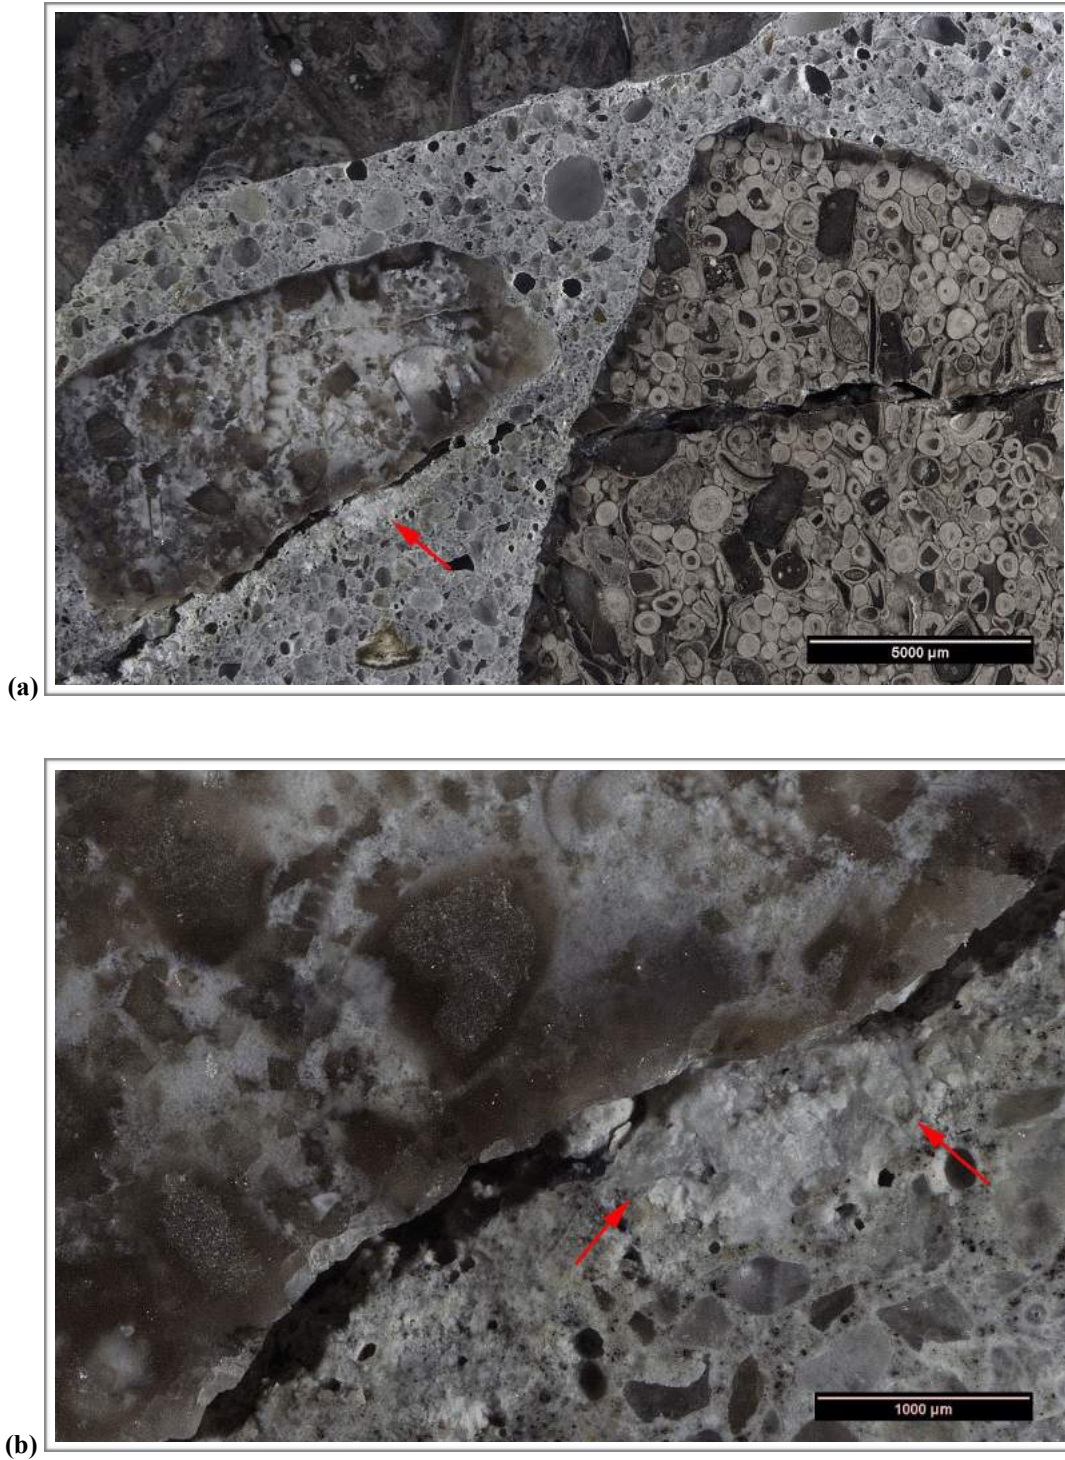
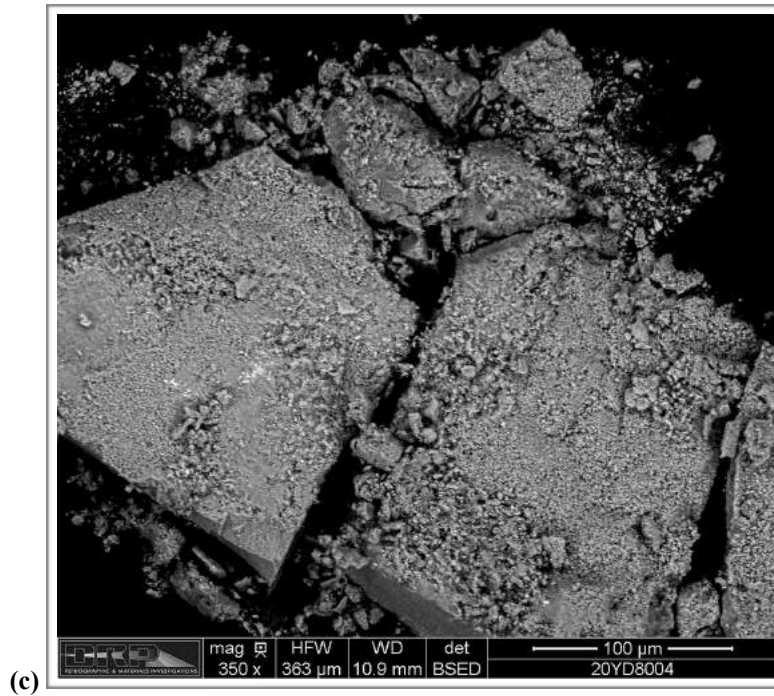
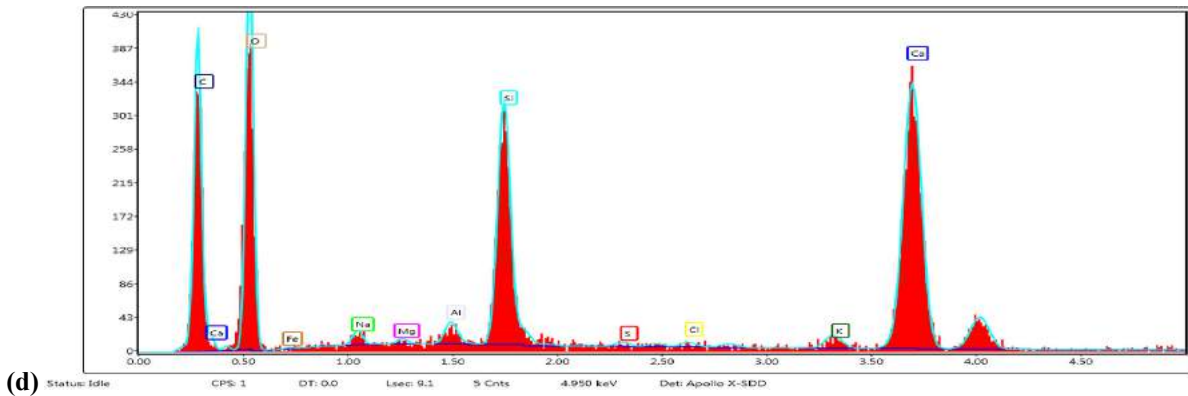
Figure C19. Reflected light photomicrographs of the polished surface showing (a) overview and (b) detail of gel deposit (red arrows) along the margin of an oolitic limestone particle about 90 mm (3 ½ in.) below the top surface. This deposit was scraped from the surface and analyzed by EDS.

Figure C19 (cont'd). (c) BSE micrograph of gel deposit removed from polished surface of core and placed on carbon tape for EDS analysis. (d) EDS spectrum of deposit showing composition of the gel.
