Louisiana Transportation Research Center

Technical Assistance Report 16-03TA-C

Evaluation of Cores from Jefferson Highway Near Airline Highway

Petrographic Investigation of Concrete Cores Extracted from Cracked
Pavement Slabs on Jefferson Highway in Baton Rouge, Louisiana
(RE: LTRC Project 16-1TA-C)

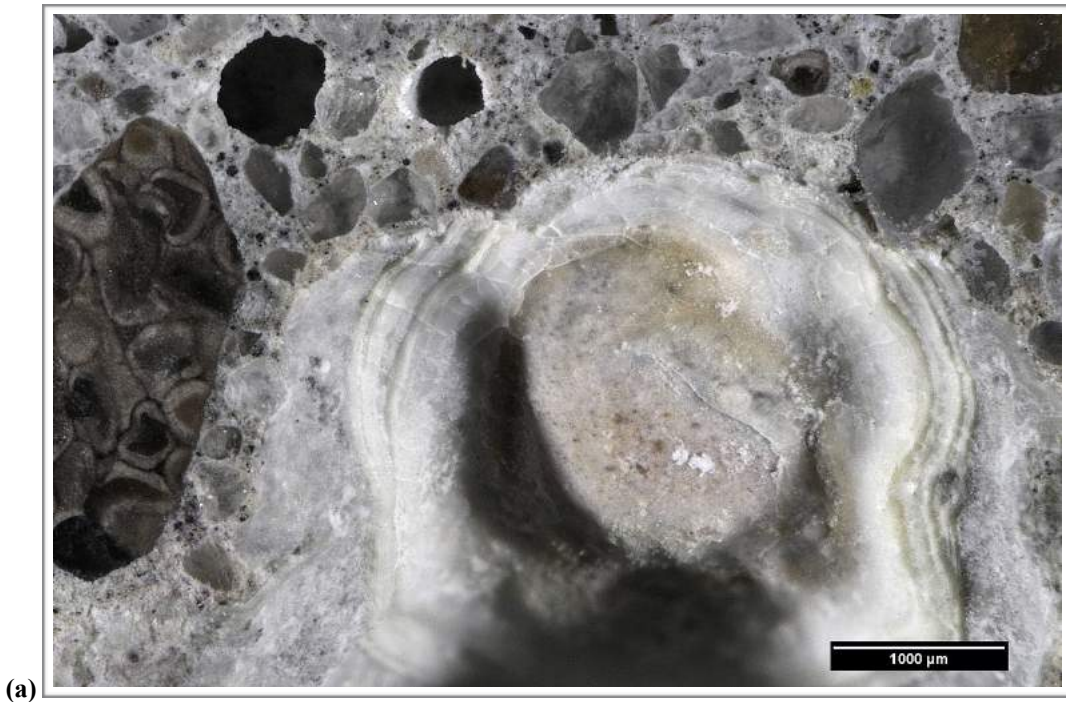
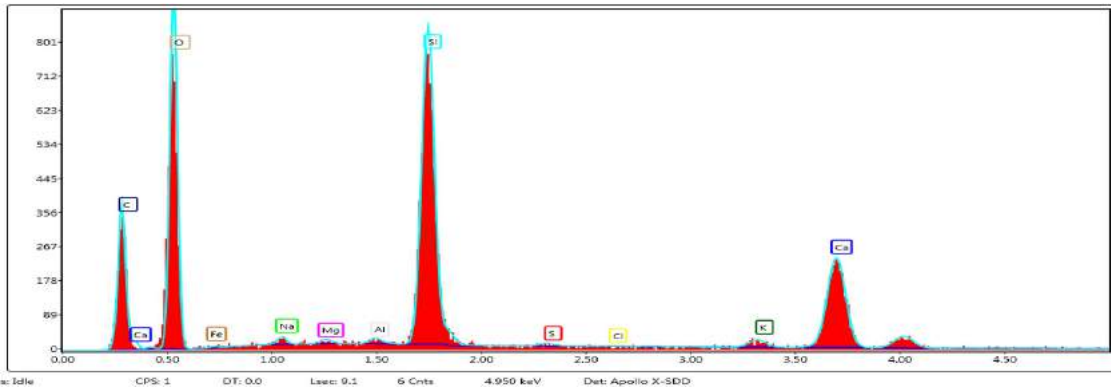
PHENOLPHTHALEIN	Entire surface stains purple except along irregular zones (microcracks) at the top of the core where not staining was observed to 6 mm (¼ in.) depth (Figure C17).
DEPOSITS	No significant carbonation observed. Minor deposits of ettringite observed in occasional voids (Figure C18). Deposits of ASR gel observed in ITZ of occasional aggregate particles and in occasional voids (Figure C19, Figure C20).

Figure C20. Reflected light photomicrograph of the polished surface showing gel deposit in a void about 130 mm (5 1/8 in.) below the top surface. This deposit was scraped from the surface and analyzed by EDS; (b) indicates the EDS spectrum obtained from the deposit.
