**MDOT RC-1617B**

**Evaluation of Bridge Decks Using  
Non-Destructive Evaluation (NDE)  
at Near Highway Speeds  
for Effective Asset Management  
– Pilot Project**

**FINAL REPORT**

Michigan Department of Transportation

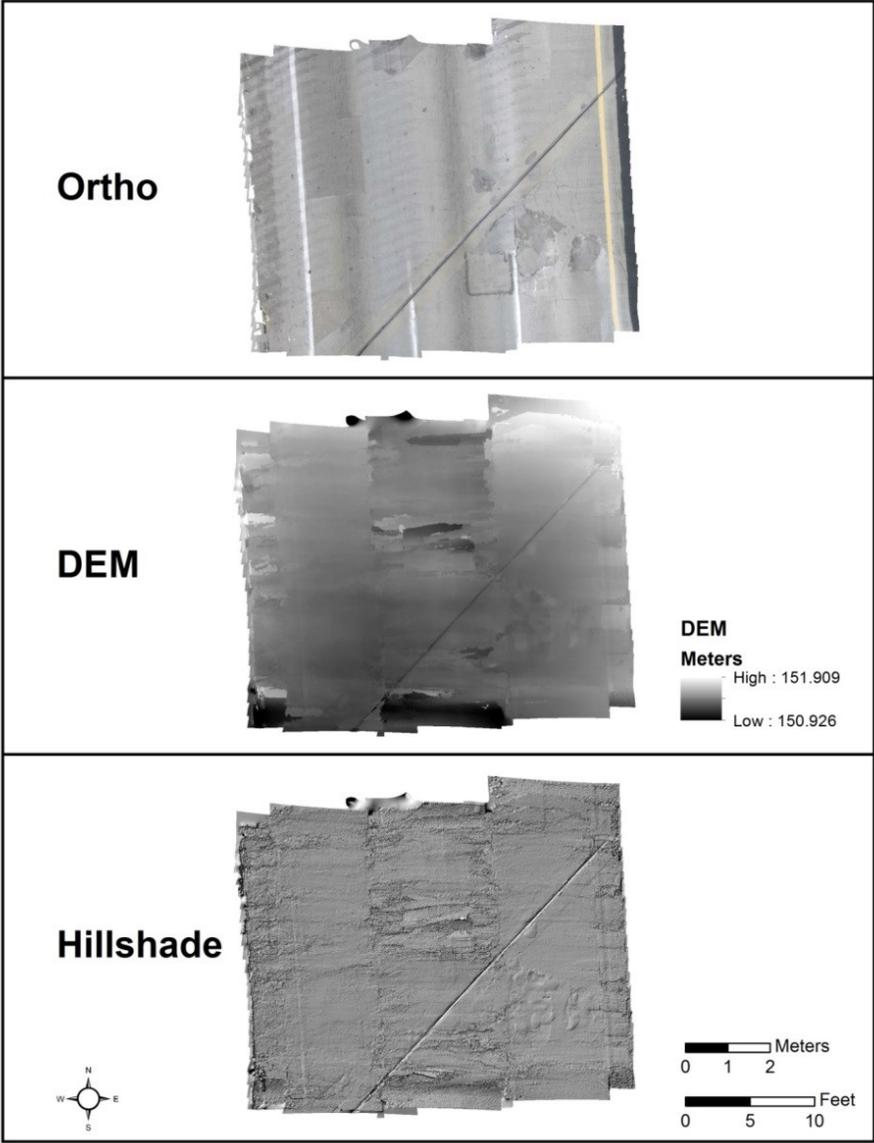
With the additional orientation defined, the north and southbound lanes of Lake Nepessing Rd were successfully reconstructed using only the geotagged RED frames. A 20 ft section of southbound I-75 using only the geotagged frames was processed as an example. Figure 16 shows the orthoimage, DEM, and Hillshade of this section. There are still parts of the 3D model, such as the edges and the center, where there is increased noise resulting in a jagged appearance in the DEM and Hillshade. This is a result of a flat road surface in the center of the model and reduced overlap at the edges. By comparison, the areas that contain the bridge joint and patching has less noise because there was more height variation.

**Figure 16: A roughly 20 ft section of I-75 SB processed through Agisoft using geotagged imagery and orientation parameters.**

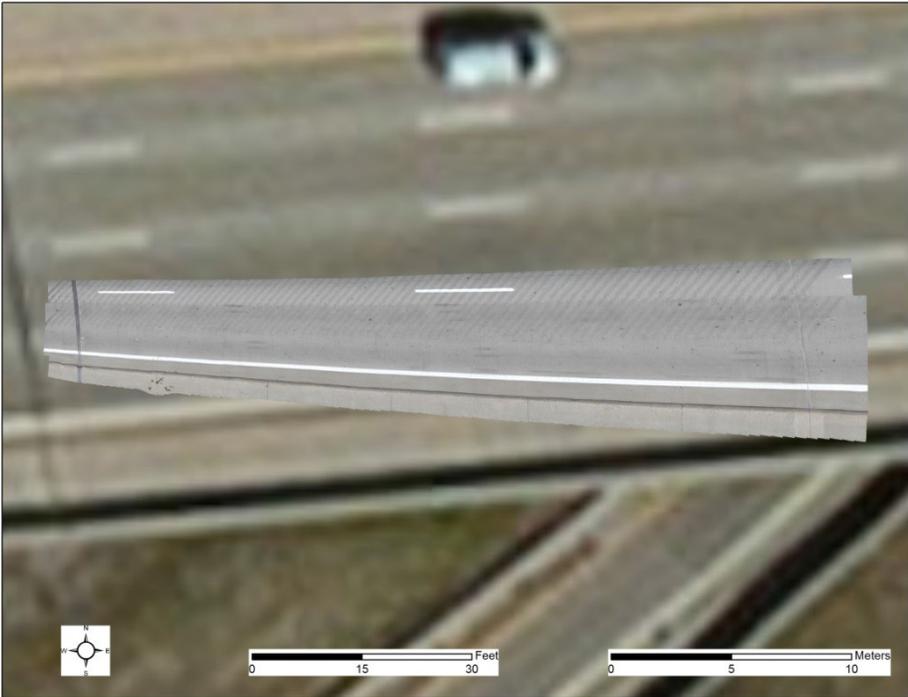
Including additional orientation information did not improve reconstruction modeling for all of the bridges in this study. However, I-696 and US-131 NB/SB, with deck surface ratings of 7 and 8/8, respectively, are very flat with very little spalling and patching, as compared to I-75 NB/SB. While adding camera orientation information was able to aid in the reconstruction of bridge decks with some height varying features, it was unable to correctly model those decks with no height variation. Figure 17 shows an example of a small section of the left lane of eastbound I-696, which was reconstructed using the additional orientation information. There is a 6 ft difference in lane width between the east and west side of the model and incorrect spatial position, showing that even with the additional information, excellent condition deck surfaces may not be accurately reconstructed.

**Figure 17: A section of I-696 modeled in Agisoft using geotagged RED imagery and camera orientation information.**

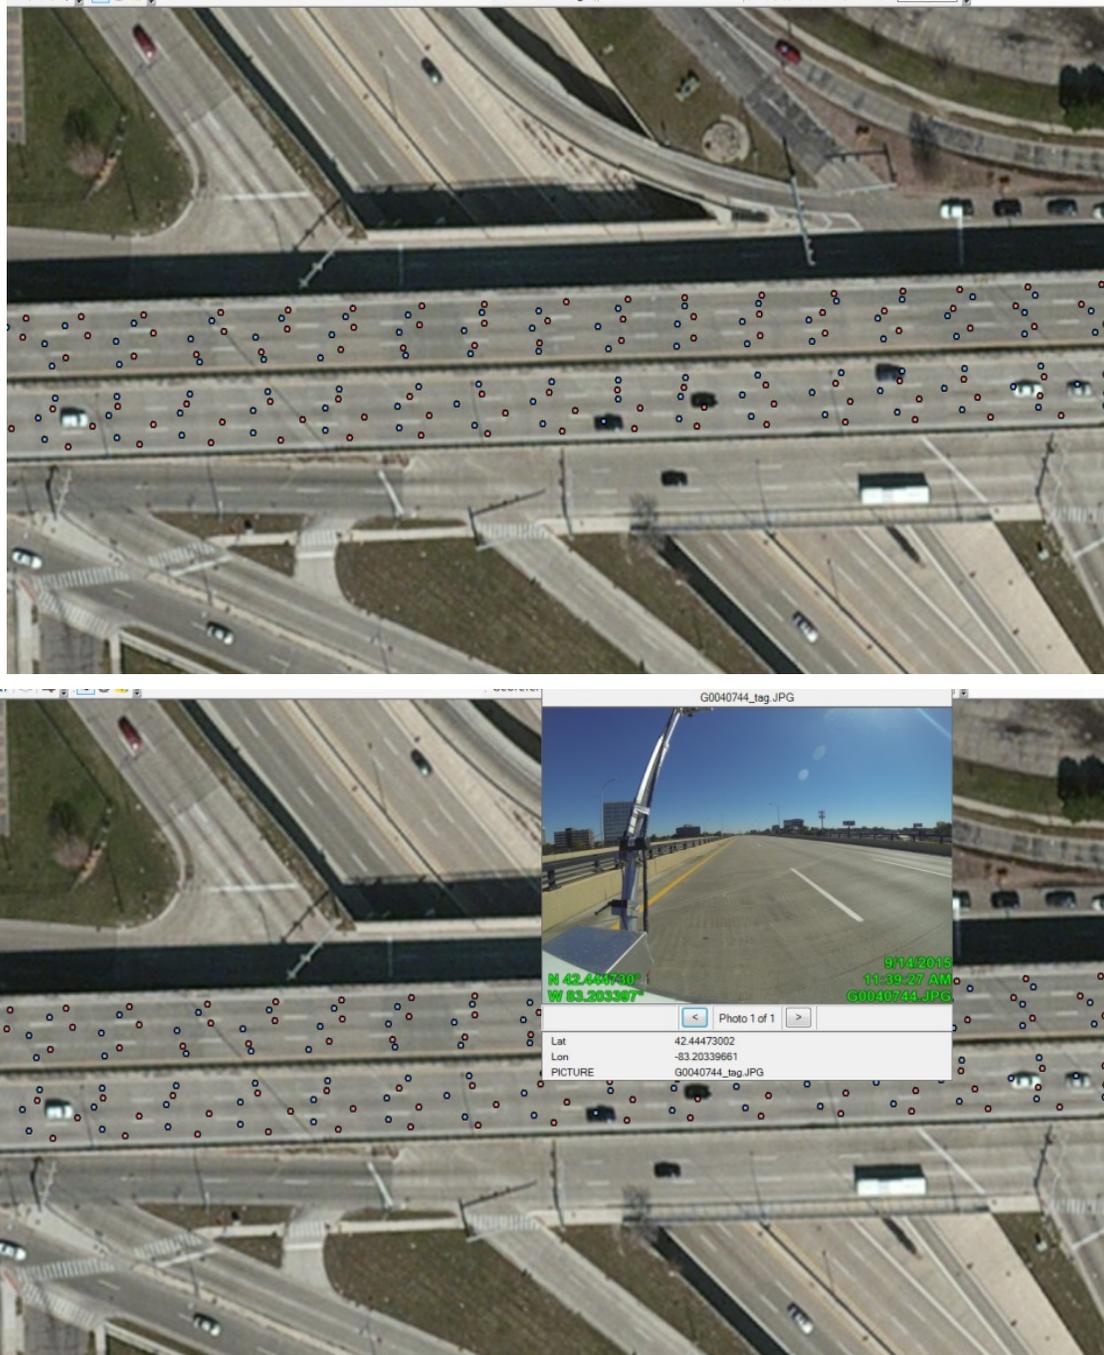
**Figure 18: A subset of the 8 Mile Bridge with BVRCS GPS data placed on the bridge (top) and the image showing the bridge deck section that corresponds to the GPS data point (bottom).**

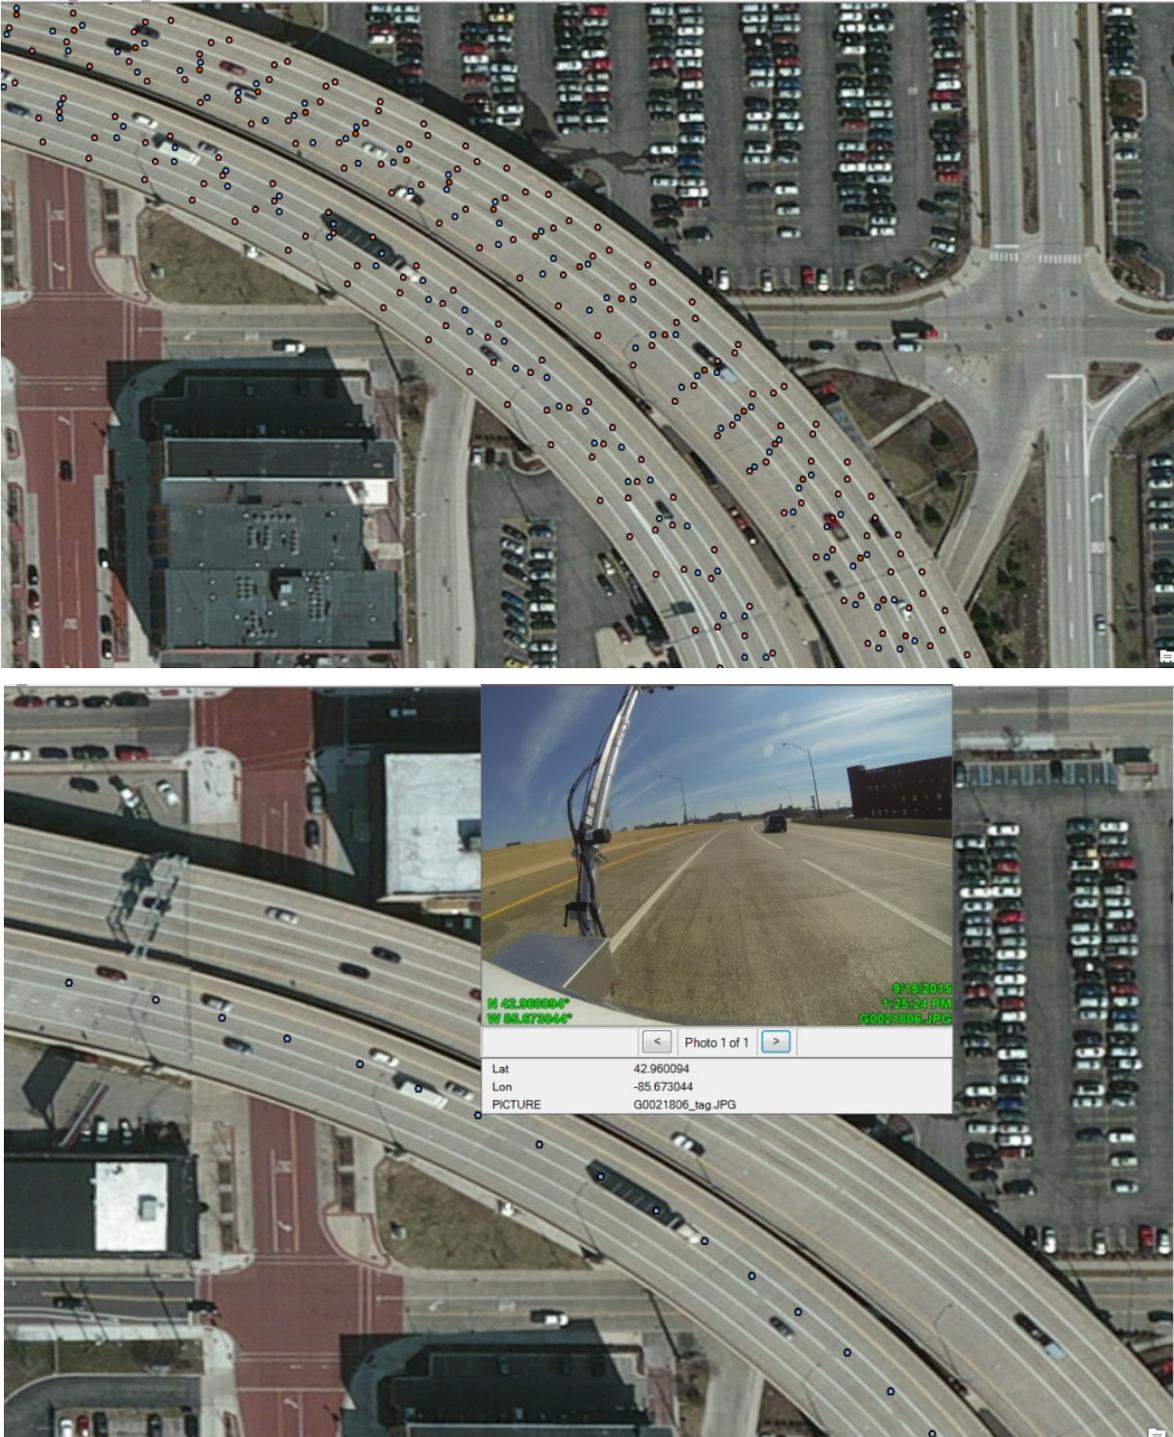
Figure 19: A subset of the US-131 NB/SB Bridges with BVRCS GPS data placed on the bridge (top) and the image showing the bridge deck section that corresponds to the GPS data point (bottom).

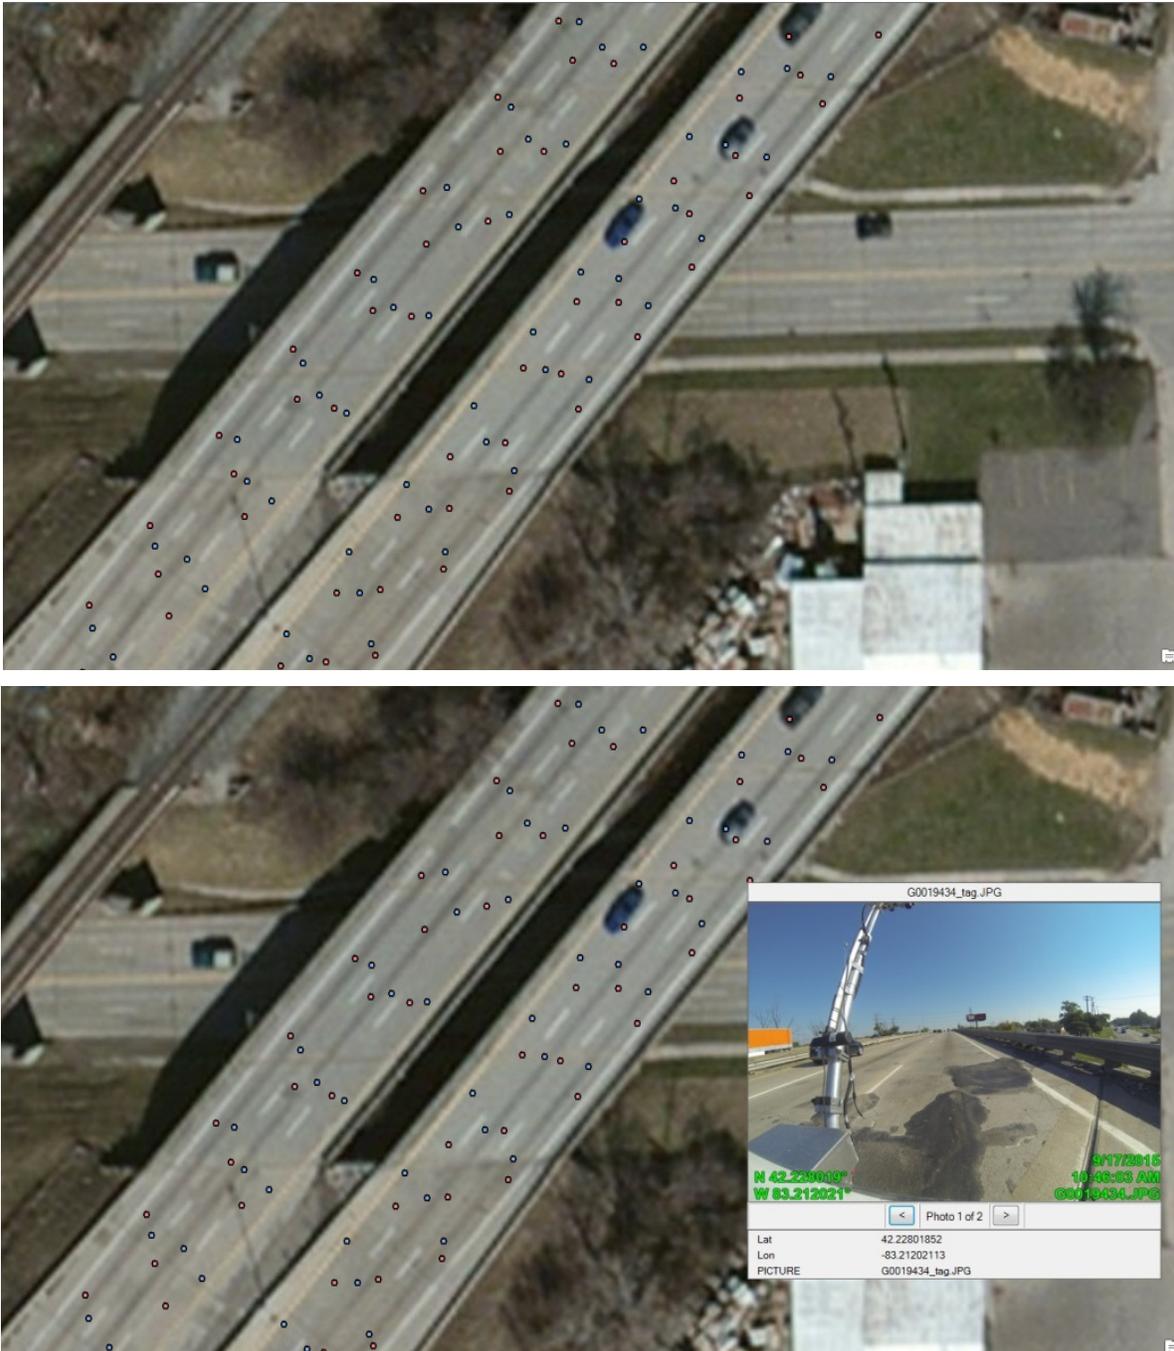
**Figure 20: A subset of the I-75 NB/SB Bridges with BVRCS GPS data placed on the bridge (top) and the image showing the bridge deck section that corresponds to the GPS data point (bottom).**

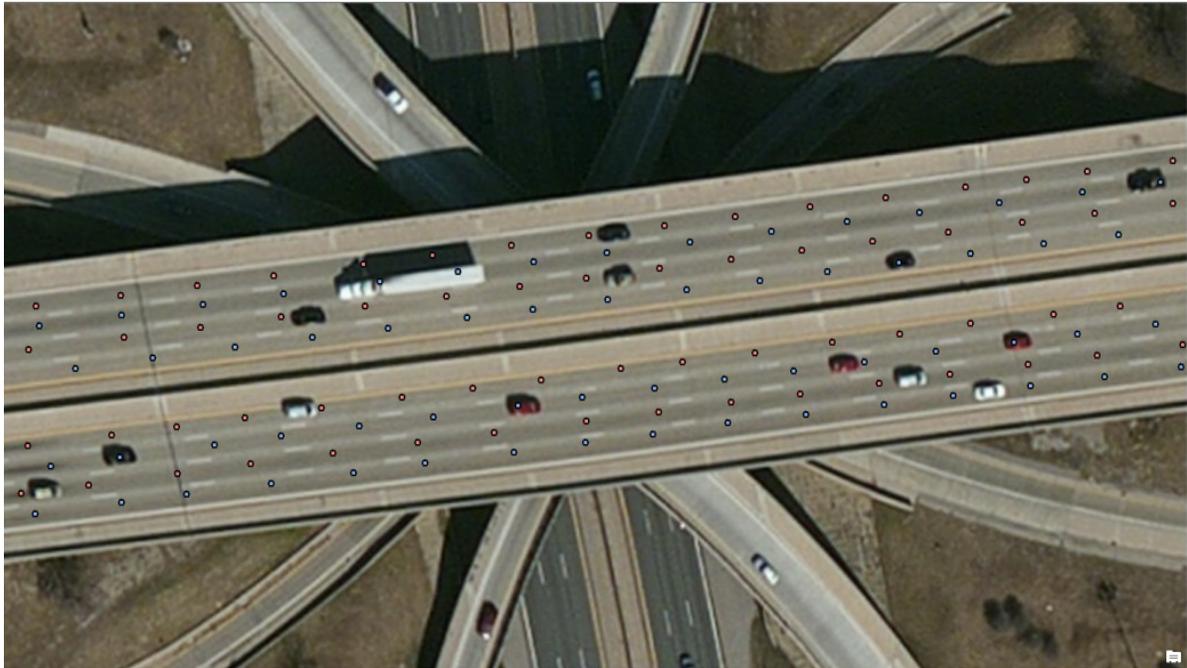
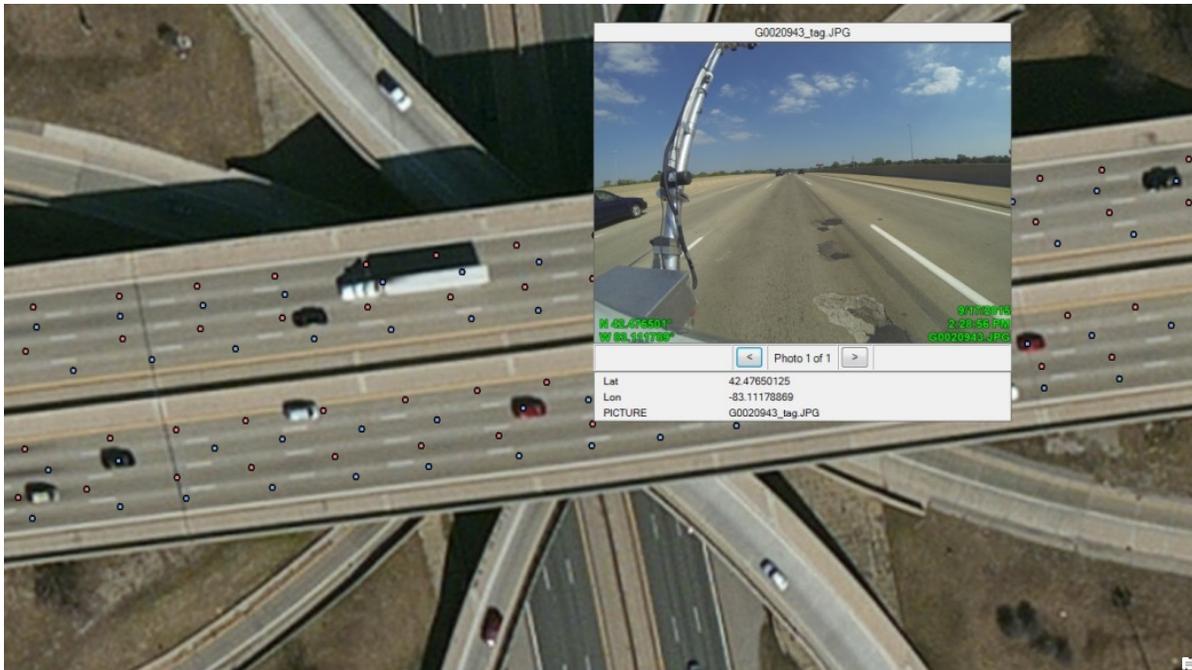
**Figure 21: A subset of the I-696 Bridge with BVRCS GPS data placed on the bridge (top) and the image showing the bridge deck section that corresponds to the GPS data point (bottom).**
