**Federal Railroad
Administration**

Locomotive Fuel Vapor Reclamation System Field Evaluation and Cost-Benefit Analysis

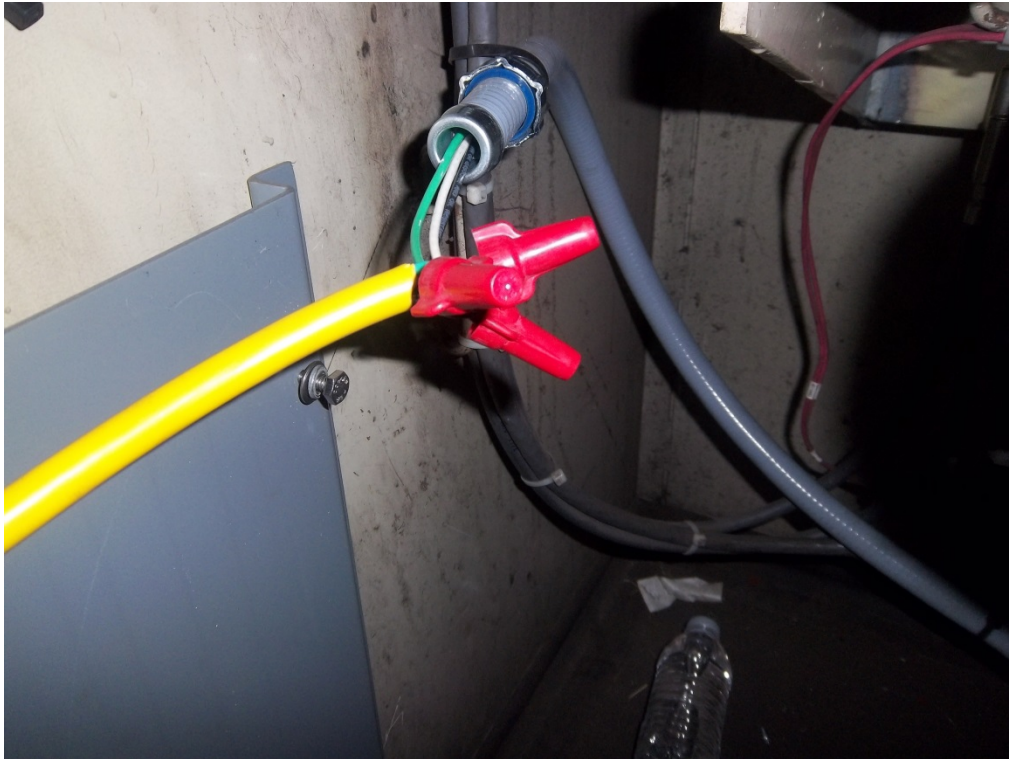
Figure 28. Power connection to the chiller from a separate source for functionality test

In the absence of a replacement inverter, a warning placard was placed on the switch board not to attempt switching 'ON', while the switches for the DVRU equipment monitoring were left 'ON', as shown in Figure 29. Prior to departing the BNSF yard at Glendive, Montana, QNA team was informed that they will be contacted again with the schedule for the replacement of the inverter.

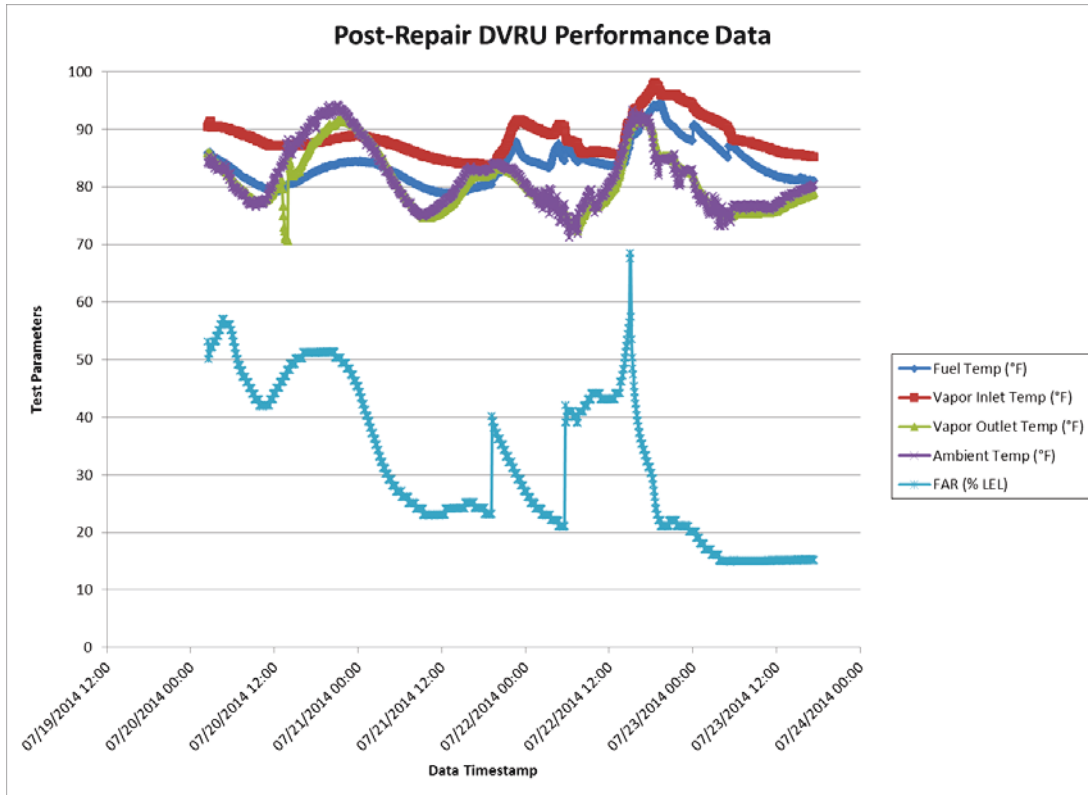
Figure 30. DVRU test parameter data following Glendive repair

The DVRU sensor output data in Figure 30 shows the variation of most parameters similar to the diurnal variation of ambient temperature, varying between 75 °F and 95 °F. Because of the shutdown of the chiller by the QNA team on July 20, the vapor outlet temperature did not drop below 70 °F, in the absence of cooling of the condenser by the circulating coolant from the chiller. The fuel temperature had minimal variations possibly due to low speed operation of the freight train hauled by BNSF9674. However, the FAR variation in this figure shows several peaks and troughs and requires some interpretation based on observed facts and possible operational scenarios. On July 20, when QNA team was present at Glendive and photographed the MSA equipment, including the vapor suction tubing, they had observed the presence of some liquid fuel in the tubing and it is possible that the ULTIMA-XIR sensor had detected above 50 percent LEL vapor passing through the inline filter initially, which later dropped close to 20 percent as the filter got stripped-off the fuel particles. Next, there were two rapid rises in the FAR curve which correspond to rise in fuel temperature from 80 °F to 95 °F, as well as ambient temperature from 72 °F to 94 °F.

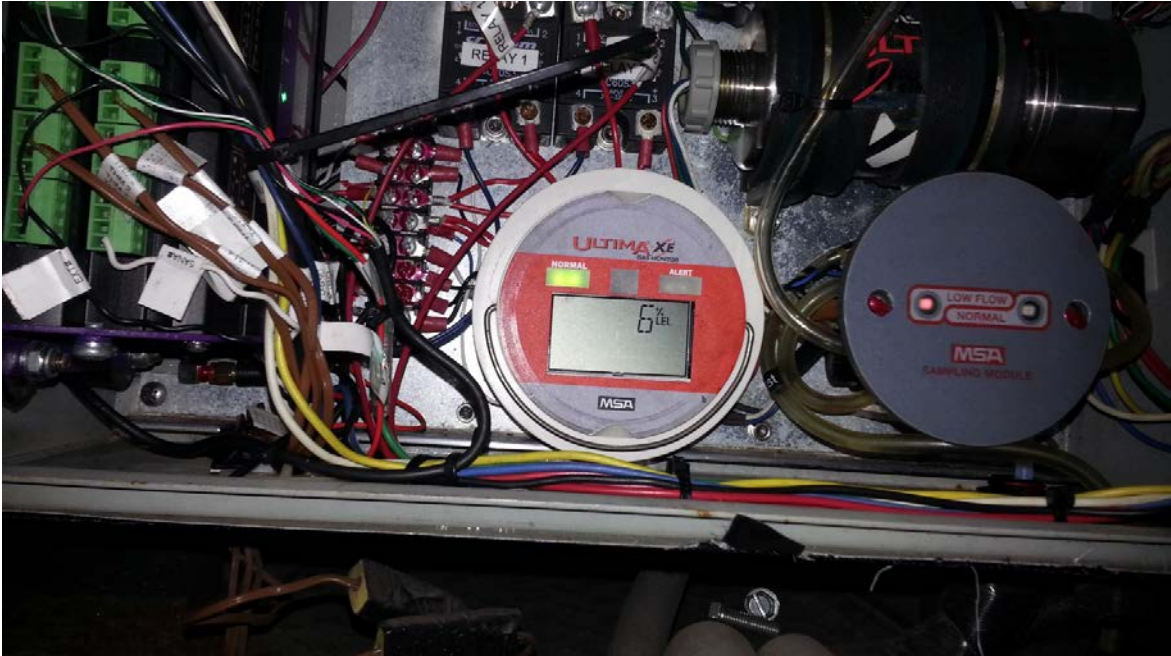
Following several interactions with BNSF management and engineering regarding the need to board BNSF9674 for the maintenance of DVRU with replacement of the burnt inverter and to investigate the reason for interruption of remote data communication, the QNA team of two engineers was permitted to do so at Glendive, Montana. Upon arrival at Glendive, the team removed the protective wrappings from the components, such as the condenser unit that was covered following the inverter breakdown during the previous visit. They found the electronics control box was powered ‘ON’, as shown in Figure 31 and manually downloaded the recorded

Figure 31. Powered ON electronics control box inside view at Glendive

Following download of the recorded data in the Data Taker, the QNA team replaced the inverter and switched on the DVRU system, which was then fully operational except the broken cellphone antenna. This could not be replaced at Glendive as the team did not have a spare and they had to rely on a manual download from the Data Taker at a later date. The QNA team carried four thermocouples for deployment within the engine room of the locomotive to monitor the fuel inlet and outlet pipe temperatures to and from the engine, as well as the engine room and ambient temperatures. The placement of thermocouples on these pipes and the 4-channel Thermocouple Data Logger used for recording the data can be seen in Figure 36.

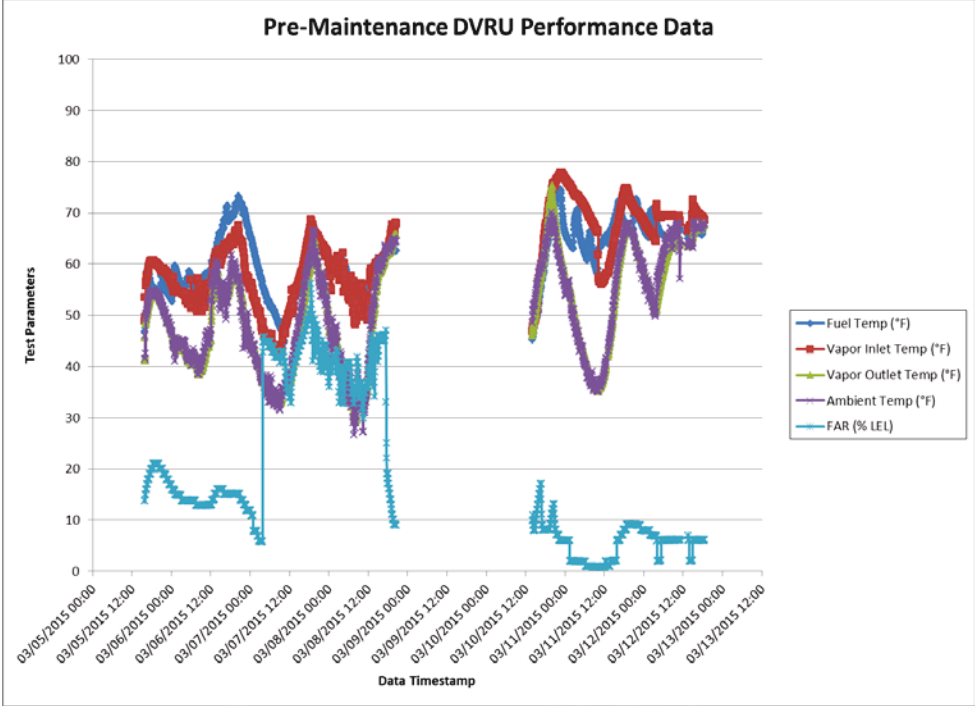
Figure 33. DVRU performance data prior to inverter replacement at Glendive

Considering that no data were transmitted or recorded in the Data Taker from July 24, 2014 until March 4, 2015, it is believed that DVRU equipment monitoring switch was turned ‘OFF’ during that period by the BNSF staff, someone switched ‘ON’ the DVRU equipment monitoring system switch over a short period in March 2015 prior to QNA team arrival for maintenance. Figure 33 shows the above data plots along with data timestamp.

It is observed from Figure 33 that the vapor inlet and outlet temperatures, as well as the fuel temperature variations with time, show nearly identical trend as that of the ambient temperature. The FAR variation data show a nominal value of around 10 to 20 percent LEL for low speed operation of the locomotive. There is a sharp rise in FAR value to about 45 percent LEL, which is accompanied by a drop in ambient temperature from 62 to 32 °F and the fuel temperature dropped from 73 to 45 °F. Since FAR magnitude normally does not rise without rise in fuel temperature, this is suggestive of a refueling of the tank including an over-fill that could force some fuel into the tubing of MSA vapor sampling pump. The tank overfill may be substantiated by the fact that the QNA team found the tank fuel gage reading close to tank full (F) mark, as shown in Figure 34; although it is common practice of the railroads not to refuel a tank above 4,500 gallons to allow vapor space and venting.

The resumed data plots to the right of Figure 33 show almost identical variation of the vapor outlet temperature with that of ambient. However, the fuel temperature and the FAR show very small variations at around 10 percent LEL, which are indicative of the locomotive’s low speed operation or idling in the yard. When the QNA team arrived at Glendive in the afternoon, they found BNSF9674 idling in the yard. They also found the electronics control box undisturbed with its additional waterproof cover intact with instructions on it. After the data download, they again shut the electronics control box and reinstalled the additional waterproof cover over it as shown in Figure 35.
